# Annual Compliance Report

Project name: Lockyer Energy Project  
EPBC Act Approval number: 2017/7994

FINAL  
28 November 2025

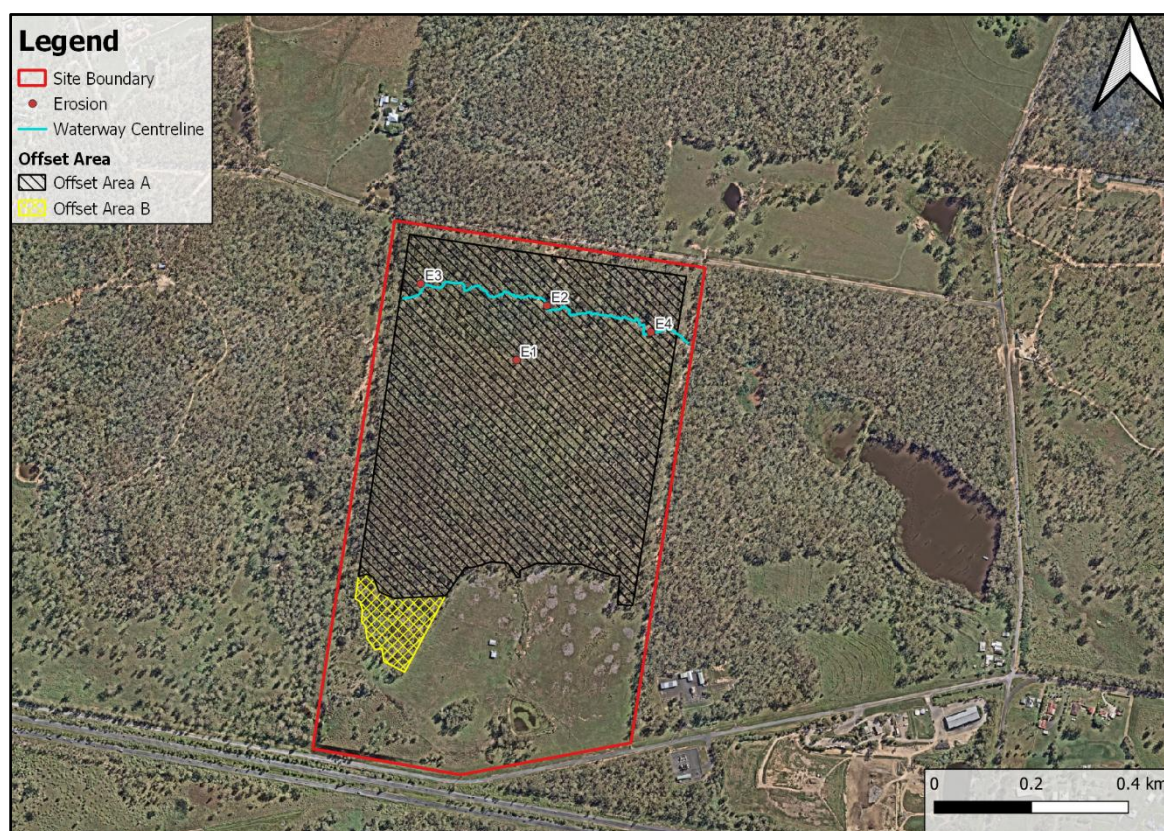
Figure 8 Areas of Erosion

Two areas of erosion denoted as E2 and E4 within the below figure, were observed to be associated with the two dams located within the Offset Area A. During the time of the survey, no water was observed within either of the dams. However, native water tolerant *Juncus sp.* was noted within and fringing the waterway (see **Plate 3**), while water tolerant canopy and sub-canopy species including soap tree (*Alphitonia excelsa*) and scattered QLD blue gums (*Eucalyptus tereticornis*) were also noted fringing the waterway banks. Dense stands of lantana (*L. camara*) were noted within the understorey adjacent to the waterway (refer to **Figure 9** below).

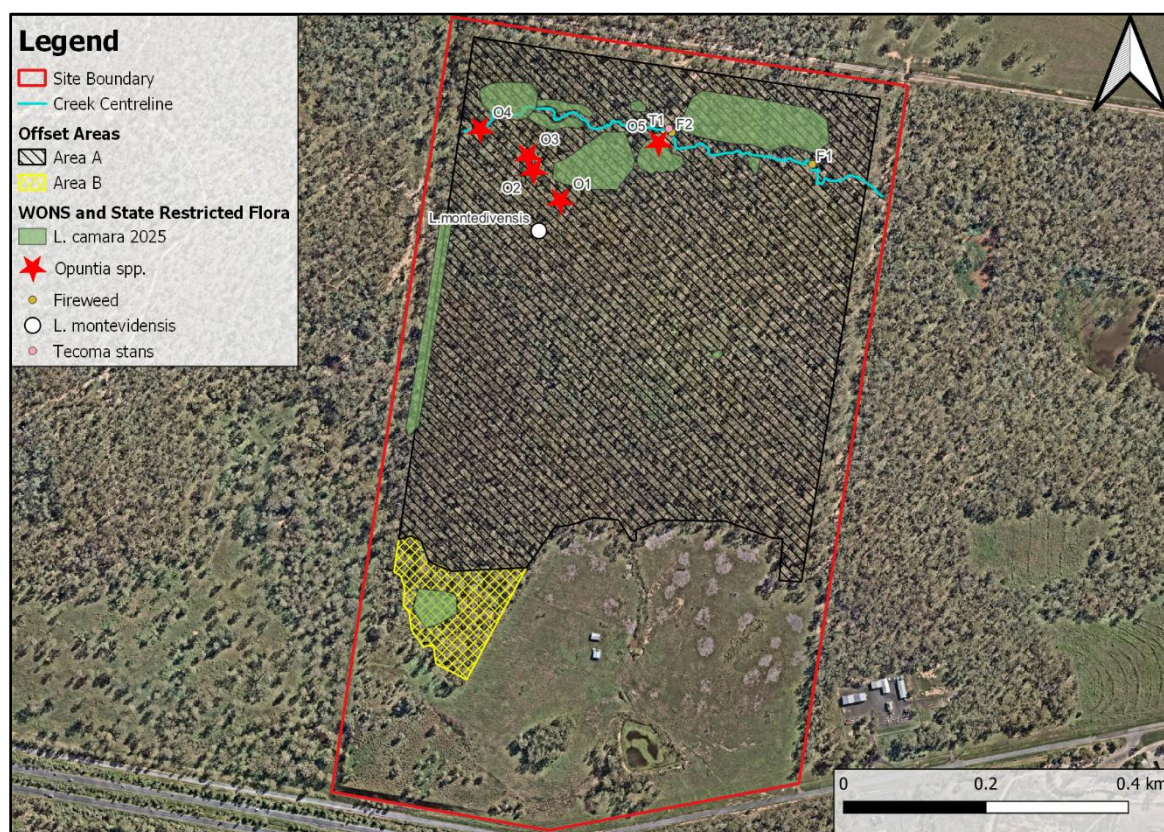
Figure 9 Location of WONS and State Restricted Flora

All species are listed as Category 3 Restricted Weeds under the Biosecurity Act. Refer to **Figure 9** for the location of patches of lantana and individual species of WONS and State listed weed species observed within the Offset. See **Table 5** for a list of weed species identified across the Offset including non-restricted pest flora species. Refer to **Appendix D** for associated photos (ie. north, east, south, west and ground layer) for significant weed species identified and **Appendix E** for a list of all flora species identified during the field surveys.

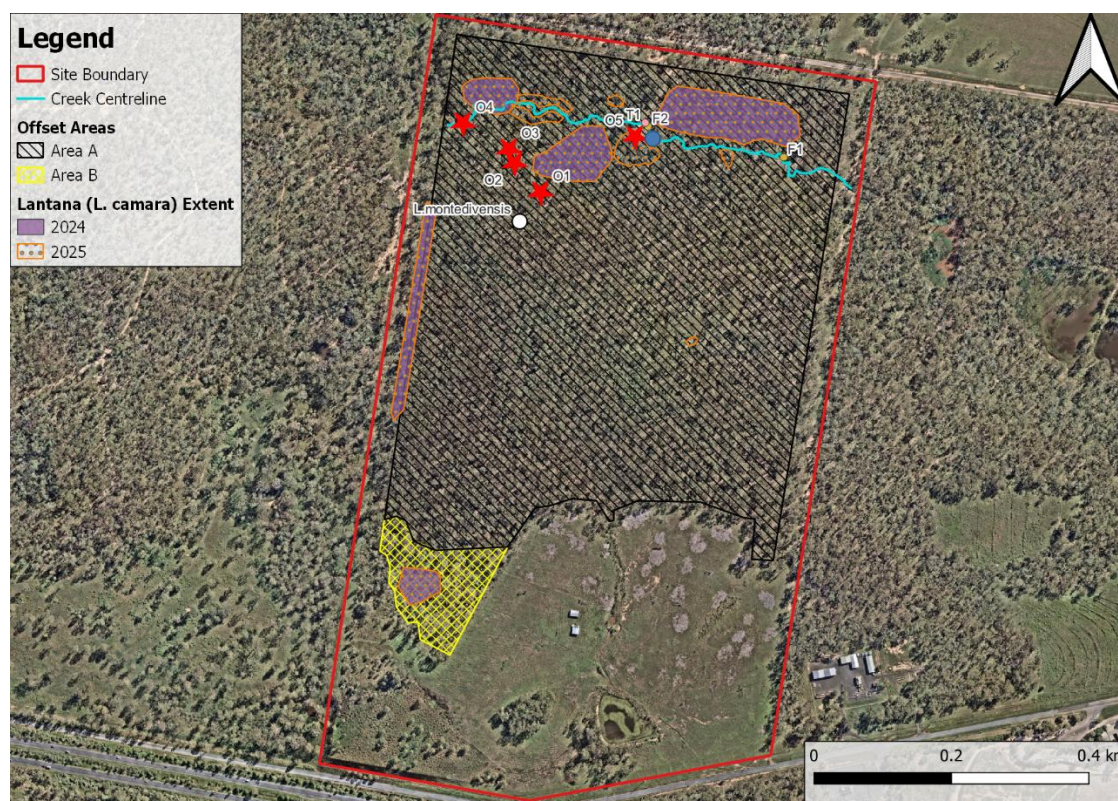
**Figure 12 Lantana (*L. camara*) Extent Across 2024 and 2025 Surveys**

**Figure 12** below illustrates the extent of lantana mapped in 2024 compared with the extent recorded in the current assessment. This expansion suggests that weed incursion is exceeding the rate of weed control currently implemented within the Offset. Weed control should be prioritised to ensure habitat quality within AU1 does not further decline in value.

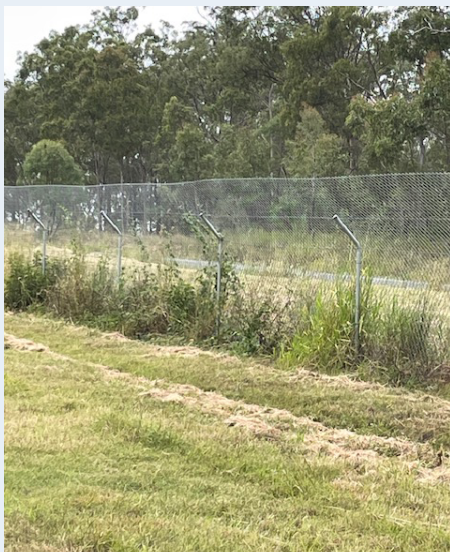
- a. The koala exclusion fence along the southern boundary of the lot is in good condition and woody weed/grass growth along the fence was successfully treated in September 2024. See before and after photographs below:

Fence before weed treatment  
(September 2024)

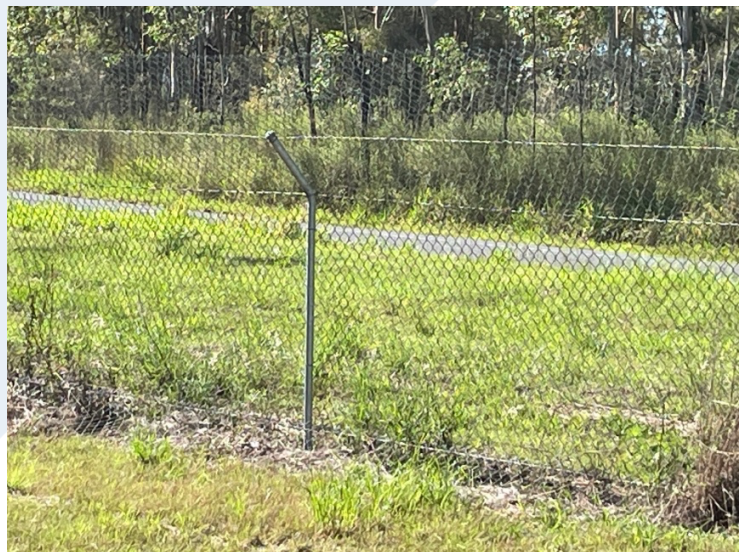
Fence after weed treatment (17 March 2025)

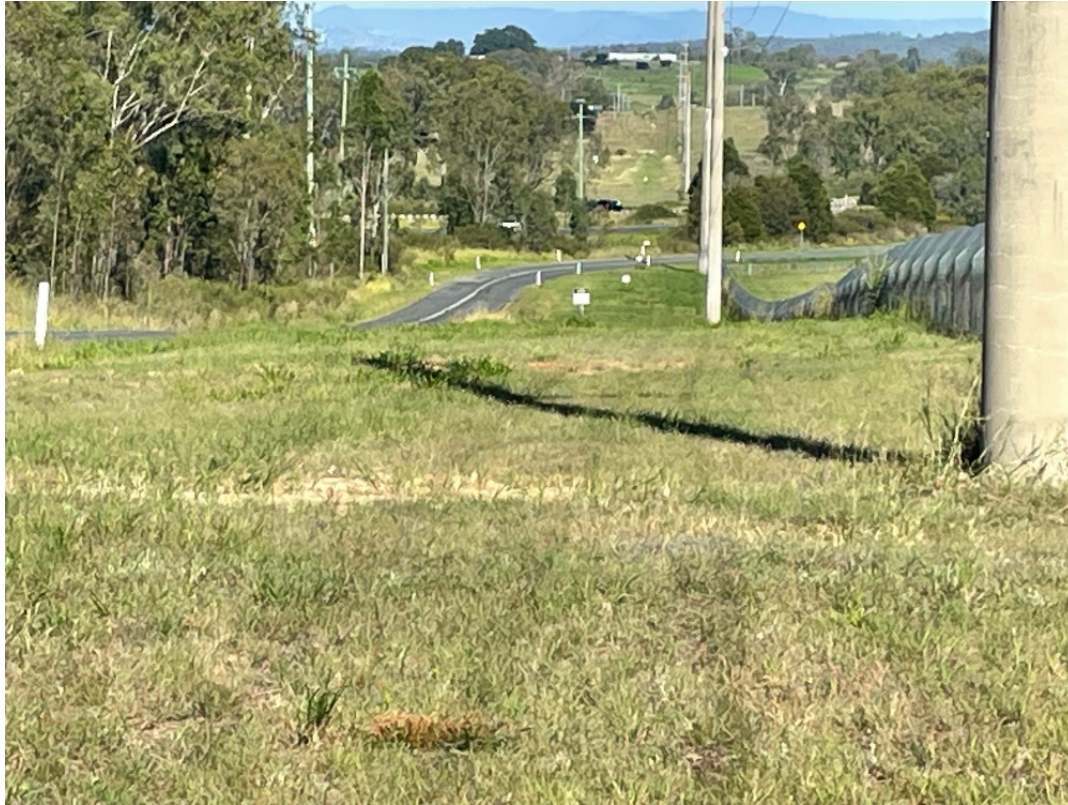
- b. The whole length of the “footpath” (i.e. the land between Ford’s Road and the front “koala-proof” fence, was mowed by Horrigan Slashing over several days ending on 4 March 2025 (immediately before the arrival of Cyclone Alfred) and is in good condition. The western end of this strip is now under water. See photograph below:

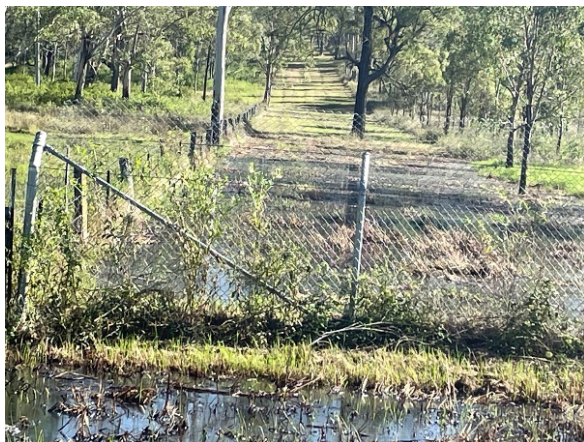
- c. The property accommodates a buried high-pressure gas pipeline, and the pipeline operator controls a 10 m wide (as opposed to the requirement in the EPBC Approval for a minimum of three metre wide) strip of mown grass (immediately inside and adjacent to the koala exclusion fence) with no woody weeds or trees. Coincidentally, the pipeline easement abuts the southern boundary of the lot. All of this 10m wide strip was also mowed by Horrigan Slashing and is in good condition. The last 200m on the western end is now covered by about 250mm of water due to the recent cyclone.

Standing water inside and outside front fence on south west corner of property

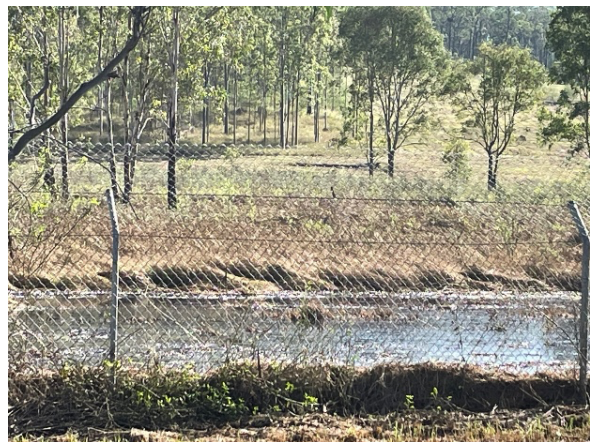
Standing water on pipeline easement within property – taken from Ford’s Road

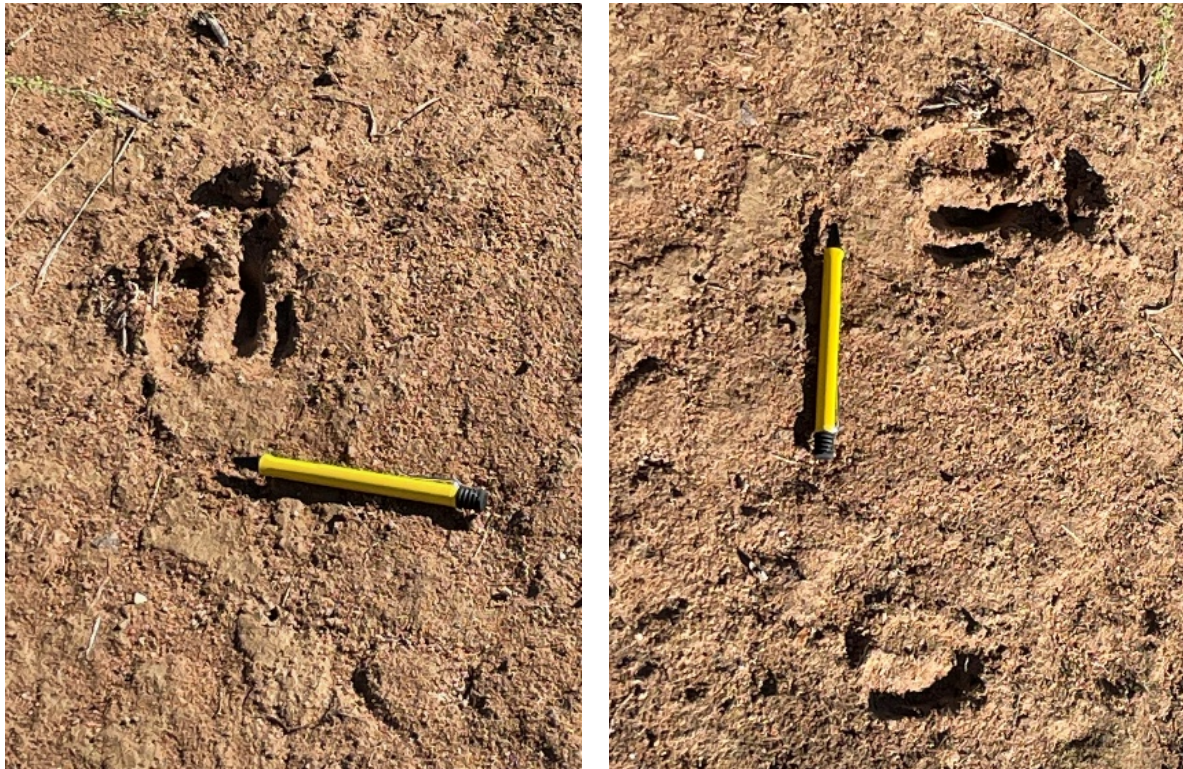
Evidence of recent (within the previous 24 hours) activity by Red Deer (*Cervus elaphus*) was located on the banks of the same dam. It suggests that at least two individuals watered at the dam. See photographs below:

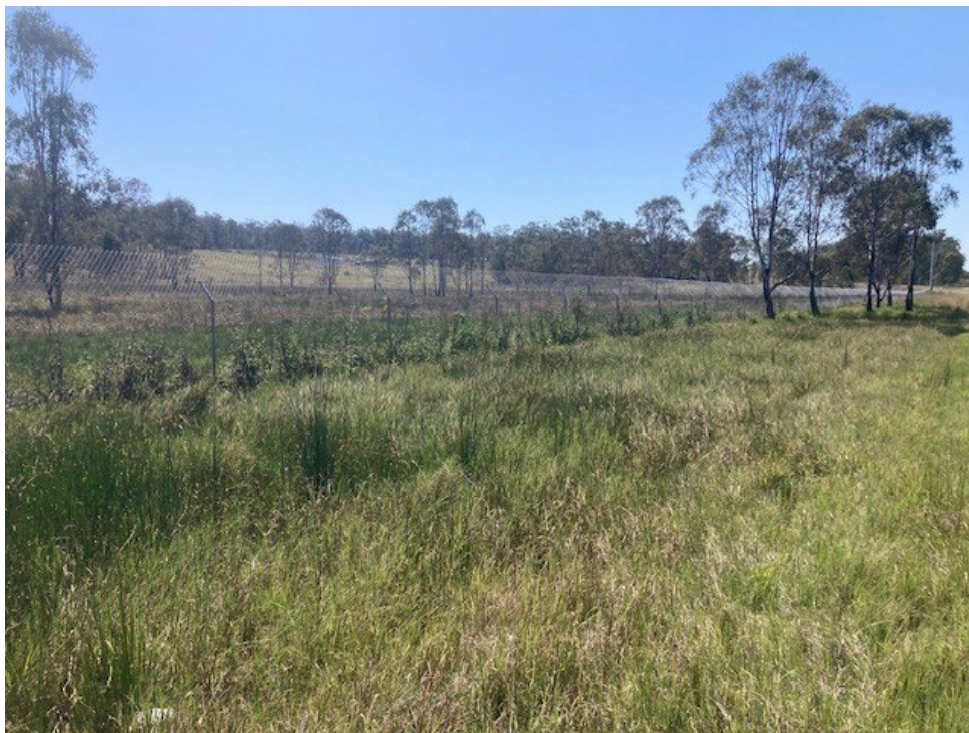
- a. The koala exclusion fence along the southern boundary of the lot is in good condition. Grass and weeds are growing within the fence wire, in the low-lying wet area in the southwest corner of the lot. Stanwell will engage our land management contractor to spray these weeds if access is available.

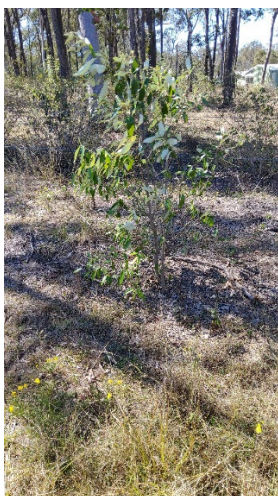
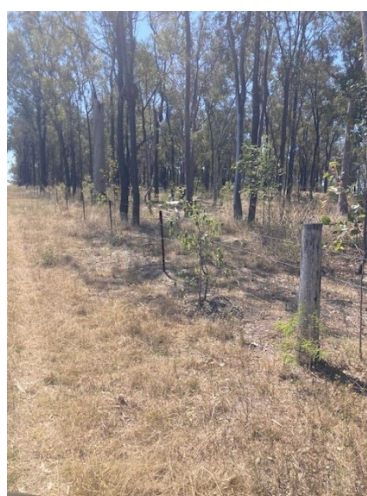
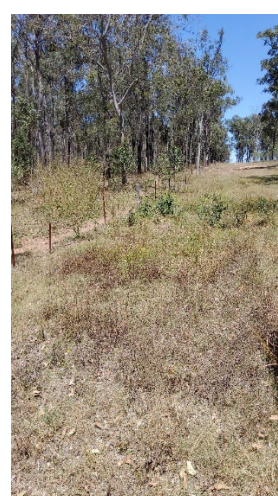
- e. A small number of regrowth trees were identified along the eastern boundary fence alignment. These will be slashed as part of the fire access track maintenance by Horrigan Slashing in mid-October.

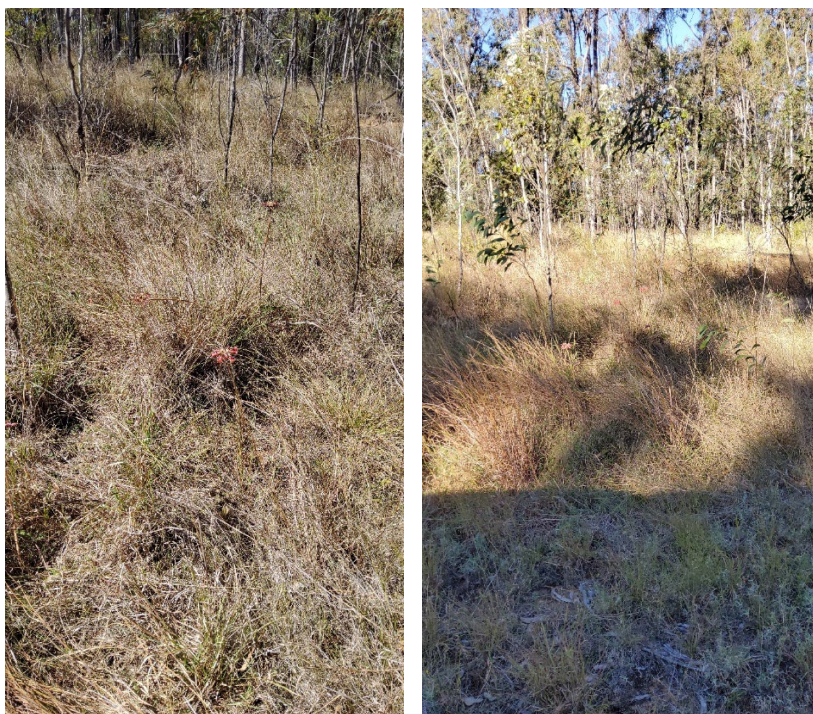
Additional environmental weeds identified during the site inspection included Mother of Millions (*Bryophyllum*) – a singular plant was identified on the neighbouring property, in the dry creek crossing. This area will need to be monitored. Additional Mother of Millions plants were identified on the western side of Offset Area A. The land management contractor will be engaged to spray the Mother of Millions in the overall spraying works for the site.

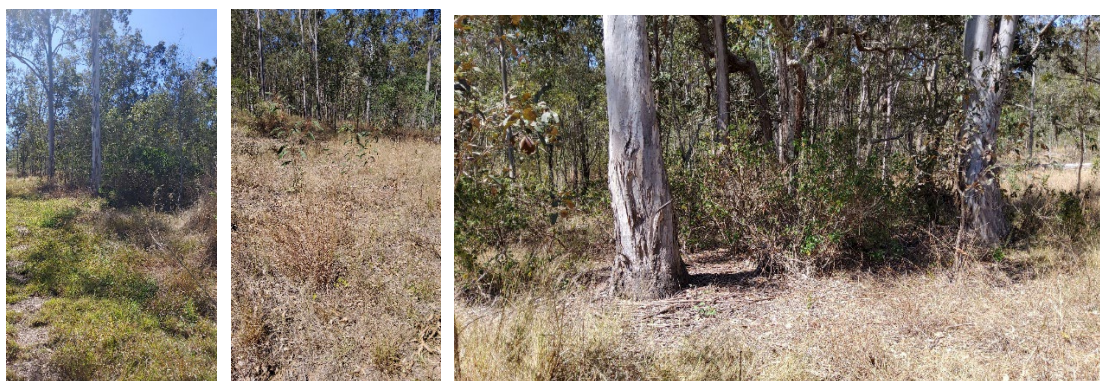
Lantana (*Lantana camara*) – The western edge of both Offset Area A & B are infested with Lantana. The late season cyclone (April) has increased the growth of the lantana; however, the prevailing hot dry weather has made conditions unfavourable for spraying of the lantana. The land management contractor will be engaged to treat the lantana in these areas and as identified in the Flora survey assessment when conditions improve for that works.
