## Interim Validation Letter (LTR01) – Proposed Lot 1, Lot 3 and Part Roads

Westlink Stage 1 – Aldington Road and Abbotts Road, Kemps Creek, NSW, 2178

Prepared for: ESR Australia

EP3244.005\_VAL\_LTR01\_ESR\_Westlink Stage 1\_v2 | 27 May 2024

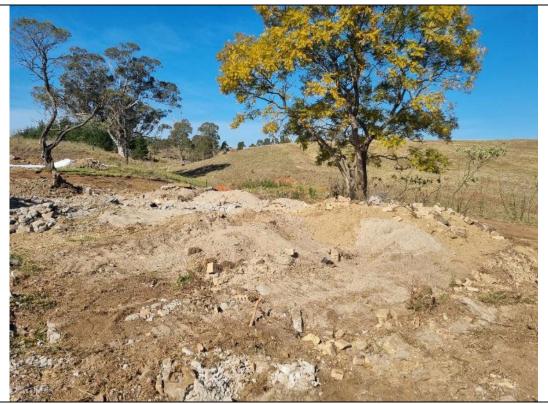
**Plate 3** – 03/08/2023

Field screening of residual rake footprint in AEC15 following in-situ mechanical raking and emu picking of bonded (non-friable) ACM fragments.

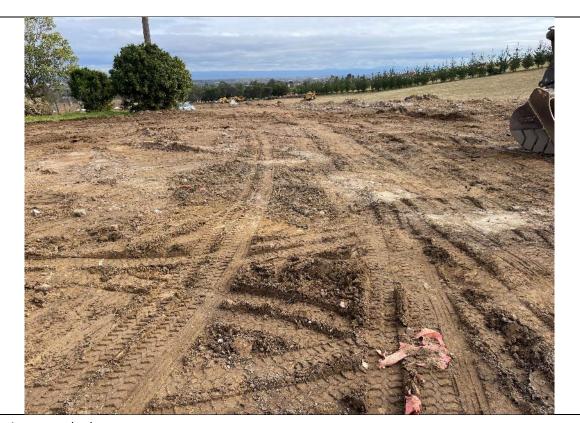
Plate 4 - 04/08/2023

Material from the former house footprint in AEC15 observed to be contaminated with a large quantity of ACM fragments and building and demolition waste. This material was excavated to approximately 0.1-0.2 mBGL and transported to the stockpile pad as B3 material requiring ex-situ treatment.

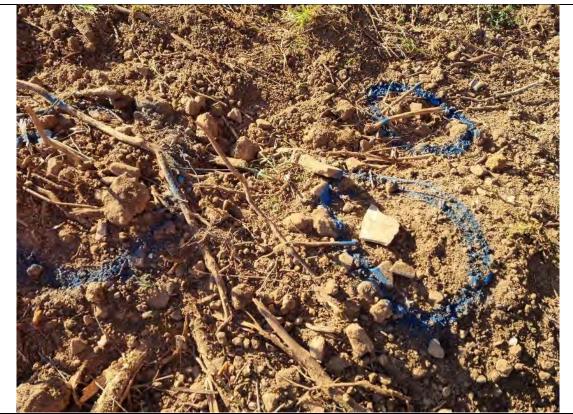
Plate 2-11/07/2023UF001 prior to remediation works; ACM fragments in poor condition identified adjacent to site entry gate.

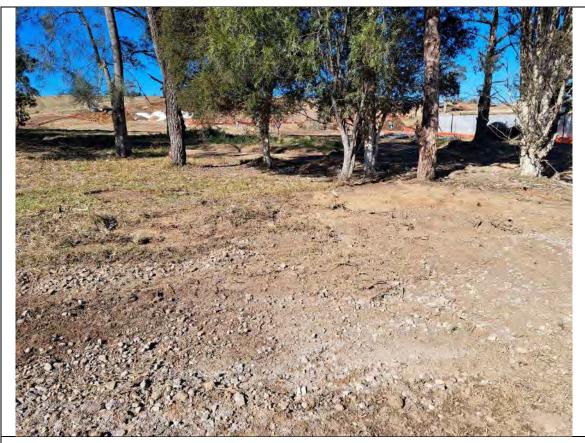
Plate 3-31/07/2023 UF001 subsequent to excavation of surficial soils as F3 material.

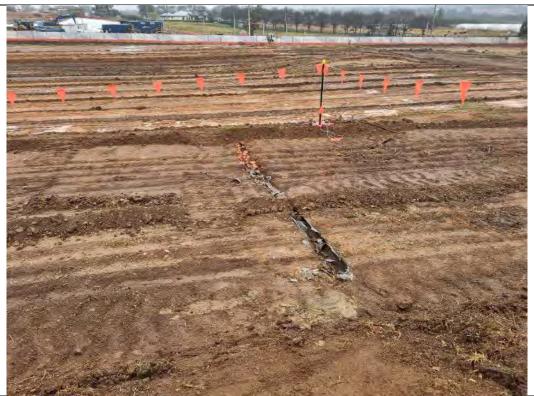
UF024	3x AC conduits identified within central batter of AEC38, east of UF015 during JKW earthworks. The 2 westernmost conduits were damaged by the JKW scrapers, with broken conduit fragments spread across the surface of the UF area. The easternmost conduit was undamaged. The length and direction of AC conduit was unknown but suspected to be similar to UF015.  The 2 westernmost conduits, soil within 1 m either side of the conduits were to a depth of 0.3 mBGS, soil across the UF extent up to a depth of 0.1 mBGS were deemed by EP Risk as friable asbestos (F3 material). The easternmost AC conduit, if removed in good condition was deemed by EP Risk as Special Waste.	Soil and 2x western most conduits excavated as F3 material for stockpiling at the central (southern) treatment and stockpiling pad.  Easternmost AC conduit removed and disposed off-site to a licensed landfill facility able to accesspecial Waste (Asbestos).

Plate 2 – 14/08/2023
UF024 (westernmost damaged conduit within AEC38 Lower) prior to remediation works.

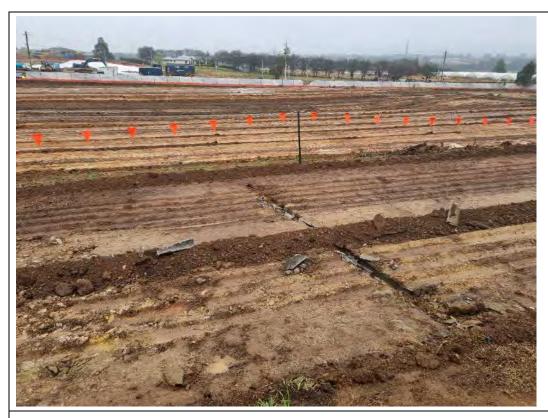
Plate 3 – 14/08/2023
UF024 (central damaged conduit within AEC38 Lower) prior to remediation works.

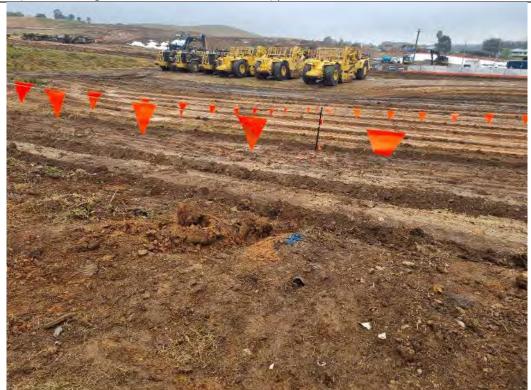
Plate 4 – 14/08/2023
UF024 (eastern undamaged conduit within AEC38 Lower) prior to remediation works.
