DILAPIDATION REPORT

Mamre Road, Kemps Creek

This report is intended to be a record of the council assets at Mamre Road, Kemps Creek at the time of the inspection.

The inspection was carried out on 19 April 2023.

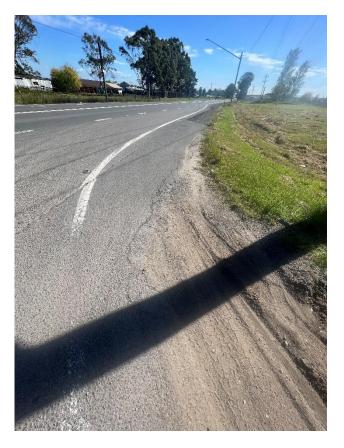
Figure 1 – Crack propagation to the road.

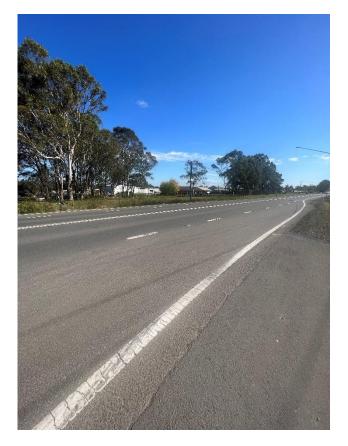
Figure 3 – Crack propagation to the road.

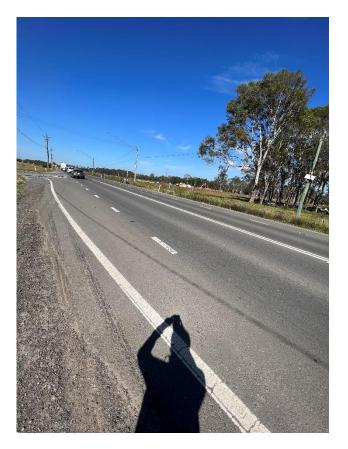
Figure 5 – Crack propagation to the road.

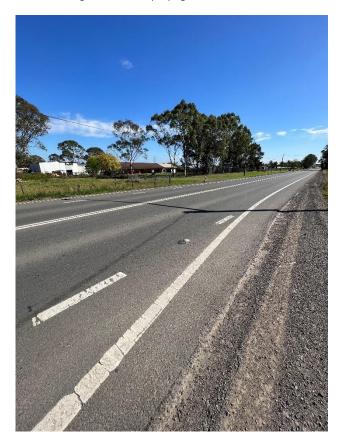
Figure 6 – Crack propagation to the road.

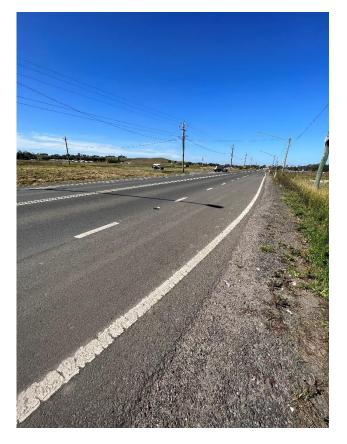
Figure 35 – General condition of the road.

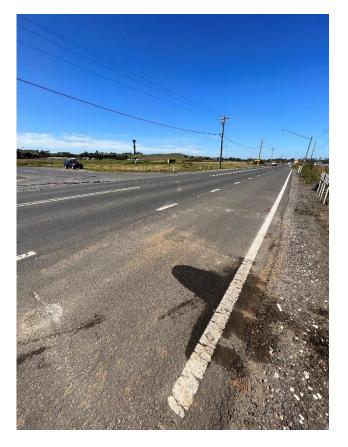
Figure 41 – Crack propagation to the road.

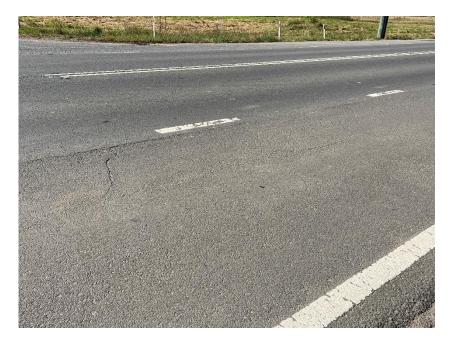
Figure 45 – Crack propagation to the road.

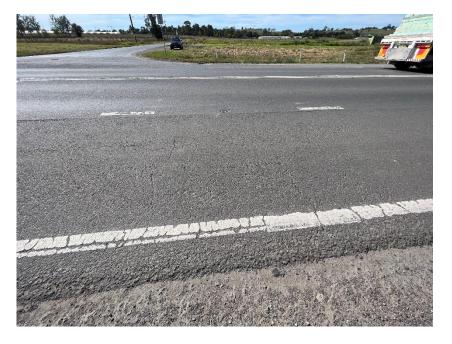
Figure 48 – Crack propagation to the road.

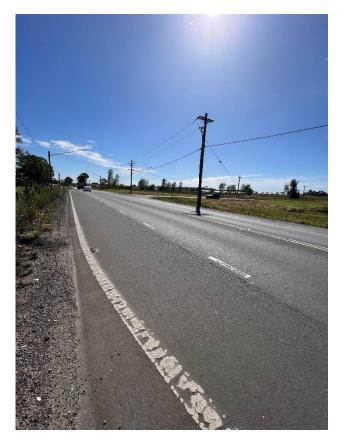
Figure 51 – Crack propagation to the road.

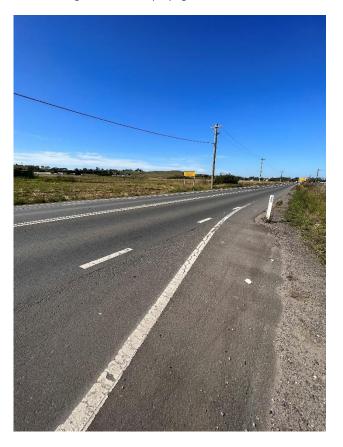
Figure 52 – Crack propagation to the road.

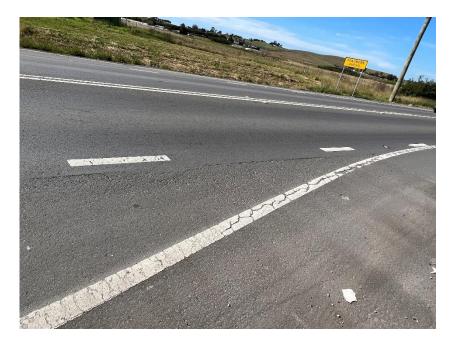
Figure 53 – Crack propagation to the road.

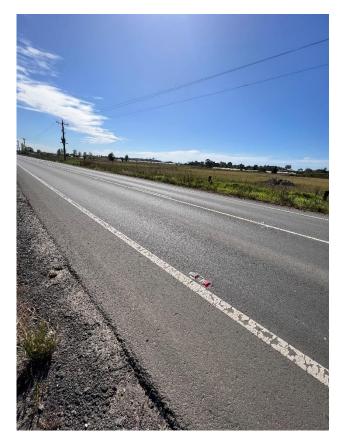
Figure 92 – Crack propagation to the road.

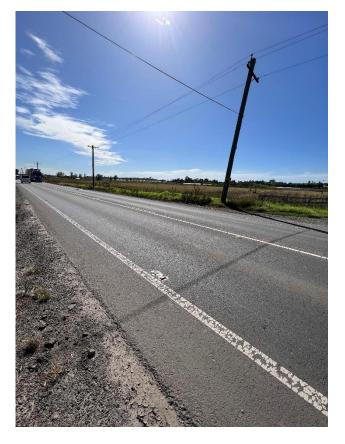
Figure 103 – Crack propagation to the road.
