# **DILAPIDATION REPORT**

**Addington Road, Kemps Creek**

This report is intended to be a record of the council assets at Addington Road, Kemps Creek at the time of the inspection.

The inspection was carried out on 18 April 2023.

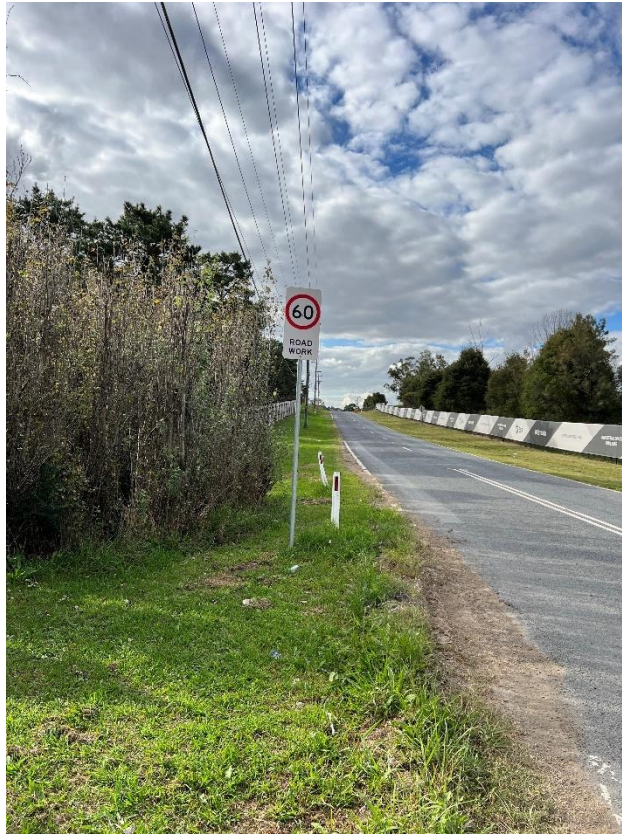
*Figure 1 – General condition of the nature strip/street signpost.*

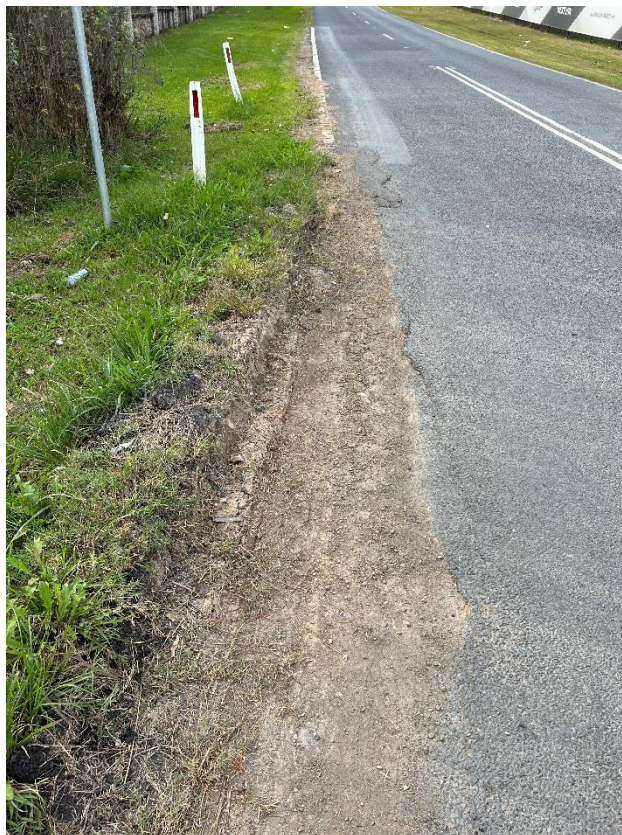
*Figure 2 – Crack propagation to the road.*

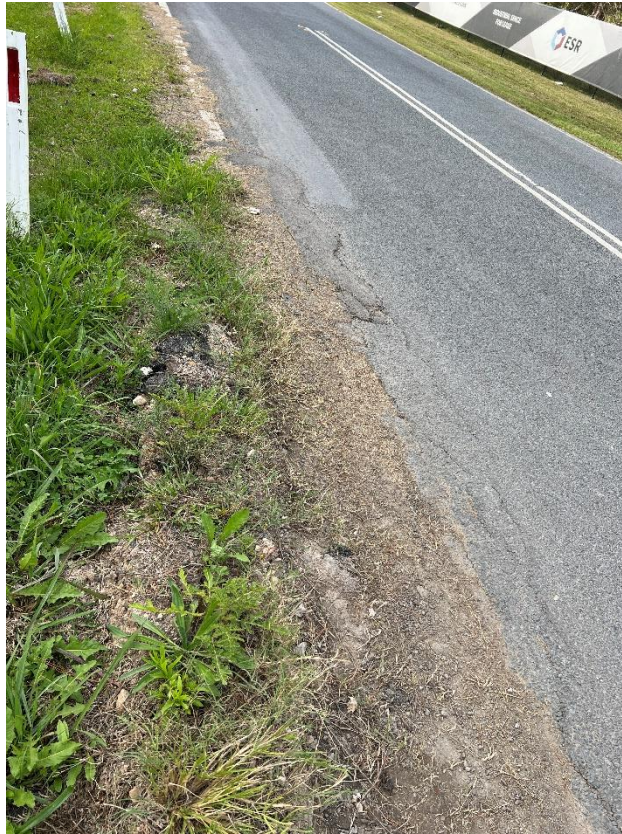
*Figure 3 – Crack propagation to the road.*

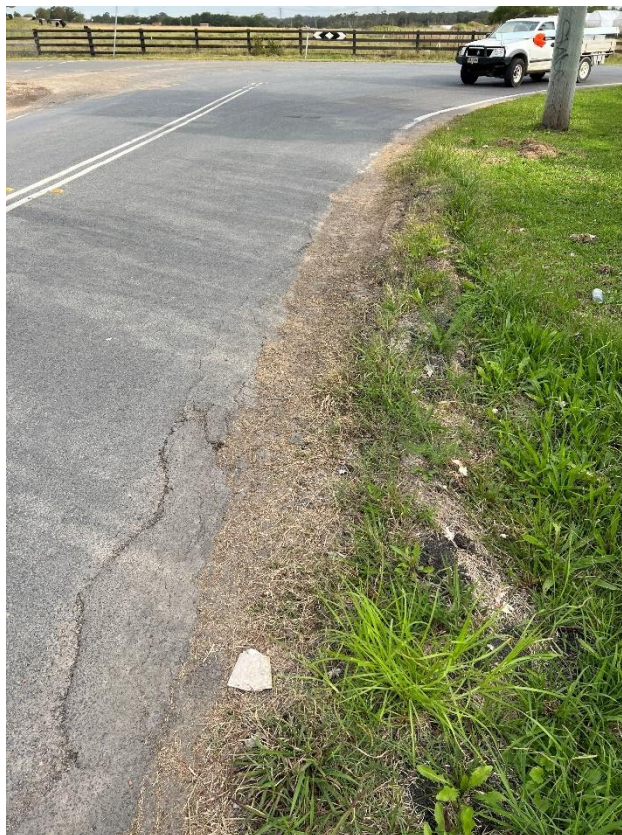
*Figure 4 – Crack propagation to the road.*

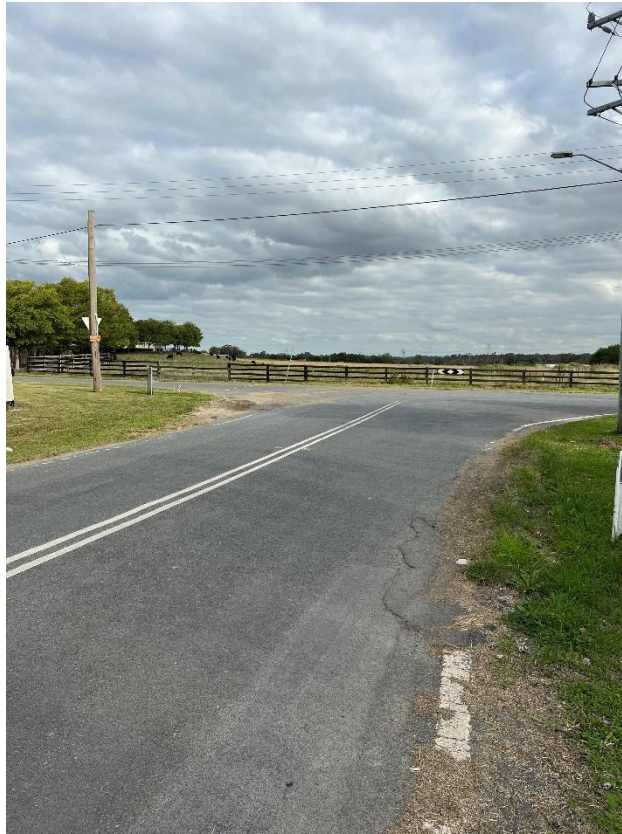
*Figure 5 – Crack propagation to the road.*

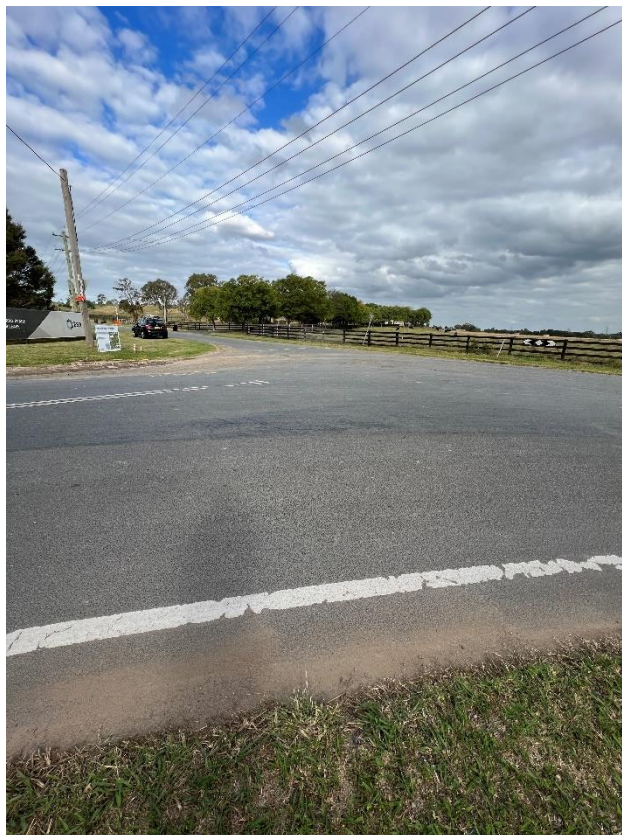
*Figure 6 – Crack propagation to the road.*

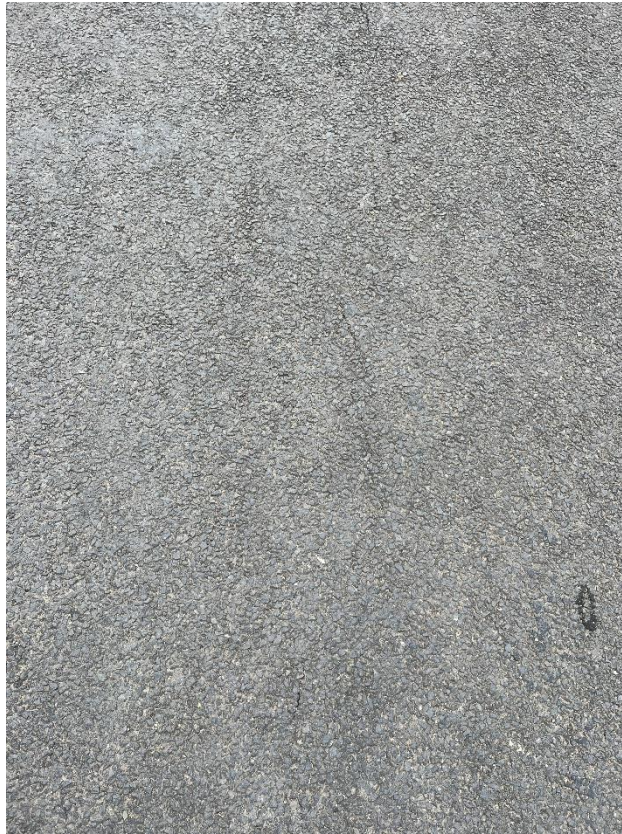
*Figure 15 – Crack propagation to the road.*

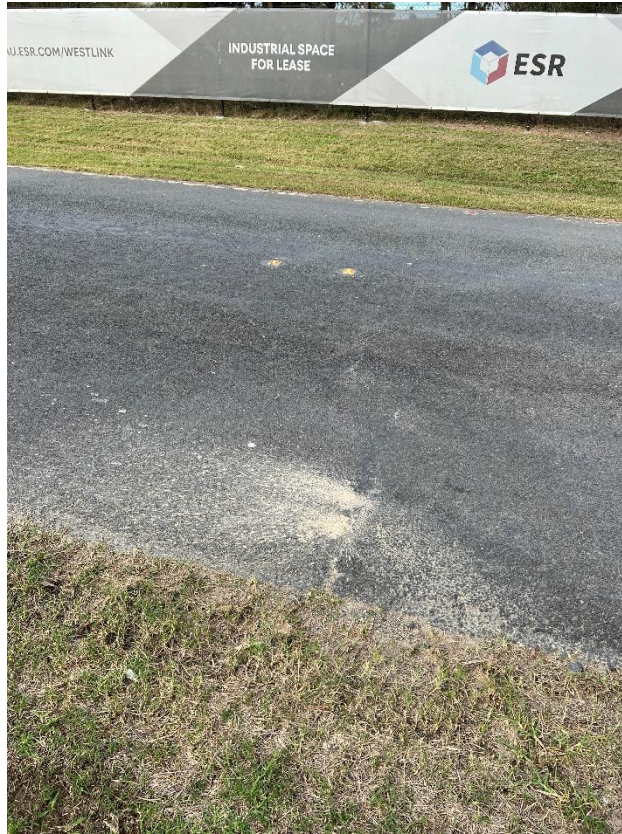
*Figure 17 – Crack propagation to the road.*

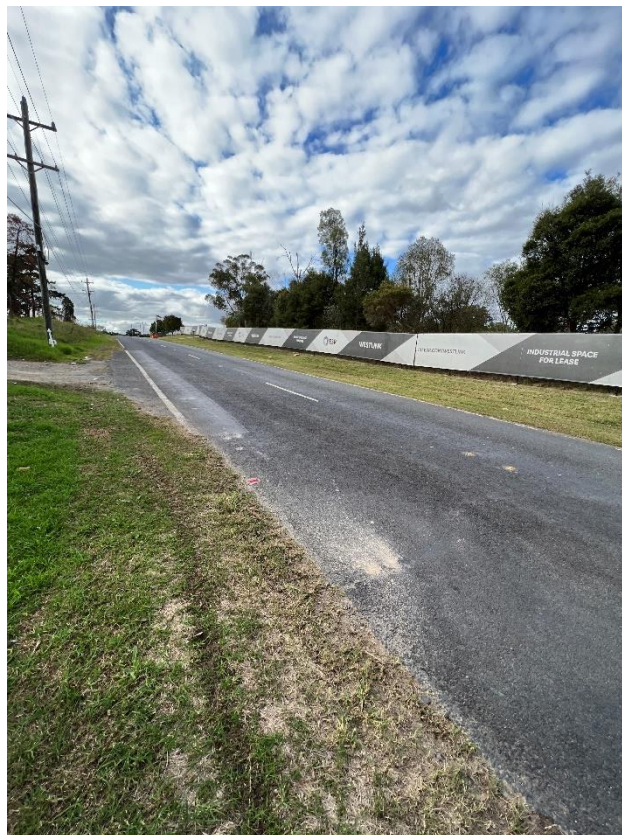
*Figure 18 – Crack propagation to the road.*

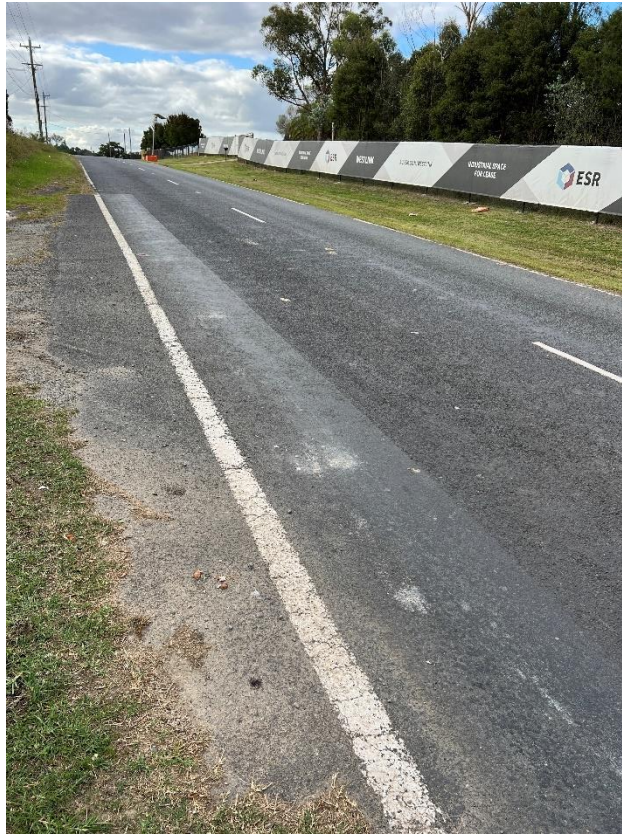
*Figure 19 – Crack propagation to the road.*

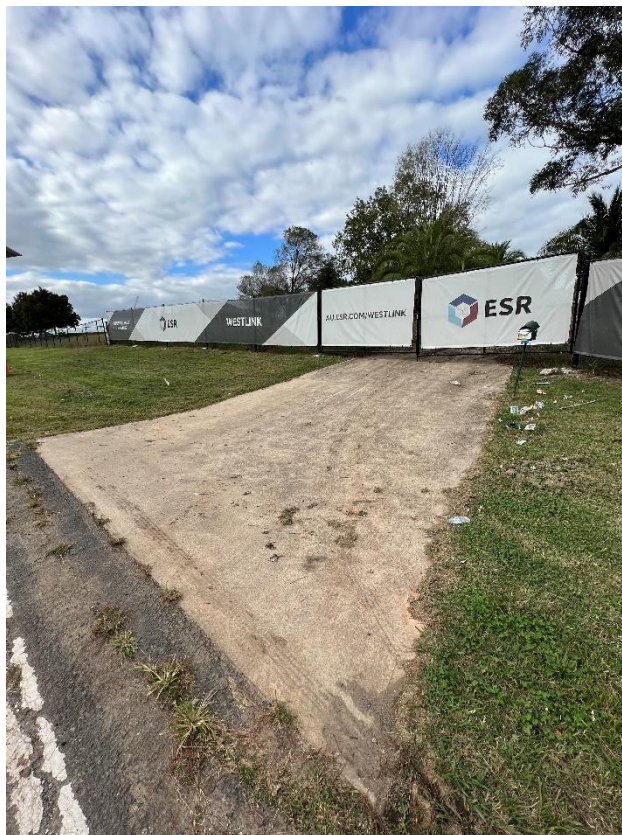
*Figure 24 – Crack propagation to the driveway.*

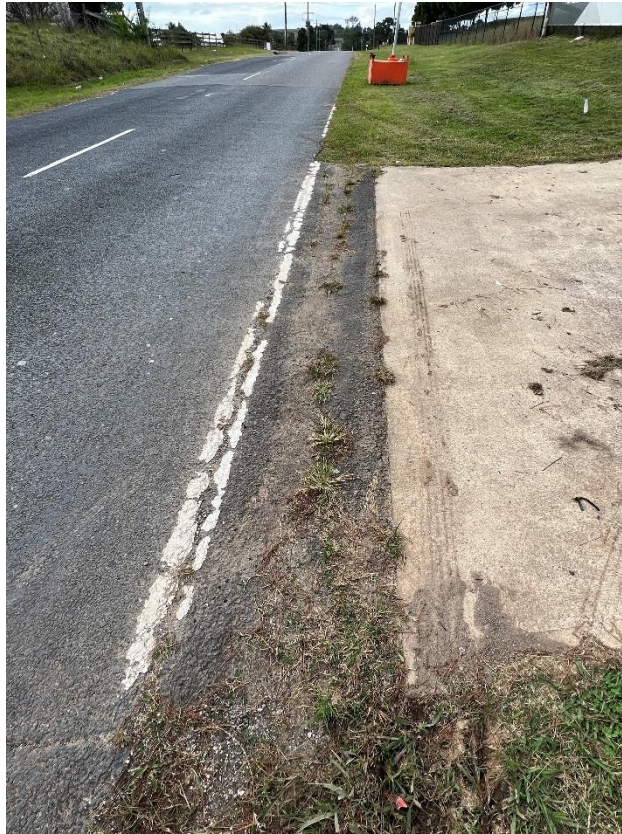
*Figure 25 – Crack propagation to the road/driveway.*

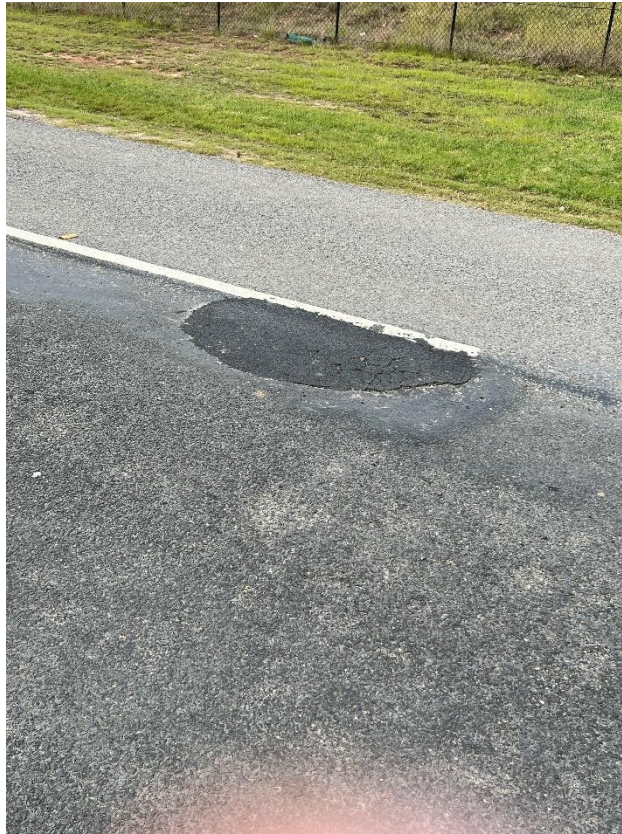
*Figure 29 – Crack propagation to the road.*

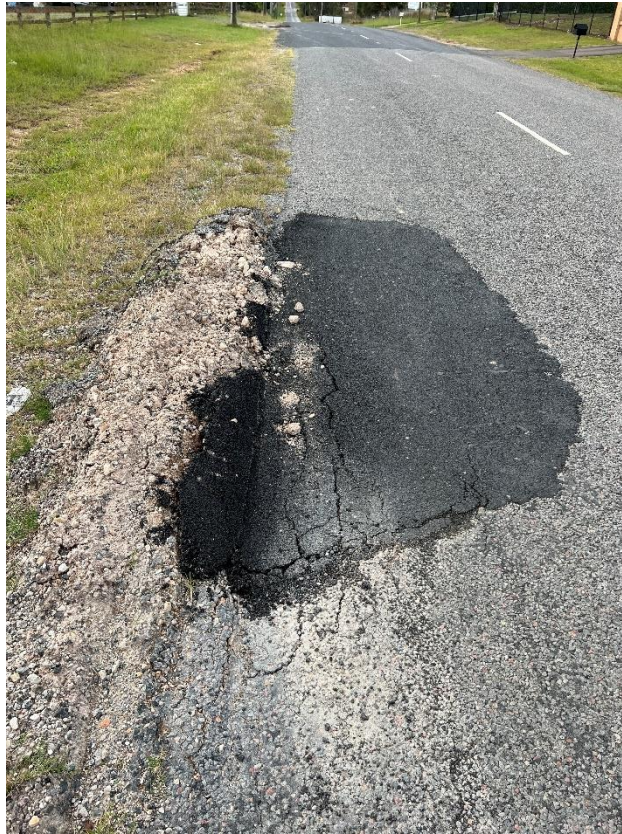
*Figure 33 – Crack propagation to the road.*

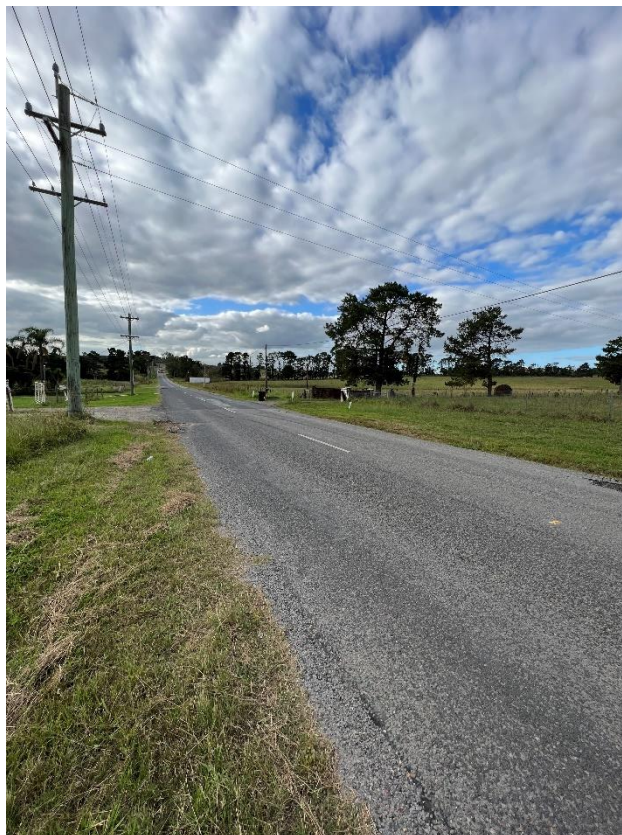
*Figure 48 – Crack propagation to the road.*

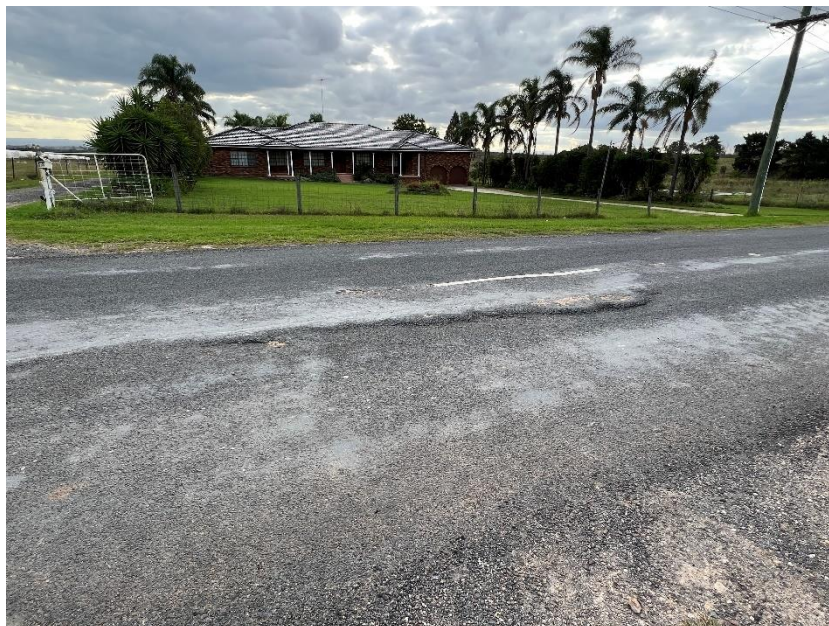
*Figure 54 – Crack propagation to the road.*

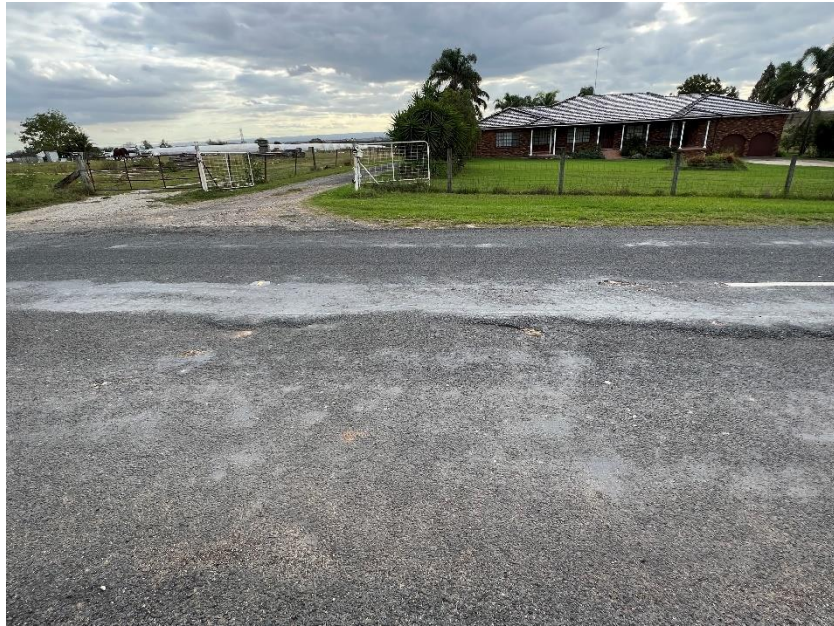
*Figure 55 – Crack propagation to the road.*

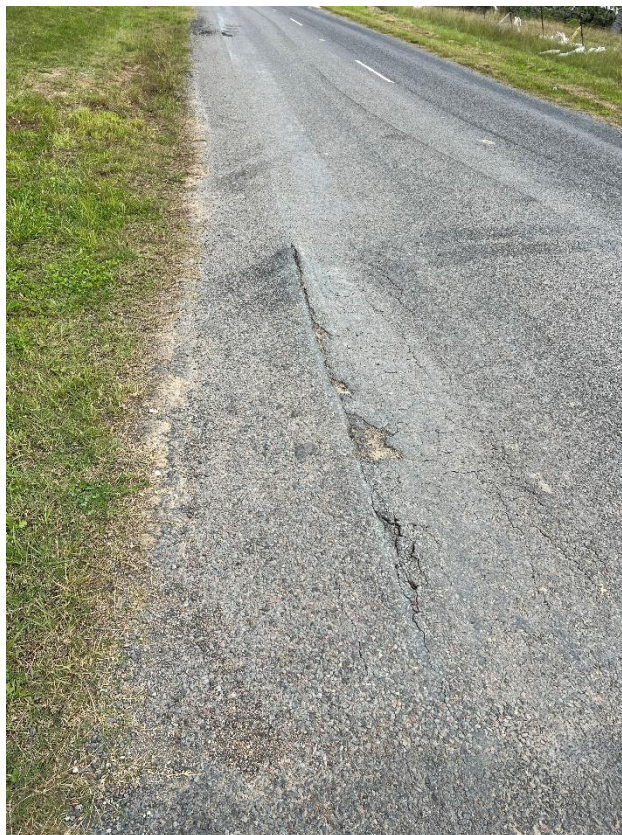
*Figure 58 – Crack propagation to the road.*

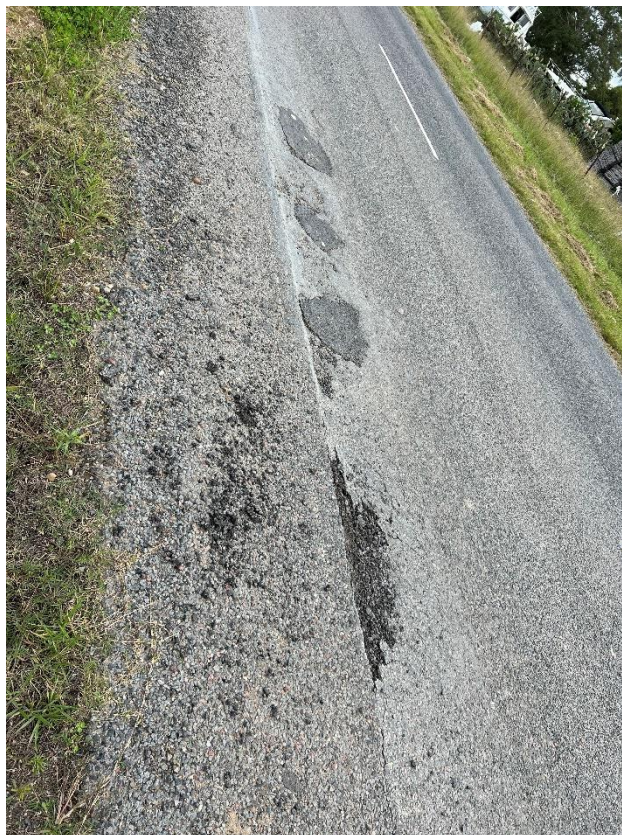
*Figure 62 – Crack propagation to the road.*

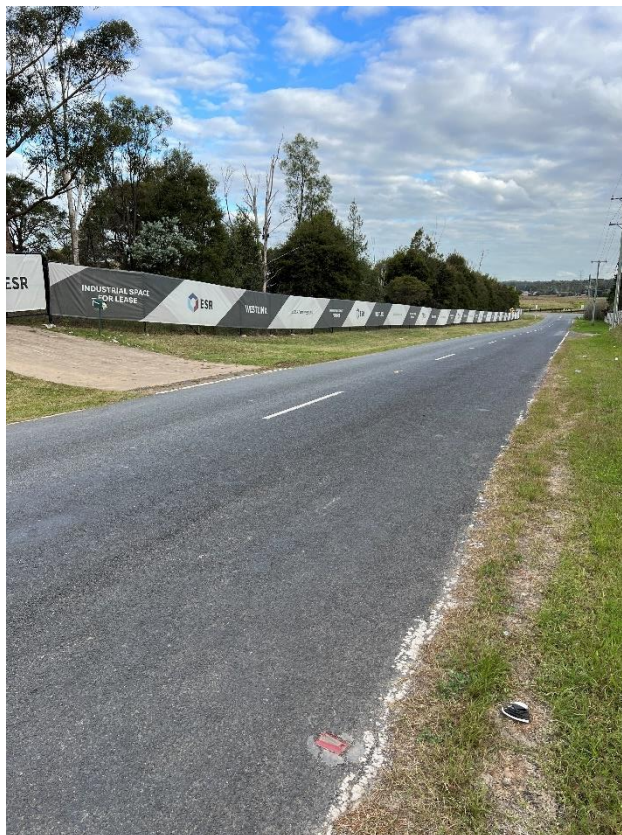
*Figure 82 – Crack propagation to the road.*

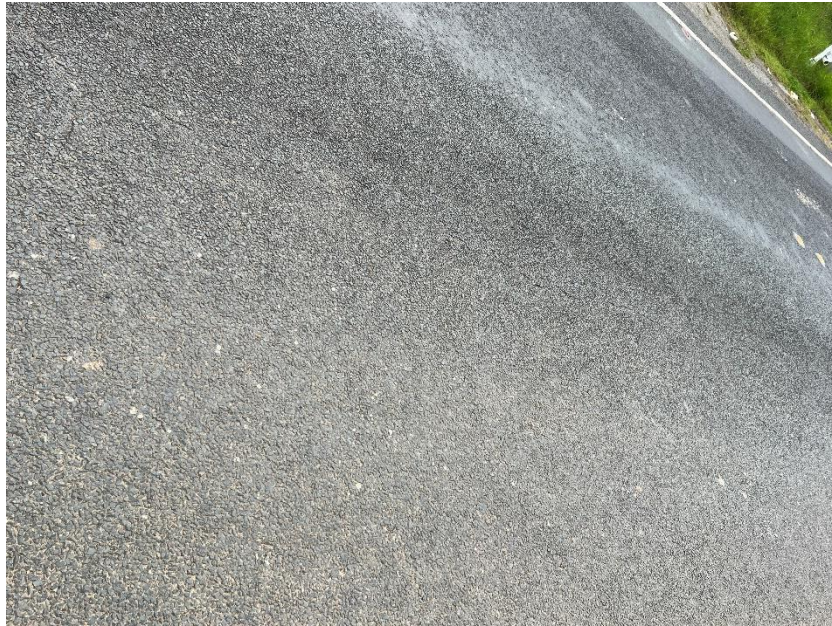
*Figure 85 – Crack propagation to the road.*

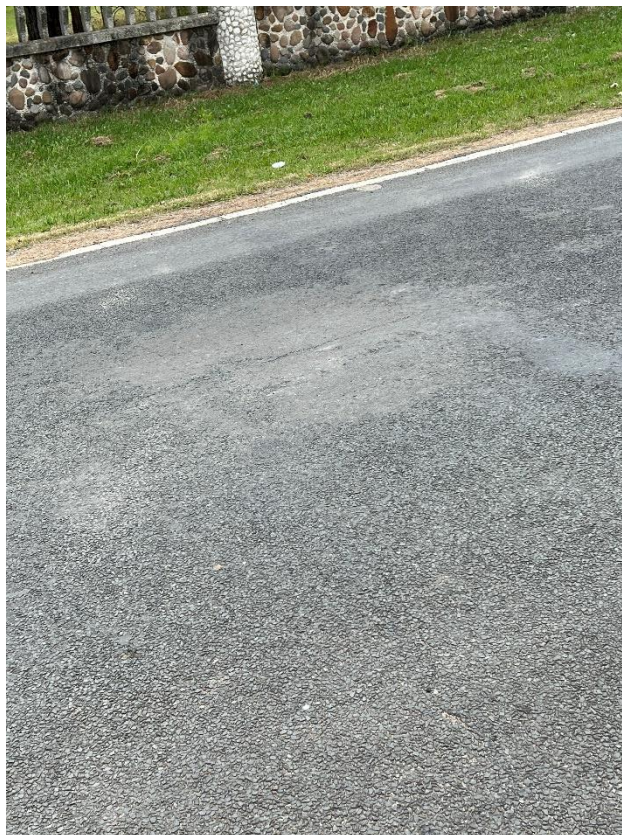
*Figure 92 – Crack propagation to the road.*
