DILAPIDATION REPORT

Abbotts Road, Kemps Creek

Prepared by: Rezoning Pty Ltd t/as Effective Building & Consultancy

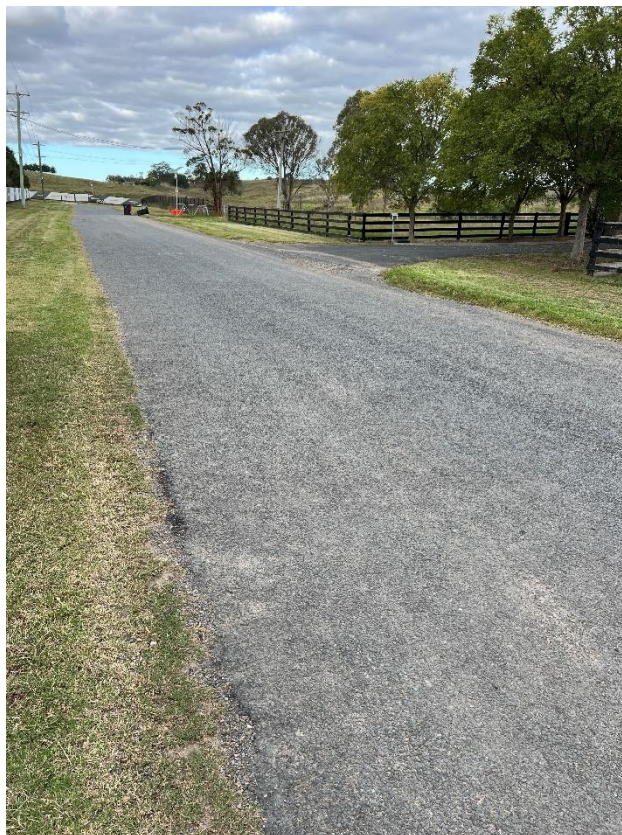
Figure 2 – General condition of the road.

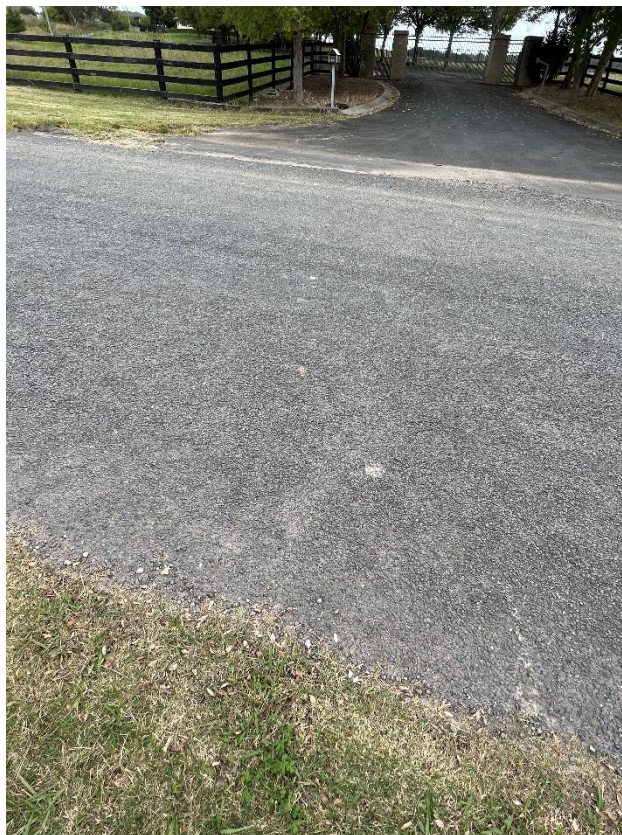
Figure 4 – General condition of the road.

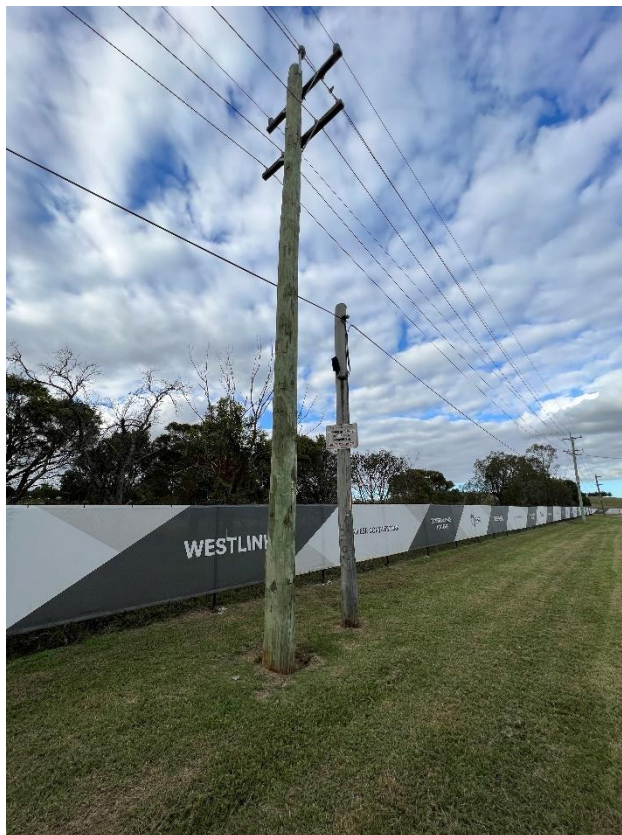
Figure 6 – General condition of the electrical post.

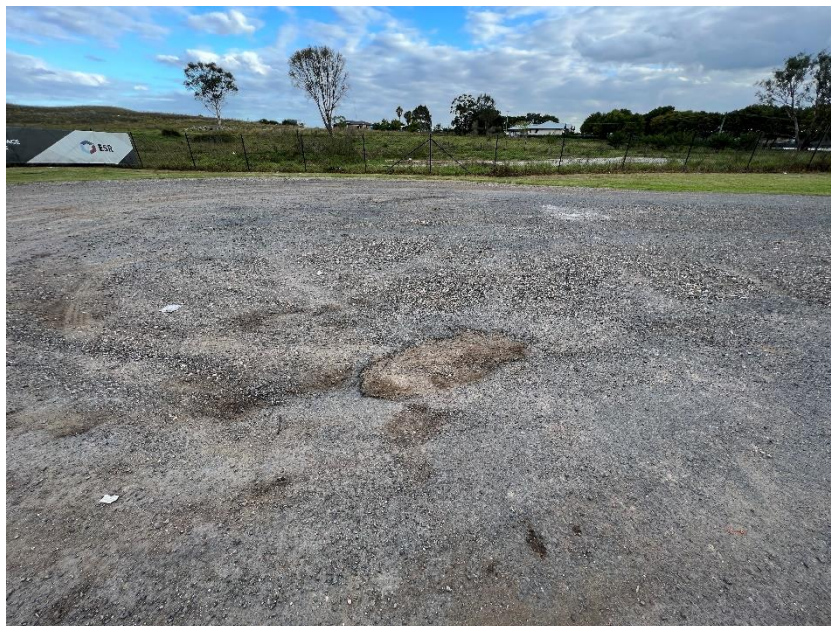
Figure 18 – Crack propagation to the road.

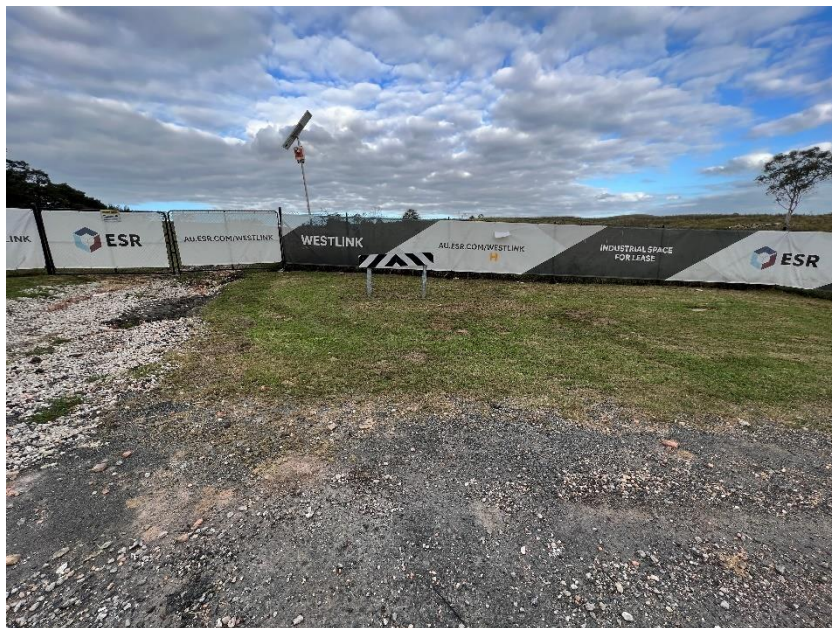
Figure 20 – General condition of the nature strip.

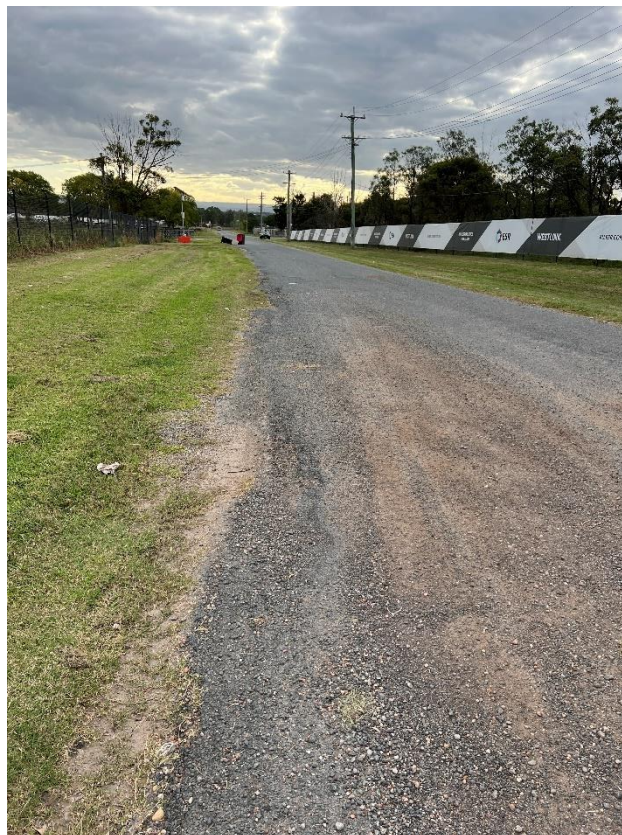
Figure 24 – Crack propagation to the road.

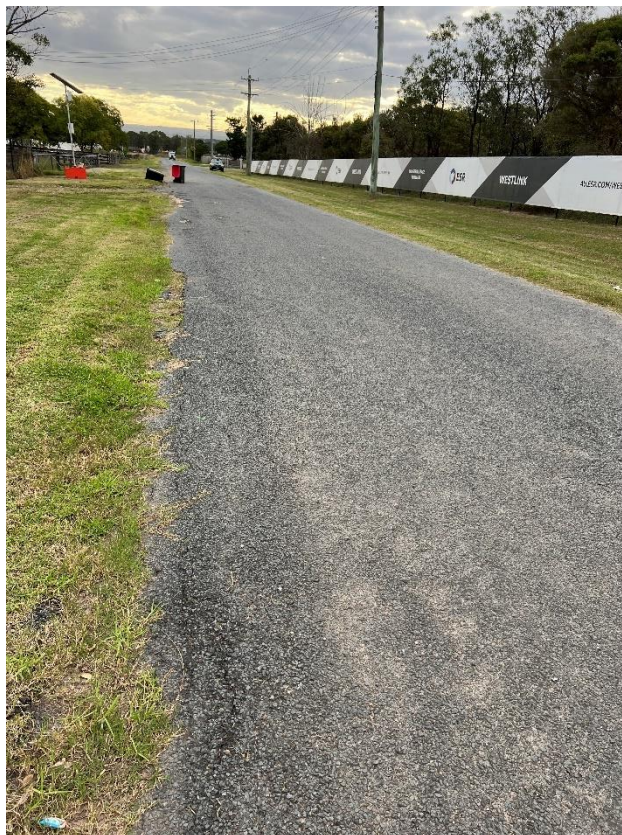
Figure 26 – Crack propagation to the road.

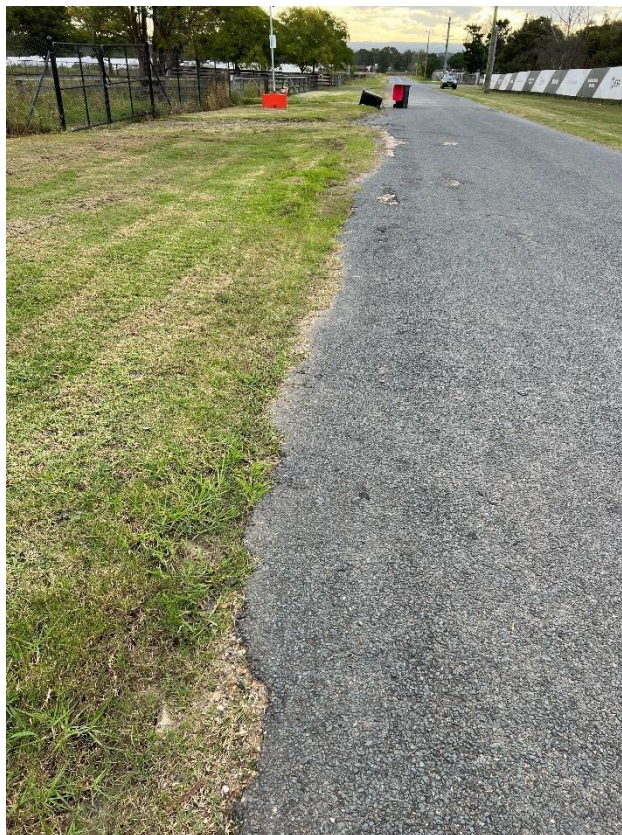
Figure 28 – Crack propagation to the road.

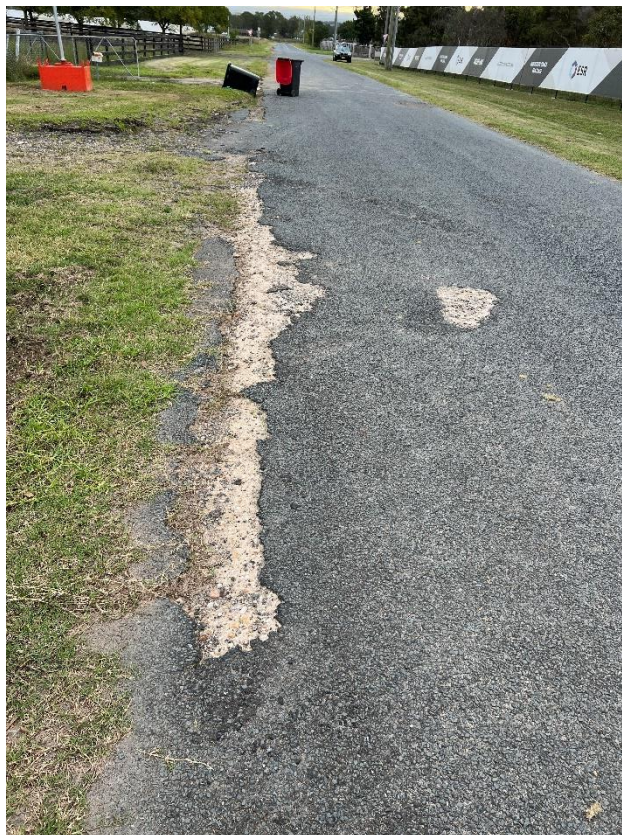
Figure 30 – Crack propagation to the road.

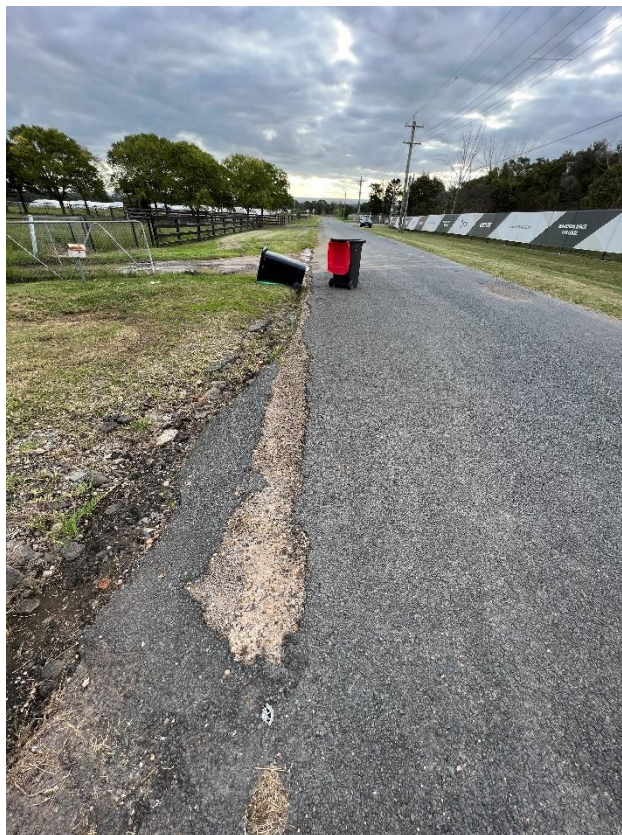
Figure 32 – Crack propagation to the road.

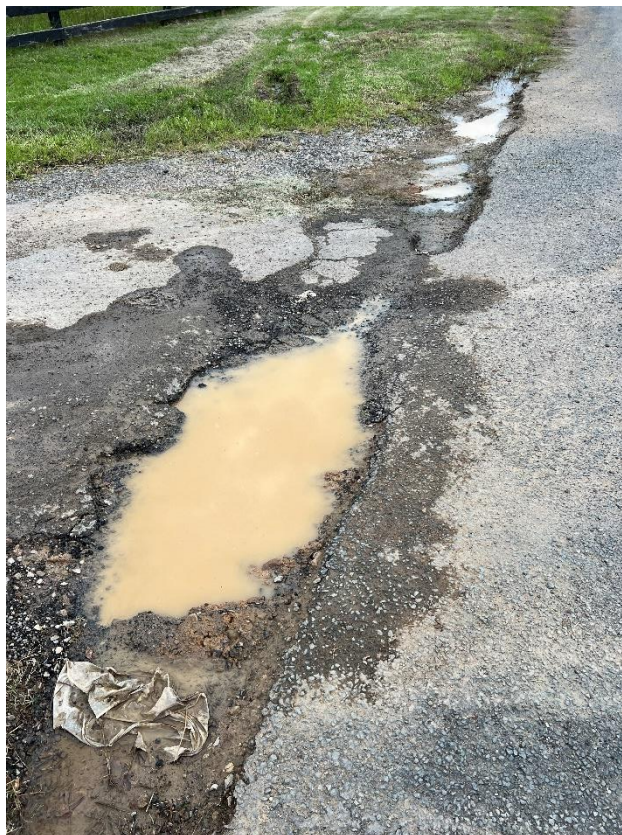
Figure 34 – Crack propagation to the driveway.

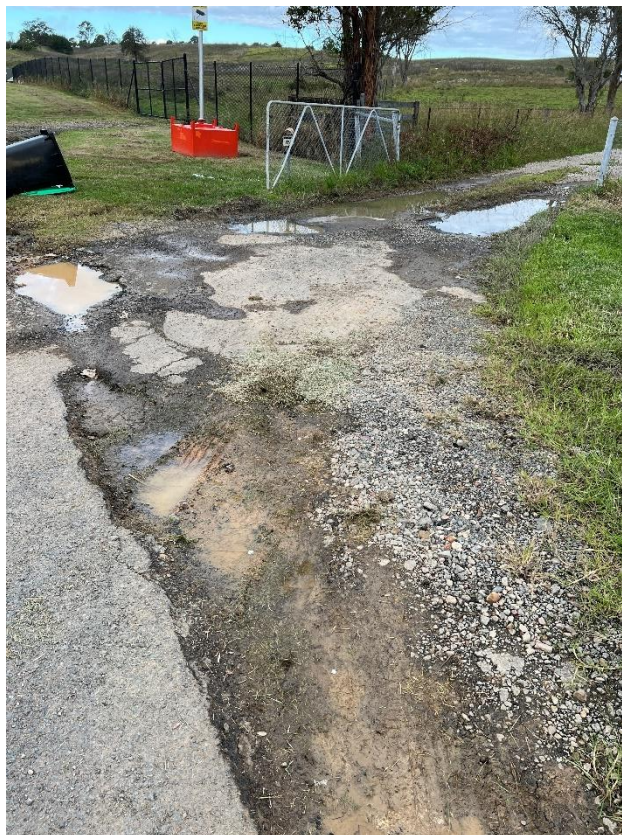
Figure 36 – Crack propagation to the driveway.

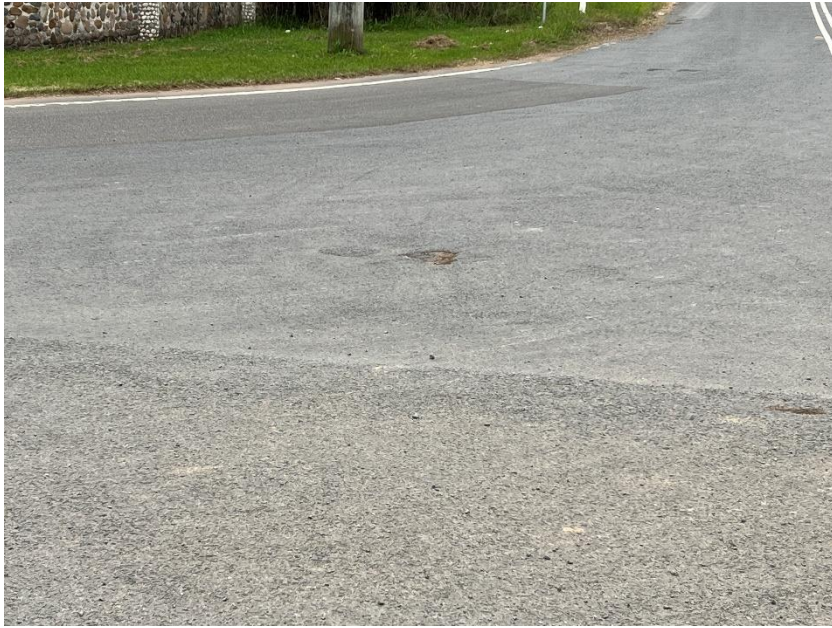
Figure 53 – Crack propagation to the road.

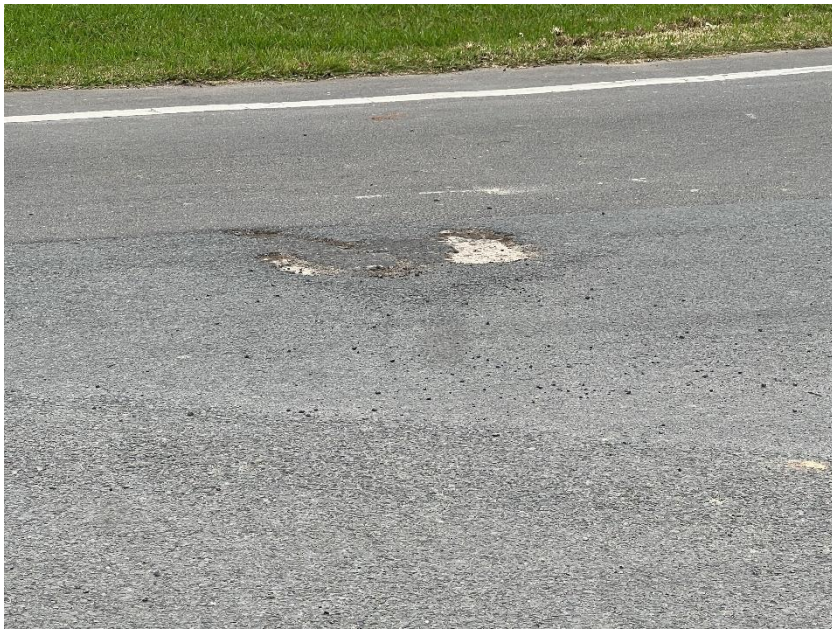
Figure 54 – Crack propagation to the road.

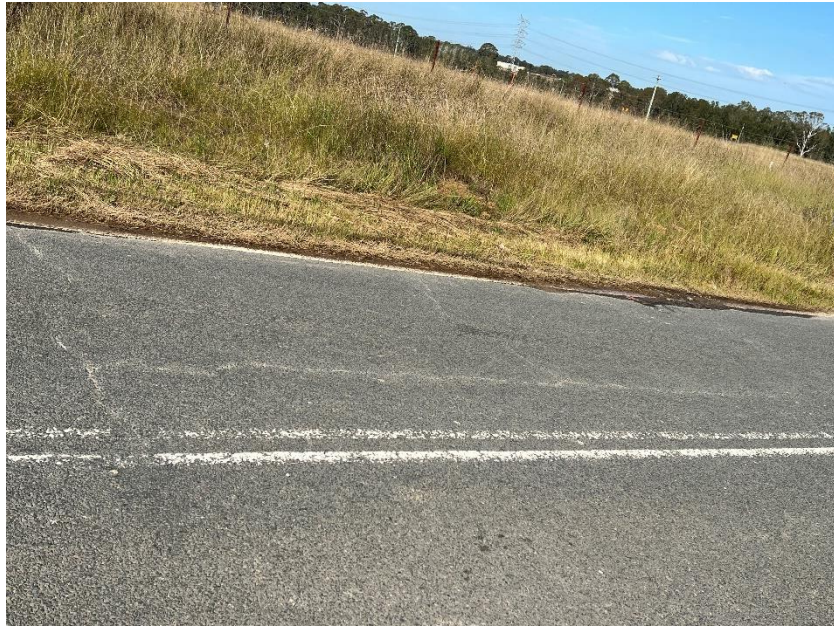
Figure 101 – Crack propagation to the road.

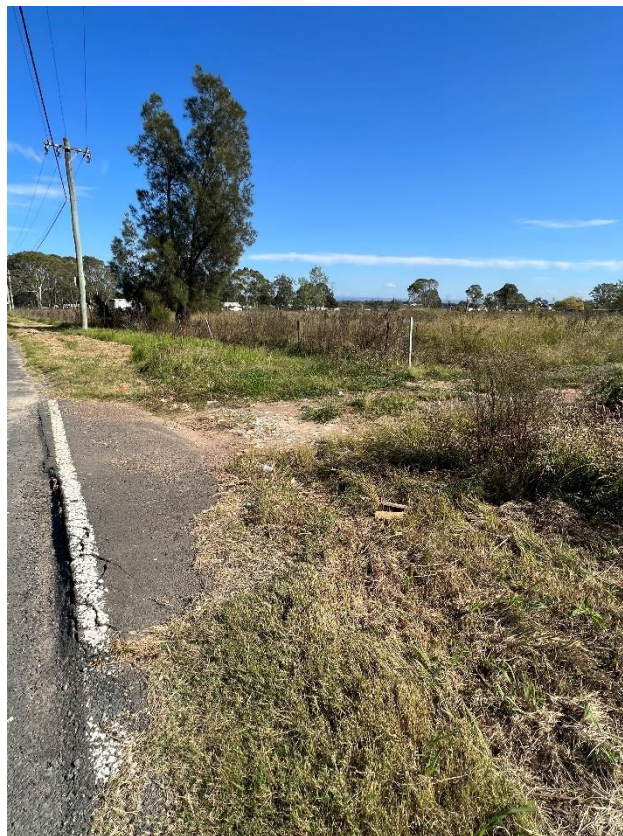
Figure 102 – Crack propagation to the driveway.

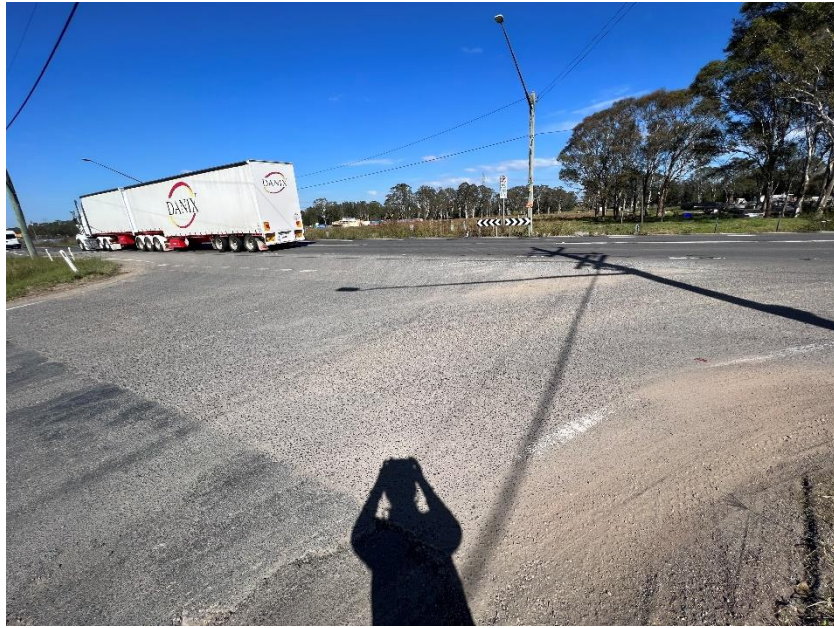
Figure 125 – Crack propagation to the road.

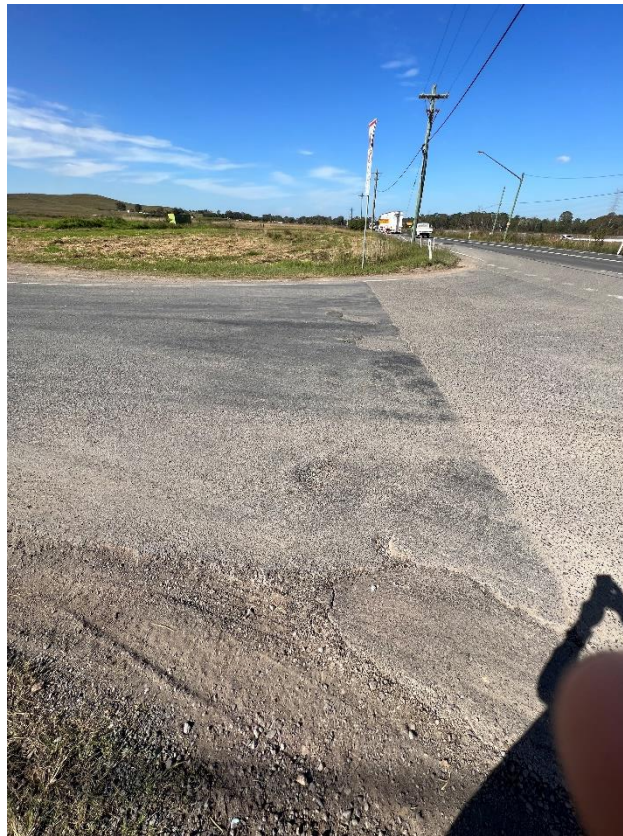
Figure 126 – Crack propagation to the road.
