# **Vacuum Grouting Successfully Introduced as a New Standard**

## Case Study

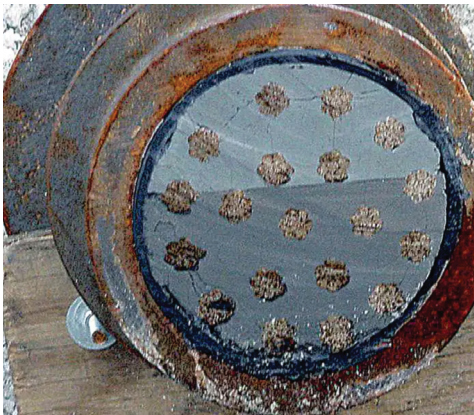
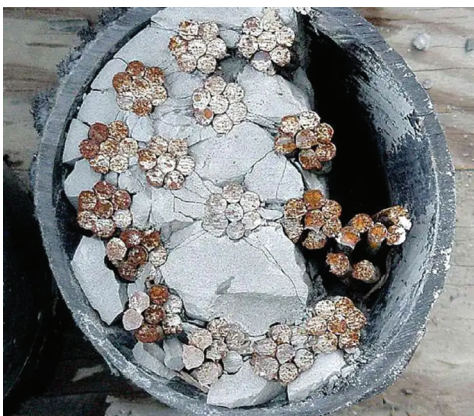
The inspection performed by the Florida Department of Transportation found voids behind the bearing plates in a significant percentage of the external tendons of the bridge. Initially, the contractor plan was to regROUT the voids by using a tremie tube method. DYWIDAG, however, proposed the use of vacuum grouting for this repair. Mock-ups were built to demonstrate the adequacy of this method (see photos).

The mock-ups consisted of tendons partially grouted in order to artificially reproduce the actual field conditions. A darker grout was used for the first grouting phase, while a lighter colour was used for the vacuum grouting phase in order to visually inspect the performance of the grouting after the dissection of the mockup.

The results of the mock-up testing proved the higher quality of the vacuum grouting and this was the method selected for the grouting of the voids. More than 700 voids were vacuum grouted between January to May of 2001.
