## Zakira's Garage

RO #26041

Vehicle: 1968 American Motors AMX Base

## Pre-Purchase Inspection (2 hours)

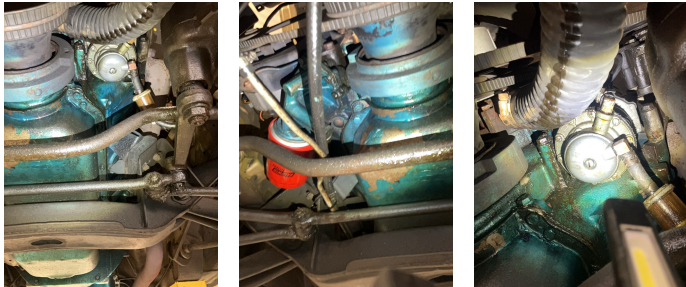
| <input type="checkbox"/> <input checked="" type="checkbox"/> <input type="checkbox"/> <input type="checkbox"/> Engine Oil | <b>Finding:</b> Several various light oil leaks on bottom side of engine. Leaks are hard to pinpoint due to large amount of residue on engine that would need cleaned and reinspected. Two noticeable oil leaks are on the fuel pump mounting surface, and the oil filter housing. |

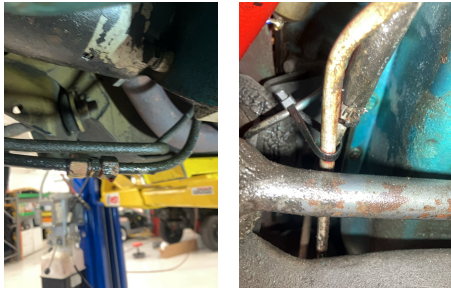
| <input type="checkbox"/> <input checked="" type="checkbox"/> <input type="checkbox"/> <input type="checkbox"/> Transmission Fluid | <b>Finding:</b> Transmission fluid leaks on transmission cooler lines at compression fitting, and hard line that connects to rubber line |

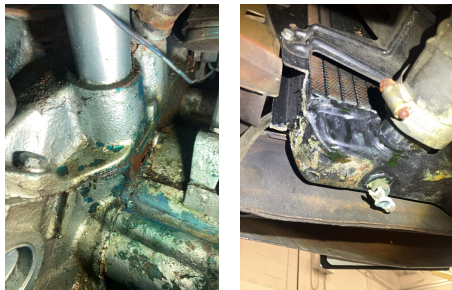
**Finding:** Upon arrival there was a puddle of coolant on the front of the engine. The puddle was cleaned off before the test drive and observed. There is a light seep of coolant from the intake manifold. Light radiator leak on bottom driver corner of radiator

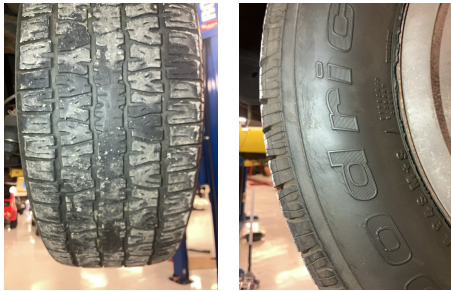
| <input type="checkbox"/> <input type="checkbox"/> <input checked="" type="checkbox"/> <input type="checkbox"/> Driver Front Tires | | <b>Finding:</b> Tire has low tread and dry rot cracks in sidewall |

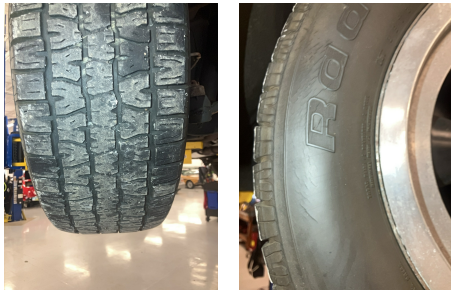
| <input type="checkbox"/> <input type="checkbox"/> <input checked="" type="checkbox"/> <input type="checkbox"/> Passenger Front Tires | | <b>Finding:</b> Tire has low tread and dry rot cracks in sidewall |
