Report on  
Desktop Geotechnical Assessment

Due Diligence Assessment  
1030 Mamre Road, Kemps Creek

Prepared for  
ResolveXO Pty Ltd

Project 208044.00  
September 2021

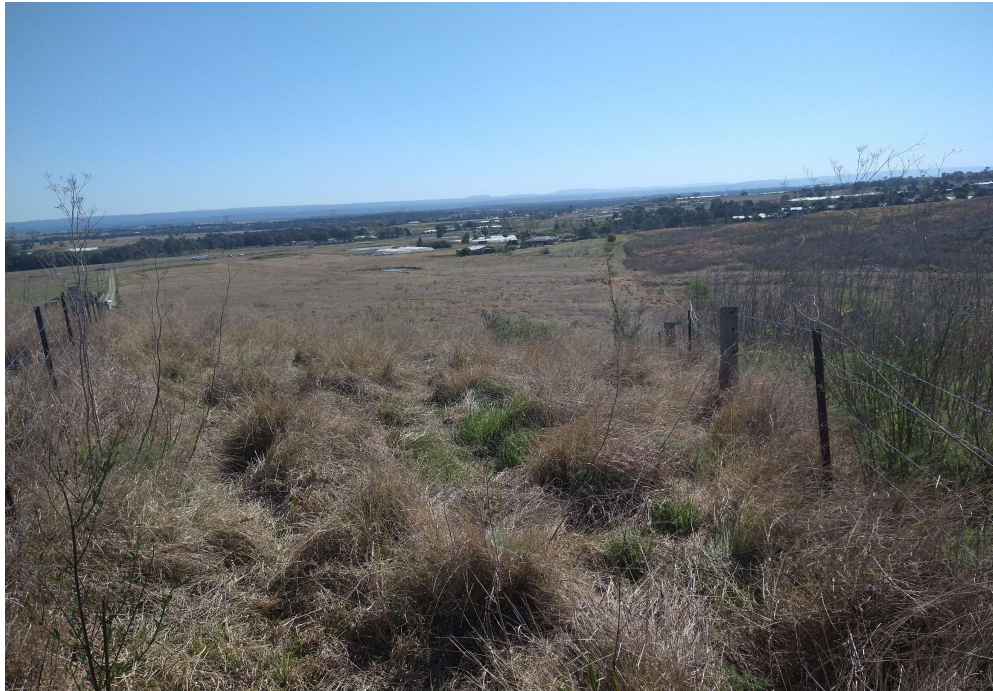
Photograph 1 - View of site from top of eastern corner. Grades 15 to 20% limited to this area

There does not appear to be any evidence of significant slope instability on the site. It is noted the grades on the northern boundary are increasing to 15 – 20 degrees and care will be required to ensure that earthworks and excavation do not adversely affect slopes which extend into the neighbouring properties.

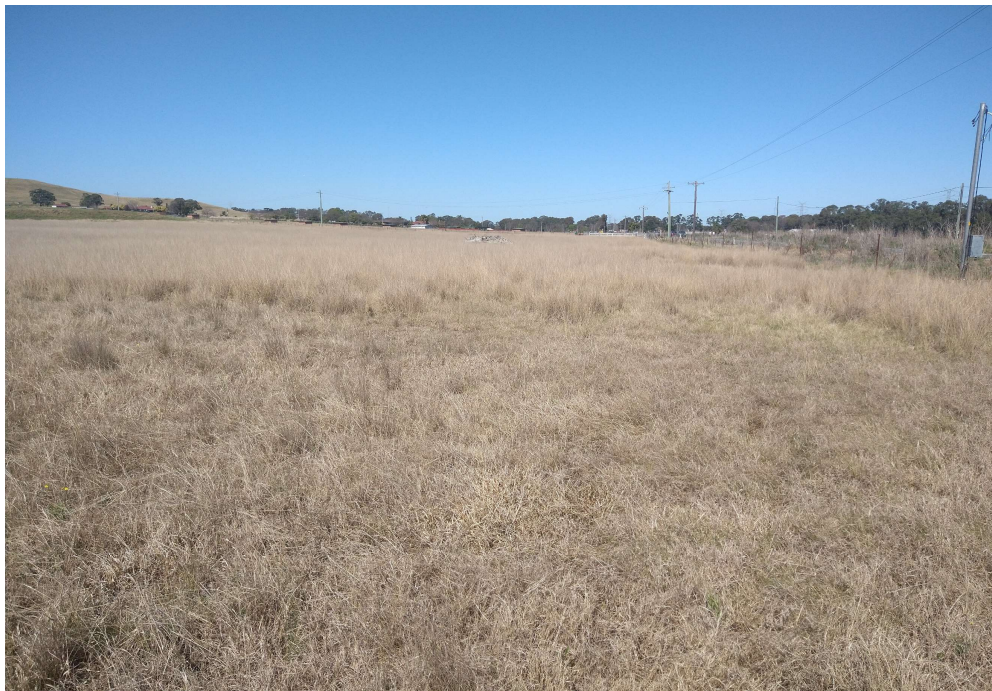
Photograph 2 - Grassed western portion. Waterlogged beneath grass

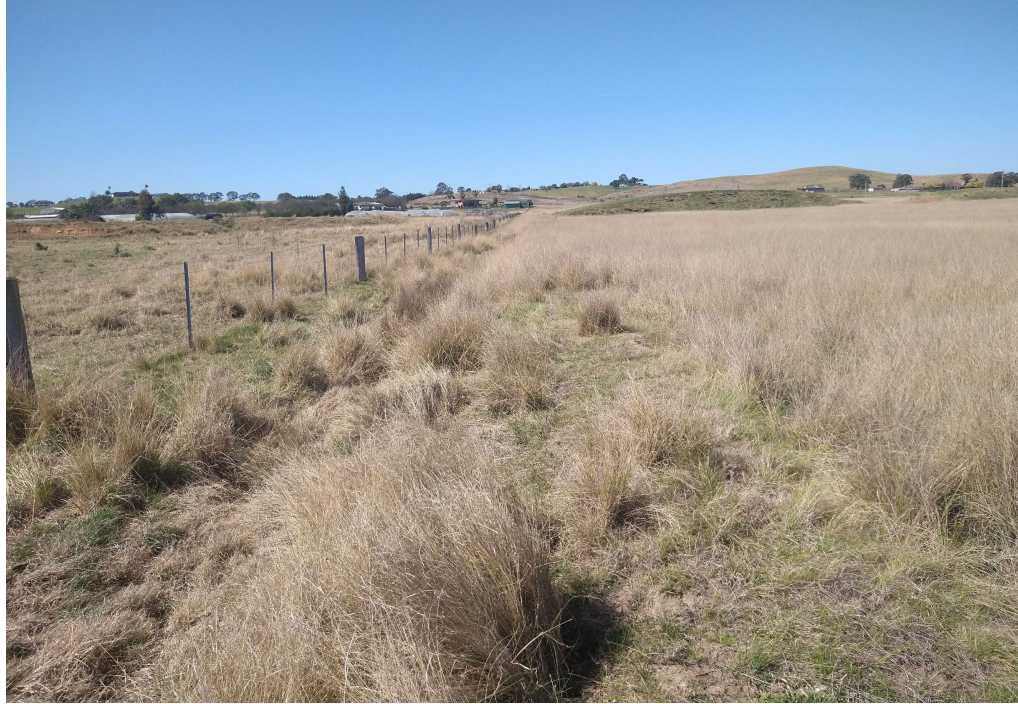
- Most of the site has gentle grades of 5 – 10 degrees upwards from Mamre Road on the western boundary (Photo 3);
- The grades steepen to 15 degrees in some areas near the north eastern boundary, then localised up to 20 degrees at the eastern corner (Photo 1);
- There is minimal change in grade from north to south (Photo 2);
- There was no evidence of recent slope instability on the site.

Photograph 3 - View of grassed paddocks looking west from north western corner

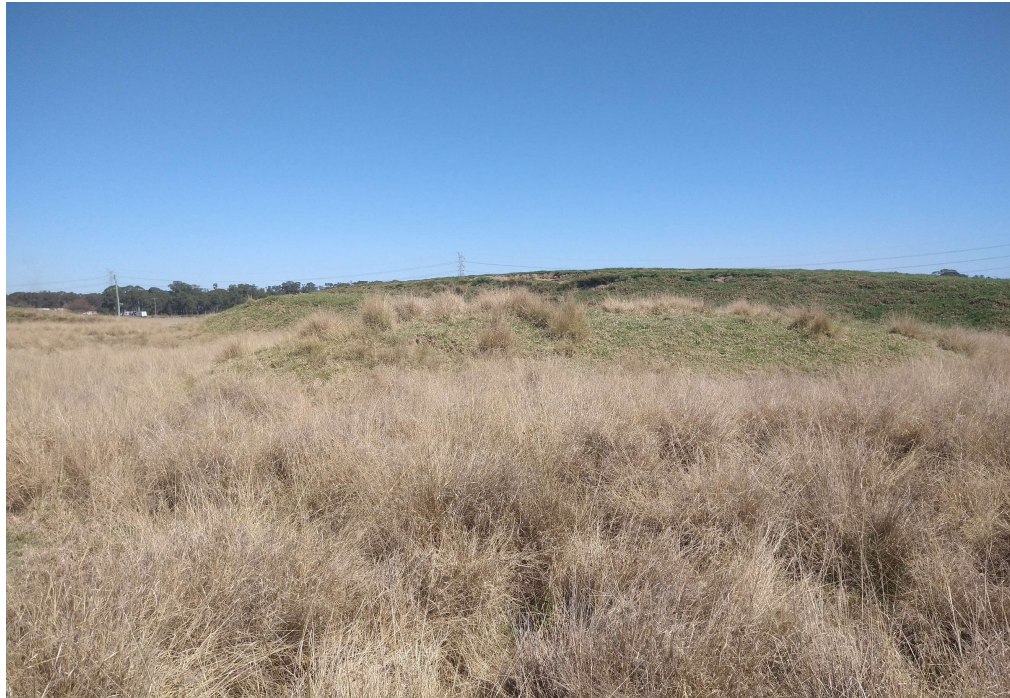
- There are several stockpiles of uncontrolled fill on the site, approximately one third from the western boundary. They appear to be soil from the proposed road alignment cut in the centre of the site (Photos 3, 4 and 11);
- Some apparently fly tipped concrete waste was in the south western paddock near the Mamre Road boundary.

Photograph 4 - Stockpiles (probably topsoil from road alignment) near lower third of site

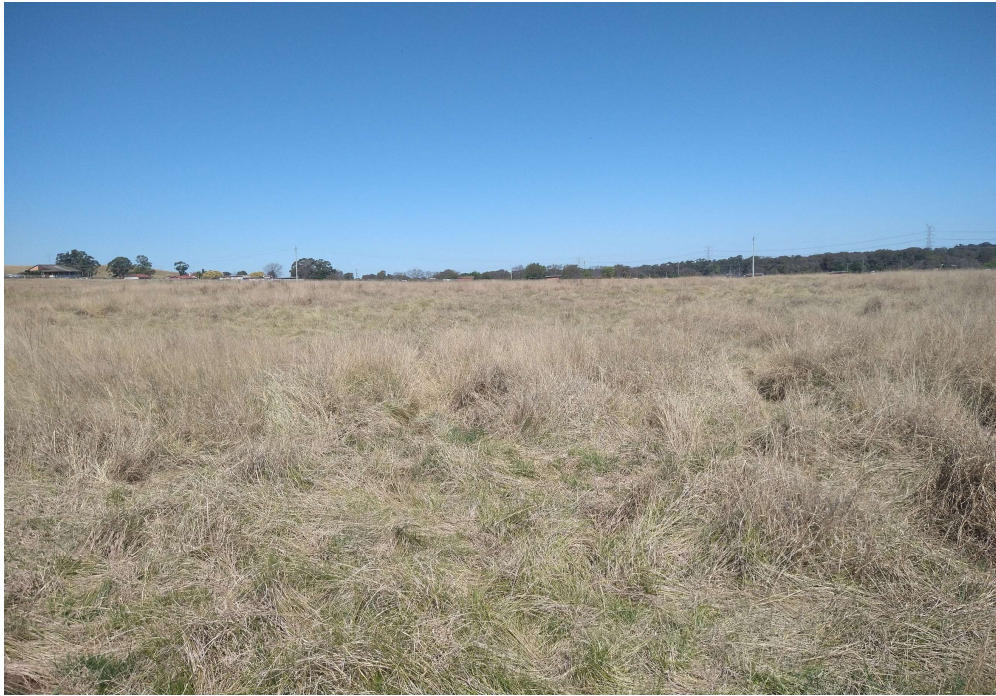
Photograph 5 - Central paddocks looking south

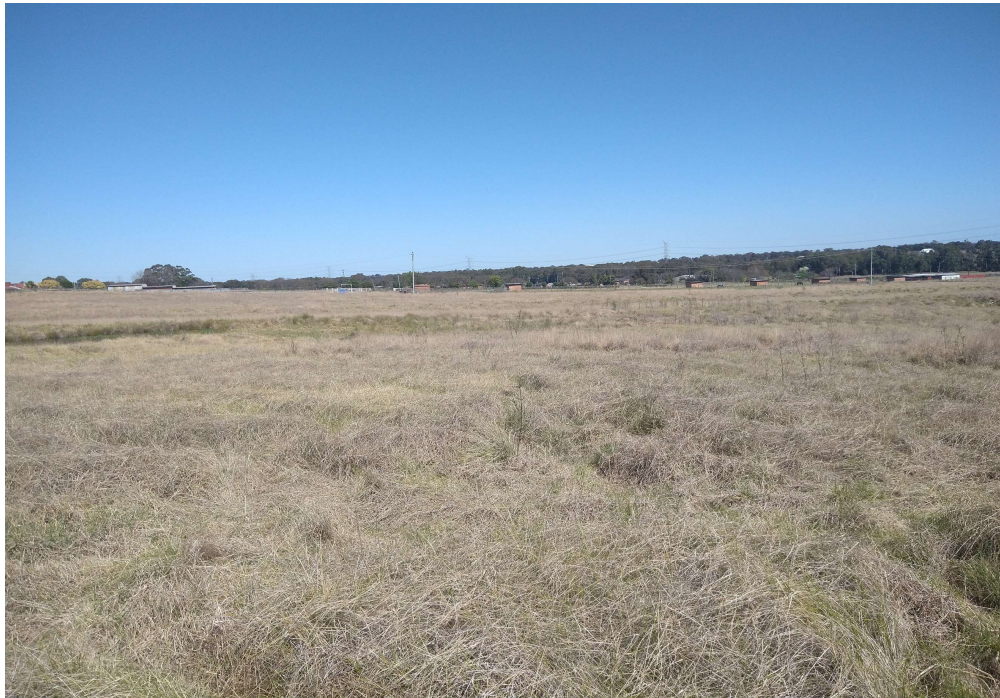
Photograph 6 - Farm dam near upper third of site

A methodology may need to be developed for desilting and filling of the dam and would incorporate:

- Disposal of water away from the dam and spreading on the ground surface;
- Excavation of the silt and water affect material then moisture conditioning (drying) prior to blending;
- Removal of the uncontrolled fill in the dam wall, drying and blending for use as controlled fill; and
- Placement of controlled fill to design levels.

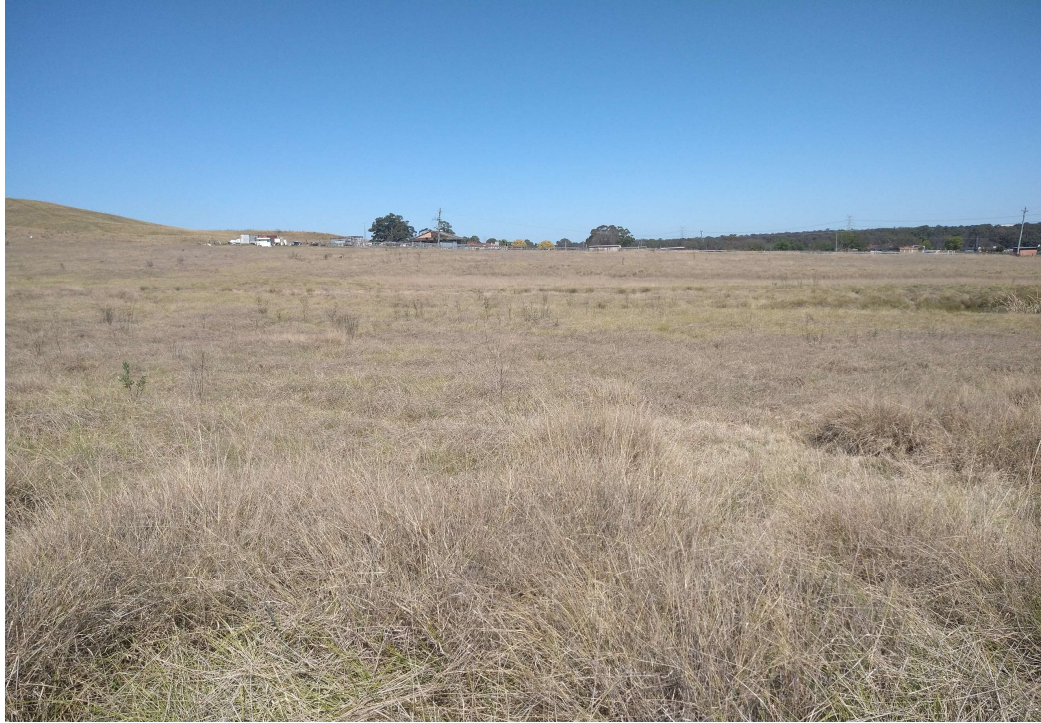
Photograph 7 - Proposed road turning circle cut into topsoil and upper residual clay layers

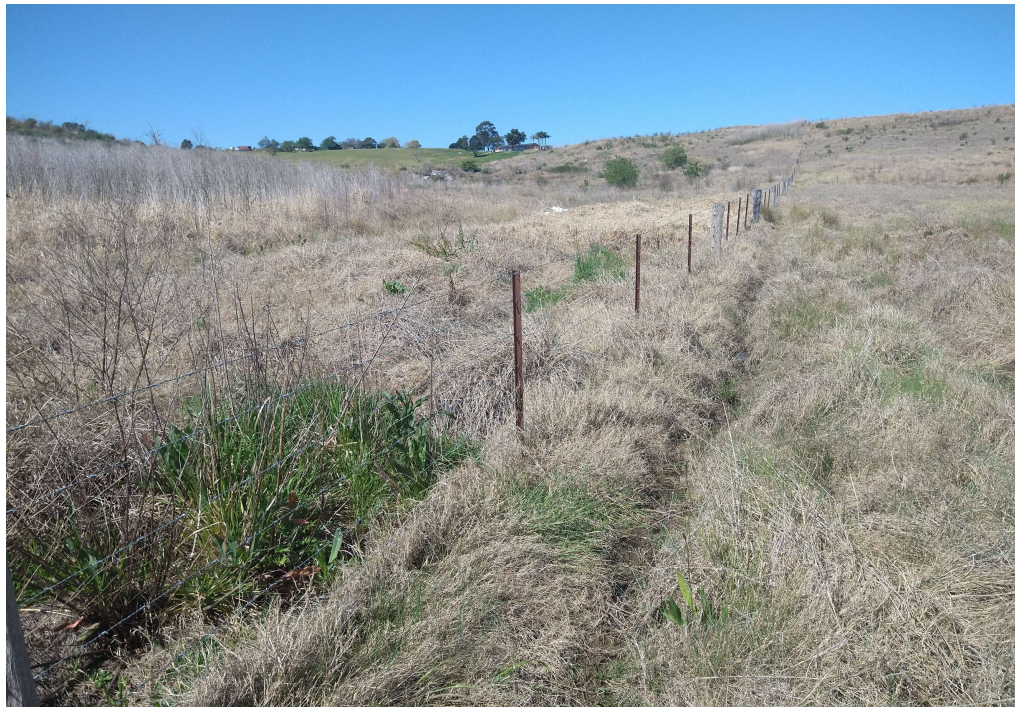
Water logging may be a significant constraint to development in the low-lying creek areas and in the eastern portion of the site where a leaking dam from the neighbouring site has saturated soils. Further investigation should be undertaken once flood studies for the site have determined the extent of flood-affected land. Further investigation must include test pit excavation to determine soil moisture profiles.

Photograph 8 - Waterlogged area on eastern boundary below dam on adjacent site

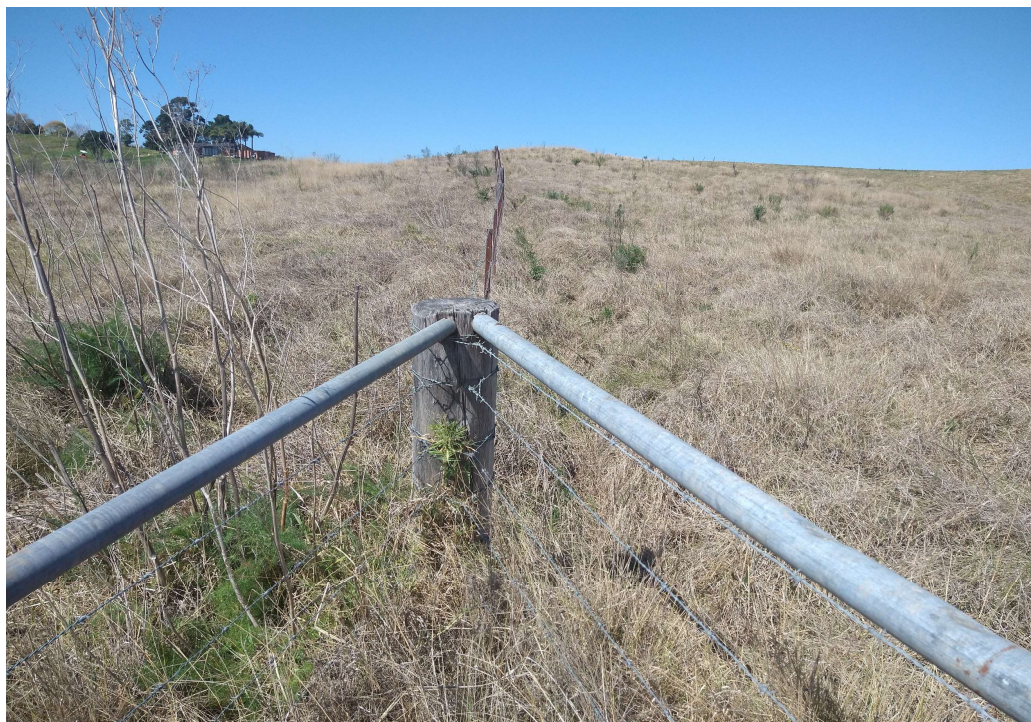
Photograph 9 - Hillslope continues up from eastern corner

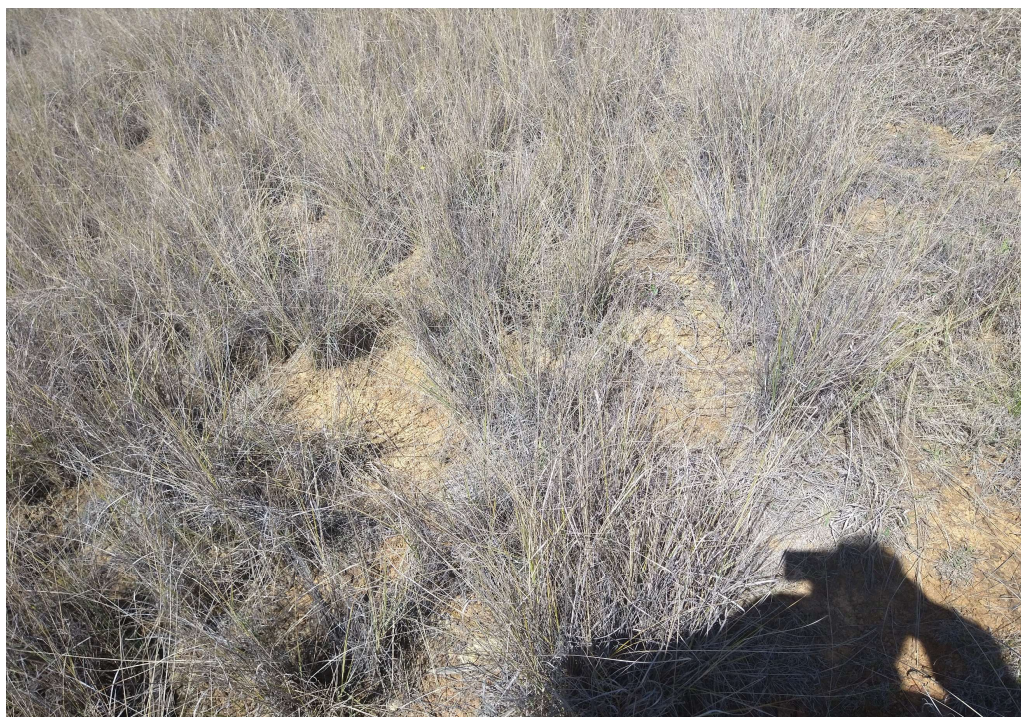
- No exposed rock was observed;
- Soil exposed in the proposed road alignment cutting as a residual gravelly clay (Photo 10);

Photograph 10 - Gravelly clay soil exposed in proposed road cutting

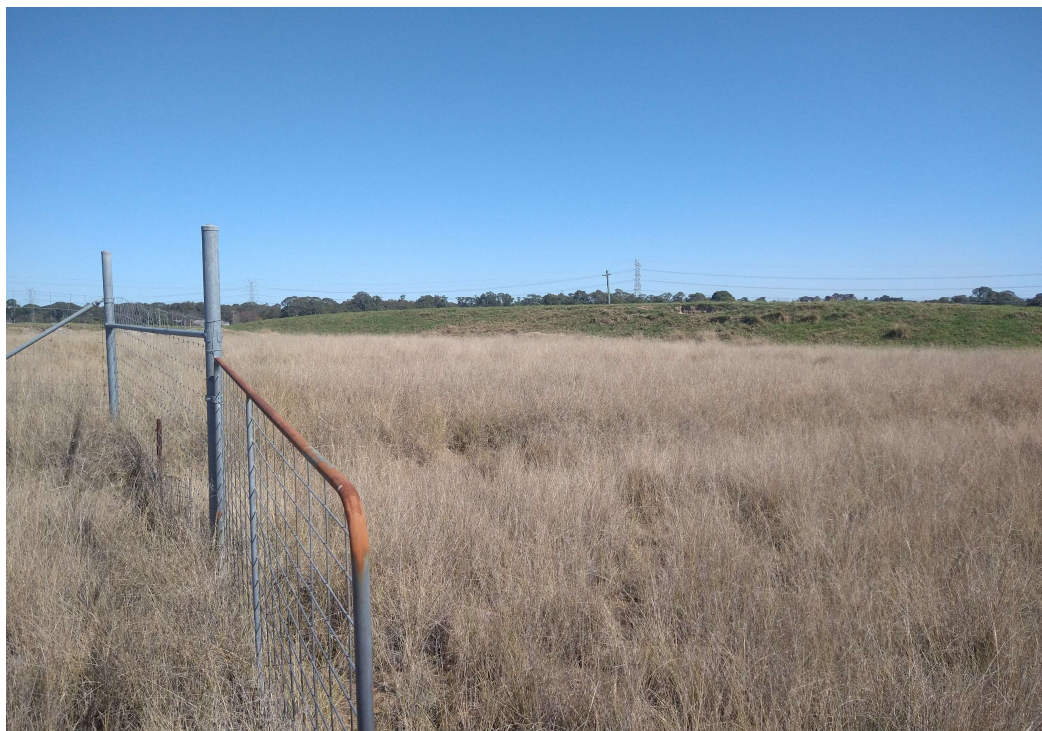
Photograph 11 - Fence line at lower third paddock
