Re: Project Review under Section 106 of the National Historic Preservation Act and/or the Antiquities Code of Texas  
**201904329**  
West Cargo Demolition Project  
N/A  
Grapevine, TX

RE: Cultural Resources Analysis for the West Cargo Demolition Project, City of Grapevine, Dallas County, Texas

### CULTURAL RESOURCES REPORT FOR THE DEMOLITION OF THE AMERICAN AIRLINES WEST WAREHOUSE, DALLAS FORT WORTH INTERNATIONAL AIRPORT, TARRANT COUNTY, TEXAS

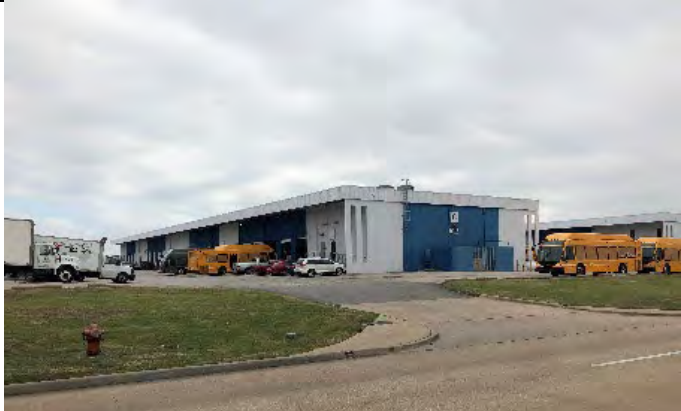
Property Name	Property Location/ Address	Construction Date/ Architectural Elements	Photograph of Resource
Building C	1920 W. Airfield Drive	1972 Modern style, two-story building constructed of steel beam framing with concrete block and concrete slab walls. The building features offices, storage or maintenance areas, and loading docks.

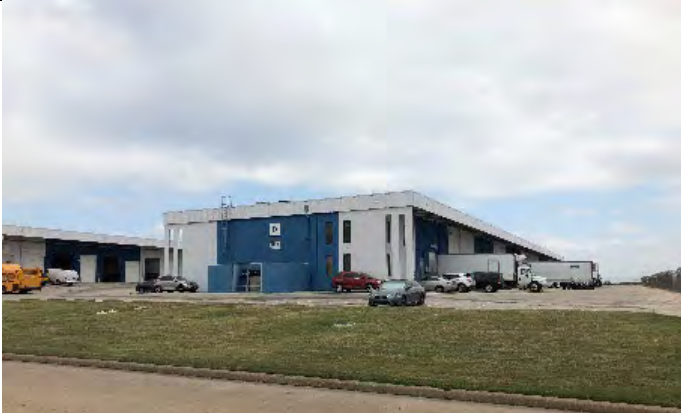
Building D	1930 W. Airfield Drive	1972 Modern style, two-story building constructed of steel beam framing with concrete block and concrete slab walls. The building features offices, storage or maintenance areas, and loading docks.

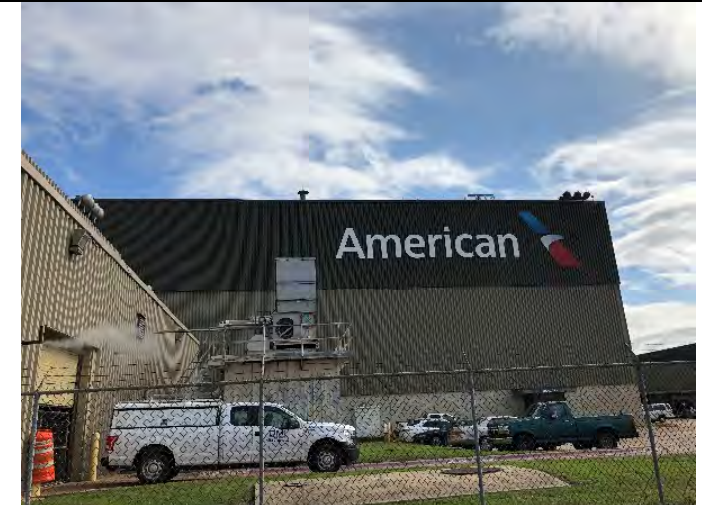
Property Identification Number	Property Location/ Address	Construction Date/ Architectural Elements	Photograph of Resource
American Airlines Hangar	Eastern terminus of W. 20 <sup>th</sup> Street	1972 or 1973 Modern airplane hangar constructed of reinforced concrete and steel beam framing.

The eastern portion of the indirect APE contains part of a multi-story aircraft hangar operated by American Airlines (AA) (**Attachment B, Photographs 21 and 22**). The building is constructed of reinforced concrete molded into a vertical rib pattern over a steel beam frame. According to historical aerial photographs, the hangar was built between 1970 and 1973 during the initial construction phase of DFW. Based on our research, we have determined that the AA hangar is not of historic age, nor has it achieved exceptional importance since its construction and does not qualify for NRHP listing under Criteria Consideration G.

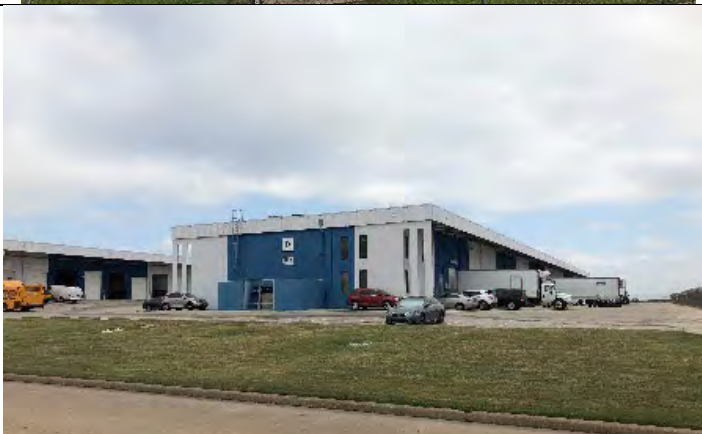
Building D	1930 W. Airfield Drive	1972 Modern style, two-story building constructed of steel beam framing with reinforced concrete walls. The building features offices, storage or maintenance areas, and loading docks.

The southeast corner of a building known as Building D (**Attachment B, Photographs 23 and 24**) is located within the western indirect APE. The Modern style building features a flat roof, reinforced concrete exterior walls, concrete block or sheet rock interior walls, steel beam framing, and concrete flooring. The building contains warehouse and enclosed office space. As of this report, a portion of Building D is used by a bussing contractor for DFW. Based on our research, we have determined that the DFW, Building D is not of historic age, nor has it achieved exceptional importance since its construction and does not qualify for NRHP listing under Criteria Consideration G.

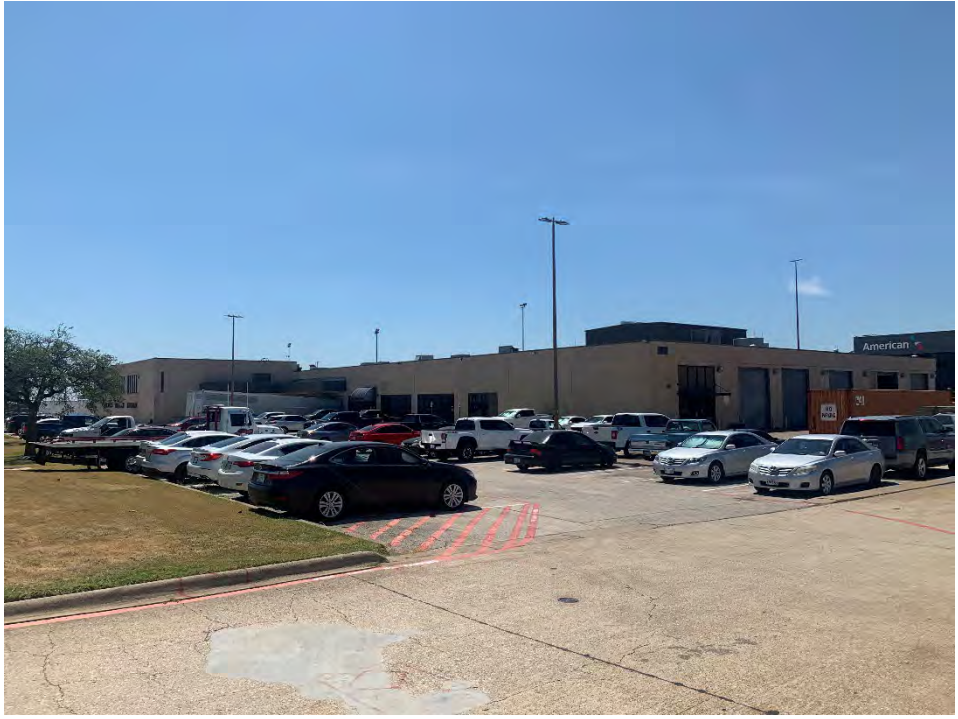
Resource	Property Name	Potential Effects Type	Construction Date/ Architectural Elements	Photograph 1
R-1	American Airlines West Warehouse (facing southwest)	Direct	c. late 1973, Brutalism-style, single story building.
