Aquatic Habitat Monitoring

What are stream habitat surveys?
Where has AQI surveyed?
Aquatic habitat monitoring attributes
Fish needs & HabRate
Summary

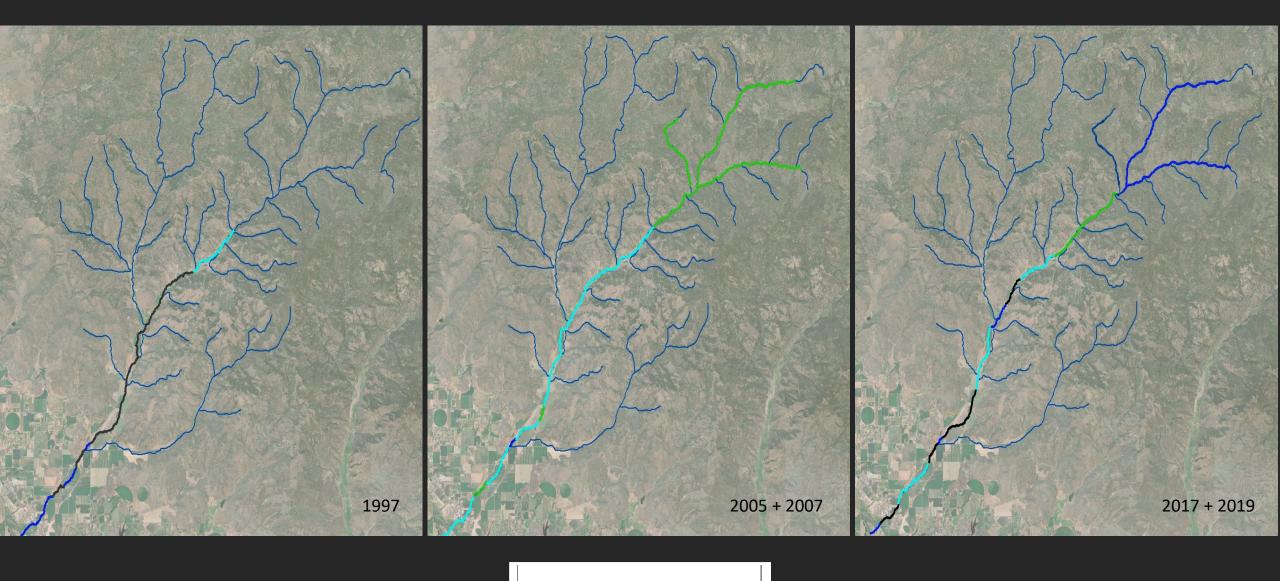
Reach level view - Percent fine sediment in riffle habitat

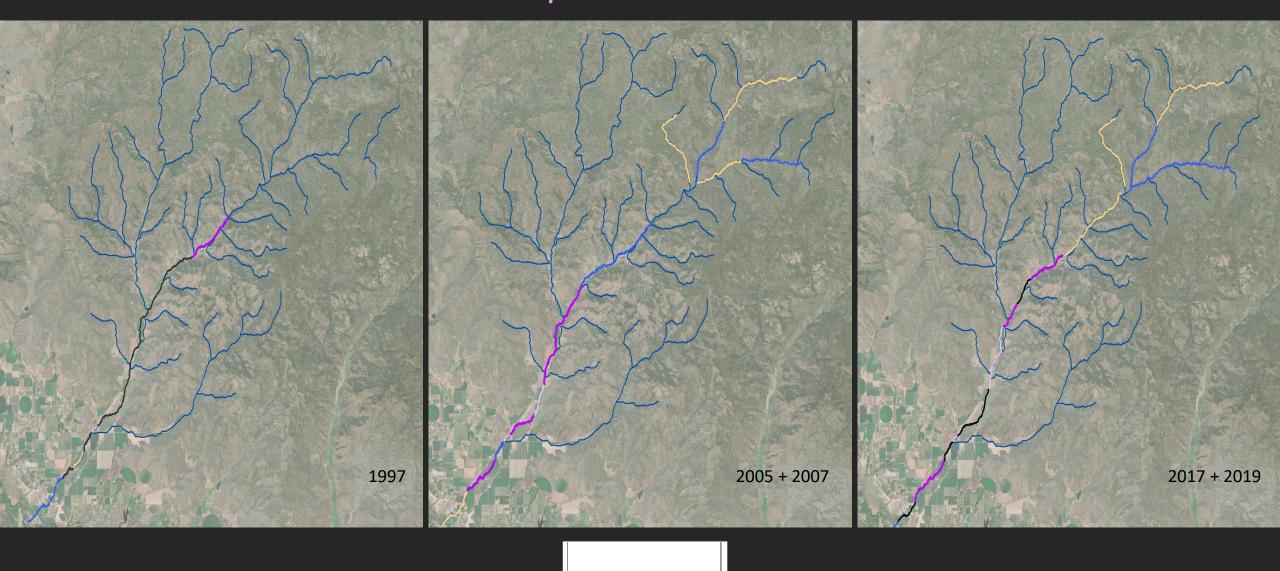
Reach level view - Percent pool habitat

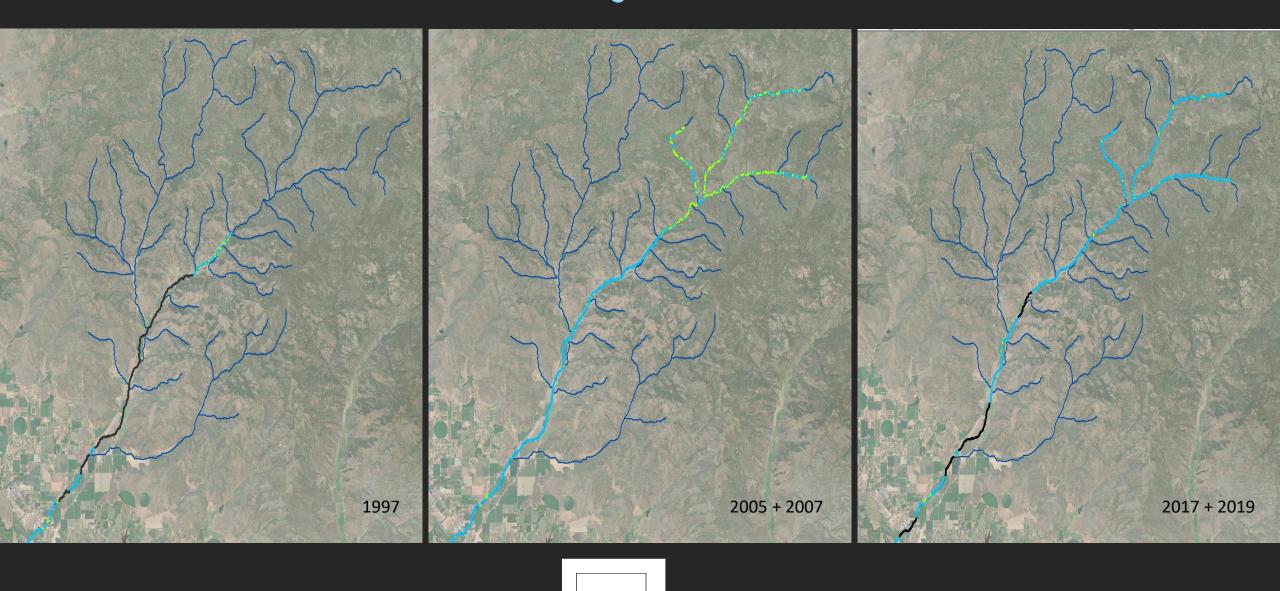
Unit level view - Habitat with gravel substrate

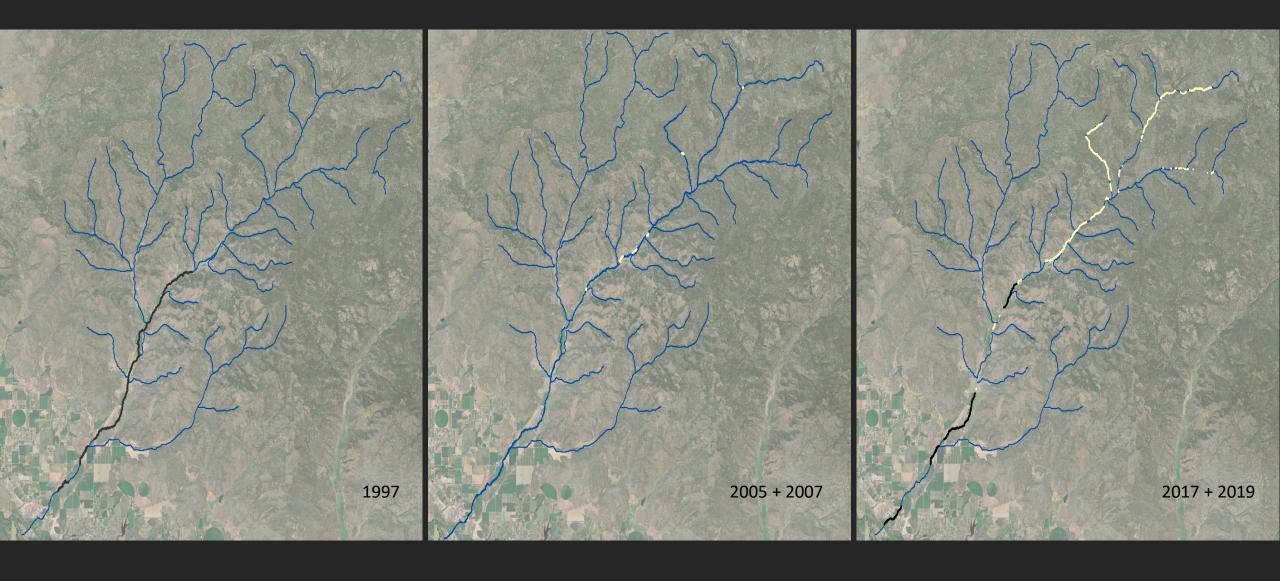
Unit level view – Dry habitat

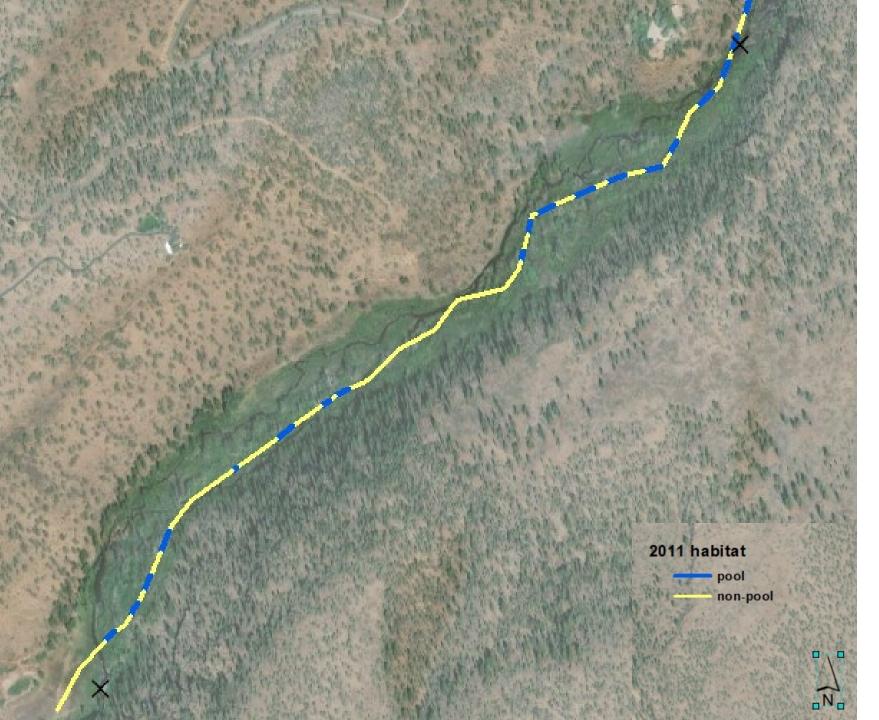
Canyon Preserve pre-restoration

straight, entrenched channel

<4% side channel habitat

low fine sediment & moderate gravel

27% pool habitat

deep pools (n=20)

4 pieces wood/km no key pieces

Canyon Preserve 5 years postrestoration

Three-fold increase side channel habitat (1600m : 3590m)

Wider channel and floodplain

High levels fine sediment & good gravel

38% pool habitat

Deep pools (n=14)

Increase complex pools (5.4/km)

28 pieces of wood/km

0.2 key pieces/km

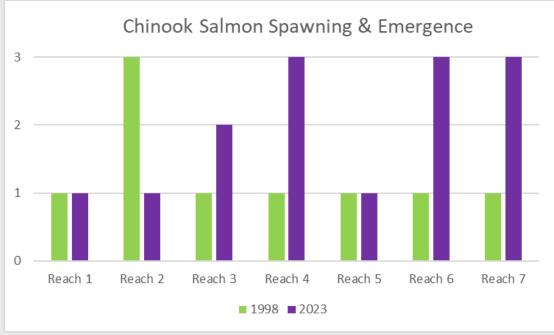
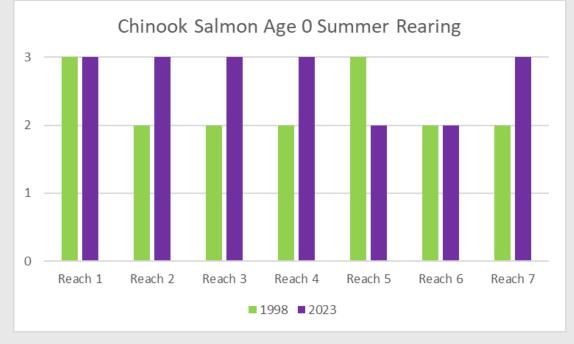
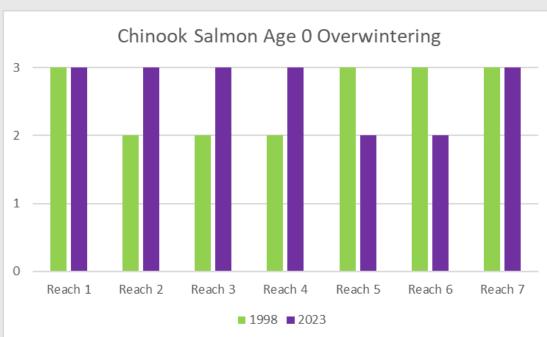
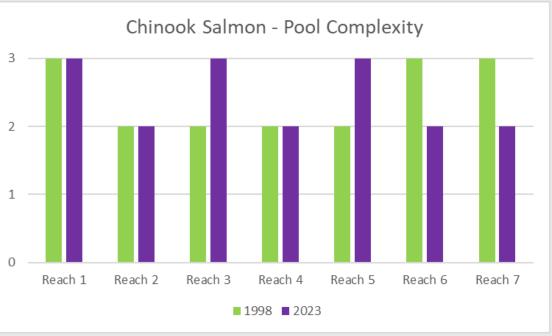
Habitat quality: 3 = good, 2 = fair, 1 = poor

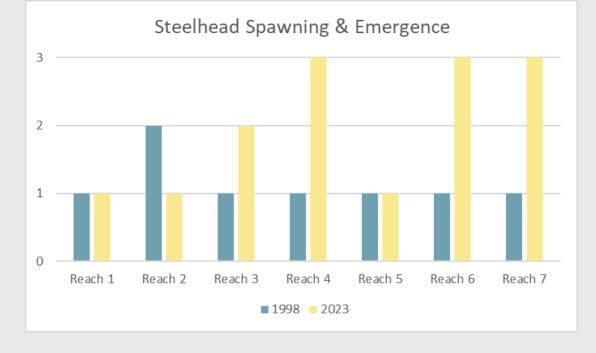
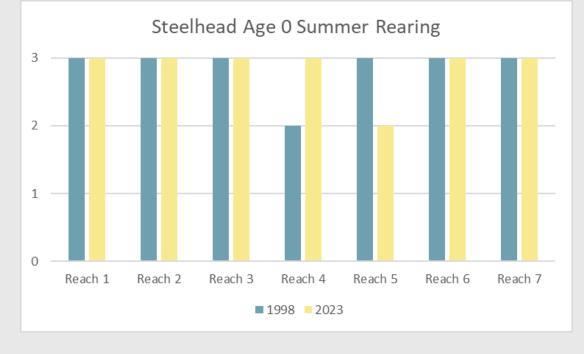
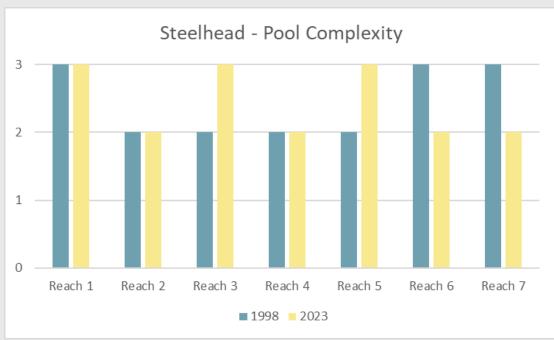
Habitat quality: 3 = good, 2 = fair, 1 = poor
