Above the Flood: Elevating Your Floodprone House

FEMA 347/ May 2000

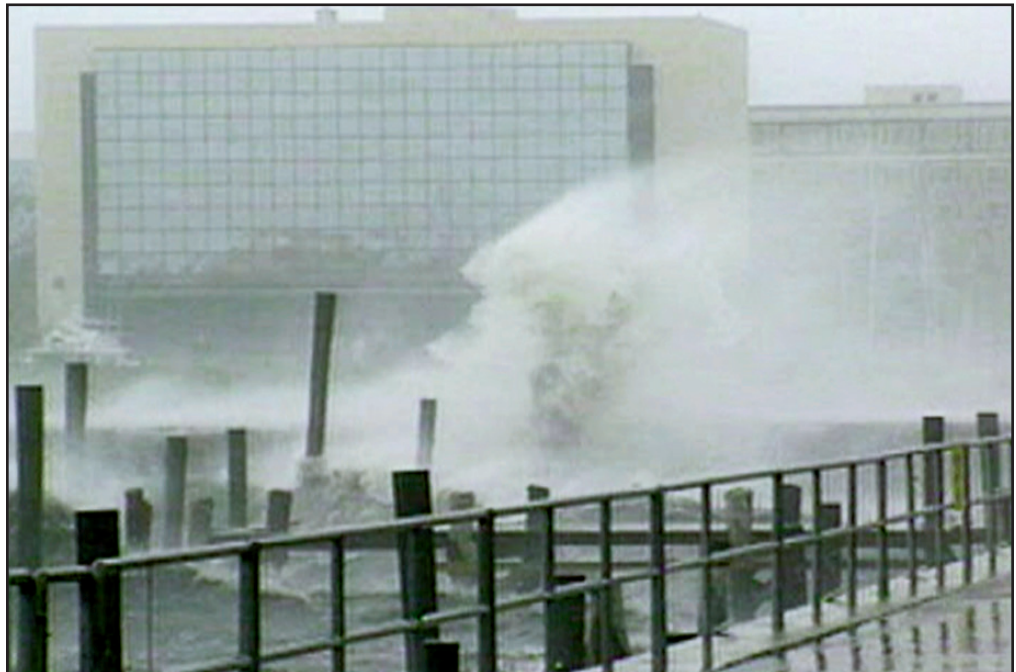
Figure 2
Damage to houses
and other buildings
was severe.

In the early morning hours of August 24, 1992, Hurricane Andrew struck south Florida with high winds and heavy rains (Figure 1). Andrew destroyed tens of thousands of homes (Figure 2) and left 180,000 people homeless. The resulting property damage totaled over 30 billion dollars.

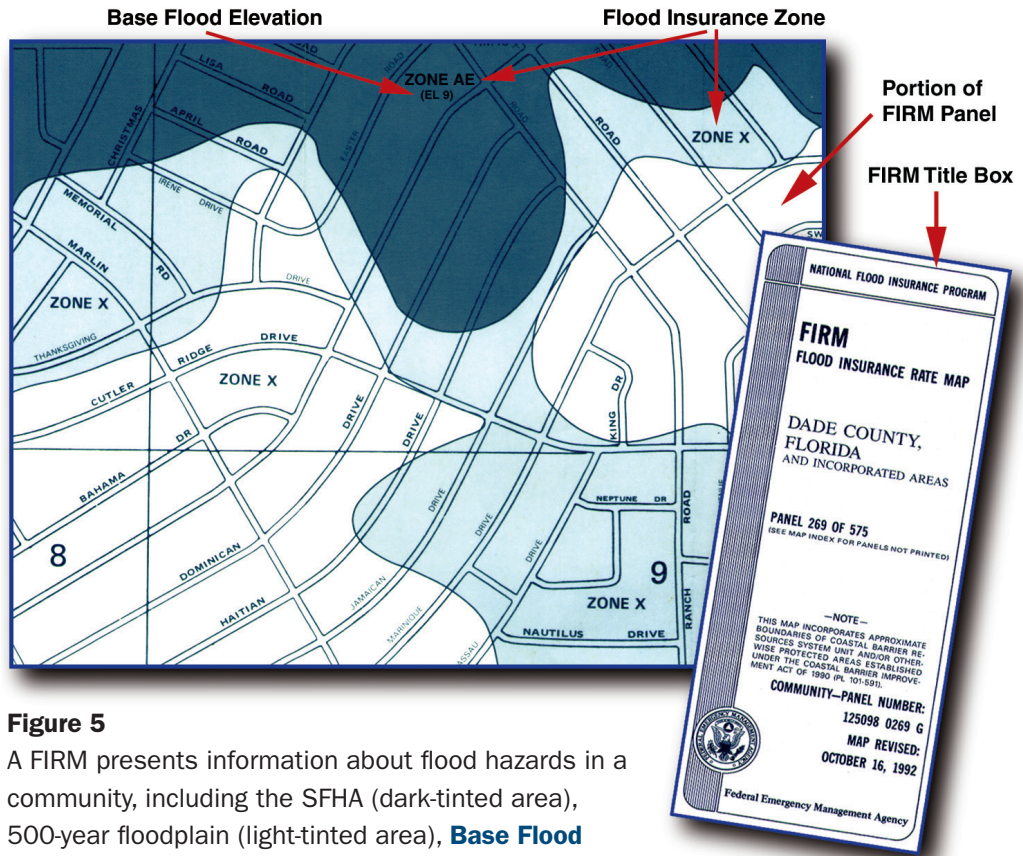
Figure 5 A FIRM presents information about flood hazards in a community, including the SFHA (dark-tinted area), 500-year floodplain (light-tinted area), **Base Flood Elevations**, (BFEs) (number in parentheses), and flood insurance zones (AE and X in this example).

Communities participate in the NFIP by enacting and enforcing floodplain management regulations to reduce future flood risks. At a minimum, these regulations govern construction in the **Special Flood Hazard Areas (SFHAs)** shown on Flood Insurance Rate Maps (FIRMs) issued by FEMA (Figure 5).

Note that the SFHA in the example in Figure 5 is designated Zone AE. This zone is only one of several applied to SFHAs under the NFIP, including V, VE, V1-V30, A, AE, A1-A30, AO, and AH. These zones indicate differences in the types and severity of flood hazards in SFHAs. For the purposes of this publication, it is sufficient to focus on the basic differences between the two main types of SFHA zones—V zones and A zones. The distinction is important because regulatory requirements associated with V zones and A zones differ significantly. As explained later in this chapter, these requirements affect the types of building elevation techniques that may be used under the NFIP.

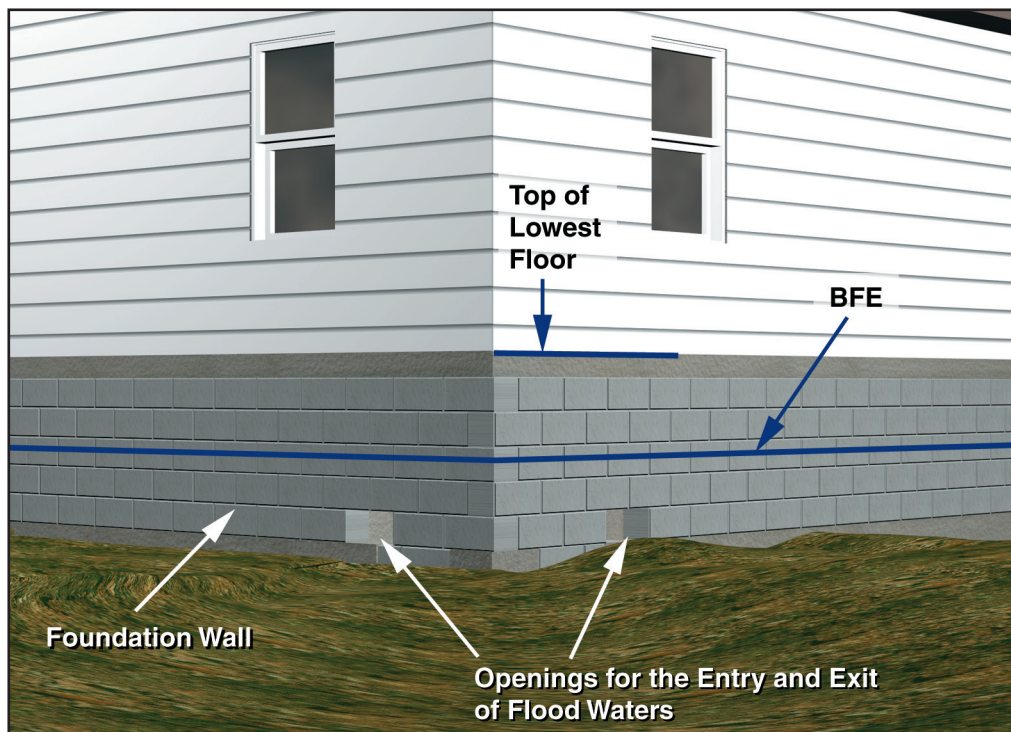
**Figure 6**

In a new, substantially improved, or substantially damaged building in an A zone, the elevation of the lowest floor must be at or above the BFE.

In A zones, where flood hazards are less severe, buildings may be elevated either on an open foundation or on continuous foundation walls below the BFE (Figure 6). Regardless of the type of foundation used, A-zone buildings must be elevated so that the **lowest floor** is at or above the BFE, as shown in Figure 6. If continuous walls are used below the BFE, they must be equipped with openings that allow flood waters to flow into and out of the area enclosed by the walls (Figure 6). Allowing the entry and exit of flood waters ensures that water pressures will be the same on both sides of the walls and reduces the likelihood that water pressure will cause the walls to fail.

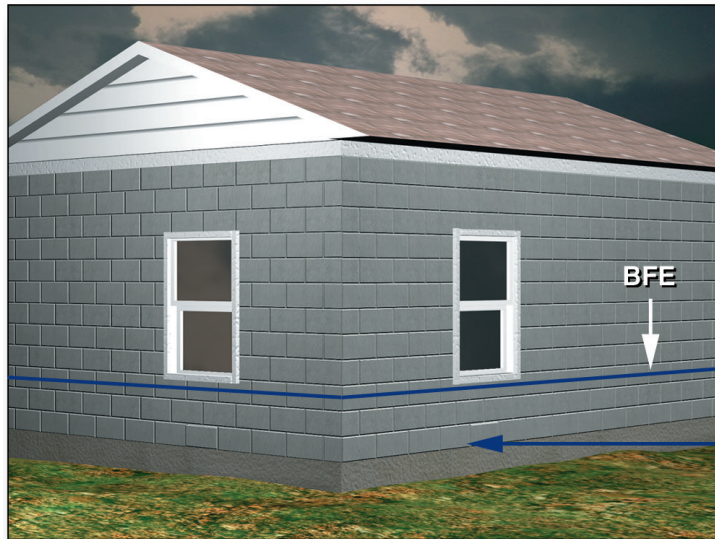
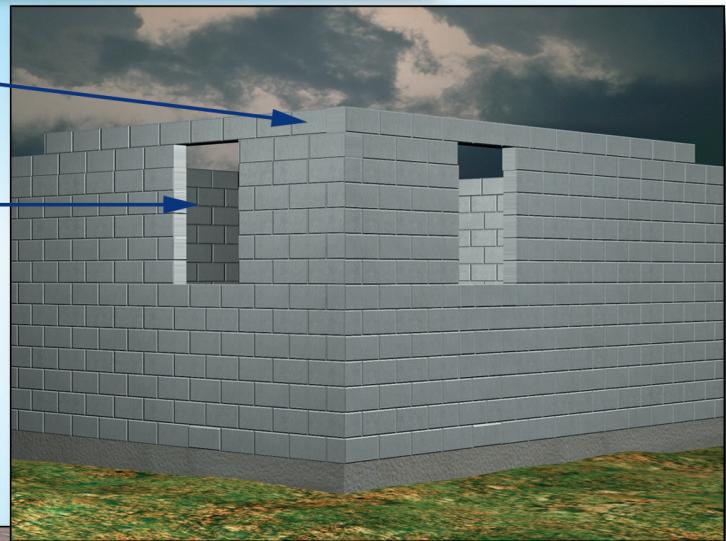
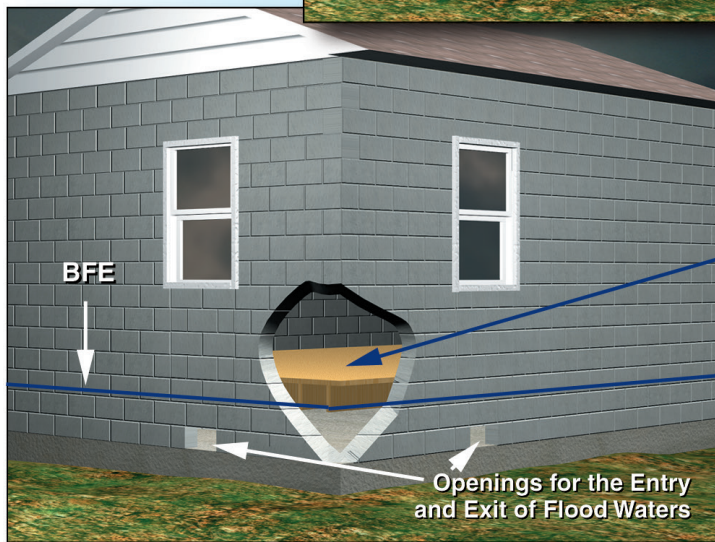
Figure 7
Technique 1 –
Extend the walls of
the house upward and
raise the lowest floor.

**House at the time
Hurricane Andrew
struck**

**Original Level
of the Lowest
Floor**

**Substantially damaged house undergoing
repairs that will bring it into compliance
with Miami-Dade County floodplain
management requirements**

**New,
Raised Floor**

**House after
completion of repairs**

1. Extend the walls of the house upward and raise the lowest floor (Figure 7).
2. Convert the existing lower area of the house to non-habitable space and build a new second story for living space (Figure 8).
3. Lift the entire house, with the floor slab attached, and build a new foundation to elevate the house (Figure 9).

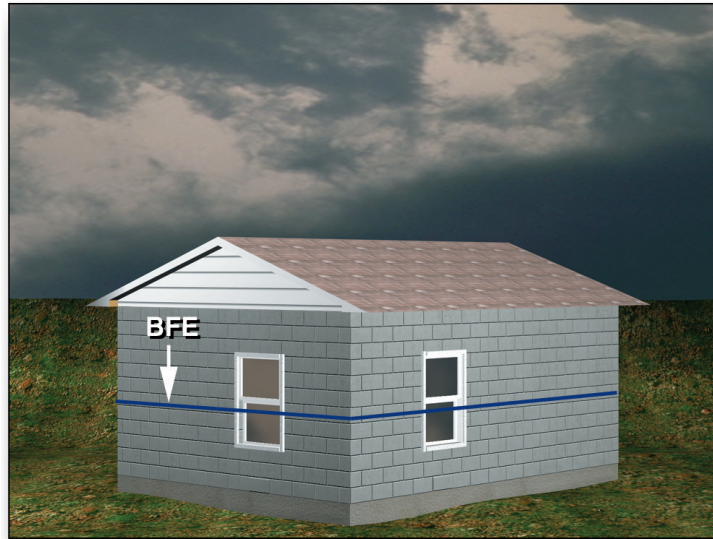
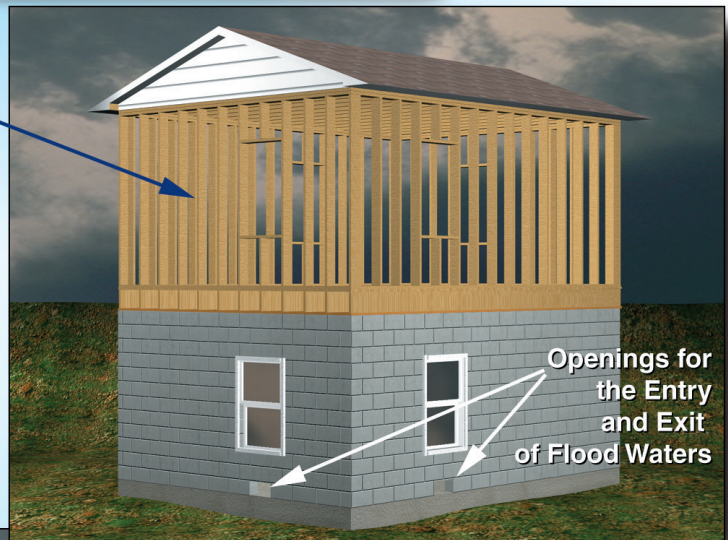
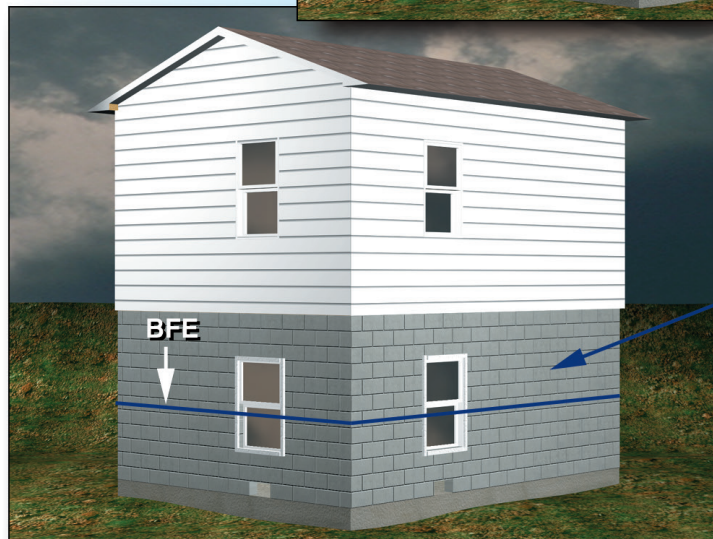
**House at the time
Hurricane Andrew
struck**

**New Second
Story Above
BFE**

**Substantially damaged house undergoing
repairs that will bring it into compliance
with Miami-Dade County floodplain
management requirements**

**House after
completion of repairs**

**Lower Area
Converted to
Non-Habitable
Space for
Storage,
Parking, or
Building
Access**

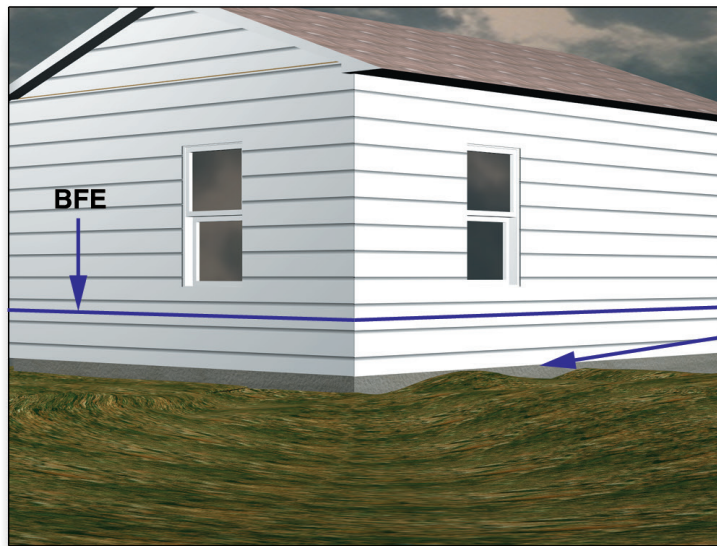
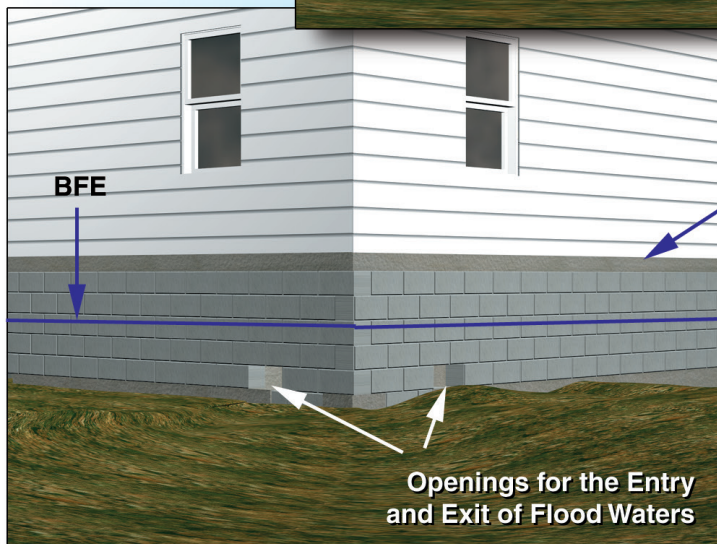
Figure 9
Technique 3 –
Lift the entire house,
with the floor slab
attached, and build
a new foundation to
elevate the house.

House at the time
Hurricane Andrew
struck

Support Cribbing

New Level
of the Raised
Lowest Floor

House after
completion of
repairs

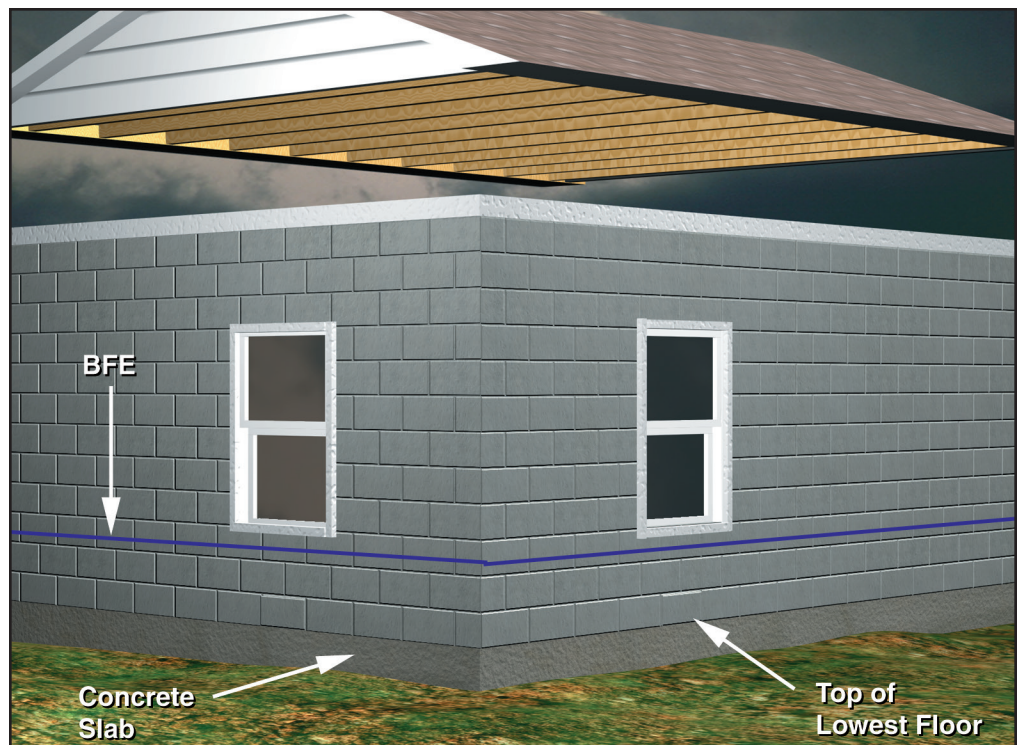
Figure 10
The first step in Technique 1 is removing the roof.

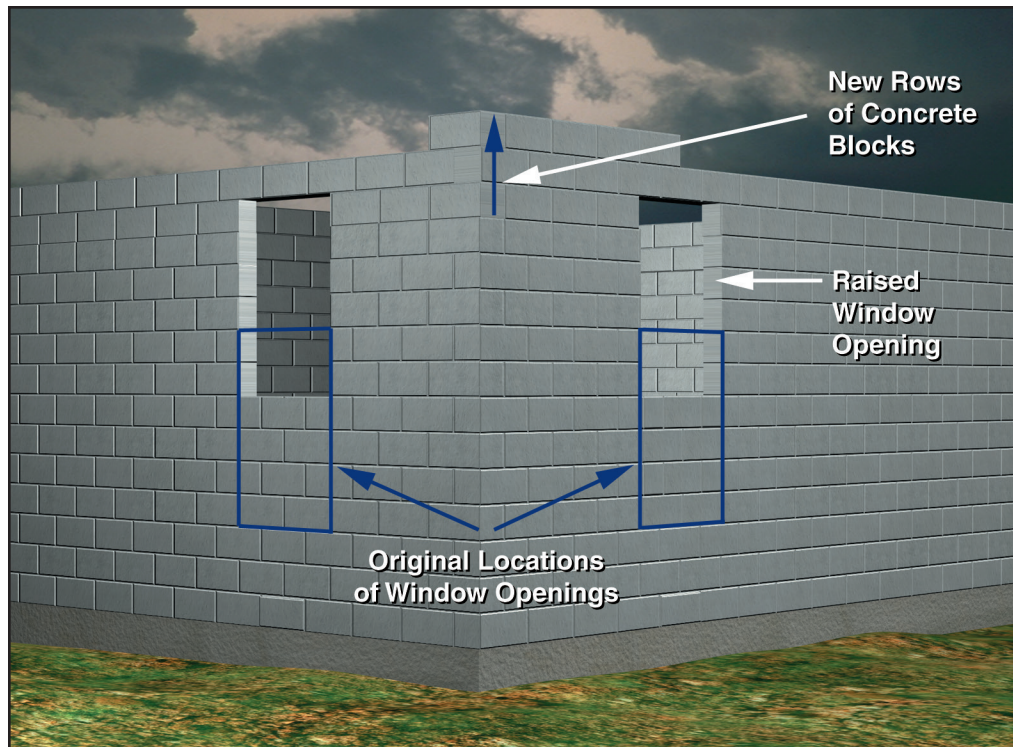
Figure 11

After the roof, windows, and doors are removed, several courses of concrete block are added to the tops of the existing walls and to the bottoms of the window openings (Figure 11). A corresponding number of blocks are removed from the tops of the window openings so that the size of the windows will remain the same. In addition, although not shown in Figure 11, concrete bond beams are formed in place at the tops of the extended walls to provide structural reinforcement.

The tops of the walls and bottoms of the window openings are raised with concrete blocks.

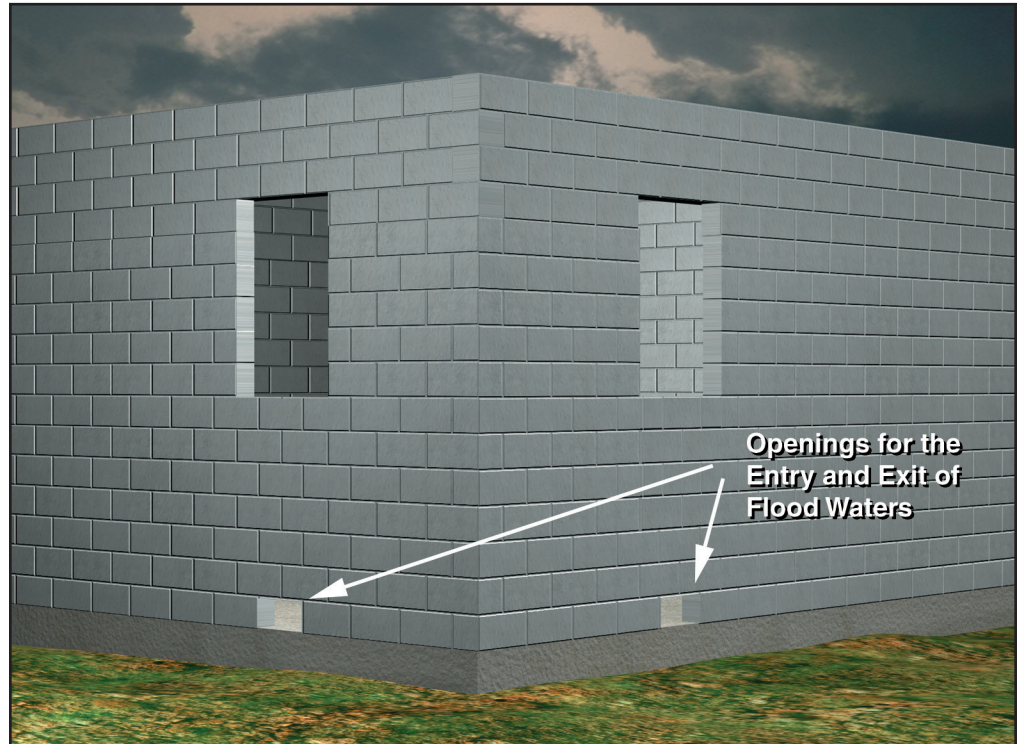
Blocks are removed from the walls of the house at selected locations within 1 foot of the ground (Figure 12). The resulting openings will allow flood waters to flow into and out of the lower area of the house so that the water pressures on both sides of the walls will remain the same. The roof and windows are then replaced, and a new wood-frame floor is constructed above the flood level (Figure 13).

Figure 12
Openings are created in the walls near the ground.

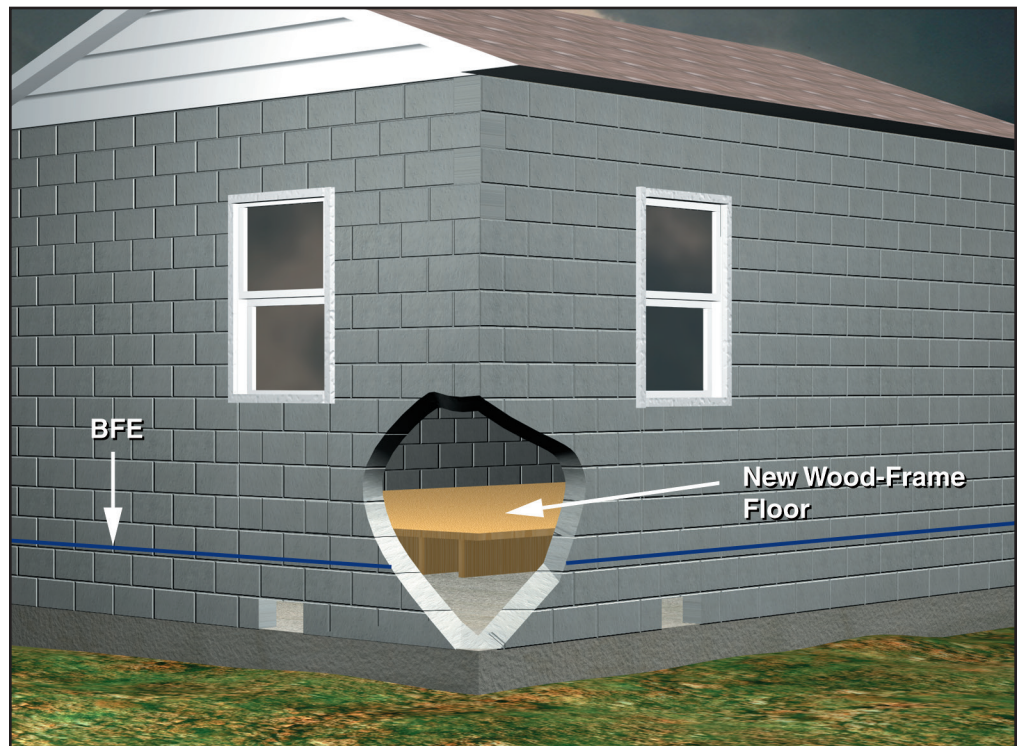
Figure 13
A new wood-frame lowest floor is constructed above the flood level, and the roof, windows, and doors are reinstalled.

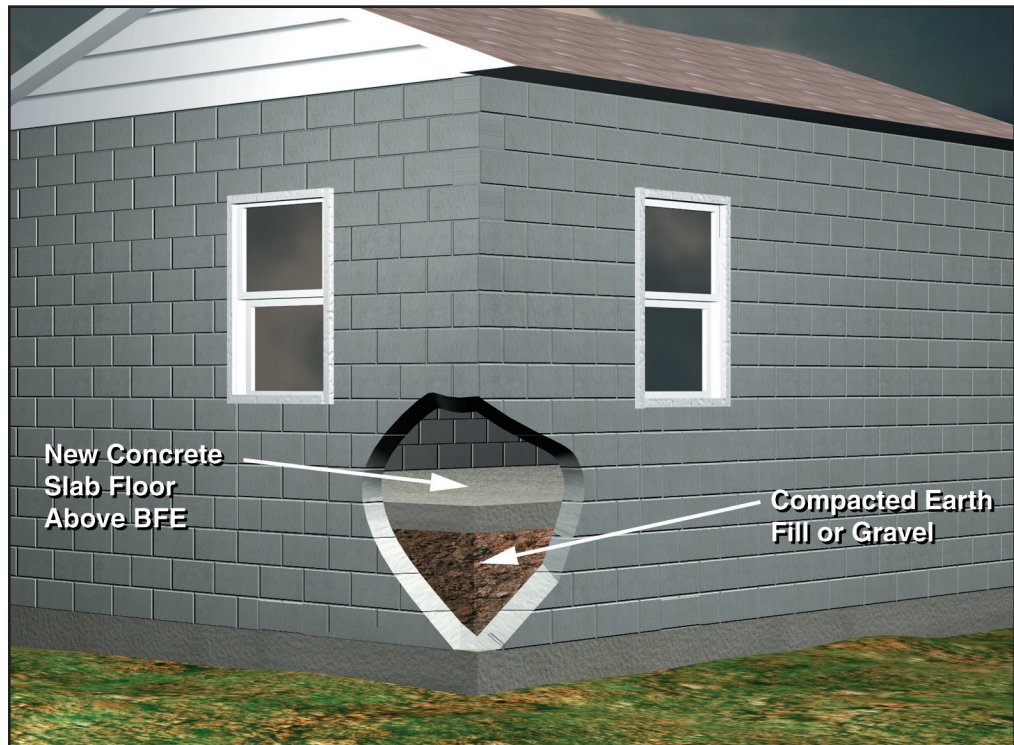
A homeowner who chooses Technique 1 may decide to build a new concrete slab floor instead of a wood floor (Figure 14). When this option is chosen, compacted fill dirt or gravel is placed on top of the old slab and the new slab floor is poured on top. Because the area below the new floor is filled with dirt or gravel, wall openings are not required.

Figure 14
An alternative to building an elevated wood-frame floor is installing a new, elevated concrete slab floor on fill placed over the old slab.

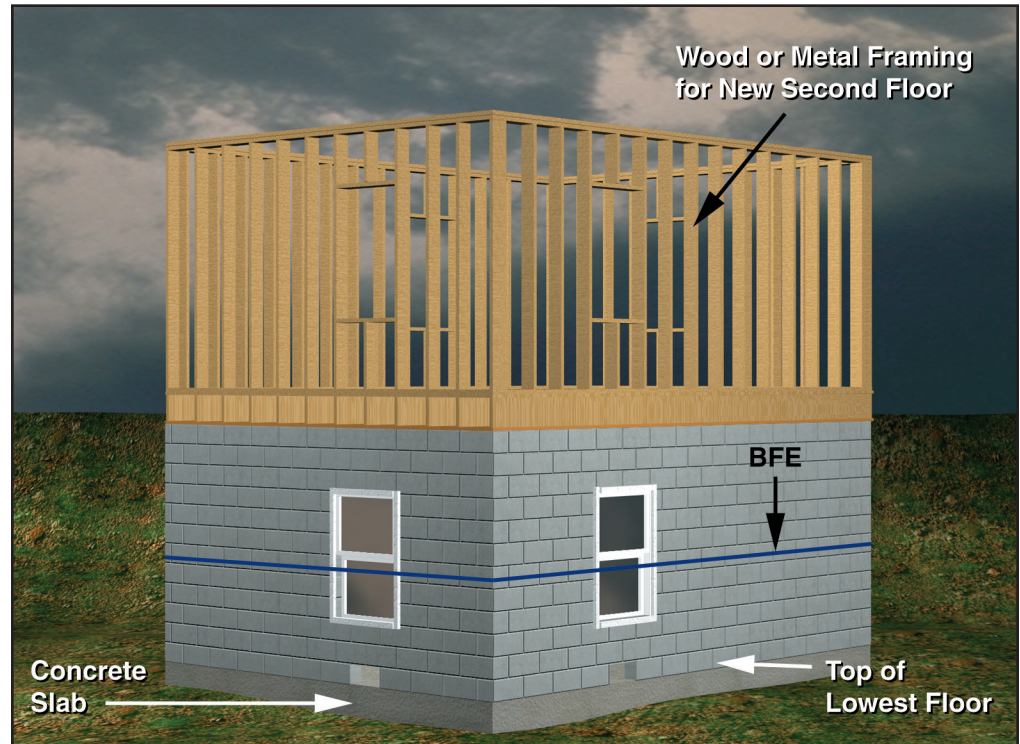
Figure 15
The new second-story floor and walls are built on top of the existing lower story.

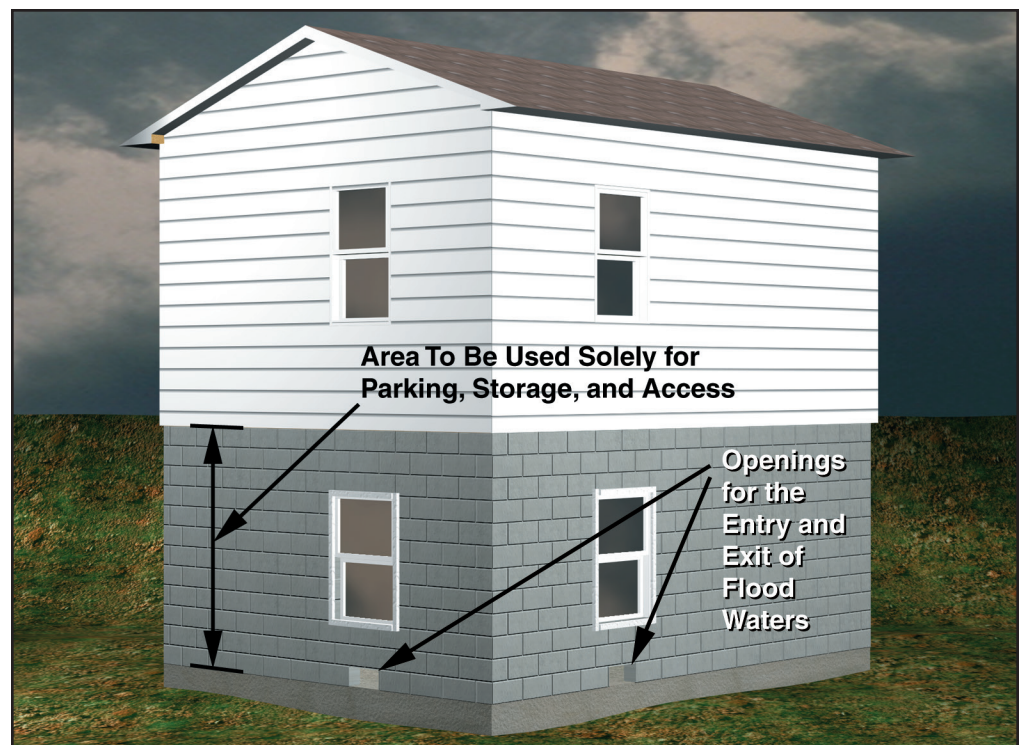
Some homeowners prefer that the second story be constructed of masonry, but wood- or metal-framing is more common, primarily because it is lighter and less expensive. The roof is replaced, and blocks are removed from the walls to allow flood waters to enter and exit. Exterior sheathing is then added to the framed walls of the second story, the new windows are installed, and siding or stucco is applied to the sheathing (Figure 16).

Figure 16
The new second-story walls are covered with siding or stucco.

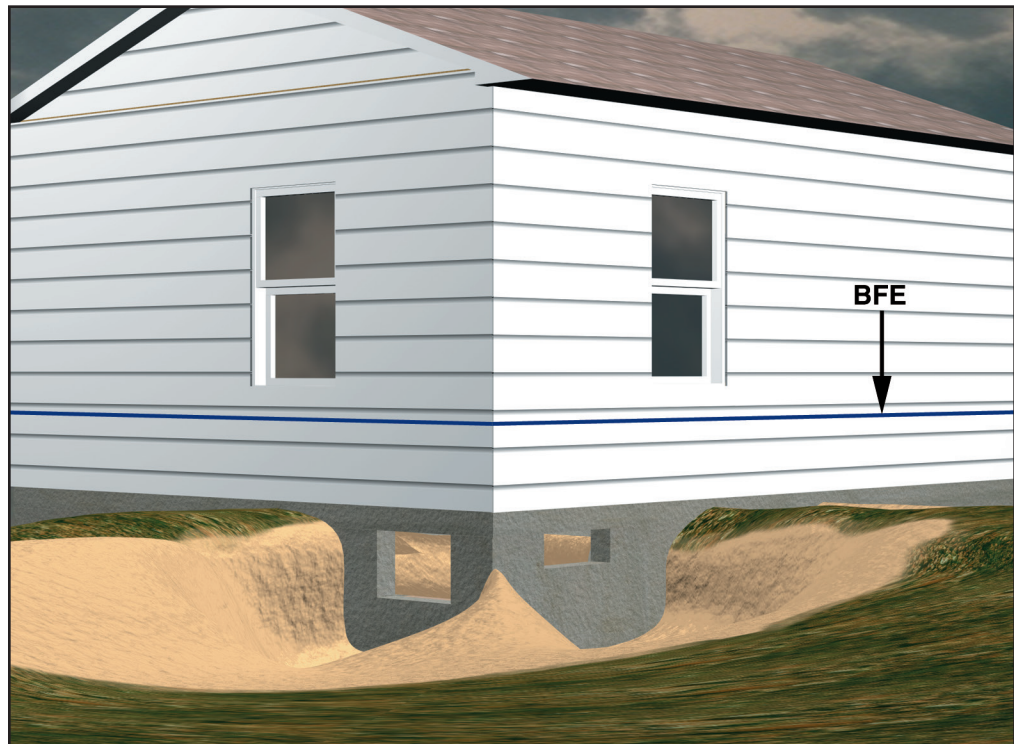
Figure 17
Trenches and tunnels under the slab provide access for the jacks and I-beams that will lift the house.

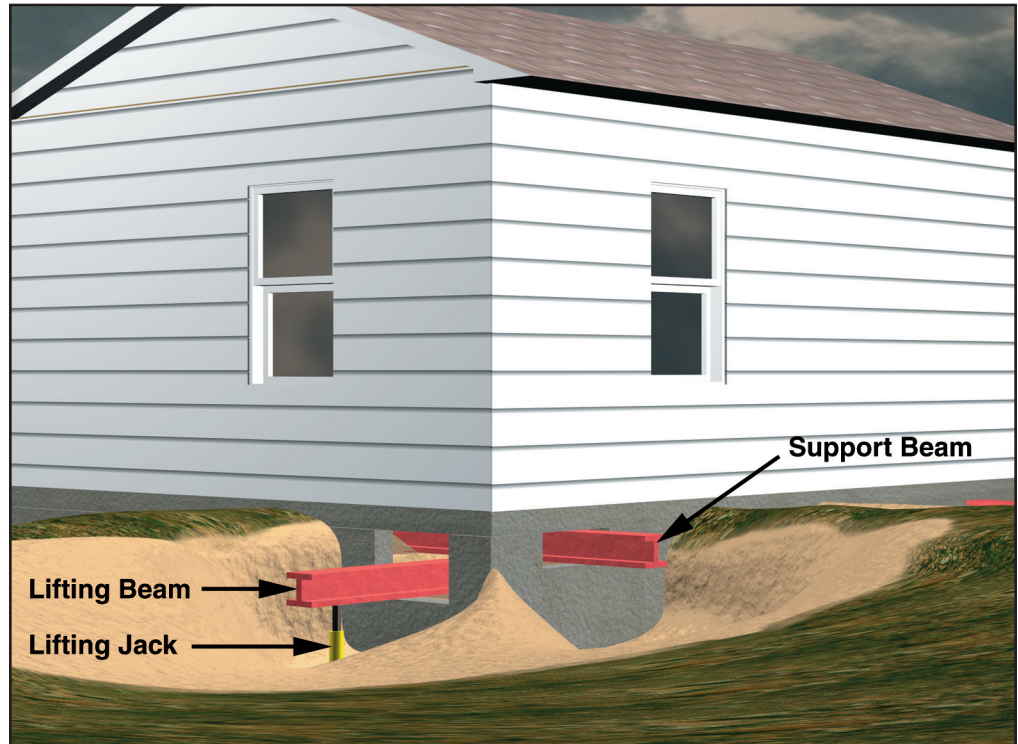
Figure 18
With I-beams and jacks in place, the house is ready to be lifted.

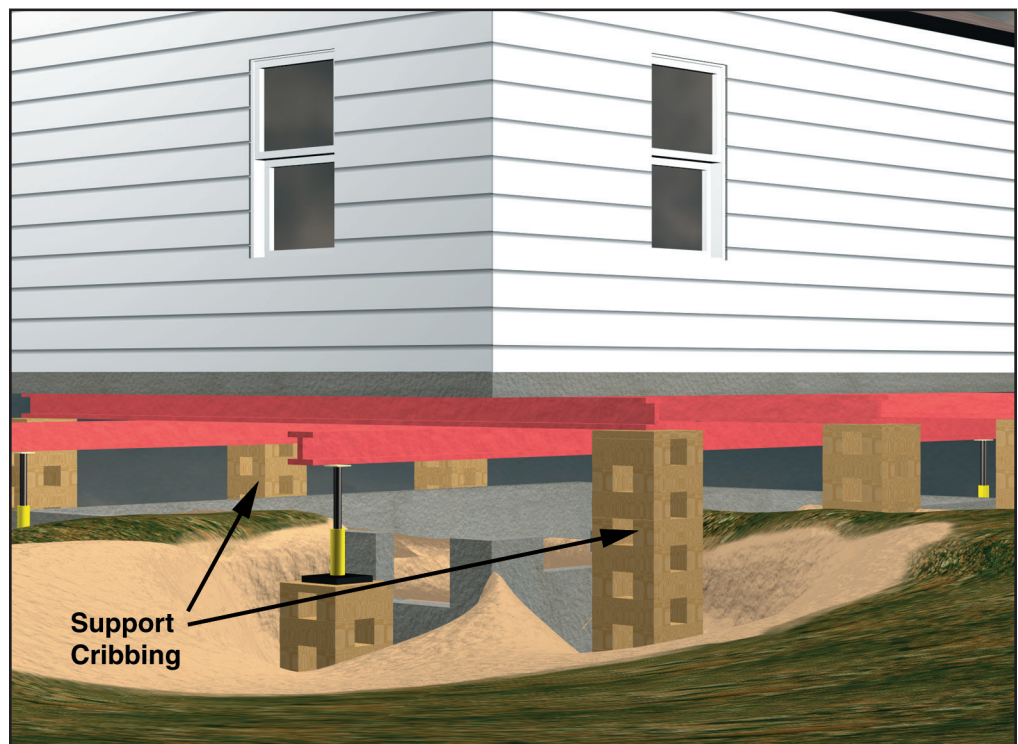
The house is then jacked up. When the jacks have extended as far as possible, the house must be supported temporarily while the jacks are raised. Both the house and the jacks are usually supported on “cribbing”—temporary piles of crisscrossed timbers (Figure 19). The jacks are then used to raise the house higher.

Figure 19
The house is temporarily supported on cribbing.

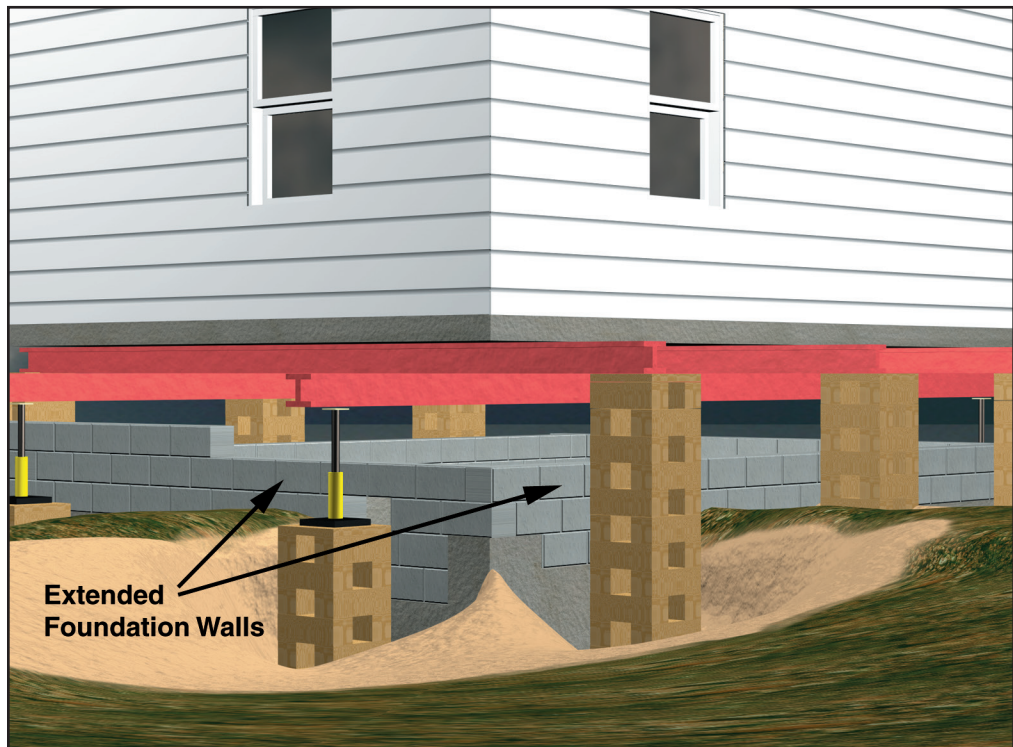
This process is repeated until the house is raised to the desired height. The foundation walls are then extended upward with additional rows of concrete block (Figure 20). As in the previous techniques, openings are made in the walls within 1 foot of the ground so that flood waters will be able to flow into and out of the area below the elevated floor. The jacks and beams are removed, and the openings left around the beams are filled with blocks (Figure 21).

Figure 20
New, extended
foundation walls are
constructed with
concrete blocks.

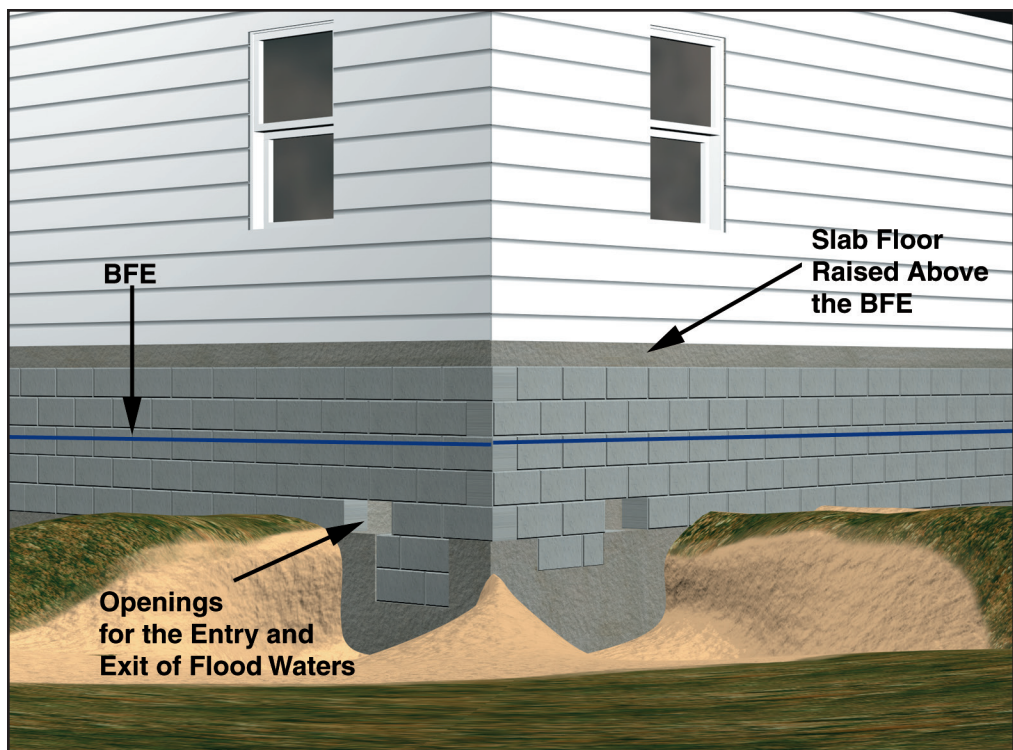
Figure 21
Elevated house and
slab on new, extended
foundation walls.

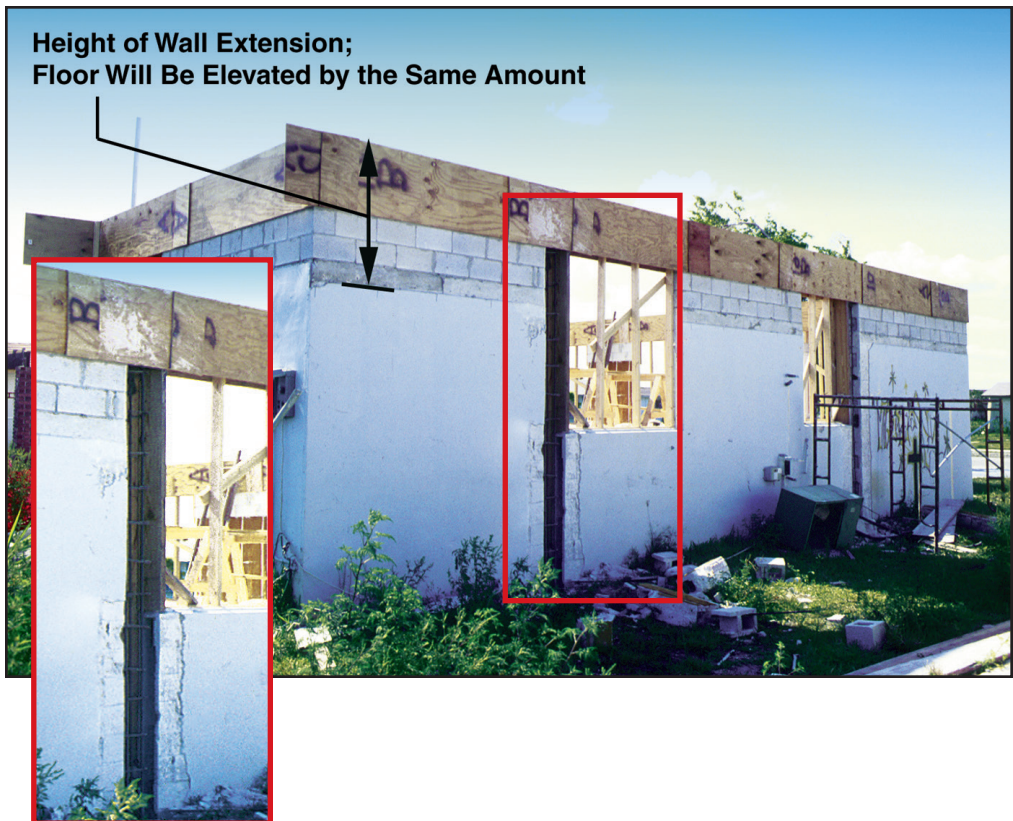
Another view of the extended walls. The vertical cuts in the walls next to the windows are for concrete tiedown columns that will be cast in place to further strengthen the extended walls against wind loads. The owner of this house was able to meet the elevation requirement by raising the floor only a few feet, as indicated by the amount that the walls have been extended.

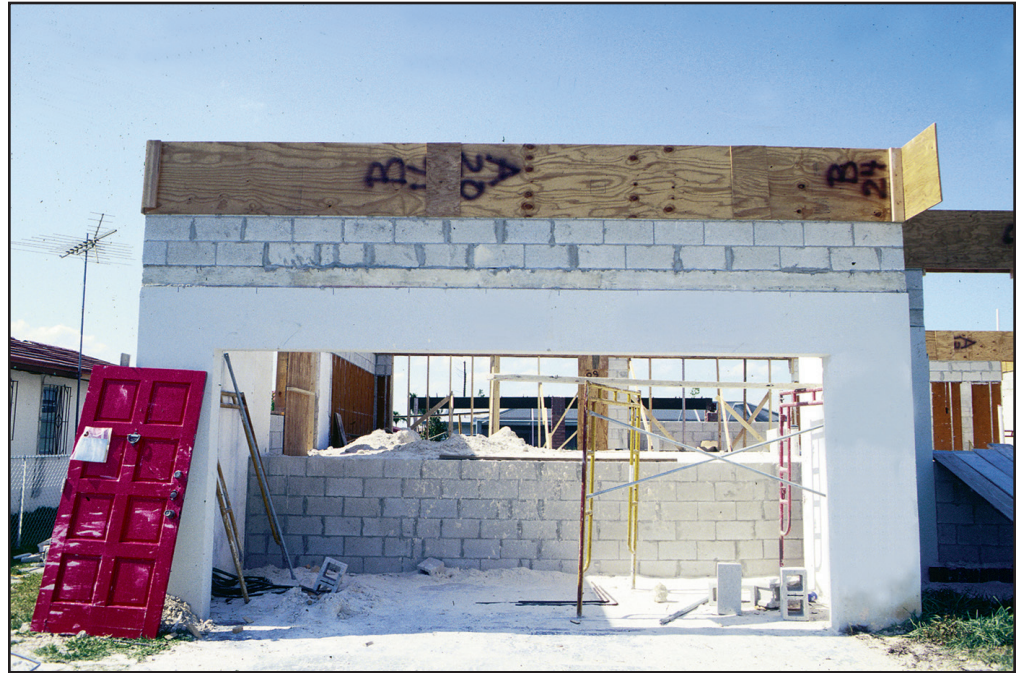
Figure 25

This view through the garage door reveals the different levels of the elevated slab floor, in the background, and the unelevated garage floor.

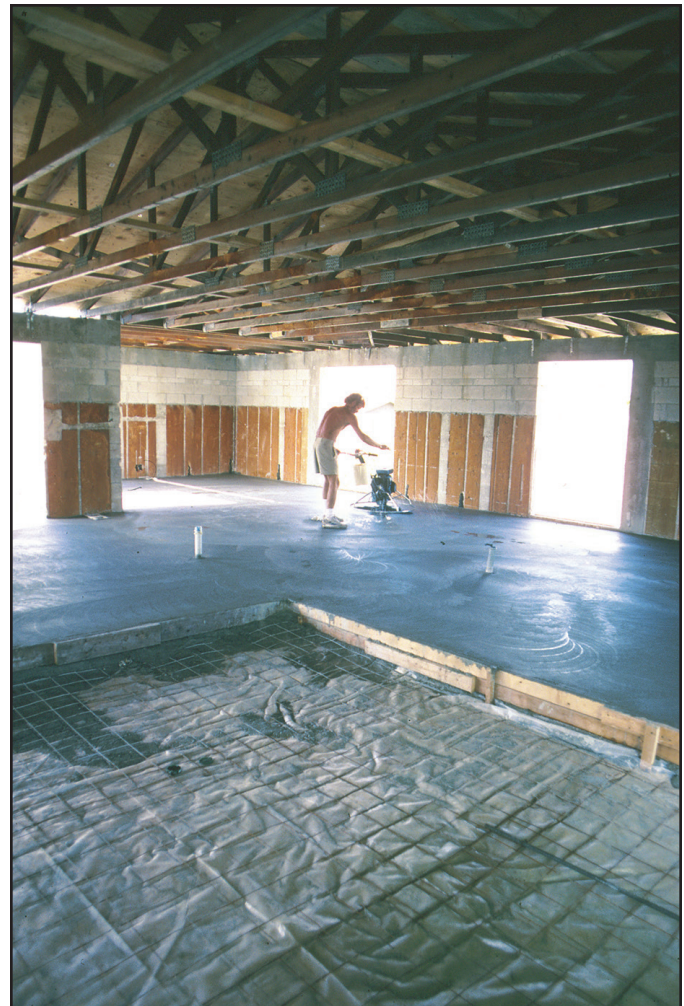
**Figure 26**

The roof has been rebuilt with the salvaged trusses, and most of the new concrete slab has been poured on top of the sand fill. The open area in the foreground, where plastic sheeting and wire reinforcement can be seen on top of the sand fill, is where the remaining part of the slab will be poured.

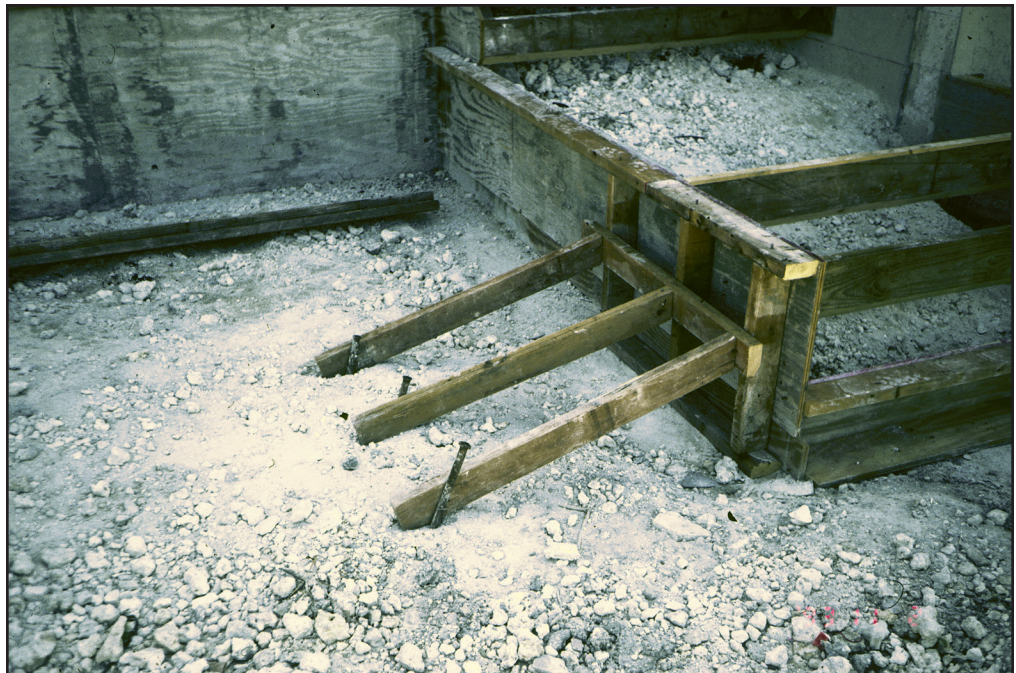
Figure 33
Wood framing for a new concrete staircase that will provide access to the elevated floor.

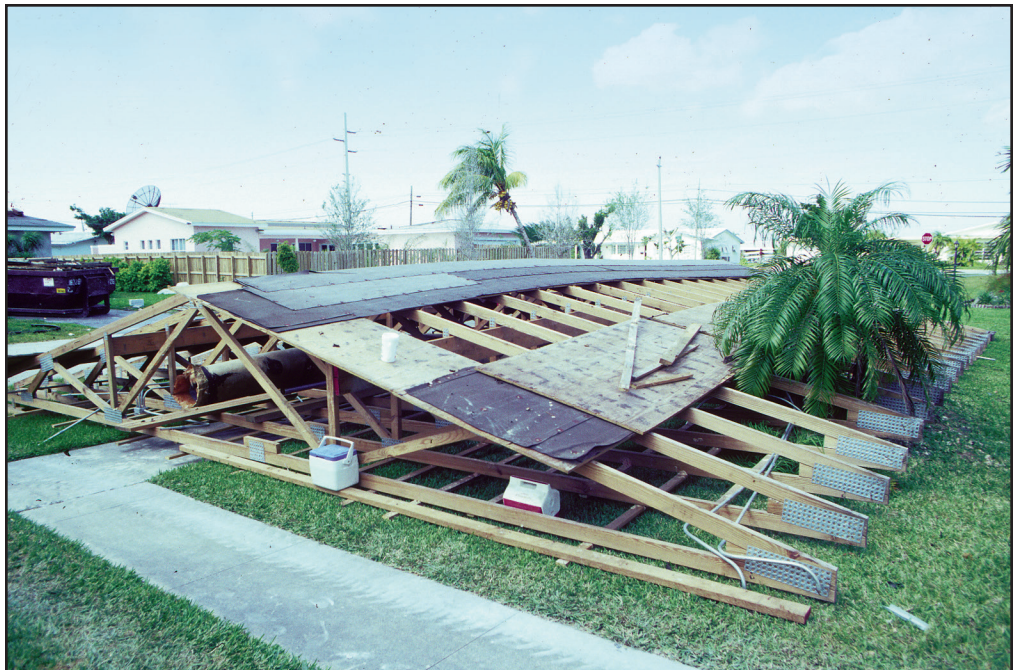
The roof of this house was removed as a single piece; the trusses were held together with bracing and portions of the original roof sheathing. This approach made it easier to reinstall the roof at the end of the project.

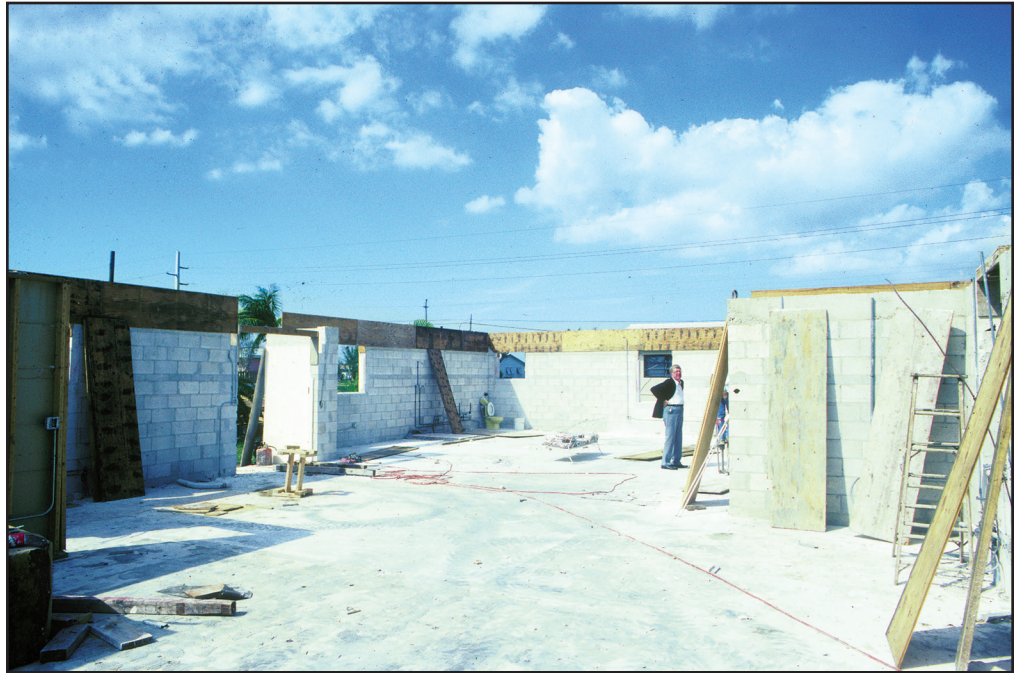
Figure 40

After the roof was removed and the storm-damaged interior gutted, the walls of the house were extended upward and a new bond beam added at the top.

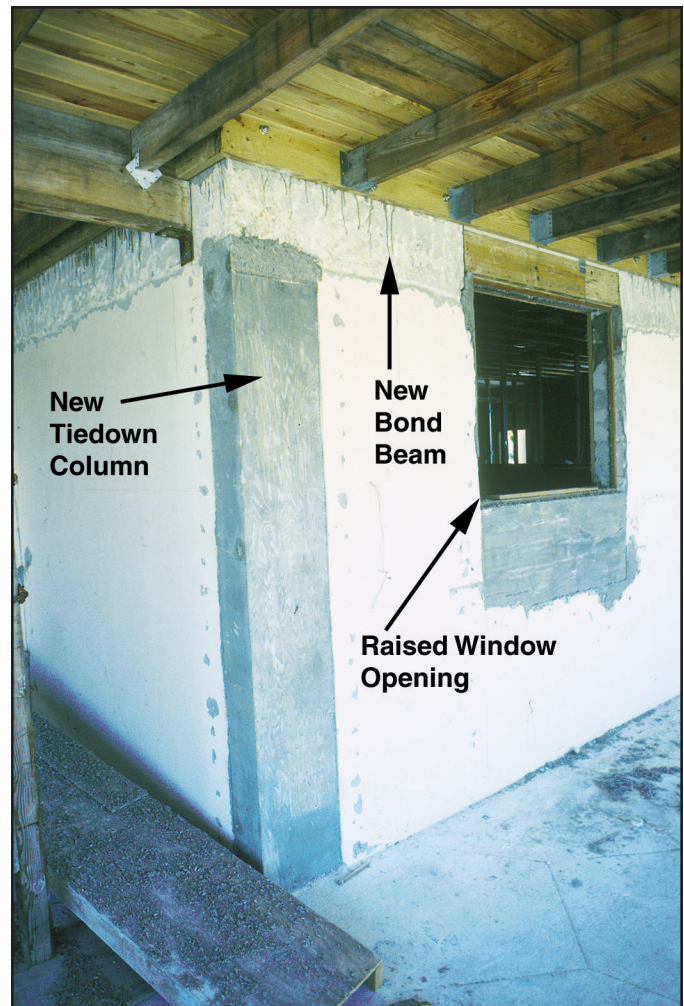
**Figure 41**

Note the new bond beam at the top of the extended wall, the new concrete tiedown column at the corner, and the raised window opening.

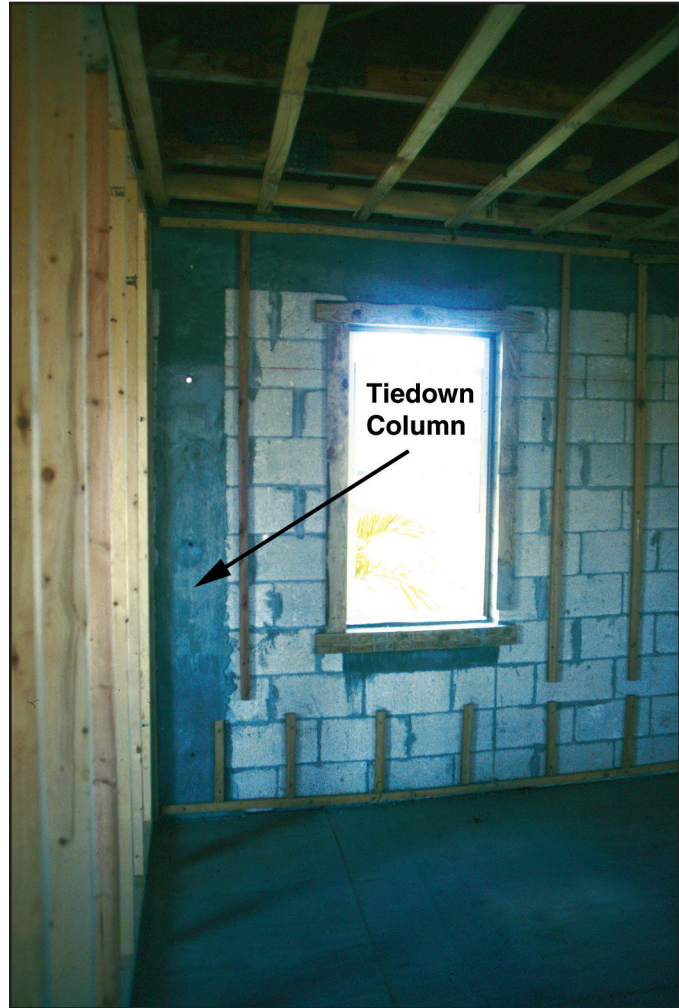
Figure 46
Concrete tiedown columns, such as the one to the left of the window in this photograph, were also used in this house.
