Above the Flood: Elevating Your Floodprone House

FEMA 347/ May 2000

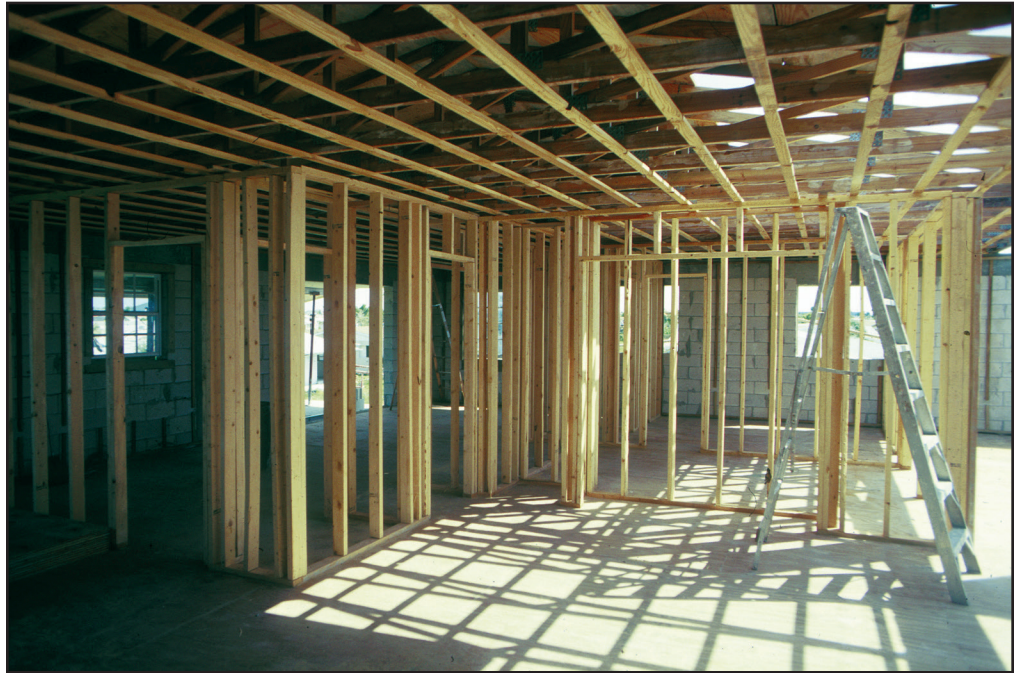
Figure 48
Wood 2 by 4 studs
were used to frame
the interior walls of
the second story.

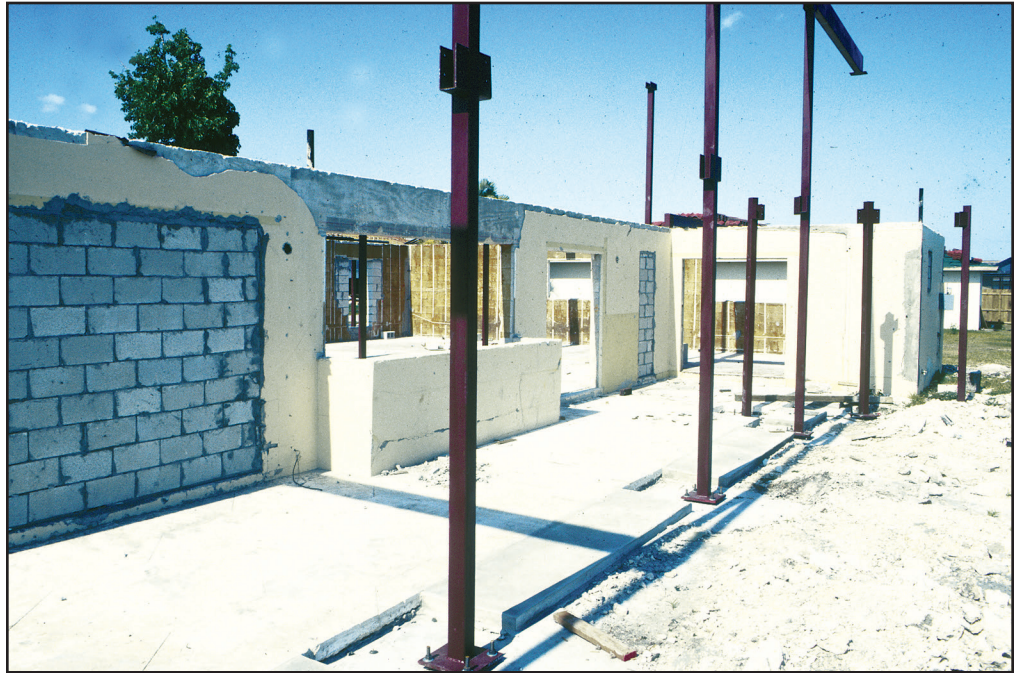
Figure 52

The existing first-story walls have been strengthened by the addition of concrete block. Metal columns and beams have been added to help support the new second story.

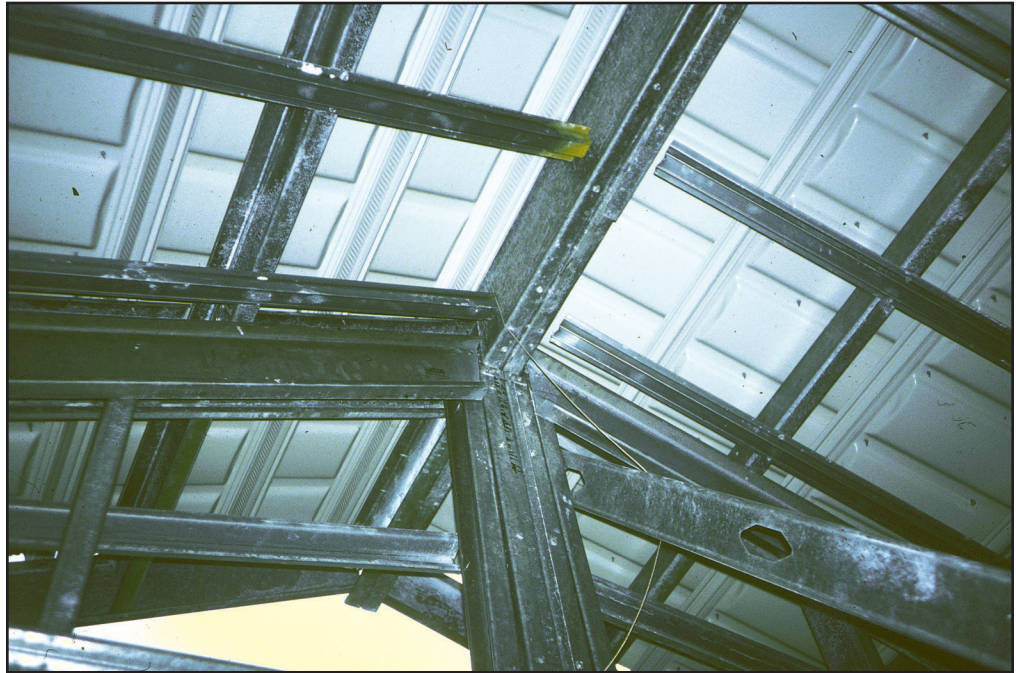
One advantage of metal framing is its relatively light weight. An additional advantage is that the screws used to attach metal-frame components provide strong connections.

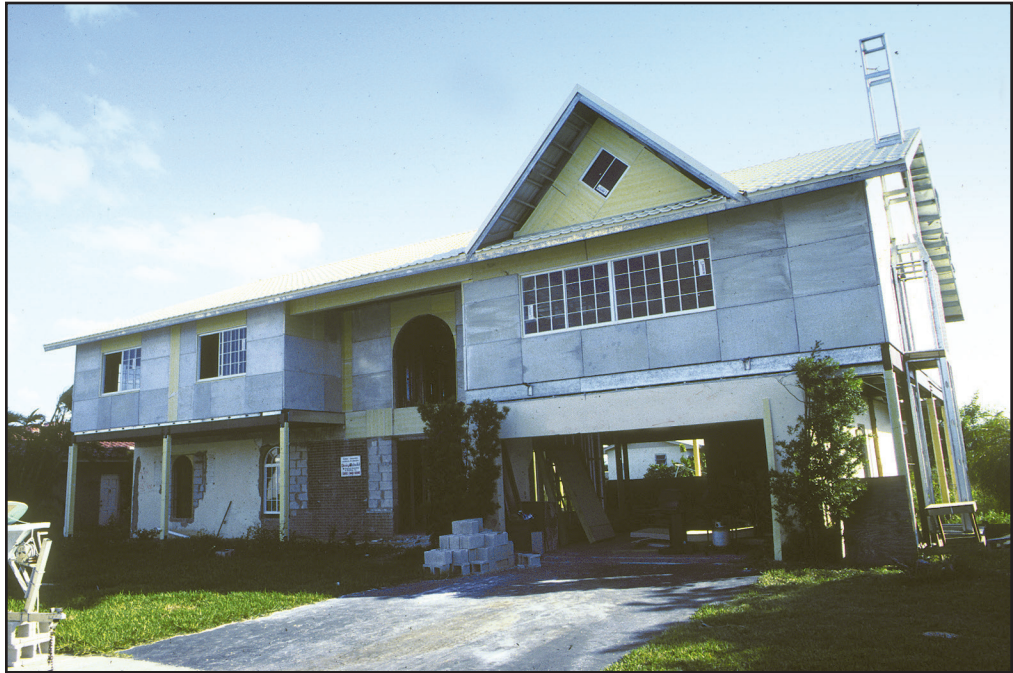
Figure 58

The new second story
nears completion.
The roof is made of
formed metal panels.

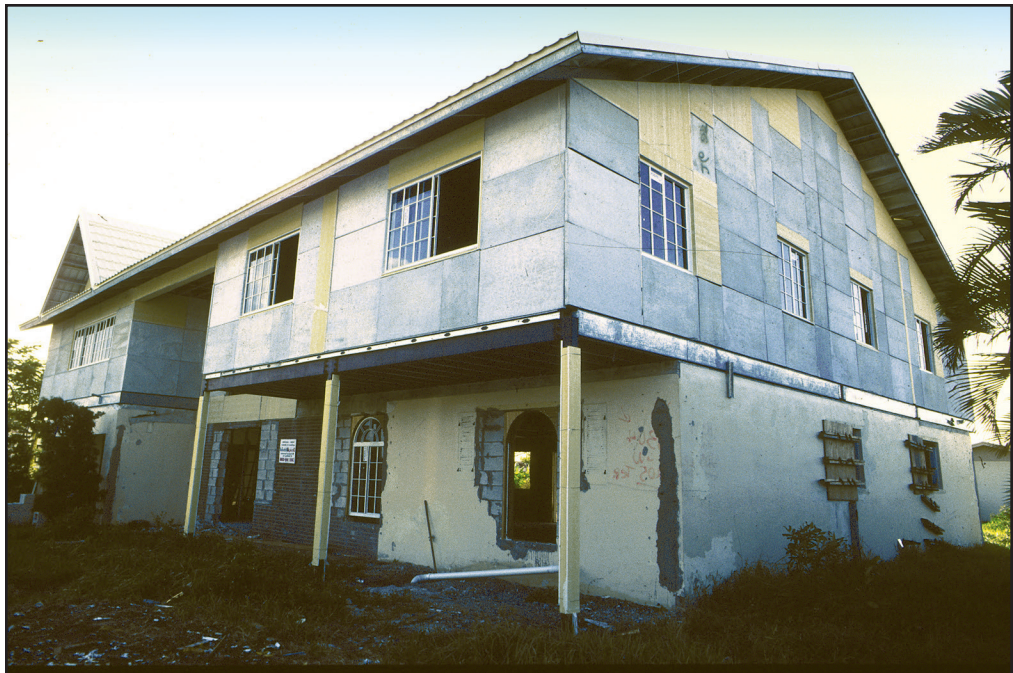
Figure 59

The exterior
walls consist of
prefabricated
concrete panels.
Innovative techniques
such as those
employed in this
project are helping
homeowners who
need practical and
economical methods
of repairing and
protecting their
houses.

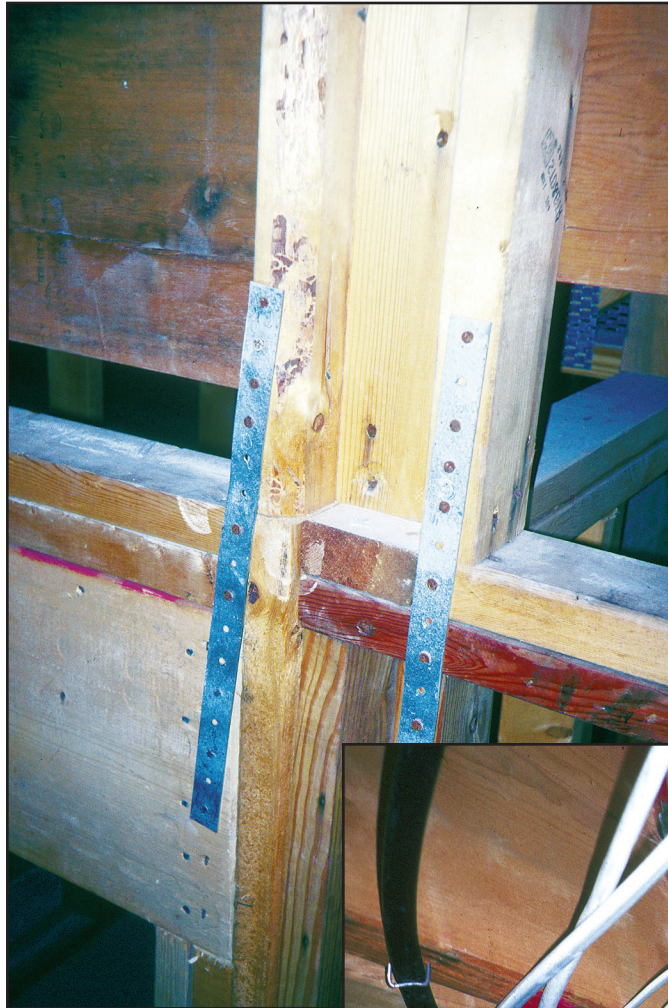
Figure 70

Metal hurricane straps are used to tie the structural members together and create a continuous load path from the roof to the foundation.

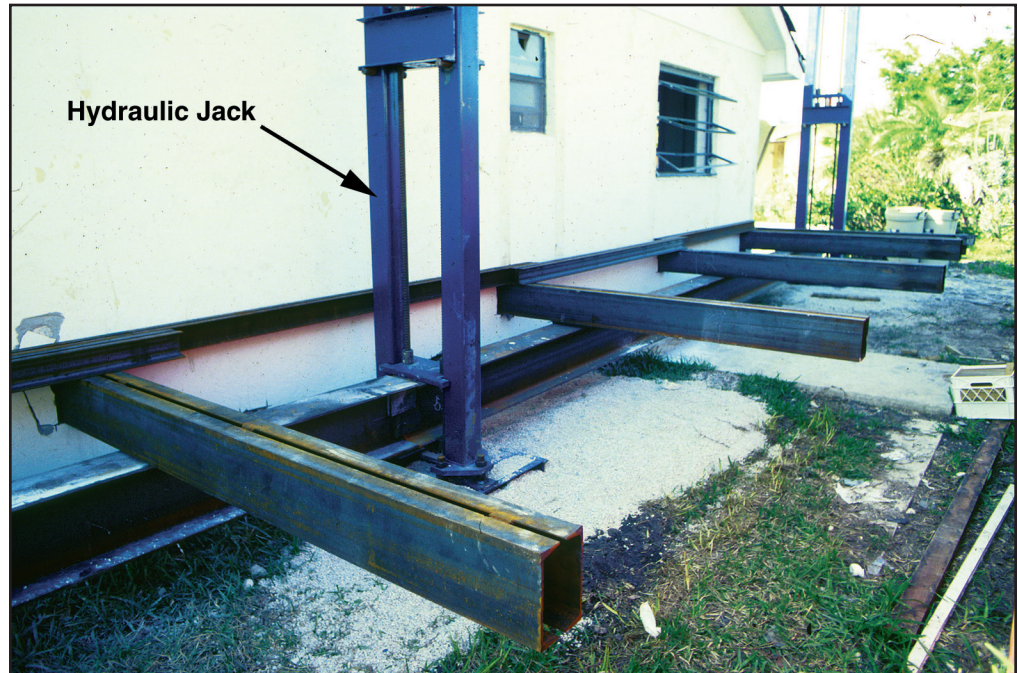
Figure 74

In this variation of Technique 3, steel beams are inserted through the walls of the house rather than under the slab. The beams span the length and width of the house and cross one another inside to create a grid. Outside the house, the beams rest on larger beams that will be raised with hydraulic jacks.

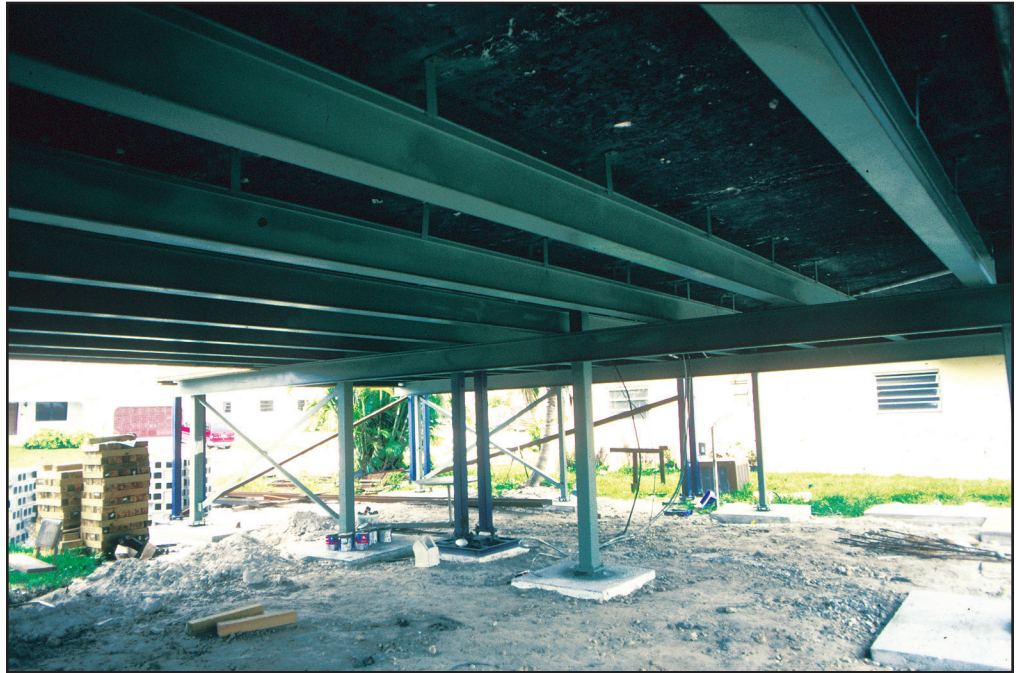
Figure 82

While the jacks and beams supported the house, new steel foundation members were installed below.
