BRAMALL HALL, STOCKPORT

Conservation Management Plan September 2010

BRAMALL HALL CONSERVATION MANAGEMENT PLAN
for STOCKPORT METROPOLITAN BOROUGH COUNCIL

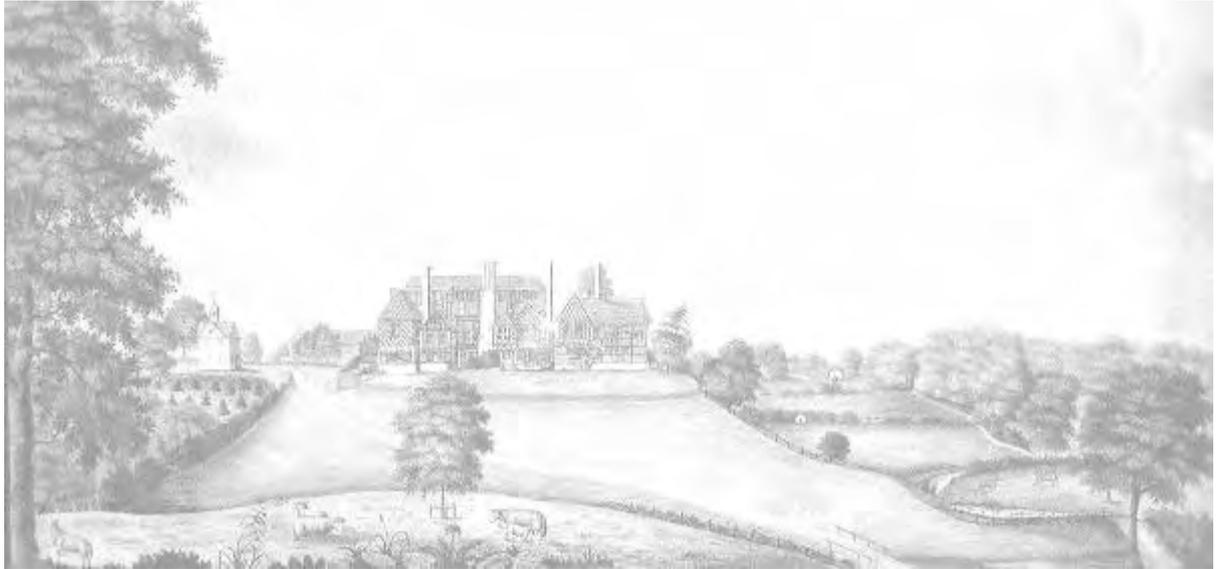
Figure 11: Bramall Hall from the east in the late 18th century overlooking parkland and fields

The view from the east (*Figure 11*) shows a narrow grass terrace in front of the hall enclosed by a wall and giving way to a large parkland area across which the main drive from Bramall Green passes. A newly planted parkland tree protected from the grazing sheep by a tree guard is also depicted. Parkland trees are also denoted to the south of the hall including a new plantation below what appears to be a gazebo or a dovecote or both, giving excellent views over the park towards the Peak District hills. Lady Brook valley to the north of the hall is shown as a series of hedged meadows terminated by woodland. Regarding the gazebo / dovecote, no physical evidence remains and it has been suggested that the garden building shown in the early view could have combined both functions.¹⁹ Its "...position suggests that the building in part at least, served as a pavilion or gazebo, perhaps commanding a view over the adjacent area of the early park, including the possible adjacent fish pond. Similarly, the provision of a cupola is consistent with the building, again at least in part, being used as a dovecote. It is possible that it combined both functions..."²⁰

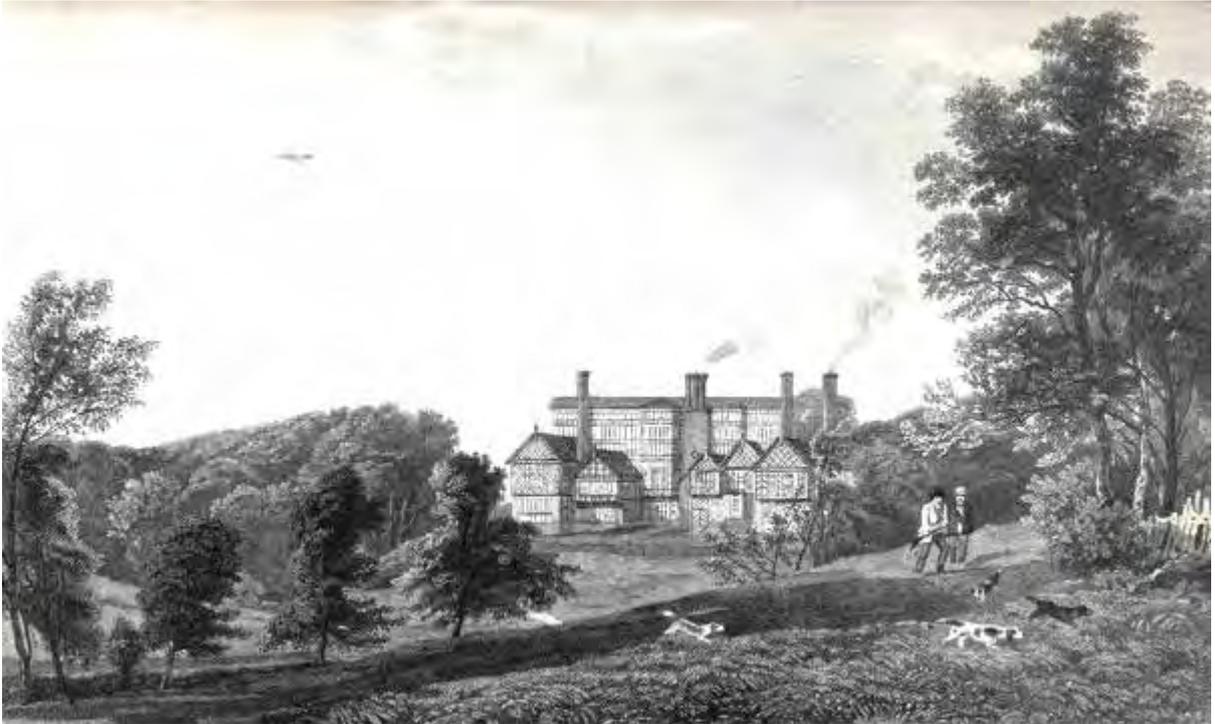
Figure 13: Bramall Hall from the east engraving by Peter de Wint c1809

Engravings of the Hall by Peter de Wint (c1809) feature the long gallery dominating the upper storey of the hall and the parkland setting from the east.²¹ The engravings show a few further details of the landscape. The outline of the lawn area in front of the west front appears to be purely figurative although the tree and shrub beds either side of the hall appear to have flowering rhododendrons and yew trees in the mix (*Figure 12*). The engraving from across the valley to the east depicts an essentially sylvan setting designed to showcase the remarkable site of the hall with its spectacular long gallery dominating the roofline (*Figure 13*).

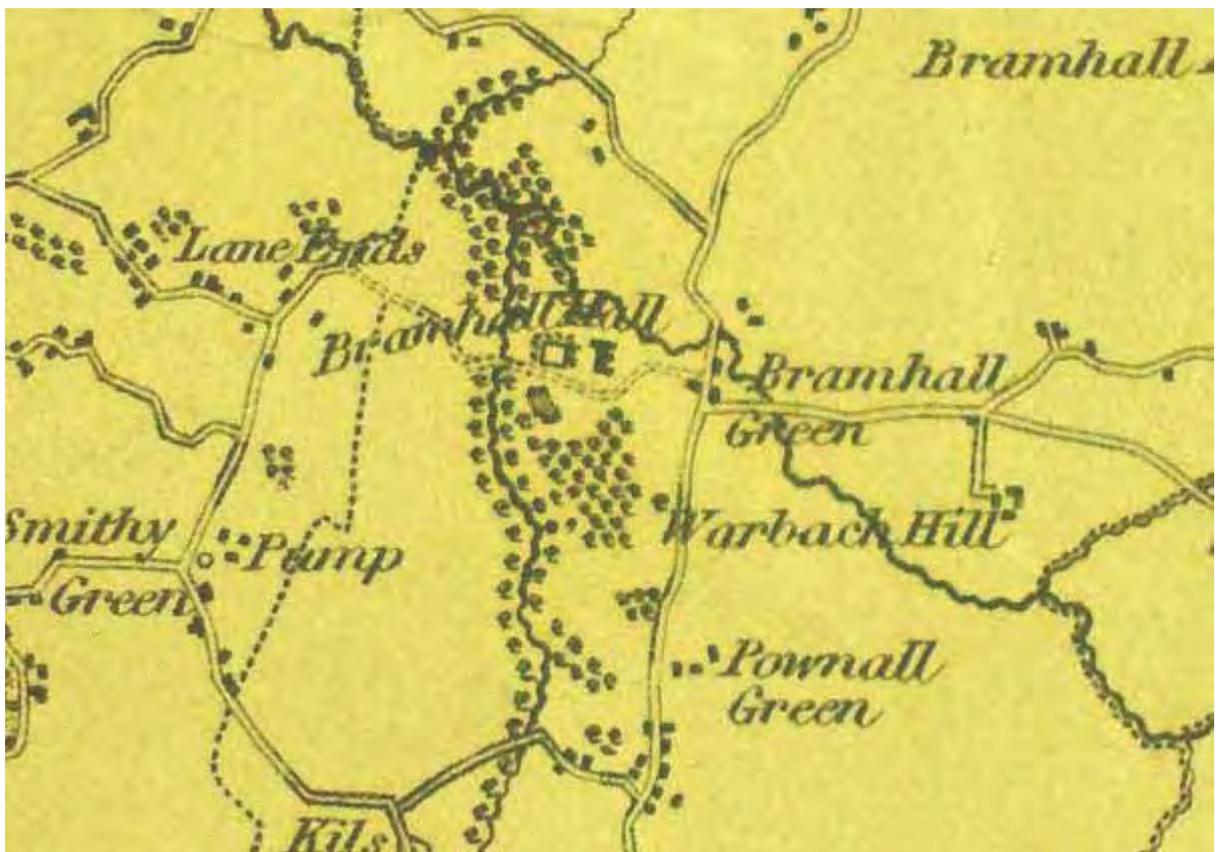
Figure 14: Detail from Greenwood's County Map of Cheshire 1819

Greenwood's County Map of Cheshire 1819 (*Figure 14*) shows a well treed landscape with the main entrance drive from Bramhall Green to the east and a back drive from Lane Ends to the west. A walled garden surrounded by a line of single trees is indicated to the west of the hall, approximately in the same position as today's walled kitchen garden. A fishpond to the south of the walled garden is denoted and Carr Wood is represented by an irregular block of dense trees. Intriguingly, the main drainage tributary feeding into Lady Brook is depicted running to the west of the walled garden through today's Bog Garden and the trough between the play / picnic area and the park's western boundary. This is no

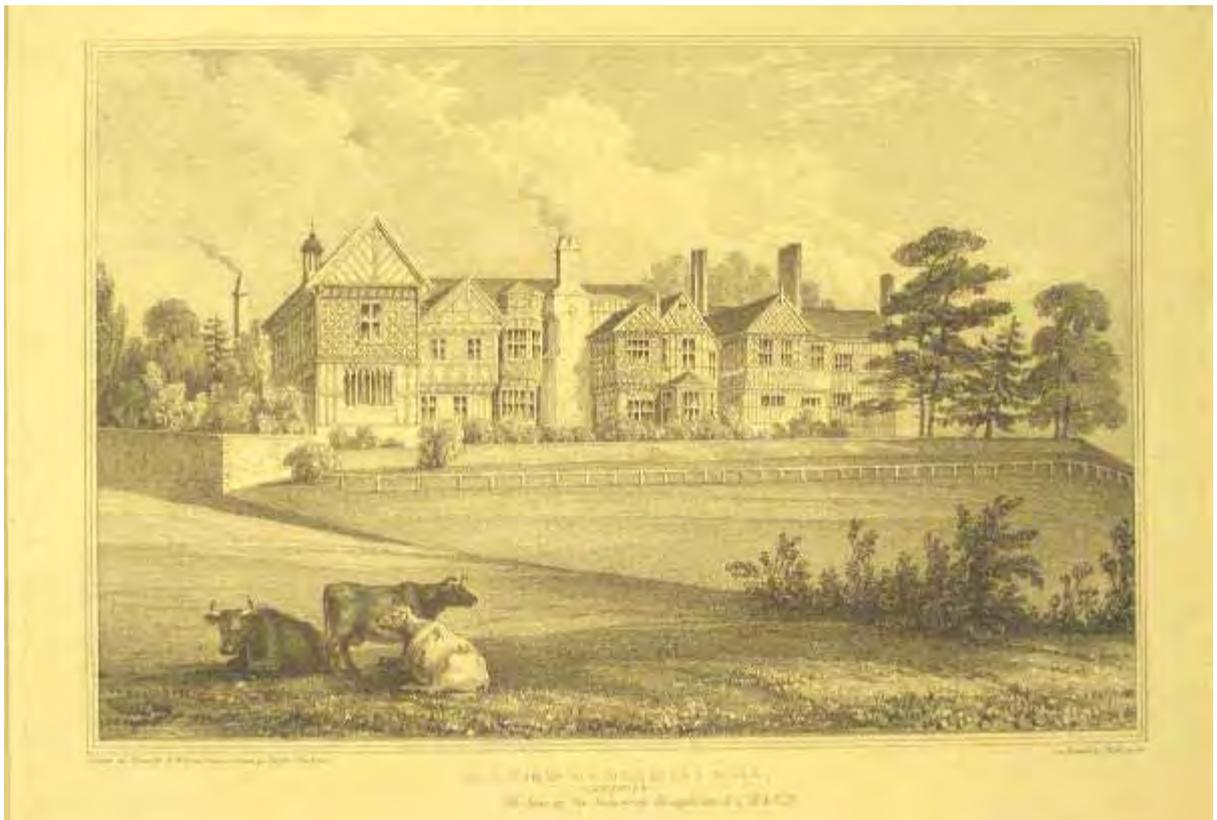
Figure 16: NE View of Bramall Hall The seat of Sir Salusbury Humphreys. Drawn on stone by W. Walton from a sketch by Ewan Christian (1836)

An engraving of 1836 of Bramall Hall – *The Seat of Sir Salusbury Humphreys* – shows the hall from the east and depicts open parkland grazed by cattle (*Figure 16*). The hall is fronted by a narrow terrace retained by a low stone wall with the grass bank below enclosed by a post and rail fence. Shrubs are planted directly outside the east front of the hall and building itself is framed by a group of three trees on the northern corner and a dense group of mixed planting on the south side of the hall suggesting a small garden area. On the west side a circular lawn is shown directly in front of the hall (*Figure 17*).

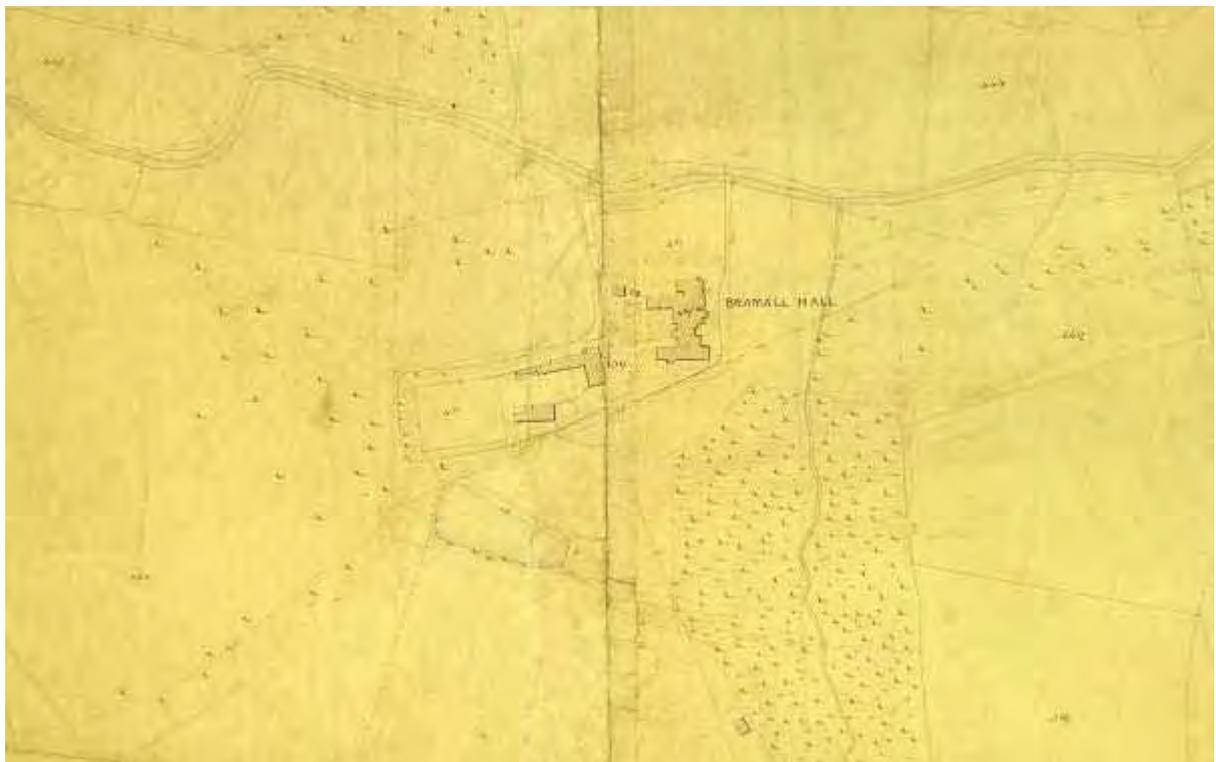
Figure 18: Extract from 1841 Tithe Map

The Tithe Map of Bramhall 1841 (*Figure 18*) shows the hall in a much larger parkland setting including the 'Park' to the west of the hall and a smaller area named 'Park front of Hall' below the eastern garden terrace. The western boundary of the western park area is bordered by woodland creating enclosed parkland. The area to the south of the Hall is also a large open area referred to as the 'Meadow'. The east drive from Bramhall Green is ornamented with parkland trees and a new plantation is shown at the start of the drive on what was previously known as 'Hillfield'. These details are also shown on the later first edition OS Map of 1872 (*Figure 22*).

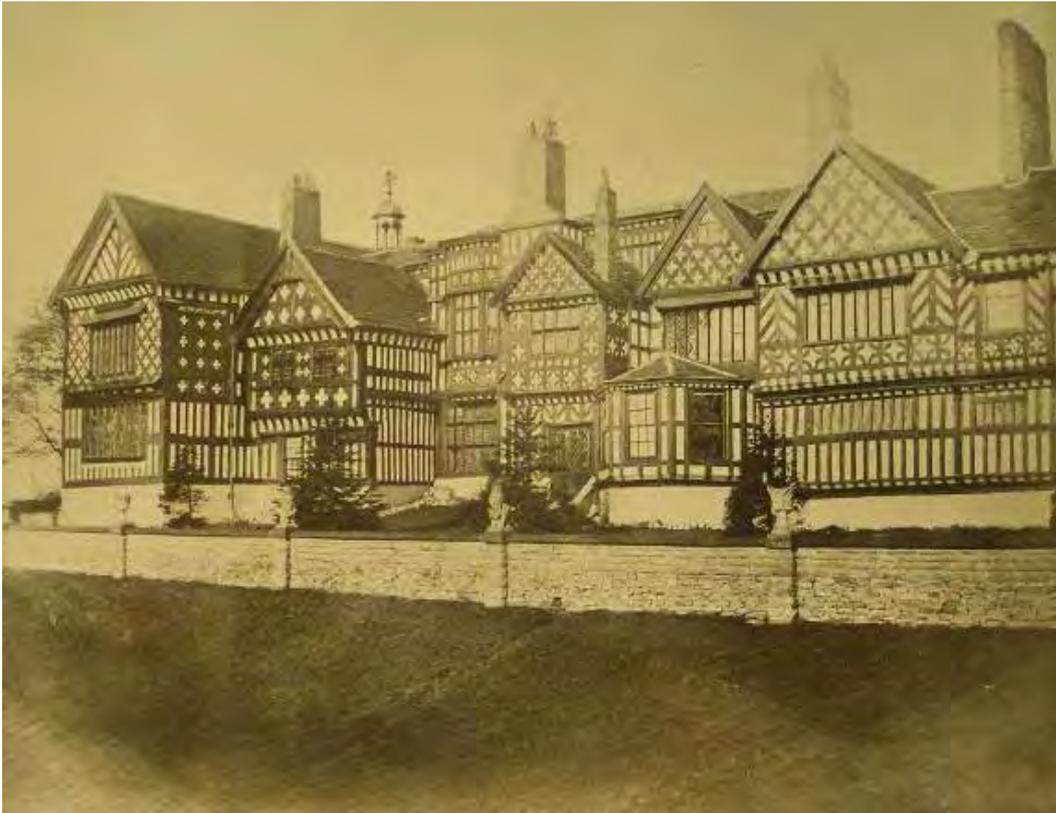
Figure 26: A close up view of the east terrace (nd but prior to Nevill changes). Davenport's terrace was built of stone, being roughly coursed at the base and regularly coursed on top with a stone coping. Note also the stone carved urns on top of the evenly space pillars. (Davenport Photographs – Album compiled by Friends of Bramall Hall 1947, Bramall Hall Collection)

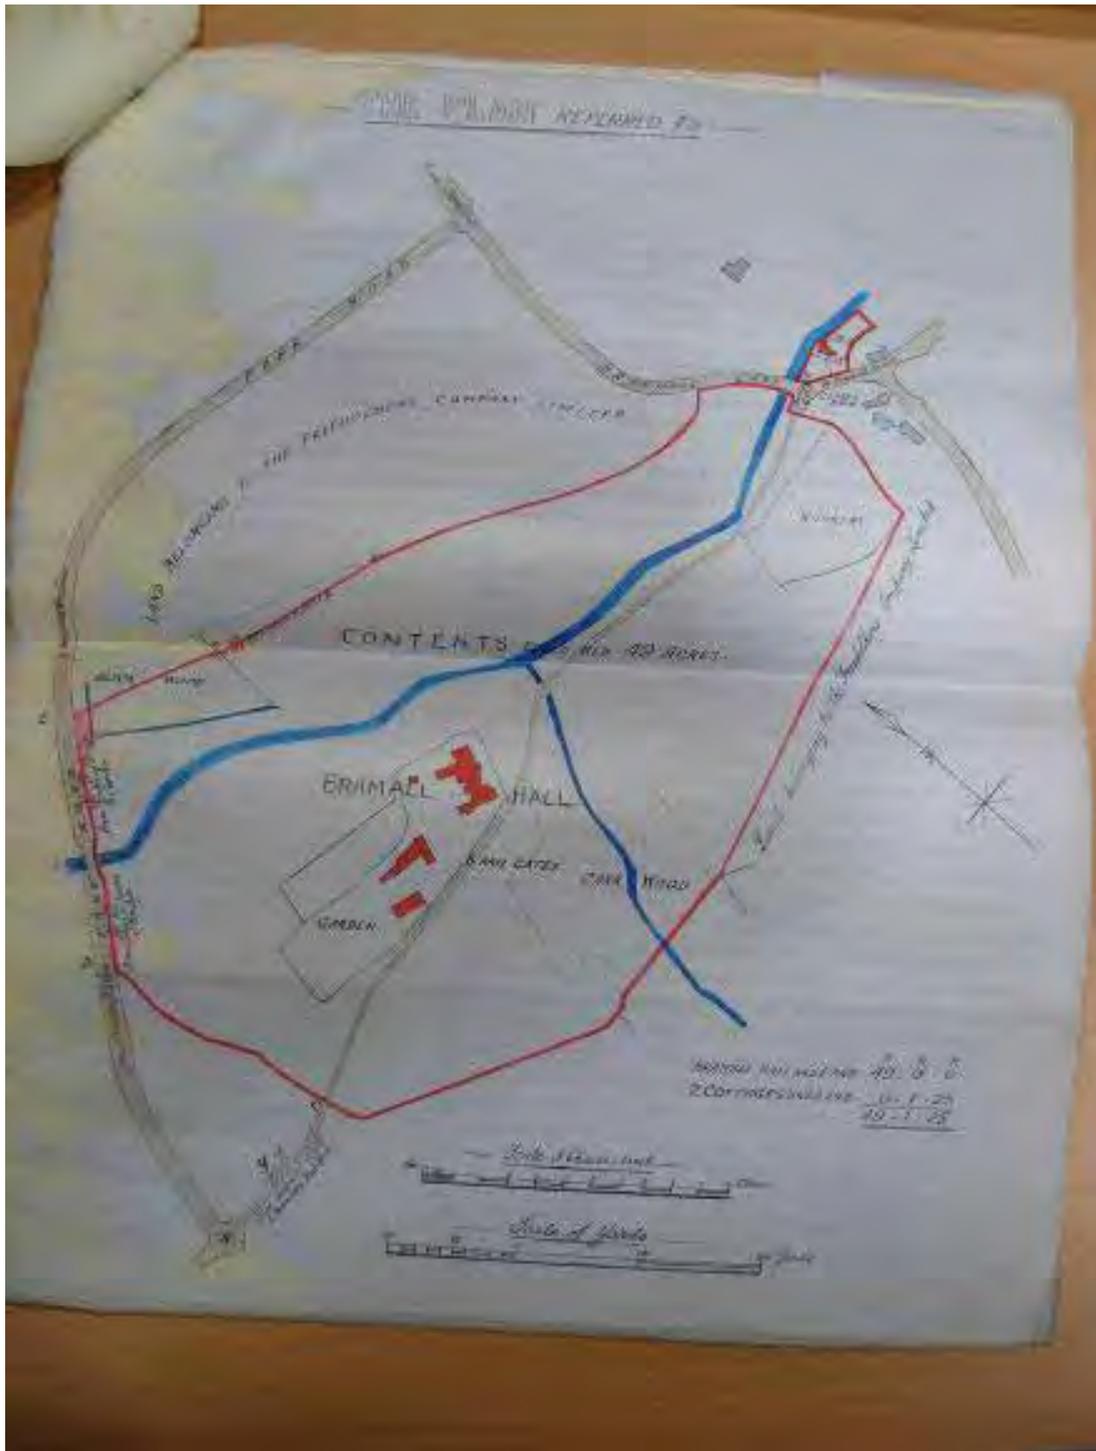
Figure 29: Plan attached to Title Deed of purchase by Charles Nevill 7th May 1883 (Stockport Town Hall Legal Department)

Charles Nevill's original purchase of Bramall Hall and Grounds is shown on the title deed dated 7th May 1883 (*Figure 29*). As he began to plan his improvements to the grounds he undertook a further purchase of 3 parcels of land in the name of his son, Thomas Nevill, in 1886 for £3,500 (*Figure 30*). These enabled him to plant up his long northern boundary, creating a screen from future villa development, as well as creating space to build his eastern lodge on Bramhall Road. The third plot of land was a southern extension of Carr Wood towards Carr Wood Road. A further purchase was made by Thomas Nevill in 1918 when he acquired a small triangle of woodland in the north-west corner of the property and a large field attached to Lodge Farm on the opposite side of Bramhall Road (*Figure 31*).

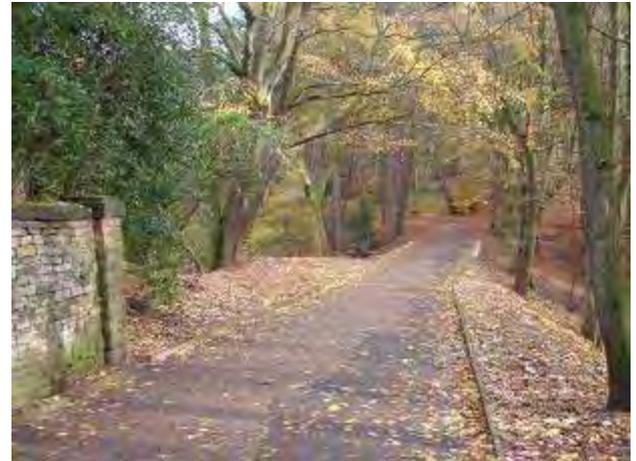
d) The new alignment necessitated the construction of a large embankment over Carr Brook.

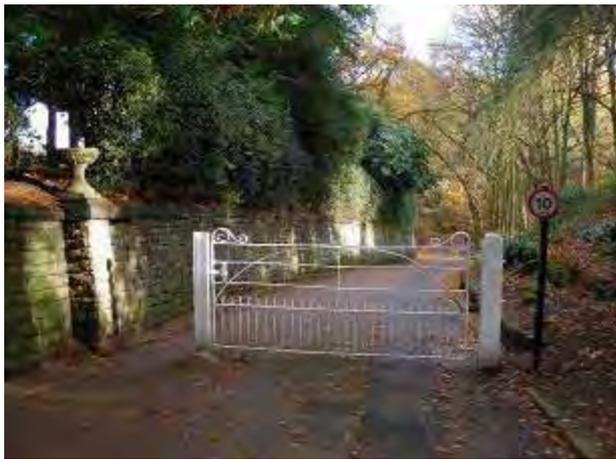
e) As part of the new route a cutting was made through the ground above Carr Wood and retained by an ornamented wall on the hall side.

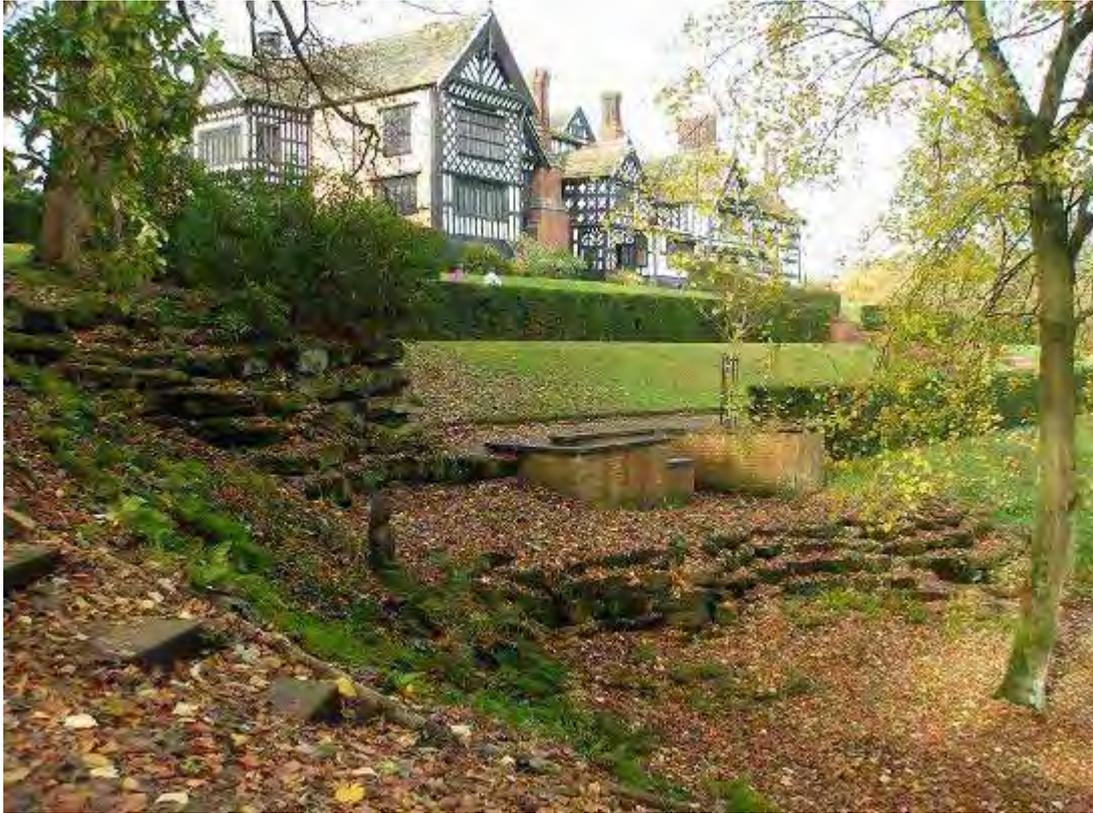
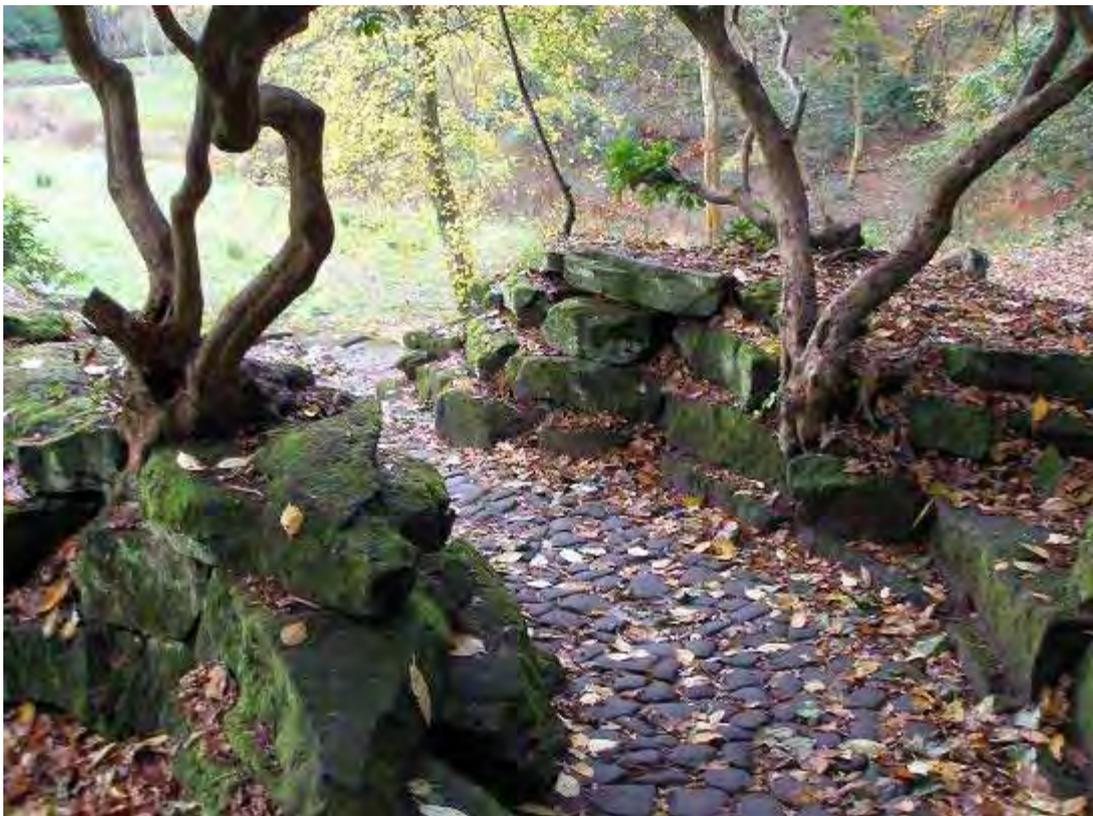
Figure 36: View of Nevill's terrace from the new drive showing the rockery formed at the southern end (above) and detail of the rockwork and stone cobbles path (below).

At the southern end of the terrace a substantial rockery was constructed of roughly quarried stone blocks as indicated on the 1898 OS Map. Within the rockery and around the bowling green area, Nevill planted largely evergreen shrubs (*Figure 36*). It is interesting that Charles Nevill was the first president of the Bramhall and Woodford District Horticultural Society founded in 1889.³²

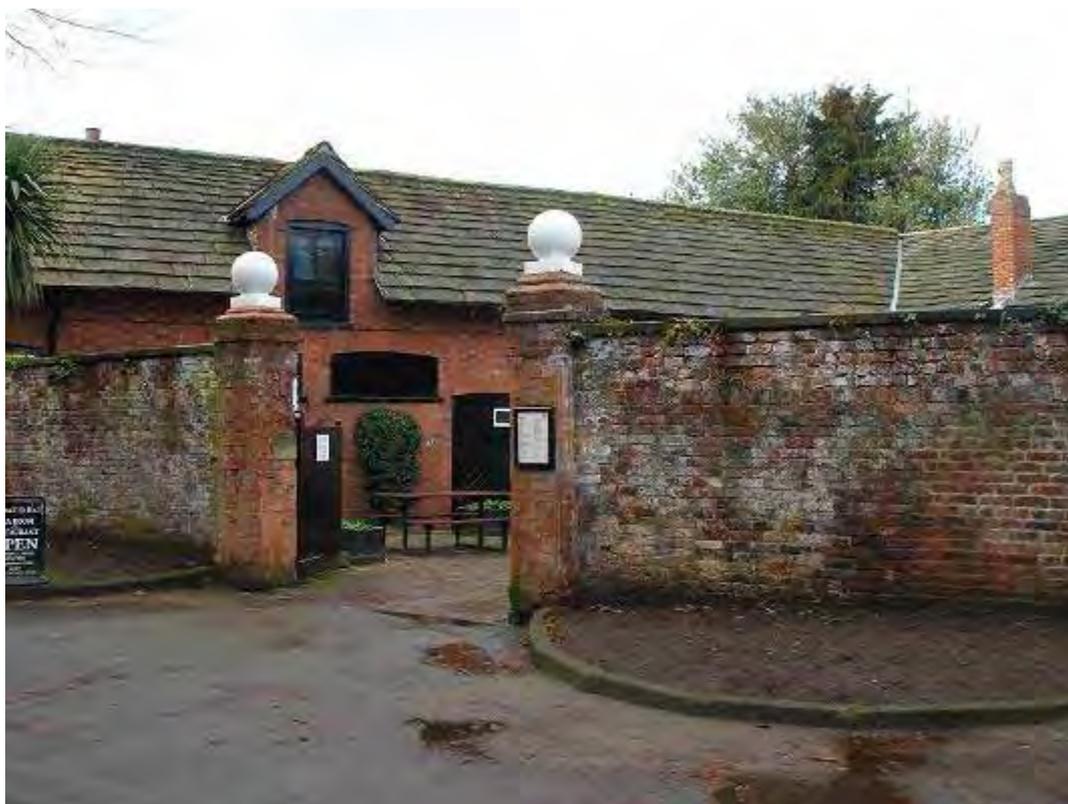
Figure 38: The new entrance arrangement to the Stable Courtyard introduced by Charles Nevill c1900

The 1898 OS map shows Nevill’s extension of the walled garden eastwards towards the stable complex. Here an alteration to the original brick wall (increased height and new gate pillars) created a new entrance to the reconfigured smaller courtyard (*Figure 38*). The glasshouse inside the walled garden is retained but has disappeared by 1909 being replaced by a smaller garden building leaning against the new wall. No internal layout is depicted but the original entrance to the walled garden is still in place and the doorway survives today (*Figure 39*). The 1909 OS map also shows the new west wing of the stable complex built around 1900 which created the enclosed courtyard which survives today.

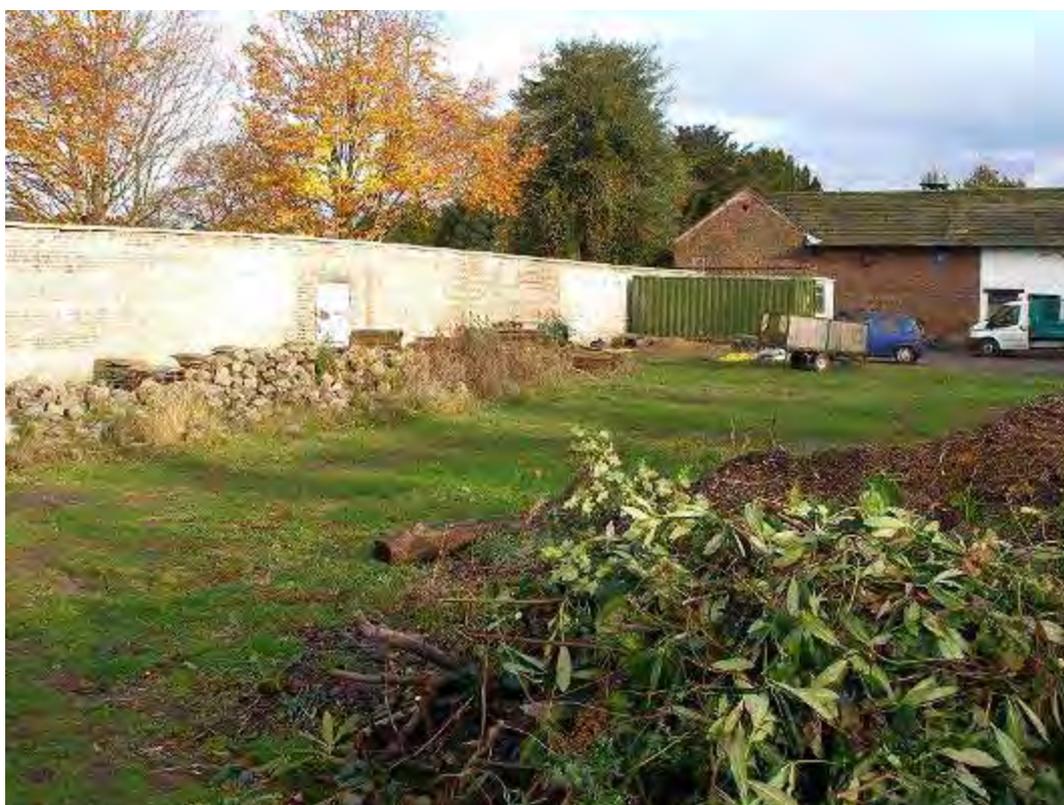
Figure 39: Inside the walled kitchen garden today. The gate in the wall was the entrance into the vinery or fernery as described in John William Handley Davenport's Inventory. The wall beyond was extended by Nevill to meet the new wing of the stable block added c1900.

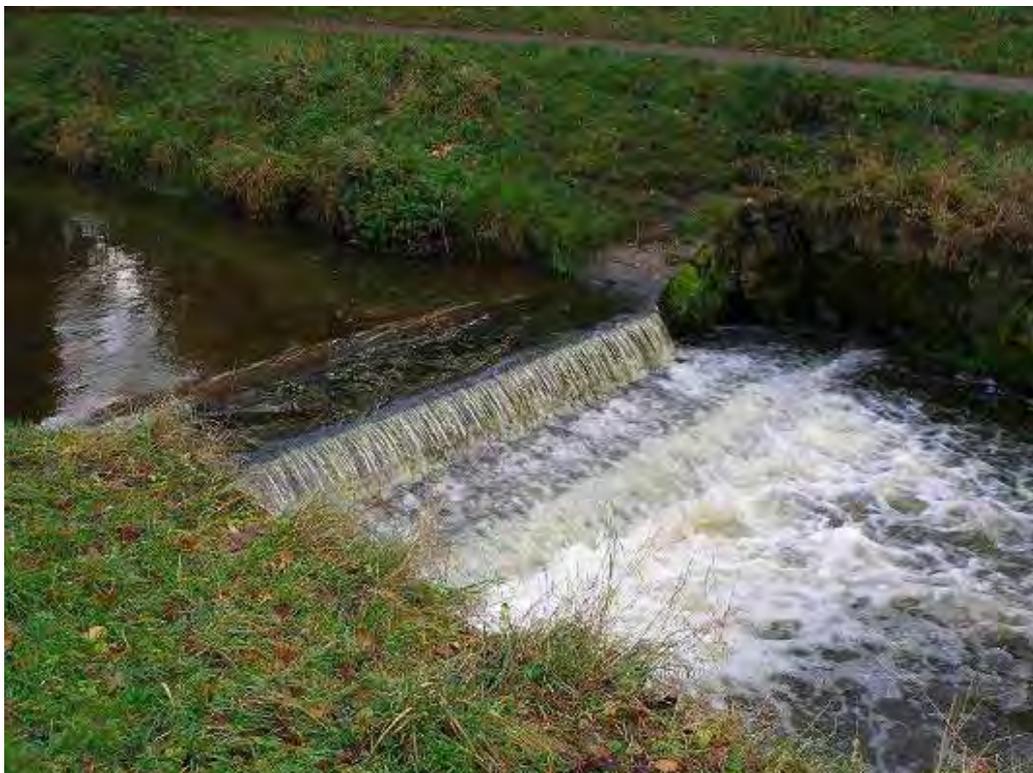
Figure 41: The first weir introduced by Nevill on the original course of the Lady Brook which enabled him to divert water into the eastern pond. This was the first pond created by Nevill and is shown on the 1898 OS Map.

Nevill made several fishing trips to Norway and the first pond he created is very reminiscent of a Scandinavian lake. He first introduced a weir on the original course of the Lady Brook (*Figure 41*) to allow water to be diverted into his first pond (eastern or upper pond) which is shown completed by 1898 (*Figure 32*). Also by this time Nevill had carried out the major engineering work on re-routing the river within a stone lined canalised section. (The stone lined embankments still survive but in a poor, eroded condition in certain stretches). The eastern pond had a number of intricate islands, presumably to enhance the fishing experience, which were planted mainly with conifers and marginal vegetation (*Figure 42*). The character of this part of the park has now changed with the growth of the trees and encroachment of self-sown vegetation (*Figure 43*).

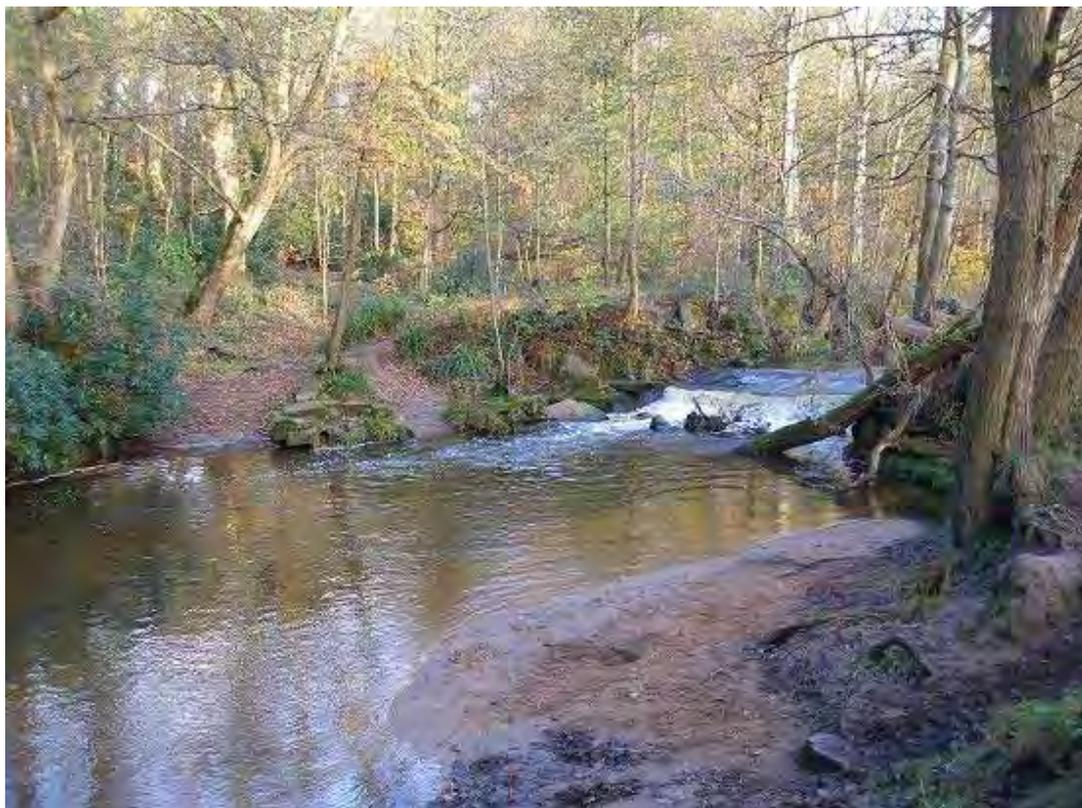
Figure 44: Nevill created a swirling pool below a cascade flanked with rocky outcrops on the re-aligned river course, which is still appreciable today.

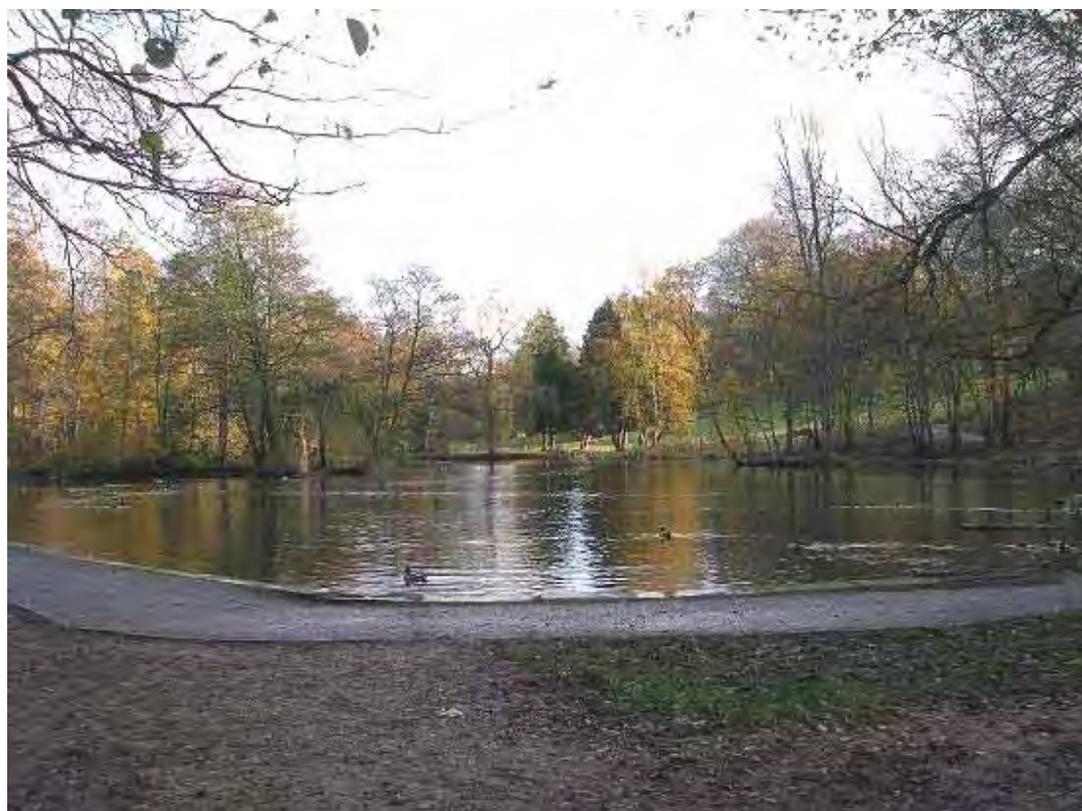
Figure 45: The western, lower lake was the last to be created with a deliberate larger open surface for aesthetic affect, complete with boathouse (now gone). The view from the hall and the lawn areas above has become obscured by recent tree growth around the lake.

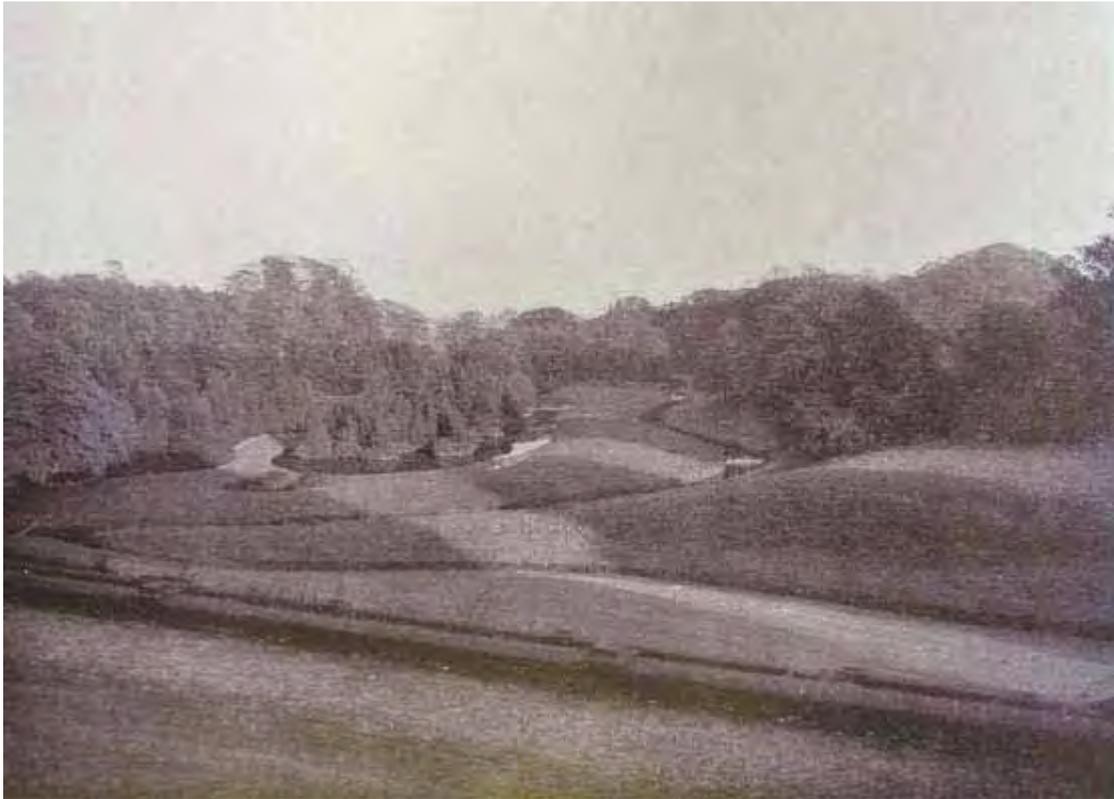
Figure 48: View from Nevill's terrace c1930 showing an open parkland with a clear view of the pond and river corridor (Illustration from early Bramall Hall Guidebook) and below the same view today.

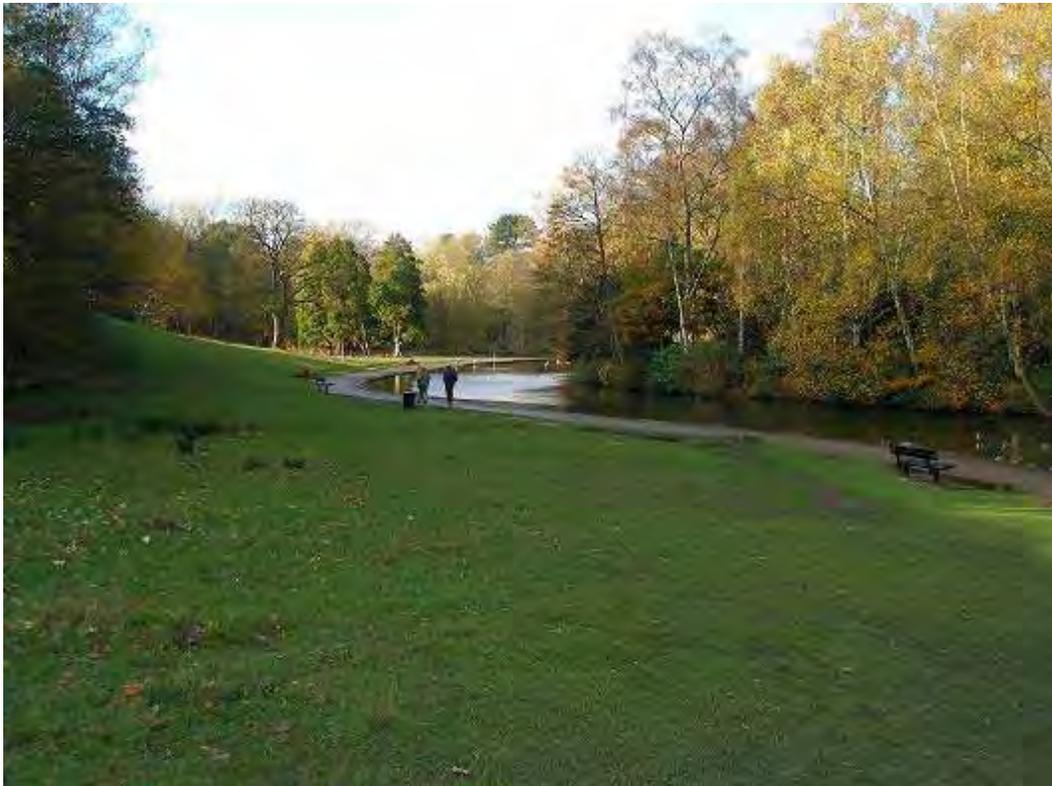
Figure 54: Lakeside path introduced by Hazel Grove and Bramhall UDC following acquisition of the park in 1935.

During the 1940s there are references to improving the path network, including the path on the south bank of the Lady Brook and around the middle pond (*Figure 54*).⁴² There were also concerns over the structural condition of the terraces, footbridges and the state of the lakes. It is interesting to note that a small plank footbridge originally crossed the causeway between the middle and lower ponds (referred to in the minutes as second and third lakes) This had become a source of danger and had been removed with, “...*the connection between the lakes being made by laying pipes and building up and cindering the path...*”⁴³ Repairs had to be made to the lower pond (*lake no. 3*) where damage to the bank lowered the water level, in effect draining it into the stream.⁴⁴ The black and white aerial photograph of the park c1940 shows the pond with no water (*Figure 55*). There are several references to the Committee attempting to procure ornamental birds for the lakes but the matter always seemed to be deferred!

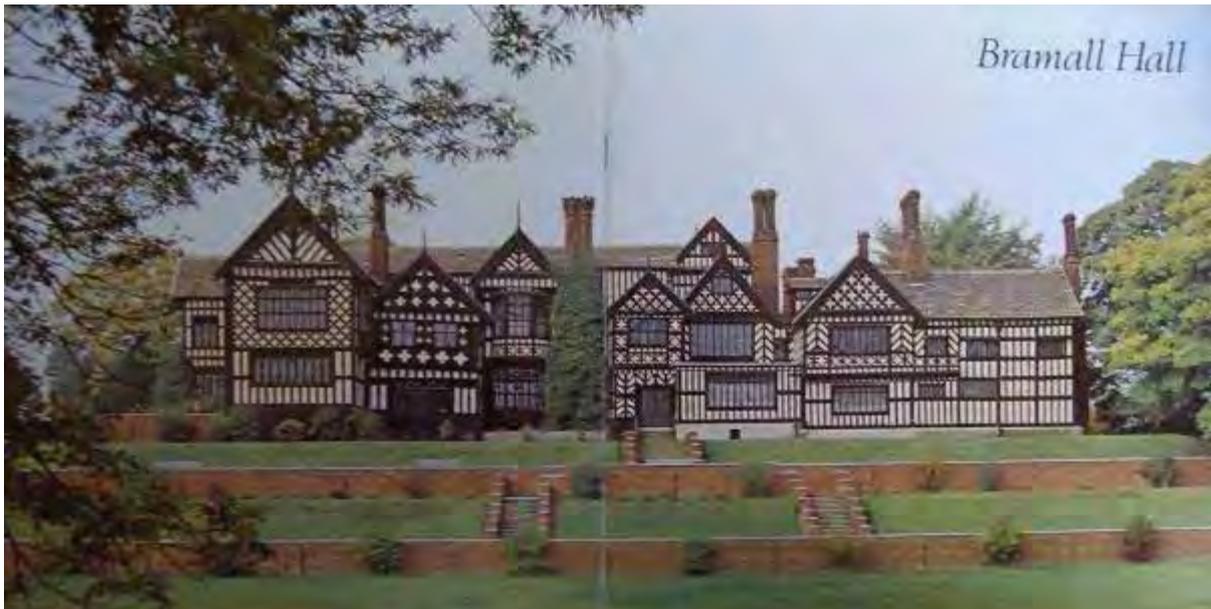
Figure 57: Cover of 1976 Guidebook showing the restored terraces

Concern over the condition of the terrace walls eventually led to the District Surveyor on 19th May 1970 to submit a scheme for re-building the terrace walls for an estimated cost of £5,500. The matter was deferred until February 1971 when F. J. Goodwin and Sons of Hazel Grove won the tender for £5,486.52.⁵¹ At the time arrangements for providing a coping were also deferred pending the availability of suitable material, but a photograph taken c1976 for the Guidebook shows a stone or a stone-like capping was used to contrast with the red brick (*Figure 57*). Comparison with earlier Guidebook photographs show that in rebuilding the walls small urns have been removed from the pillars and the previously 'sloping' stone capping on the flights of steps have been replaced with a rather visually jarring step arrangement. Since then there has been further repairs to the walls and the fronts have been planted with yew and in the case of the upper flight of steps with berberis.

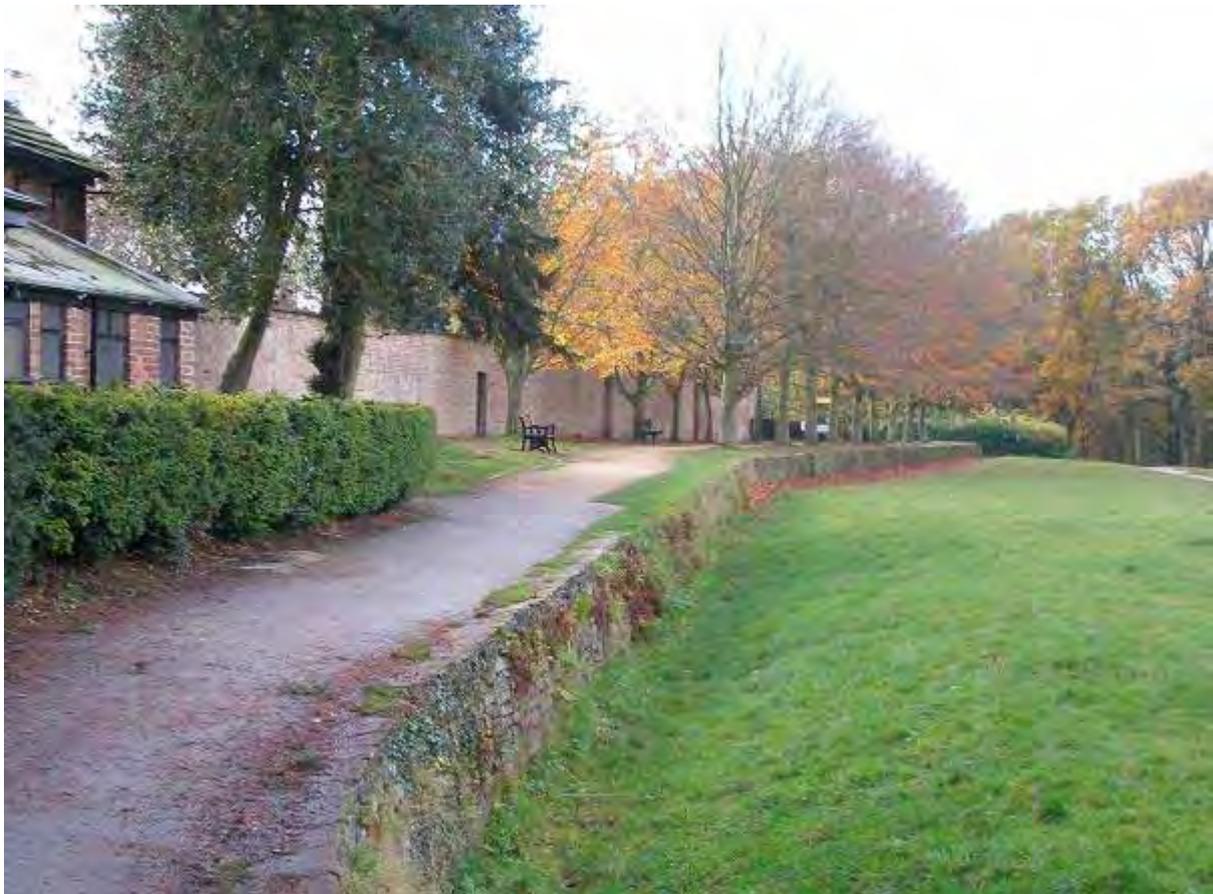
Figure 58: View of ha-ha walk and beech avenue planted in 1983 to replace the over mature beech trees which had damaged the ha-ha wall.

Since local government reorganisation in 1974 the management of Bramall Hall Park passed to Stockport Metropolitan Borough Council and a number of developments have taken place. The large car park to the south of the hall and the small 'overflow' car park at the entrance from Hall Road were already in place when the Borough Council took over the park but the smaller car park was improved in 1985. In 1983 a line of very large beech trees on the northern side of the walled garden, which were dropping limbs and causing damage to the ha-ha wall, were removed. Replacement beech trees were planted and the damage to the wall repaired (*Figure 58*). Tree planting was also carried out below the

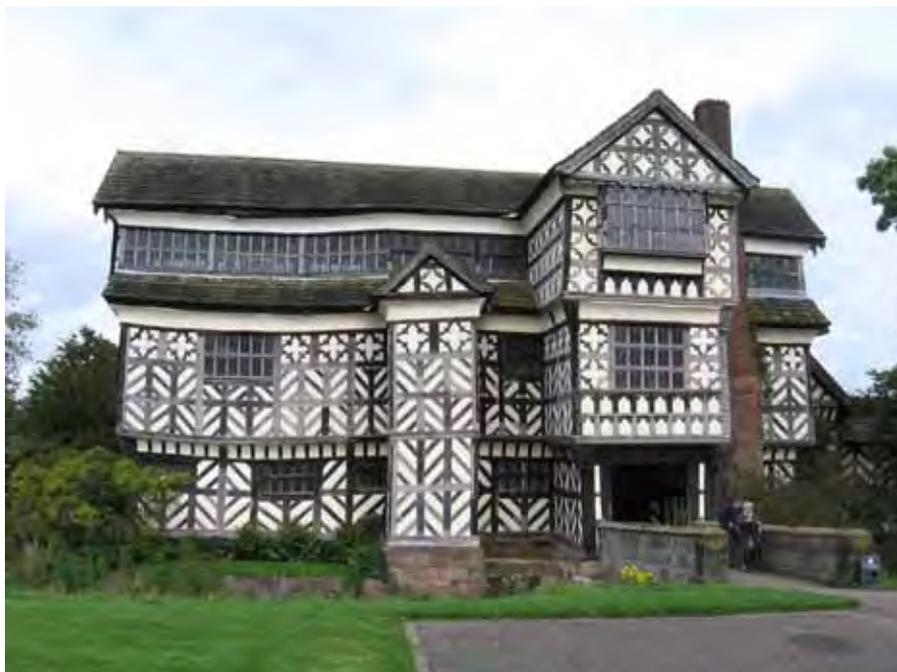
Figure 59: Little Moreton Hall, with C16 long gallery built onto an earlier gatehouse range

Of the houses mentioned, Little Moreton Hall (*Figure 59*) probably represents the most complete example, retaining the courtyard plan and long gallery. The particular circumstances of its history mean that this house escaped substantial alteration in the C18 and C19. At Rufford only the great hall remains relatively untouched, with loss of family wing and rebuilding of the services. Bramall and Speke fall somewhere between – in both cases C19 owners effected repairs and restorations which enabled the buildings to continue in family use for a period at least. Another significant factor is the preservation of elements of the setting, which has been lost at houses such as Baguley, Ordsall and Sutton and severely compromised at Speke. At Bramall and Rufford, on the other hand, a parkland setting has been preserved, in part at least, and Little Moreton Hall stands in the countryside.

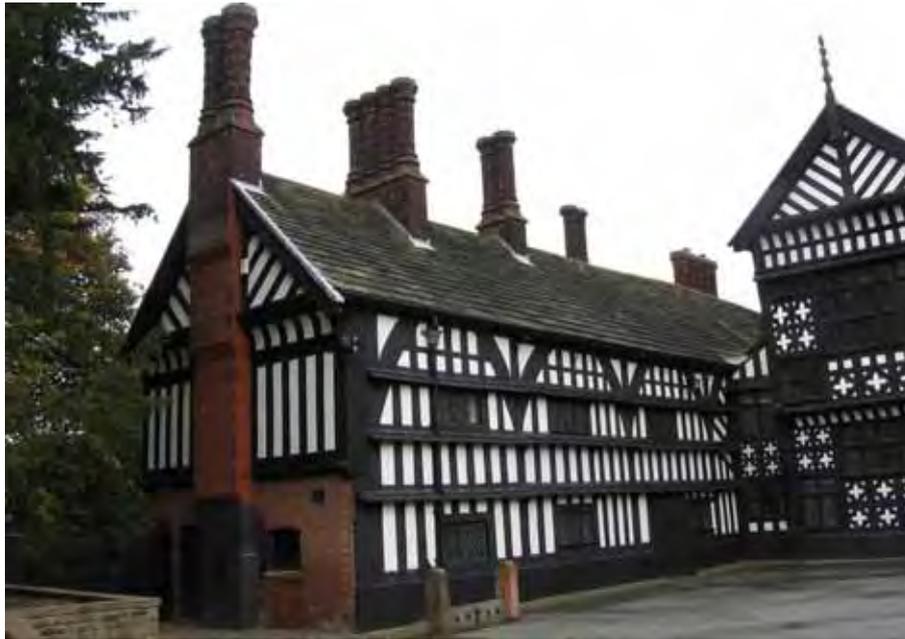
Figure 60: North wing, with in-filled gap between this and the hall range, to the right

The North wing (*Figure 60*) has been previously associated with a C14 date and is often described as a service wing. In fact the wing appears to have originated as a relatively high status range, probably for family members or possibly as independent lodgings, and with a roof consistent with a perhaps mid C15 date. With first floor rooms formerly open to the roof, this is comparable with the South wing in form, but almost certainly of earlier date. The North wing roof open trusses (*Figure 61*) have some parallels with Welsh examples where the suggested date range is the first half of the C15 (Dr Philip Dixon, pers. comm.).

The north wing was completely detached from the main building with a gap (subsequently in-filled) between it and the main building. This is shown particularly clearly on a late C18 view of the place from the West (*Figure 62*), held at Bramall Hall.
