BRAMALL HALL, STOCKPORT

Conservation Management Plan September 2010

BRAMALL HALL CONSERVATION MANAGEMENT PLAN
for STOCKPORT METROPOLITAN BOROUGH COUNCIL

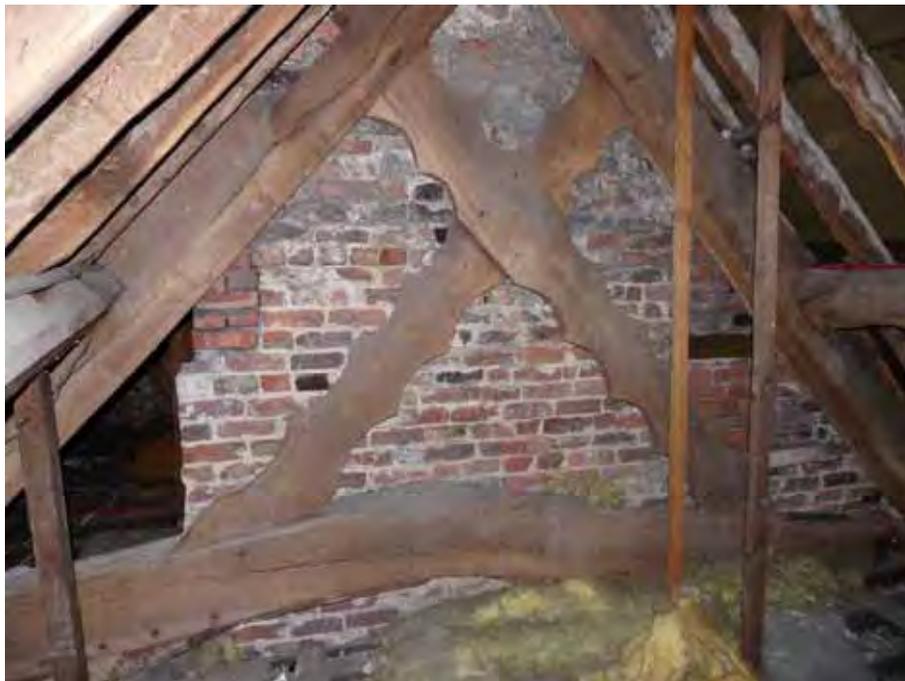
Figure 61: One of two C15 open roof trusses in the N wing, the stack is a later insertion

The conjectural C14 building would almost certainly have consisted of a hall, open to the roof and probably heated by a central hearth, with a screens passage and services in rooms at one end and private family rooms at the other. Some sources suggest that the present hall structure may retain C14 work, but no direct evidence has been found to support this theory. A partly truncated closed truss between the attic (S3) over the Plaster Room and the attic (S4) over the Withdrawing Room may be the earliest fragment of roof structure extant in the hall range but appears to be no earlier than the C15 in date; dendrochronological dating may shed more light on the construction sequence.

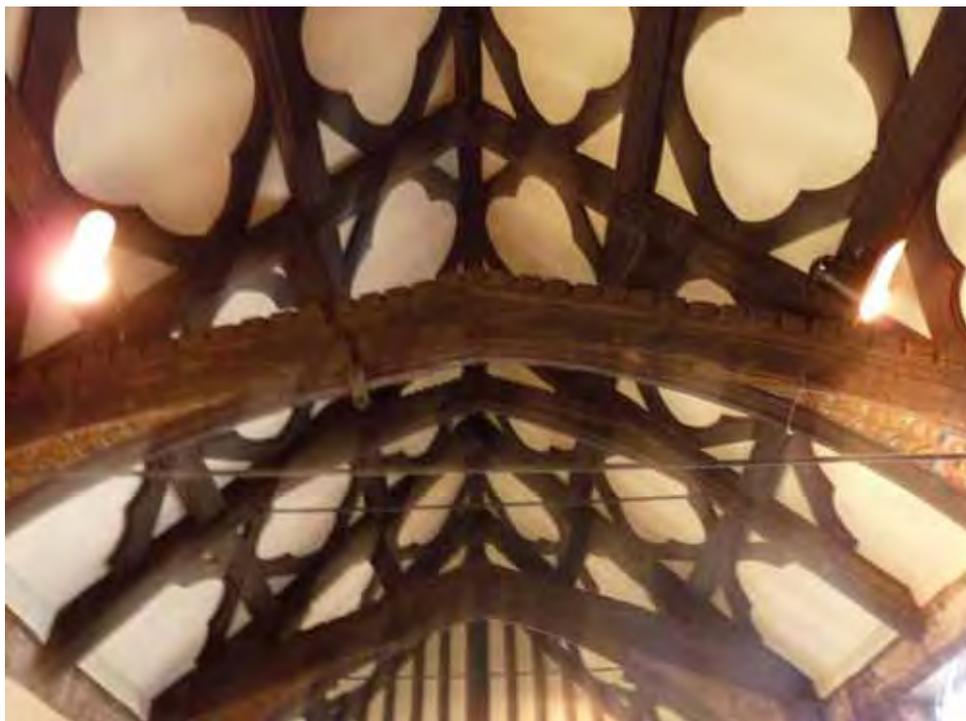
Figure 63: The roof to the Ballroom (F2)

The date of the South wing is also conjectural. The pattern of external timber-framing and bracing of the walls of the North and South wings is very similar, possibly in order to create a symmetrical appearance. The scale, roof structure and decorative detailing is quite different however, with details in the South wing suggesting a late C15 date, and a higher status. On the other hand certain elements such as the mullioned windows, including those uncovered in the chapel during the 1880s and an oriel supported by arms of the Bromale family, have led some writers to suppose that it is C14, substantially rebuilt in the C15 as high status family rooms with chapel and reception rooms below. Other sources (for example Emery) suggest that the wing, including the chapel, is of one late C15 build. The upper Western room (F2) in this range is exceptional for the high quality of the timber detailing, with cusped windbraces, brattishing and spandrel carving to arch-braced tie-beams (*Figures 63 and 64*). The latter feature is also seen at Little Mitton Hall, Lancashire, thought to date from circa 1500.

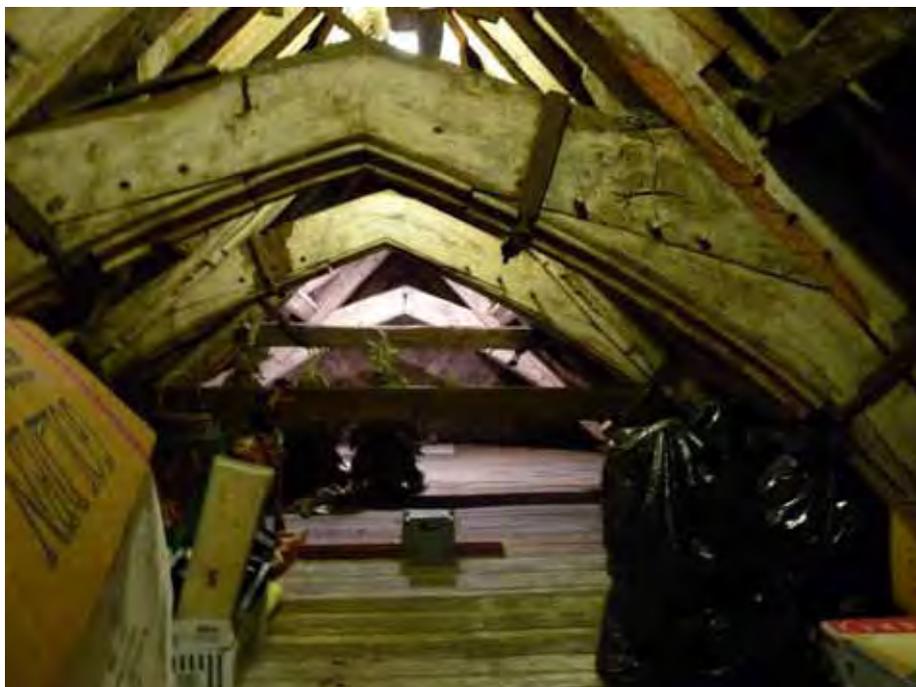
The roof over the eastern part of the wing has a slightly different roof form, also richly decorated, with steeply cambered, moulded tie-beams and cusped wind braces, and evidence that the whole room was decorated with a polychrome painted scheme, in the early C17.

Figure 64: Richly moulded open roof in the east side of the South wing

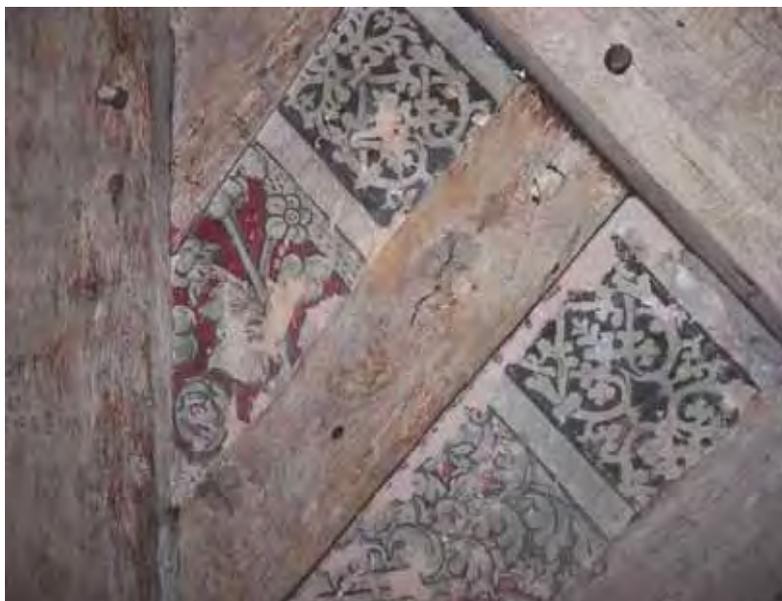
Figure 66: Detail of early C17 'Antique' decoration within E gable of S wing attic (S1)

A later scheme, executed in a style often known as *Antique* work, is of early C17 date (*Figure 66*). A comparable local scheme is at Wythenshawe Hall, Wythenshawe. A similar design, with putti holding scrolls or drapery, is seen in both examples. Alfred Burton recorded the discovery of a black, red and white painted scheme in the roof space (S1) over the Chapel, with a date of 1610 and Davenport initials painted on the west end of this space, partly destroyed during 1880s roof repairs for Nevill. This scheme survives in good condition within the east gable and the fragment from the west end of the roof dated 1610 was salvaged and preserved in a frame, now in the Nevill Room (F5) (*Figure 67*). Advice to painters written by Henry Peacham in 1606 gives a good general idea of the approach which appears to have been adopted for both types of decorative work extant at Bramall: ‘An unnatural or unorderedly composition for delight sake, of men, beasts, birds, fishes, flowers etc without ... Rime or Reason ... You may, if you list, draw naked boyes riding and playing ... Ribands, Satyres, Tritons, Apes ... and any kind of wild trail or vinet after your own invention, with a thousand more such idle toyes, so that herein you cannot bee too fantastical’ (quoted in Davies, 2008).

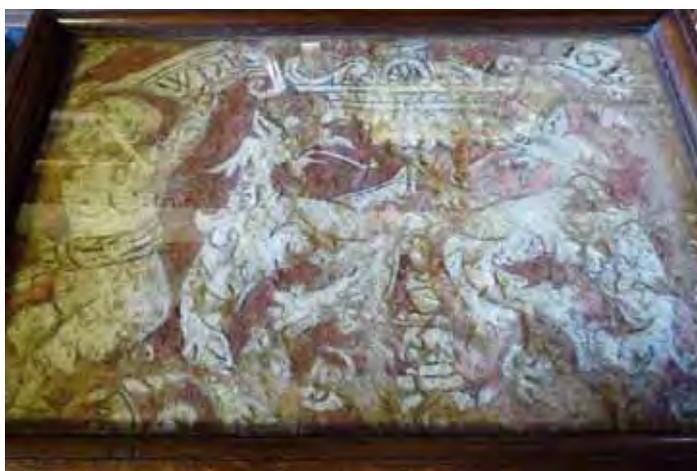
Figure 67: Fragment of decorated plaster dated 1610 from the west end of the roof space S1 over the chapel, now in the Nevill Room (F5)

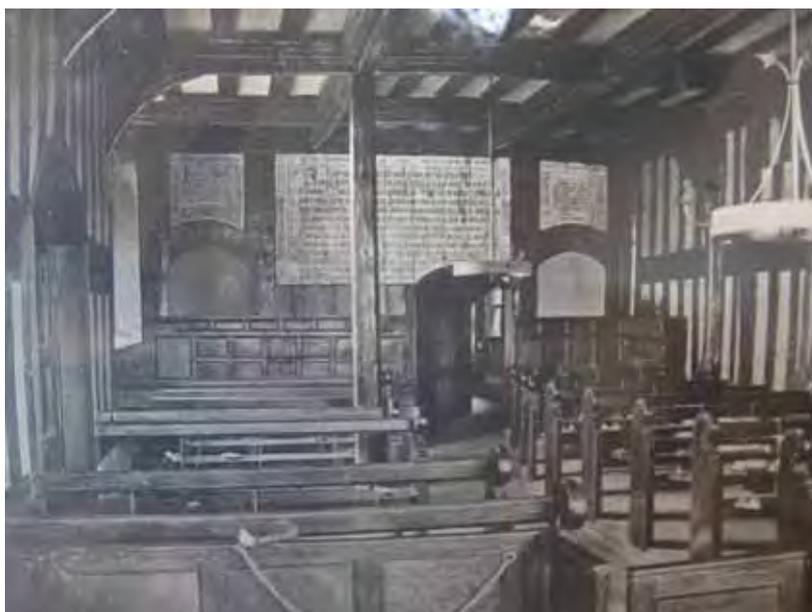
Figure 68: The chapel prior to late C19 restoration by Nevill, showing painted text on the west wall (from a photograph in the chapel, probably taken by Malcolm Davenport between 1855 and 1869)

The Chapel (G4) (*Figure 68*) is a room of very high quality which incorporates some original and some restored windows similar to those of the other part of the wing. The survival of a chapel in recognisable form is notable, with parallels elsewhere, although this is an unusually large example. Wall paintings here include a Crucifixion figure of pre-Reformation date overlaid by post-Reformation black letter inscriptions. Late medieval stained glass was reinstated to the east window as part of a 1940s restoration, following another major phase of restoration in 1938 paid for by Charles Wrigley and undertaken by the Manchester architects Oakley & Sanville.

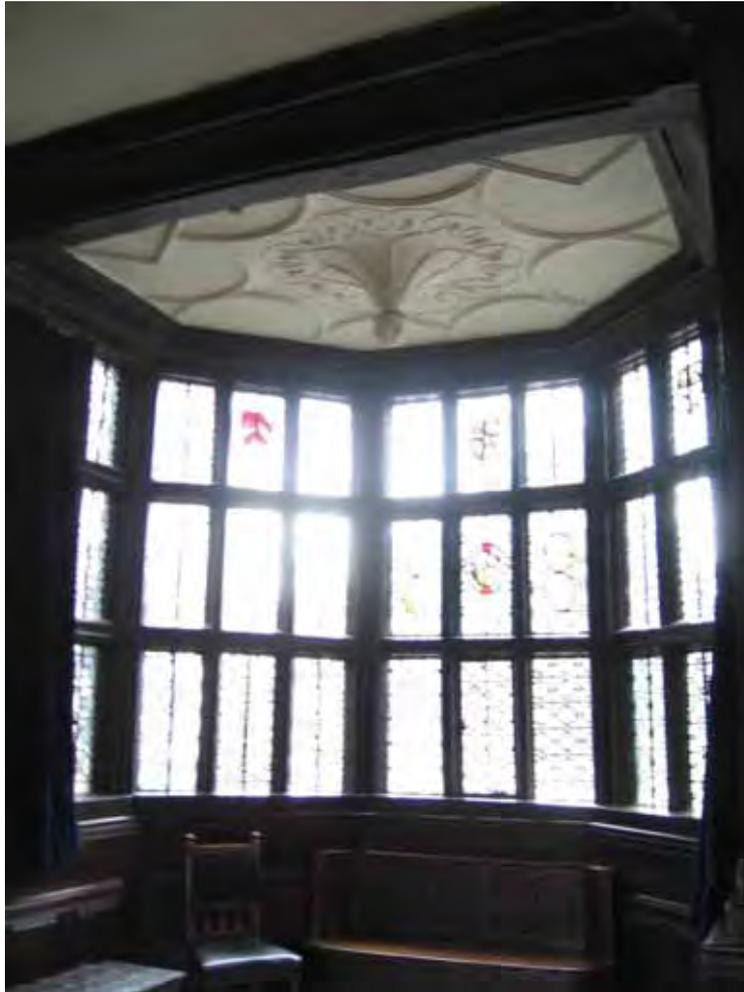
Figure 69: The hall bay with late C16 plasterwork

Of what was probably an ornate plasterwork ceiling only one part, with a pendant, survives in the hall bay; the present plaster ceiling for the body of the Great Hall is plain (*Figure 69*), with beams added by Nevill. The fragment of plaster pendant detail in the bay suggests that the whole room would have been decorated with a rich plaster ceiling, similar to the late C16 Withdrawing Room (F8) ceiling in the room above. The polygonal hall bay is a fine example of a type often found at the high end of houses of this status, comparable with those at Little Moreton Hall, Samlesbury Hall and others (*Figures 70 and 71*). The fireplace and doors to the west porch, shop and central service passage are late C19 in date, but the east porch door is a good example of an early framed door probably of C16 date, and the north door leading to the staircase is a fine quality panelled door of late C16 date that matches the first floor Withdrawing Room doors.

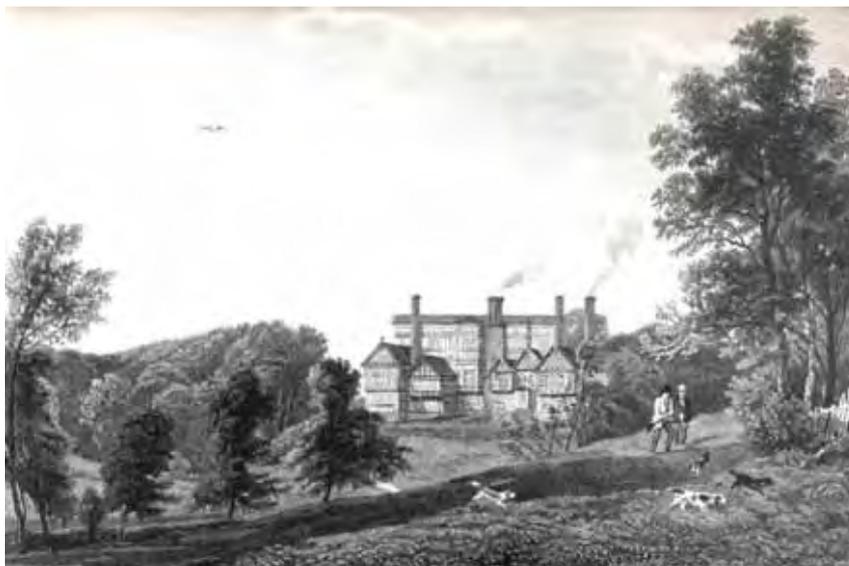
Figure 72: Engraving by Peter de Wint from 1809 sketch, showing the long gallery; it was removed shortly after 1809

The arrangements in the hall range reflect a major phase of alteration for the Davenports in the late C16. The work included remodelling or, more likely, the rebuilding of the north part of the hall range to create a chamber above the hall, a long gallery at second floor level over the full length of the hall range and associated north-west stairs. The long gallery was taken down after 1809 (*Figure 72*).

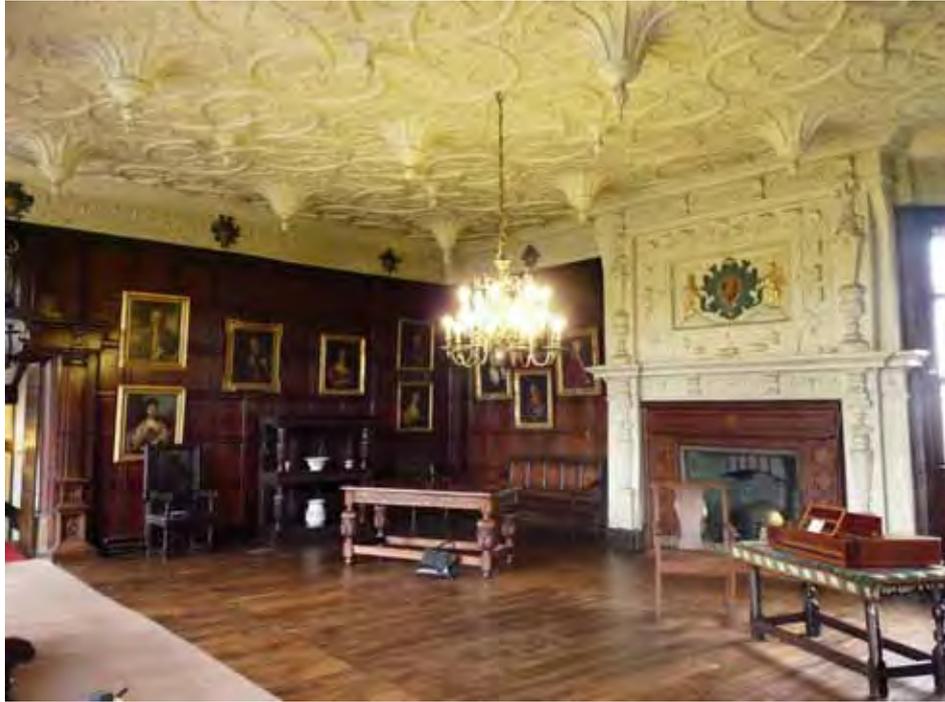
Figure 73: Withdrawing Room from the SW

The Withdrawing Room above the Hall (F8) (*Figure 73*), a room often described as a Great Chamber, reflects increased levels of comfort and has a highly decorative treatment. This would have been, with the Long Gallery, the highest status area in the late C16 and C17, where the family could entertain guests in an environment reflecting their wealth, loyalties and aspirations.

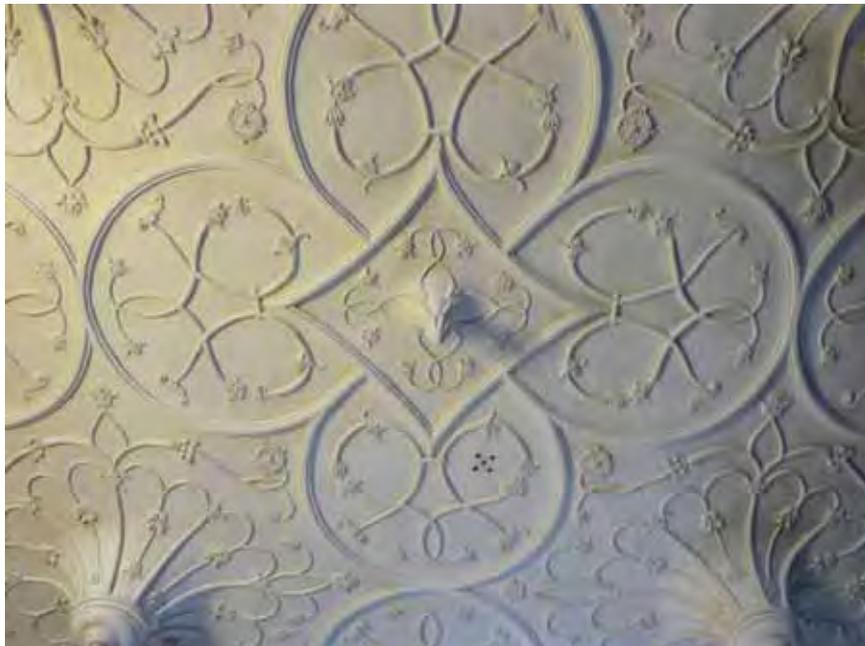
Figure 74: Withdrawing Room ceiling detail

The ornate plasterwork ceiling (*Figure 74*) features curvilinear geometric forms incorporating trail designs with pendants of several different designs. The design, with stars, lozenges and quatrefoils, is a simplified version of one illustrated by Walter Gedde published in 1615. His *Booke of Sundry Draughtes* incorporated patterns drawn from a wide range of sources, including many current before the date of publication (*Figure 75*).

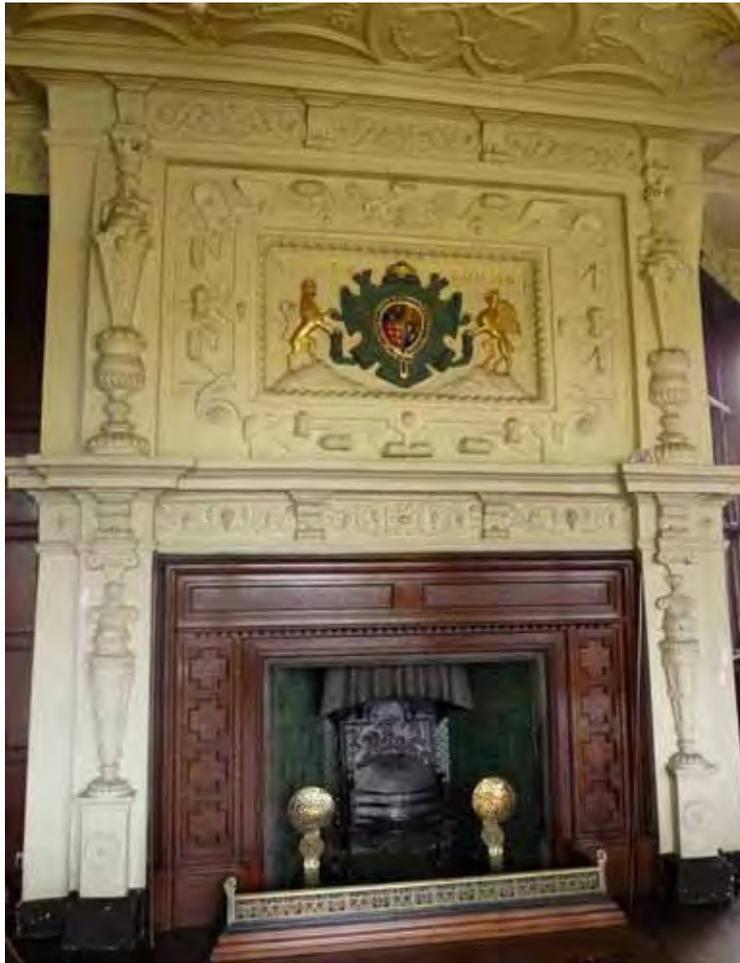
Figure 77: Withdrawing Room fireplace with late C16 overmantel (oak infill is late C19)

The plasterwork chimneypiece (Figures 76 and 77) with demi-figures, or terms, and a strapwork overmantel cartouche reflects the taste current at the time. The cartouche is very close to patterns, widely disseminated at the time, by Jan Vredeman de Vries, published in Antwerp in the mid C16 and commonly used as a source in England thereafter.

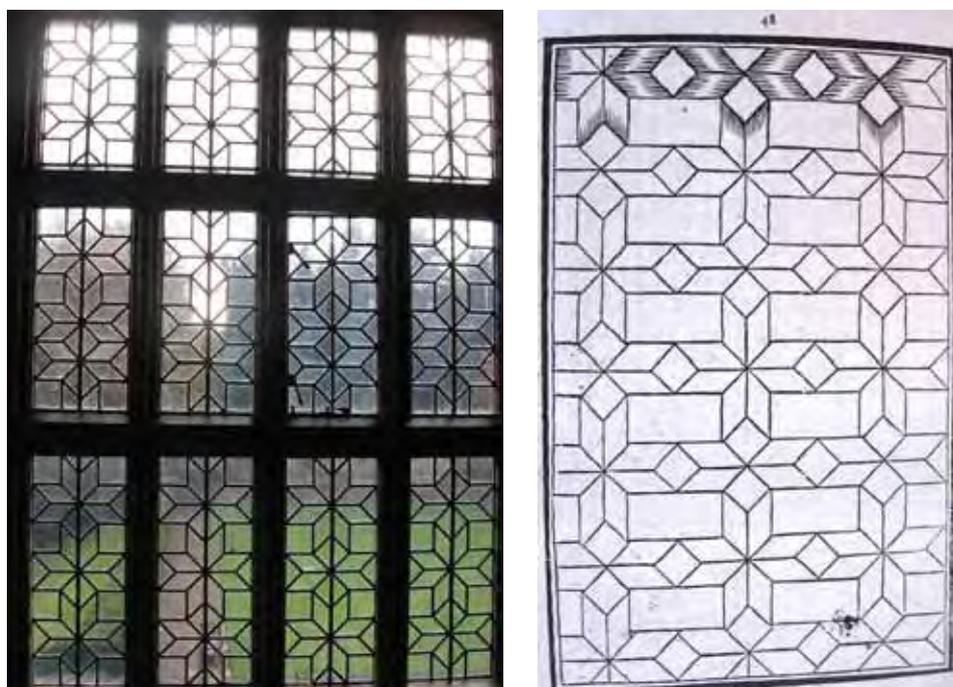
Figure 79: Leaded glazing, South stair, similar to a pattern illustrated by Walter Gedde, Figure 48, Booke of Sundry Draughtes

One of the notable decorative features of the complex is the window leading. It was commented on by Henry Taylor, who described it as ‘having much beauty, the leadwork being arranged in ingenious interlacing patterns’. In some places it appears to be original, probably dating from the end of the C16, when the fashion for extensive glazing had been spread by improved constructional and manufacturing techniques and by liberally glazed Great Houses of the type designed by Robert Smythson. Some of the glazing patterns can be related to those appearing in Walter Gedde’s book of *Sundry Draughtes* noted in connection with the plasterwork. It is apparent that during the 1880s original patterns were copied for new or replacement glazing (*Figure 79*). One of the patterns is also used for windows in the bay at Little Moreton Hall, raising the possibility that this may have been a source for the design. The trompe-l’oeil effects are also seen in the tumbling cube design, also illustrated by Gedde, in the Anteroom window. The extremely high quality of the work, intricacy of the patterns and common features makes it possible that the same craftsman or team was involved at Little Moreton and Bramall (*Figure 80*). Such work is very vulnerable to accidental damage, as well as changing fashions, and it very rarely survives.

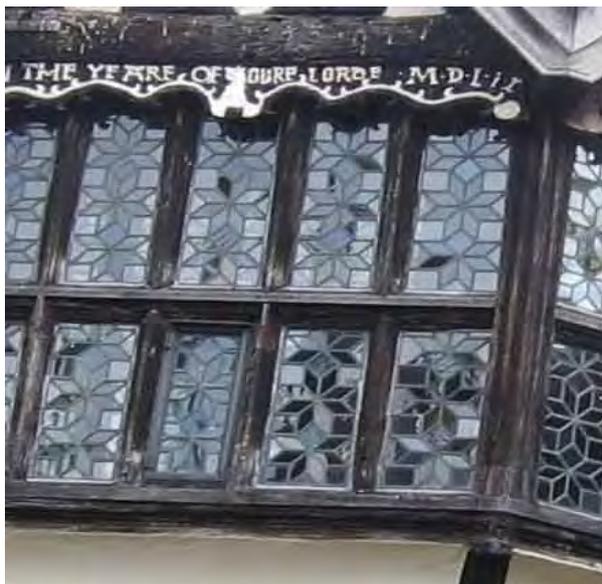
Figure 80: Comparable glazing detail, Little Moreton Hall

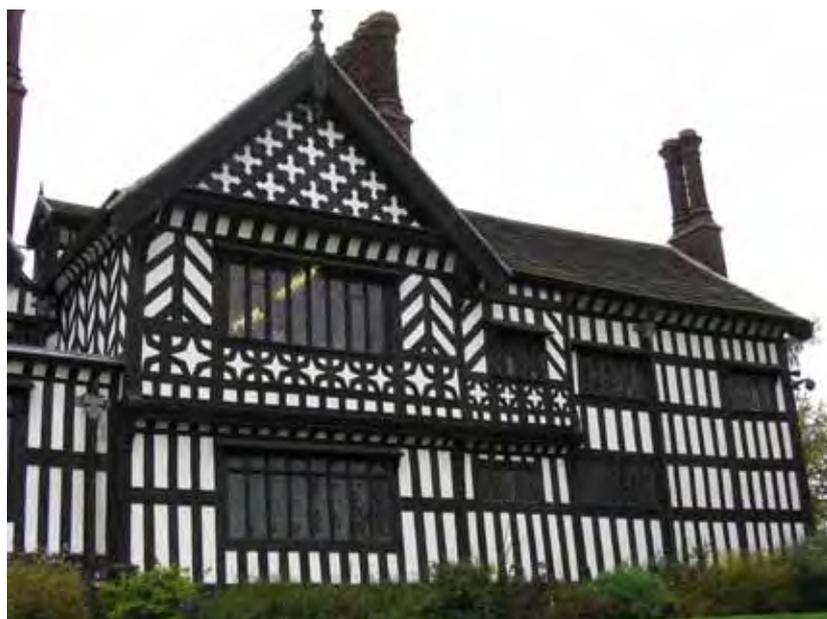
Figure 81: NE range with kitchen in gabled cross wing to left and pantries to right in added, plainer range

The original kitchen site is unknown. Kitchens were often placed in line with a central service passage, such as the one which exists at Bramall (G15, G25). The fall of land in this area means that it may not have conformed to the norm, and as at Chetham's Hospital (now School and Library) in Manchester, where land falls away in similar fashion, it could have been placed to one side. The exact history and date of the present kitchen (G17) is unclear. A plinth against the West wall adjacent to the passage suggests that it is of separate build to the North Wing, however it is in line with the wing and beneath the same roof line. Further investigation of the (currently inaccessible) roof structure may assist with interpretation and phasing here.

The 10th William Davenport, who inherited in the mid C18, seems to have been responsible for some alterations to the hall and estate. A ground-floor room in the North wing ((G26) now a staff room) has an overmantel with classical pilasters and panelling probably of mid-C18 date. This suggests the room enjoyed relatively high status, possibly acting as an estate office or private sitting room. The present stable range originated in the C18 as a symmetrical block facing the main building. It is possible that it was built after the demolition of the West courtyard range in circa 1774. The building seems to have been augmented in several phases, with the addition of a North range (now the café and kitchens) in the late C18 or early C19 (*Figure 81*).

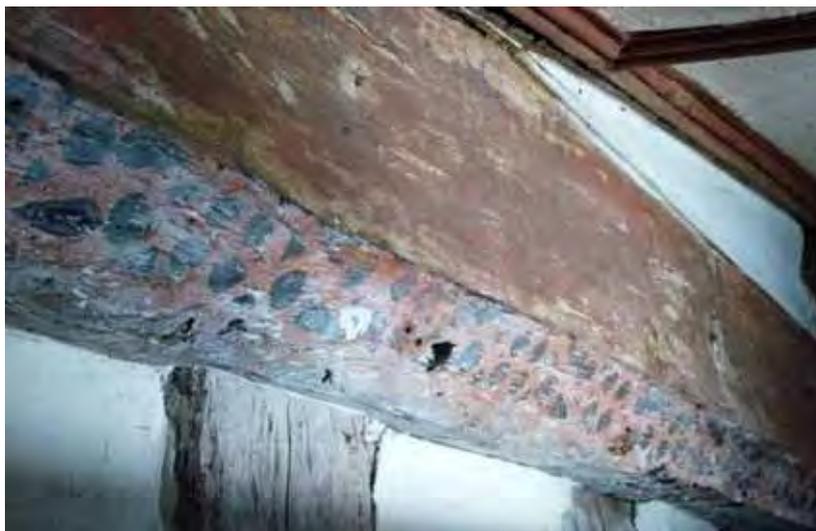
Figure 82: Stencilled decoration to tie-beam beam soffit, and C16 ceiling in the Plaster Room

Panelling was removed from the Plaster Room in the 1980s and the exposed timber-framing shows doors in different positions, though the partitions (which do not follow partitions on the ground floor) are almost certainly the originals. There are traces of red coloured painted decoration on beams in the Plaster Room, the detail partly lost and partly obscured, but the colours suggest it may have been early C17 Antique work (*Figure 82*); it does not extend to the surviving roof truss on the partition line between hall and Plaster Room, suggesting the decoration was done after the Plaster Room was ceiled. The Paradise Room incorporates a plasterwork frieze of C17 character.

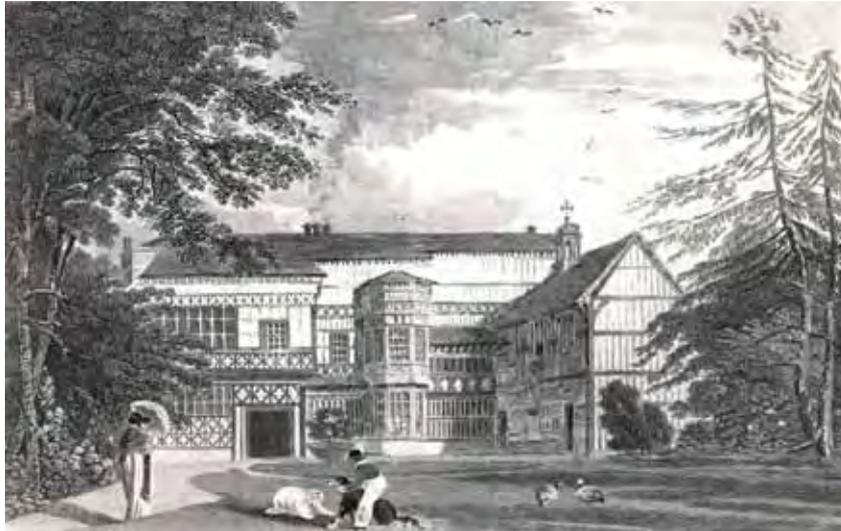
Figure 84: Sash windows to the west elevation, in an engraving by Peter de Wint from a sketch of 1809 (Ormerod 1882)

An account of 1790 (by Lord Torrington, quoted in Dean) states that by that time many original windows had been replaced by sashes, also shown in views of the hall from the early C19, such as an engraving by de Wint of 1809 (*Figure 84*).

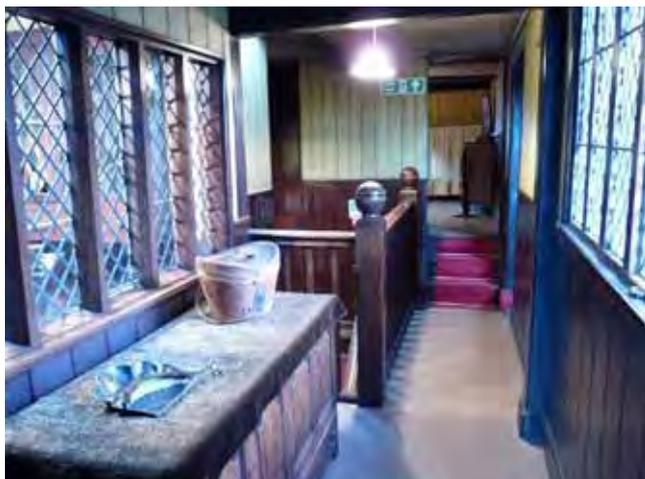
Figure 88: Part of the servants' accommodation on the second floor of the NE wing, added in the late C19 by Nevill

Nevill created a guest suite in the first floor of the North wing (F27, 28, 29, 30) and refurbished and altered servants' accommodation on that side of the complex. The undated late C19 plans suggest that the north-western wall of the North wing was partially rebuilt and re-fenestrated, and that partitions between first-floor rooms were rebuilt. Judging by Henry Taylor's birds-eye view showing the place before Nevill's work, this part of the North wing had already been rebuilt or encased in brick, hiding or partly removing the original timber frame.

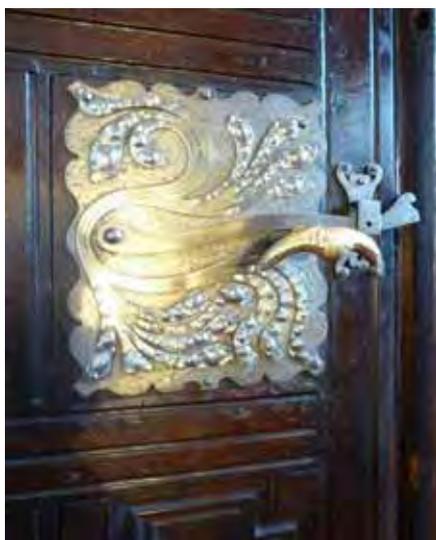
Figure 89: Door plate and handle designed by Armitage on the outer face of north Withdrawing Room door

Extensive repairs and replacement of internal fixtures such as doors were carried out, with new door furniture added to historic doors. At the head of the principal staircase, an attic room was re-fitted as a sitting room for Mary Nevill, with Arts and Crafts fittings designed by GF Armitage, dated 1891 over the fireplace. Nevill was assisted by George Faulkner Armitage (1849-1937) of Altrincham, who created high quality fittings including carved fireplaces and fine door furniture to his own design (*Figure 89*). These elements of the refurbishment are of outstanding quality and reflect an eclectic taste incorporating stylistic elements associated with Arts and Crafts style and the Aesthetic Movement, notably in the use of Japanese motifs such as sunflowers.

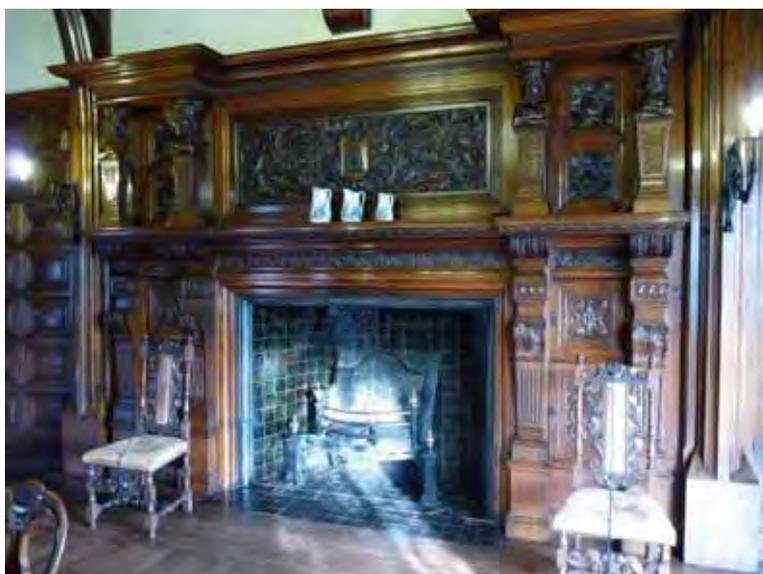
Figure 90: Richly carved fireplace installed in the first floor room above the chapel (F5), for Nevill, designed by Armitage with Aesthetic Movement motifs

The room above the chapel (F5) was fitted out with a new timber ceiling, moulded posts, fireplace (*Figure 90*), glazing and panelling, for use as a billiard room. This work was probably done in the 1890s; Burton does not refer to work in the room before his death in 1890. A two-storey projection on the south side of the chapel (G3 and F4) is also Nevill's work, dated 1896, but this is not shown on the 1880s proposal plans. Improved services such as heating, with apparatus installed beneath the hall floor, and almost certainly, new plumbing, kitchen and sanitary arrangements were made at this time. A cloakroom with WC (G14) was installed in the former butler's pantry below the principal stair, and the butler's pantry relocated to the panelled room (G26) in the N wing, with new fitted shelving.

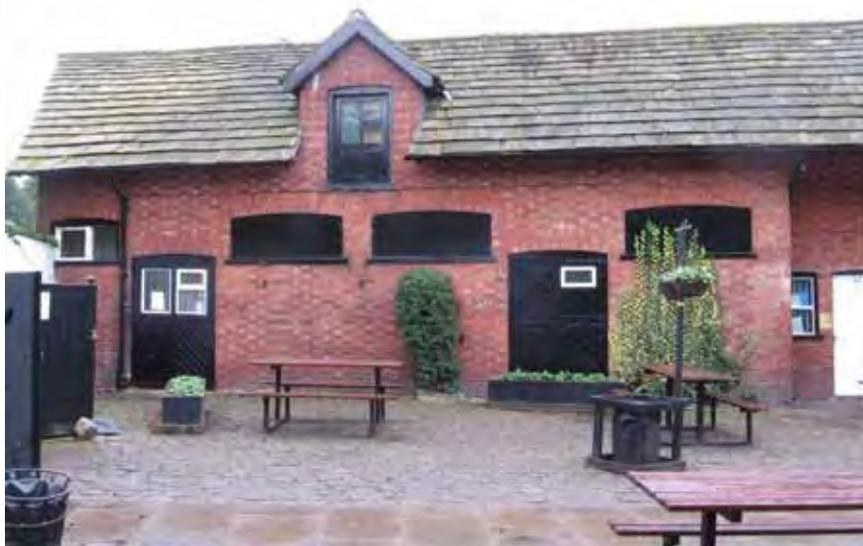
Figure 91: West stable range, added by Nevill c.1900

Other work involved the outbuildings and ancillary accommodation. It is known that Nevill demolished some buildings in the walled garden area, including a shippon (Burton Ms), but it is not clear where this building originally stood. Current excavations have not found building footings in the area of a large building shown in the 1st edition OS map, but a timber-framed building could have had very shallow footings, vulnerable to loss during any levelling works in the walled garden area. Additions were made to the stables in circa 1900 (*Figure 91*) when a West range was added, comprising stalls for four horses and a tack room with loft over. For further details of the alterations of this period see Appendix B.

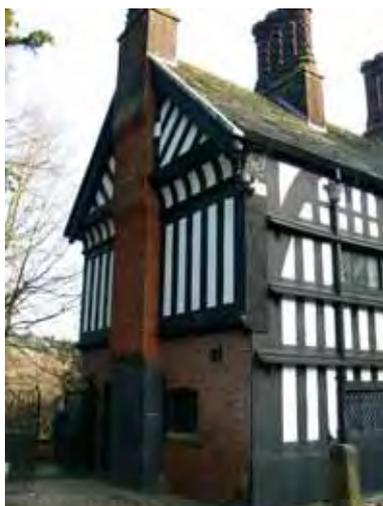
Hall's North Wing South Façade

Repairs and changes made in the mid C20 included major works to the south façade of the North Wing. Here the historic pattern of the timber frame was replicated with cement render and slightly recessed infill panels painted 'black and white' (on brick wall which replaced much or all of the original frame). This obviously lacks 'authenticity' in the sense of its 'newness' and its form of construction. Today such an approach would be highly questionable within the context of a Grade I Listed Building. This poses questions of management and presentation for the longer term:

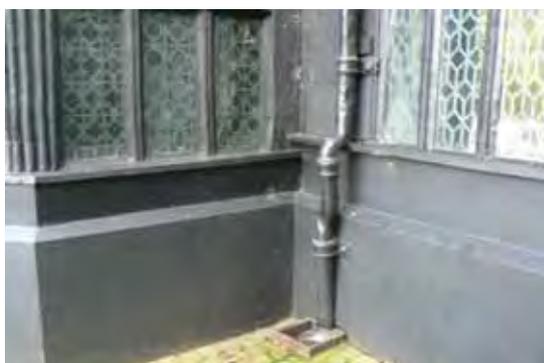
Hall West Courtyard Rendered Plinth

There is a C20 plain rendered base to all three of the west courtyard facades. Originally the timber frame structures will have sat upon a sandstone plinth. This will have deteriorated and at various stages over the long history of the building replaced together with decayed sole plate and lower posts. It could be argued that a sandstone plinth be reinstated. It is a different case to the south façade's mock timber frame in that the rendered plinth has no 'authenticity' value either in its age, material or in its replicating the aesthetic appearance of the original. Its one virtue is its visual neutrality and simplicity (compare to base to east façade). At the north façade and parts of west the posts/studs appear sit directly upon the concrete plinth with no sole plate. (Most probably the sole plate and framing have been removed, if there are remnants of timber then they will be vulnerable to decay). This has eroded some of the character and visual interest of the original form of construction. There now being too much plain surface with hard edges painted dark grey compared to the soft red sandstone of the original.

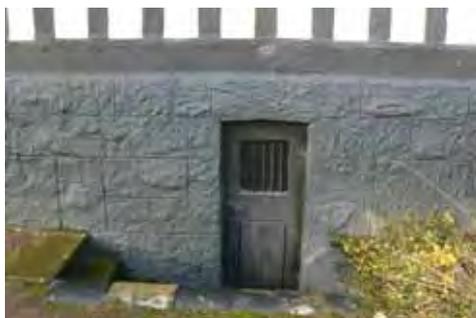
Hall East Façade Cement Rendered Plinth

East façade C20 cement render applied (probably to brick) to give the impression, in low relief, of stone. It looks totally unconvincing.

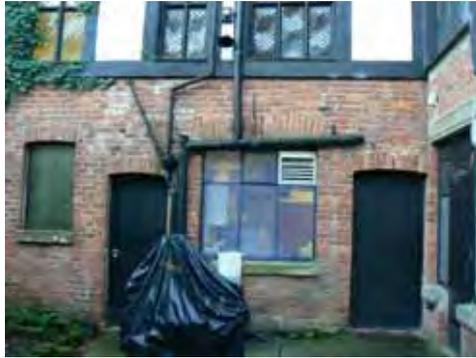
Hall NE Wing West Facade

North East Wing (rear yard) C20 pipe-work and ground floor frames with outer polycarbonate sheet for security. Although, not on the visitor trail these interventions are of low quality in design and materials.

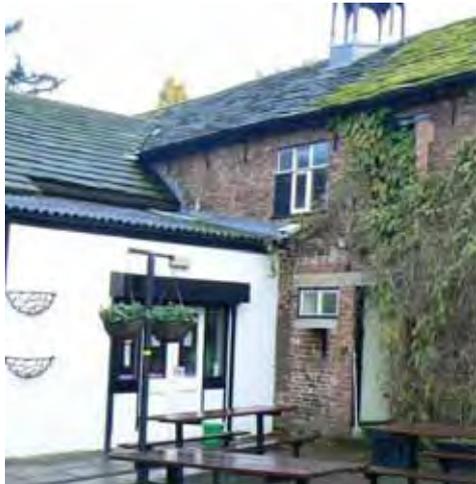
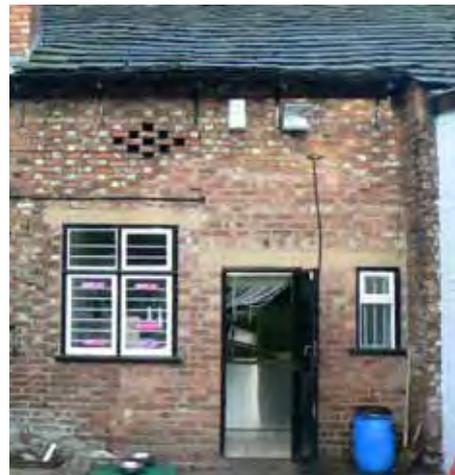
Stables North Range Courtyard Façade

Extension to the Stables café with its corrugated sheet roofing and roller shutter box is crudely designed and unsympathetic to its location. Alterations to the Stable East Range and the Stable North Range have involved concrete lintels, window openings and frames which are of poor design and out of character with the historic building.

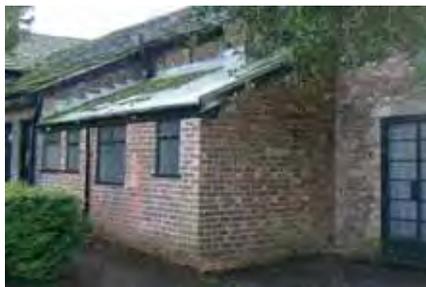
Stables North Range Cafe Toilets

The design and material quality of the Stable Café Toilet Block are crude in their own terms and a poor fit with the historic building it abuts. (In comparison the public toilet block, although not of particular merit, integrates and sits more comfortably with the historic building, sharing a continuity of roof line and stone covering, no windows, and better quality brick.

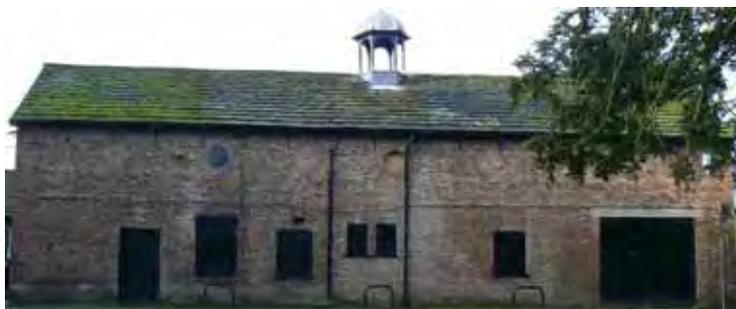
Stables East Range East Façade

The East Range is the most prominent building in the stables complex and its east façade overlooks and is prominent from the Halls West Courtyard entrance. The building survives intact in its overall form, roof and upper parts of facade but later window and door openings have been randomly punched into its east façade eroding the ‘ordered’ character of the design. Especially unfortunate is the wide vehicle door with exposed concrete lintel. There is the possibility of improving the façade’s appearance by modifying the ground floor openings even finding new uses that would involve opening doors and windows.

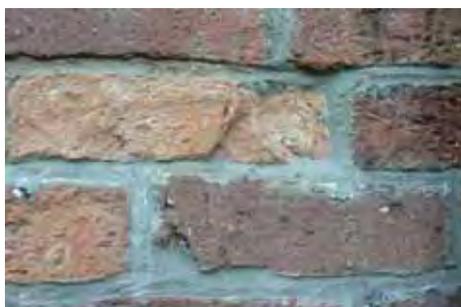
Hall and Stables Generally Cement Re-Pointing

Recent cement mortar re-pointing which is found in various locations is harmful to the brick in the long term and visually out of character. The traditional binder for mortar is lime, and this would have been used throughout the majority of the building’s history. Lime has a much more sympathetic and forgiving character and is the appropriate material for use in the majority of historic building repairs.

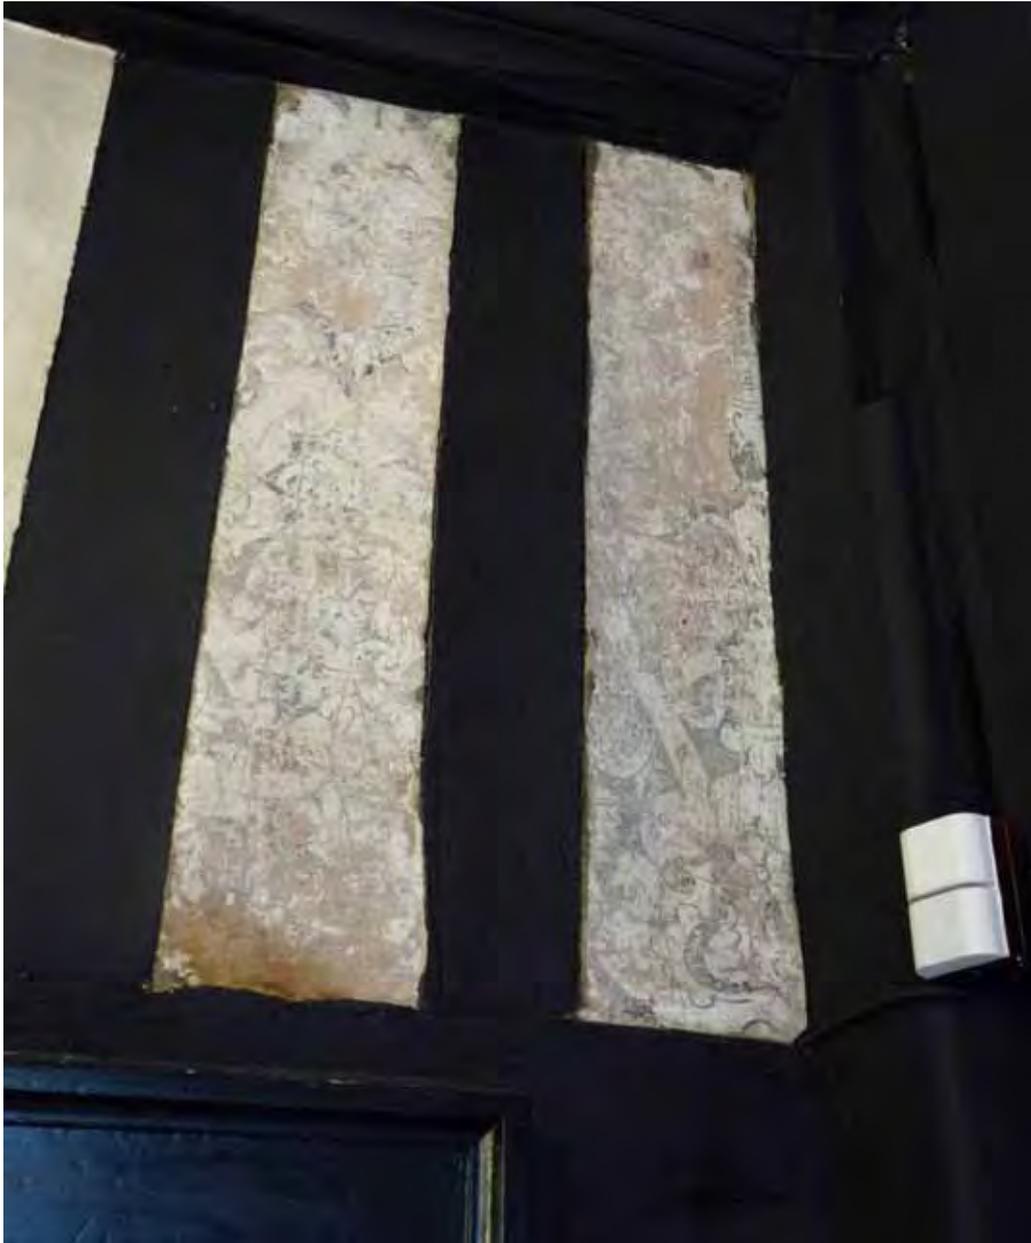
Surviving C16 painted wall decoration in NE corner of room

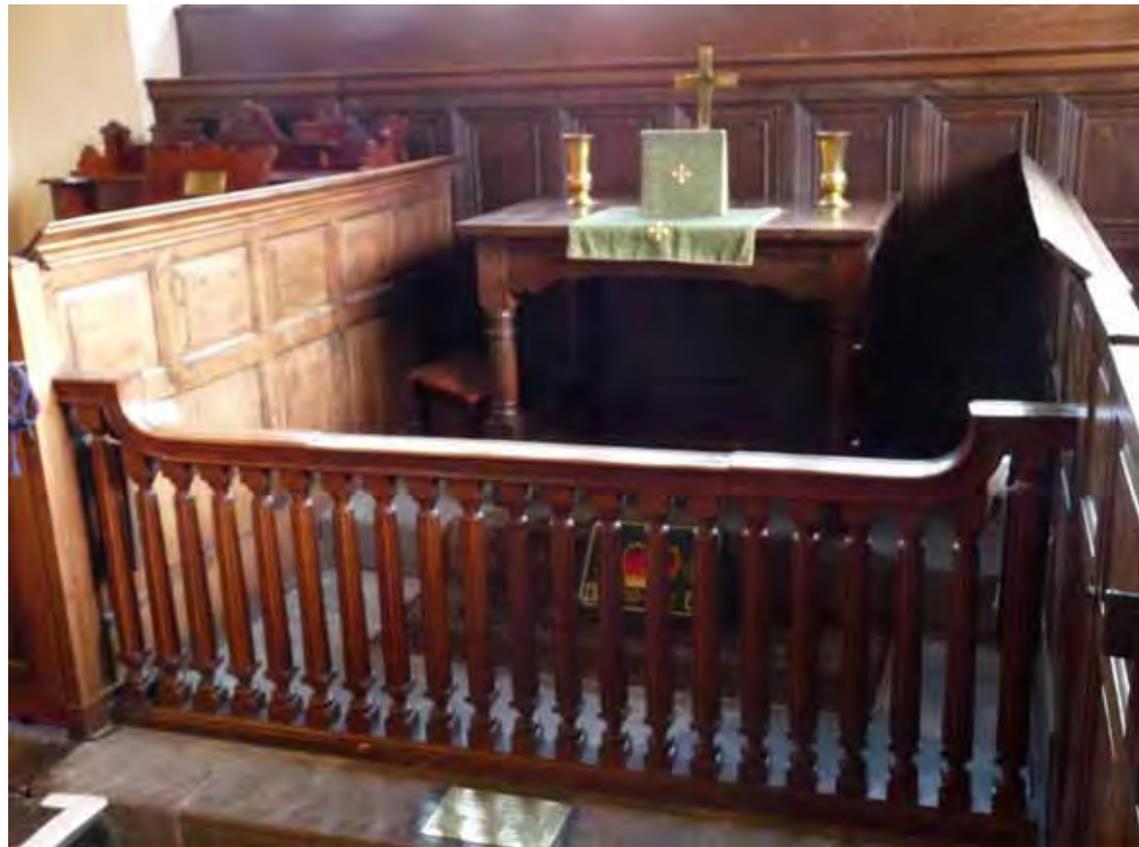
Sanctuary, restored 1930s with funding from Charles Wrigley

The chapel was restored at the expense of Charles Wrigley, a local resident by the architects Oakley & Sanville, work undertaken in 1938 using 19th century photographs by Cyril Davenport as a reference (Dean, 1999; plans held by Stockport Council Conservation department). The work included replacement of decayed timber, repairs to the fabric and new sanctuary fittings; photographs in the Bramall Hall collection show the chapel before and after this work. A new East window of nine lights was installed, and a small window of three lights installed on the South side. The Victoria and Albert Museum had bought ancient glass from the chapel in 1927 and this was returned on loan and reinstalled in the East window in 1947. The pews were renewed in two phases, on the north side in 1938 and the south side in 1945-46.

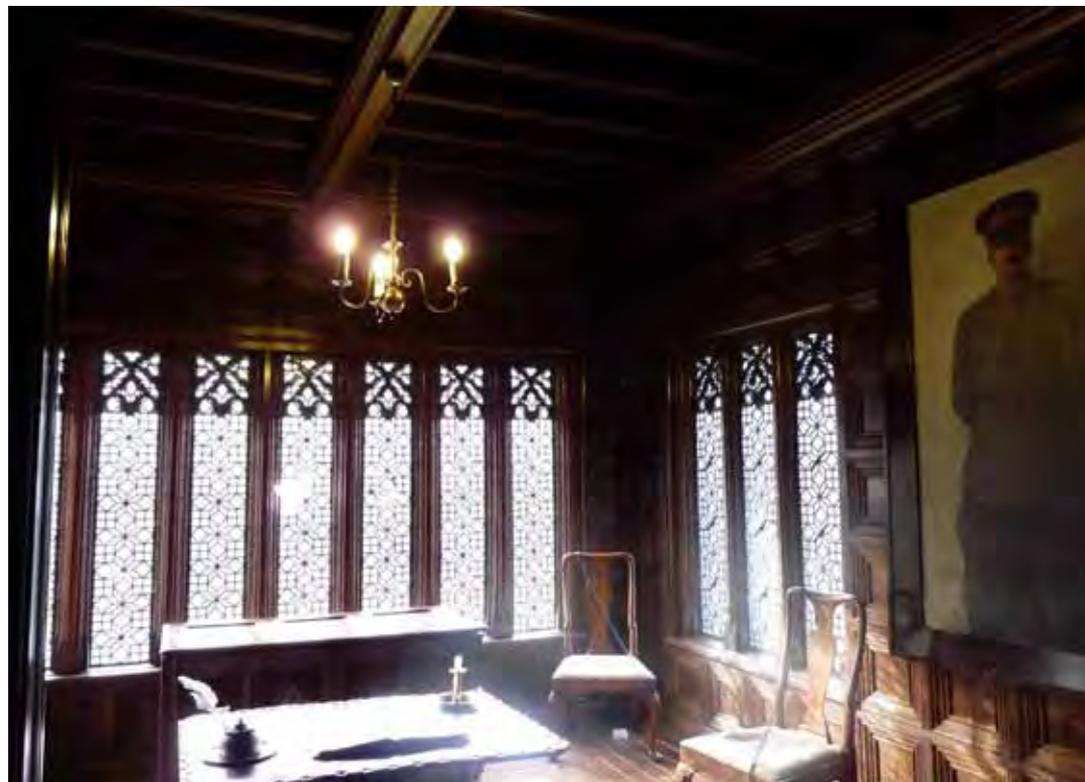
F4 - Bay on south side added in 1890s by Nevill, from the north

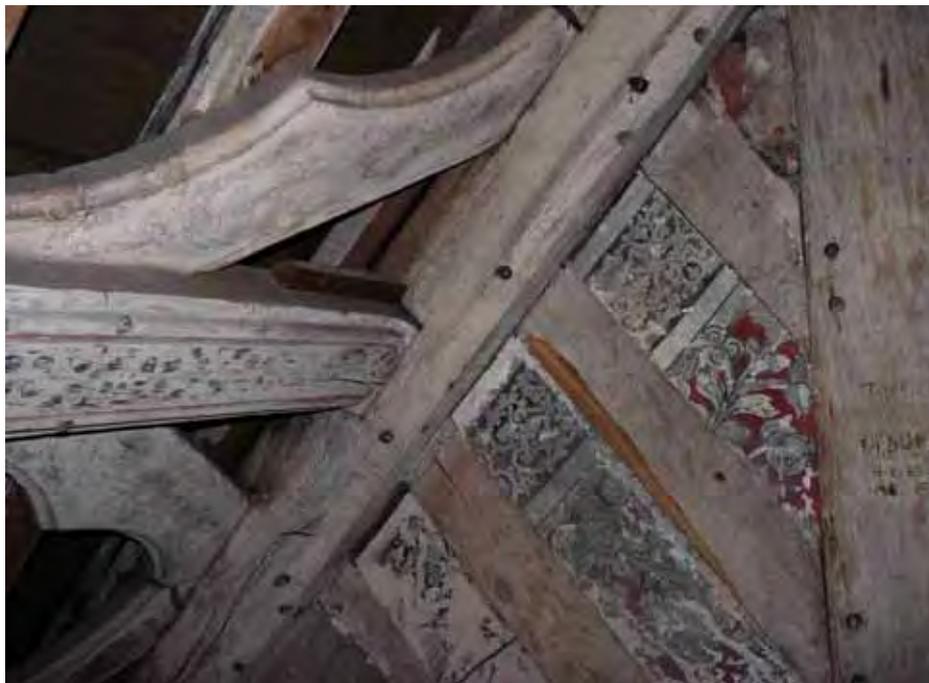
E gable end with painted decoration

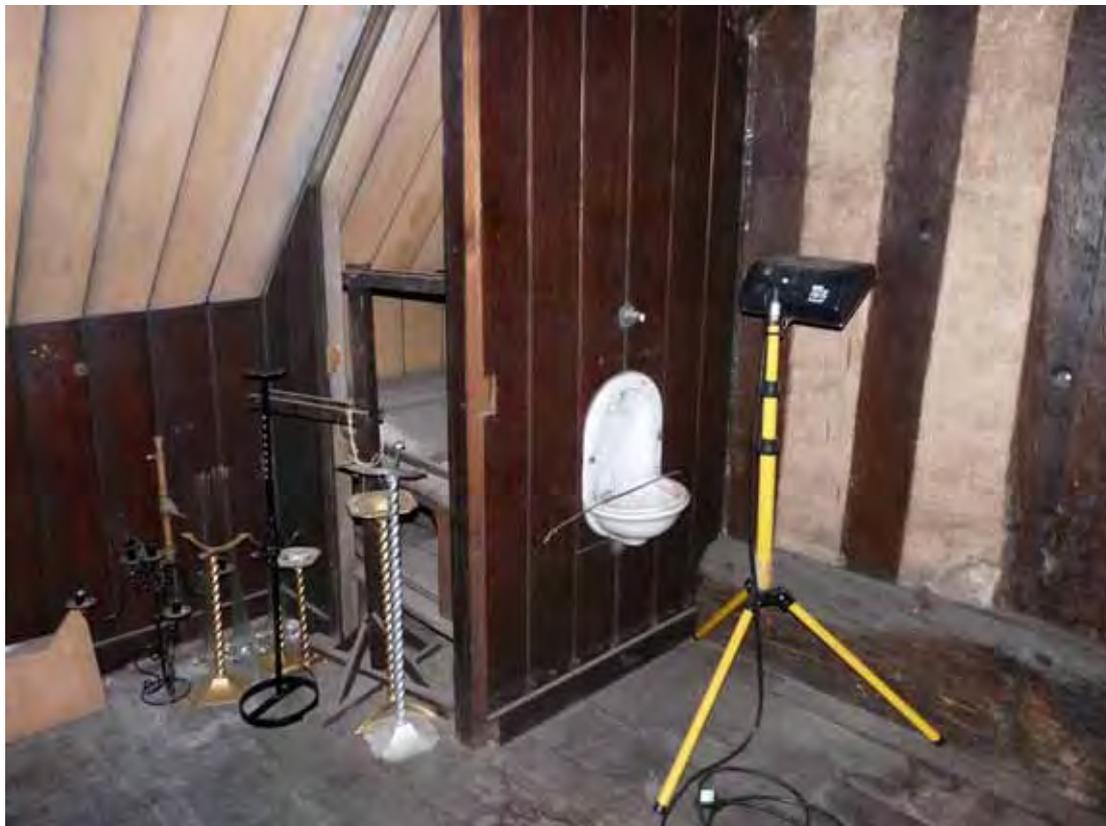
Landing urinal and late C19 joinery, from NE

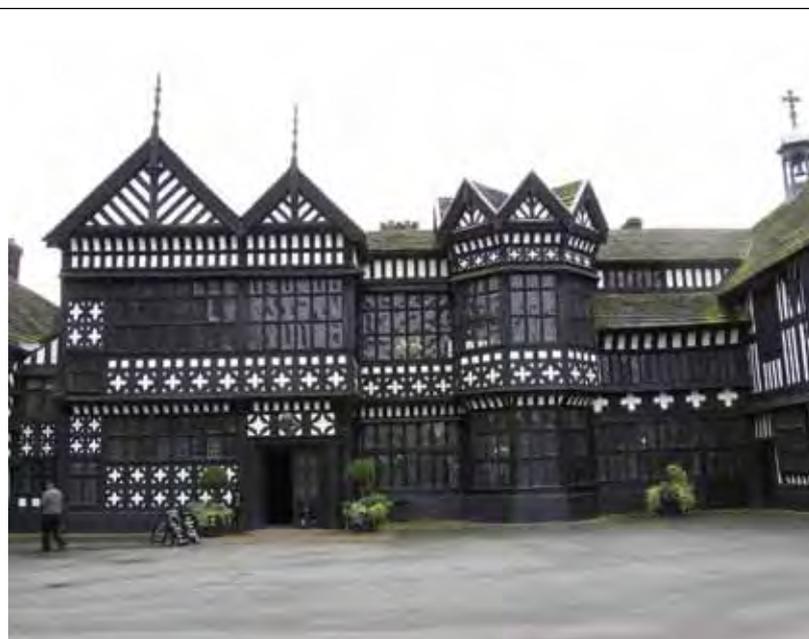
Hall Range from the W, with late C19 gables added by Nevill
