BRAMALL HALL, STOCKPORT

Conservation Management Plan September 2010

BRAMALL HALL CONSERVATION MANAGEMENT PLAN
for STOCKPORT METROPOLITAN BOROUGH COUNCIL

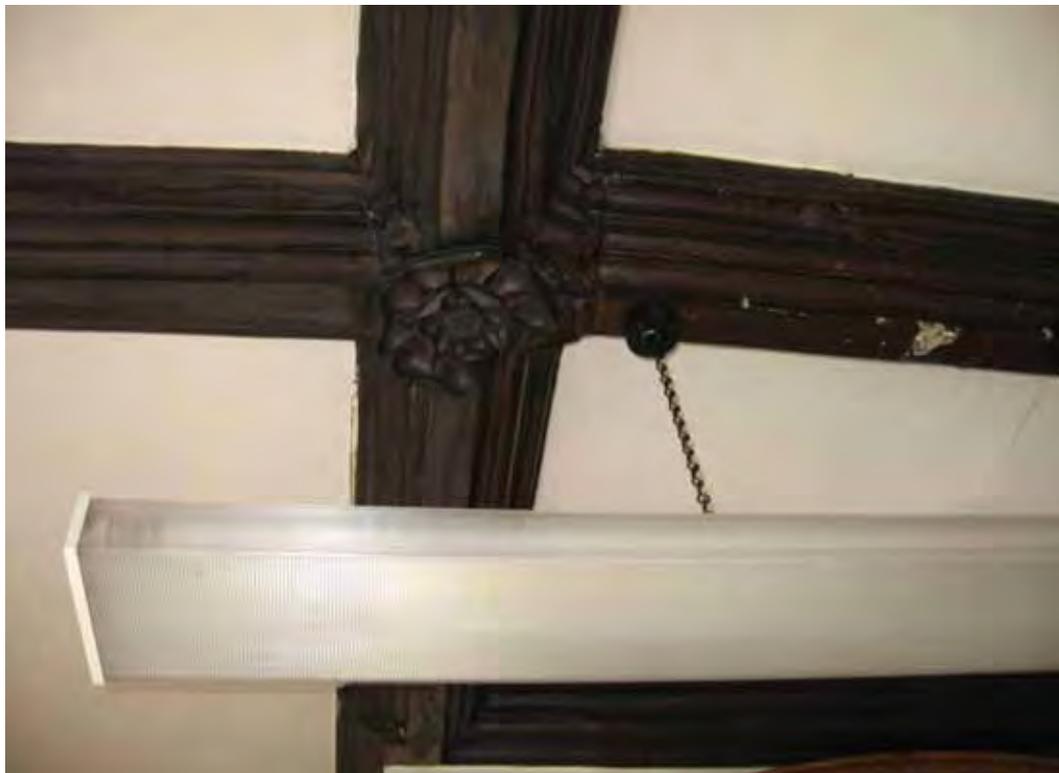
Detail of rose boss on moulded ceiling beams in library

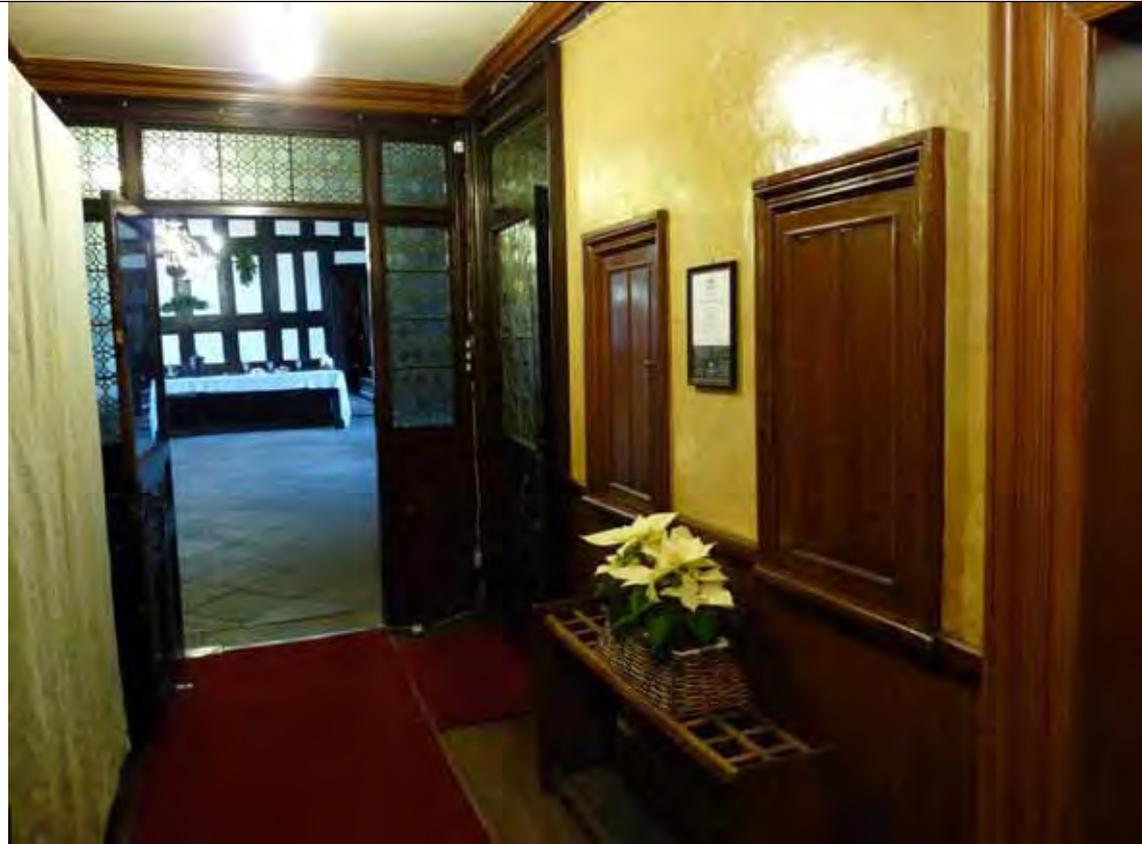
BRAMALL HALL AND PARK, STOCKPORT GAZETTEER	Zone Item Ref No	Hall, Hall range Service Passage G15
---	---	--

Passage from the N

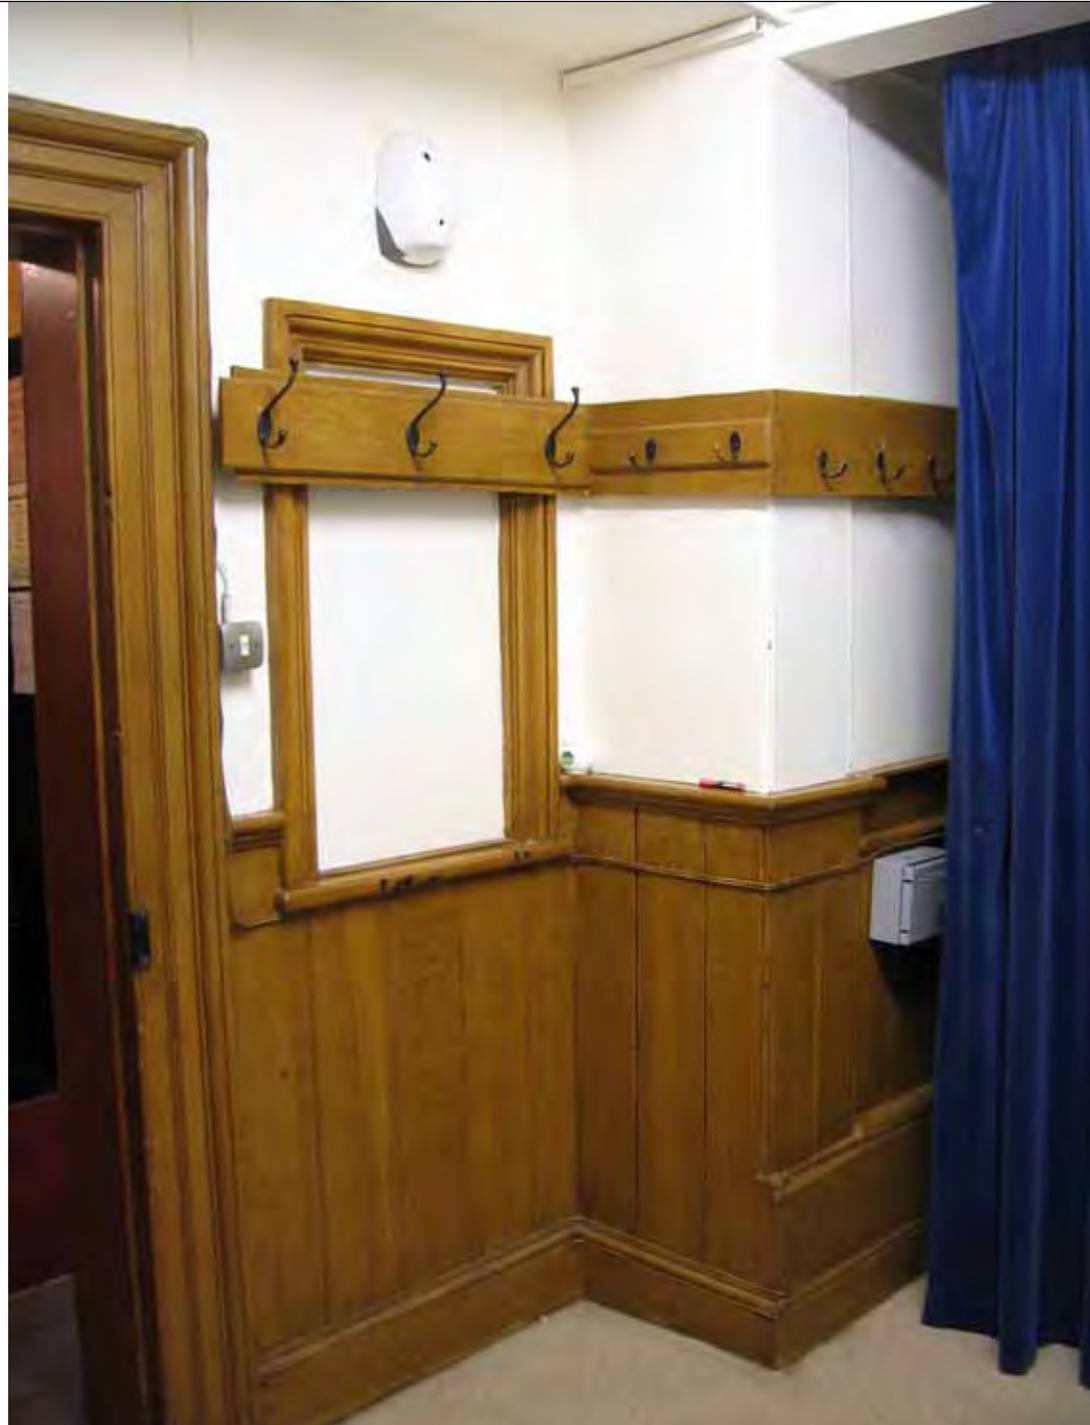
BRAMALL HALL AND PARK, STOCKPORT GAZETTEER	Zone Item Ref No	Hall, Hall range Gents cloakroom G18
---	---	--

cloakroom from the W, with former bath alcove to right behind curtain

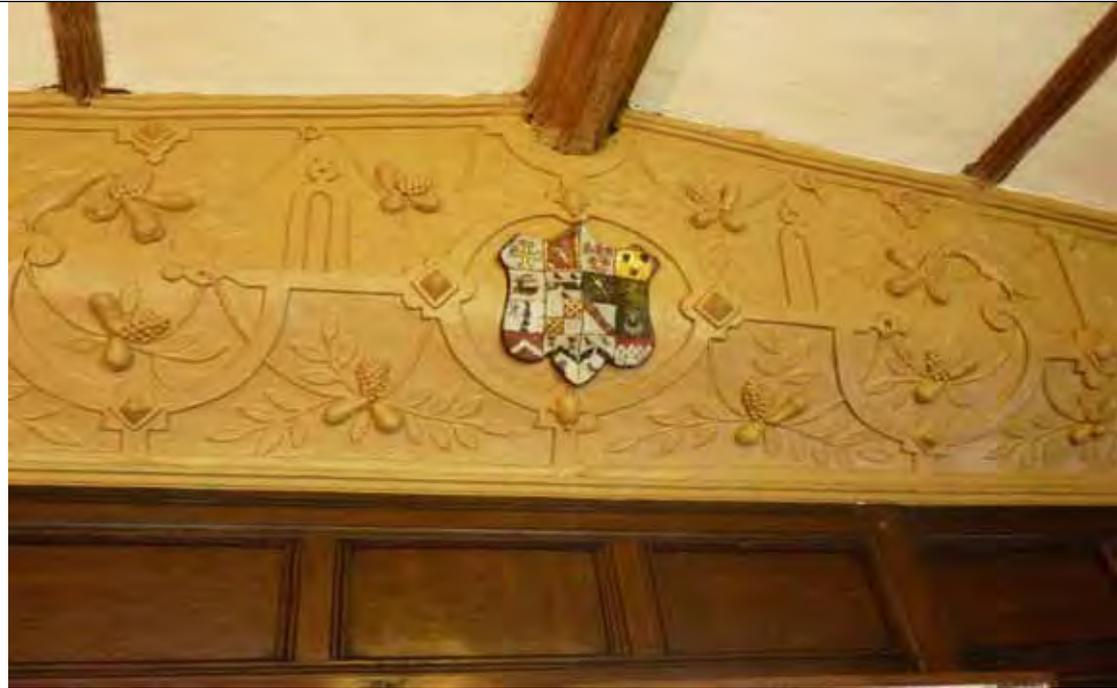
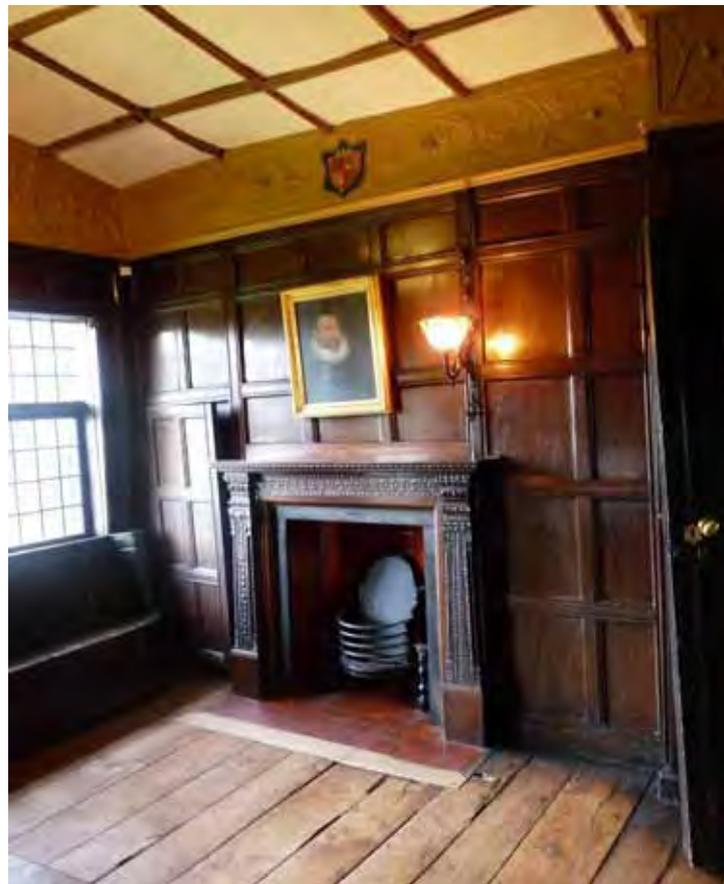
BRAMALL HALL AND PARK, STOCKPORT GAZETTEER	Zone Item Ref No	Hall, Hall range first floor Paradise Room F6
---	---	---

Paradise Room – strapwork plaster frieze on W wall from the E

Paradise Room from the NW

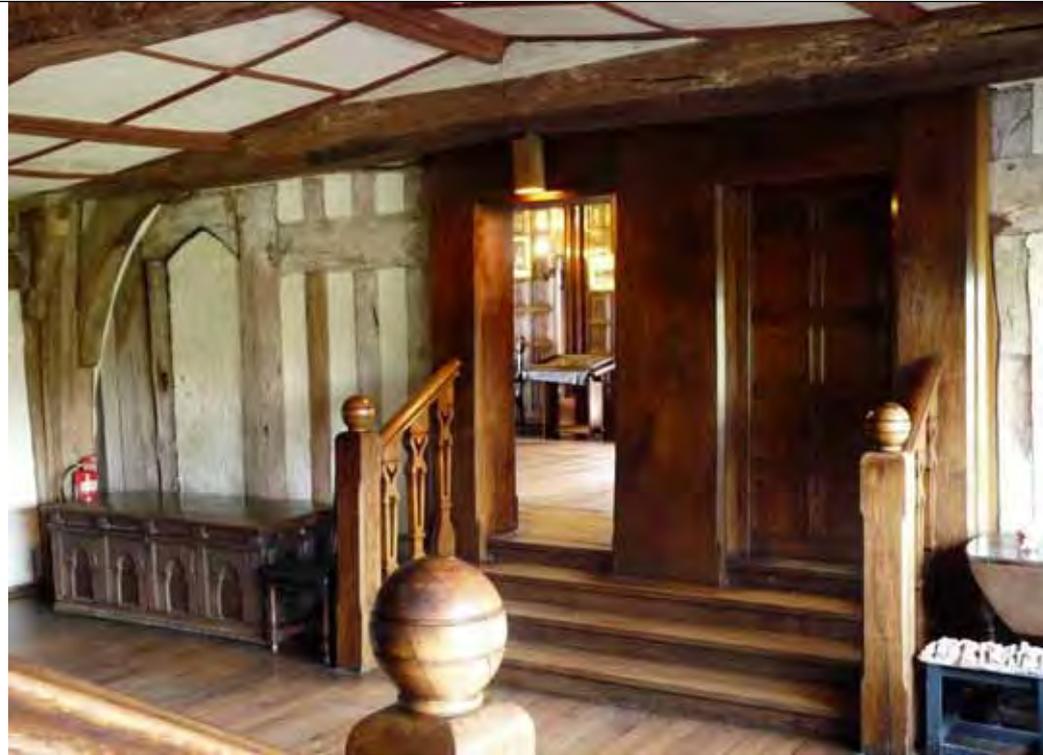
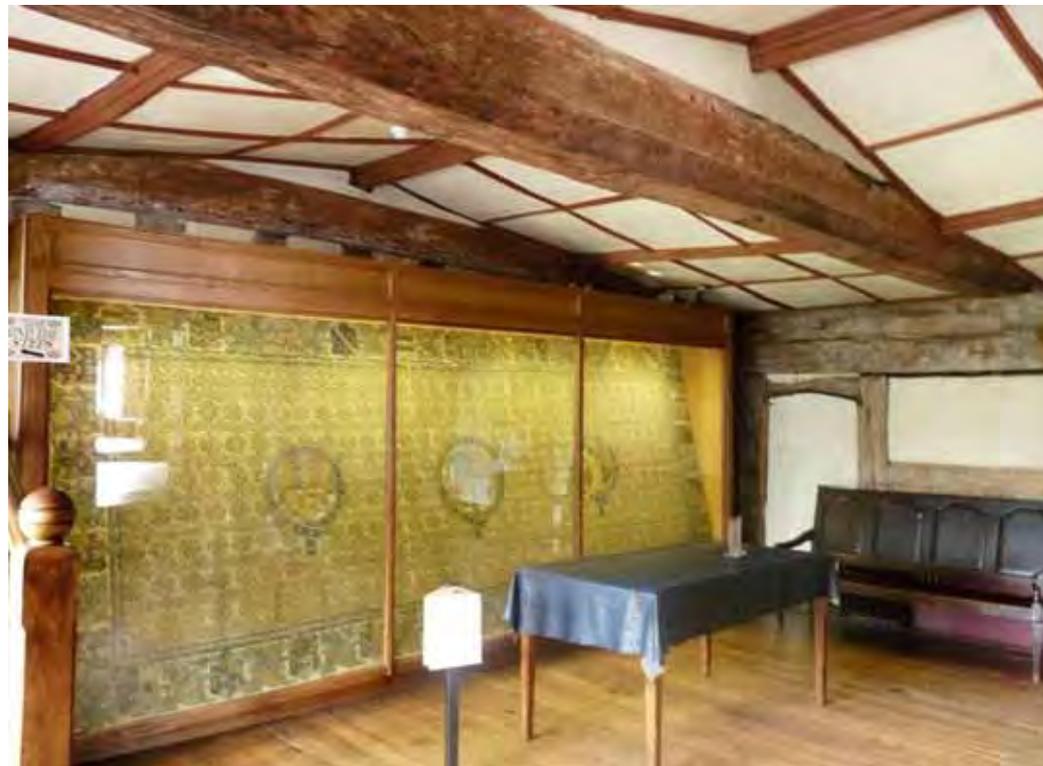
Zone Hall, Hall range
Item Plaster Room
Ref No F7

Plaster Room from the NW

Plaster room and Davenport tapestry from the SW

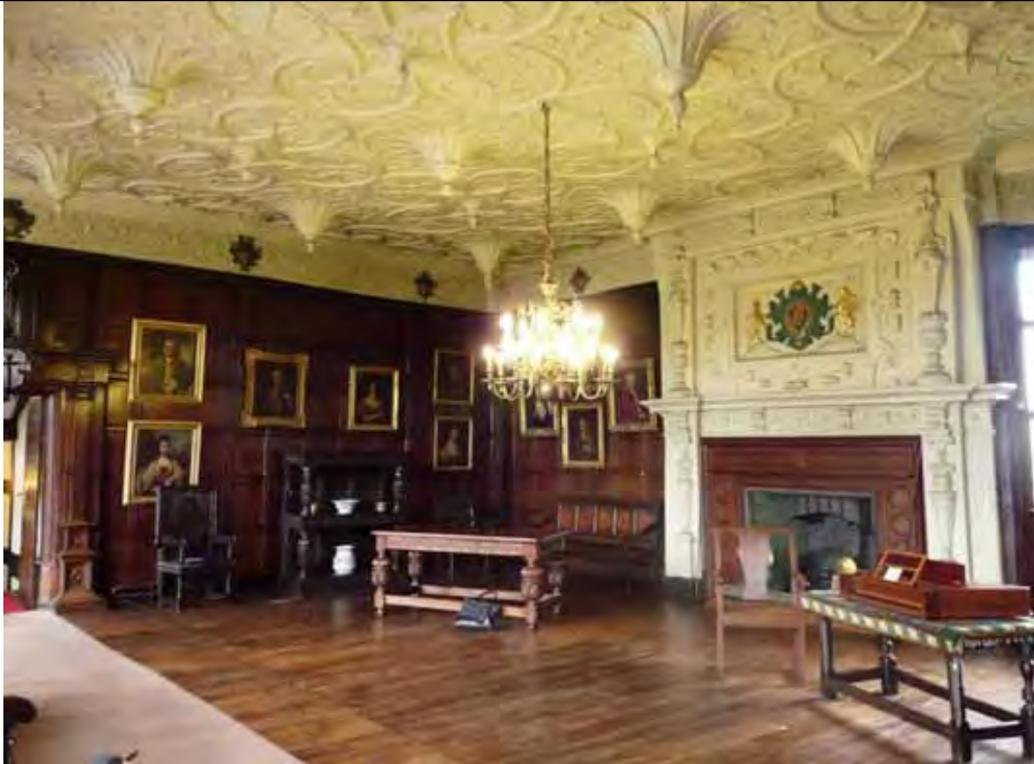
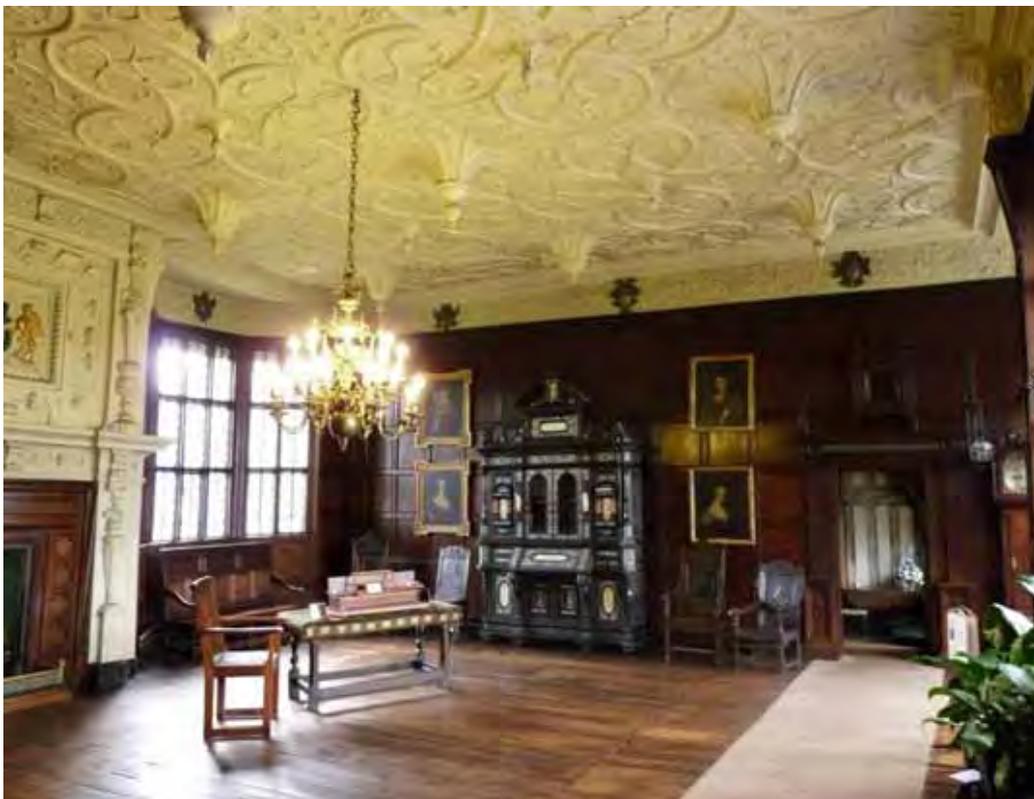
BRAMALL HALL AND PARK, STOCKPORT GAZETTEER	Zone Item Ref No	Hall, Hall range 1 st floor Drawing Room F8
---	---------------------------------	--

Drawing Room from the SW

Drawing room from the NW

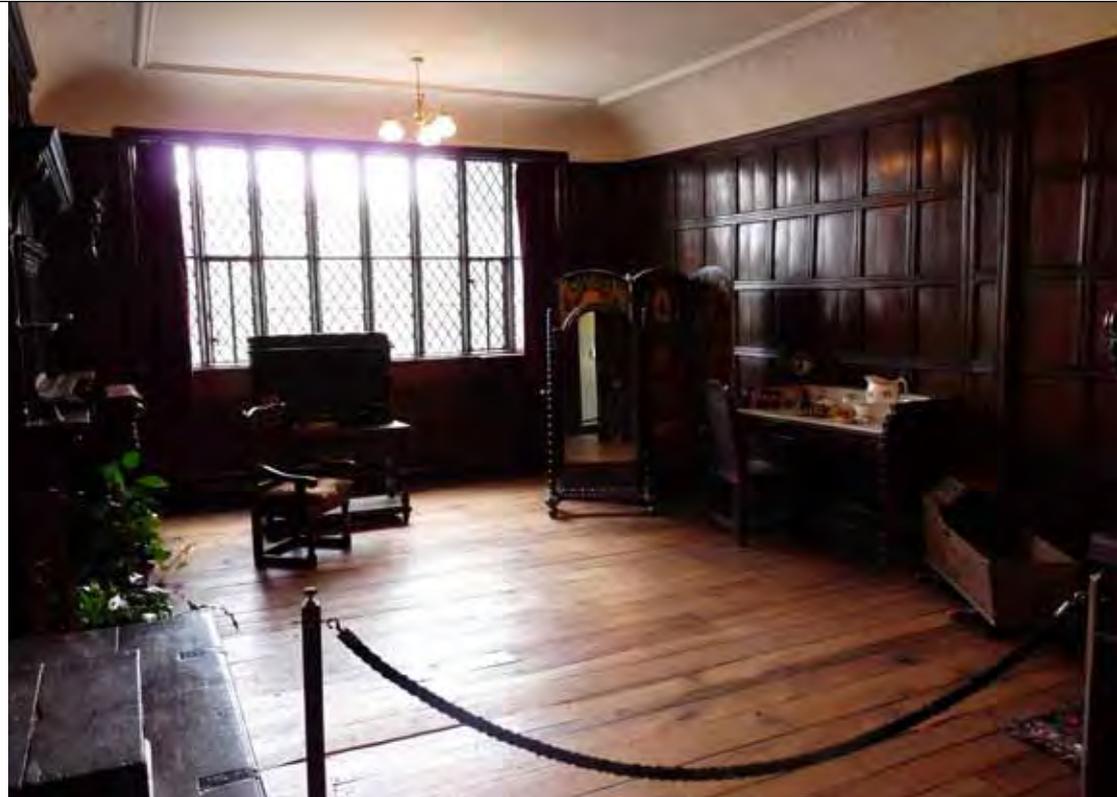
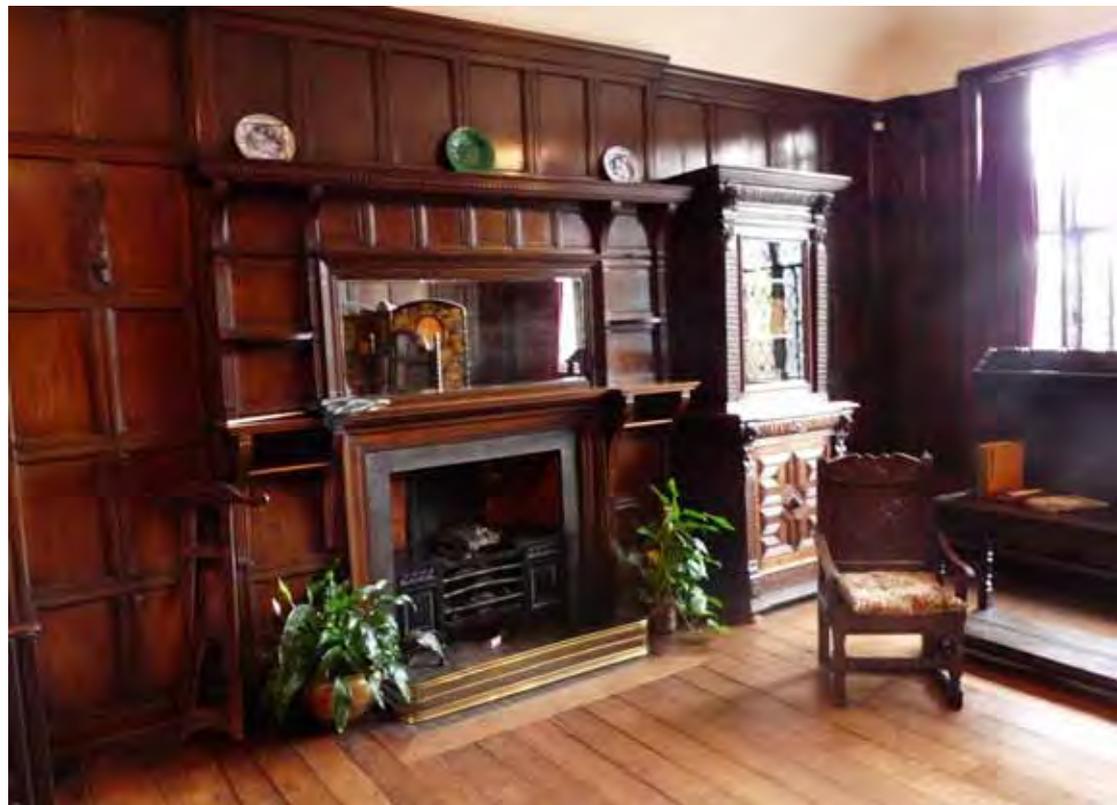
Zone Hall, Hall range
Item Davenport Room
Ref No F11

Davenport Room - from the W

Davenport Room from the S

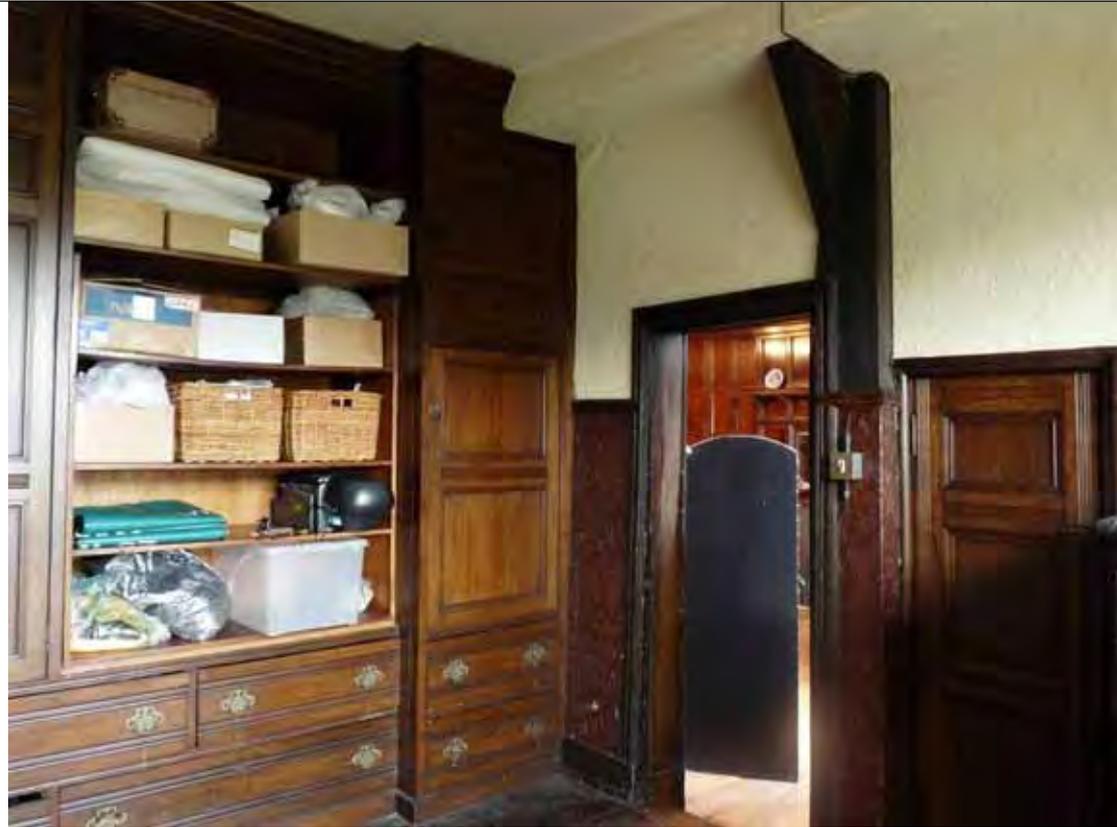
BRAMALL HALL AND PARK, STOCKPORT GAZETTEER	Zone	Hall, Hall range
	Item	Dressing Room off Davenport Room
	Ref No	F11A

Dressing room to Davenport Room, from SE

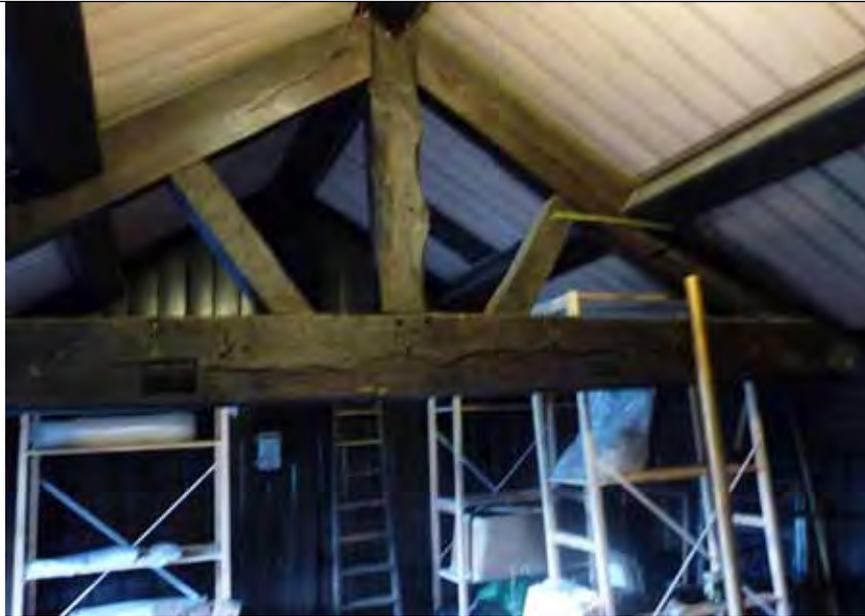
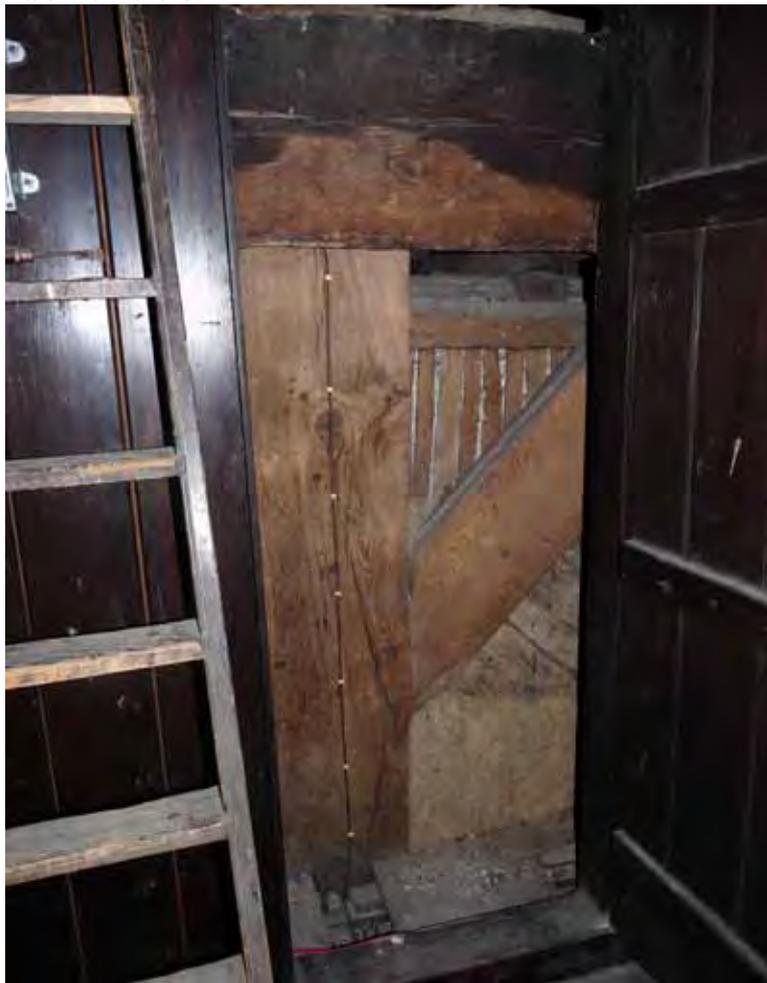
BRAMALL HALL AND PARK, STOCKPORT GAZETTEER	Zone Item Ref No	Hall, Hall range Attic over Plaster Room S3
---	---	---

Attic from the S

Truncated truss behind lining of N wall

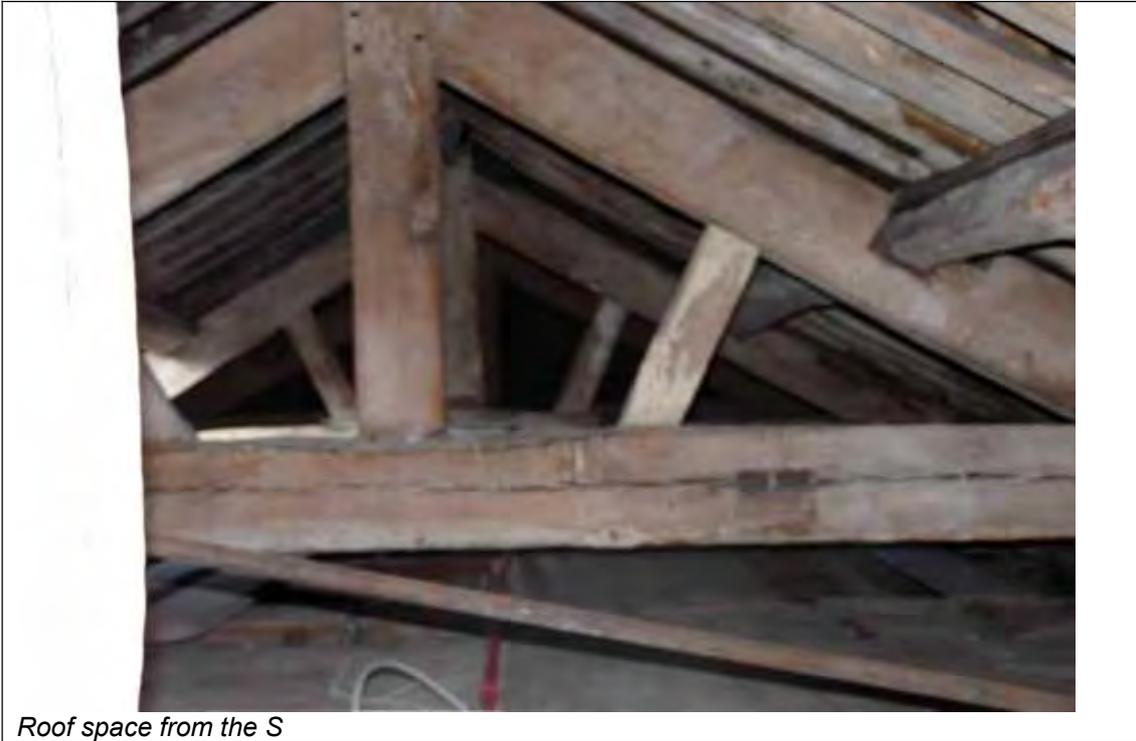
BRAMALL HALL AND PARK, STOCKPORT GAZETTEER	Zone Item Ref No	Hall, Hall range second floor Attic over Drawing Room S4
---	---	--

Roof space from the S

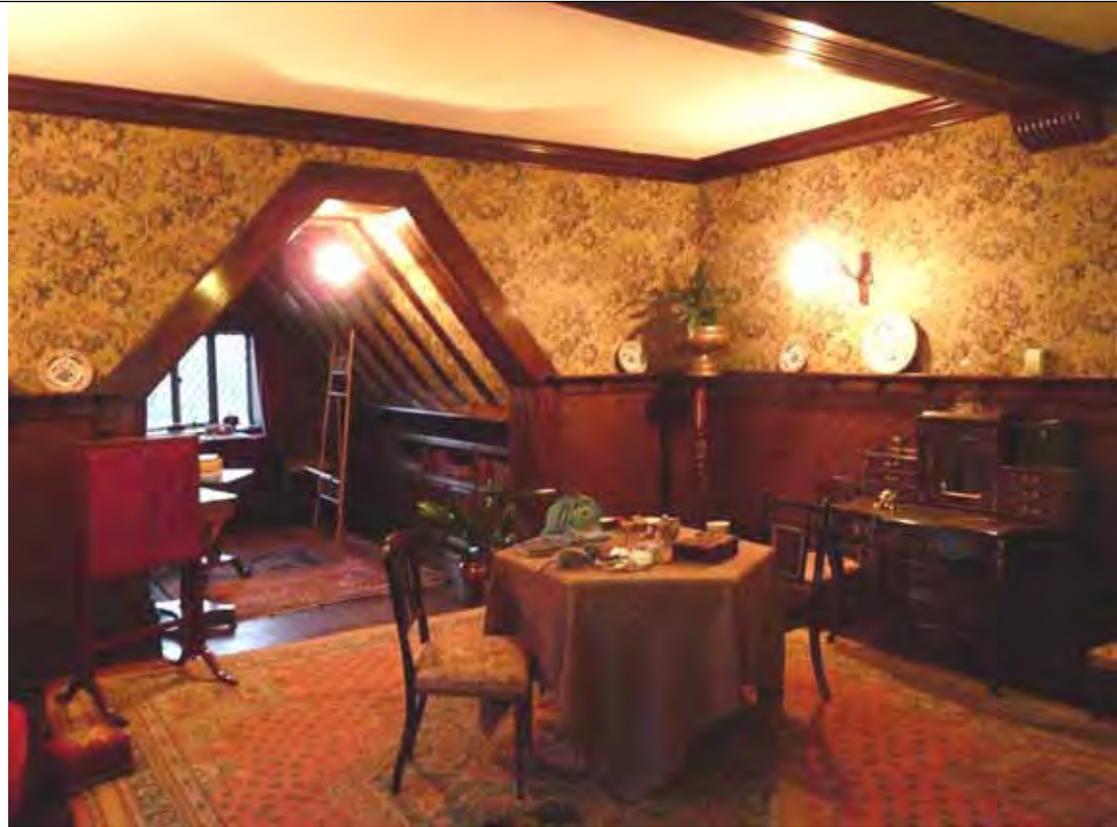
BRAMALL HALL AND PARK, STOCKPORT GAZETTEER	Zone Item Ref No	Hall, Hall range Mary Nevill's Boudoir S6
---	---	---

Boudoir from the W

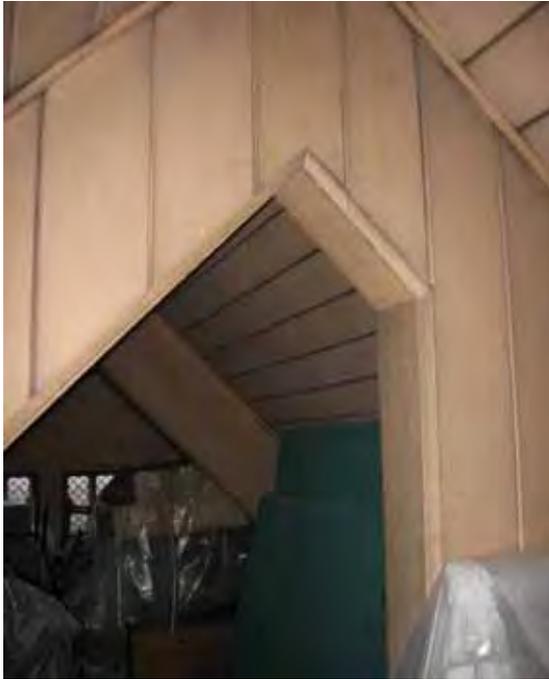
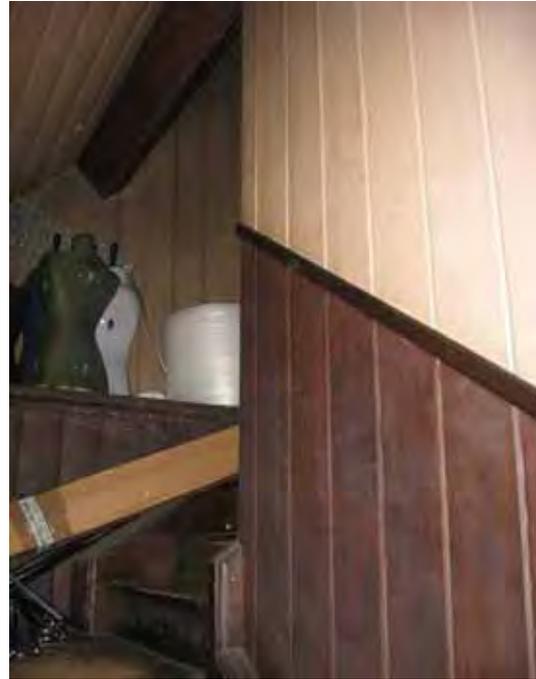
BRAMALL HALL AND PARK, STOCKPORT GAZETTEER	Zone Item Ref No	Hall range Attic over S6 T6
---	---------------------------------	-----------------------------------

- Susceptible to damage by insertion and maintenance of services.
- Further investigation of structure recommended

Attic and attic stairs from the W

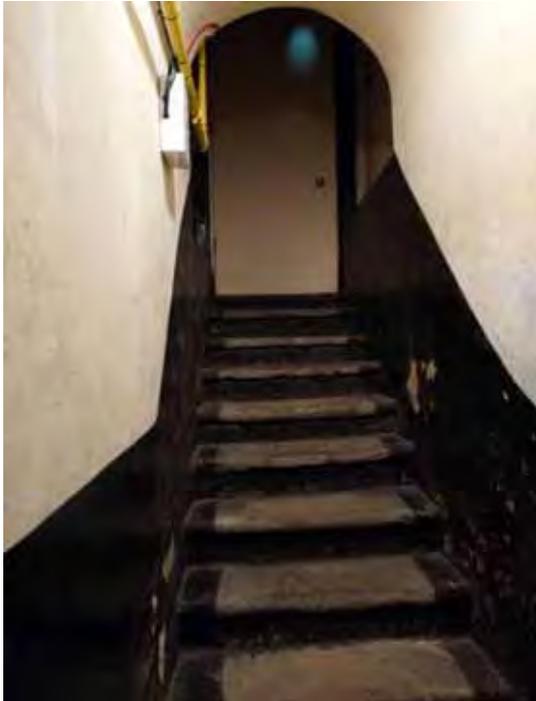
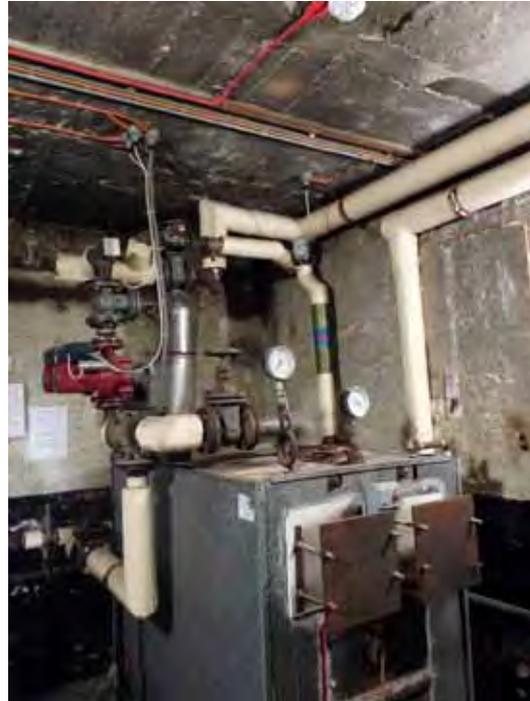
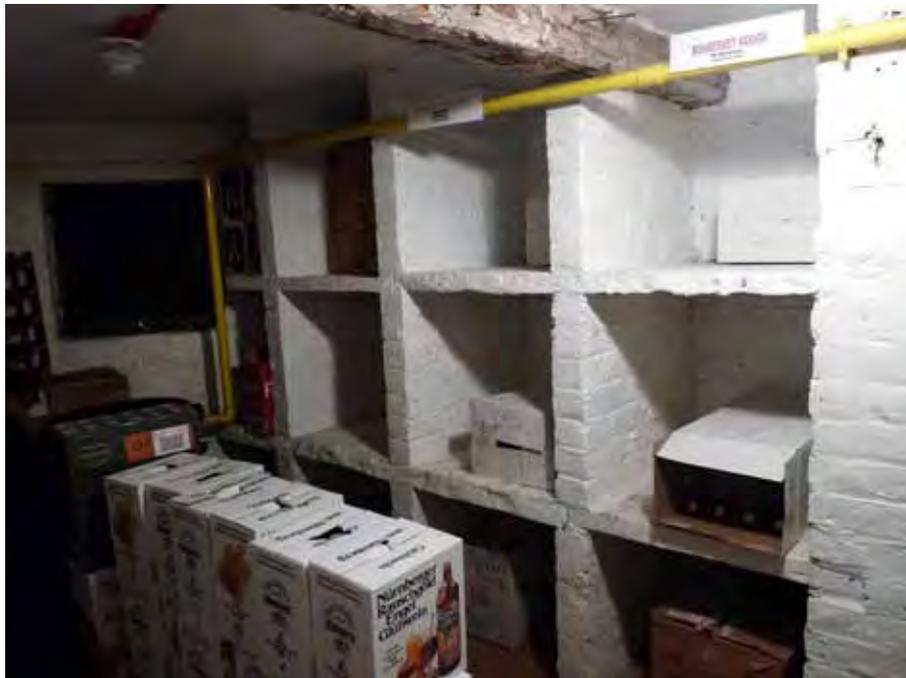
BRAMALL HALL AND PARK, STOCKPORT GAZETTEER	Zone Item Ref No	Hall range Basement B1-B6
---	---------------------------------	---------------------------------

- Susceptible to damage by insertion and maintenance of services.
- Vulnerable to neglect as only in partial use
- Further investigation of structure recommended
- Boiler needs replacement

cellar stairs from the E

gas boiler in S cellar chamber (B1)

Late C19 wine bins with C17 beam to ceiling (B4 and B5)

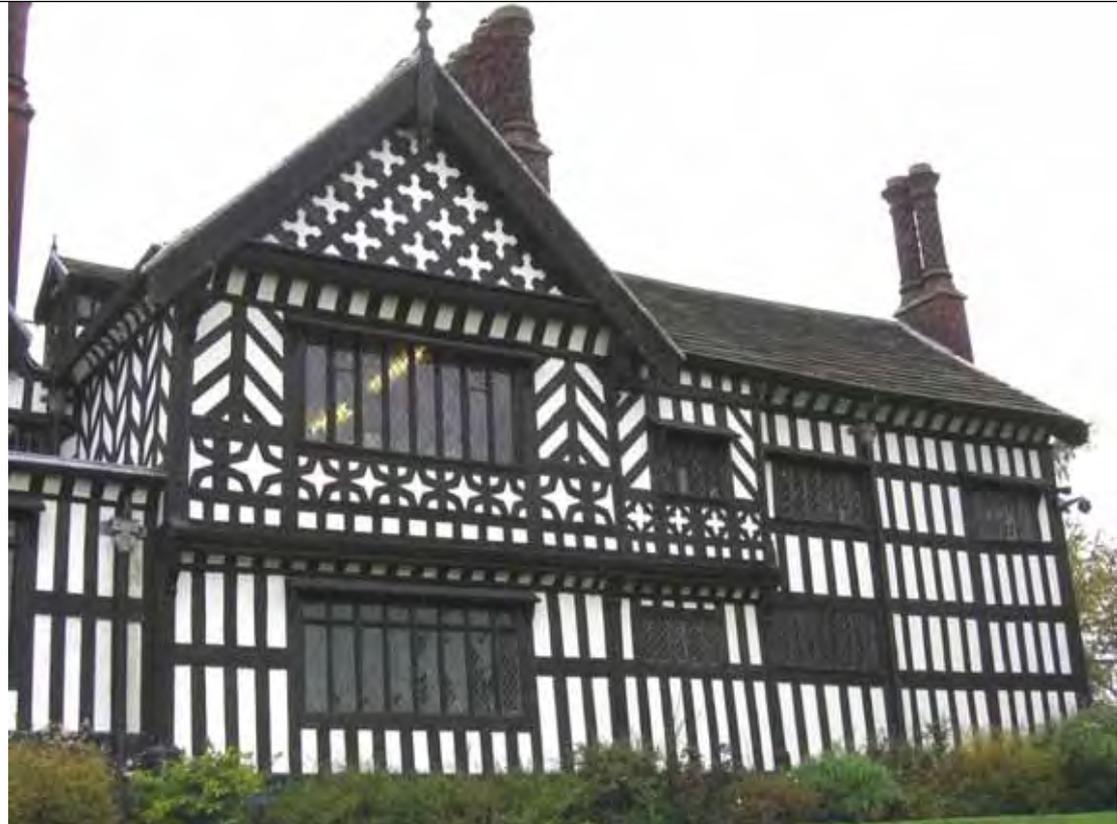
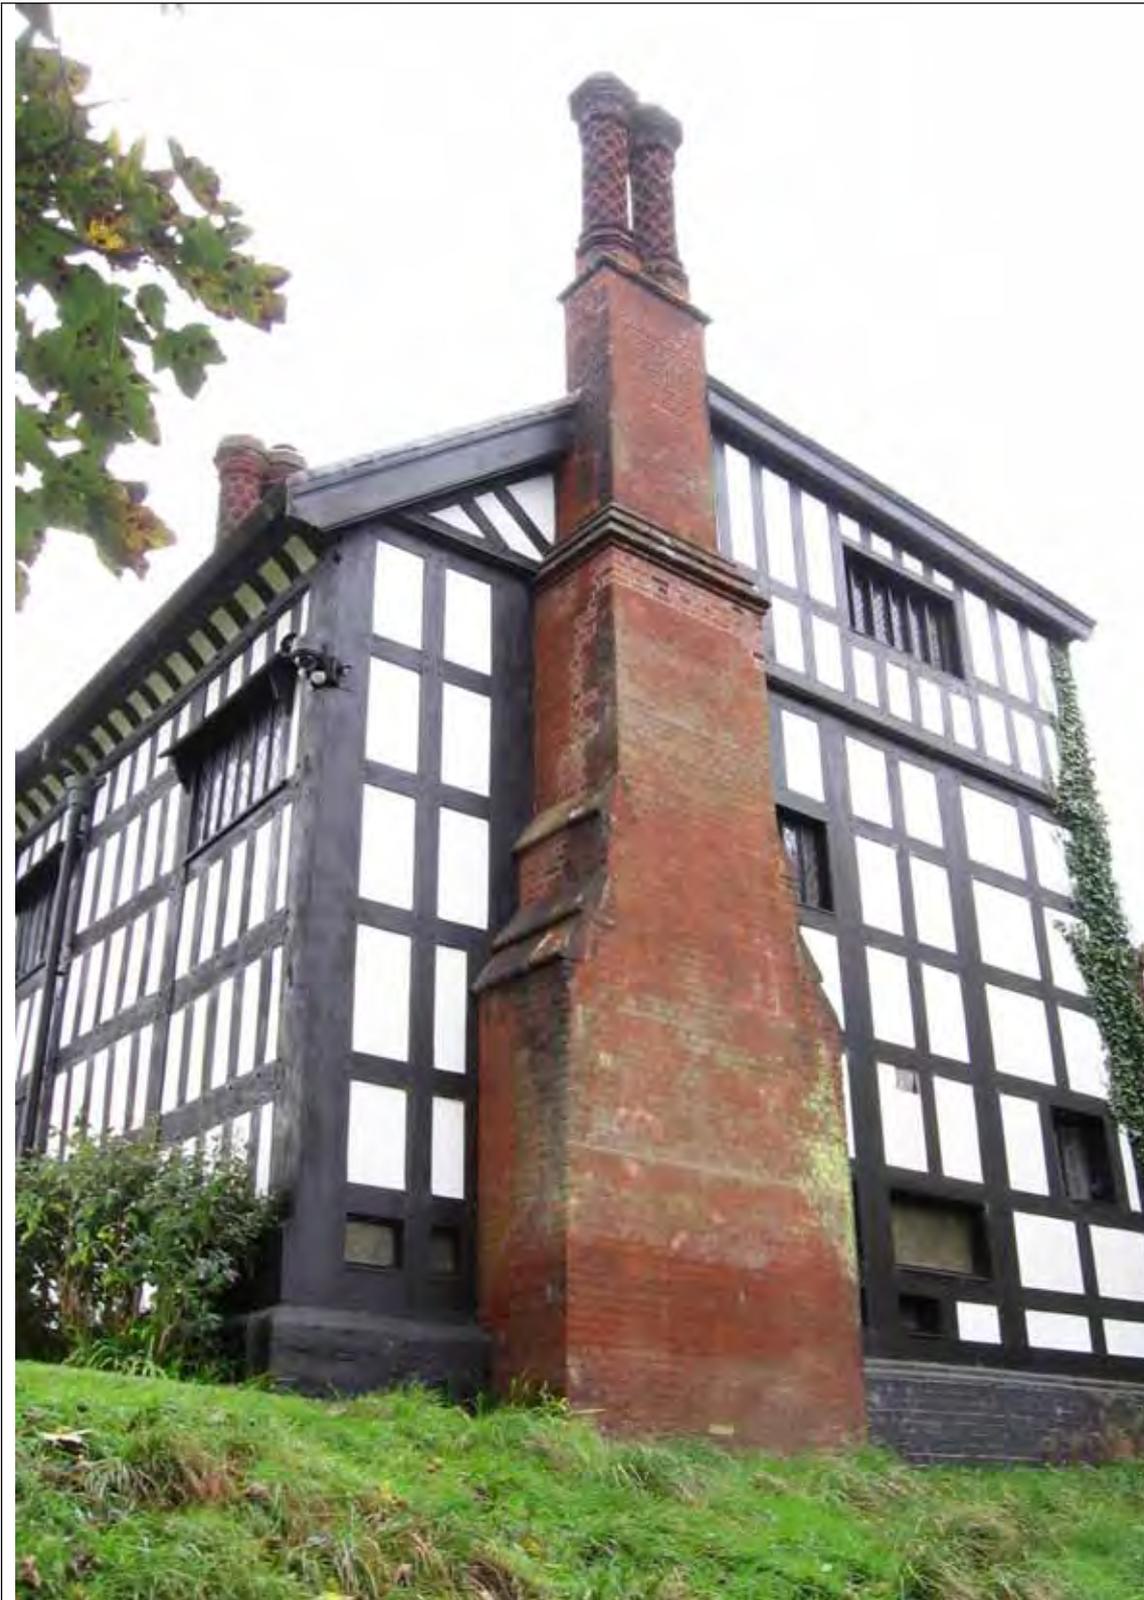
**Hall : NE Wing
Over view**

- Lack of information about origins of this wing and lack of analysis of the surviving structure – dendro and measured survey strongly recommended
- The structure is at risk of damage by insertion and maintenance of modern services

NE wing from the E

NE wing from the NE – Nevill stack and upper floor additions

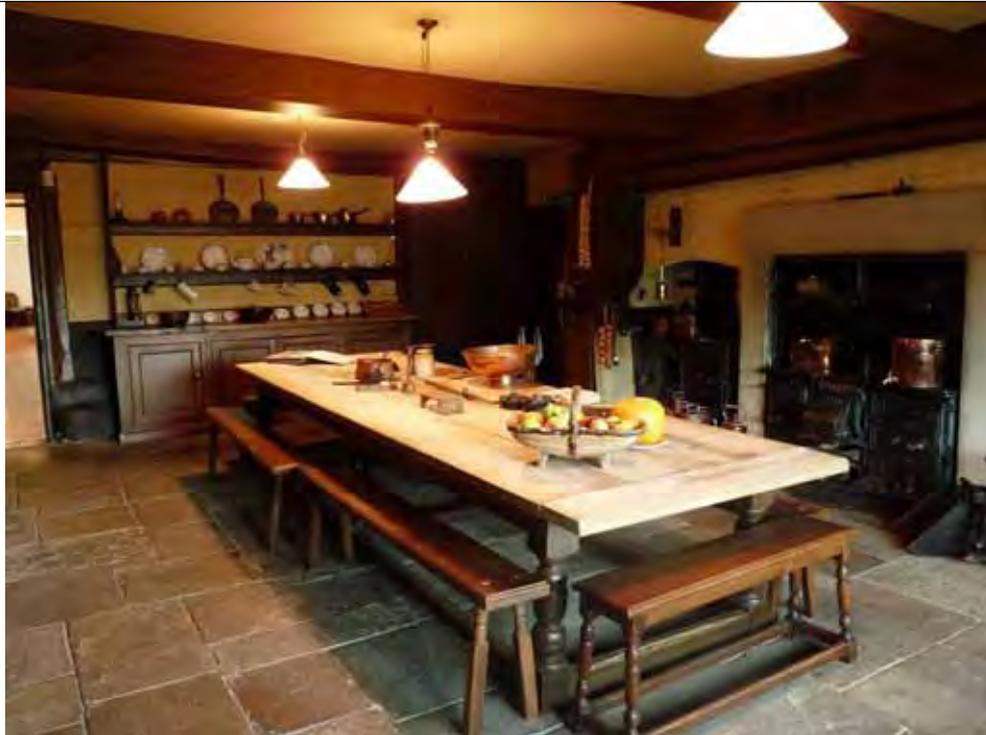
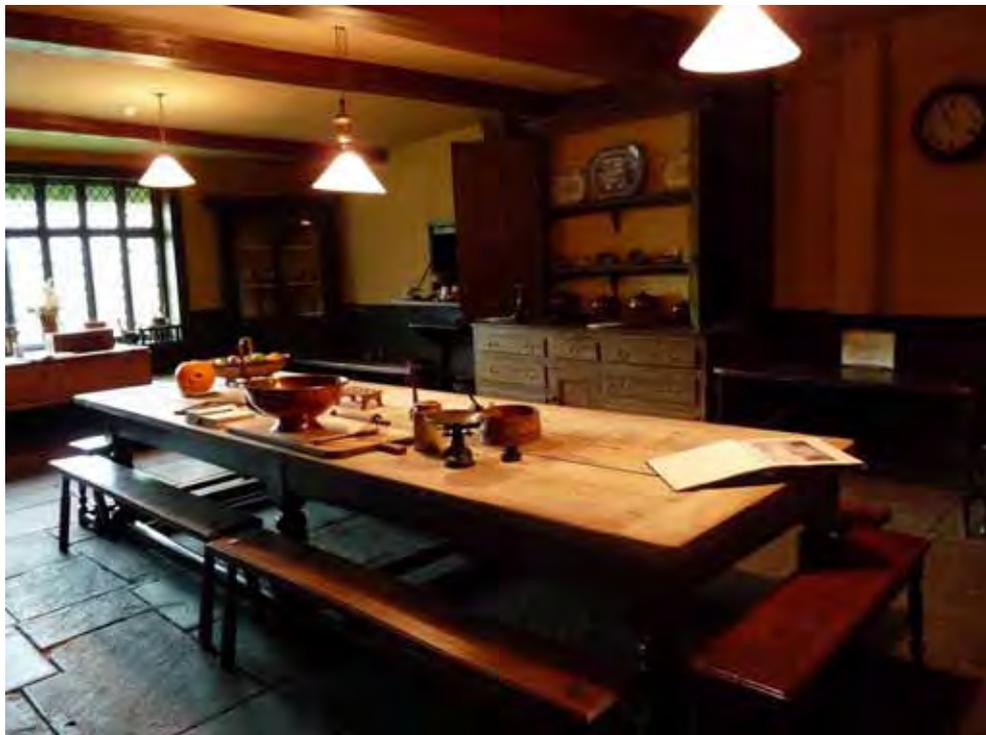
**NE Wing
kitchen
G17**

- Kitchen in NE wing probably added to replace earlier kitchen on unknown location in C16
- Construction: Timber framed walls on stone plinth, deep chamfered C16 ceiling beams, stone floor.
- Large kitchen fireplace on N wall with chamfered stone surround, possibly C17
- Lit by mullioned window to E
- Features: C18 cupboard on W wall, C19 dressers on S and W wall, cupboard doors added to S wall in late C20. 6-panelled doors to lobbies probably c.1800.

Kitchen from the E

Kitchen from the NW

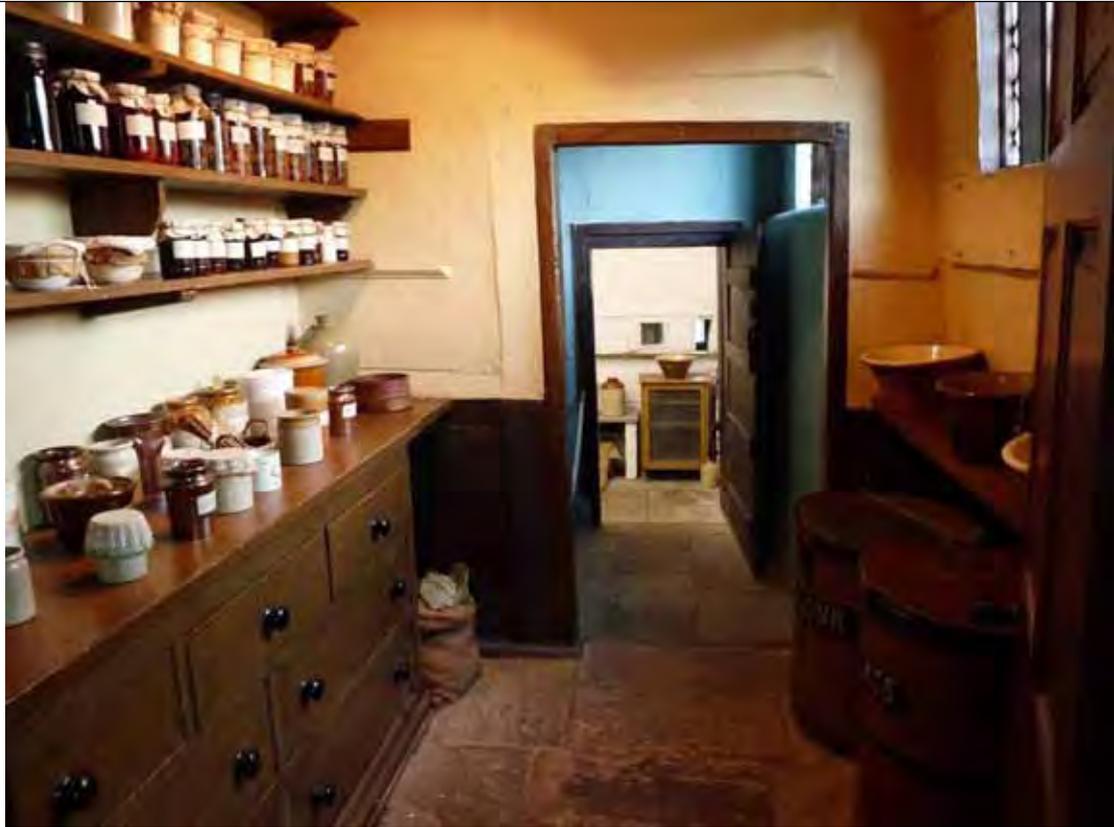
**NE Wing
pantry
G18**

pantry from the S

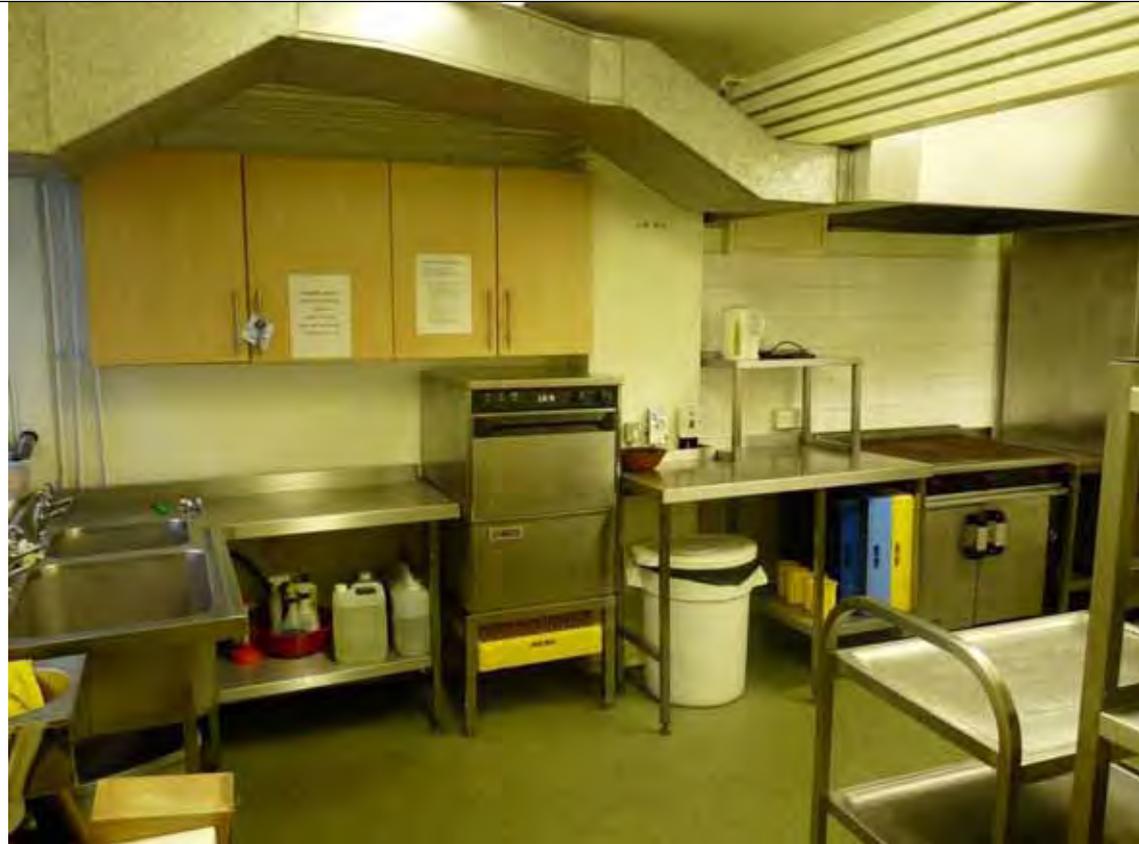
**NE Wing
Catering kitchen
G20**

kitchen from the S
