BRAMALL HALL, STOCKPORT

Conservation Management Plan September 2010

BRAMALL HALL CONSERVATION MANAGEMENT PLAN
for STOCKPORT METROPOLITAN BOROUGH COUNCIL

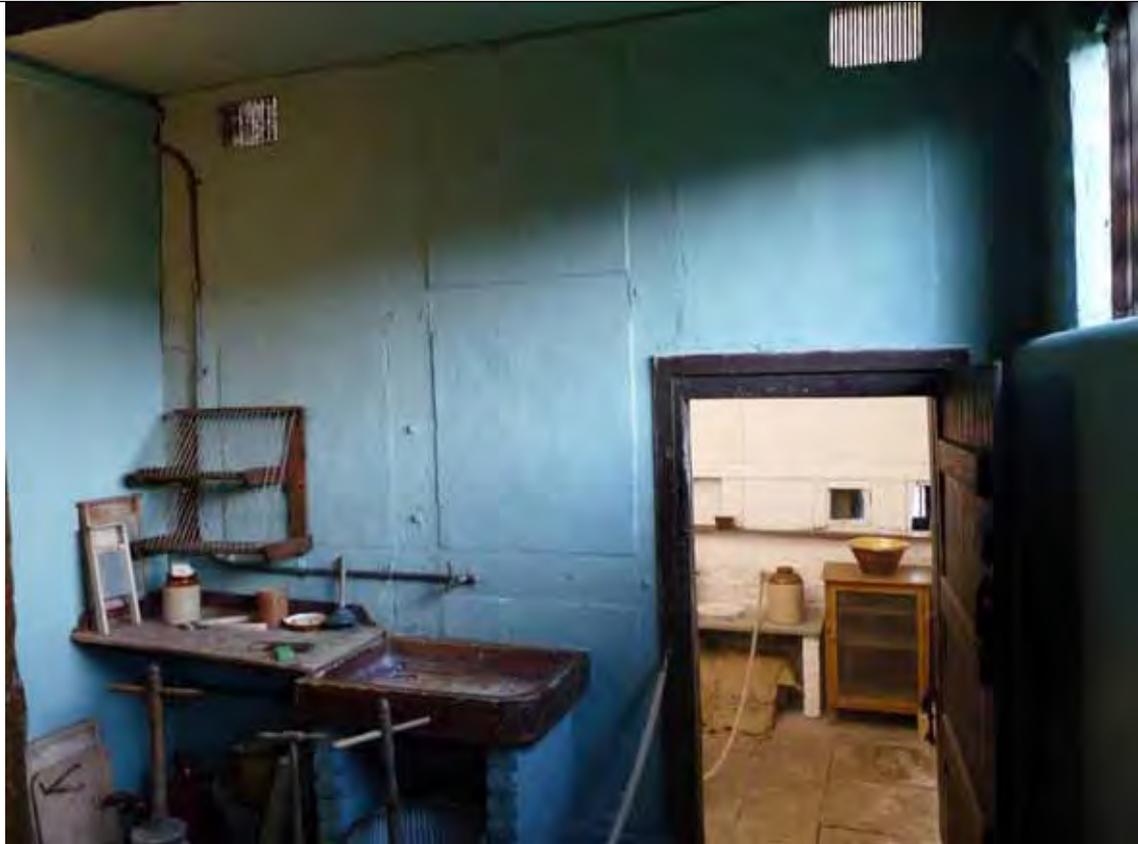
**NE Wing
pantry
G21**

- Presented as part of the visitor route
- Doorway to S up steps into pantry not shown on 1936 plan, so later insertion
- Door to W to catering kitchen now blocked
- Features: ceramic sink replaced as part of C20 visitor route presentation

pantry from the S

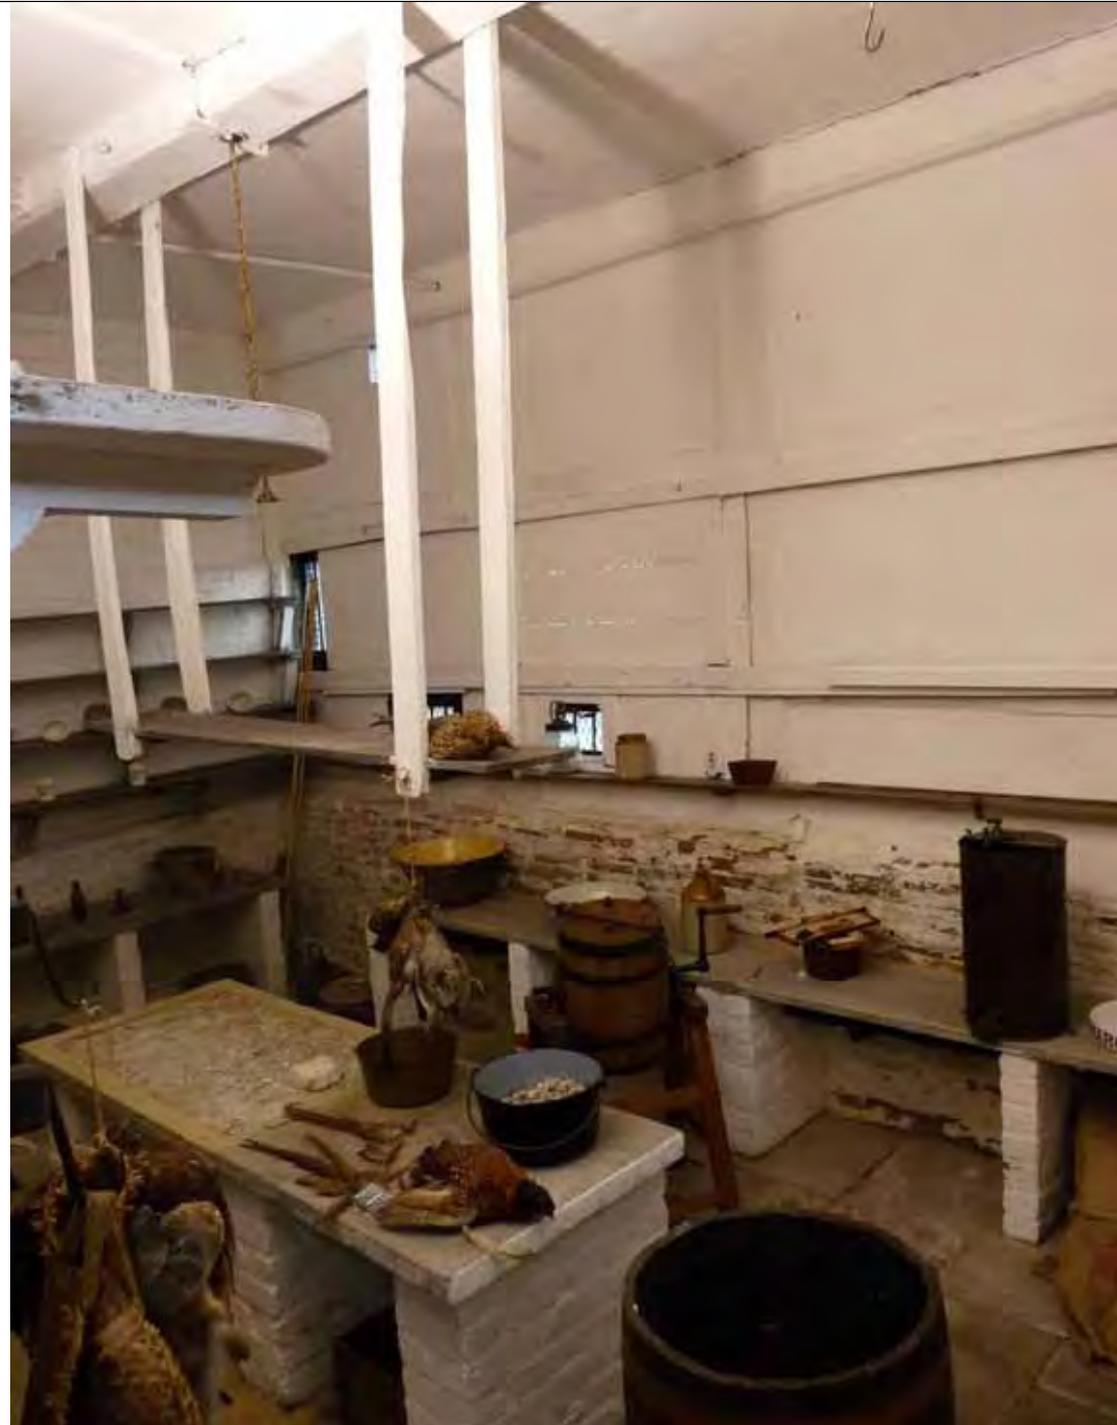
**NE Wing
larder
G22**

larder from the S

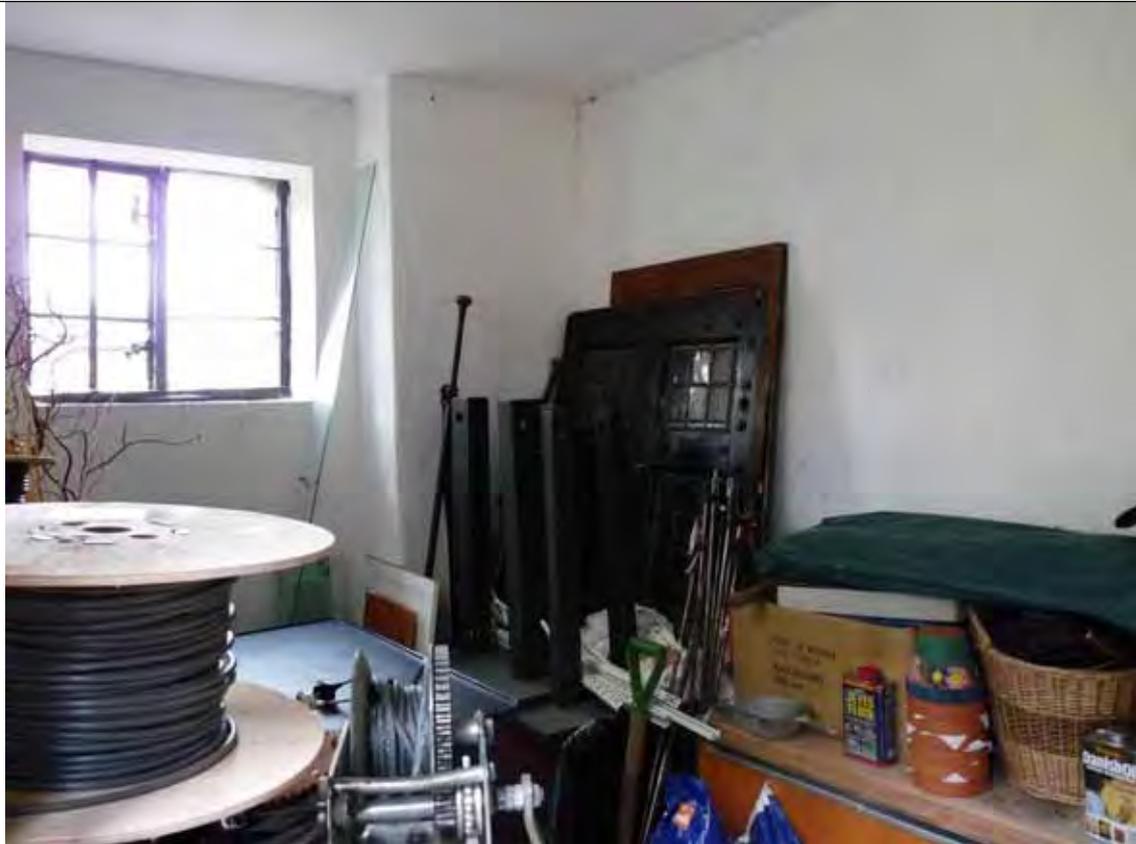
**NE Wing
Fuel store
G23**

- Part of NE wing probably added to provide new services in C16
- Construction: Timber framed walls on stone plinth, repaired late C19
- Services room on W side of the NE wing entered yard, shown on 1860 plan as part of scullery and on Burton plan as two spaces, a WC and a cleaning room with service staircase

store from the S

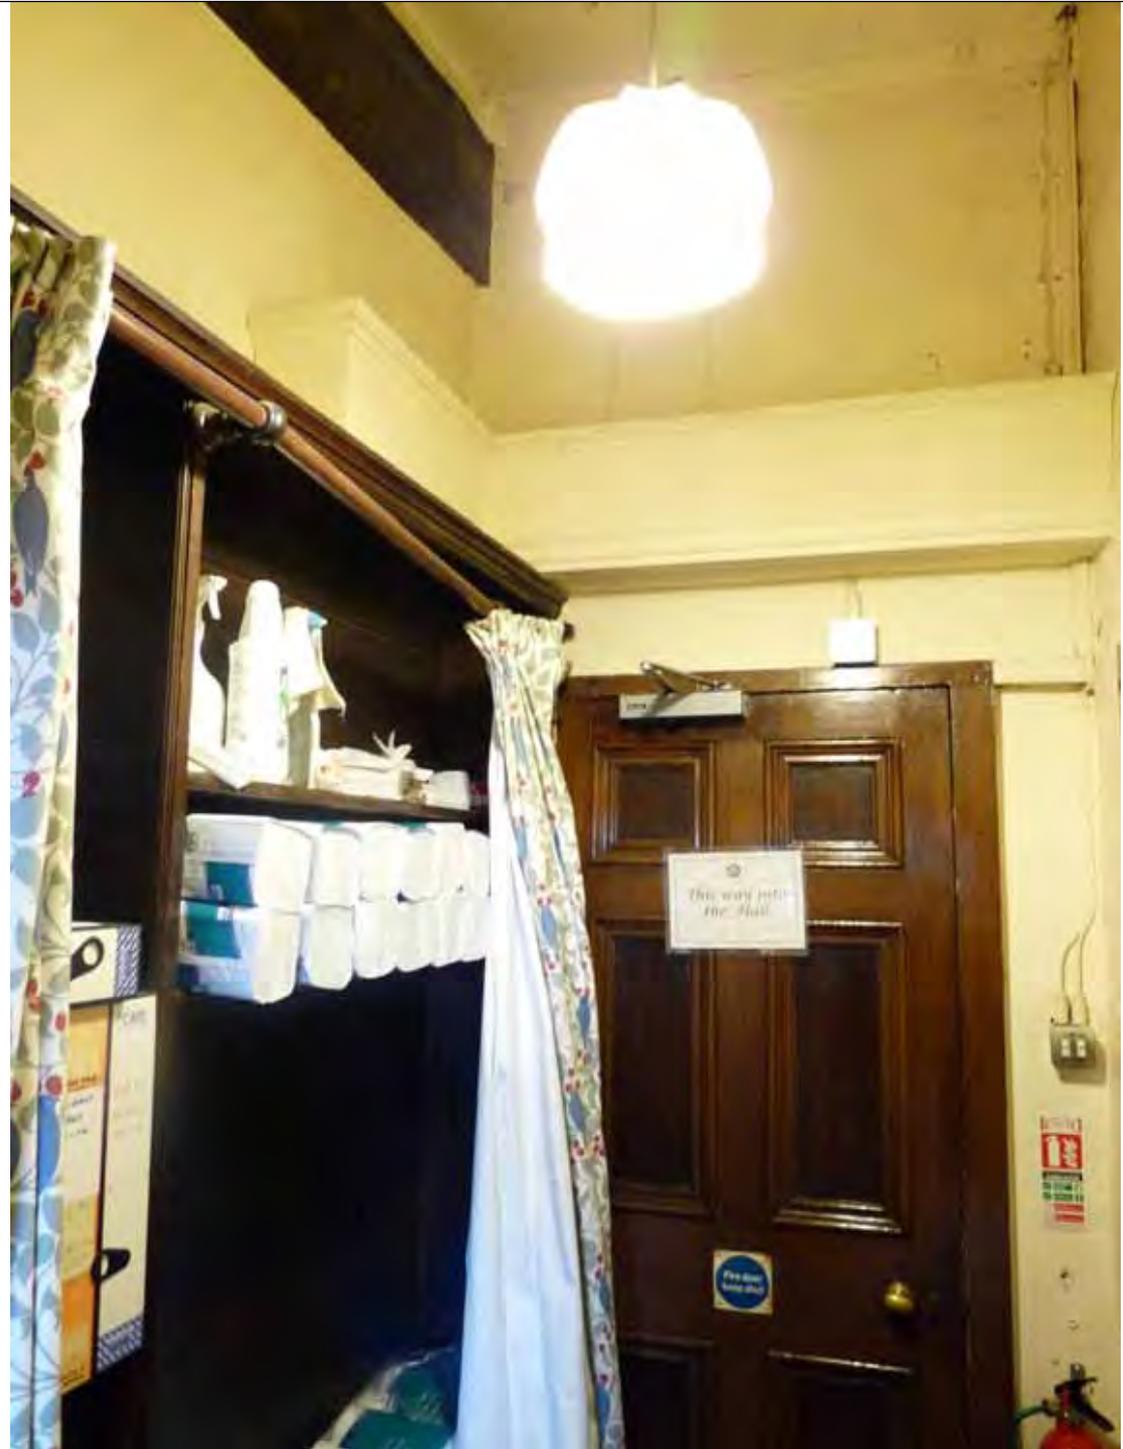
**NE wing
lobby
F15**

F15 lobby from the E, with C19 shelving to left, part of timber-frame above to left

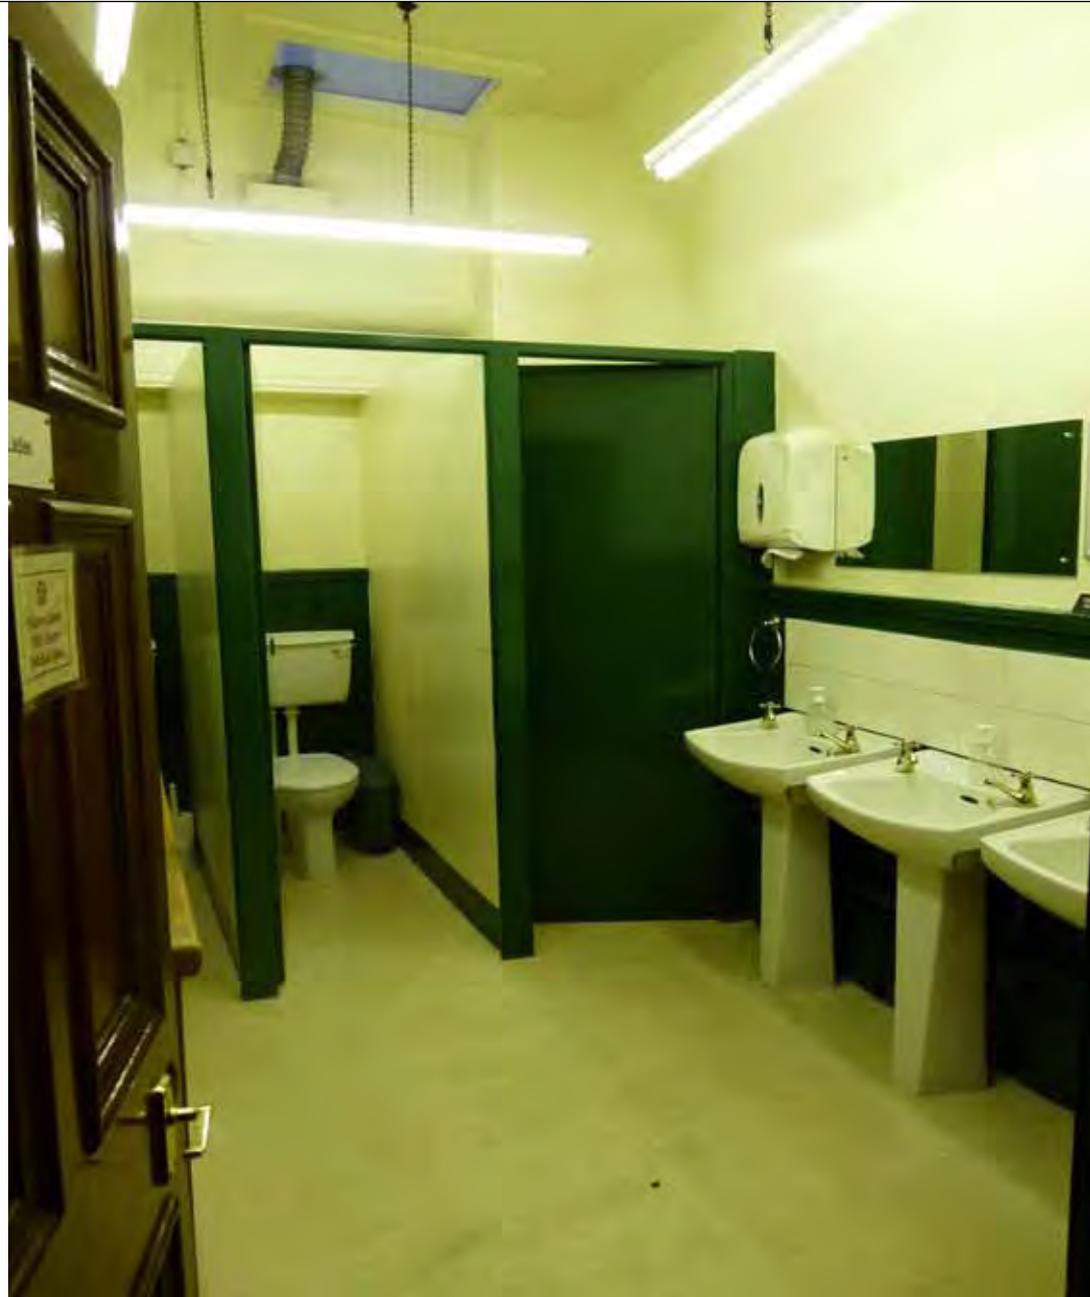
**NE wing
Ladies WC
F16**

Ladies WC from S

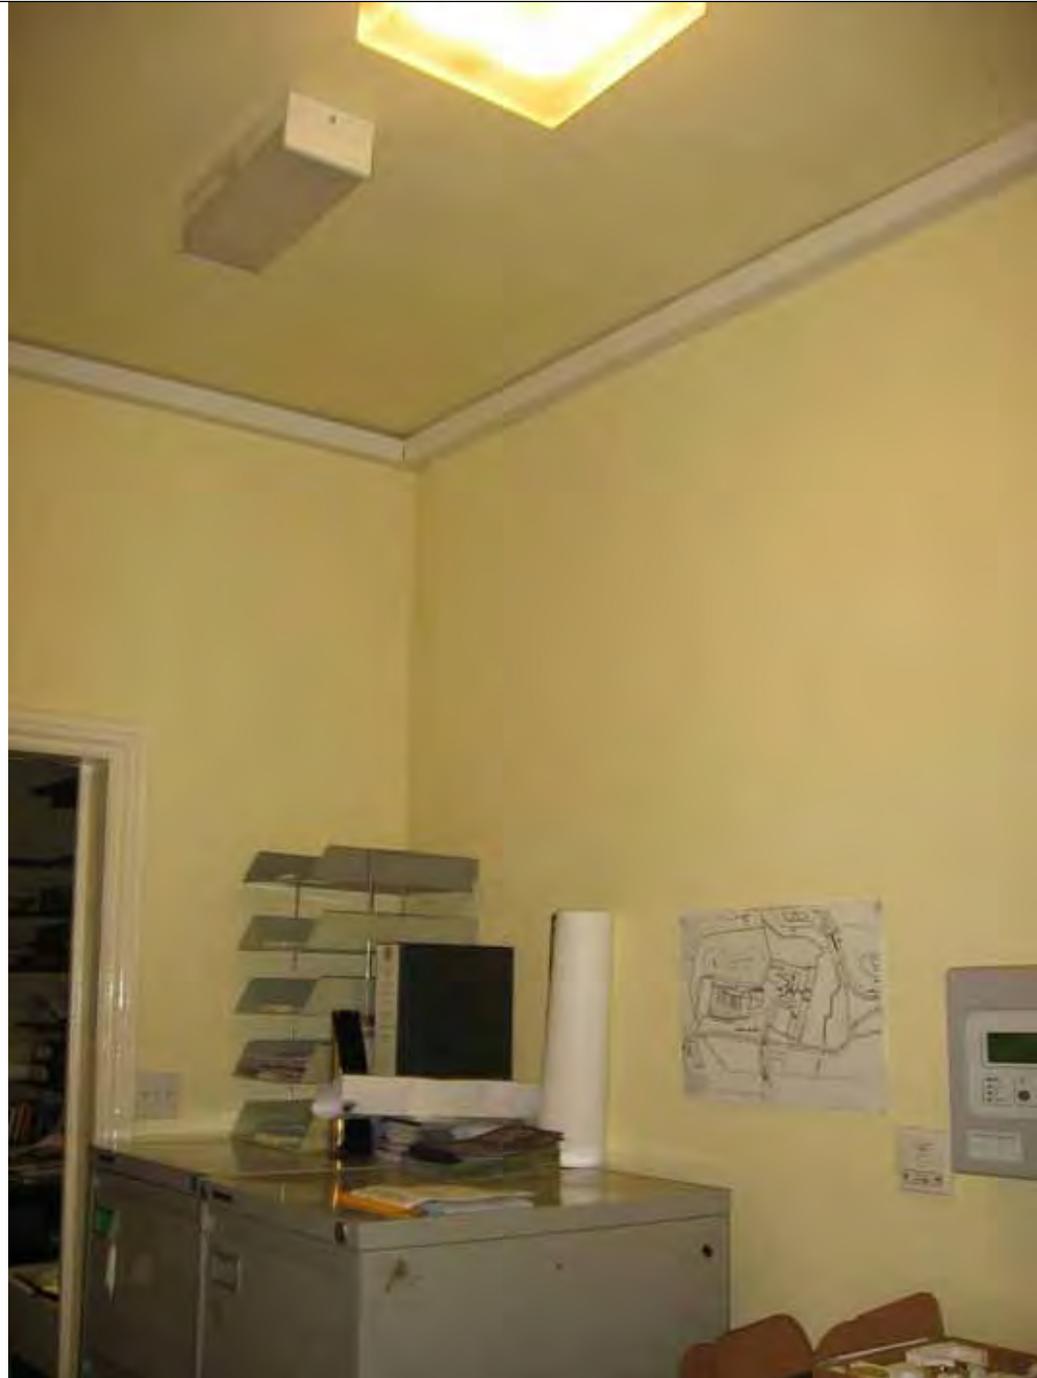
**NE wing
lobby
F20**

F20 from the N

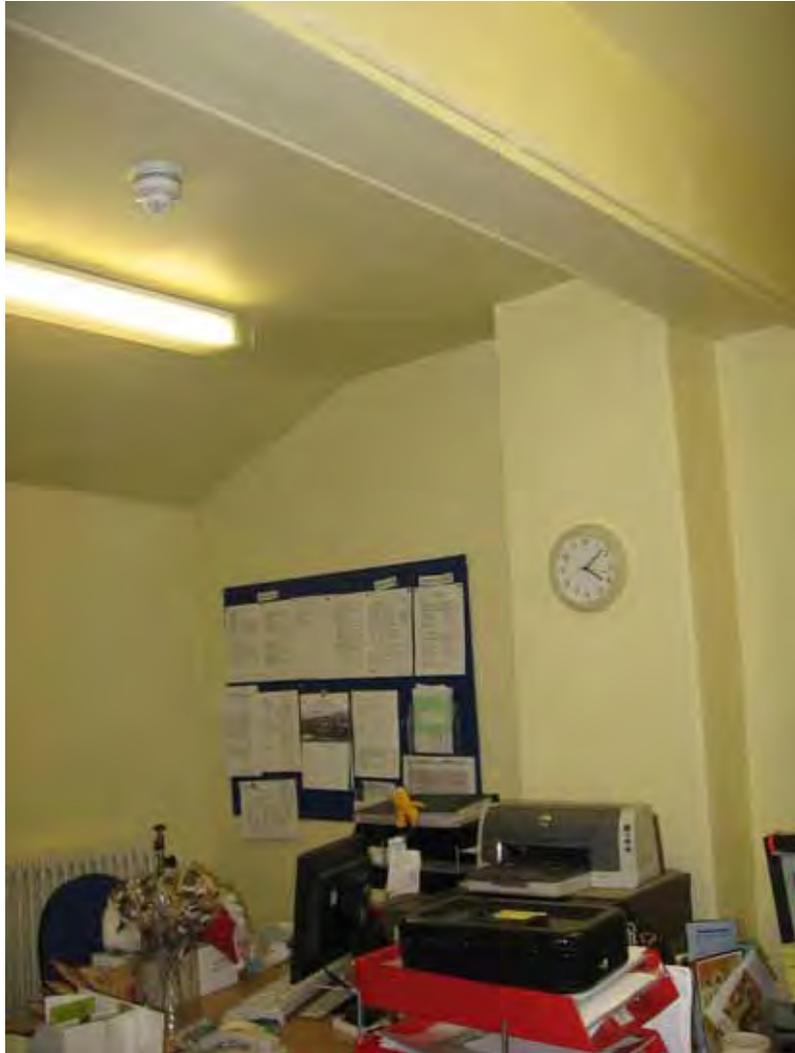
BRAMALL HALL AND PARK, STOCKPORT GAZETTEER	Zone Item Ref No	NE wing office F24
---	---------------------------------	--------------------------

Office from the S

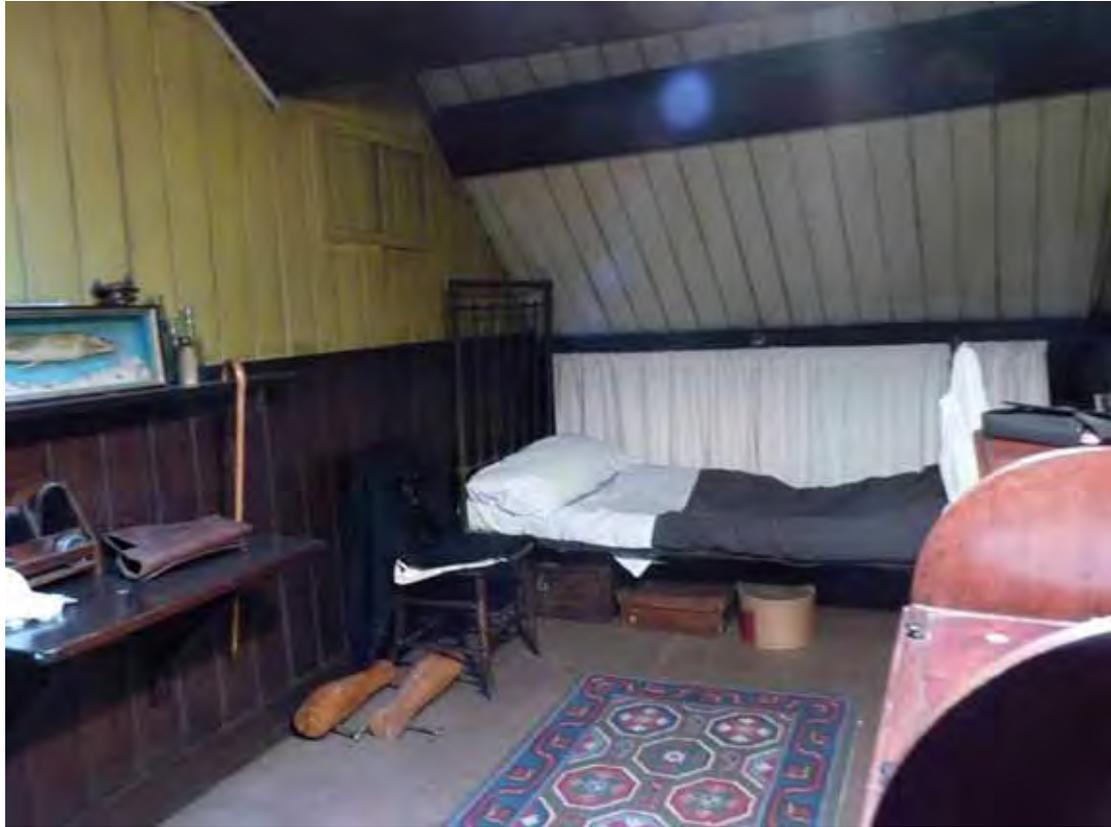
BRAMALL HALL AND PARK, STOCKPORT GAZETTEER	Zone Item Ref No	NE wing Valet's room S9
---	---	-------------------------------

From the N

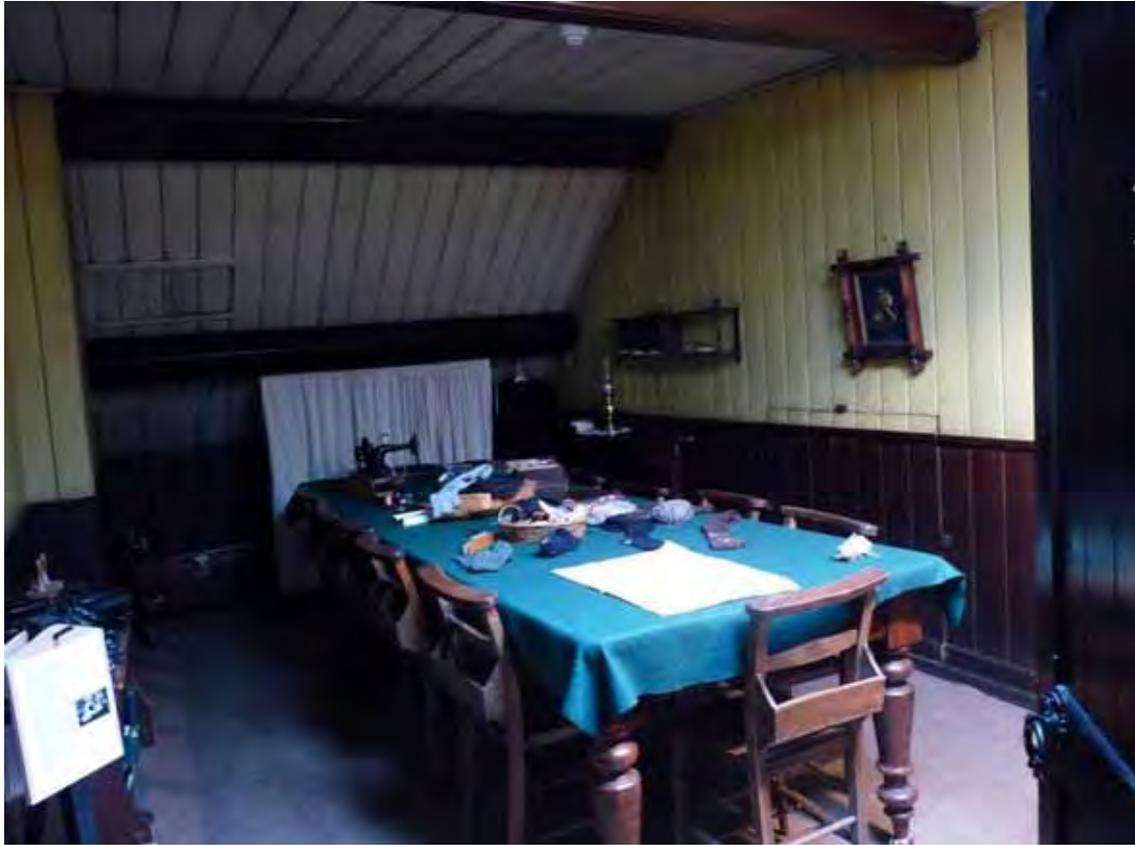
BRAMALL HALL AND PARK, STOCKPORT GAZETTEER	Zone Item Ref No	NE Wing Sewing room S11
---	---------------------------------	-------------------------------

From the W

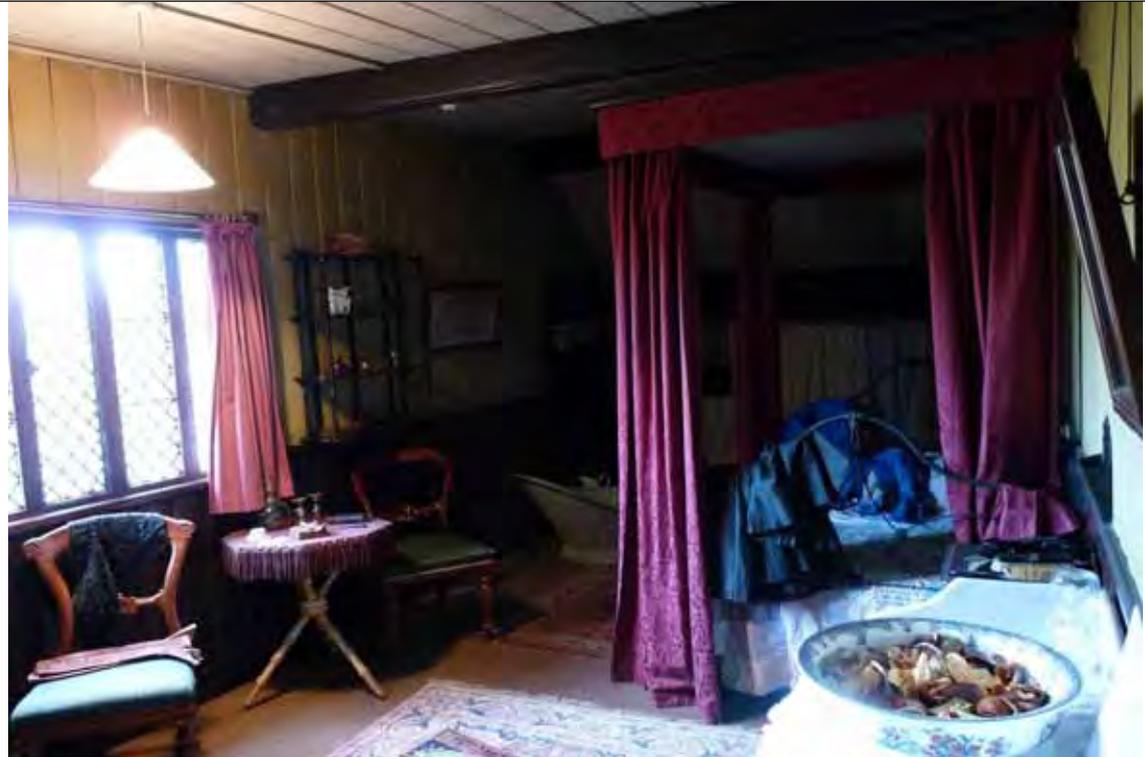
BRAMALL HALL AND PARK, STOCKPORT GAZETTEER	Zone:	NE Wing
	Item:	Second floor Housekeeper's room
	Ref No:	S13

From the W

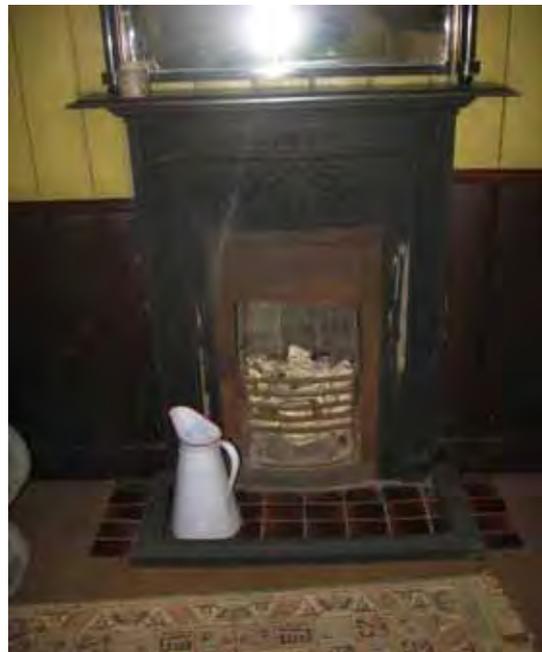
Fireplace in Housekeeper's Room

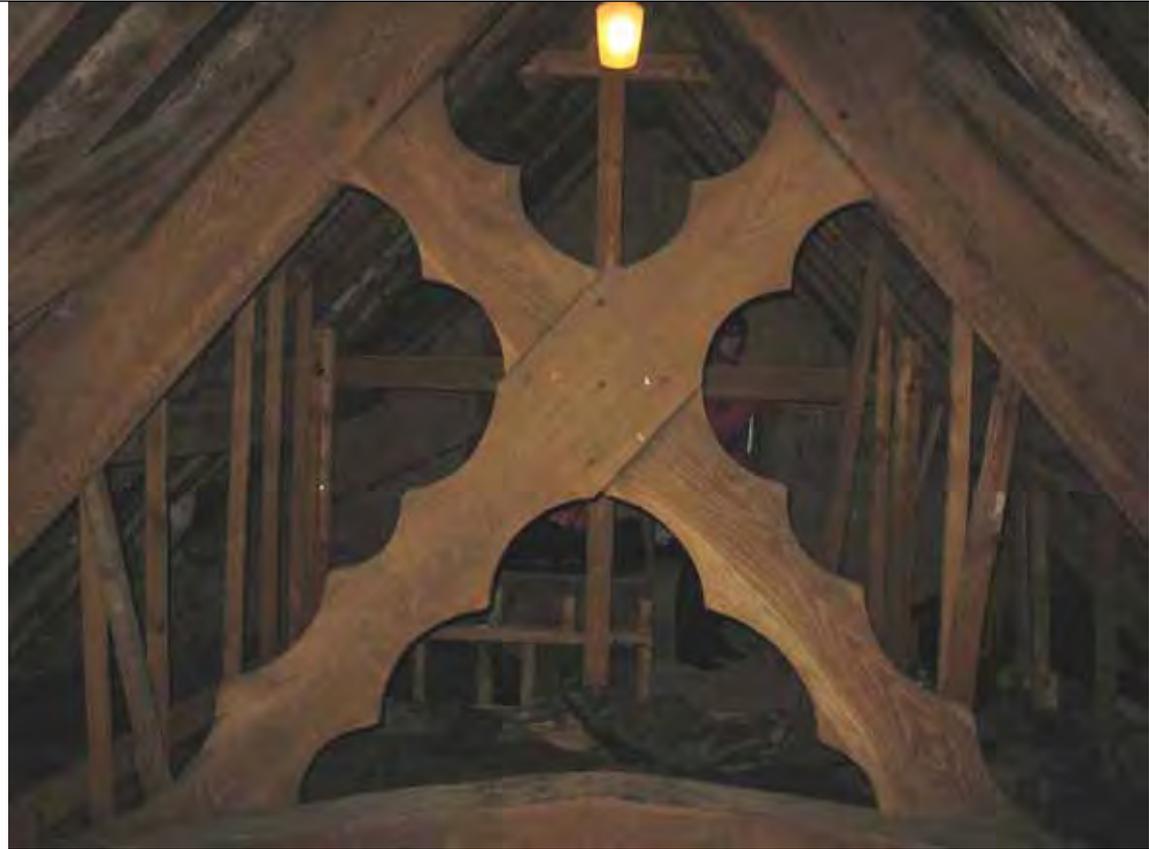
One of two cusped open roof trusses in N wing

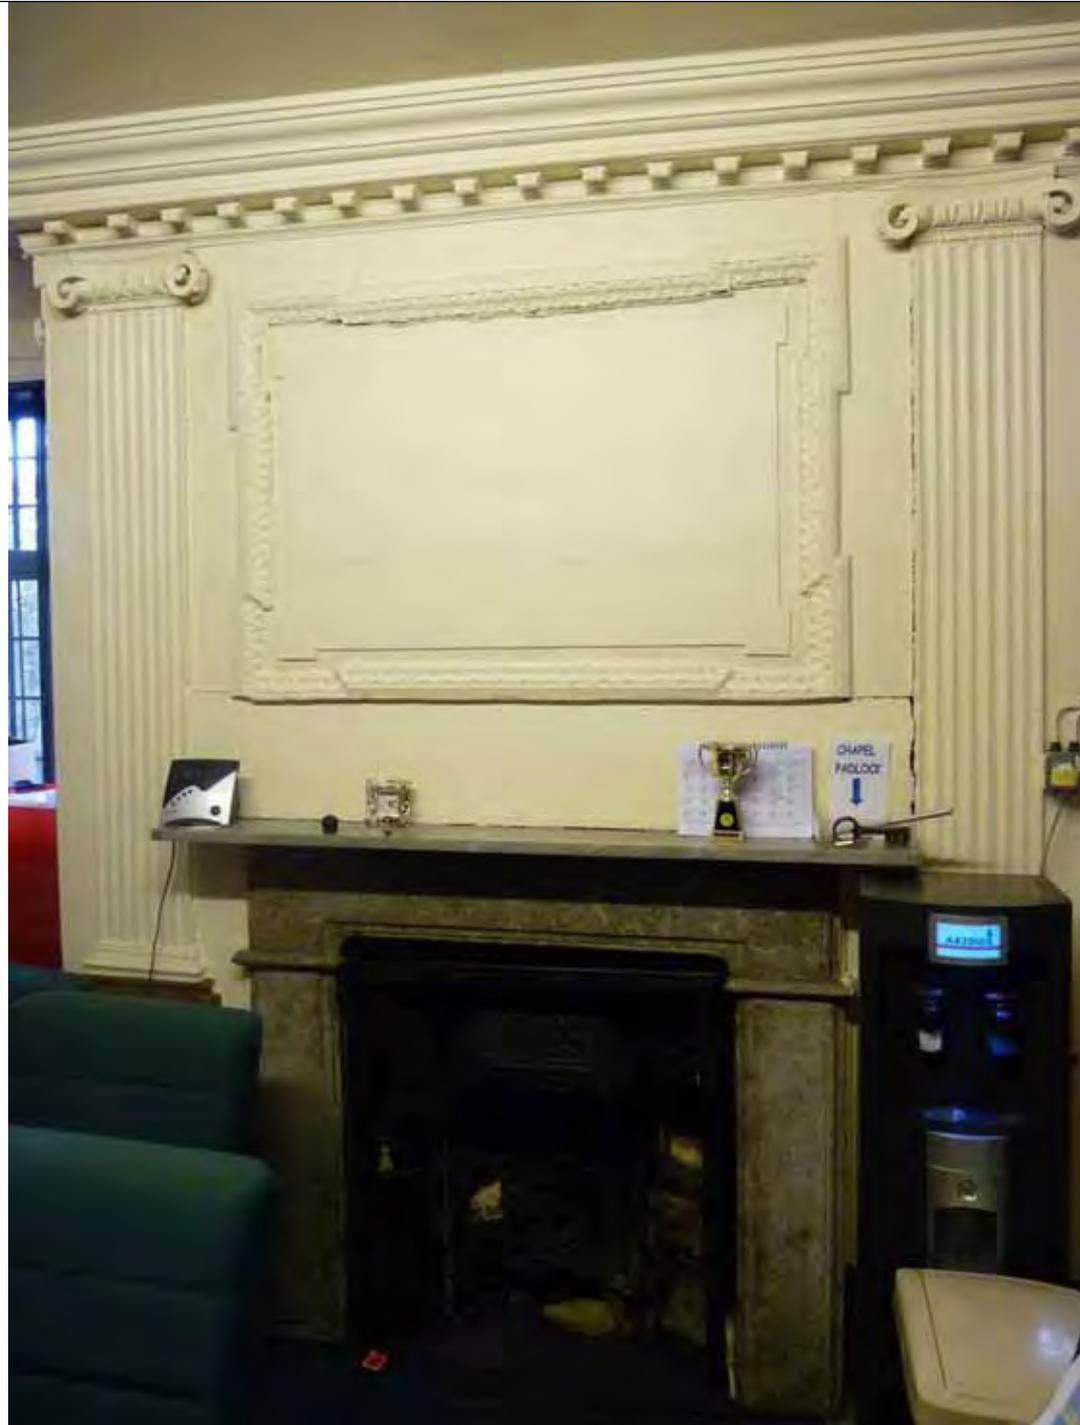
BRAMALL HALL AND PARK, STOCKPORT GAZETTEER	Zone Item Ref No	N Wing Staff room G26
---	---------------------------------	-----------------------------

Fireplace on N wall from the S

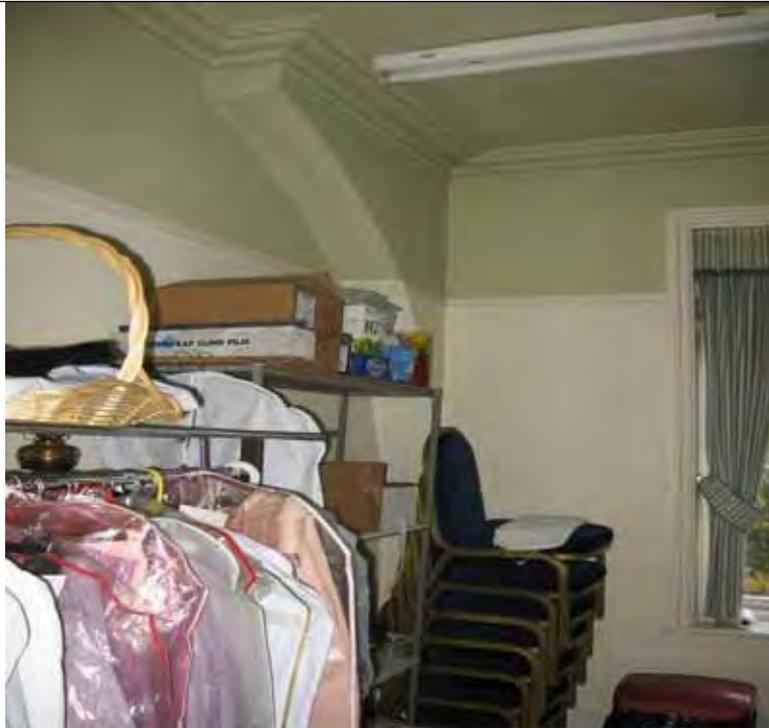
BRAMALL HALL AND PARK, STOCKPORT GAZETTEER	Zone Item Ref No	N Wing Kitchen F29
---	---------------------------------	--------------------------

F29 from the S, with boxed in brace to tie-beam visible

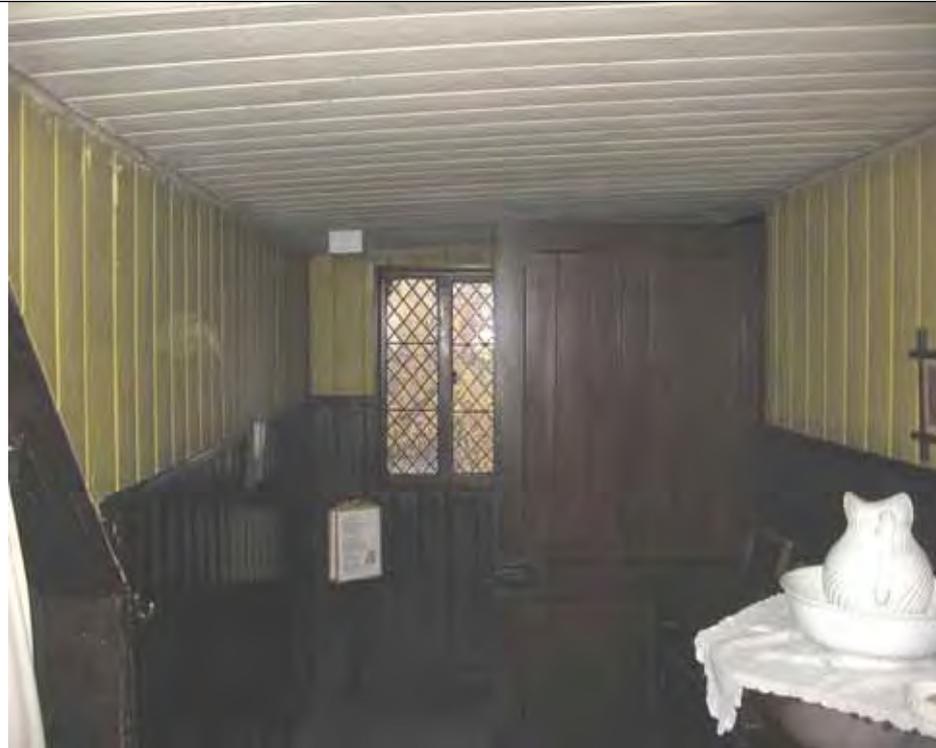
BRAMALL HALL AND PARK, STOCKPORT GAZETTEER	Zone Item Ref No	N wing attic Maid's room S7
---	---------------------------------	-----------------------------------

S7 from the S, the low-pitched roof is late C19

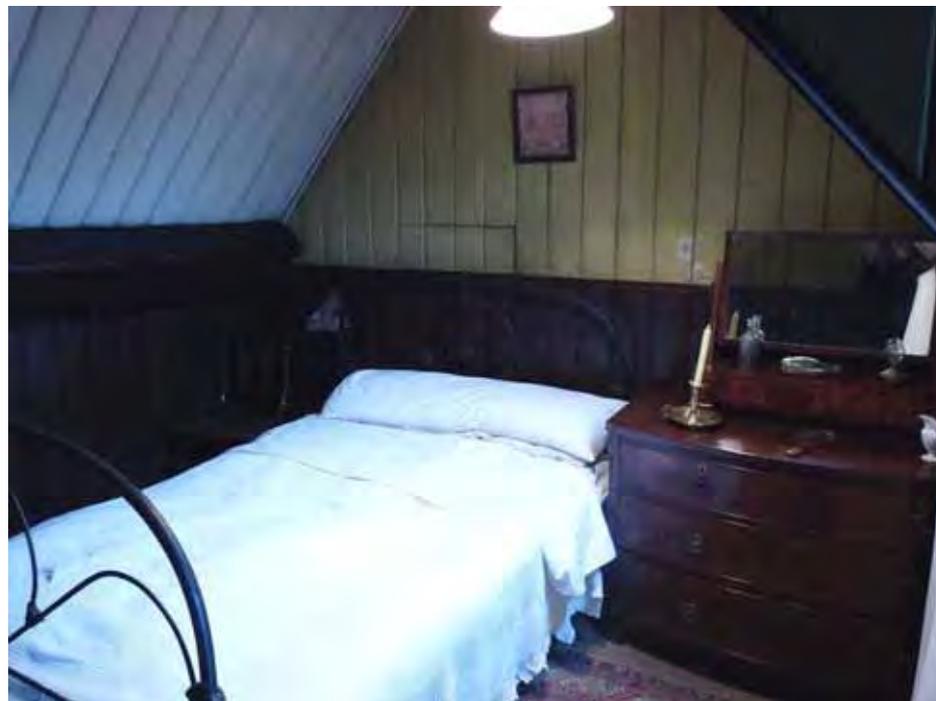
S7 from the E, the medieval roof void S14 is beyond the partition

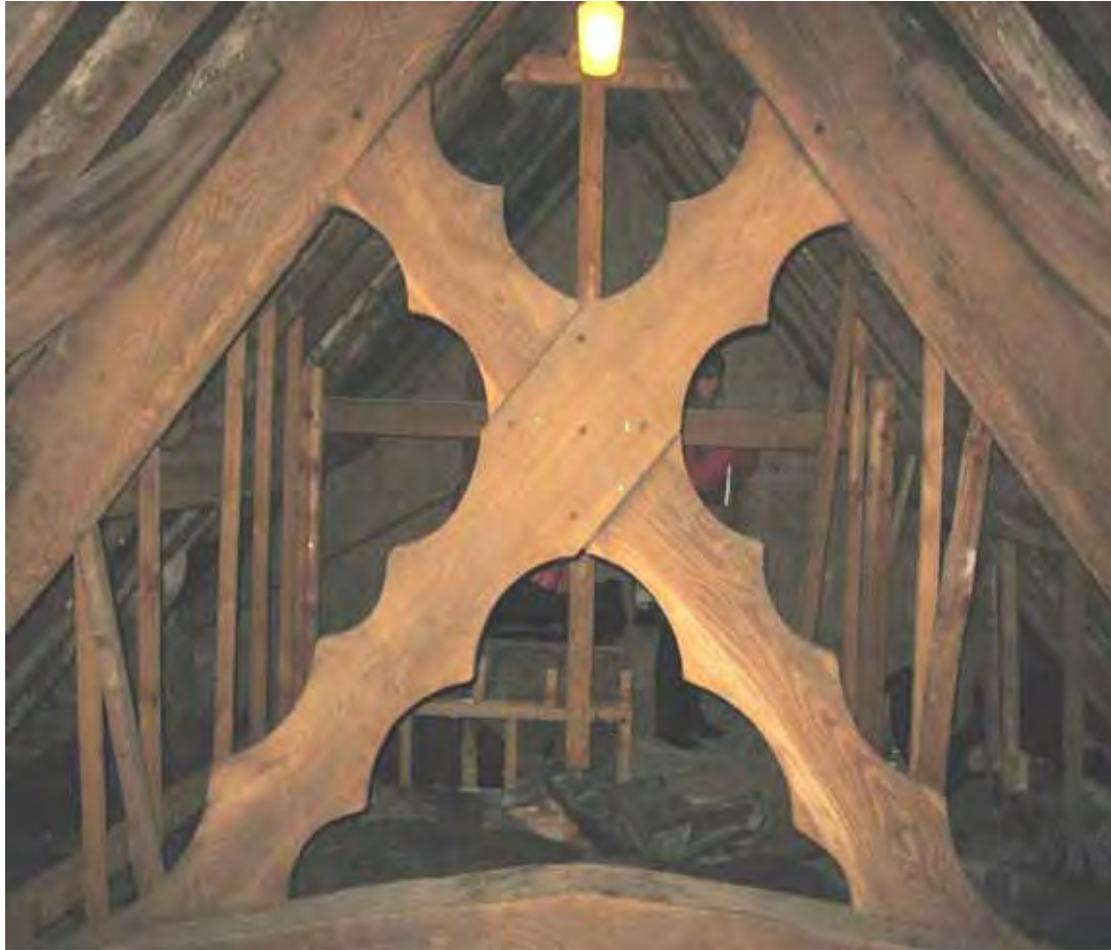
BRAMALL HALL AND PARK, STOCKPORT GAZETTEER	Zone Item Ref No	N wing Roof space S14
---	---------------------------------	-----------------------------

One of two cusped open trusses, from the W

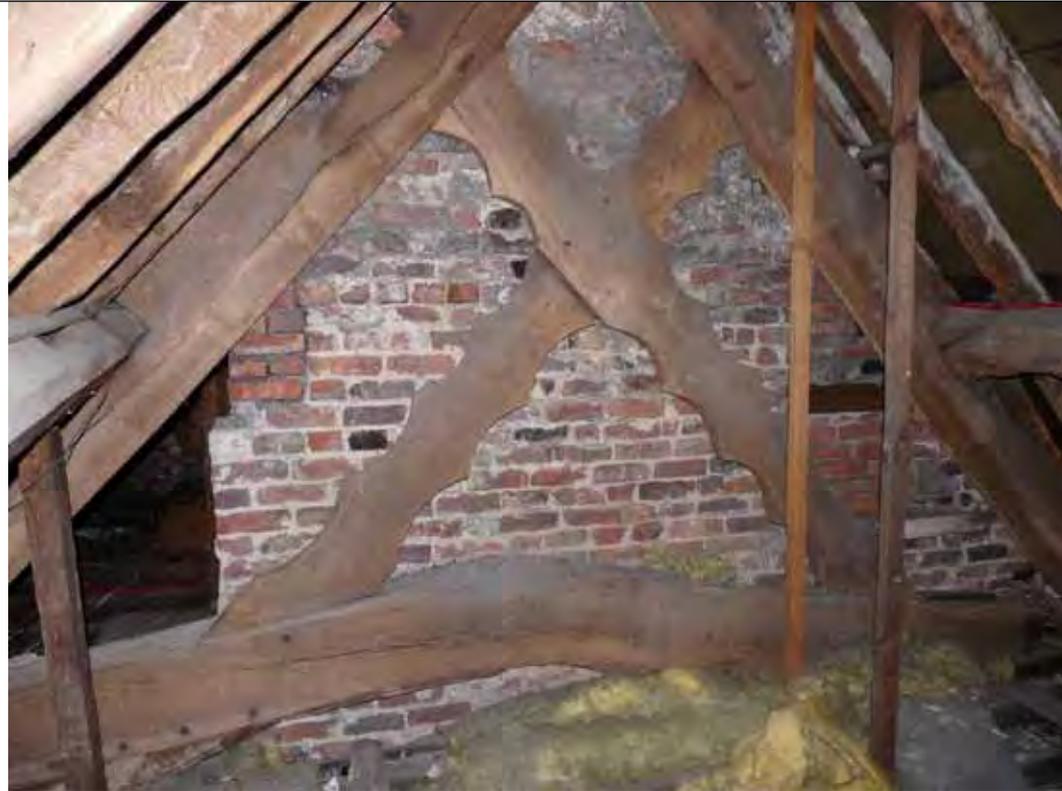
Cusped open truss with cambered moulded tie-beam, and inserted stack, from E

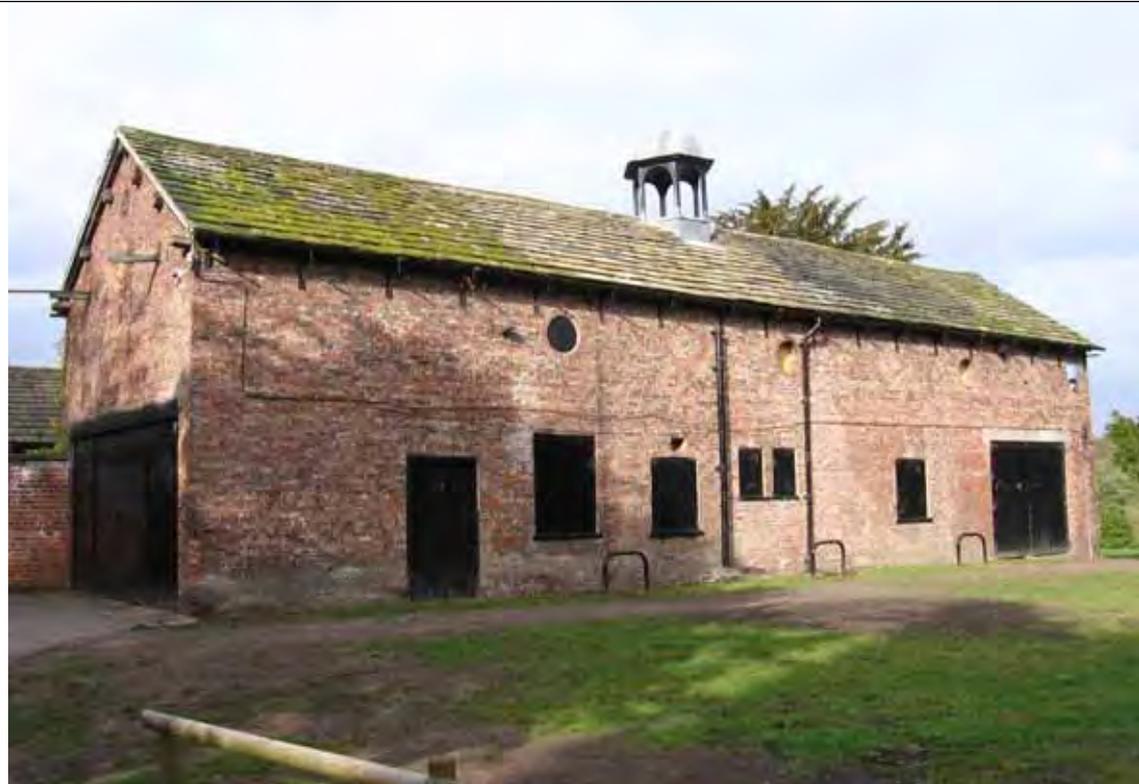
- East elevations retains stable character, but blocked stable doors and windows give this elevation a 'blind', unused appearance.
- Lack of interpretation of former use or appearance
- West elevation degraded by poor quality mid C20 alterations, visible from courtyard.

East elevation of east stable range

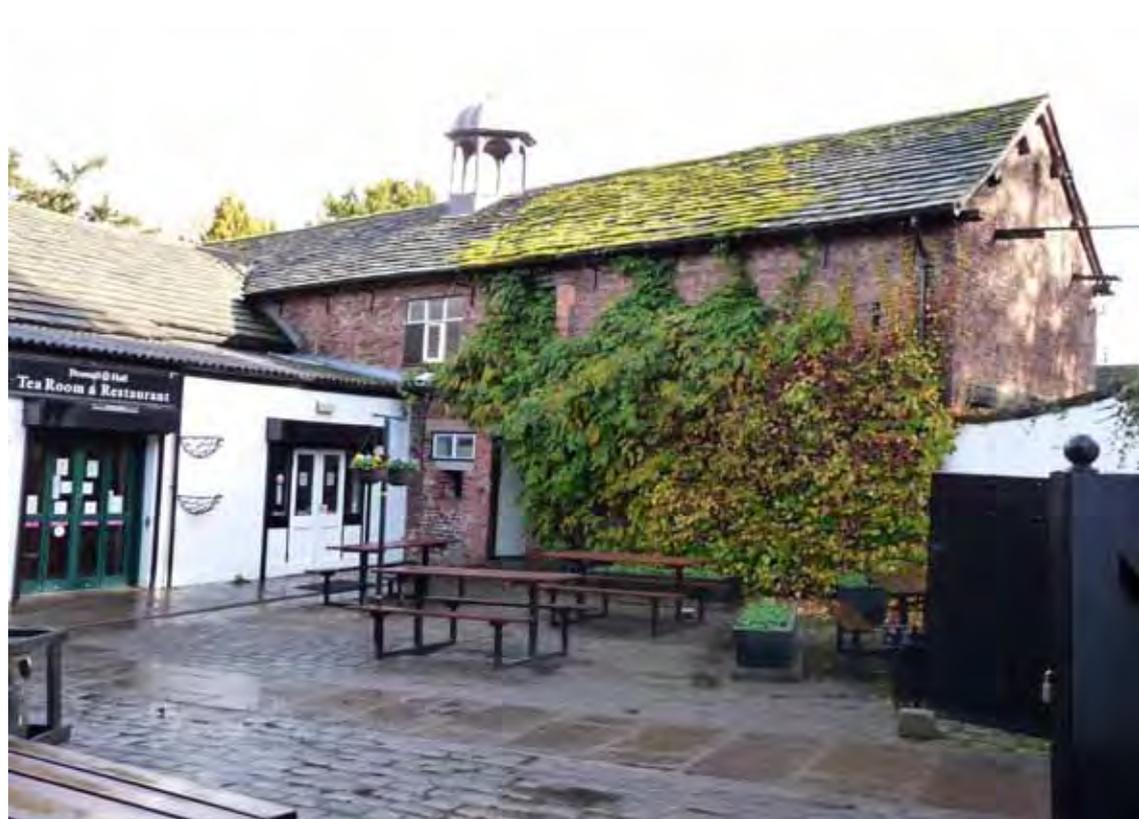
West elevation

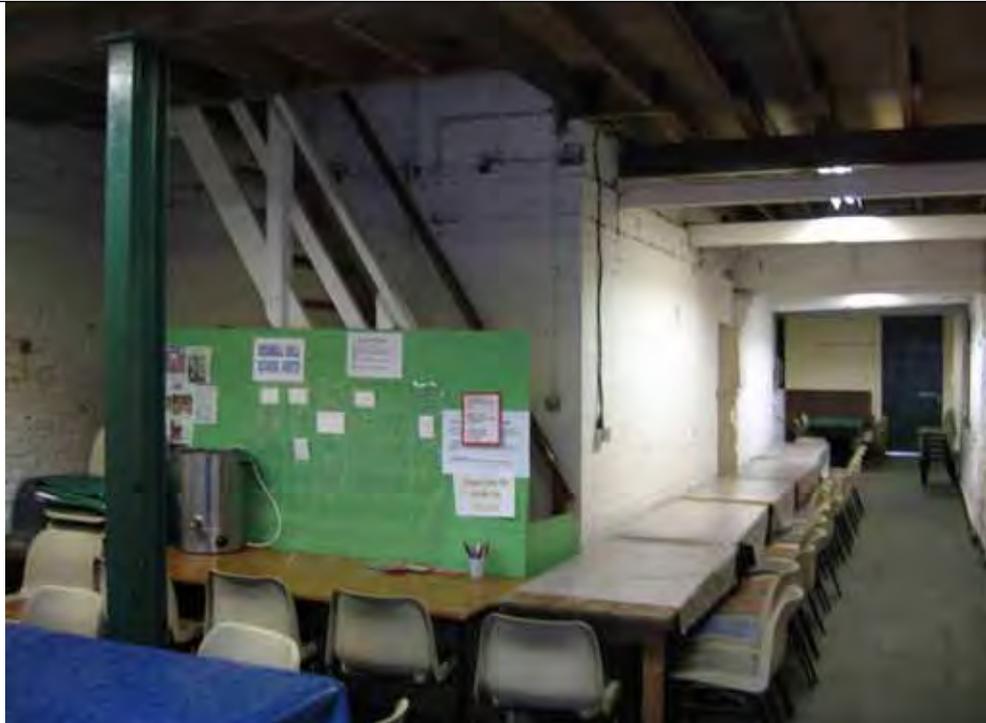
- The building's roof structure may incorporate medieval timbers re-used from the hall and further investigation is recommended
- Interior retains little historic character at ground floor and presents low quality, badly lit environment for current school users.
- 1940s inserted brick rooms intrude into spatial quality of the interior.

Interior of east stable range from the south; 1940s brick rooms beyond stairs

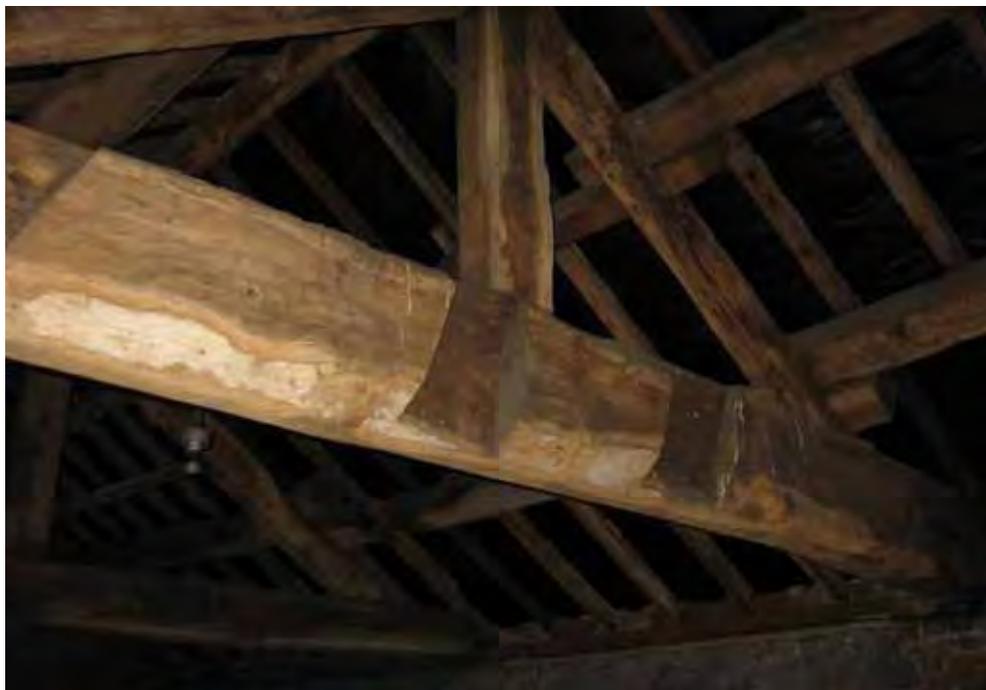
re-used roof timbers in roof, north end from the south-west

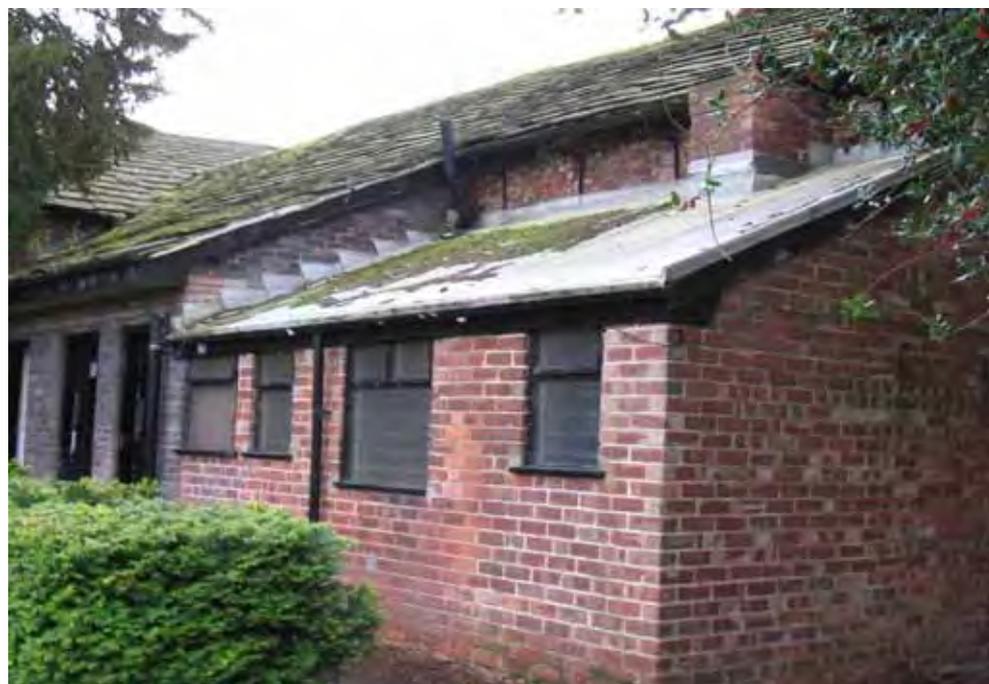
North elevation with C20 additions, from NW
