BRAMALL HALL, STOCKPORT

Conservation Management Plan September 2010

BRAMALL HALL CONSERVATION MANAGEMENT PLAN
for STOCKPORT METROPOLITAN BOROUGH COUNCIL

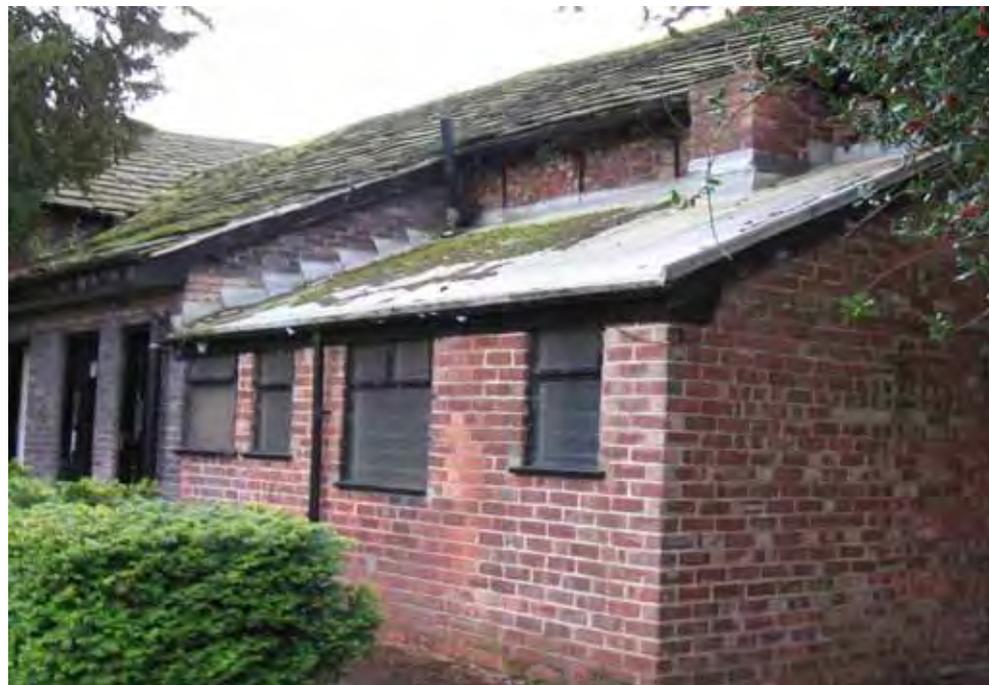
North elevation with C20 additions, from NW

- South elevation retains some historic fabric and features but also obscured by later interventions. North elevation facing the gardens lacks historic character due to additions.
- Lack of interpretation of former use or appearance.

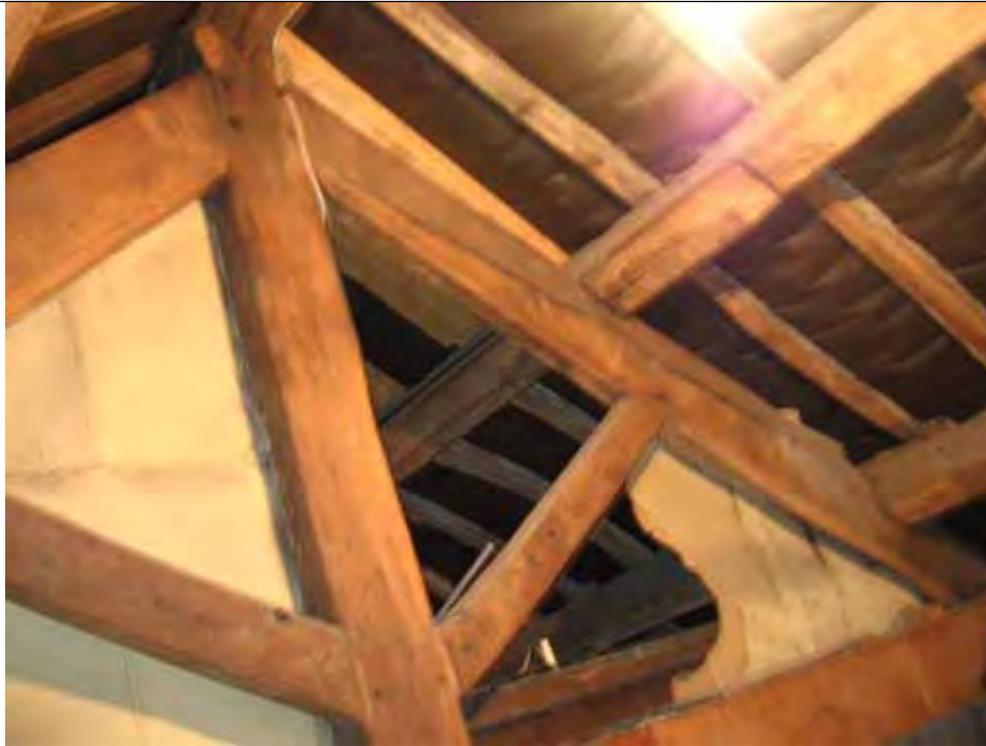
Roof over west end of N range

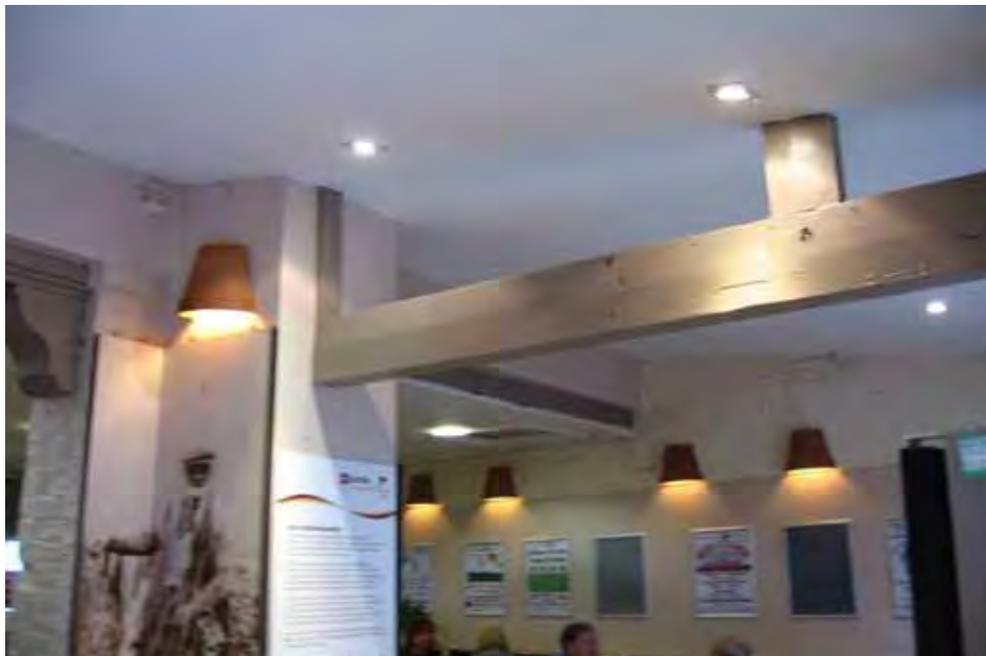
Café interior with roof of S lean-to to right, from SW

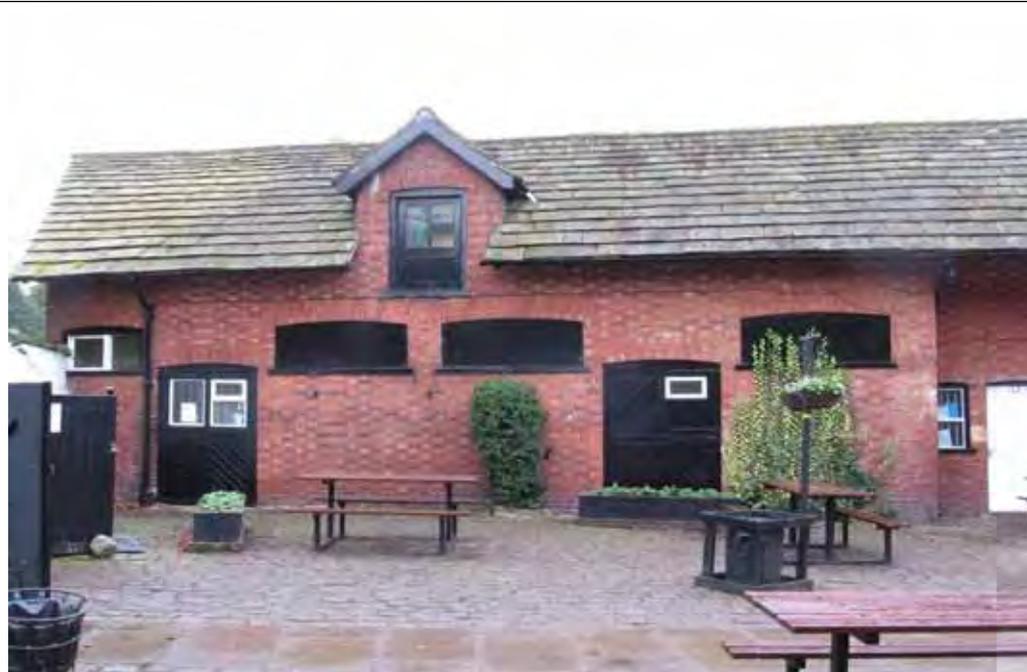
- East elevations retains Edwardian stable character, but blocked stable windows give the courtyard elevation a 'blind', unused appearance
- West elevation degraded by poor quality mid C20 alterations, visible from walled garden.

East elevation of west stable range

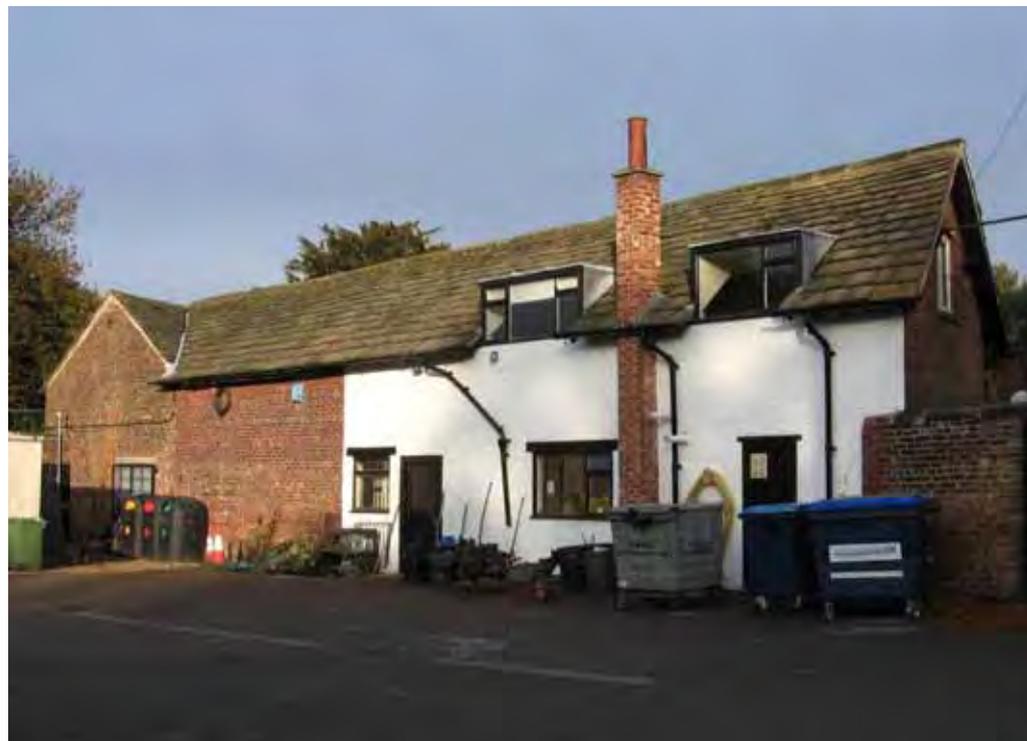
West elevation from walled garden

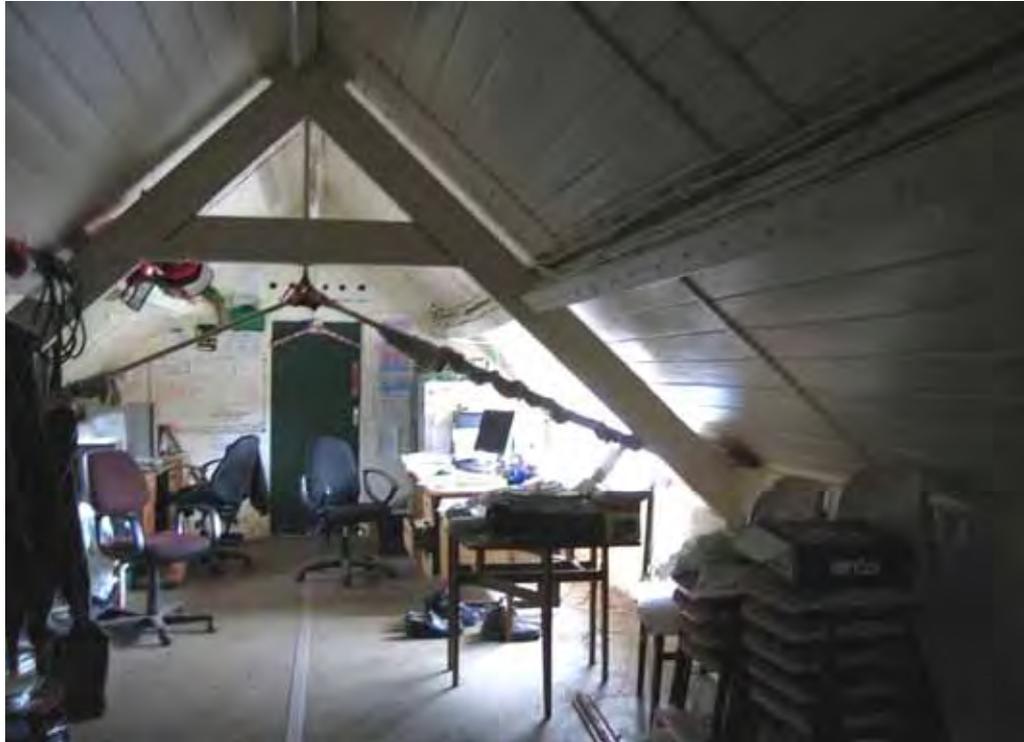
Attic interior of west stable range, from the North

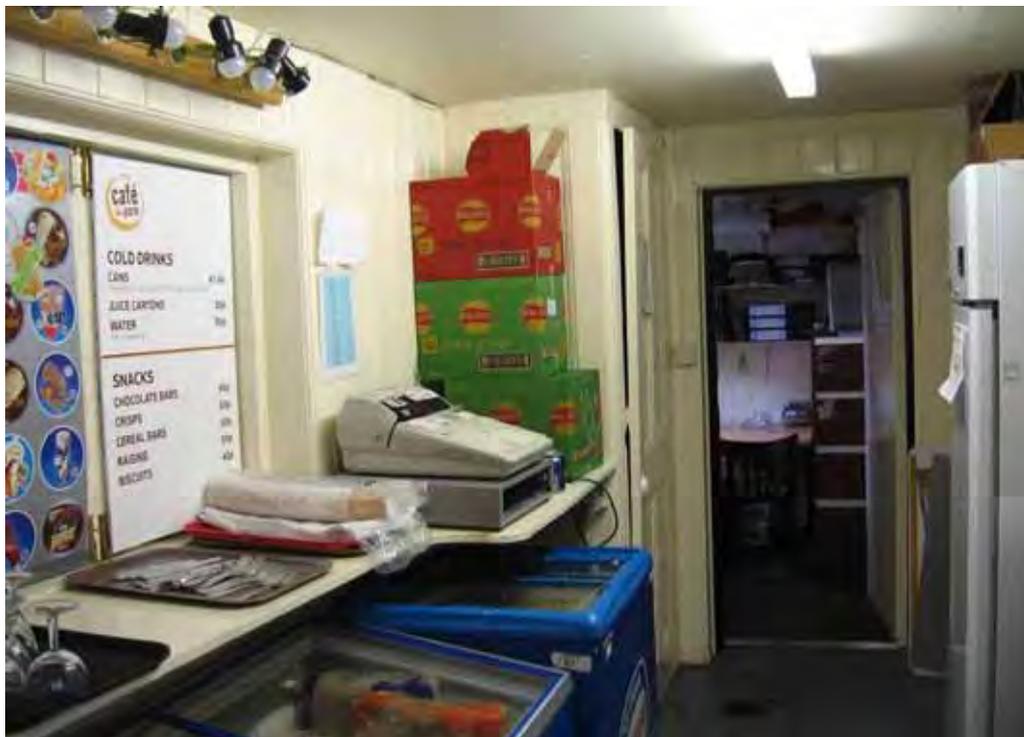
Interior of former tack room, from the North

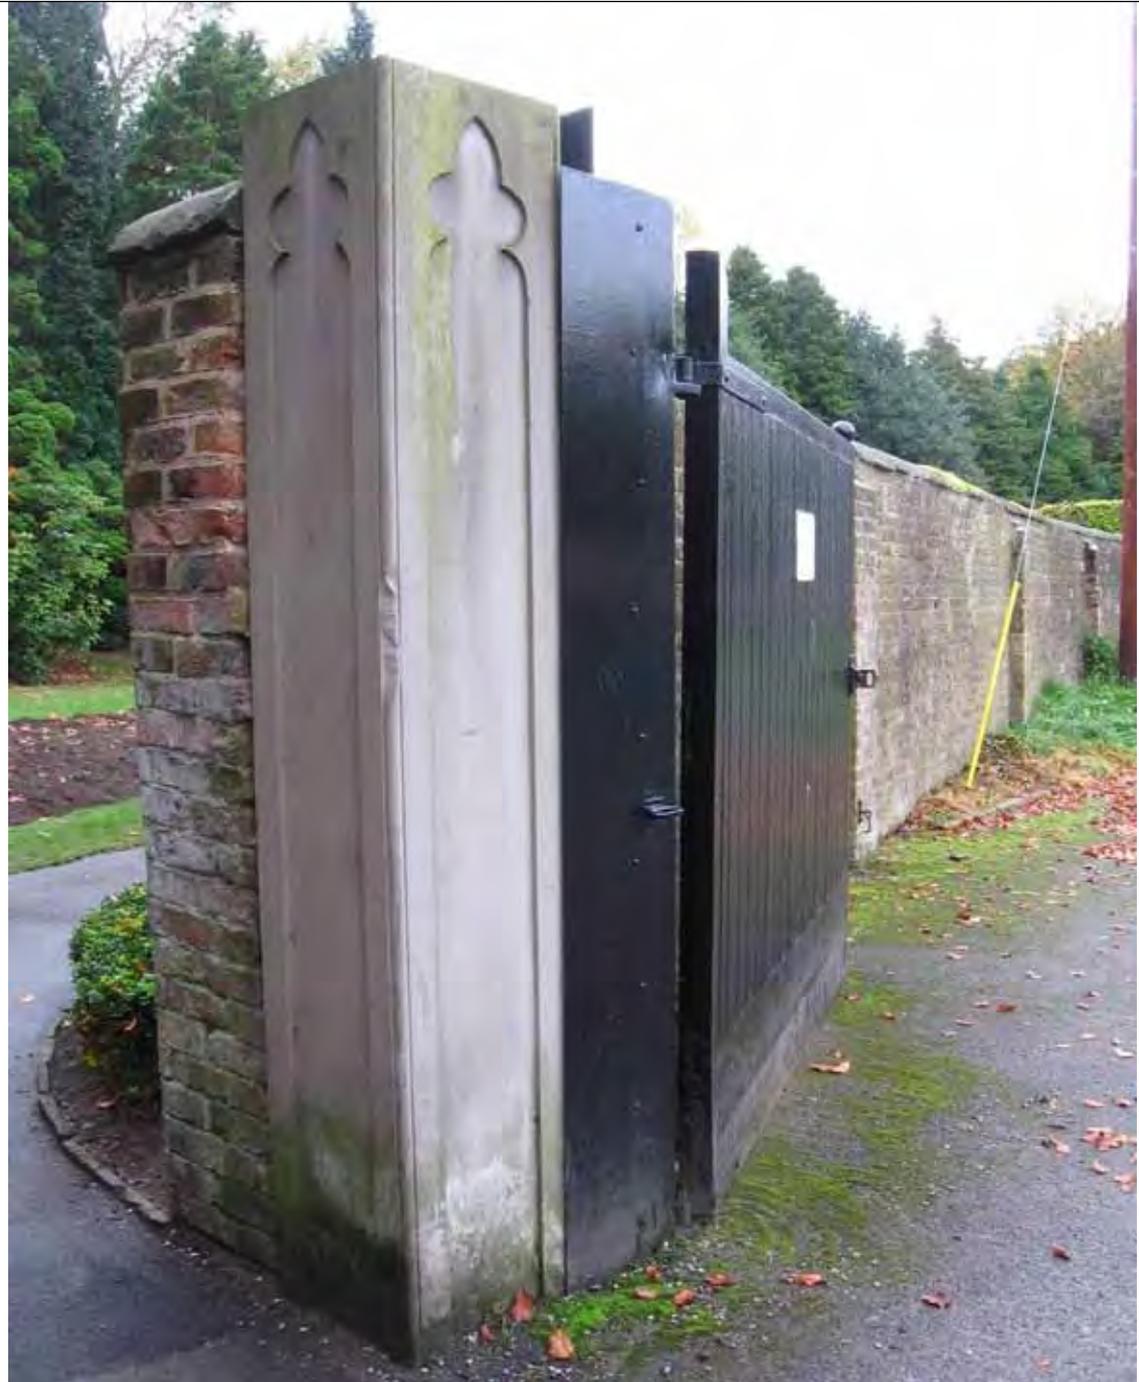
S gate pier and garden wall from the east

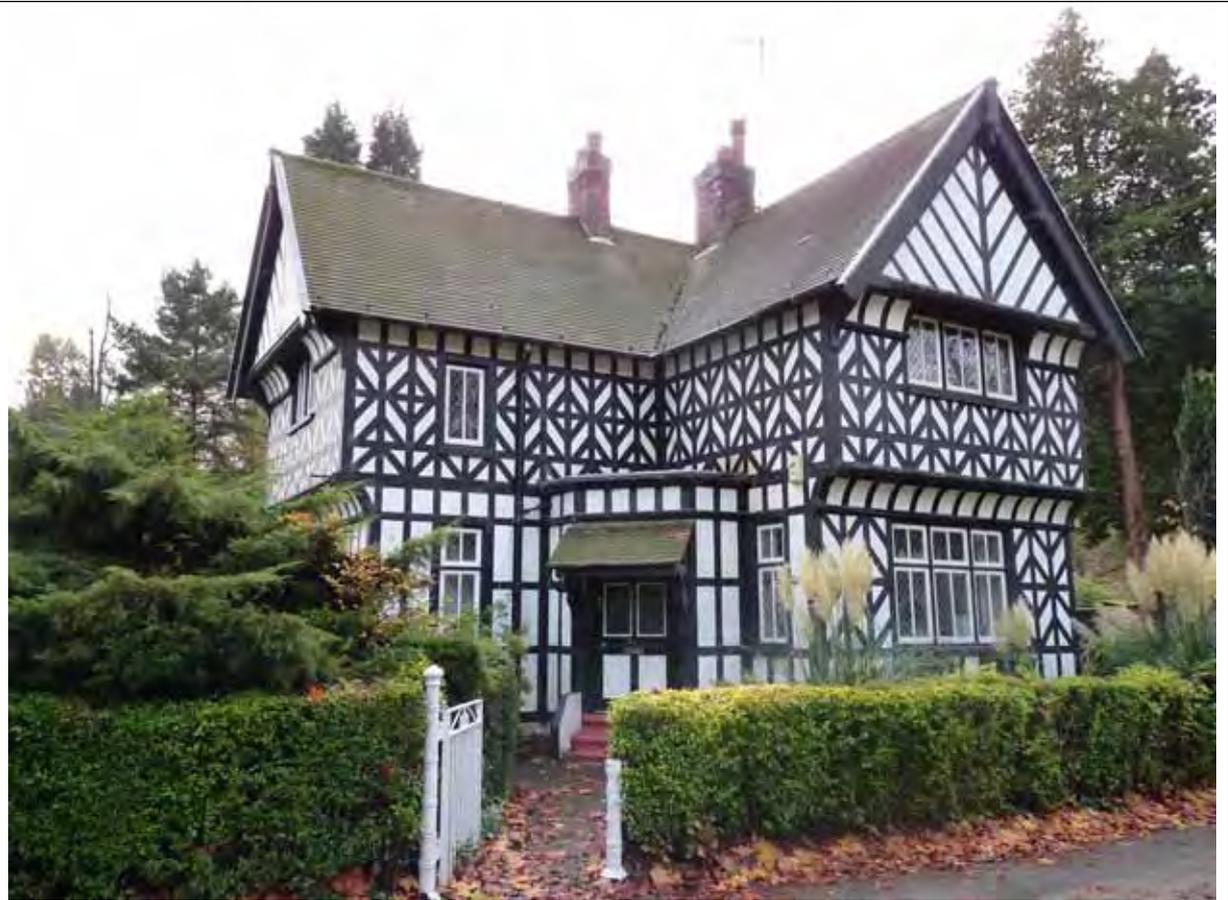
- Currently in poor state of repair, in particular external applied "timber frame"

East Lodge from the north

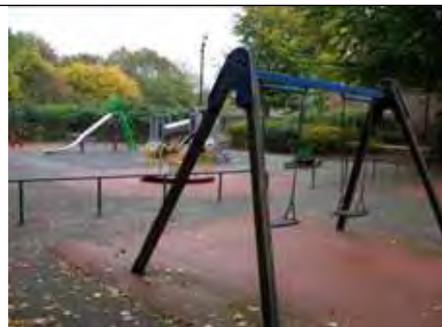
This is the site of the play area which is surfaced in a combination of tarmac and wet pour and surrounded by a paling fence and an ornamental shrub hedge consisting of berberis /holly / mahonia /cotoneaster. A small Bound gravel terrace (or sitting area) occupies the east side next to walled the garden. The area is looking tired and worn with certain items of equipment looking past their best.

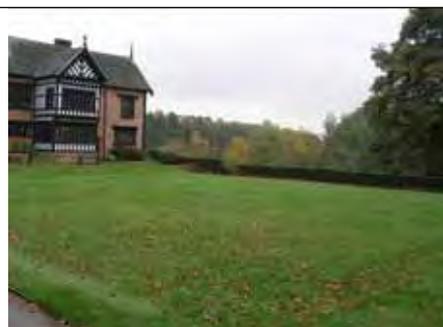
A square sunken lawn surrounded by plants typical of a Victorian shrubbery with evergreen trees provides formal interest to the south of the Hall. The lawn is surrounded by a 1.8m tarmac path with stone edge, in good condition. Ten bench type seats secured on unsightly concrete pads provide standard seating. The northern boundary consists of herbaceous planting against the façade of the Hall. The eastern boundary consists of a yew hedge and low brick wall retaining a terrace. Stone steps provide access to a lower level on both sides at the corners. The southern boundary is now populated with modern shrubs, most of which are past their best and over mature.

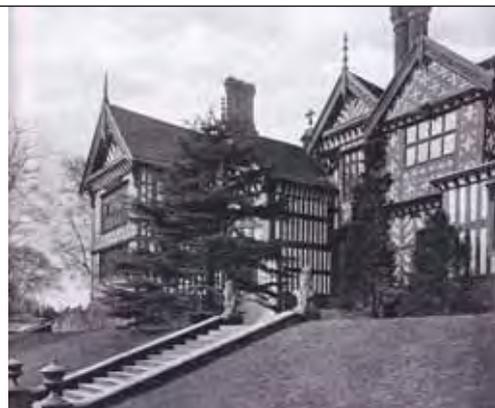
- This original terrace was replaced with two terraces with low brick retaining walls and steps between the two; an arrangement that survives today. Nevill also built a rockery of large sandstone blocks at the southern end (see separate entry).

The terraces as built by Nevill

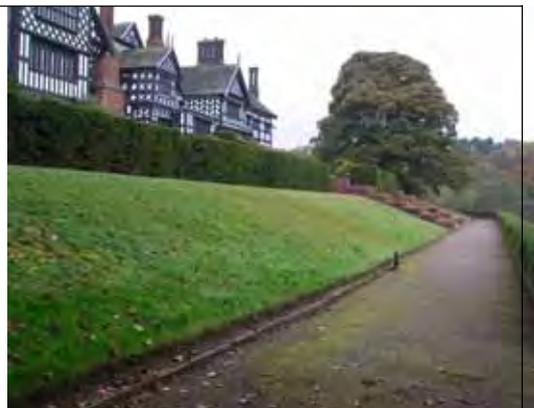
- Council minutes from Hazel Grove and Bramhall UDC record that the walls were in a poor state of repair during the 1930s and 1940s and eventually in 1971 the terrace walls were rebuilt at a cost of £5,436.

Yew hedges bitmac paths and engineering brick retaining walls detract from original design intention.

The terraces today

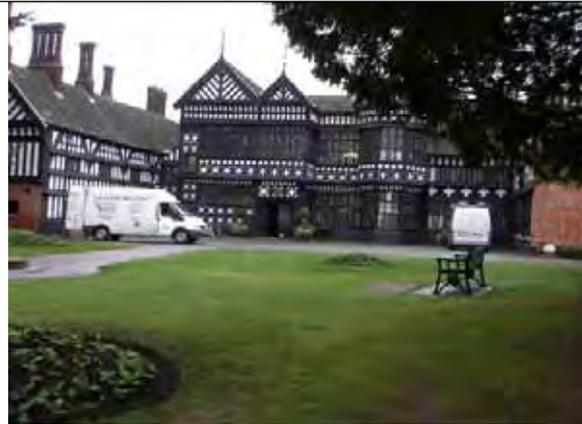
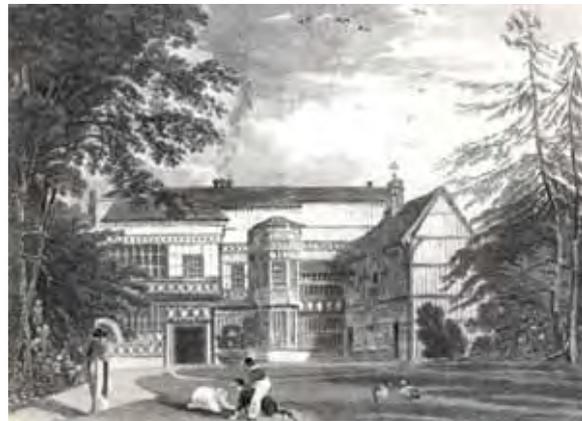
The central lawn area is framed by groups of mature yew trees with extensive areas of bare earth under the yew trees and a scruffy lawn. The ha-ha comprised a curving dry stone wall, approximately 1.2m in height with stone coping in reasonable condition. Ferns, ivy etc grow from interstices in the wall. The ha-ha is breached by a stone rampart of modern construction leading to the 'archery lawn' and a desire line extends across the lawn to the play area beyond, which is unsightly.

The main entrance front of the Hall today, in a photograph of around 1870 and an engraving of 1809.

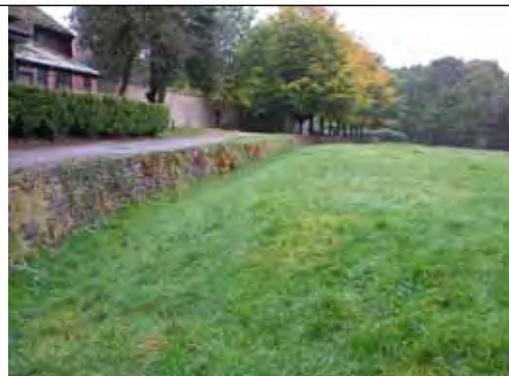
The ha-ha comprises a curving dry stone wall, approximately 1.2m in height with stone coping in reasonable condition. Ferns, ivy etc grow from interstices in the wall. The ha-ha is breached by a stone ramp of modern construction leading to the 'archery lawn' and a desire line extends across the lawn to the play area beyond which is unsightly. The eastern end of the ha-ha has been rebuilt as vertical dry stone wall 0.9m high and associated with a recently planted beech avenue.

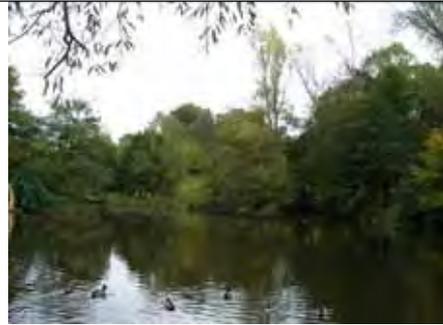
The large island on the east pond has a stand of pines planted by Nevill, all apparently in good condition. The islands are all treed and have populations of rhododendron which add low level interest. Sadly the bank of the ponds are now overgrown with a host of naturally regenerating willows, alder sycamore obscuring their form and the islands that populate them. The ponds have silted up badly and several of them have now only a relatively shallow depth of water.

The key issue however, is erosion and in several places, the river is now undermining the stone lined river banks and is in danger of breaking through the thin bank which separates some of the lakes from the river. The river is also enclosed by trees for much of its length.

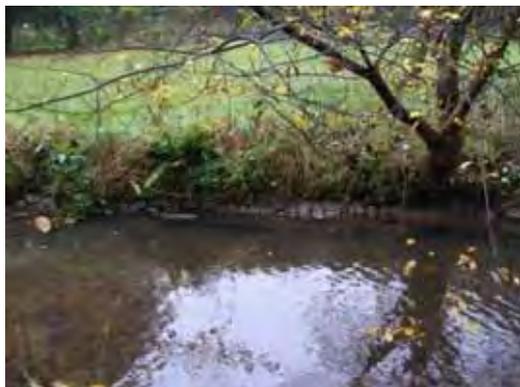
Stone sett revetment to sides of river bank. Mostly intact on north bank for first stretch broken/disturbed in places by colonising trees. Variable condition and intactness along course of river.

Erosion is causing significant sections to collapse.

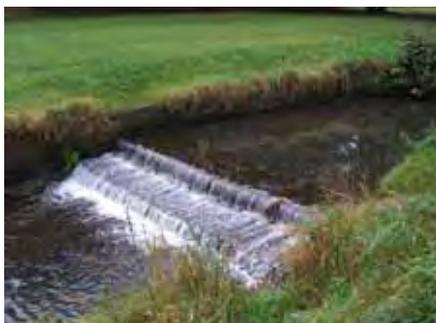
Weir constructed from stones forming 2 'steps' approximately 1m wide and 300 mm high .Stone retaining wall – good condition apart from south side, where wall has crumbled. Part of Neville's works to the water course.

Maintenance. Repair to southern wall.

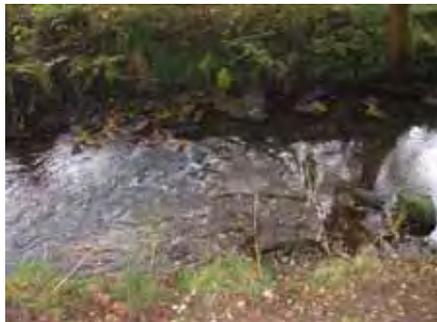
Apron of stone forming a low weir – in poor condition – approx 1.5m wide. Part of Neville's work to the water course.

Maintenance - some repair work is needed

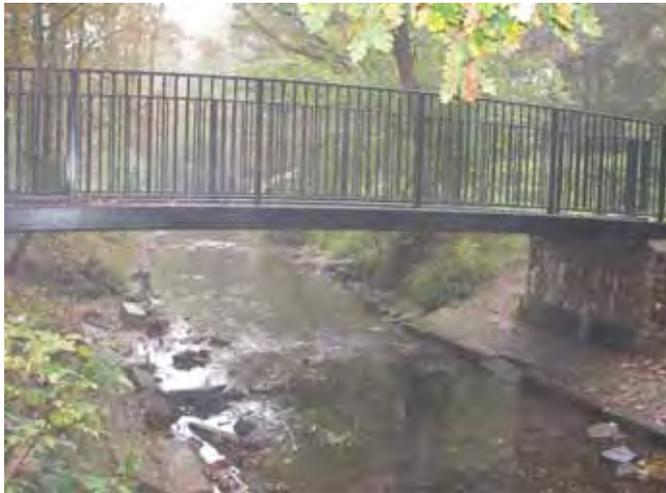
BRAMALL HALL AND PARK, STOCKPORT GAZETTEER	Zone	E
	Item	Footbridge
	Ref No	EG13

History and Description
Modern, metal railing footbridge. Steelwork span on stone Piers – The stone lined base to the river channel below the bridge is in poor condition.

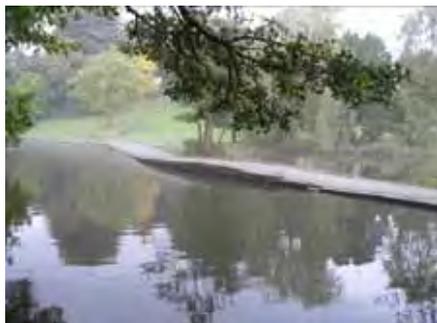
BRAMALL HALL AND PARK, STOCKPORT GAZETTEER	Zone E Item Causeway Ref No EG14
---	---

Causeway – stone edge both side and tarmac path. Stone edged causeway separating middle pool from lower pool. Connecting pipe between two ponds lies beneath. Good condition but bitmac surface municipal in appearance.

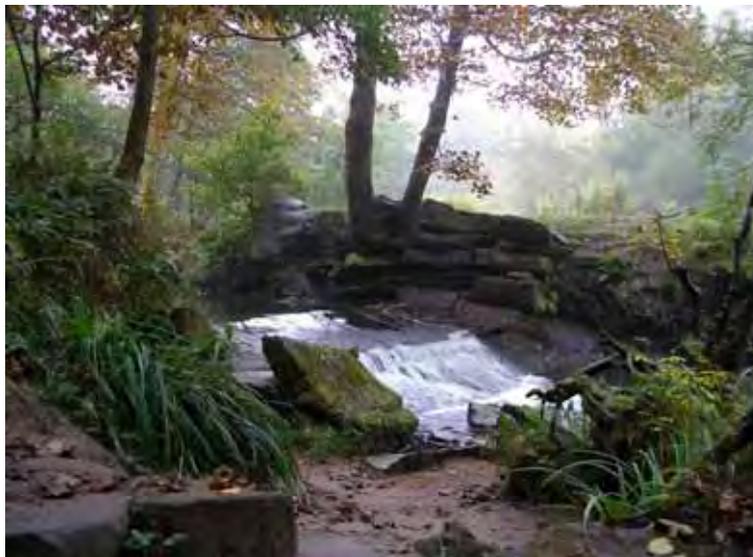
BRAMALL HALL AND PARK, STOCKPORT GAZETTEER	Zone E Item Cascade Ref No EG15
---	--

Under threat from tree growth and erosion

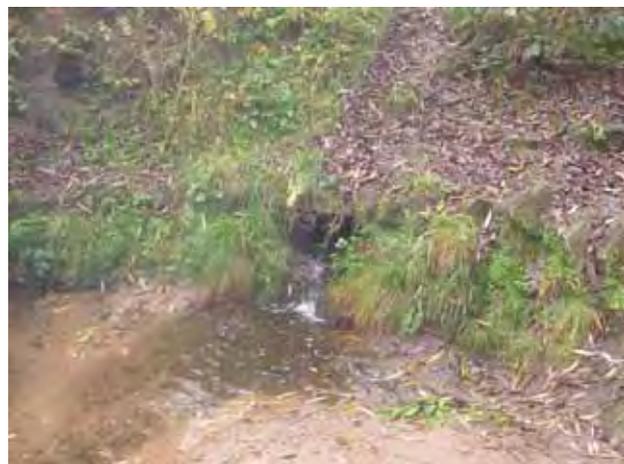
BRAMALL HALL AND PARK, STOCKPORT GAZETTEER	Zone E Item Lower Pond outlet Ref No EG16
---	--

History and Description Outlet to lower pool.

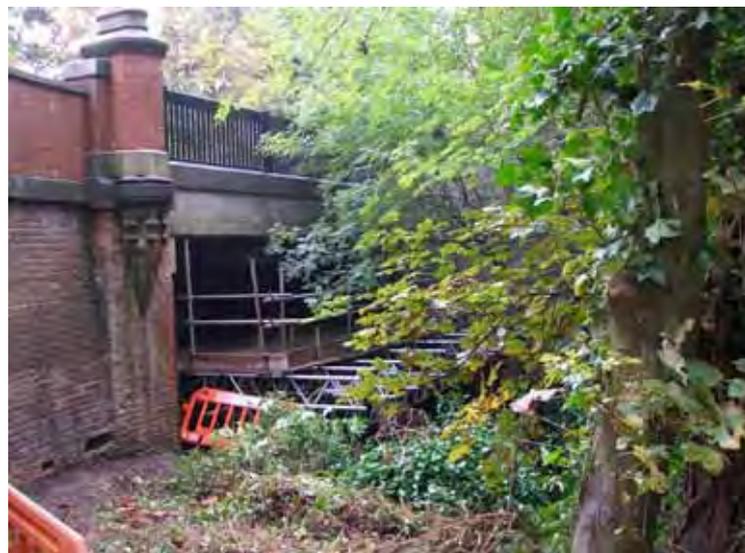
BRAMALL HALL AND PARK, STOCKPORT GAZETTEER	Zone	E
	Item	Bramall Park Road Bridge
	Ref No	EG17

History and Description
Bramall Park Road Bridge. Brick and stone piers. Upper with upper parapet section has been rebuilt in mid/late 20 th century. Concrete deck. A recent programme of repair and repointing has been completed 2009.

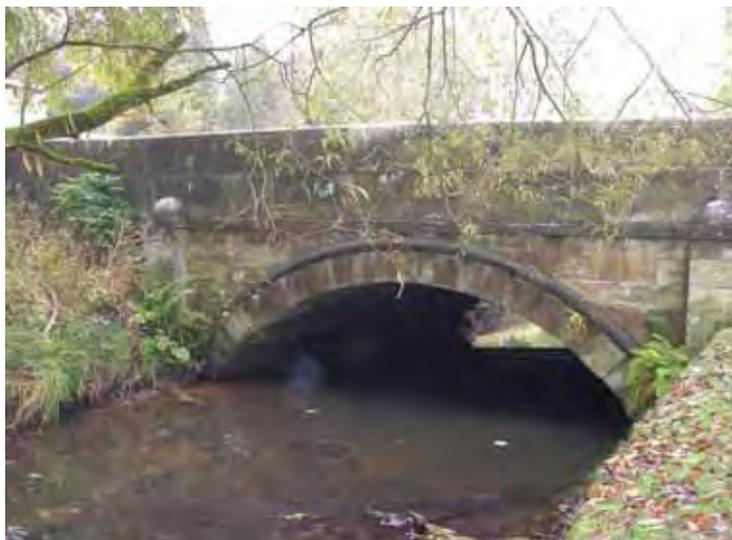
BRAMALL HALL AND PARK, STOCKPORT GAZETTEER	Zone	E
	Item	Stone bridge over Ladybrook river
	Ref No	EG18

Road bridge at eastern end of park solid sandstone bridge over river with parapet appears to be in good condition.

Part of SMBC is regular inspection programme ?
