Remedial Action Plan

Project
Proposed Residential Subdivision
290-308 Aldington Road and 59-63 Abbots Road
Kemps Creek NSW

Report No
13546-ER-2-2

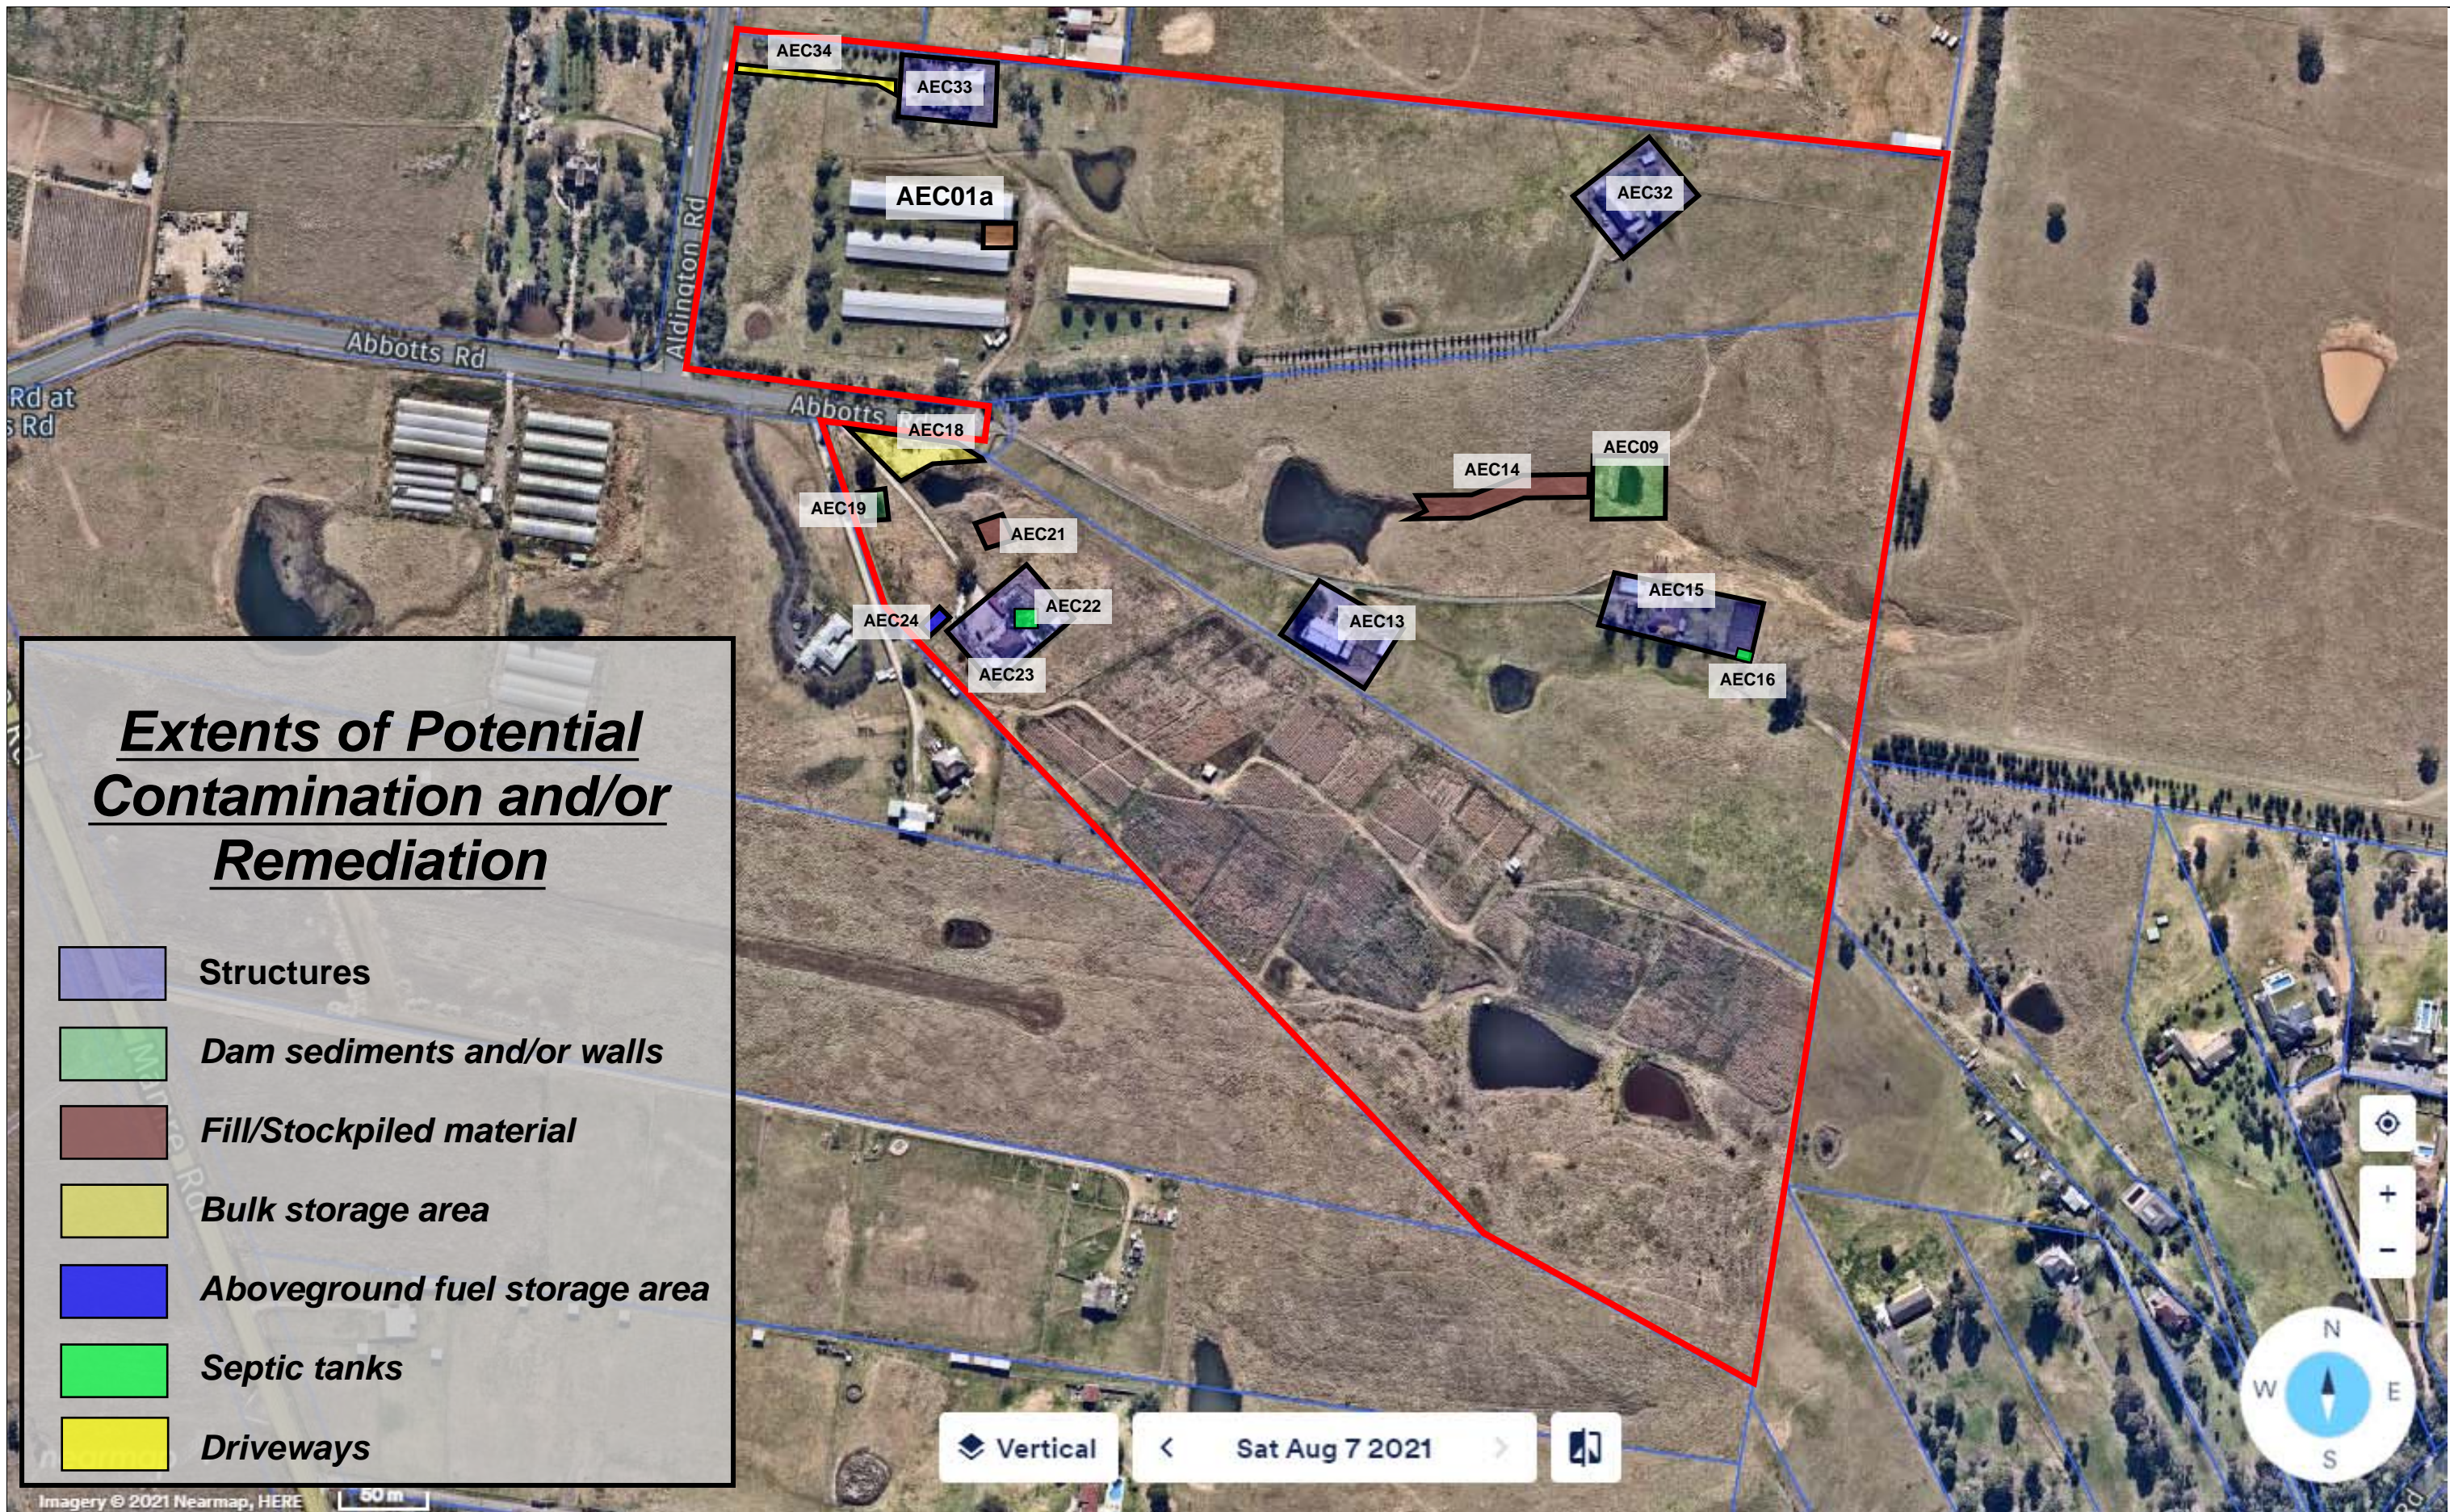
Extents of Potential Contamination and/or Remediation

- Structures
- Dam sediments and/or walls
- Fill/Stockpiled material
- Bulk storage area
- Aboveground fuel storage area
- Septic tanks
- Driveways
