Remediation Action Plan

Proposed Industrial Development  
Westlink Stage 2, 1030-1064 Mamre Road  
Kemps Creek

Prepared for  
ESR Australia

Project 211619.02  
October 2022

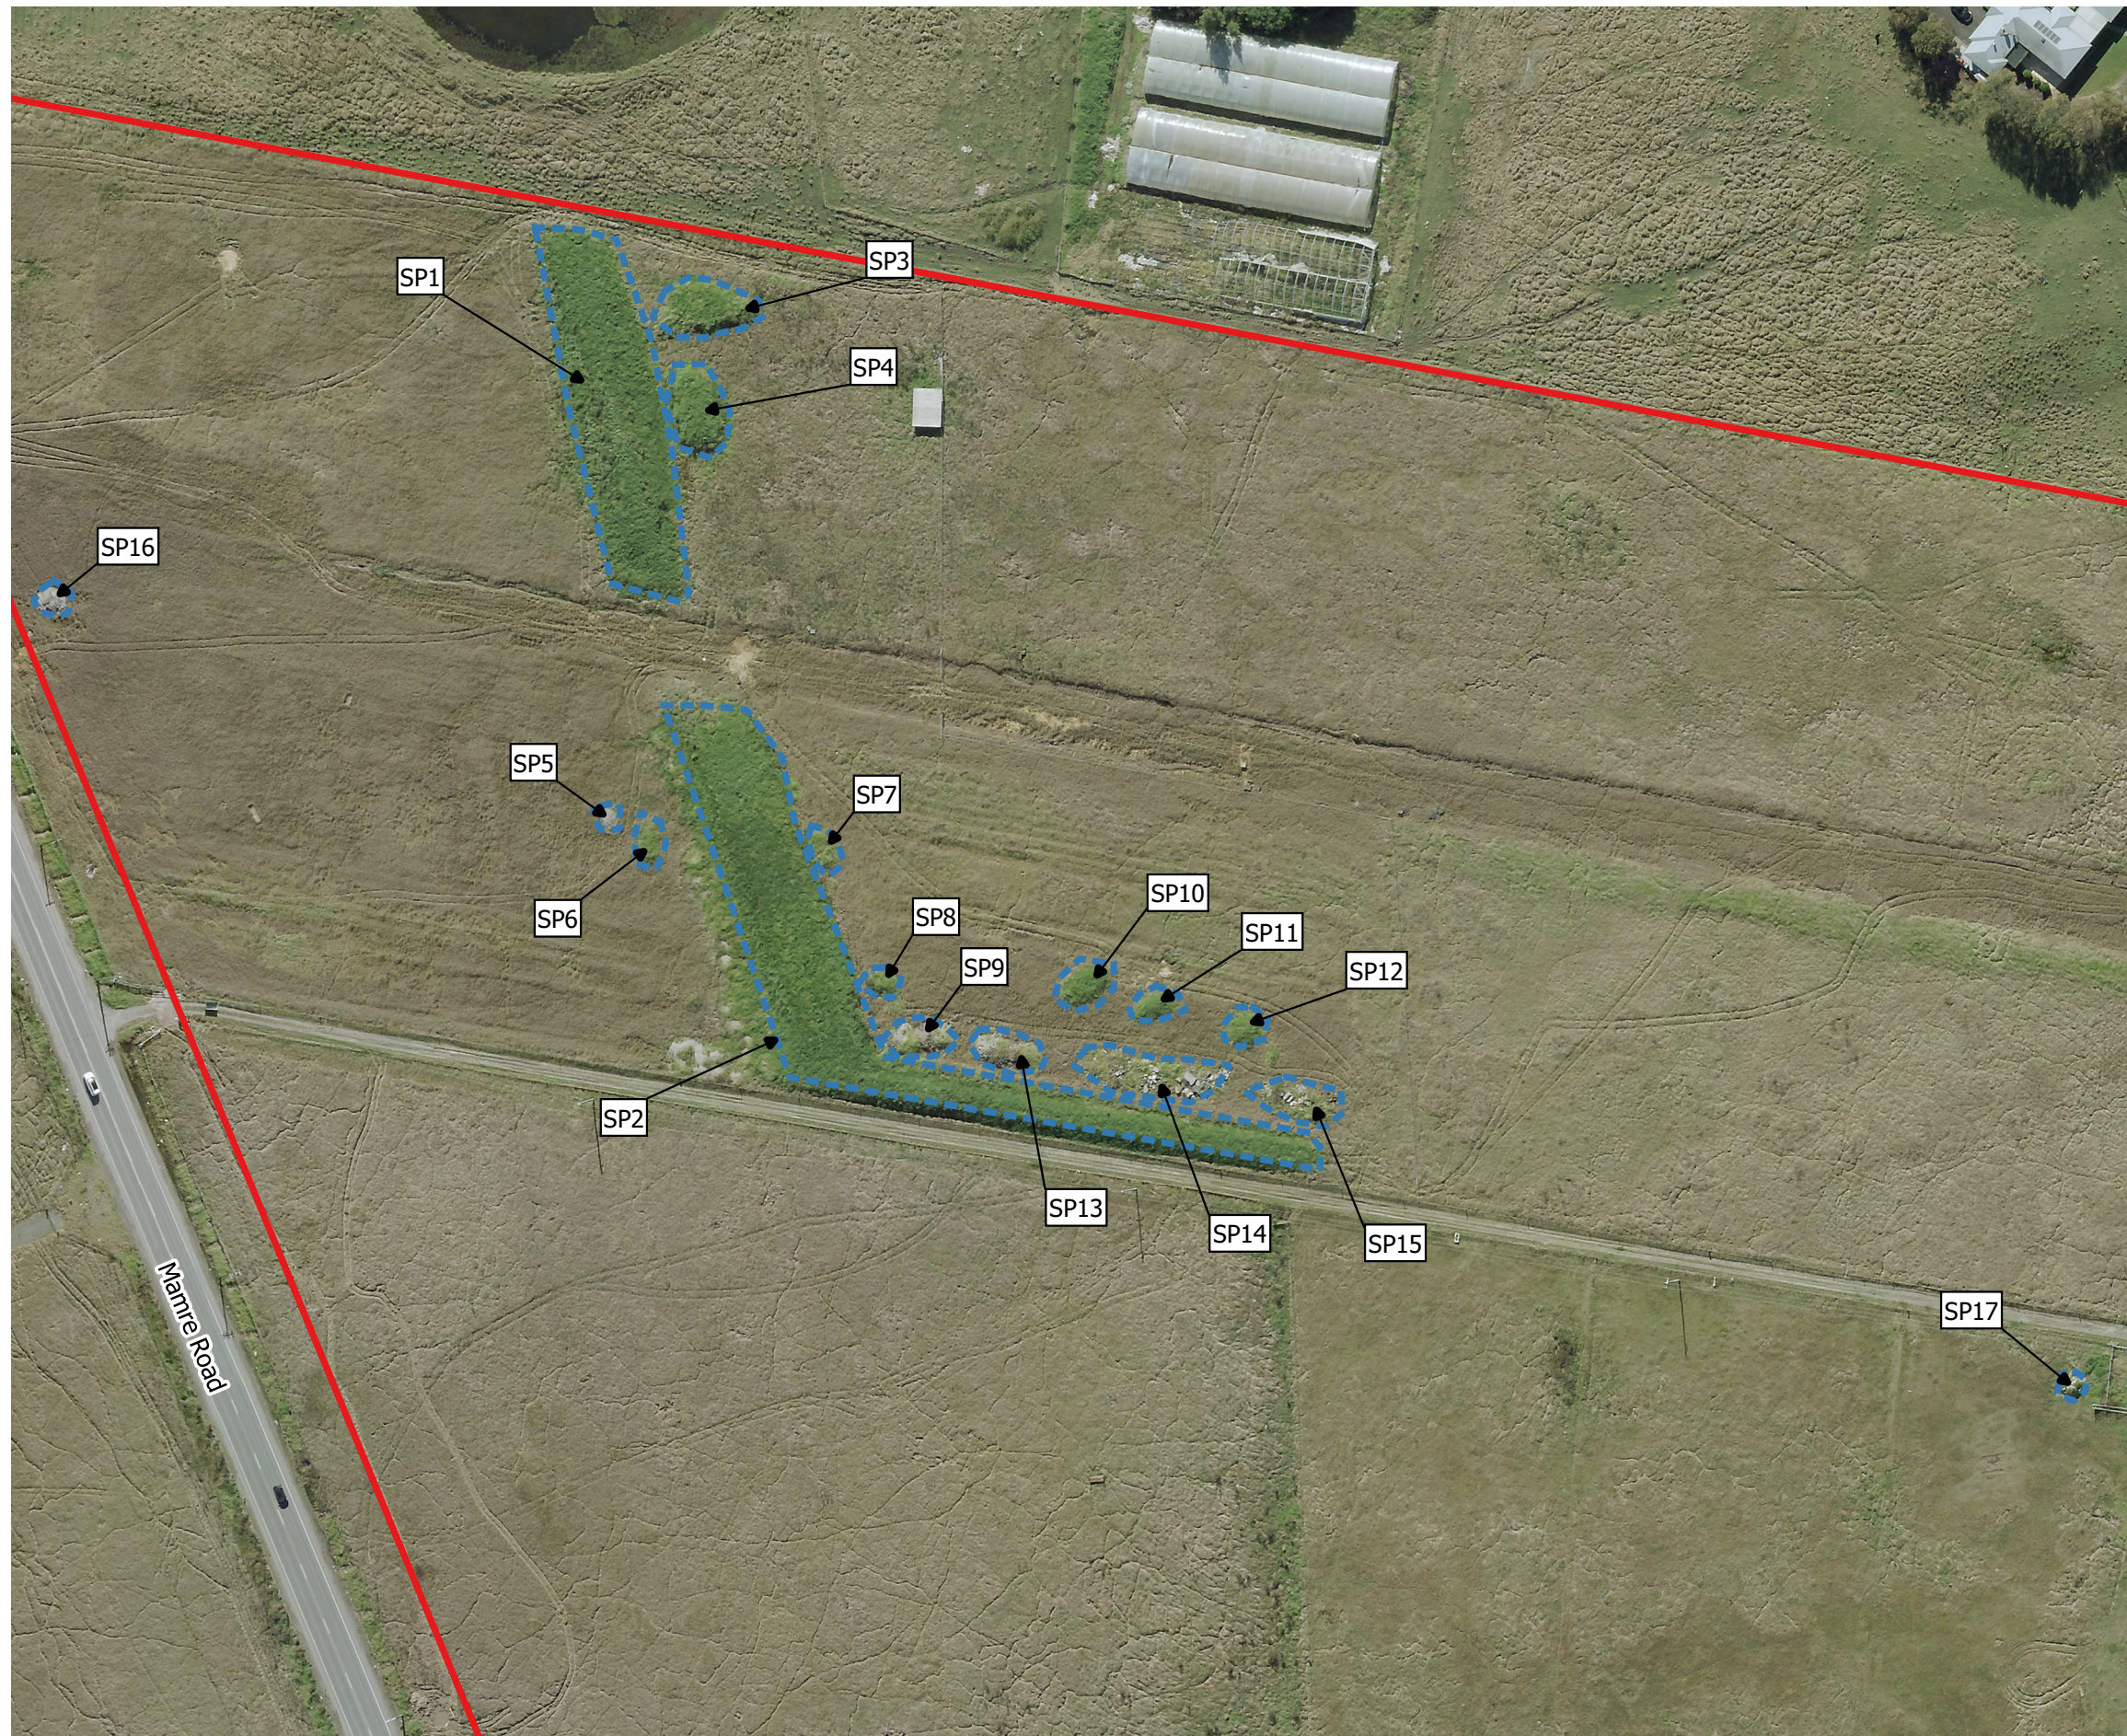
- Notes:
1. Basemap from metromap.com.au
  2. Site boundary inferred from NSW spatial services lot boundary.
  3. Stockpile footprints surveyed 01/08/22 by DP and are indicative only.

The lithology encountered during the investigation was generally a silty clay topsoil overlying alluvial and residual clays on siltstone bedrock. The stockpiles that were present at the western end of the site and were subject to sampling generally comprised clay fill with varying proportions of sand and gravel, building rubble in the form of concrete, metal and plastic were observed in some of the test pits into stockpiles (TP17, SS1 to SS3) as shown on Drawing 3a, Appendix A.

The lithology encountered during the investigation was generally consistent with observation during previous investigations (refer to previous sub-subsections). The stockpiles that were present at the western end of the site generally comprised clay fill with varying proportions of sand and gravel. Building rubble in the form of brick, concrete, rebar, metal, wire, glass, rubber, fabric, styrofoam, vinyl, terracotta, tile and plastic along with ash, clinker and charcoal and fibrous cement material (later confirmed to be ACM by laboratory analysis) were observed in some of the test pits excavated into the stockpiles as shown on Drawing 3a, Appendix A.

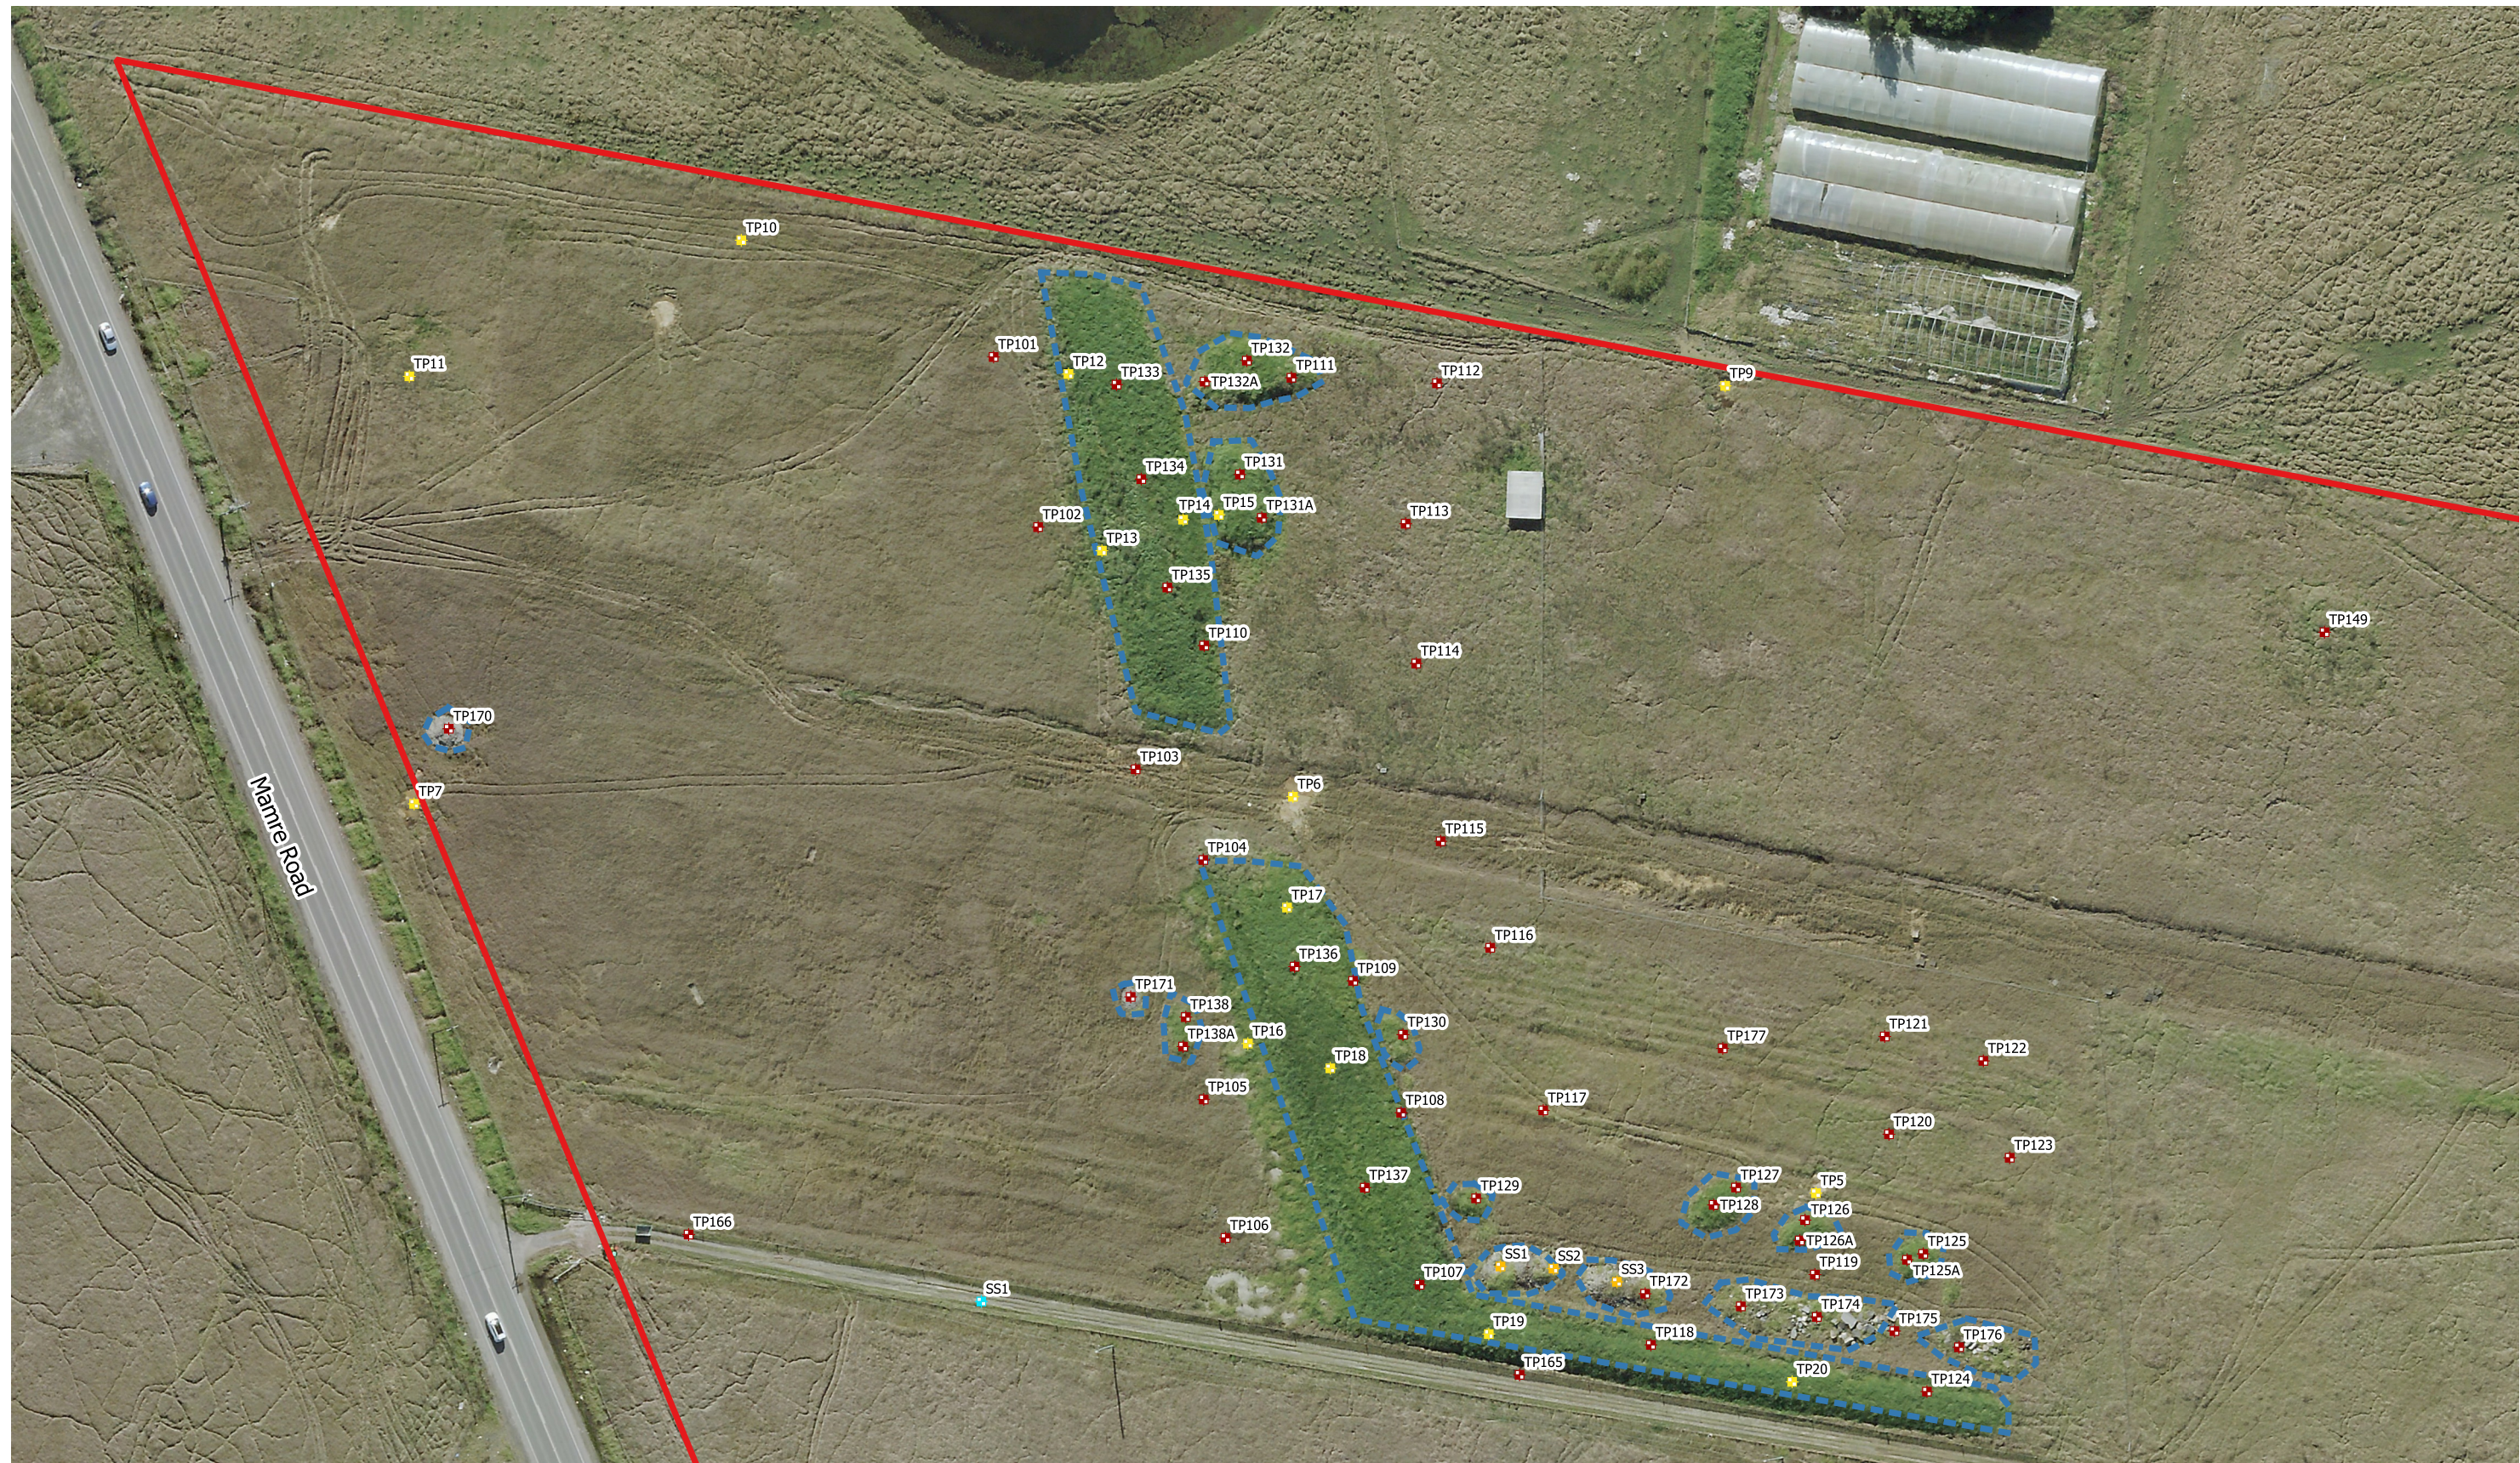
Notes:  
1. Basemap from metromap.com.au  
2. Site boundary inferred from NSW spatial services lot boundary.  
3. Stockpile footprints are approximate only.

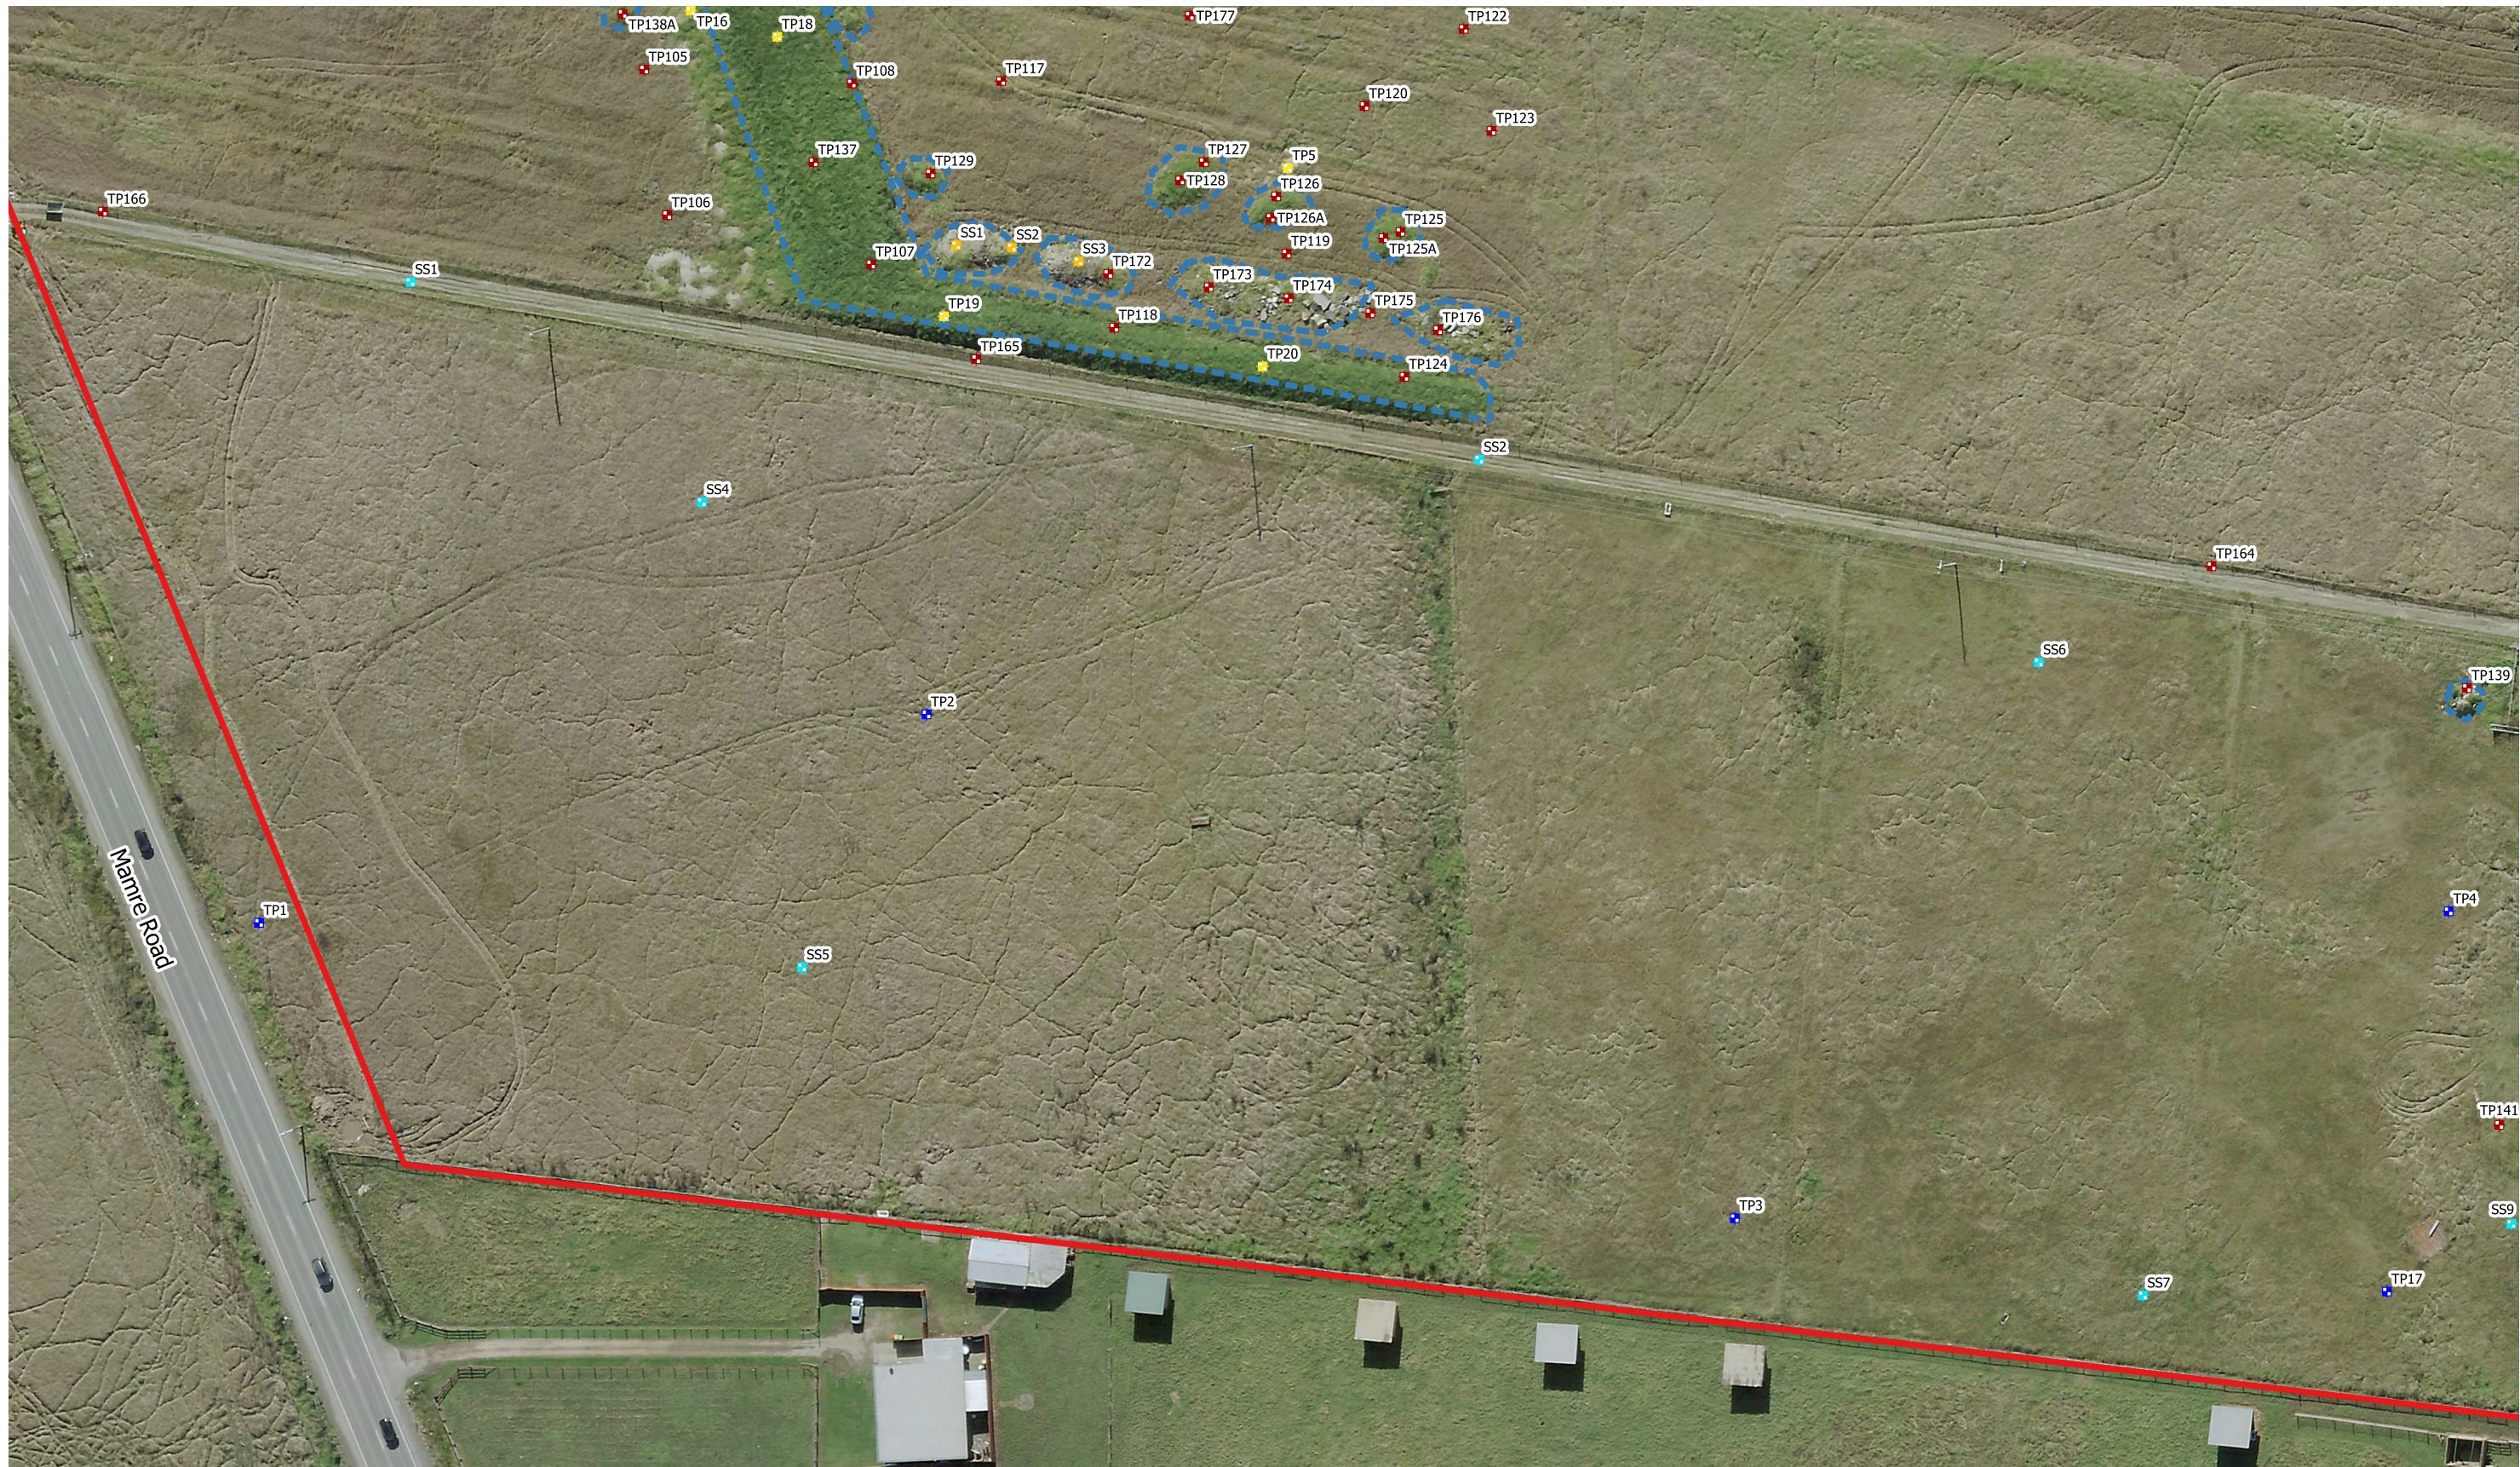
Notes:  
1. Basemap from metromap.com.au  
2. Site boundary inferred from NSW spatial services lot boundary.  
3. Stockpile footprints are approximate only.

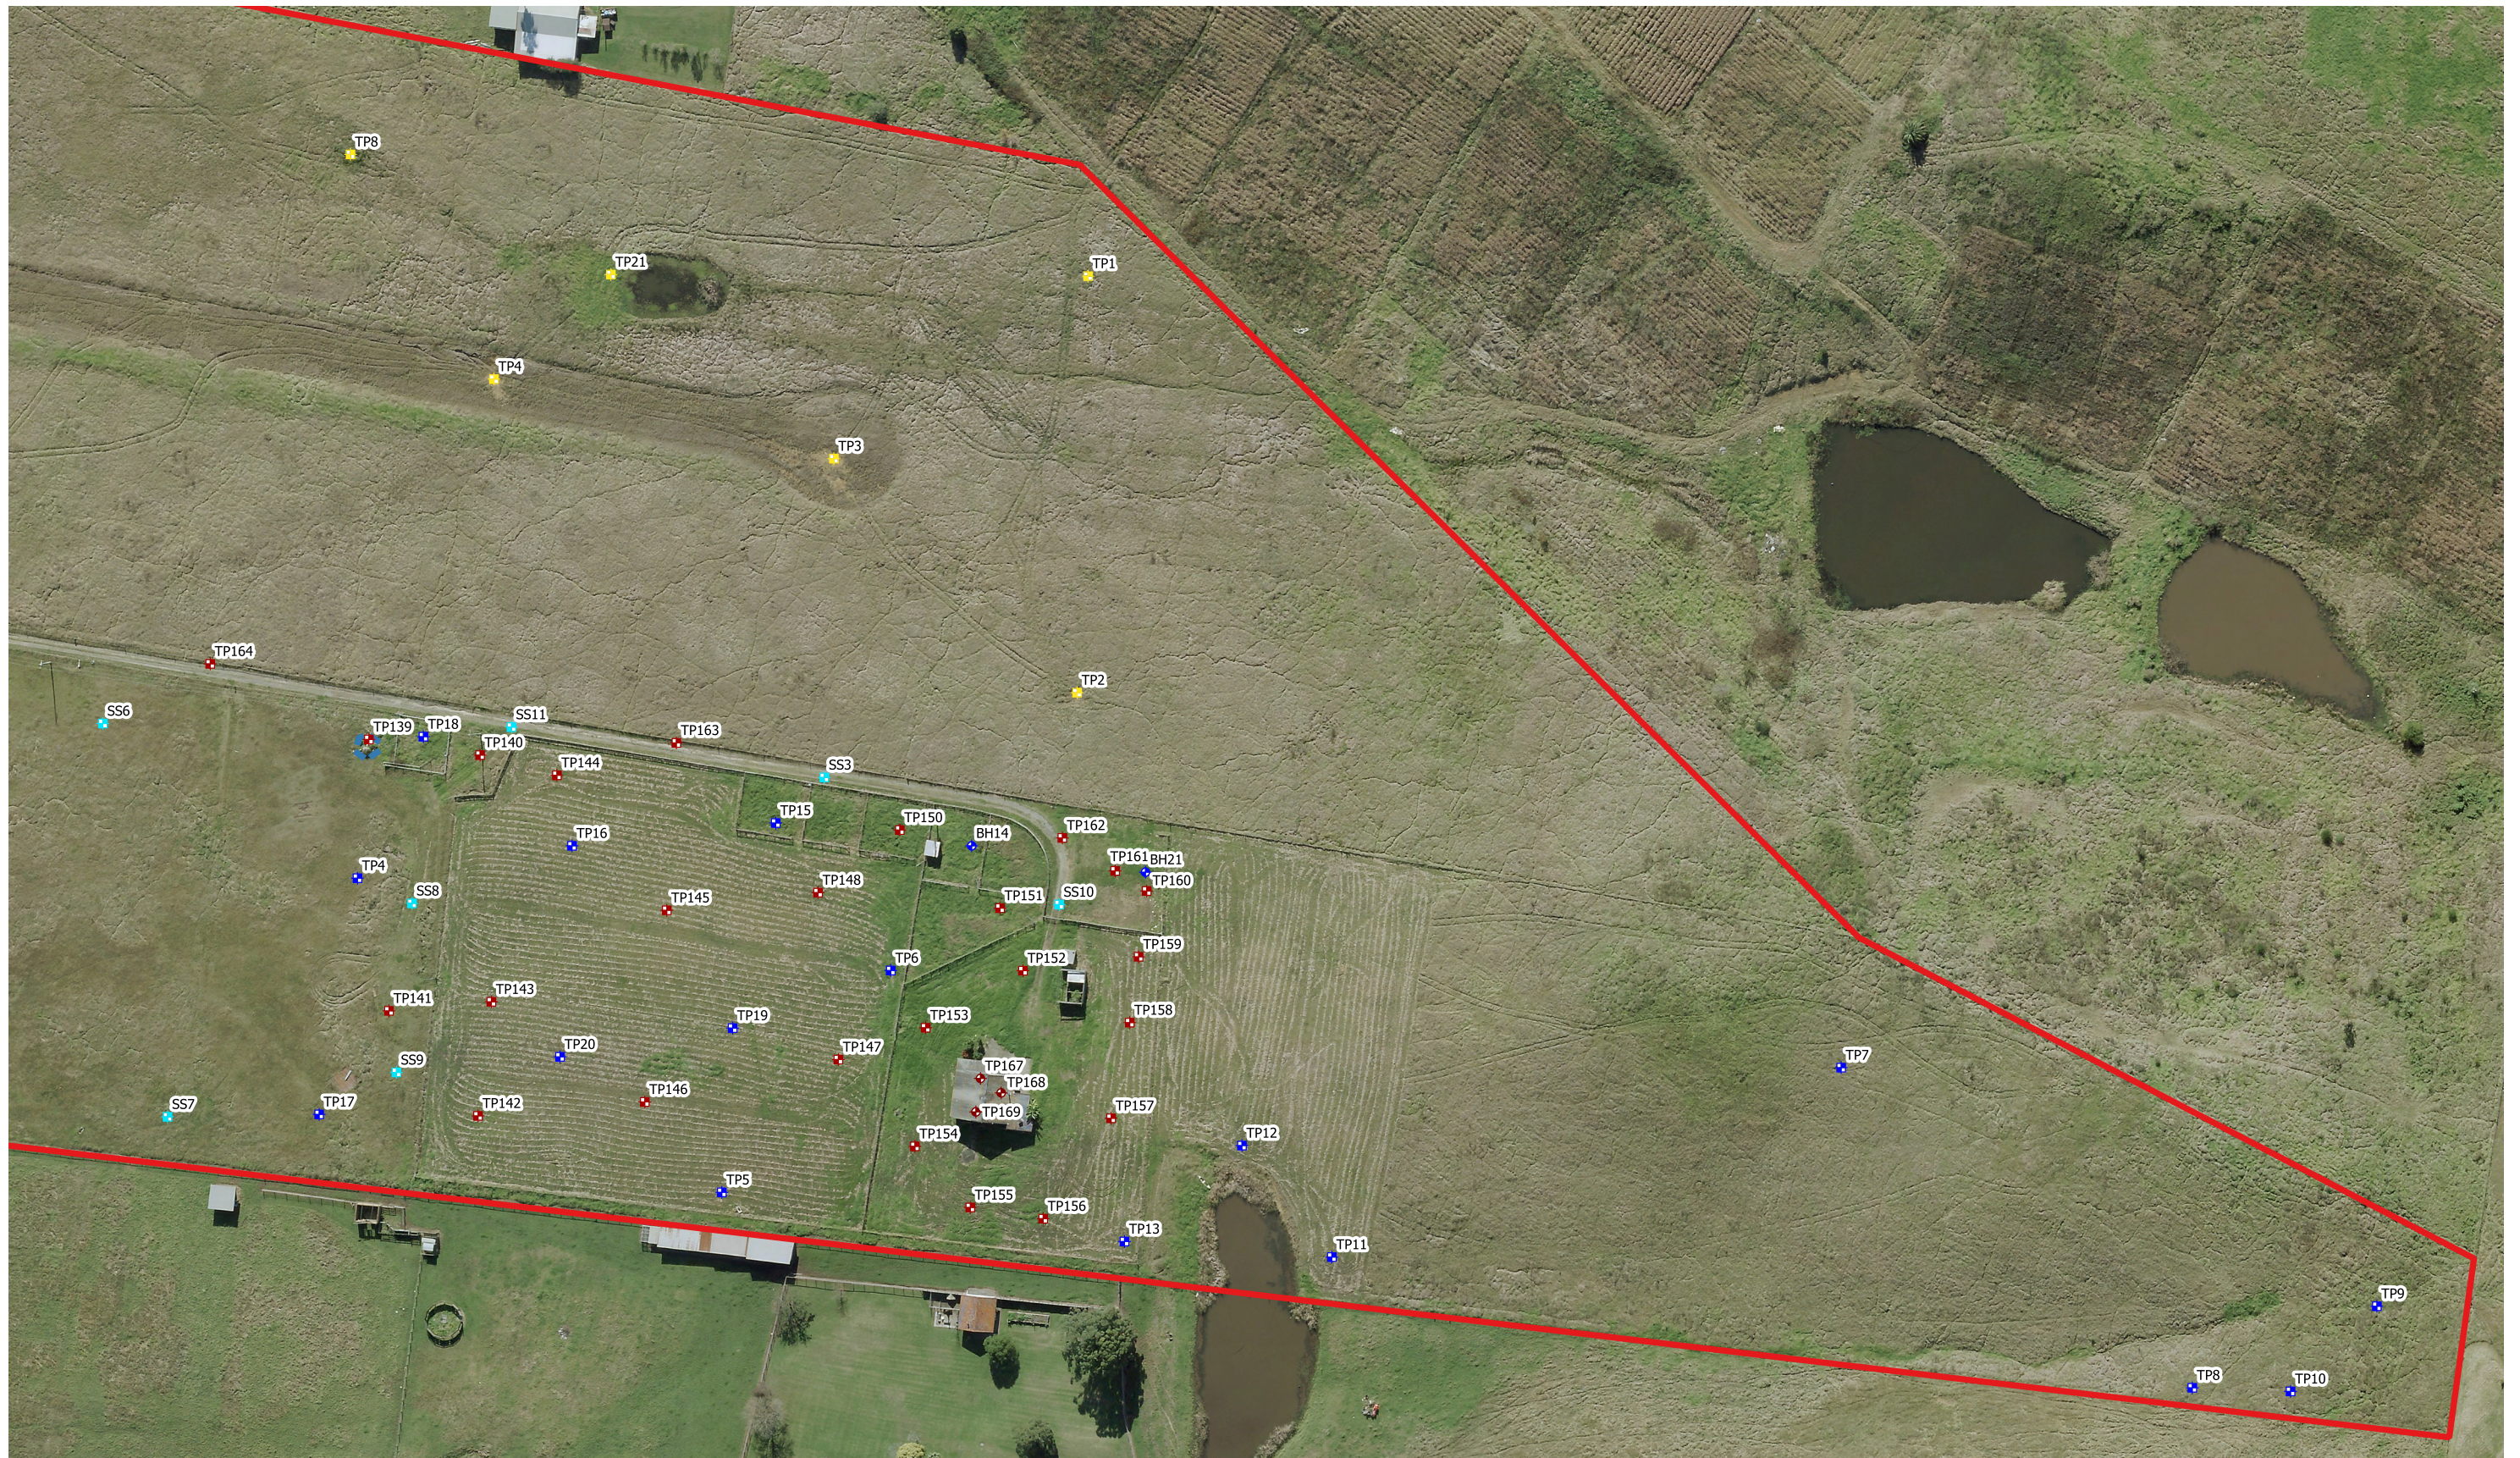
Notes:  
1. Basemap from metromap.com.au  
2. Site boundary inferred from NSW spatial services lot boundary.

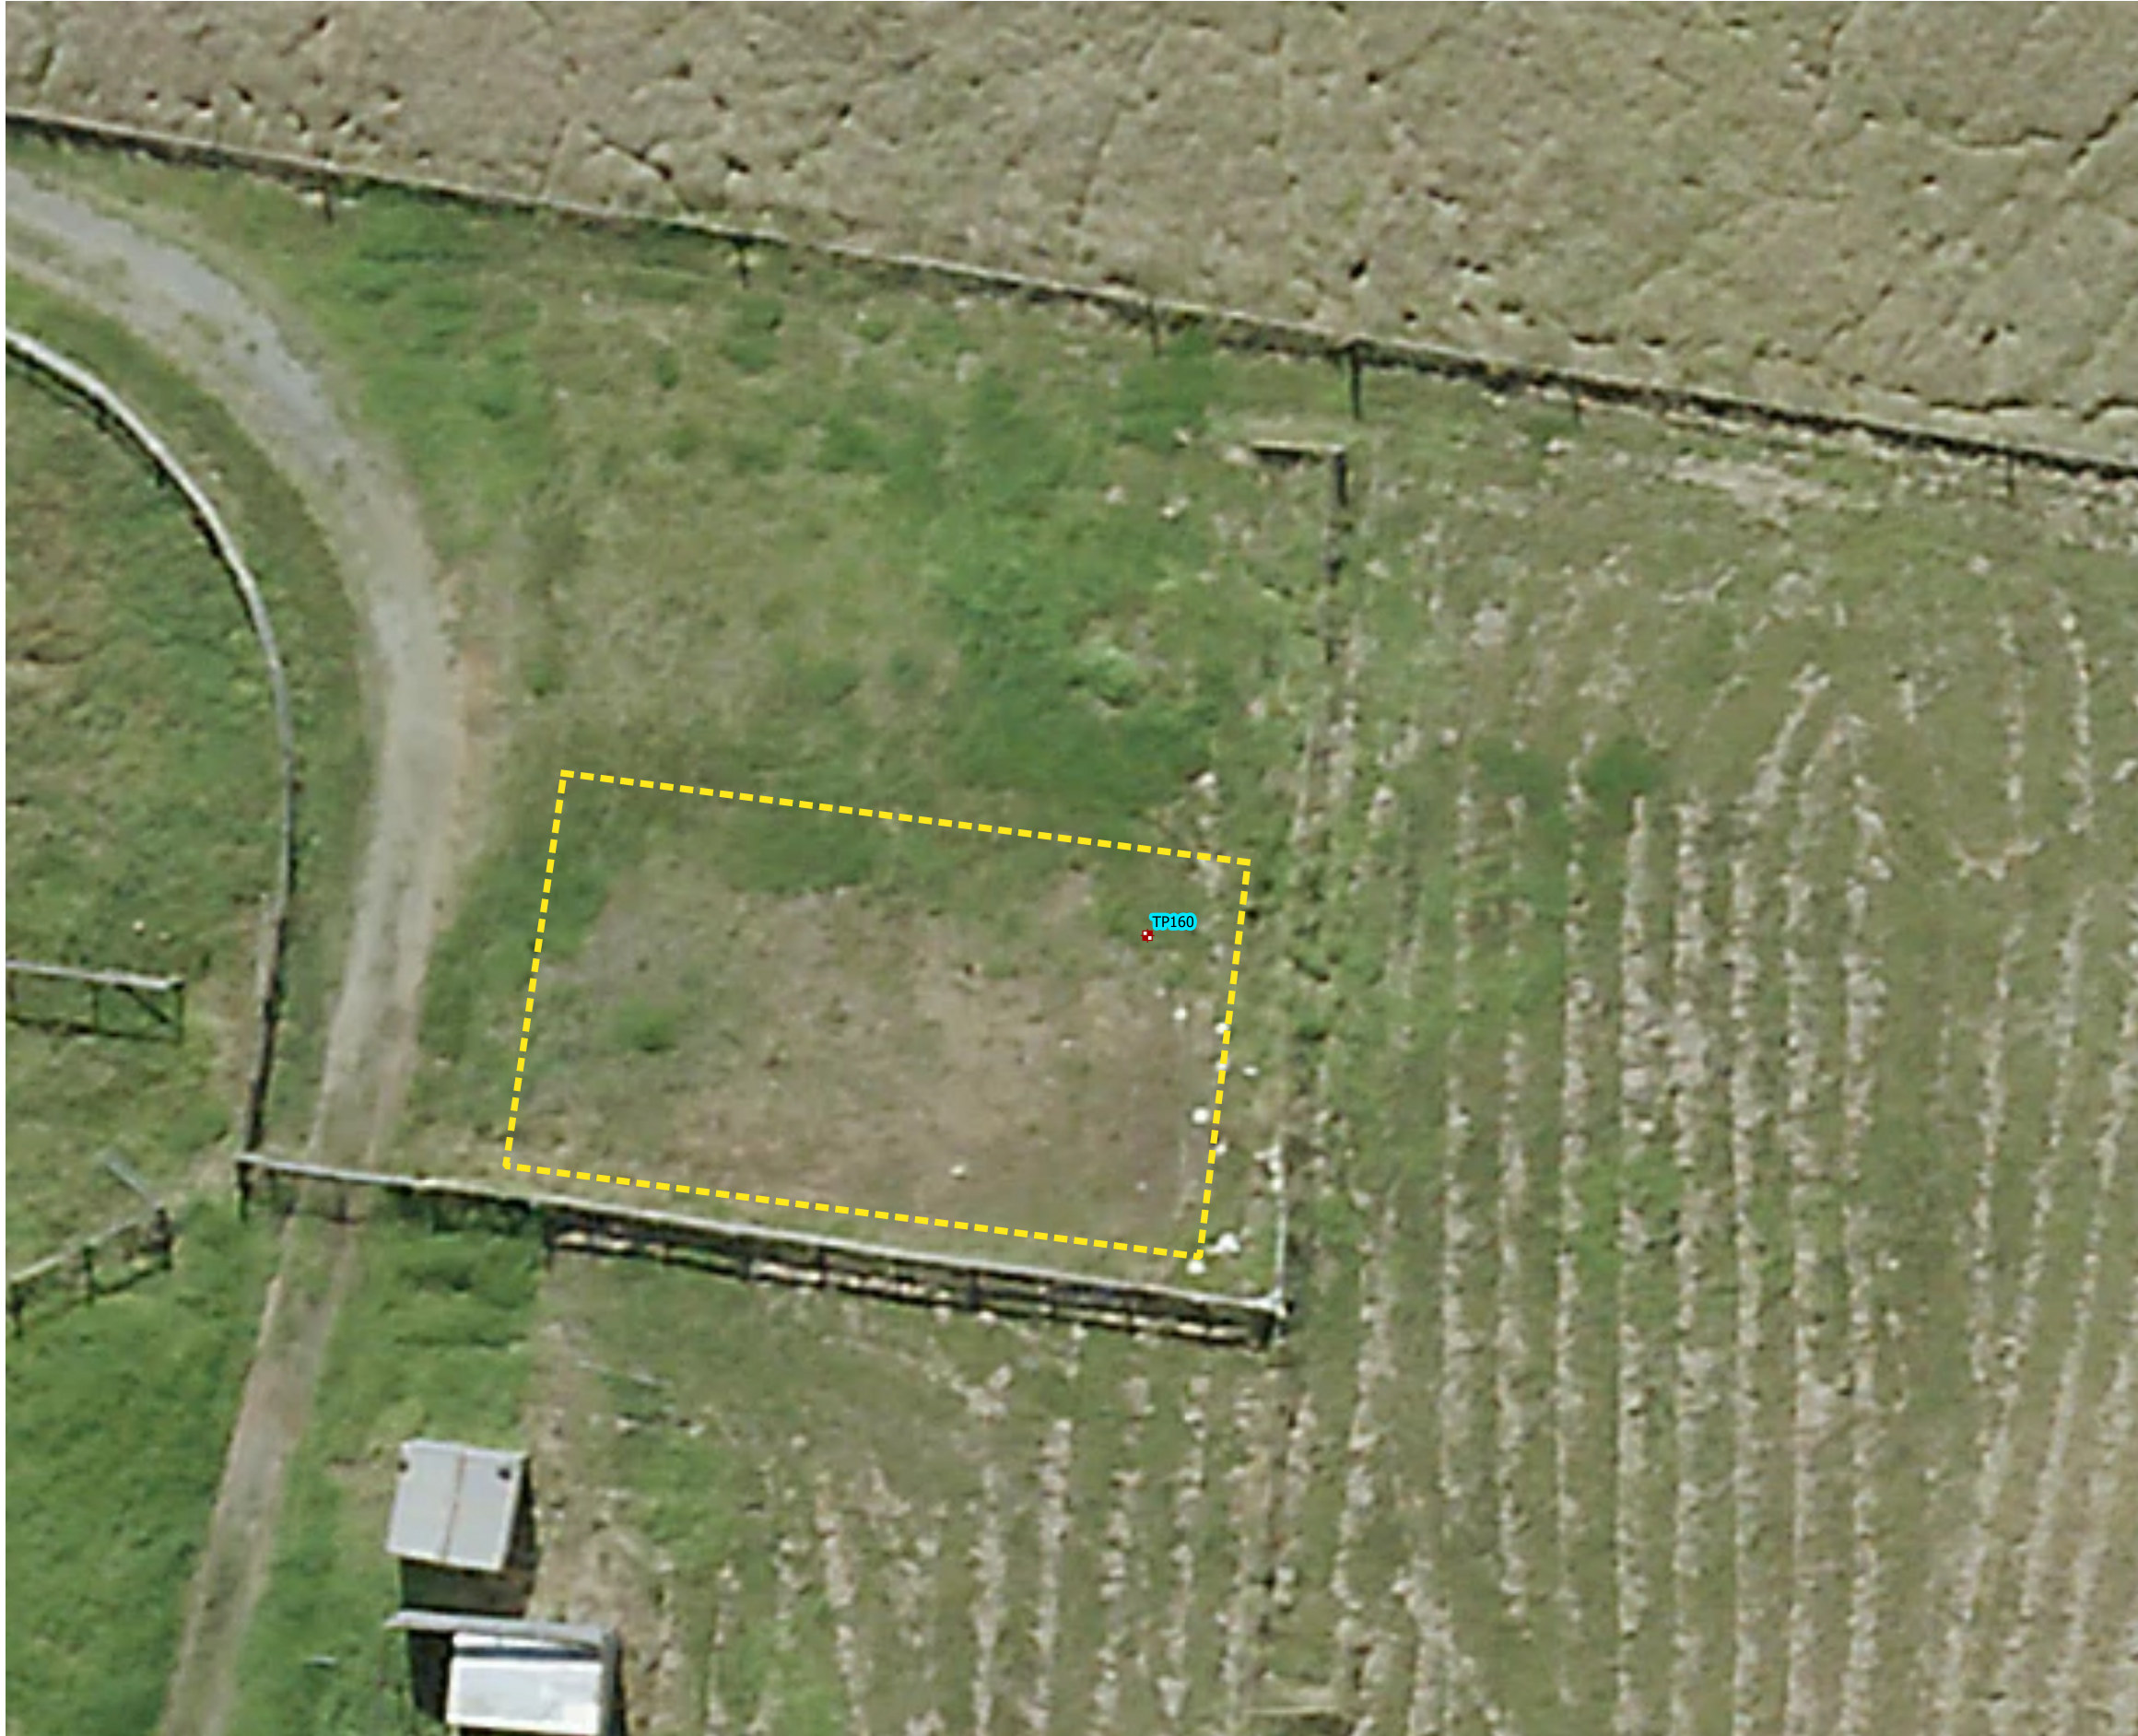
Drawing 6: Remediation Area 9

- Notes:
- 1. Basemap from metromap.com.au
  - 2. Remediation Area footprint is approximate only.
