**Report on Geotechnical and Salinity
Investigation**

Proposed Industrial Development

3 Johnston Crescent, Horsley Park

Project 86826.09

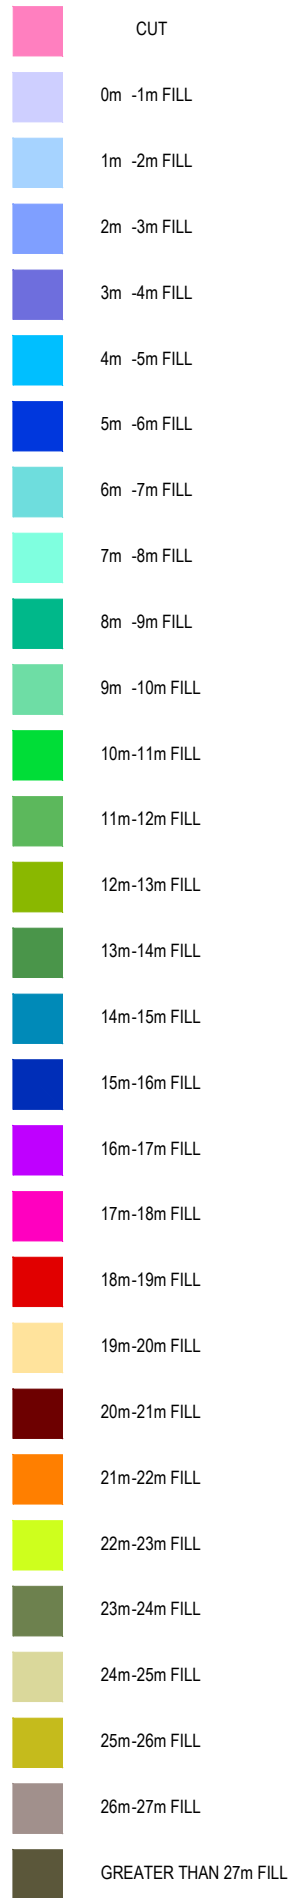
Total cut -101.718m³
Total fill 558703.996m³
Total balance 558602.278m³

AMENDMENT DETAILS						STATUS		SCALE		CLIENT		PROJECT		DRAWING TITLE			
FIRST ISSUE	DESIGN	DRAWN	CHECK	APPD.	DATE	AUTHORISED FOR ISSUE:		0 10 20 30 40 50 60 70 80						PLAN SHOWING DEPTHS OF FILL			
01	AR	PW	KM	KM	15/03/2023	BY: KIM MURPHY		SCALE 1:1000 (A1)						CSR HP - FINAL			
					04/04/2023	SIGN: <i>K. J. Murphy</i>		SCALE 1:2000 (A3)						CSR HP - FINAL LOT FILL PLAN			
						Registered Surveyor No. 1677								DISCLAIMER			
						DATE: 04/04/2023								ALL DIMENSIONS TO BE CHECKED ON SITE BY CONTRACTOR			
														PRIOR TO CONSTRUCTION. USE WRITTEN DIMENSIONS ONLY. DO			
														NOT SCALE. NOT FOR CONSTRUCTION UNLESS STAMPED BY			
														CERTIFYING AUTHORITY			
														PROJECT No. X13044-FILL			
														DRAWING No. 01			
														MILESTONE			
														REVISION			
														1

Based on the subsurface conditions encountered during the investigation, and considering those available from the due diligence documentation, it is apparent that the site is underlain by varying depths of fill ranging from 3.2 m to 12.3 m outside of the deep backfilled quarry pit and up to 13.8 m within the quarry pit near the southern lot boundary.

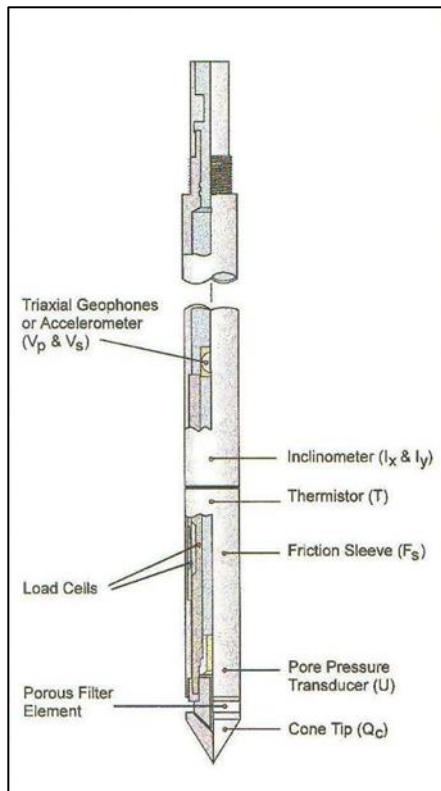
Figure 1: Cone Diagram

- Cone tip resistance q_c
- Sleeve friction f_s
- Inclination (from vertical) i
- Depth below ground z

The inclinometer in the cone enables the verticality of the test to be confirmed and, if required, the vertical depth can be corrected.

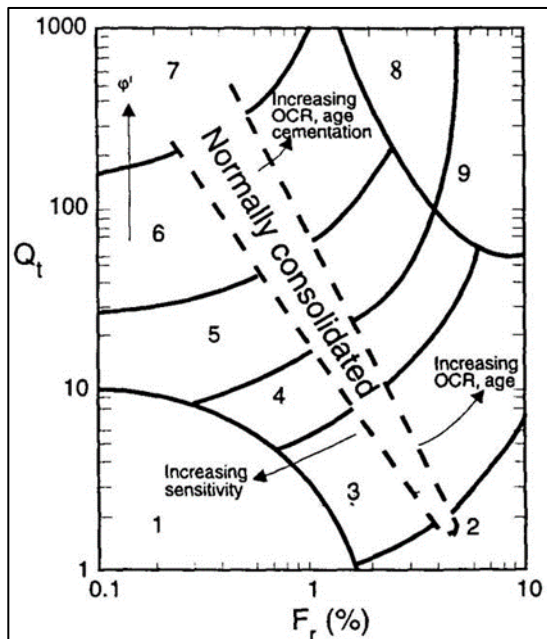
Figure 3: Soil Classification Chart

The CPT parameters can be used to infer the Soil Behaviour Type (SBT), based on normalised values of cone resistance (Q_t) and friction ratio (Fr). These are used in conjunction with soil classification charts, such as the one below (after Robertson 1990)

DP's in-house CPT software provides computer aided interpretation of soil strata, generating soil descriptions and strengths for each layer. The software can also produce plots of estimated soil parameters, including modulus, friction angle, relative density, shear strength and over consolidation ratio.

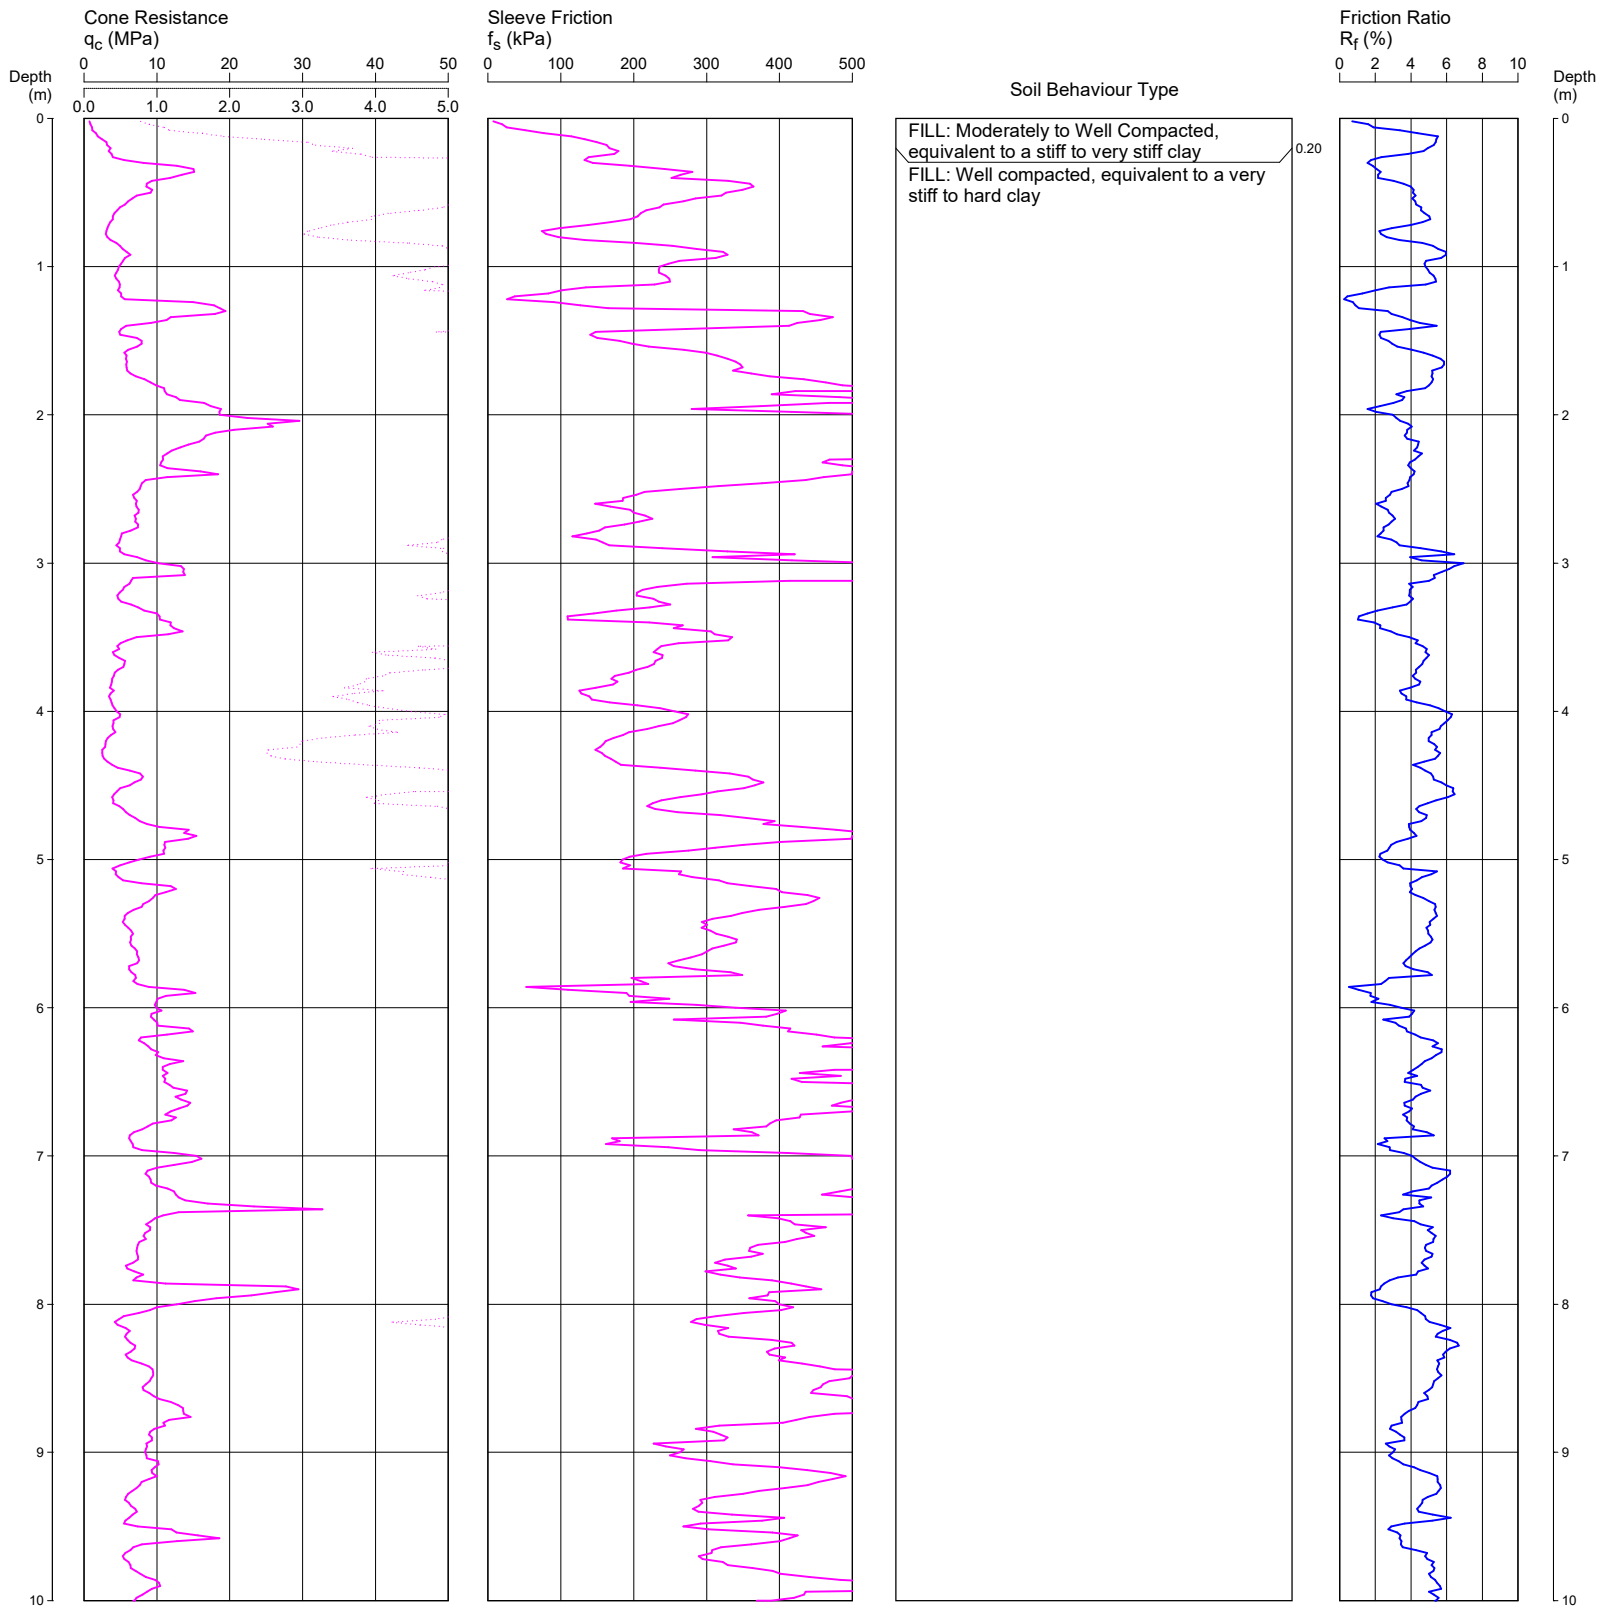
REMARKS: TEST DISCONTINUED DUE TO BENDING ON FILLING
NO GROUNDWATER OBSERVED AFTER WITHDRAWAL OF RODS

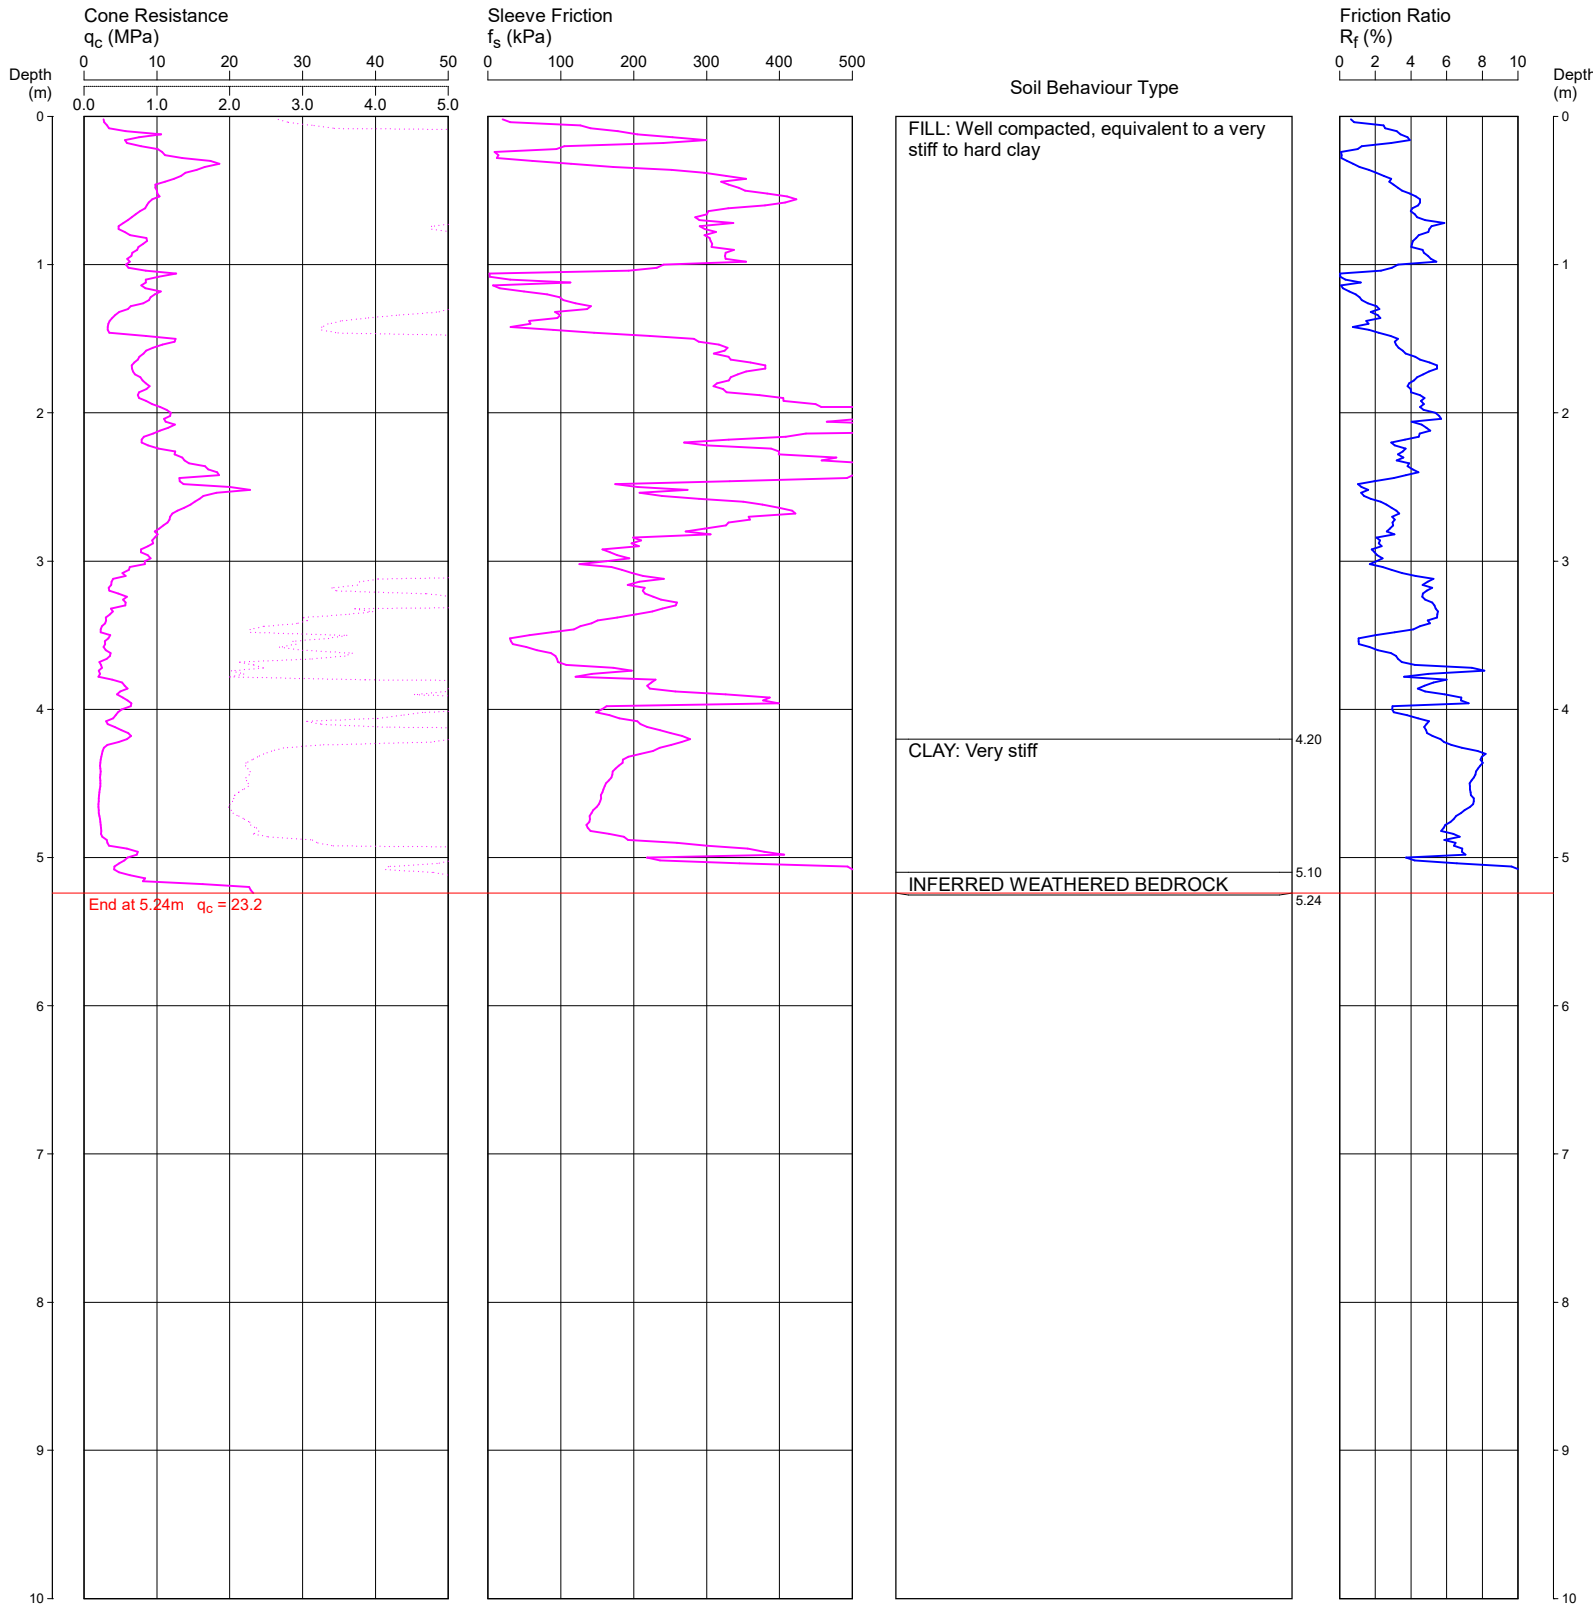
REMARKS: TEST DISCONTINUED DUE TO BENDING NEAR INFERRED WEATHERED ROCK
HOLE COLLAPSED AT 3.6M AFTER WITHDRAWAL OF RODS

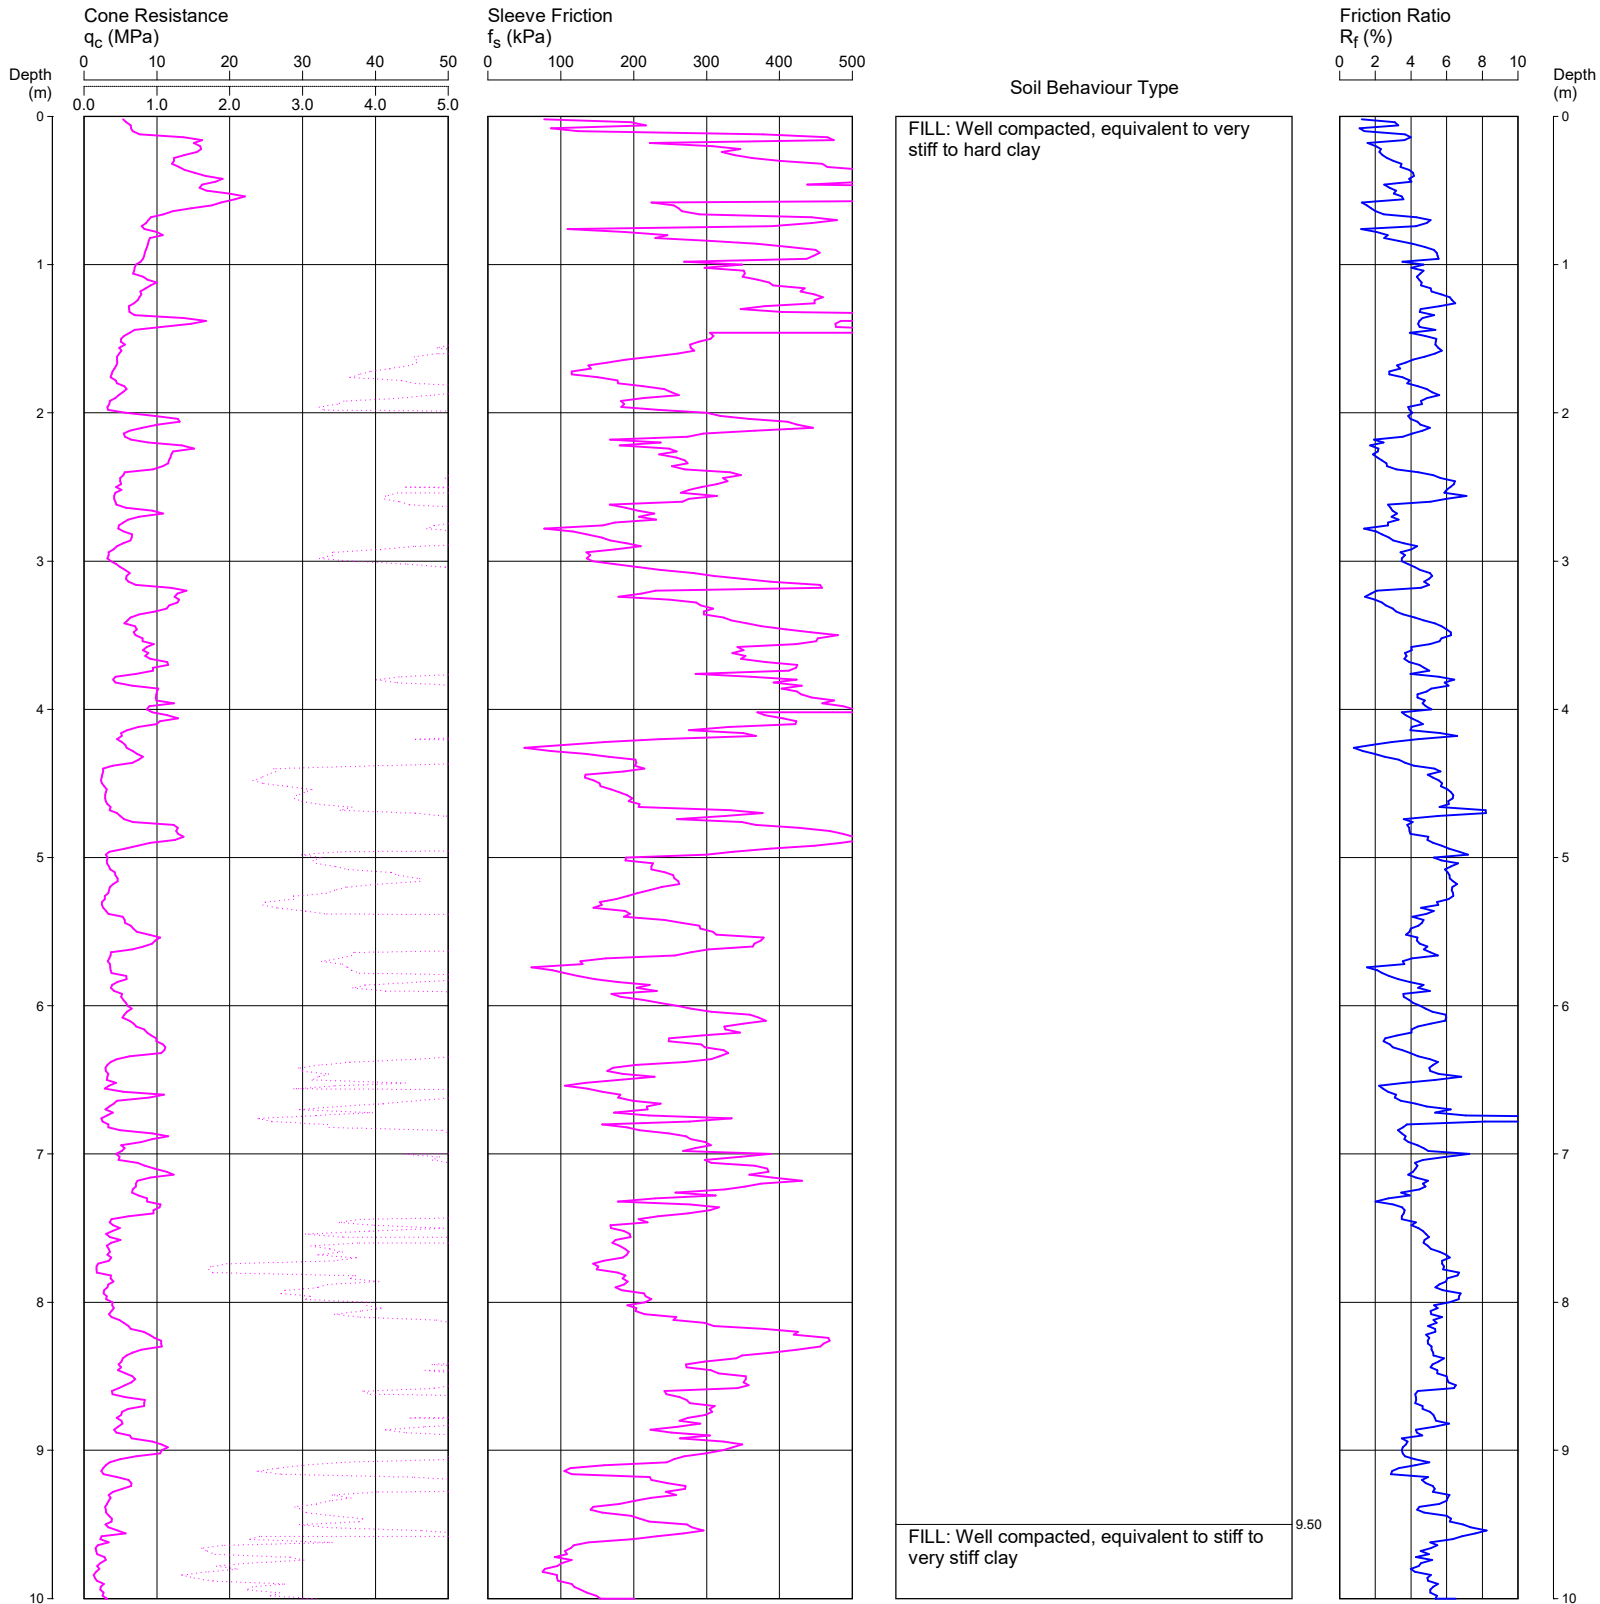
REMARKS: TEST DISCONTINUED DUE TO BENDING NEAR INFERRED WEATHERED ROCK
HOLE COLLAPSED AT 9.5M AFTER WITHDRAWAL OF RODS

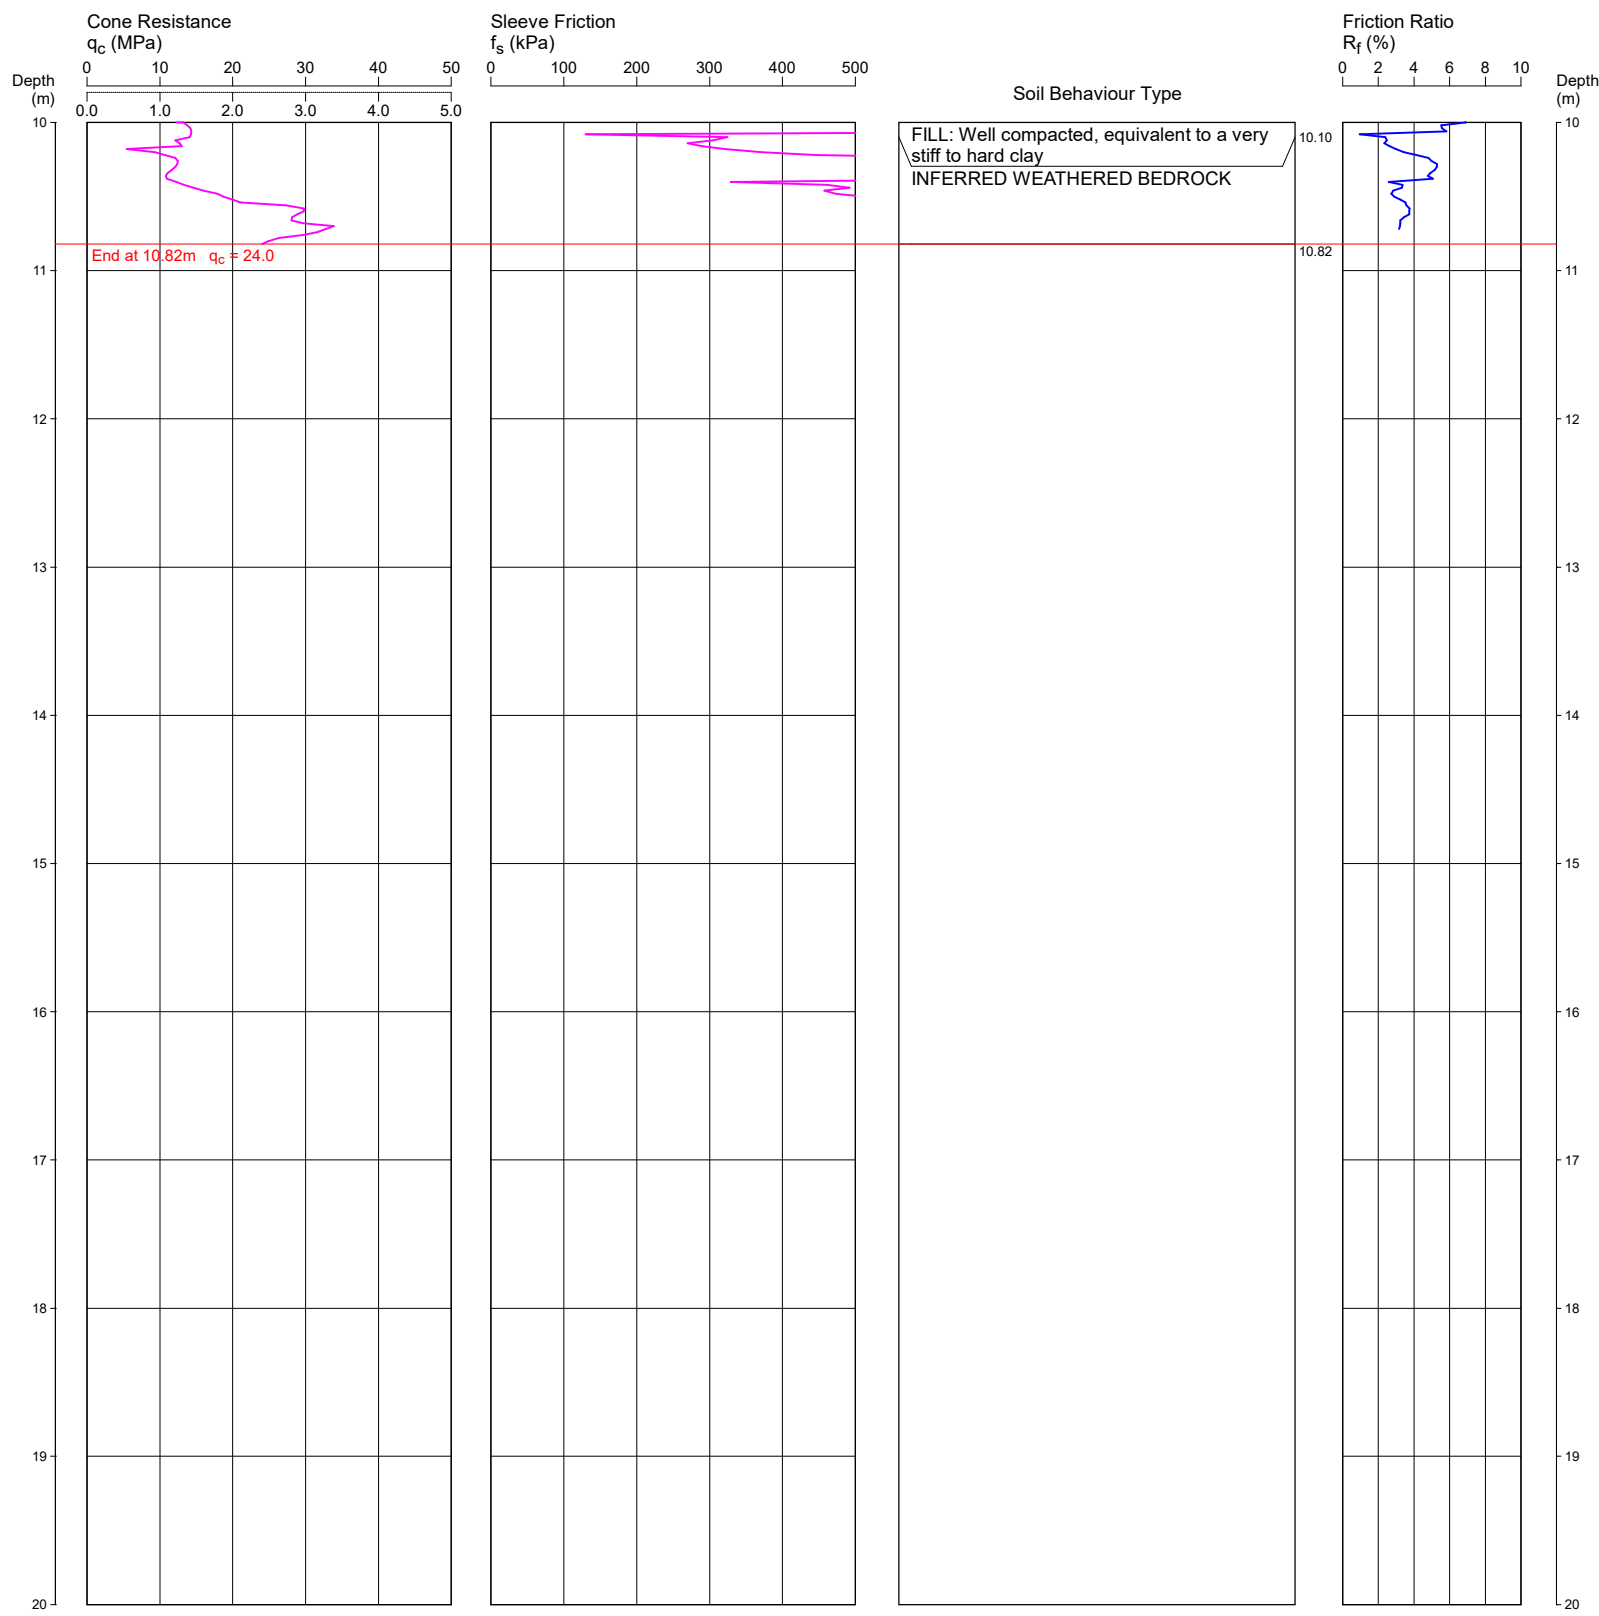
REMARKS: TEST DISCONTINUED DUE TO BENDING ON (or NEAR) INFERRED WEATHERED ROCK
NO GROUNDWATER OBSERVED AFTER WITHDRAWAL OF RODS
