Horsely Logistics Park SSD

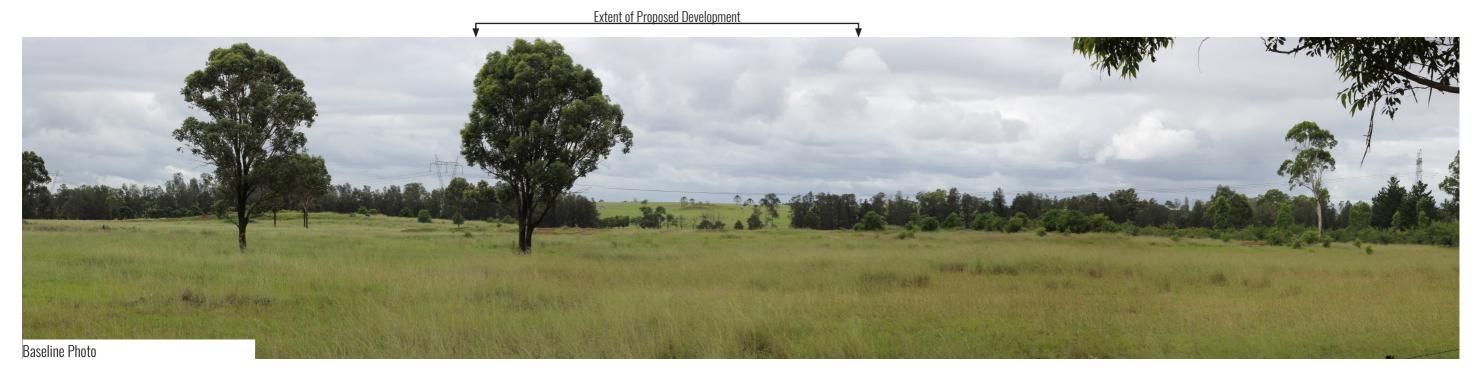
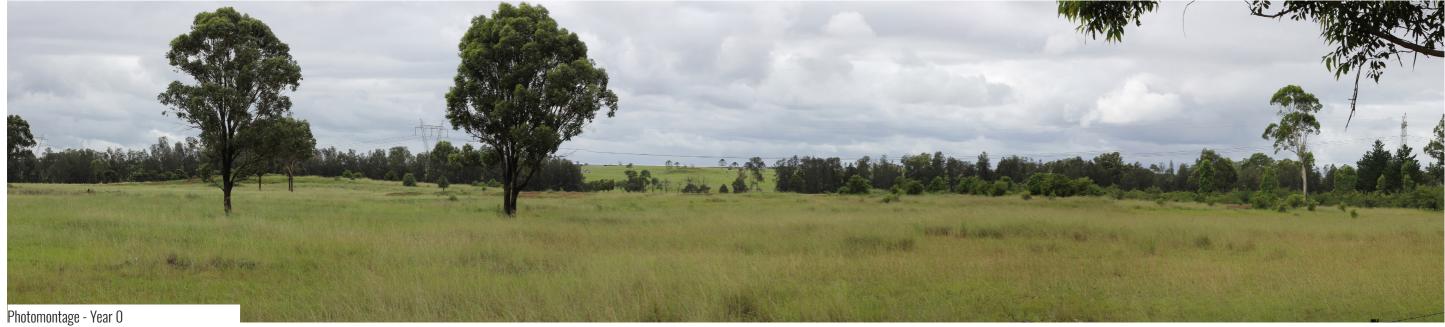
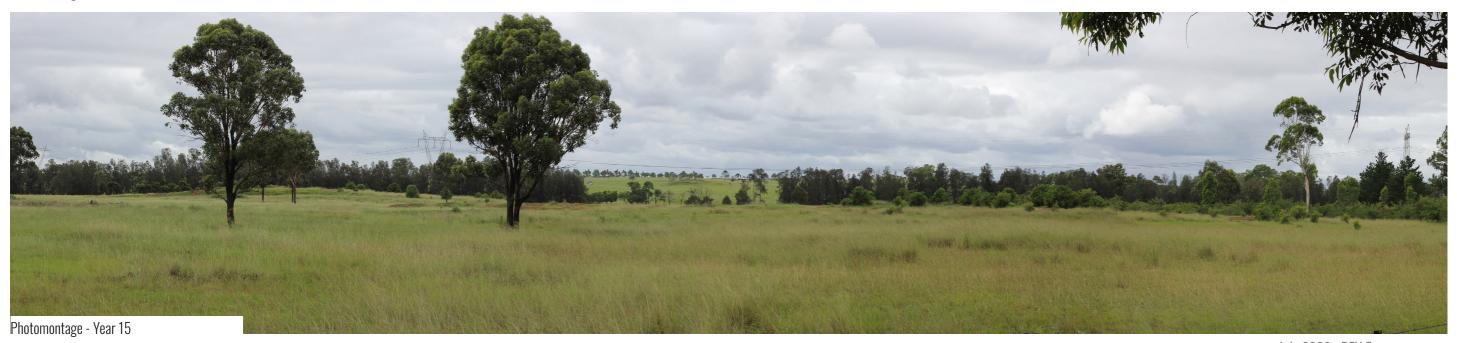
Figure 40: Viewpoint 9 - Bowood Park, Bowood Road, Mount Vernon - Looking North (Photomontage)

Viewing Location	Bowood Park, Bowood Road, Mount Vernon - Looking North
GPS	33°50'59"S, 150°48'41"E
Elevation (Eye-level)	70.45m AHD
Date and Time	16th Dec 2020 - 1.53pm
Baseline Photo & Photomontage Figure	Figure 41
Visual Description	
Approx. Viewing Distance from Site Boundary	1.8km
View description & prominence of the development	This visual receptor is located within Bowood Park, Mount Vernon which is situated 1.8km south of the site. A small number of nearby second-storey residential dwellings, may also experience a similar type of view to the baseline image in Figure 37. The park did not appear to be heavily used and there did not seem to be a clear access way other than a closed vehicular gate.
	The view was taken from the north eastern corner of the park and looks north towards elevated pastoral lands with scattered trees and bushland. The site is located centrally within the view beyond the hill on the horizon. The view is free of development except for electricity pylons.

Visual Sensitivity	Not all areas of the park experience this view, as there is the presence of mature trees along the northern and eastern boundary. However, the view does have some clear scenic value and is likely to be held in high regard by the local community. It is therefore, judged that the sensitivity of this visual receptor is high .
Magnitude of Change	The proposed development will form a barely noticeable component of the view, with only the very tops of southern warehousing seen. The view would be very similar to the baseline situation and therefore, it is judged that the magnitude of change would be very low.
Significance of Visual Impact	The significance of the visual impact at this location is judged to be minor .

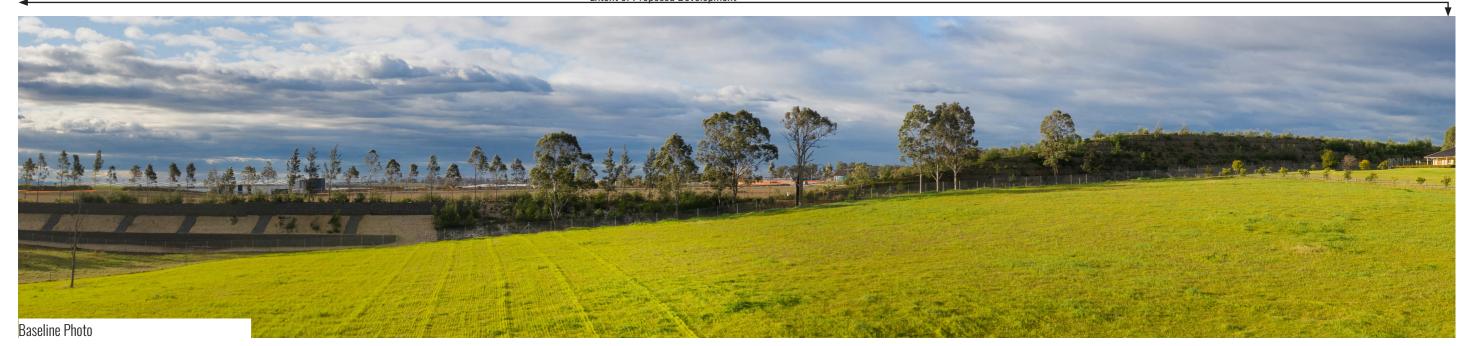
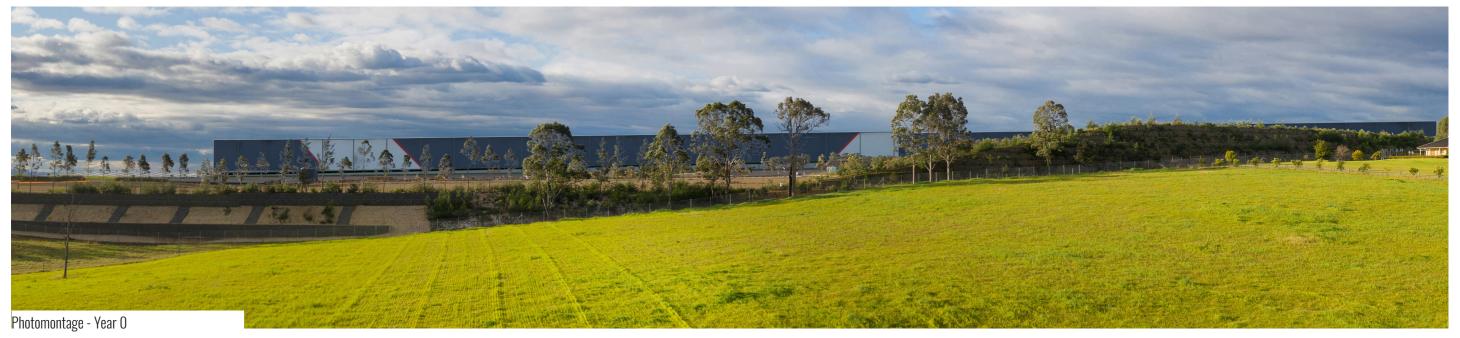
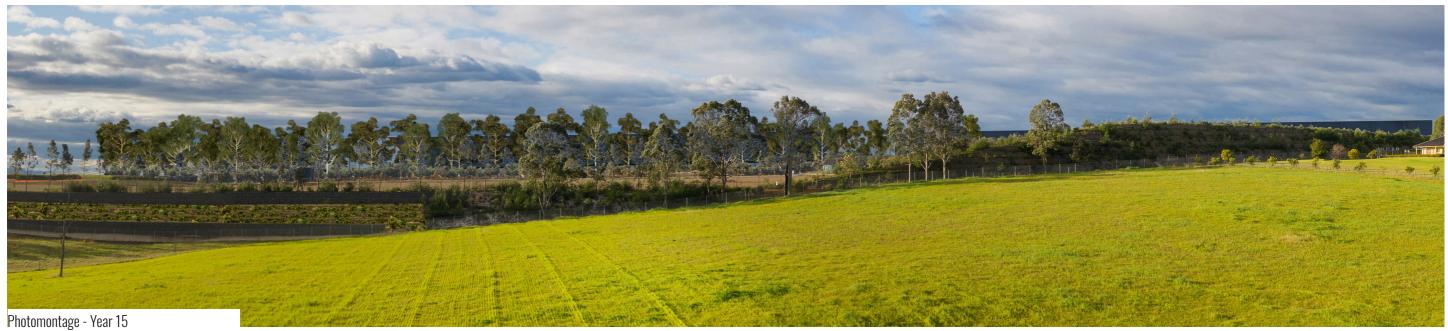
Figure 41: Viewpoint 10 - Jacfin Lands, Aldington Road, Kemps Creek - Position 1 - Looking North (Photomontage)

As can be seen in the baseline photograph, the development site is located in close proximity to the north of the Jacfin site. In the foreground, pastoral lands are seen together with the existing Terramesh bund, Gabion

walling and recently planted vegetation. In the background of the image, the site is seen with partial views of new industrial development to the north.

demonstrated by the photomontage opposite, the ESR development will be clearly noticeable in the view. However, following maturity, landscape mitigation planted along the southern site boundary should be effective

at screening the development. Therefore, it is judged that the magnitude of change would be **medium.**
