Remedial Action Plan

Huntingwood East  
Augusta Street, Blacktown NSW

8 May 2024

62742/146178 (Rev 4)  
JBS&G Australia Pty Ltd

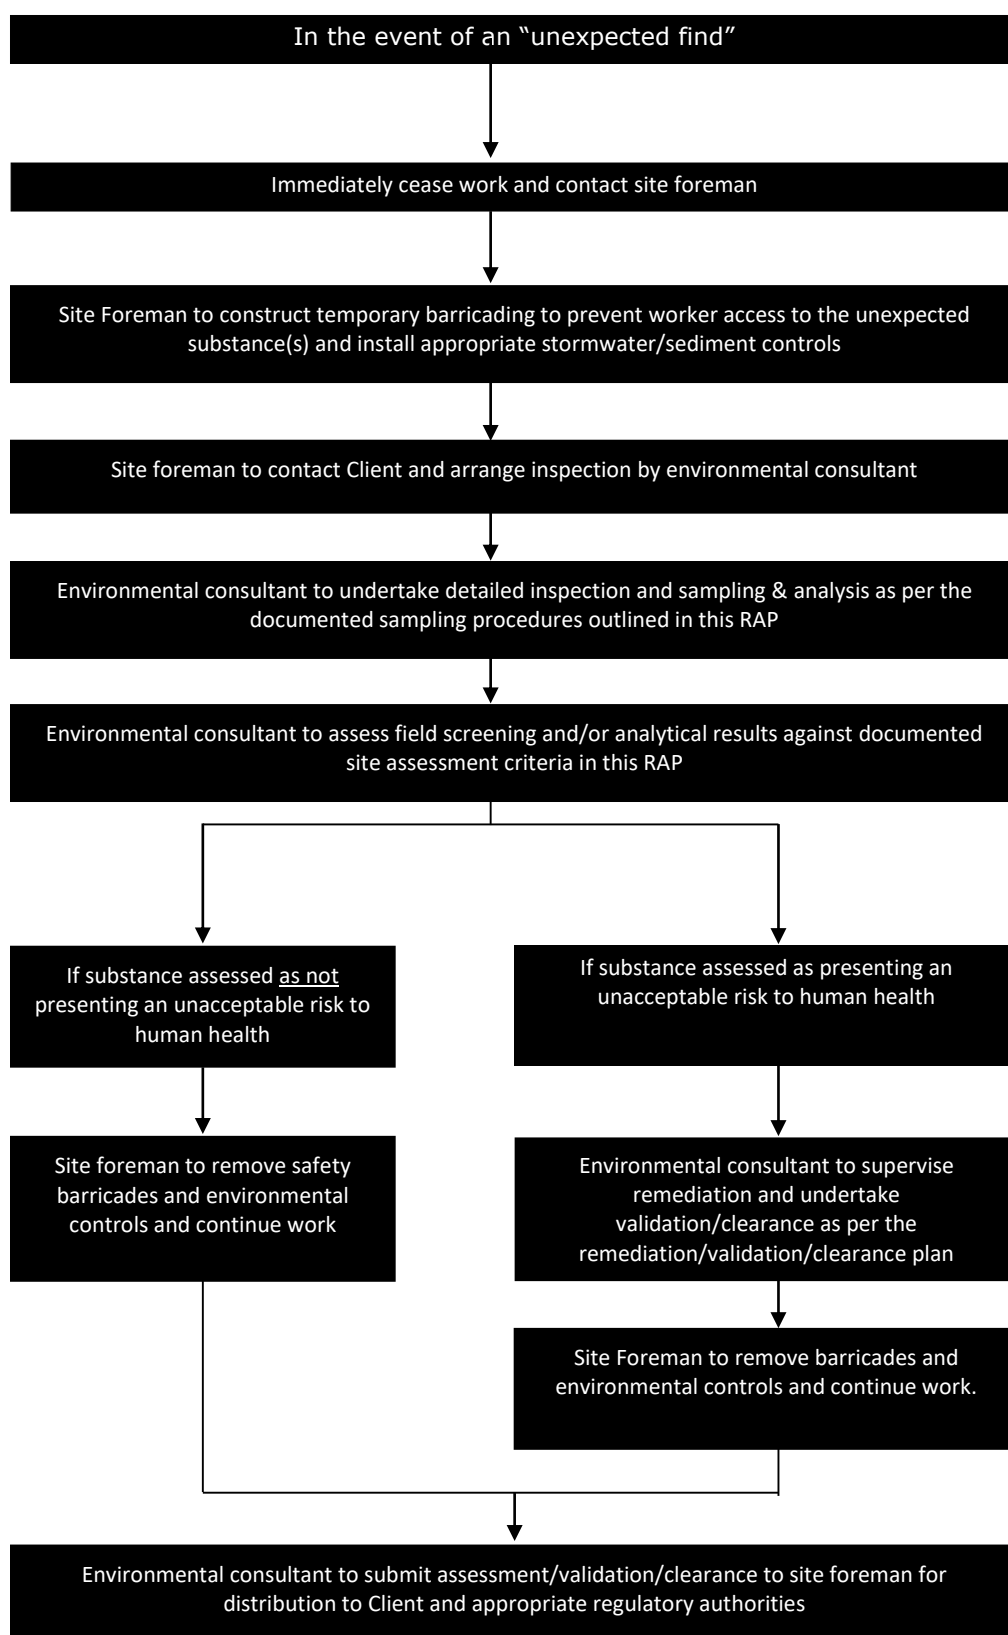
**Flowchart 8.1: Unexpected Finds Protocol**

The UFP shall be specifically implemented in response to the identification of any potential indicators of contamination within the former Telstra Exchange site as observed following demolition of site structures.

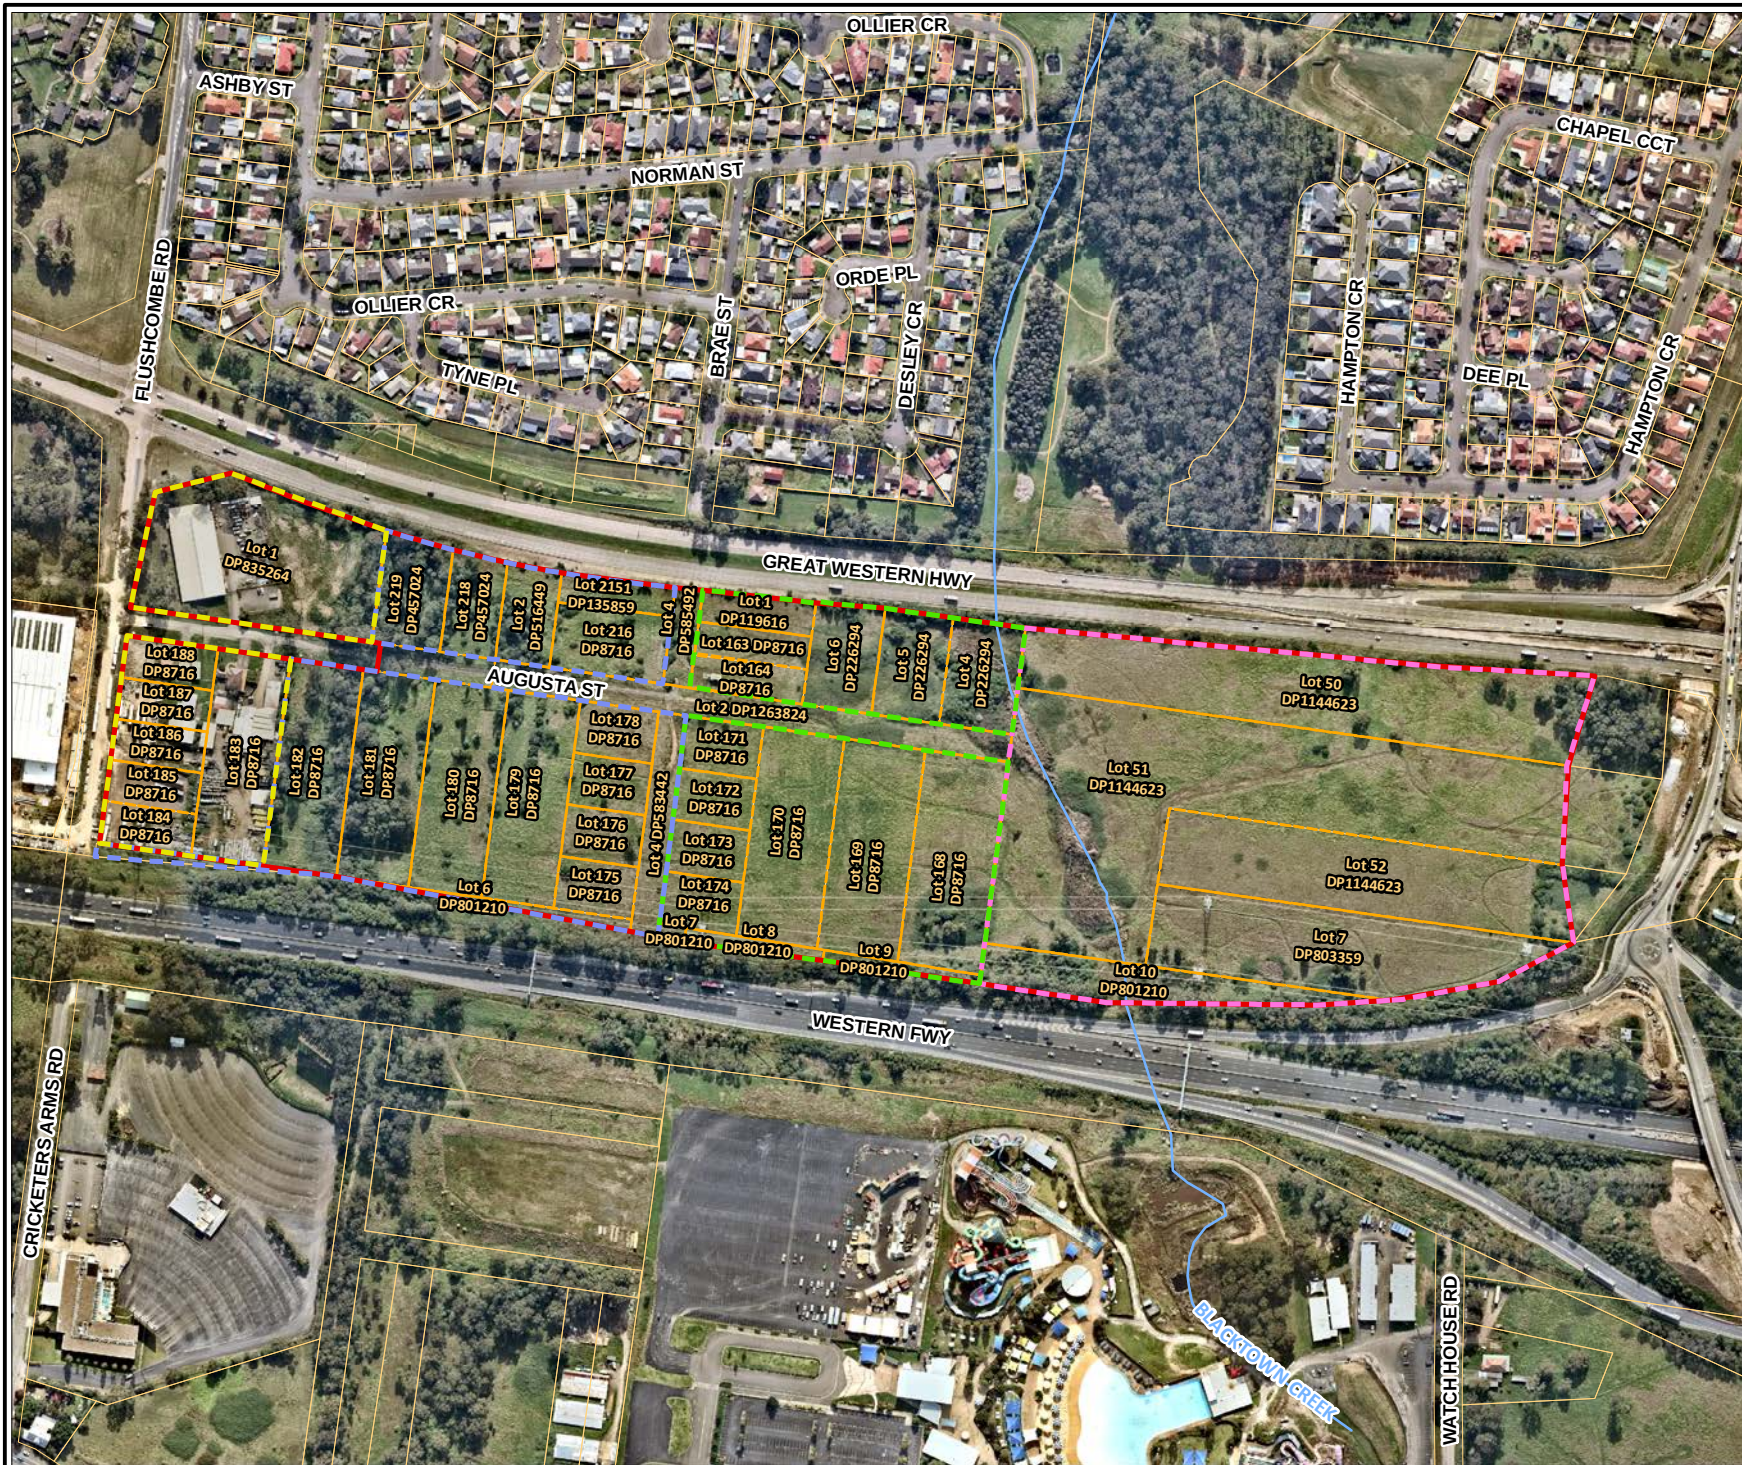
**FIGURE 2**

- Legend**
- Approximate Site Boundary
  - Lot / DP
  - NSW Cadastre (DFS1, 2021)
  - Assessment Areas**
  - Western Assessment Area
  - Central Western Assessment Area
  - Central Eastern Assessment Area
  - Eastern Assessment Area

**SITE LAYOUT**

The location of the site is shown in **Figure 1**, and the current layout is shown in **Figure 2**. The site details are summarised in **Table 2.1**.

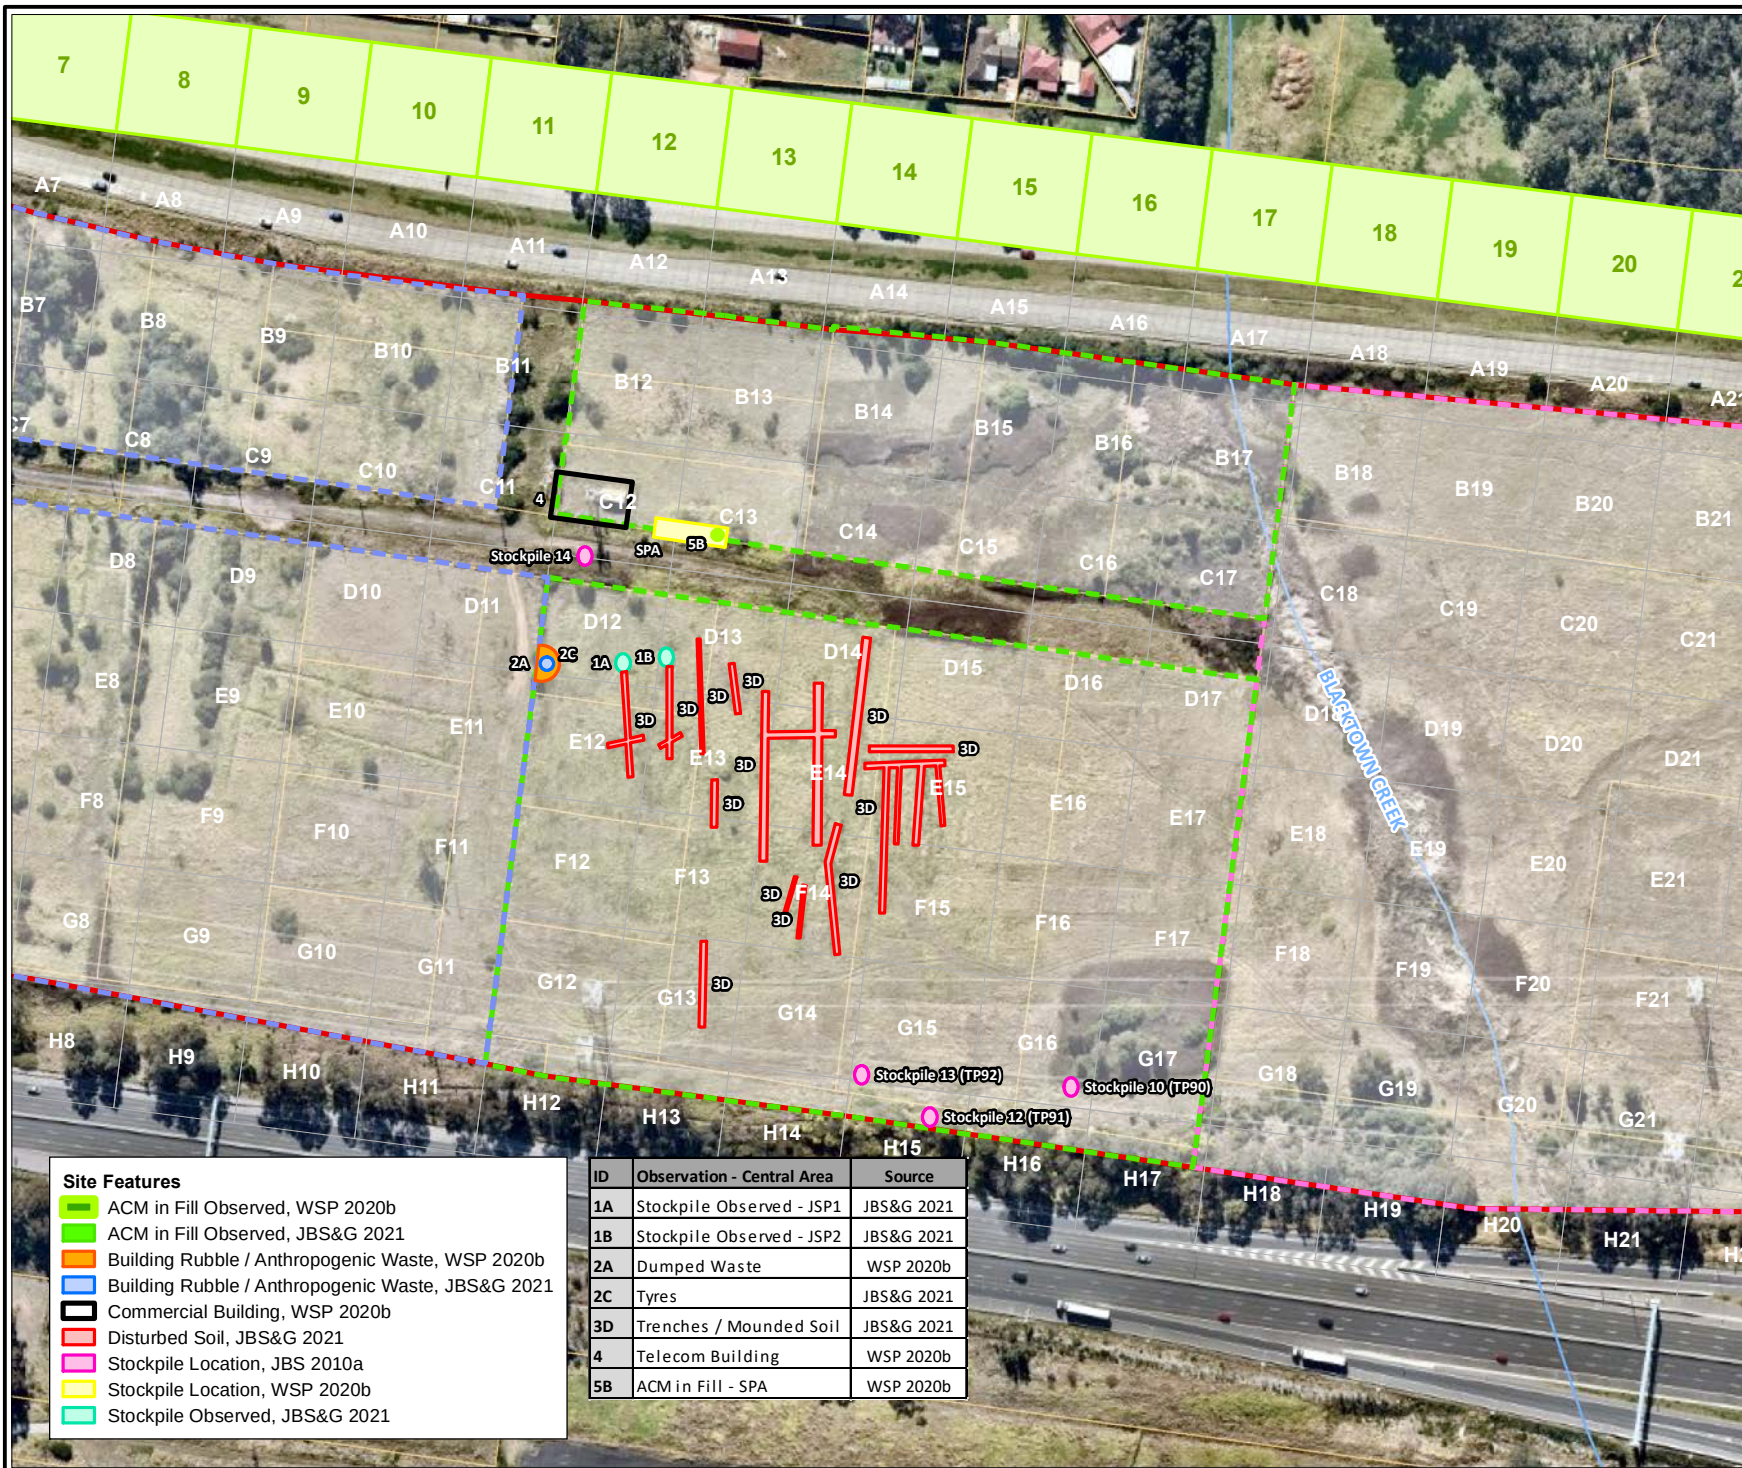
**FIGURE 4B**

The following was observed within the Eastern Central Assessment Area (See **Figure 4B**):

- A Telstra exchange within Lot 164 DP 8716.
- A stockpile of tyres, and two small stockpiles (grassed covered but assumed to be soil) were observed in the eastern portion of the area.
- Trenches were also observed in the central southern portion of the area with mounded soil adjacent to the trenches.
- Built up land was observed in the north eastern portion of the area.

**SITE INSPECTION OBSERVATIONS  
AND LOCATION OF HISTORICAL  
STOCKPILES –  
CENTRAL EASTERN  
ASSESSMENT AREA**

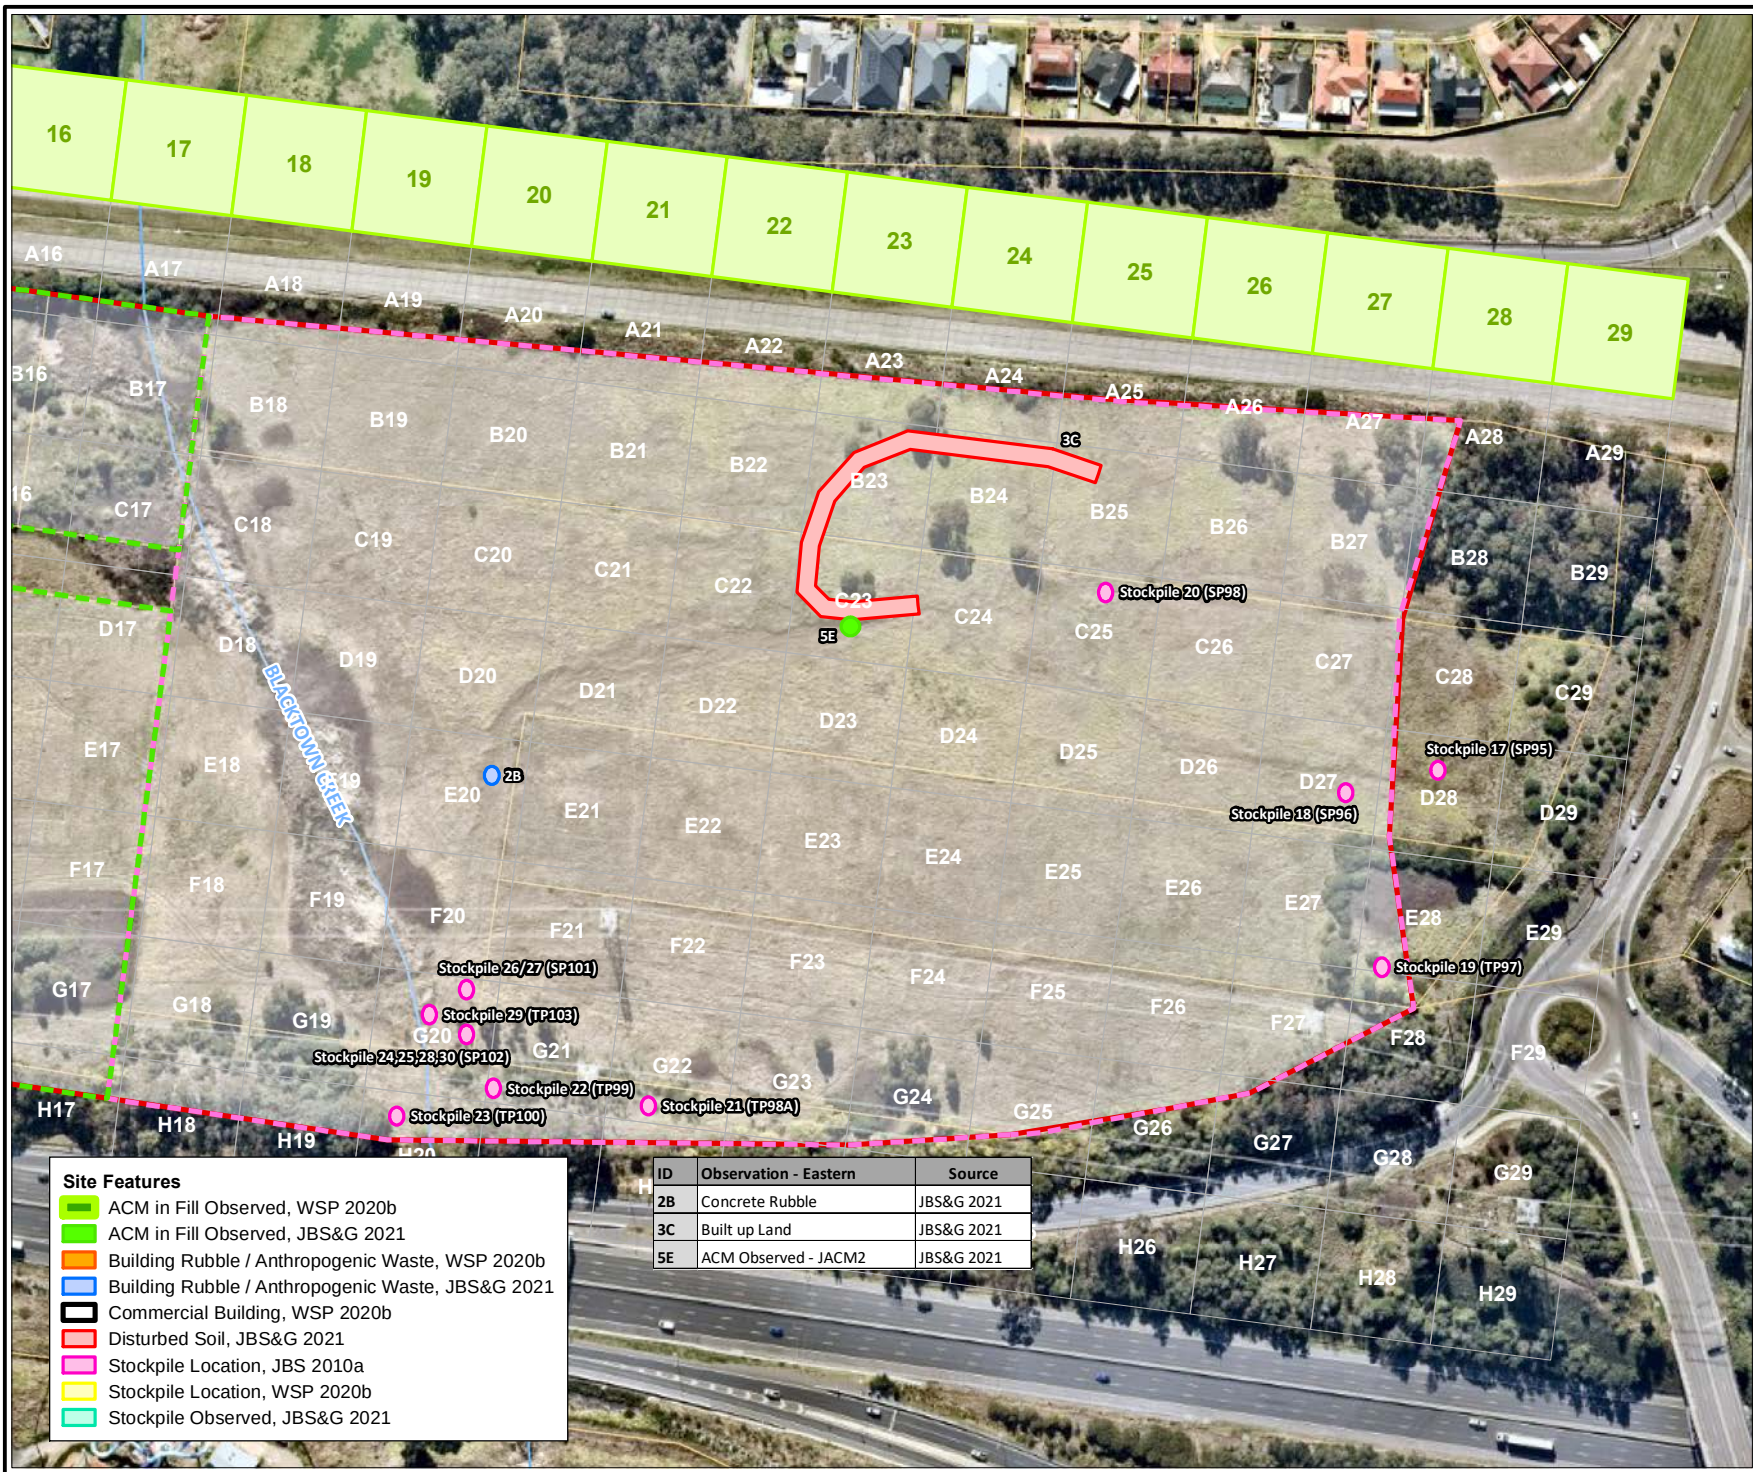
**FIGURE 4C**

The following was observed within the Eastern Assessment Area (See **Figure 4C**):

- Built up land and a small stockpile was observed in the north portion of the area.
- Two potential ACM fragments were observed on the dirt access road in the central portion of the area.
- Discarded concrete was observed adjacent to the dirt access road.

**SITE INSPECTION OBSERVATIONS  
AND LOCATION OF HISTORICAL  
STOCKPILES –  
EASTERN ASSESSMENT AREA**

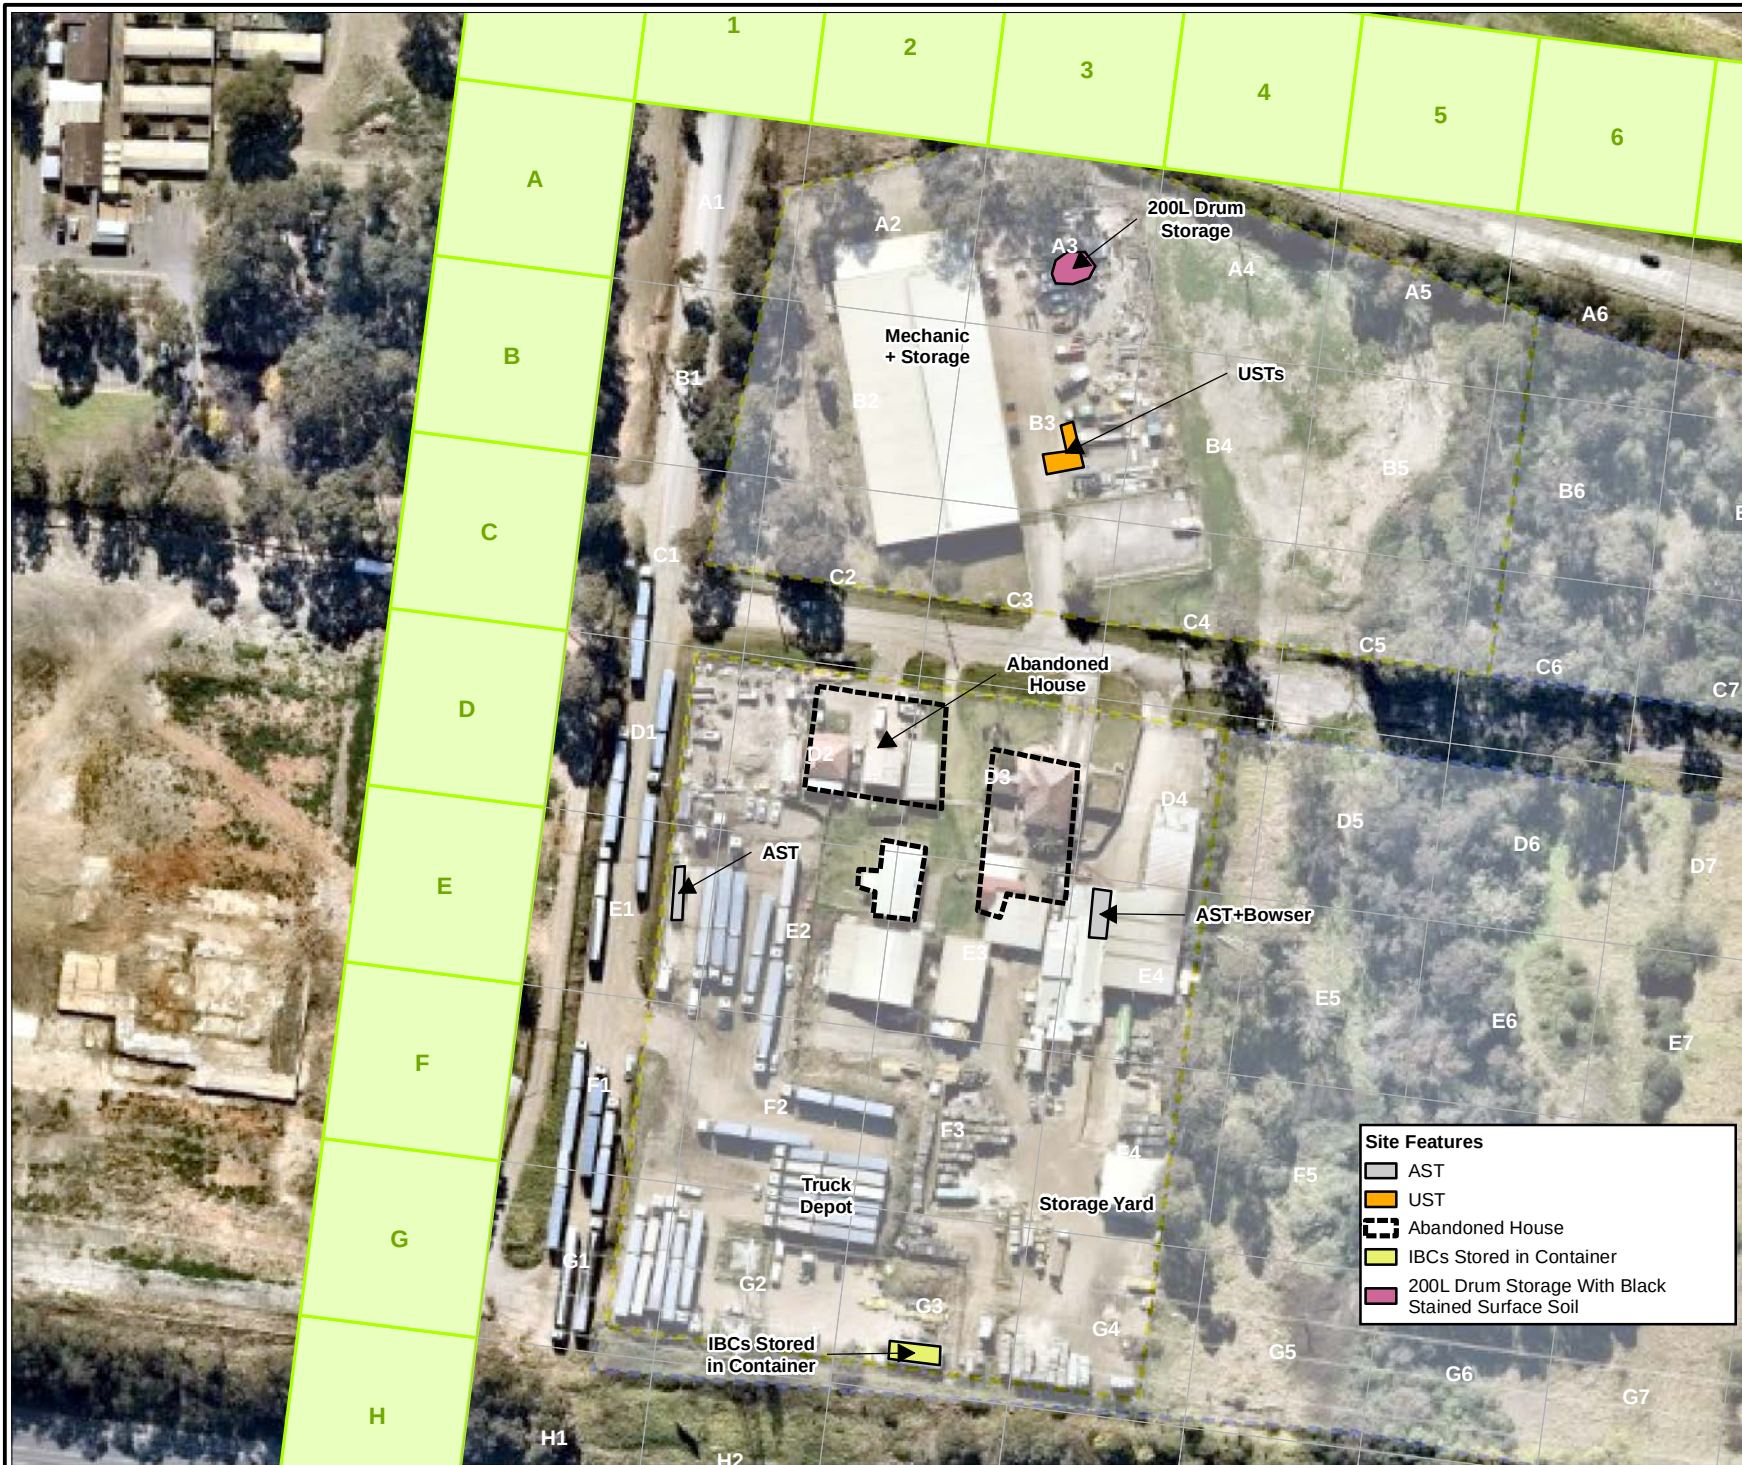
**FIGURE 4D**

The following was observed with the Western Assessment Area (See **Figure 4D**):

- An operational mechanic workshop with disused USTs, 200 L diesel storage drums, and scrap car parts. Surface staining was observed in the vicinity of the 200 L drums and leaking car parts.
- The eastern part of Lot 1 DP 835264 contains a large stockpile/mound.
- The southern part of this area contained four abandoned houses.
- An operational truck depot was present in the southwestern portion of the site. An AST with bowzers was present on the western boundary. A storage container along the southern boundary contained IBCs.
- Storage yard was present in the southeastern portion of this area. An AST and bowser was present in this portion.

- AST
- UST
- Abandoned House
- IBCs Stored in Container
- 200L Drum Storage With Black Stained Surface Soil

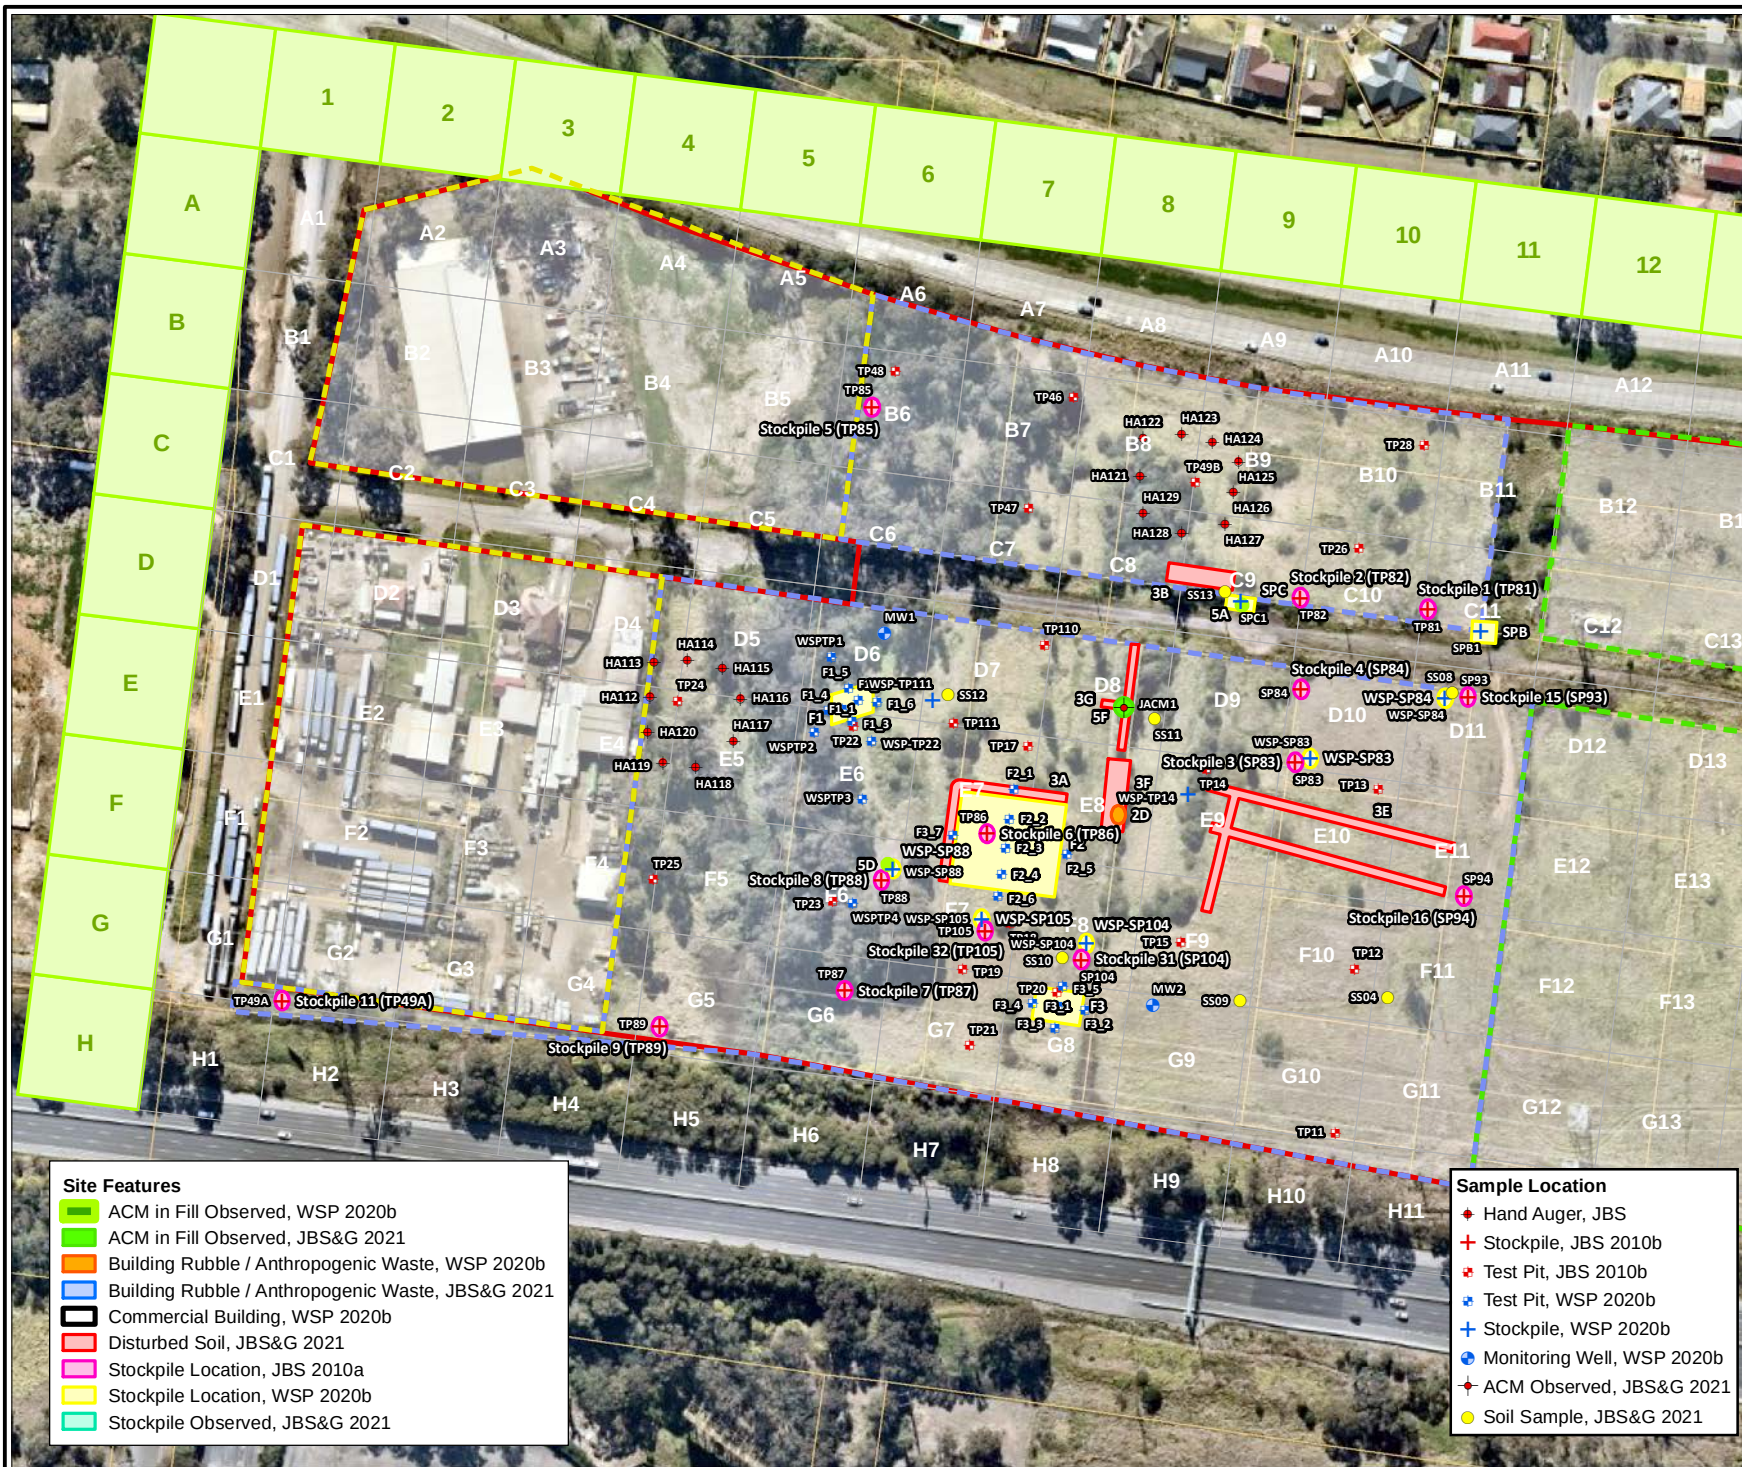
FIGURE 5A

- Hand Auger, JBS
- Stockpile, JBS 2010b
- Test Pit, JBS 2010b
- Test Pit, WSP 2020b
- Stockpile, WSP 2020b
- Monitoring Well, WSP 2020b
- ACM Observed, JBS&G 2021
- Soil Sample, JBS&G 2021

During the assessment, soil samples were collected from 131 locations, comprising 64 grid-based and 67 targeted locations. Sample locations are shown in **Figures 5A, 5B and 5C** and analytical tables against the updated site assessment criteria are provided as **Appendix A**. It is noted JBS refers to sample / stockpile locations with the prefix SP and / or TP interchangeably in some cases. In this assessment we have adopted a convention of using the prefixes used in the sample IDs as shown in **Table C, Appendix A**.

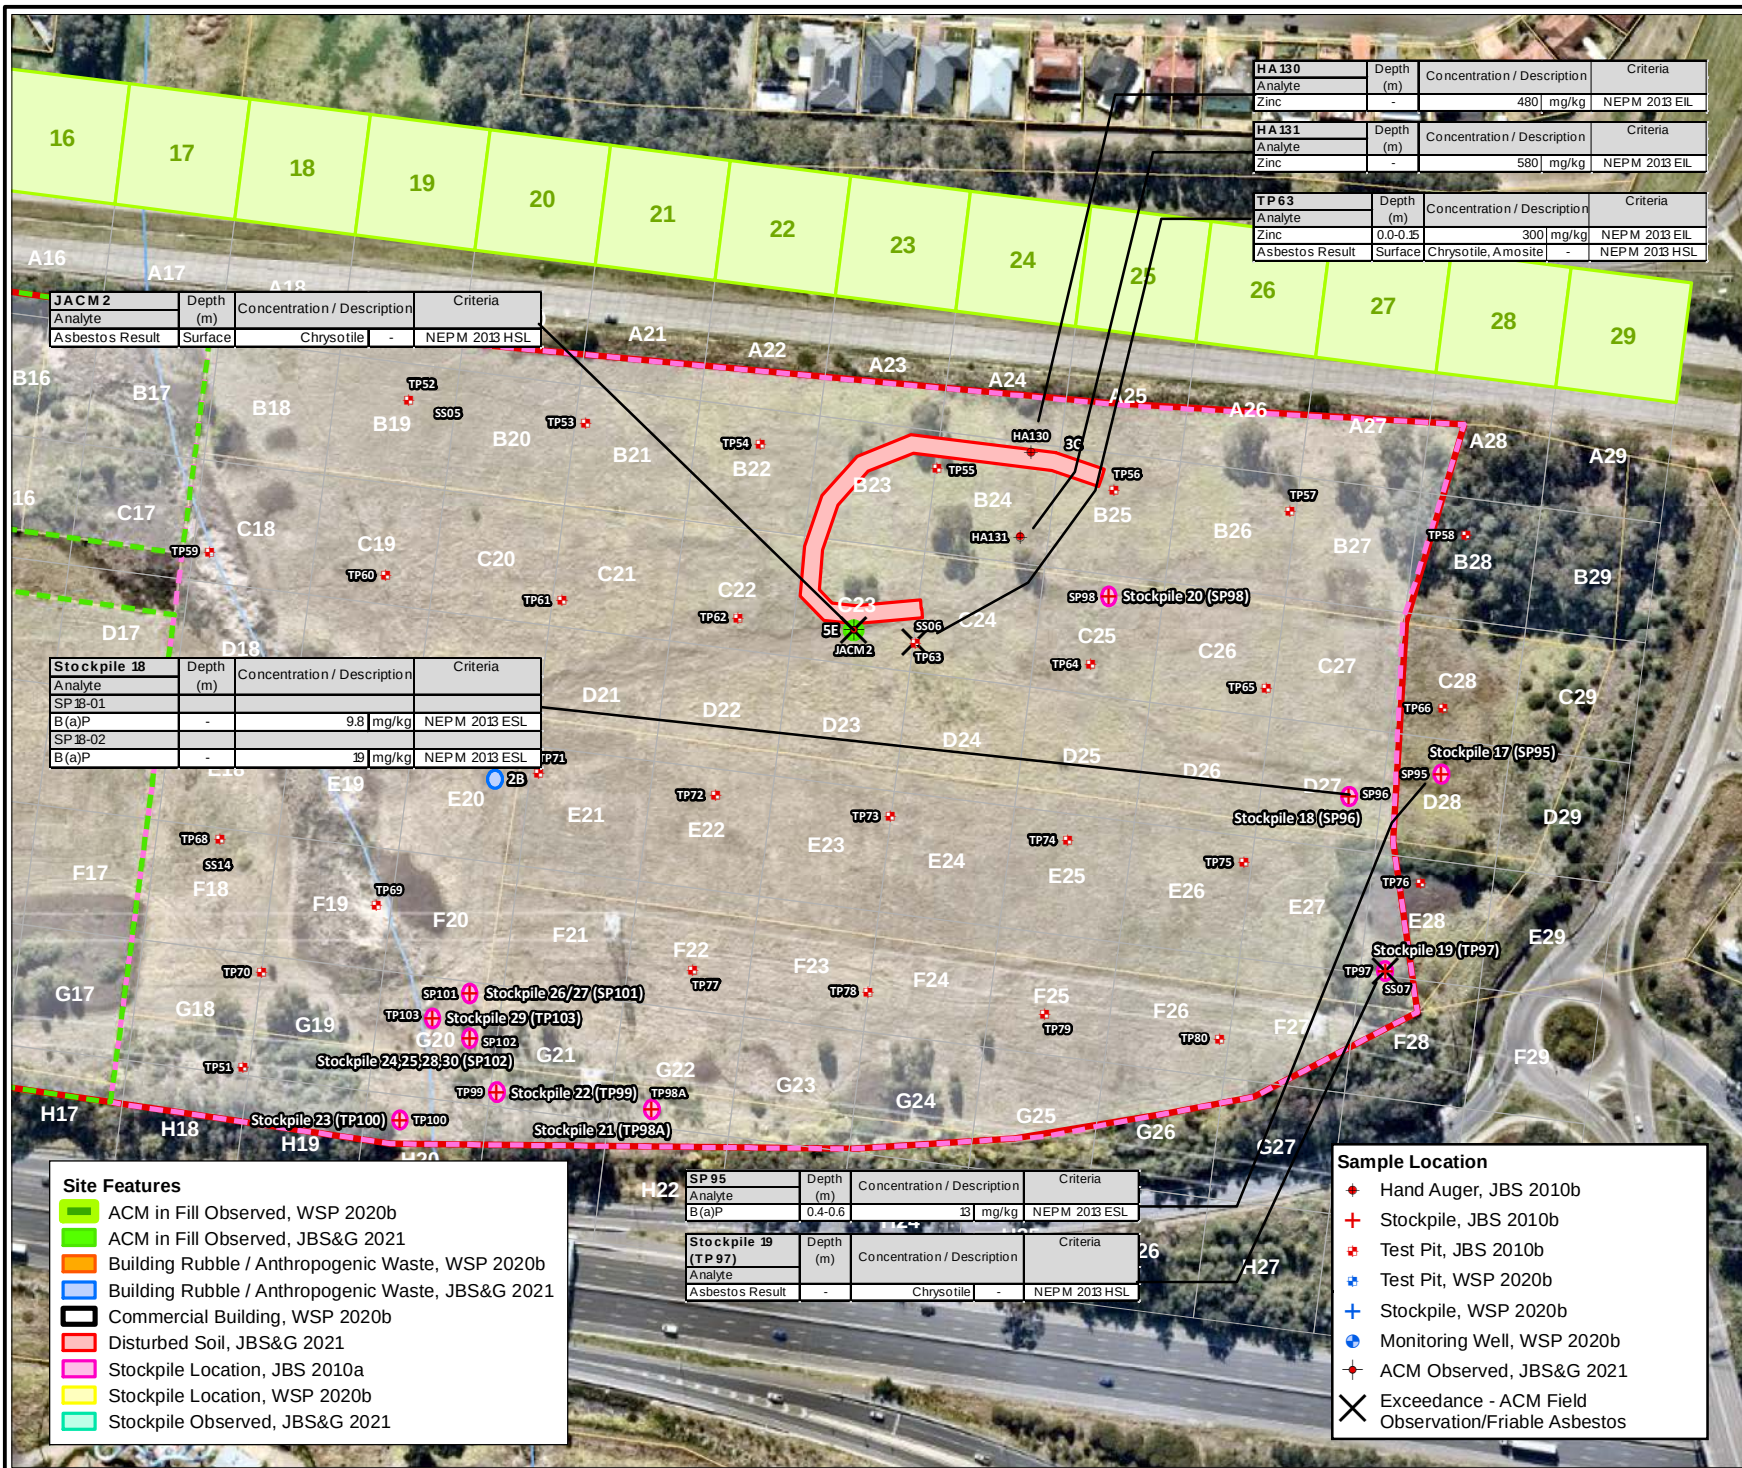
**FIGURE 6C**

**SOIL EXCEEDANCES -  
EASTERN ASSESSMENT AREA**

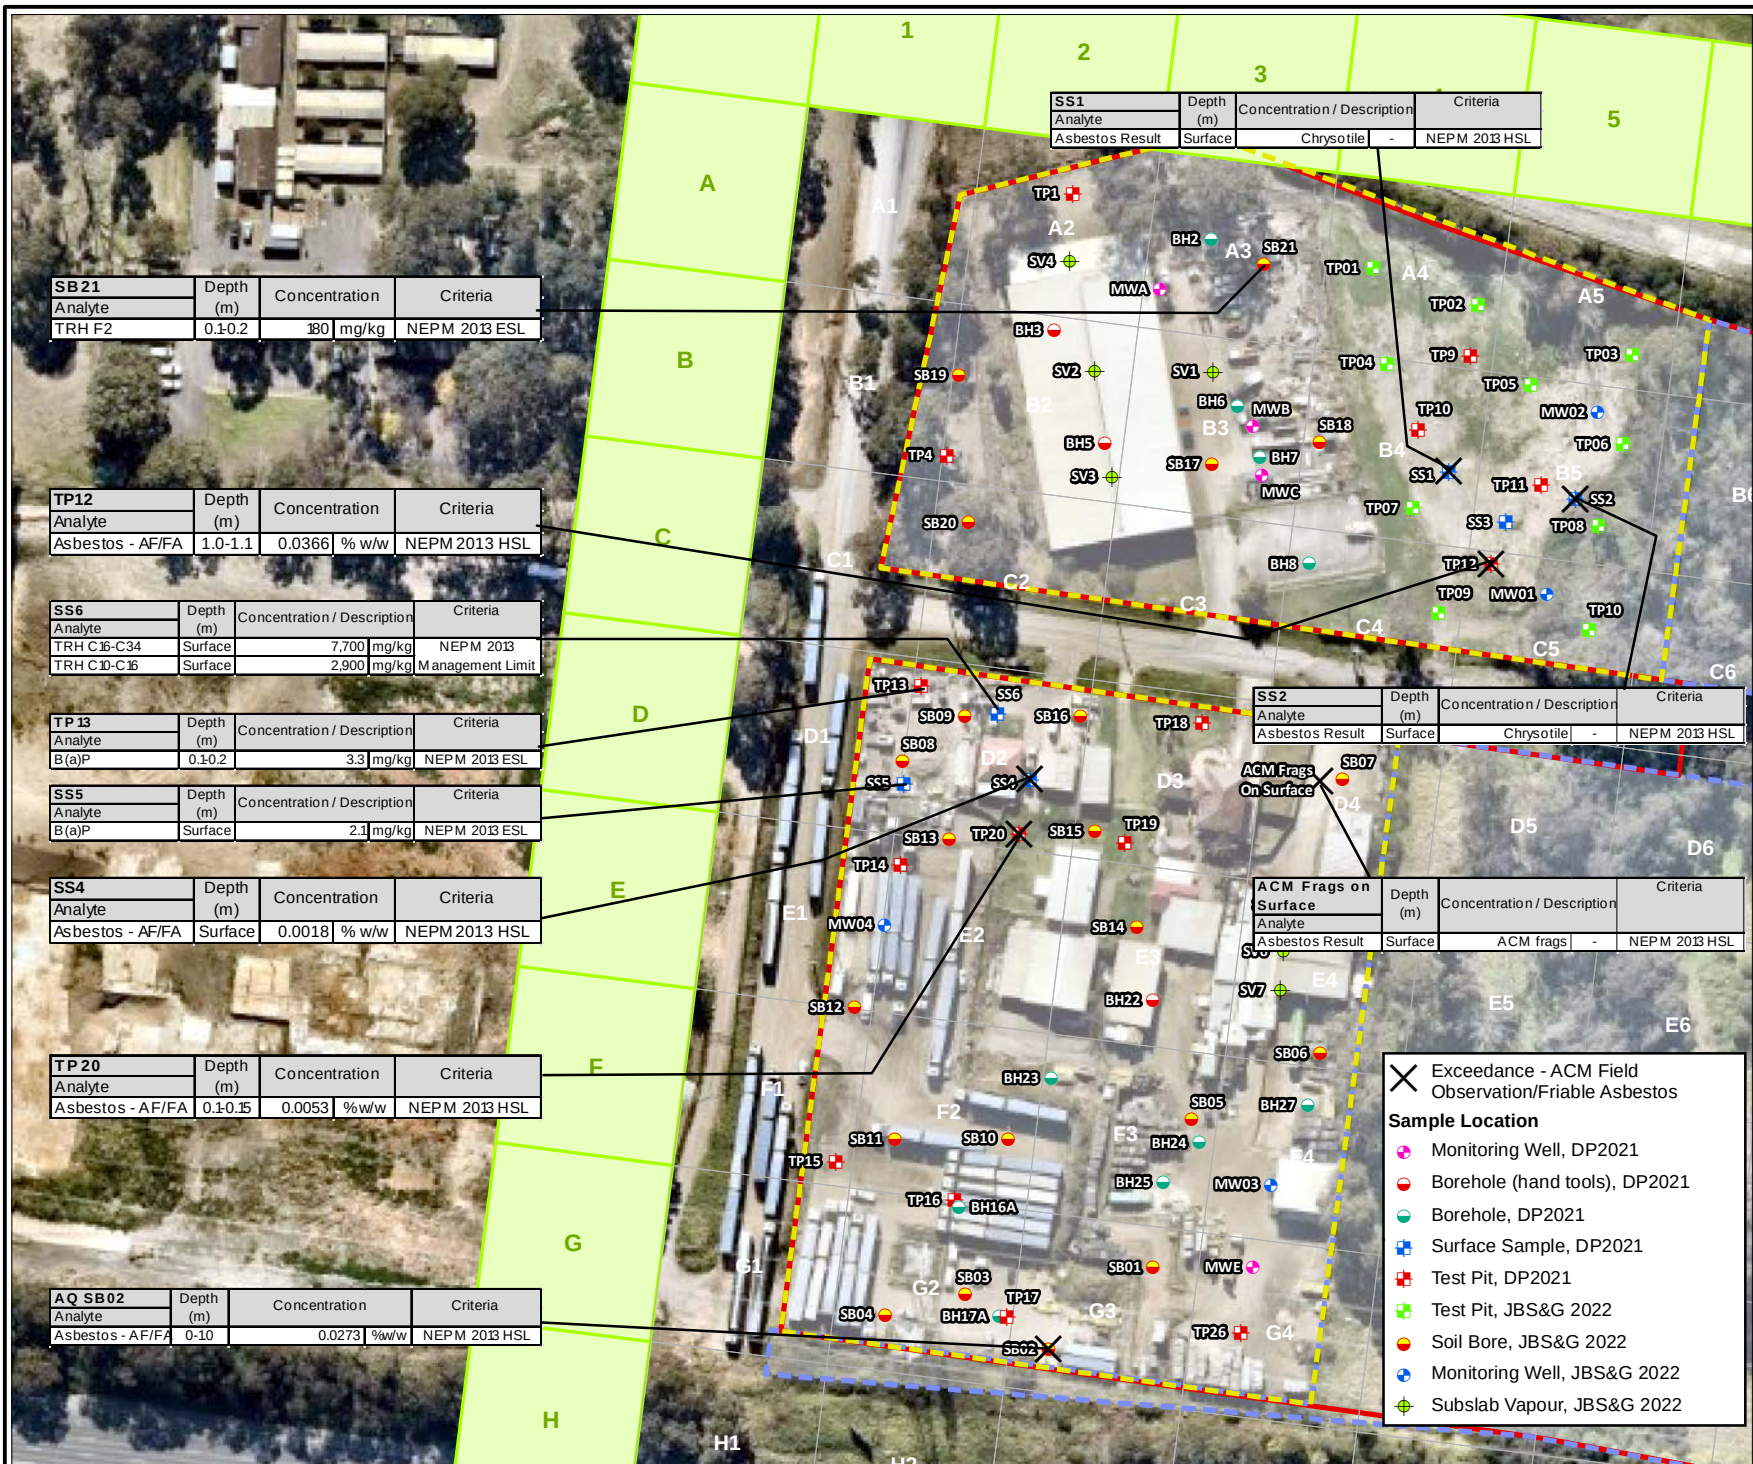
**FIGURE 6D**

- TRH C10-C16 (2,900 mg/kg) and TRH C16-C34 (7,700 mg/kg) at surface sample location SS6 exceeds management limits (1,000 mg/kg and 3,500 mg/kg, respectively). TRH F2 (180 mg/kg) at surface sample SB21-0.1-0.2 exceeds ecological criteria (180 mg/kg) and is located within stained and odorous soils in the vicinity of 200L drums.

**SOIL EXCEEDANCES -  
WESTERN ASSESSMENT AREA**

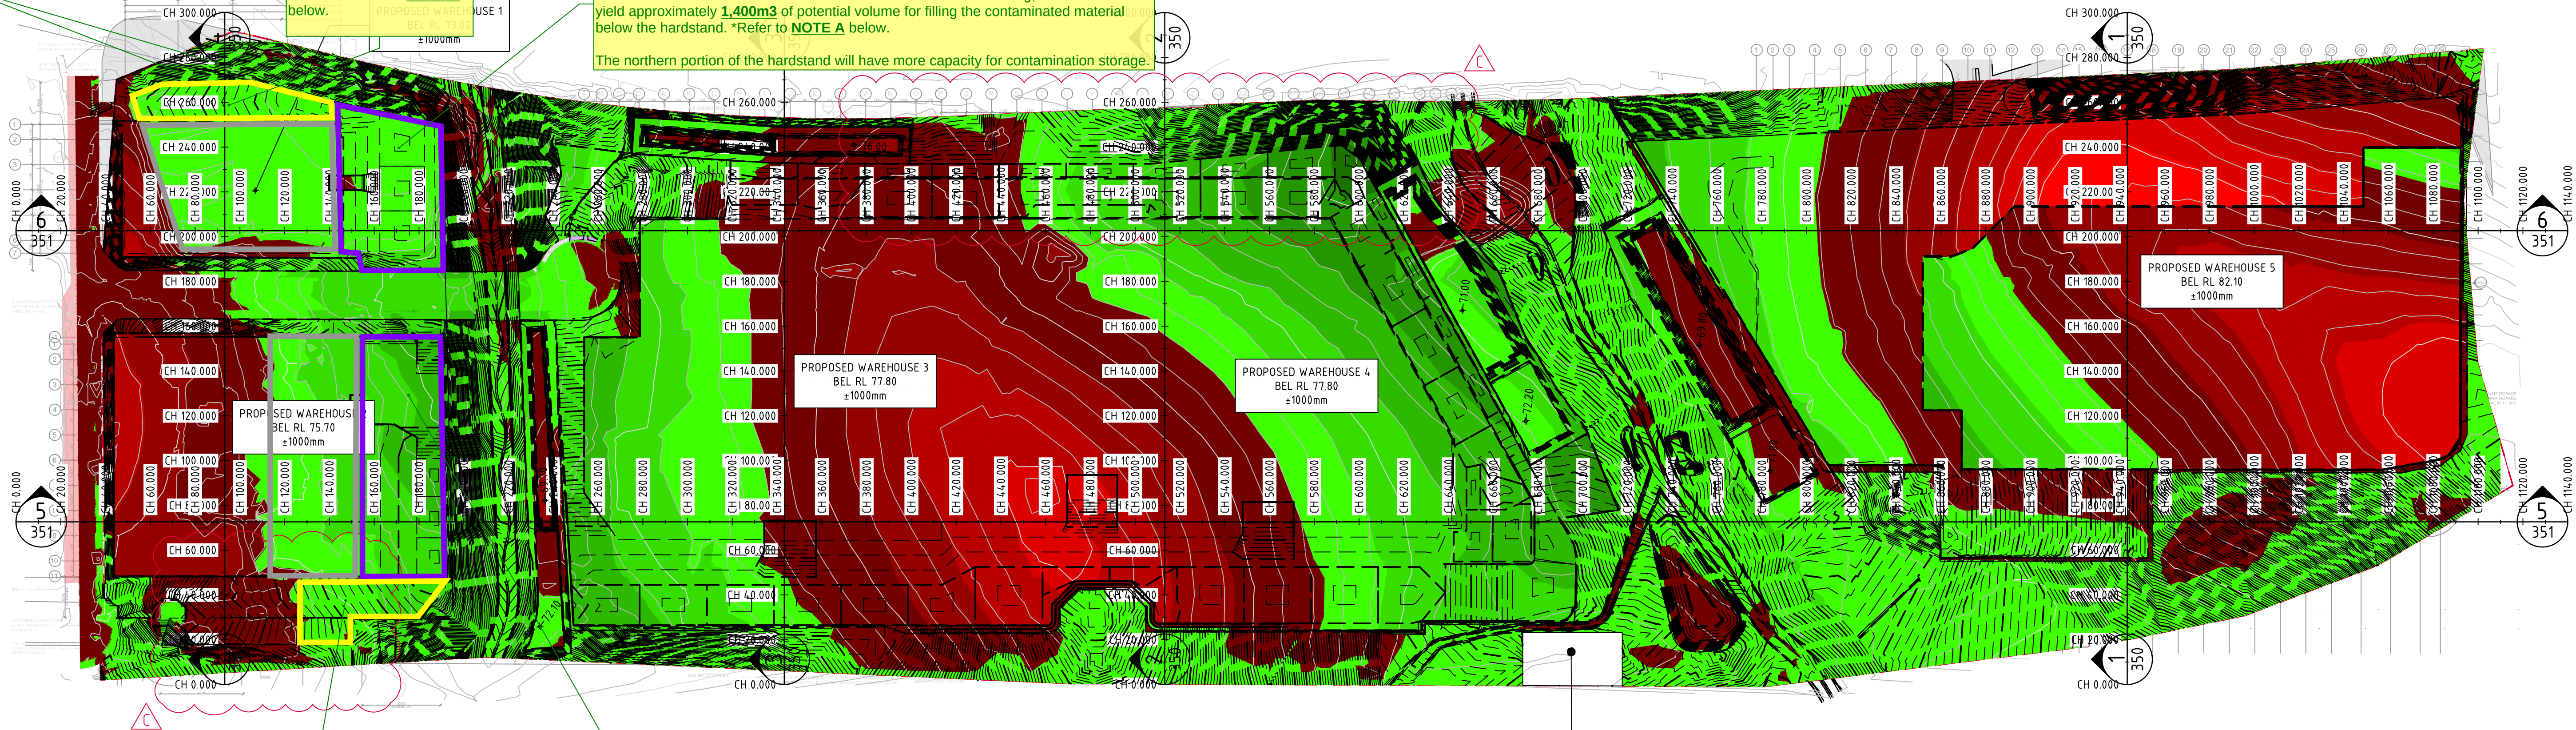
Assessed the feasibility of capping the contaminated material beneath the hardstand. Allowing for a 500mm cap over the contaminated material, and excluding the OSD tank's volume of approximately 1,200m3, spoil for services @ 1500m3/ha and starting the fill of the contaminated material at least 1V:1H from the face of the building, would area yield approximately **8,000m3** of potential volume for filling the contaminated material below the hardstand. \*Refer to **NOTE A** below.
