Remedial Action Plan

Huntingwood East  
Augusta Street, Blacktown NSW

8 May 2024

62742/146178 (Rev 4)  
JBS&G Australia Pty Ltd

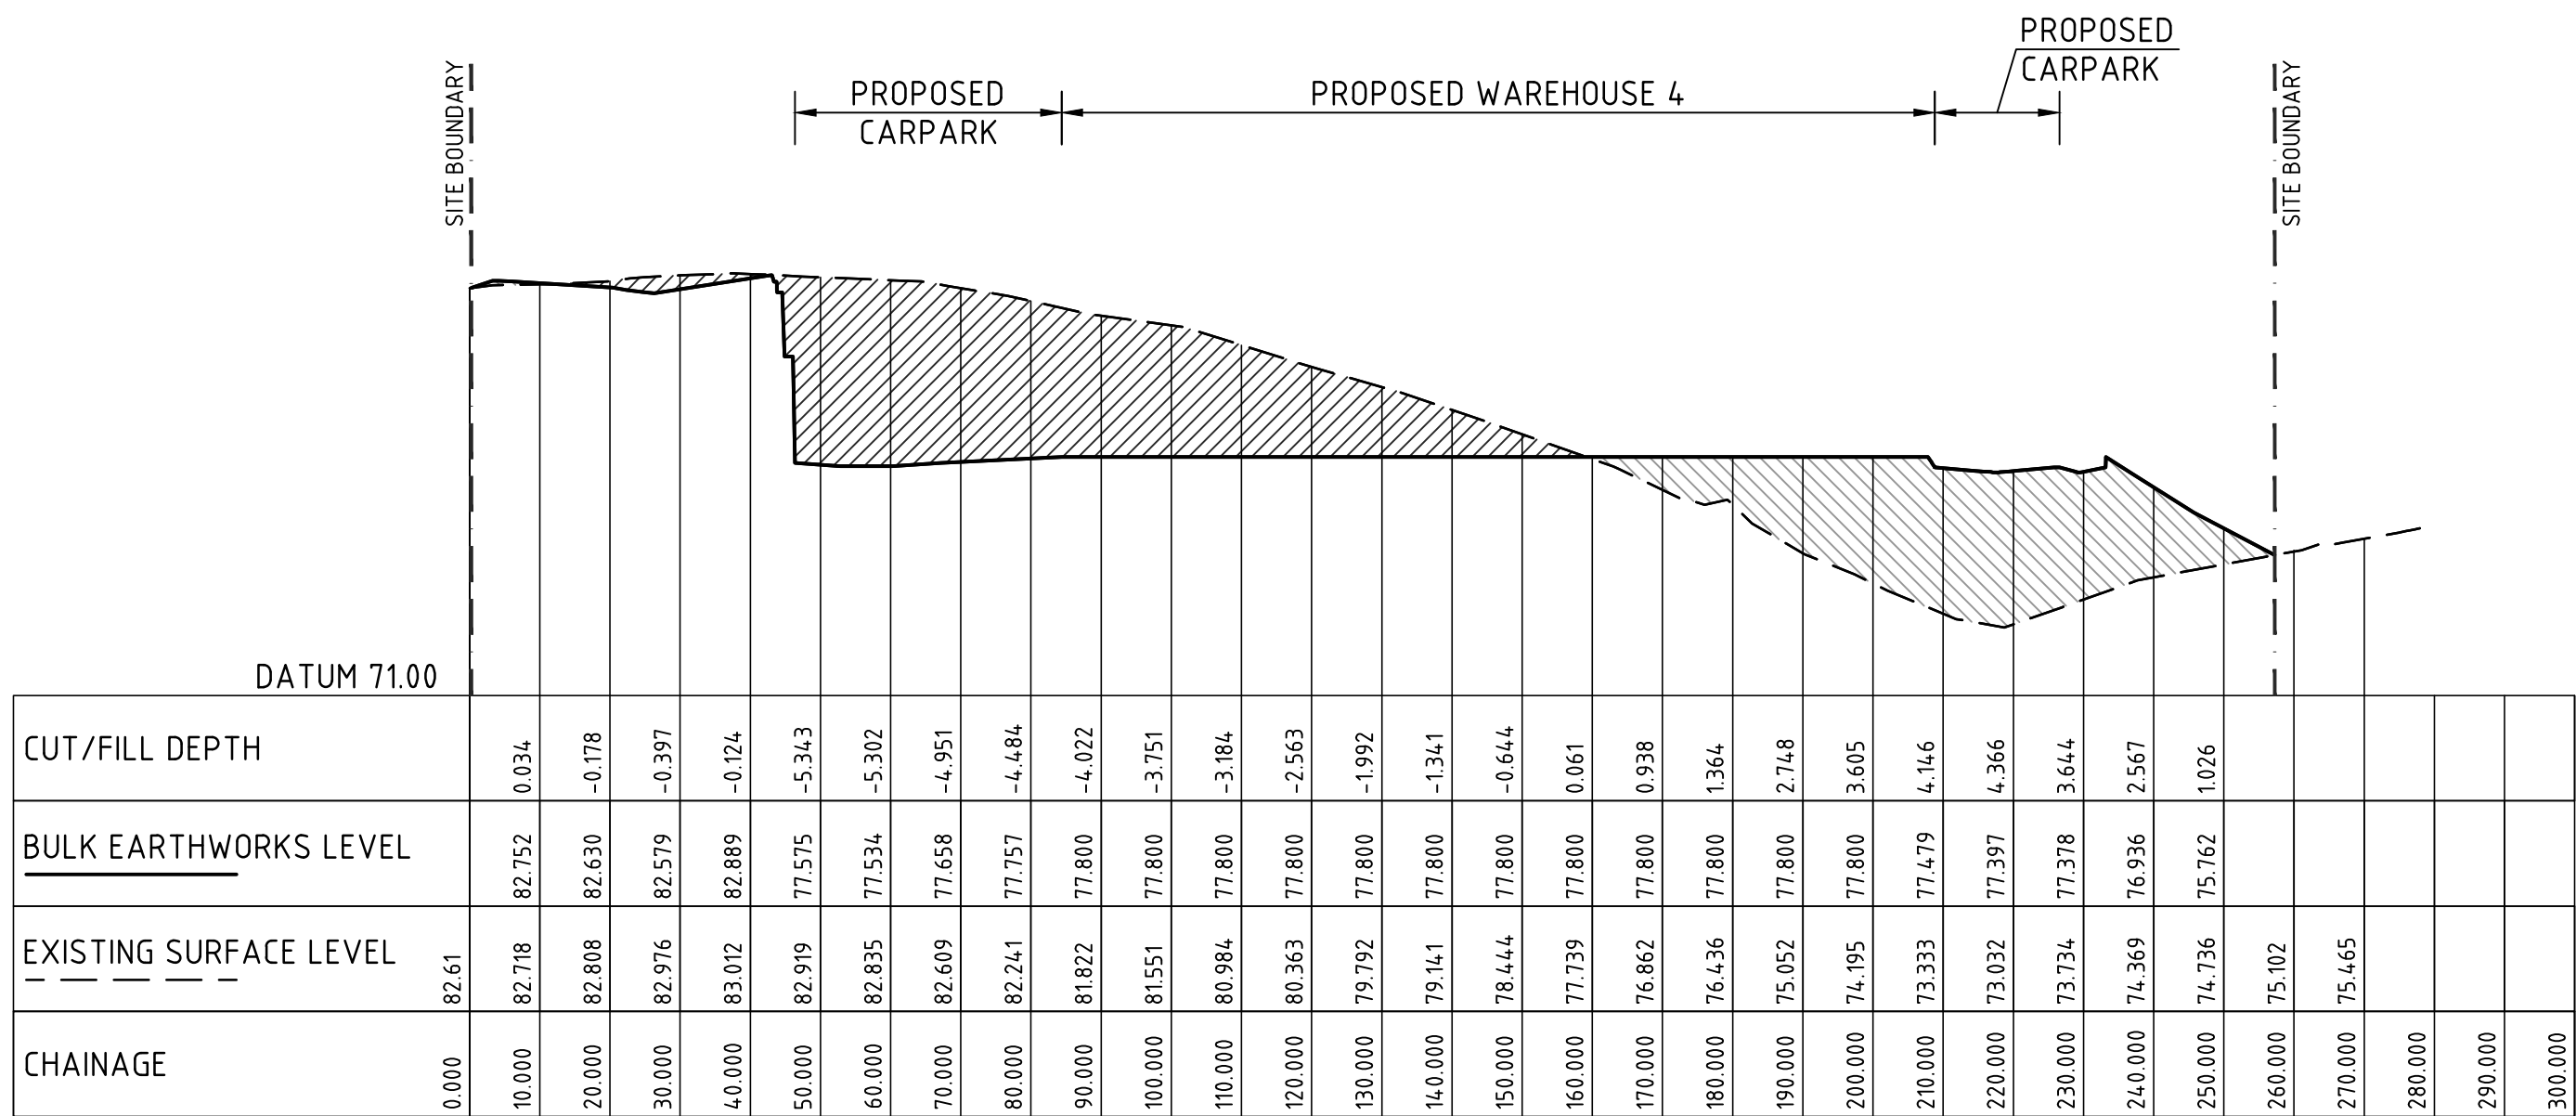
SECTION 2  
HORIZONTAL SCALE 1:1000  
VERTICAL SCALE 1:200

The geotechnical engineer to verify the suitability of the contaminated material for foundation (bearing capacity), provide insights into the long- and short-term modulus (E value) of the soil, -CBR value, guidance on shrinkage and swelling, identification of material type, and related recommendations.

Impacted fill will be managed to the extent achievable via containment and the implementation of permanent physical separation which eliminates the inhalation exposure pathway for airborne asbestos fibres

The materials to be contained onsite under a marker and capping layer (that comprises 0.5 m of clean capping material and/or hardstand);

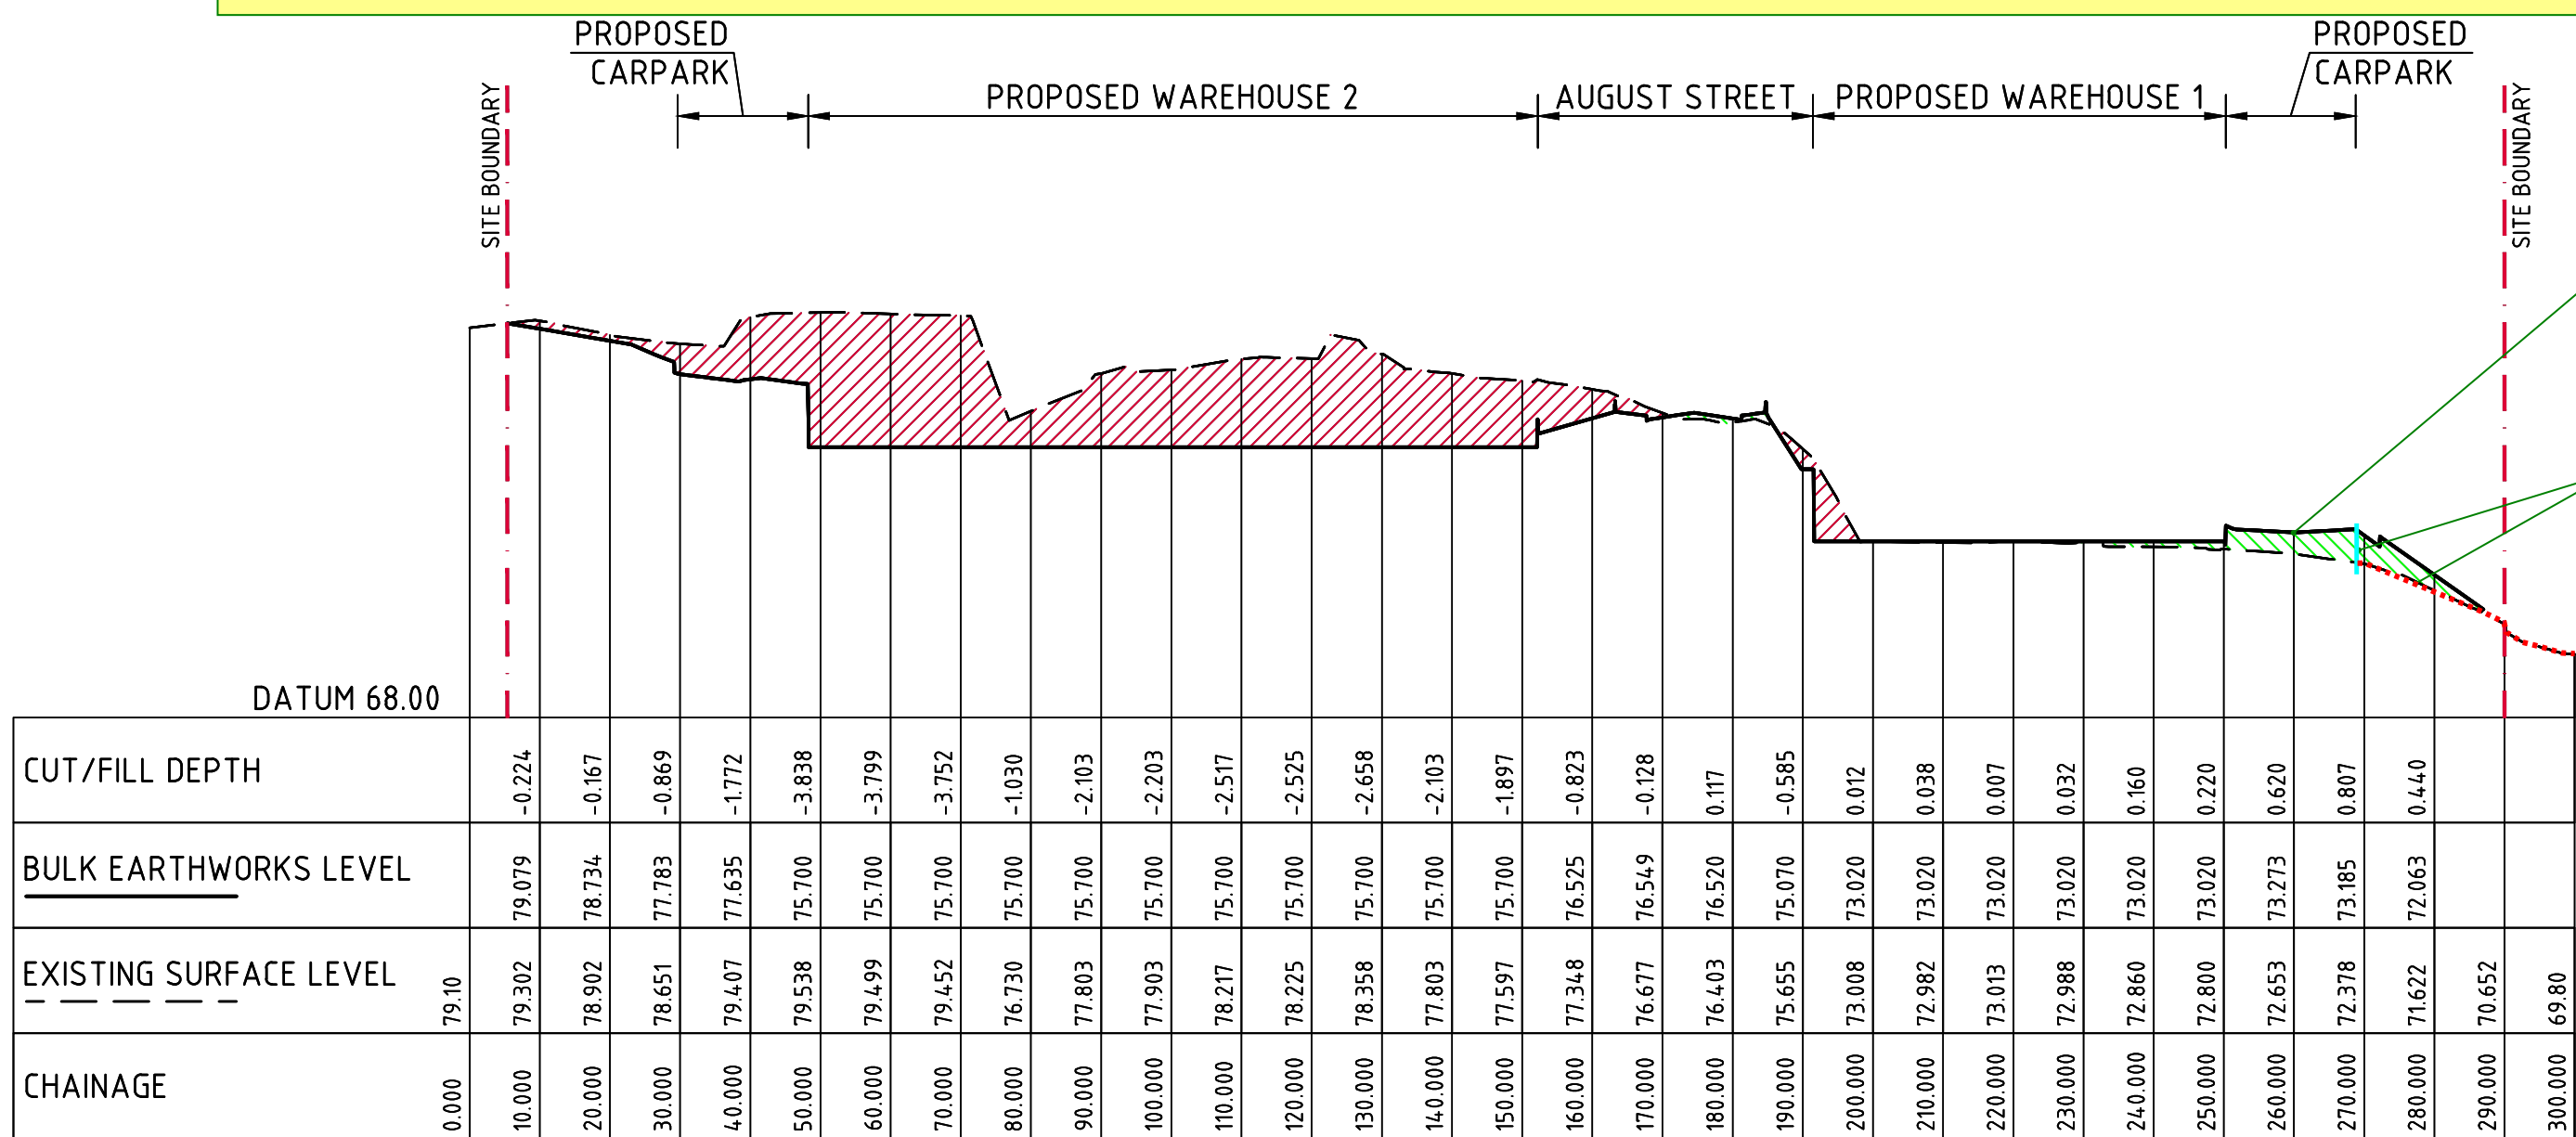
SECTION 4  
HORIZONTAL SCALE 1:1000  
VERTICAL SCALE 1:200

Some opportunity to utilise the fill below the carpark for capping of contaminated material

Recent request from client to keep existing levels outside car park to retain trees, no opportunity for capping
