Remedial Action Plan

Huntingwood East  
Augusta Street, Blacktown NSW

22 August 2023

62742/146178 (Rev 1)

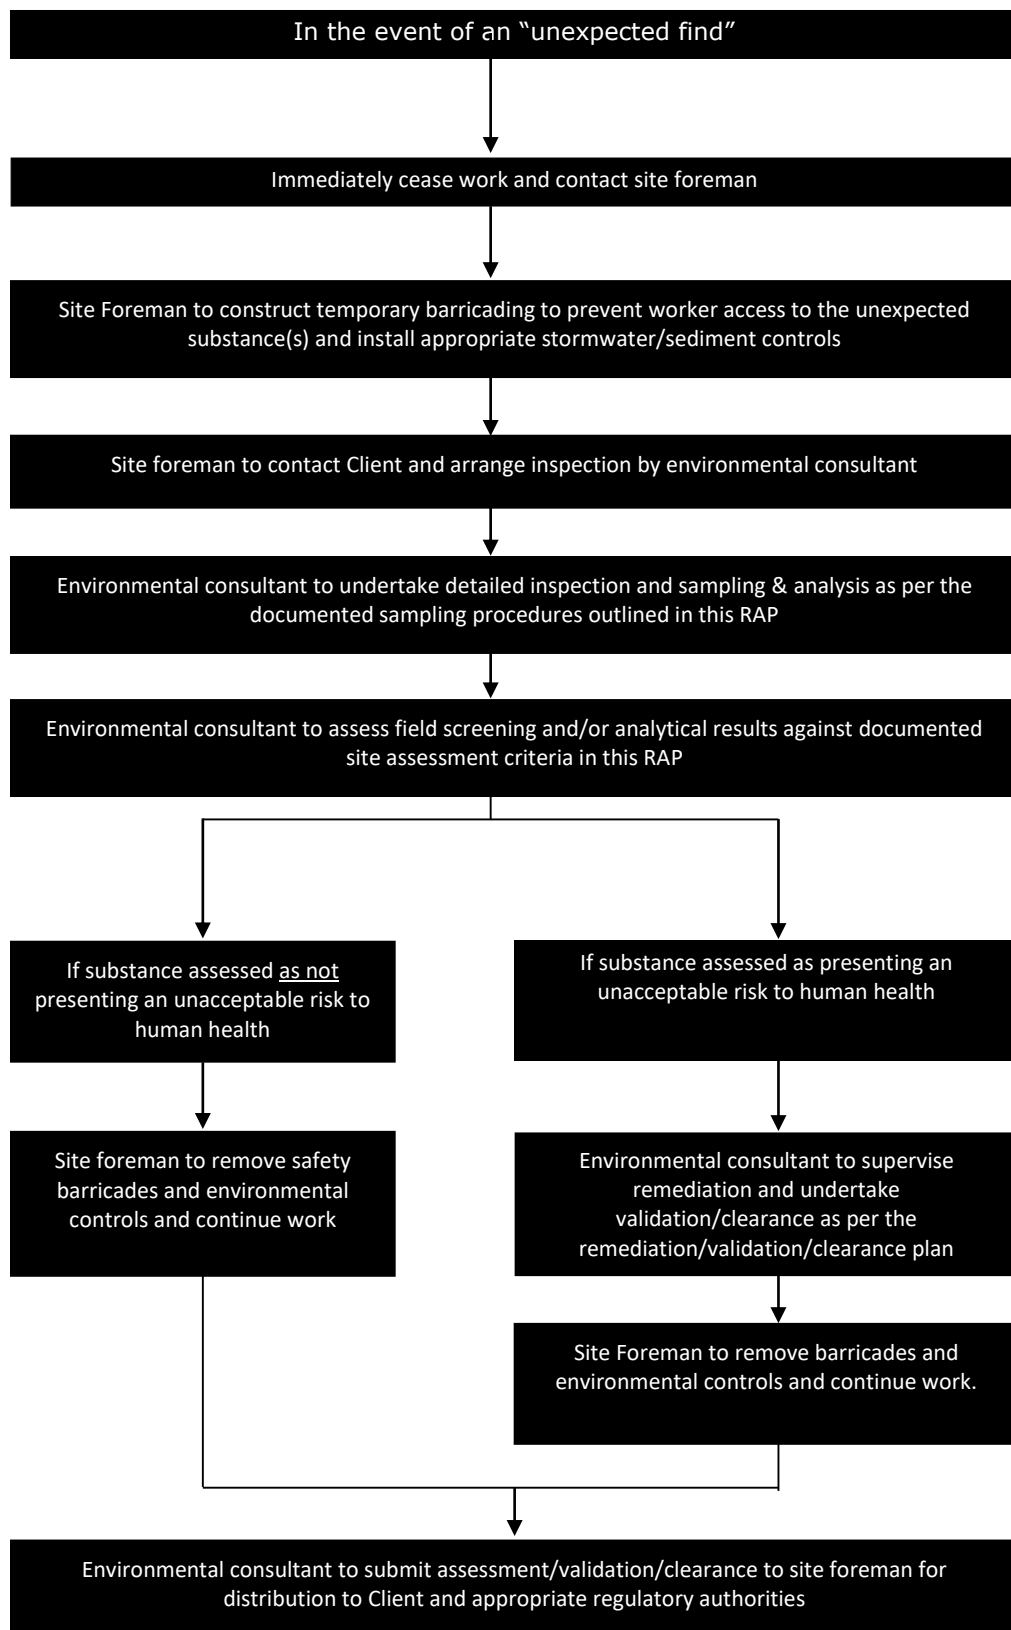
**Flowchart 8.1: Unexpected Finds Protocol**

The UFP shall be specifically implemented in response to the identification of any potential indicators of contamination within the former Telstra Exchange site as observed following demolition of site structures.

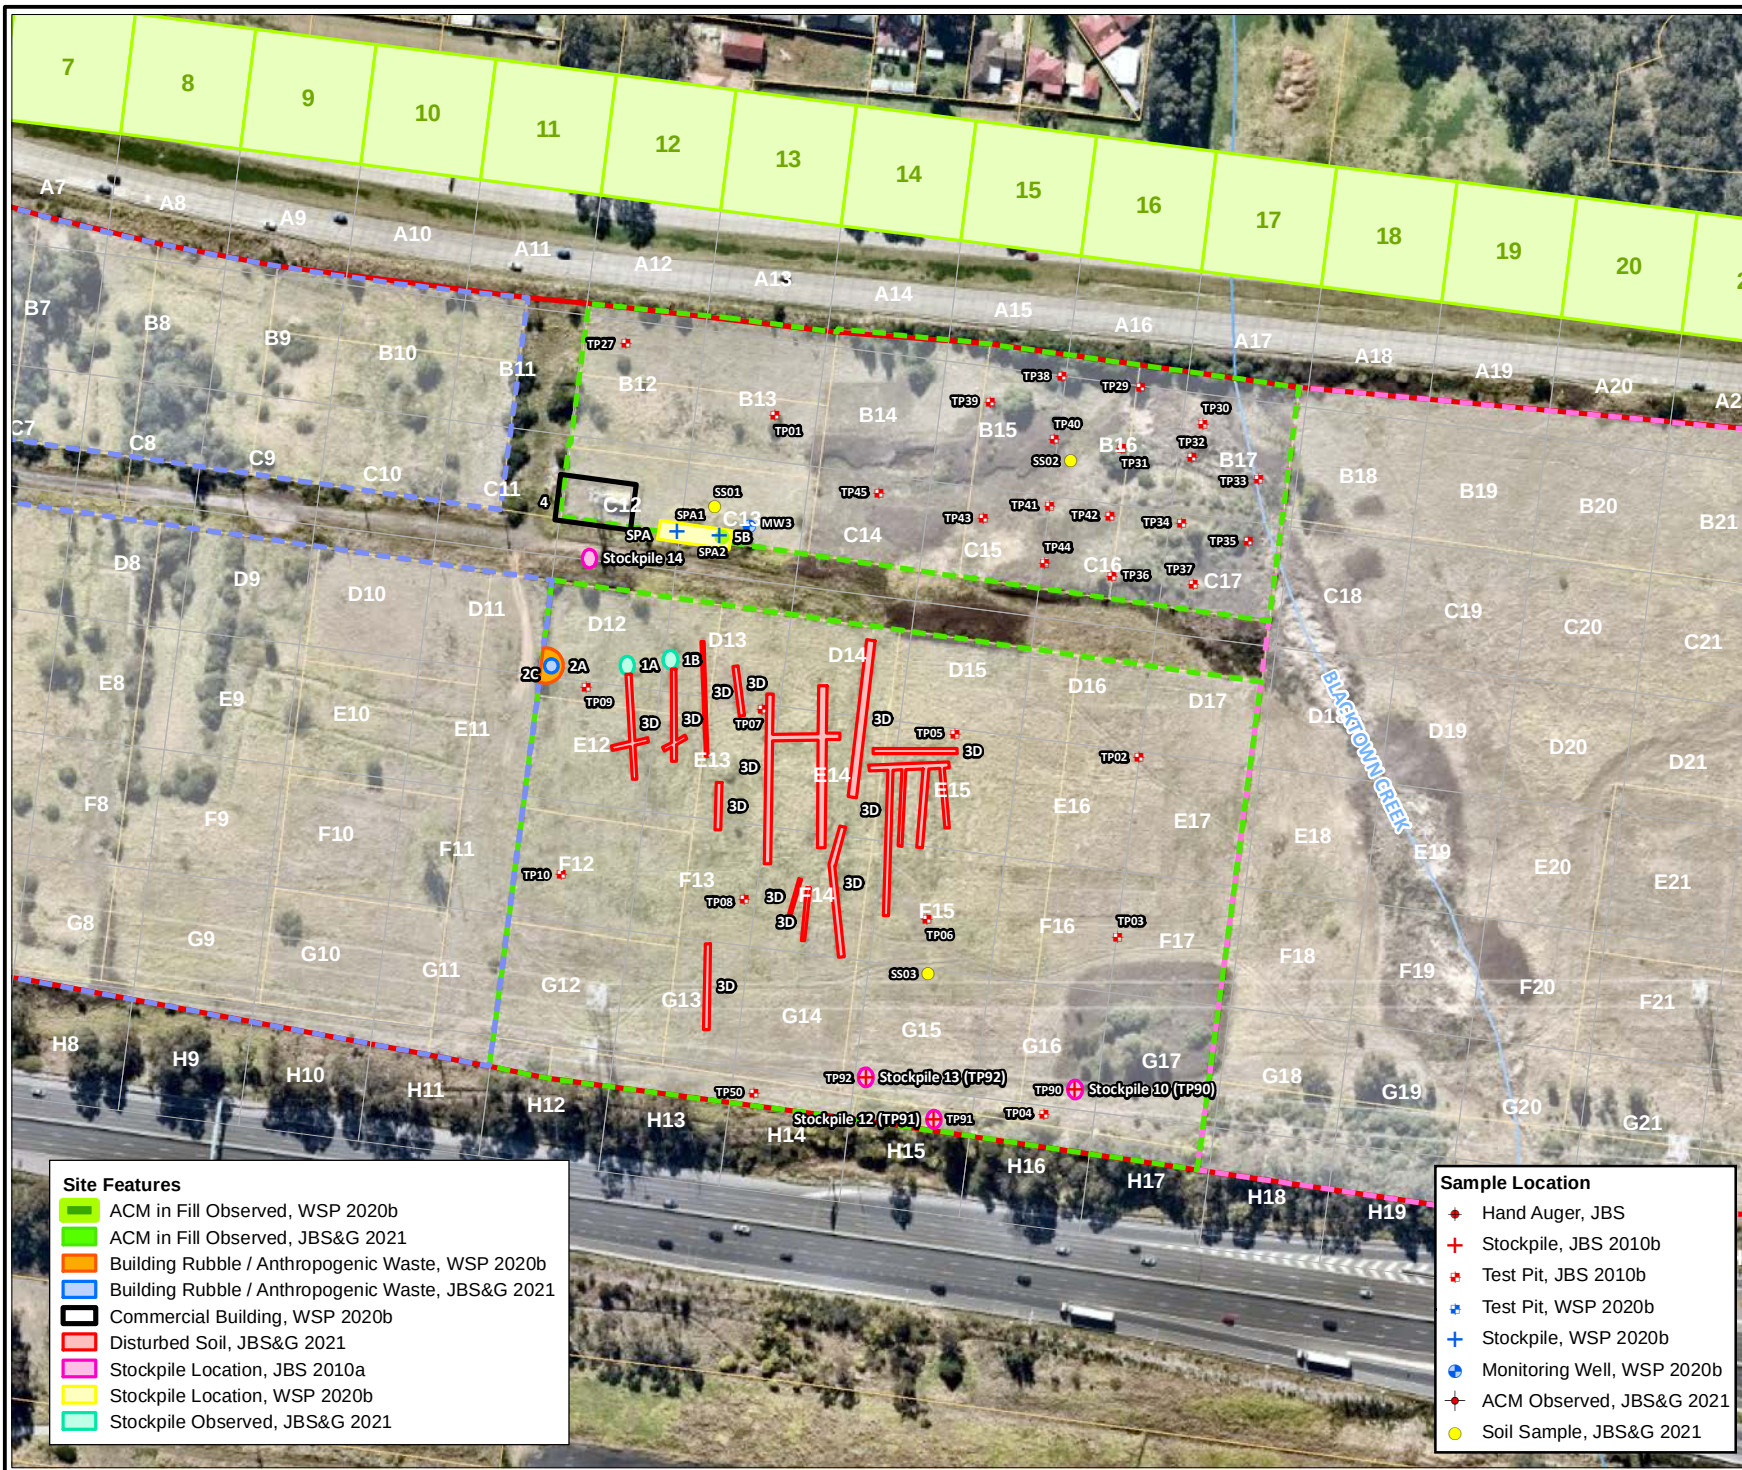
**FIGURE 5B**

**HISTORICAL SAMPLE LOCATION-  
CENTRAL EASTERN  
ASSESSMENT AREA**

During the assessment, soil samples were collected from 131 locations, comprising 64 grid-based and 67 targeted locations. Sample locations are shown in **Figures 5A, 5B and 5C** and analytical tables against the updated site assessment criteria are provided as **Appendix A**. It is noted JBS refers to sample / stockpile locations with the prefix SP and / or TP interchangeably in some cases. In this assessment we have adopted a convention of using the prefixes used in the sample IDs as shown in **Table C, Appendix A**.
