# Annual Compliance Report

Project name: Lockyer Energy Project  
EPBC Act Approval number: 2017/7994

FINAL  
28 November 2025

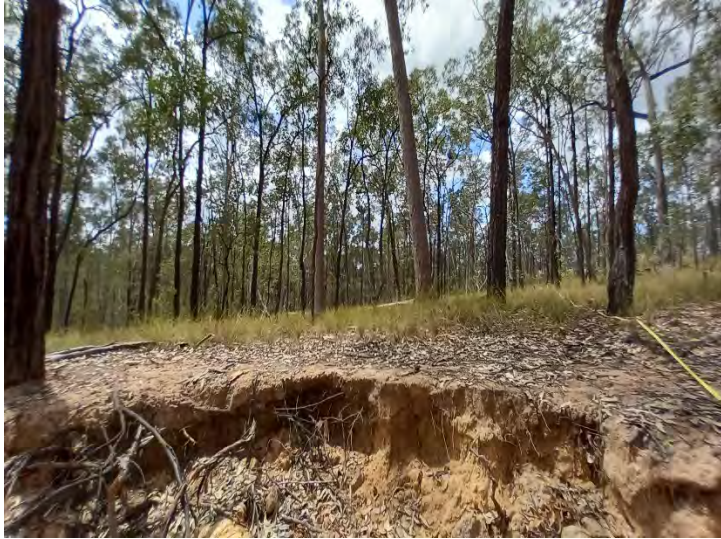
| Area of Erosion | GPS Location | Appendix C Photo Ref. | Notes |
|---|---|---|---|
| E1 | -27.529160, 152.274468 | Plate 1 to Plate 5 | Flow of water north towards creek line. |

Plate 1 Erosion 1 north view.

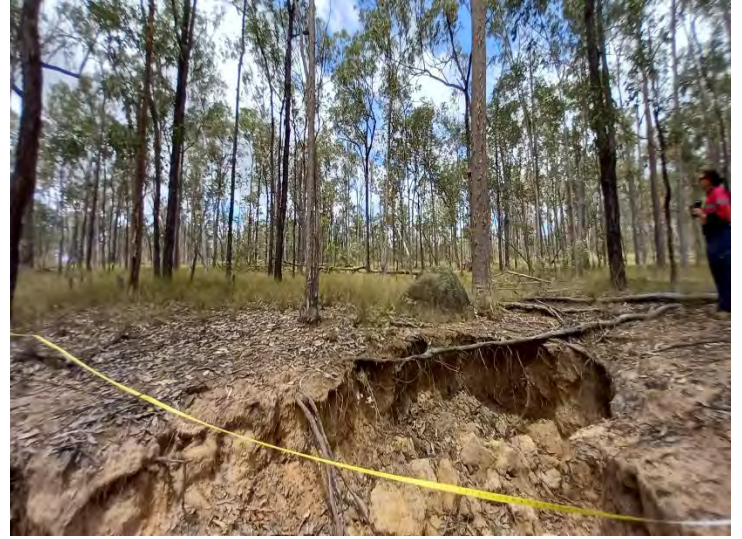
Plate 2 Erosion 1 east view.

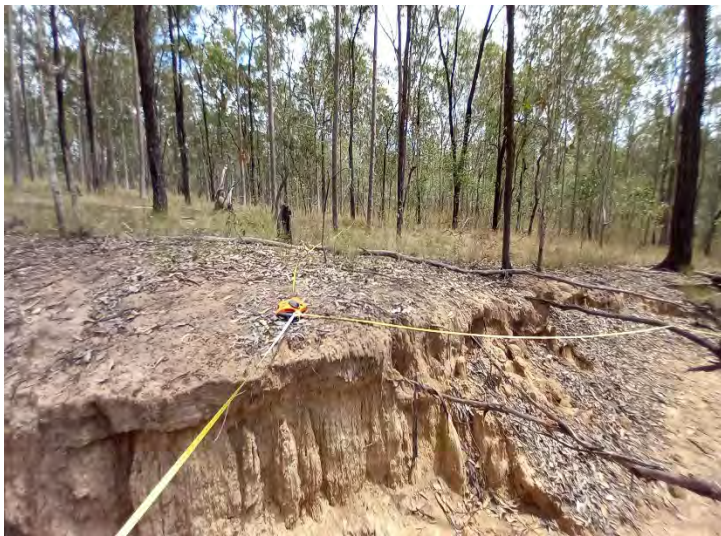
Plate 3 Erosion 1 south view.

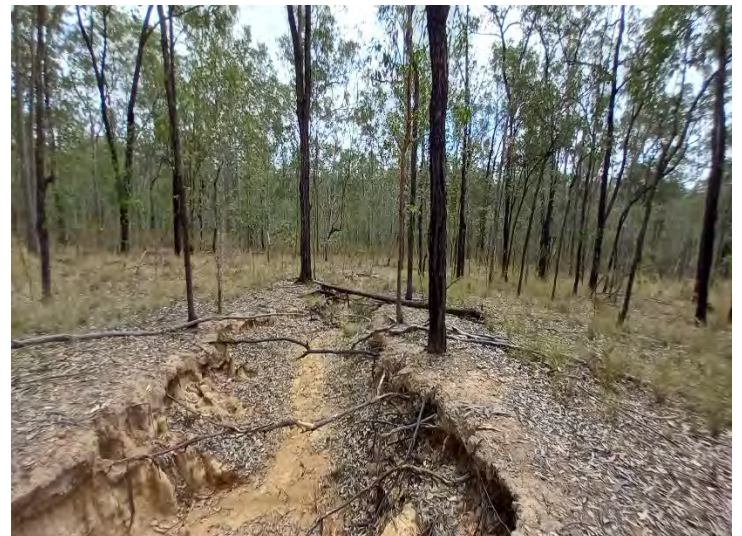
Plate 4 Erosion 1 west view.

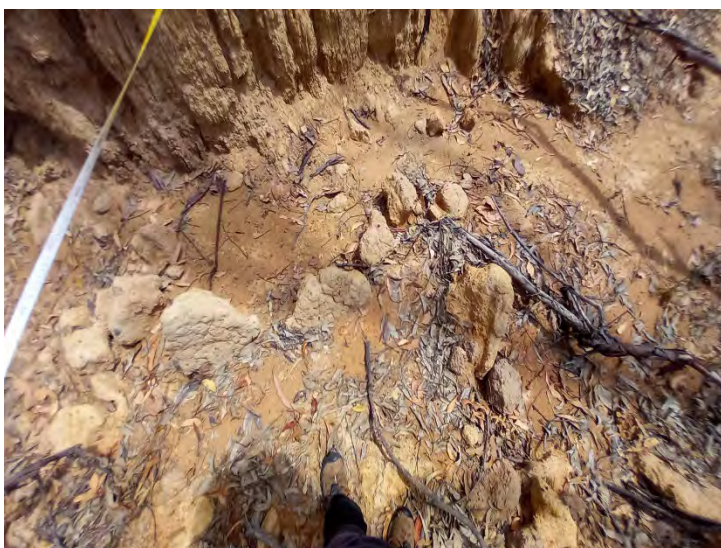
Plate 5 View of soil at Erosion 1.

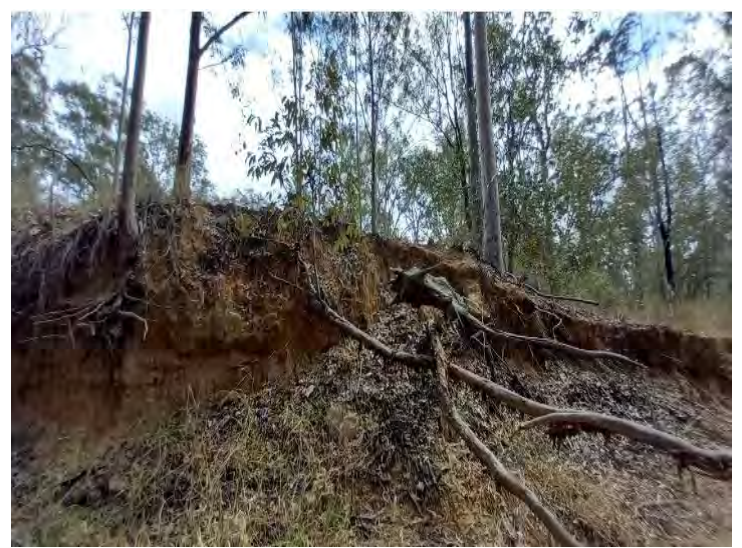
Plate 6 Erosion 2 north view.

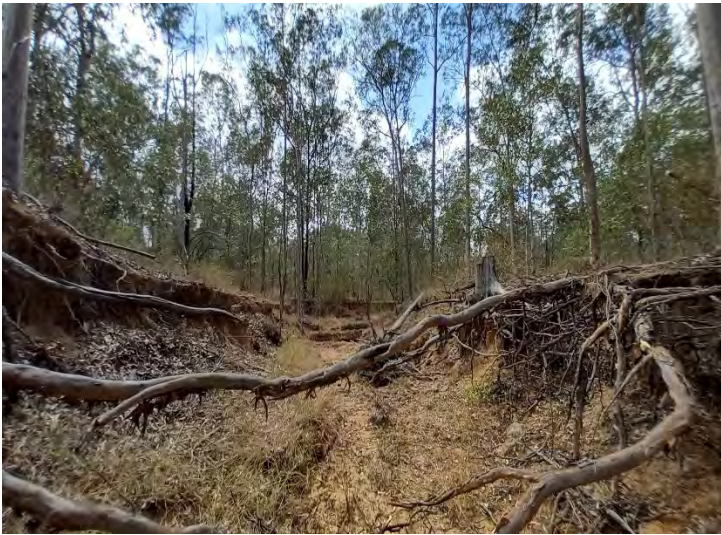
Plate 7 Erosion 2 east view.

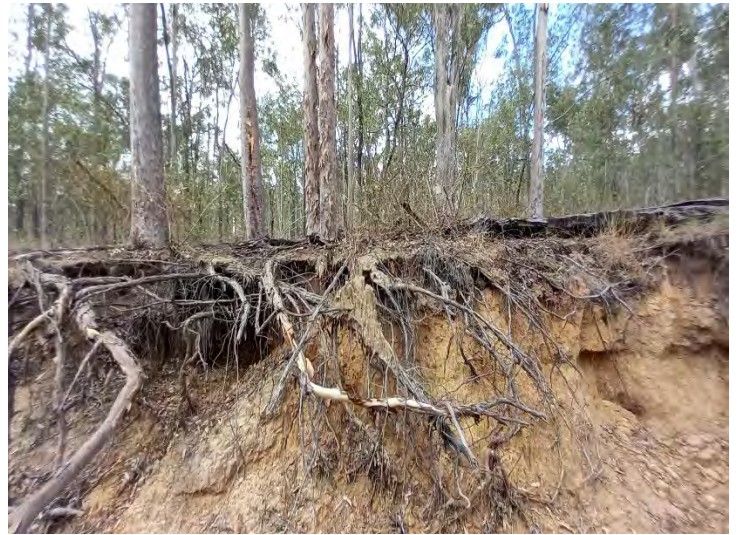
Plate 8 Erosion 2 south view.

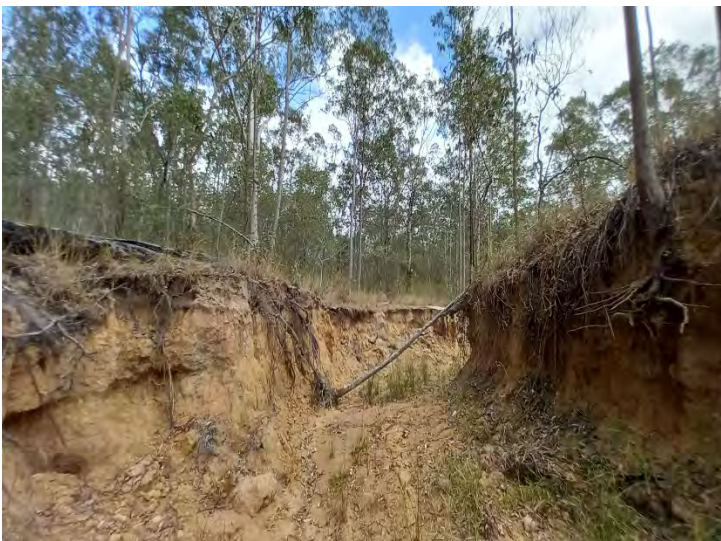
Plate 9 Erosion 2 west view.

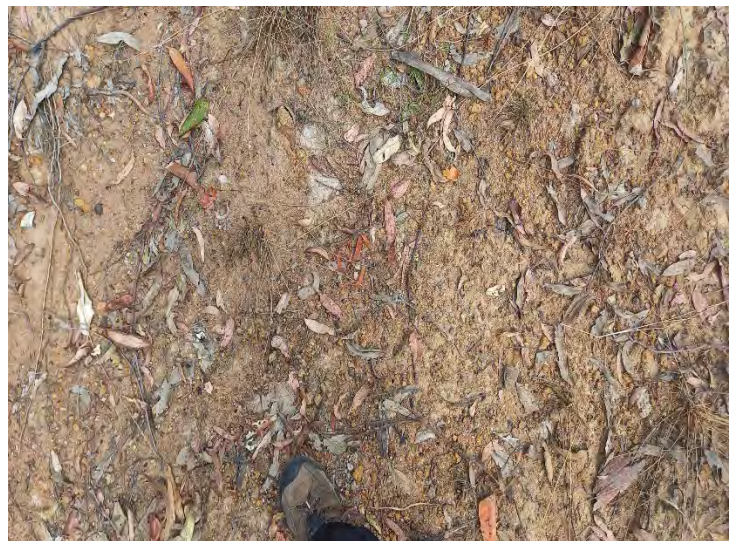
Plate 10 View of soil at Erosion 2.

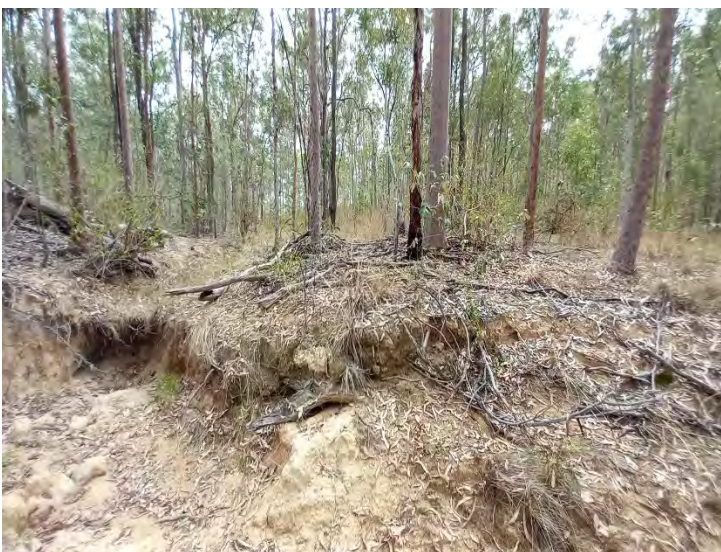
Plate 11 Erosion 3 north view.

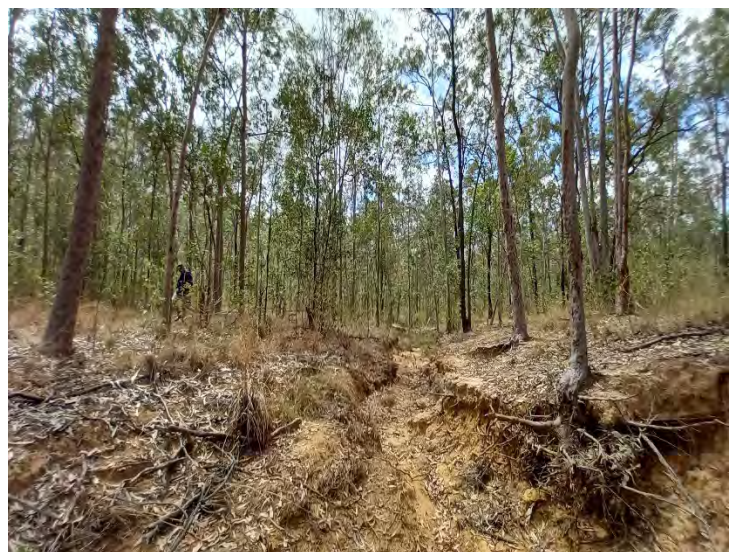
Plate 12 Erosion 3 east view.

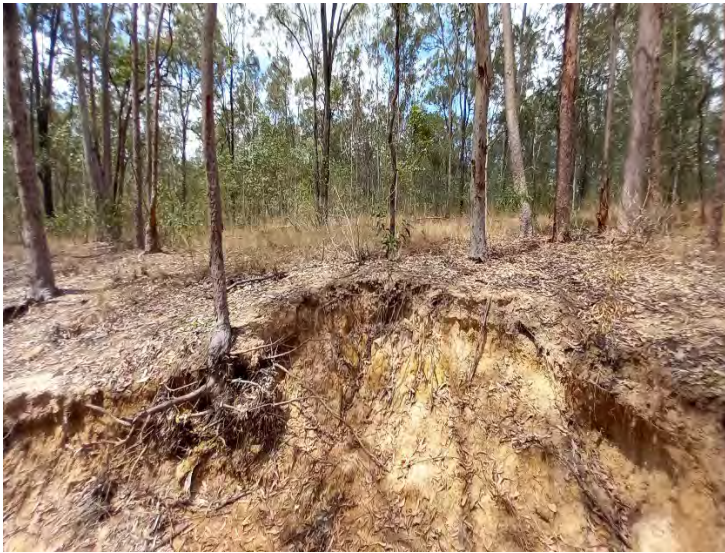
Plate 13 Erosion 3 south view.

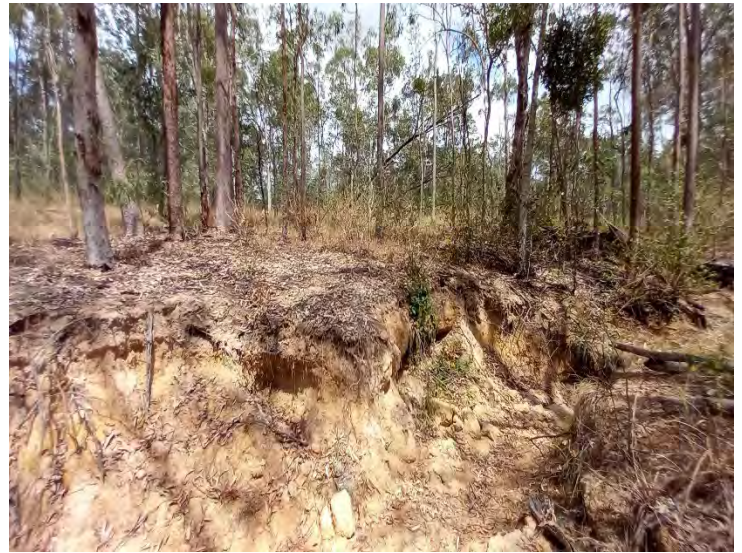
Plate 14 Erosion 3 west view.

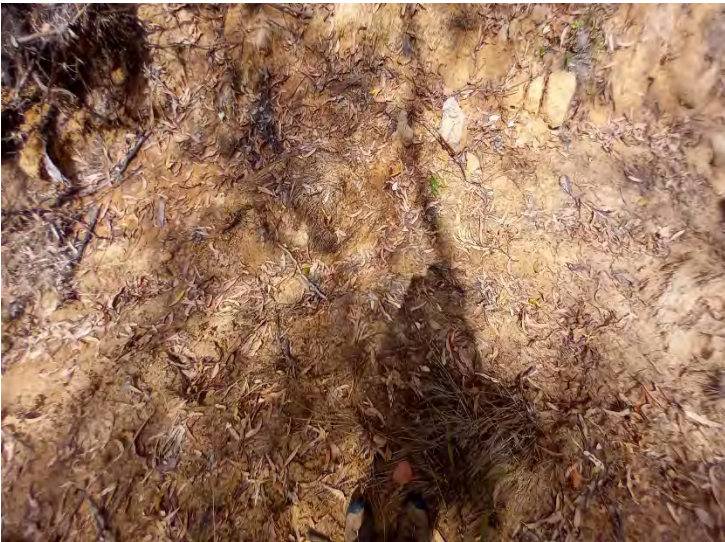
Plate 15 View of soil at Erosion 3.

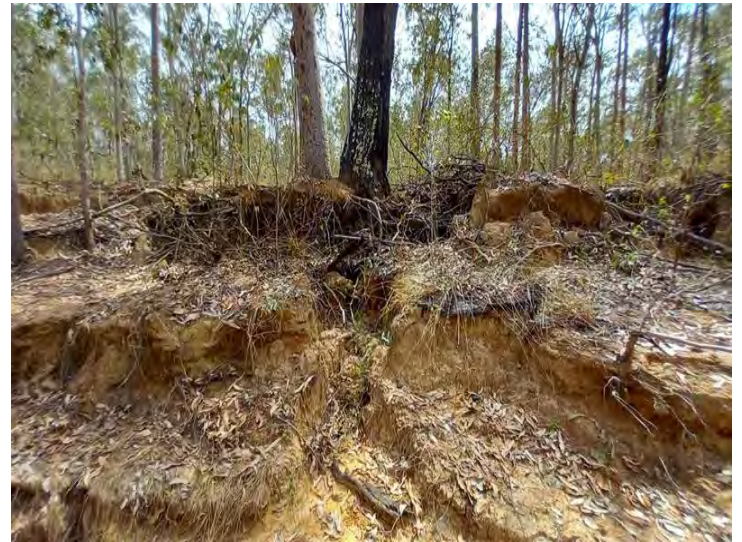
Plate 16 Erosion 4 north view.

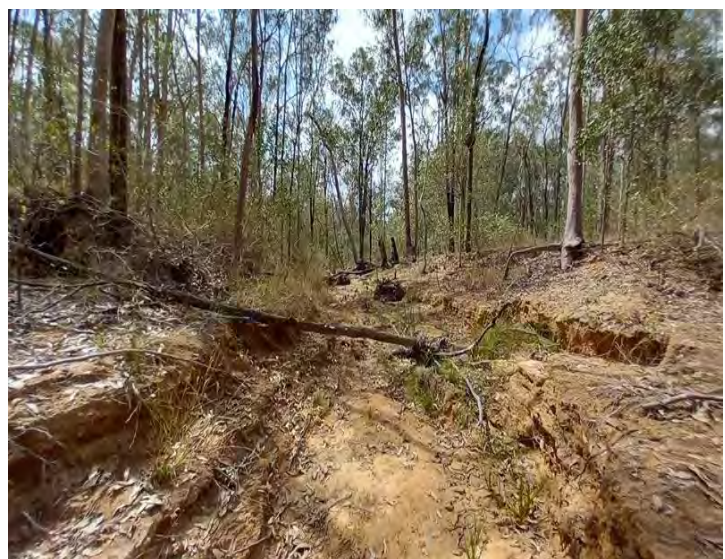
Plate 17 Erosion 4 east view.

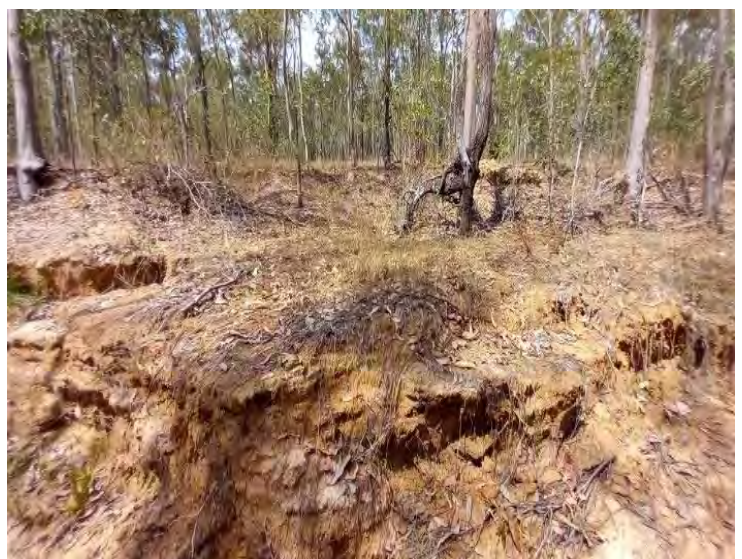
Plate 18 Erosion 4 south view.

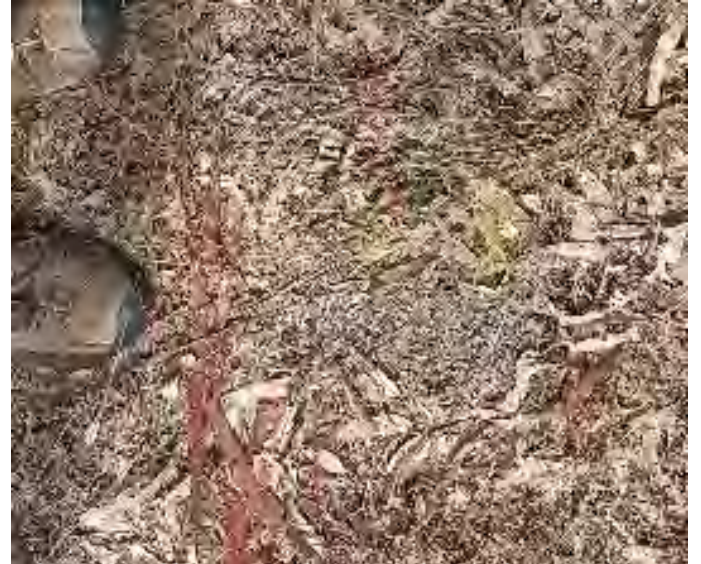
Plate 20 View of soil at Erosion 4.
