Report on  
Desktop Geotechnical Assessment

Due Diligence Assessment  
1030 Mamre Road, Kemps Creek

Prepared for  
ResolveXO Pty Ltd

Project 208044.00  
September 2021

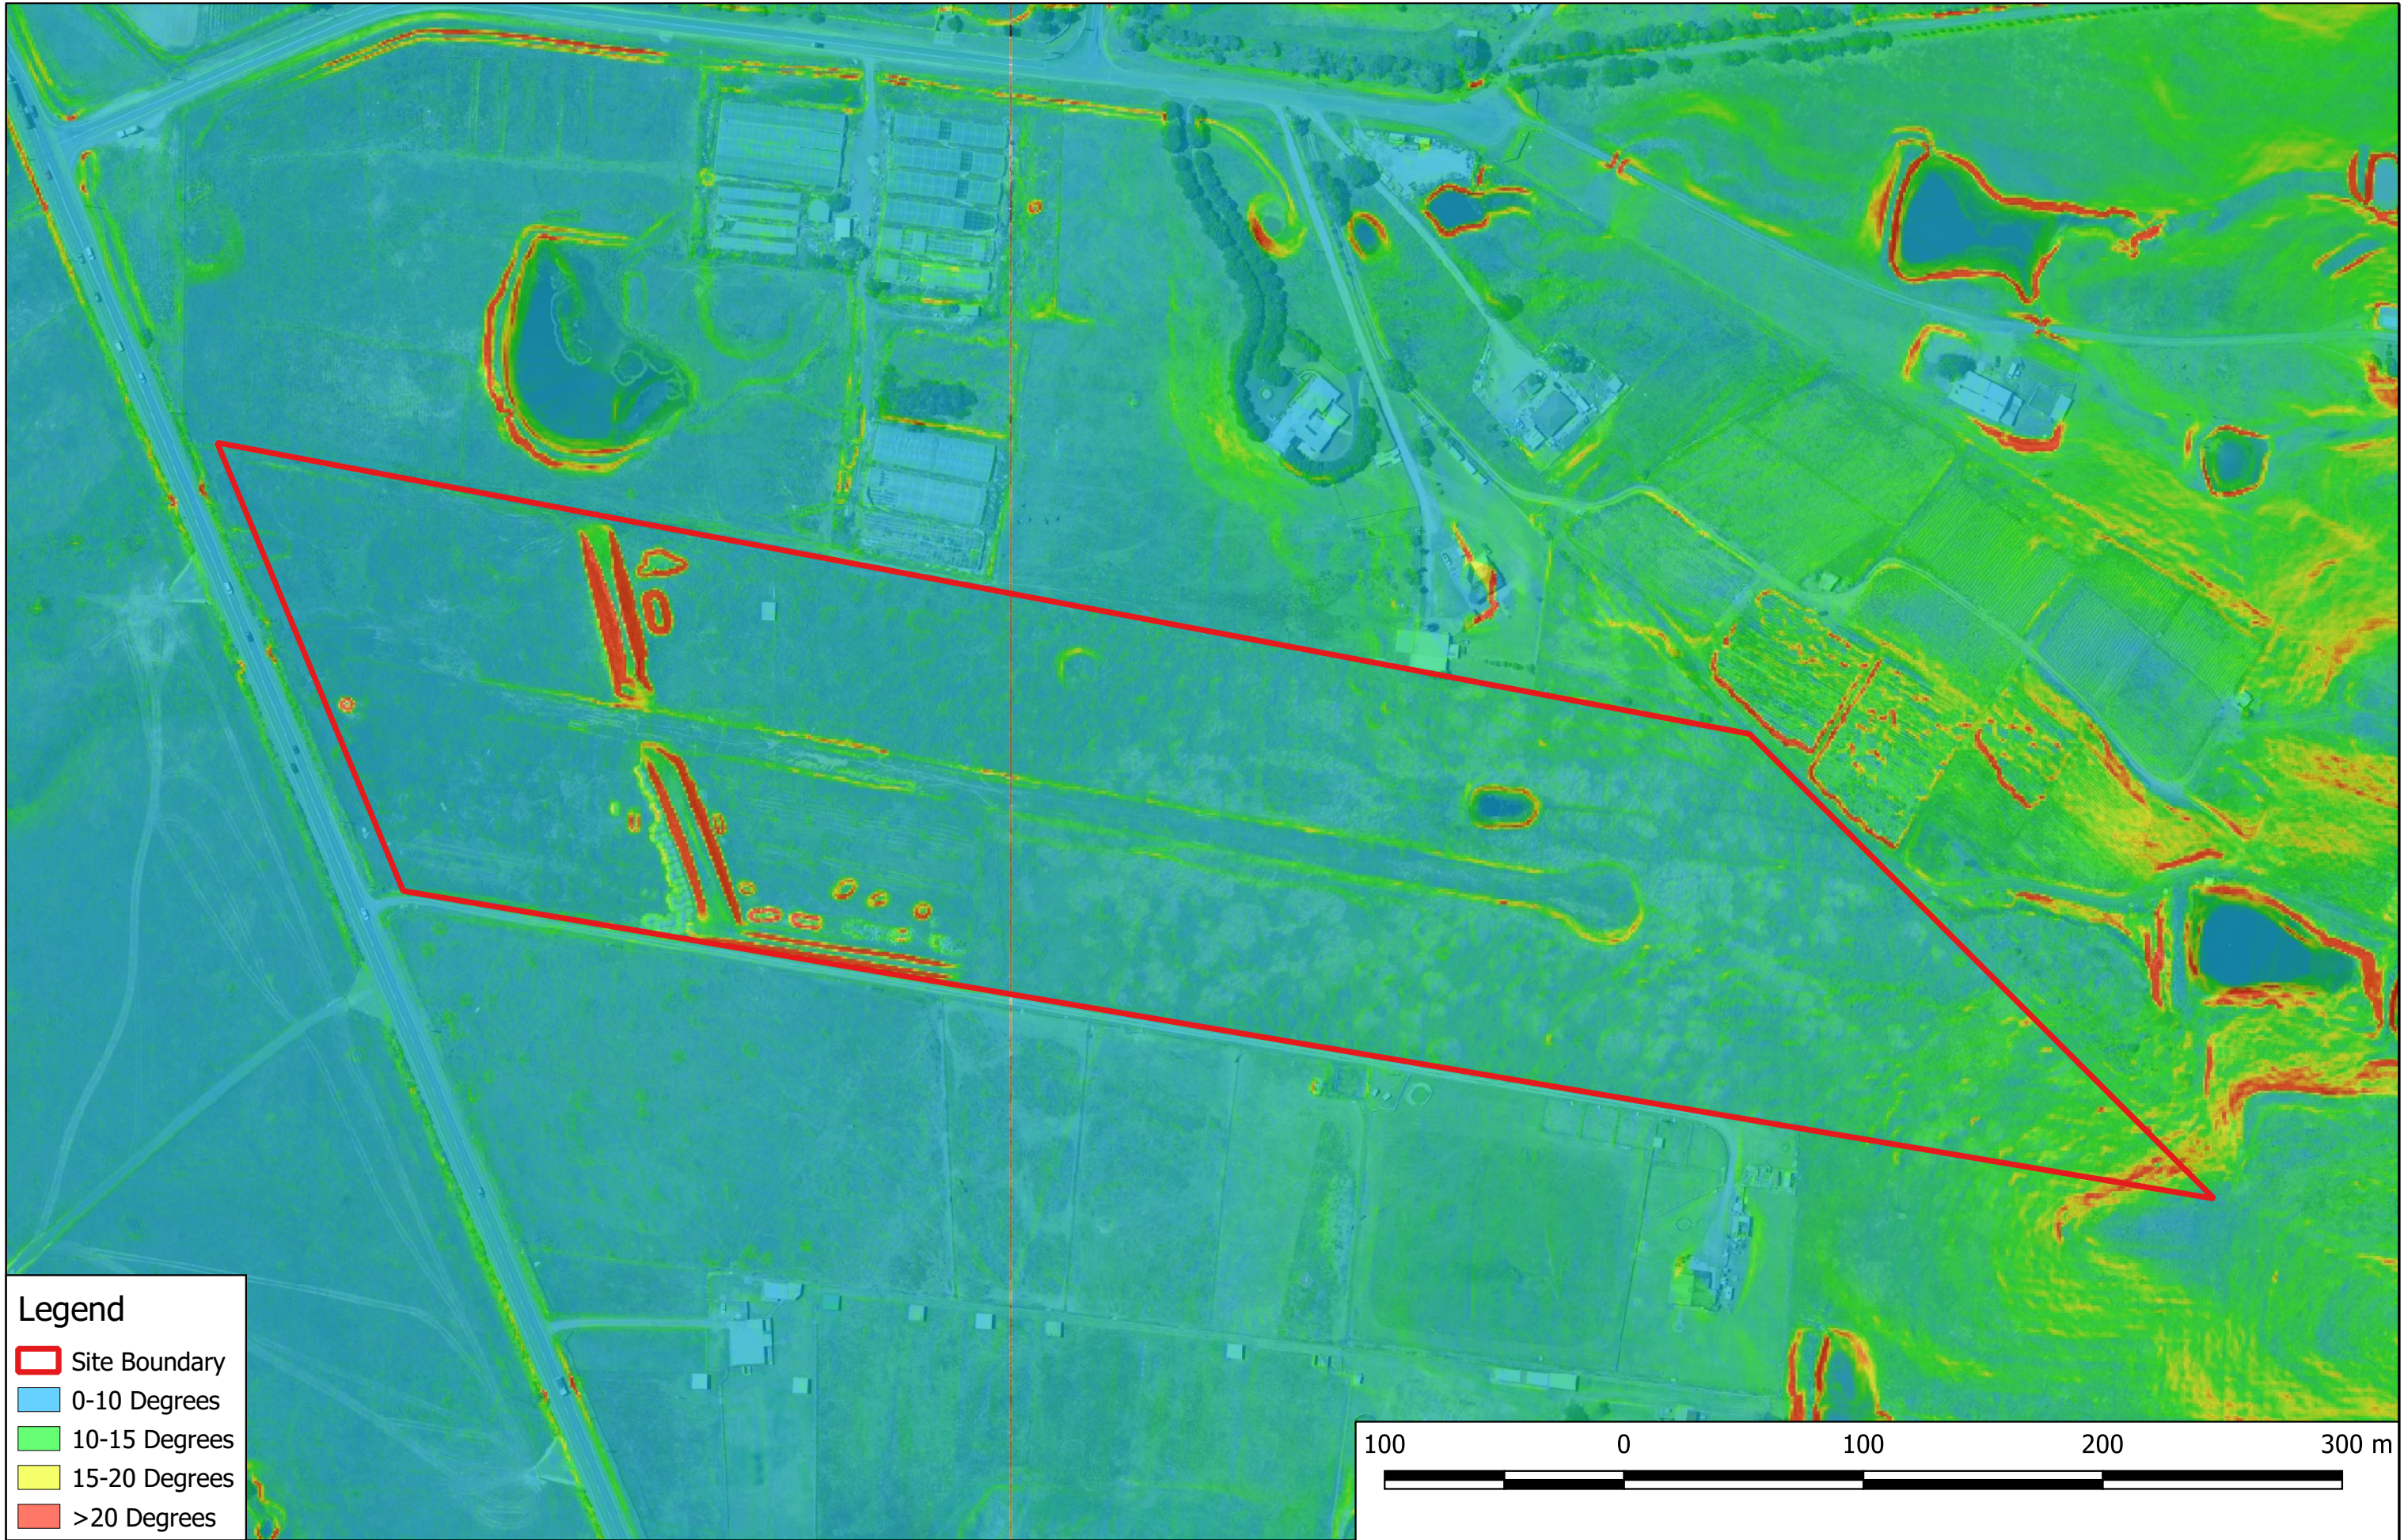
Most of the site gently slopes down to the west with hills located in the eastern portion of site. The overall difference in level across the site is approximately 39 m from RL 82 m relative to Australian Height Datum (AHD) to RL 43 m. The eastern slopes in the hilly area of site are generally in the range of 10-20 degrees with peaks in excess of 20 degrees situated at the peak on the south eastern boundary with the ridge running in a north easterly direction. Further slope analysis is shown in Drawing 2 in Appendix A.

There does not appear to be any evidence of significant slope instability on the site. It is noted the grades on the northern boundary are increasing to 15 – 20 degrees and care will be required to ensure that earthworks and excavation do not adversely affect slopes which extend into the neighbouring properties.
