19th Street Redevelopment – Building 1 and 2 Project Definition Document

Date: February 2022

Document Number: NCOM-040
Dallas Fort Worth International Airport

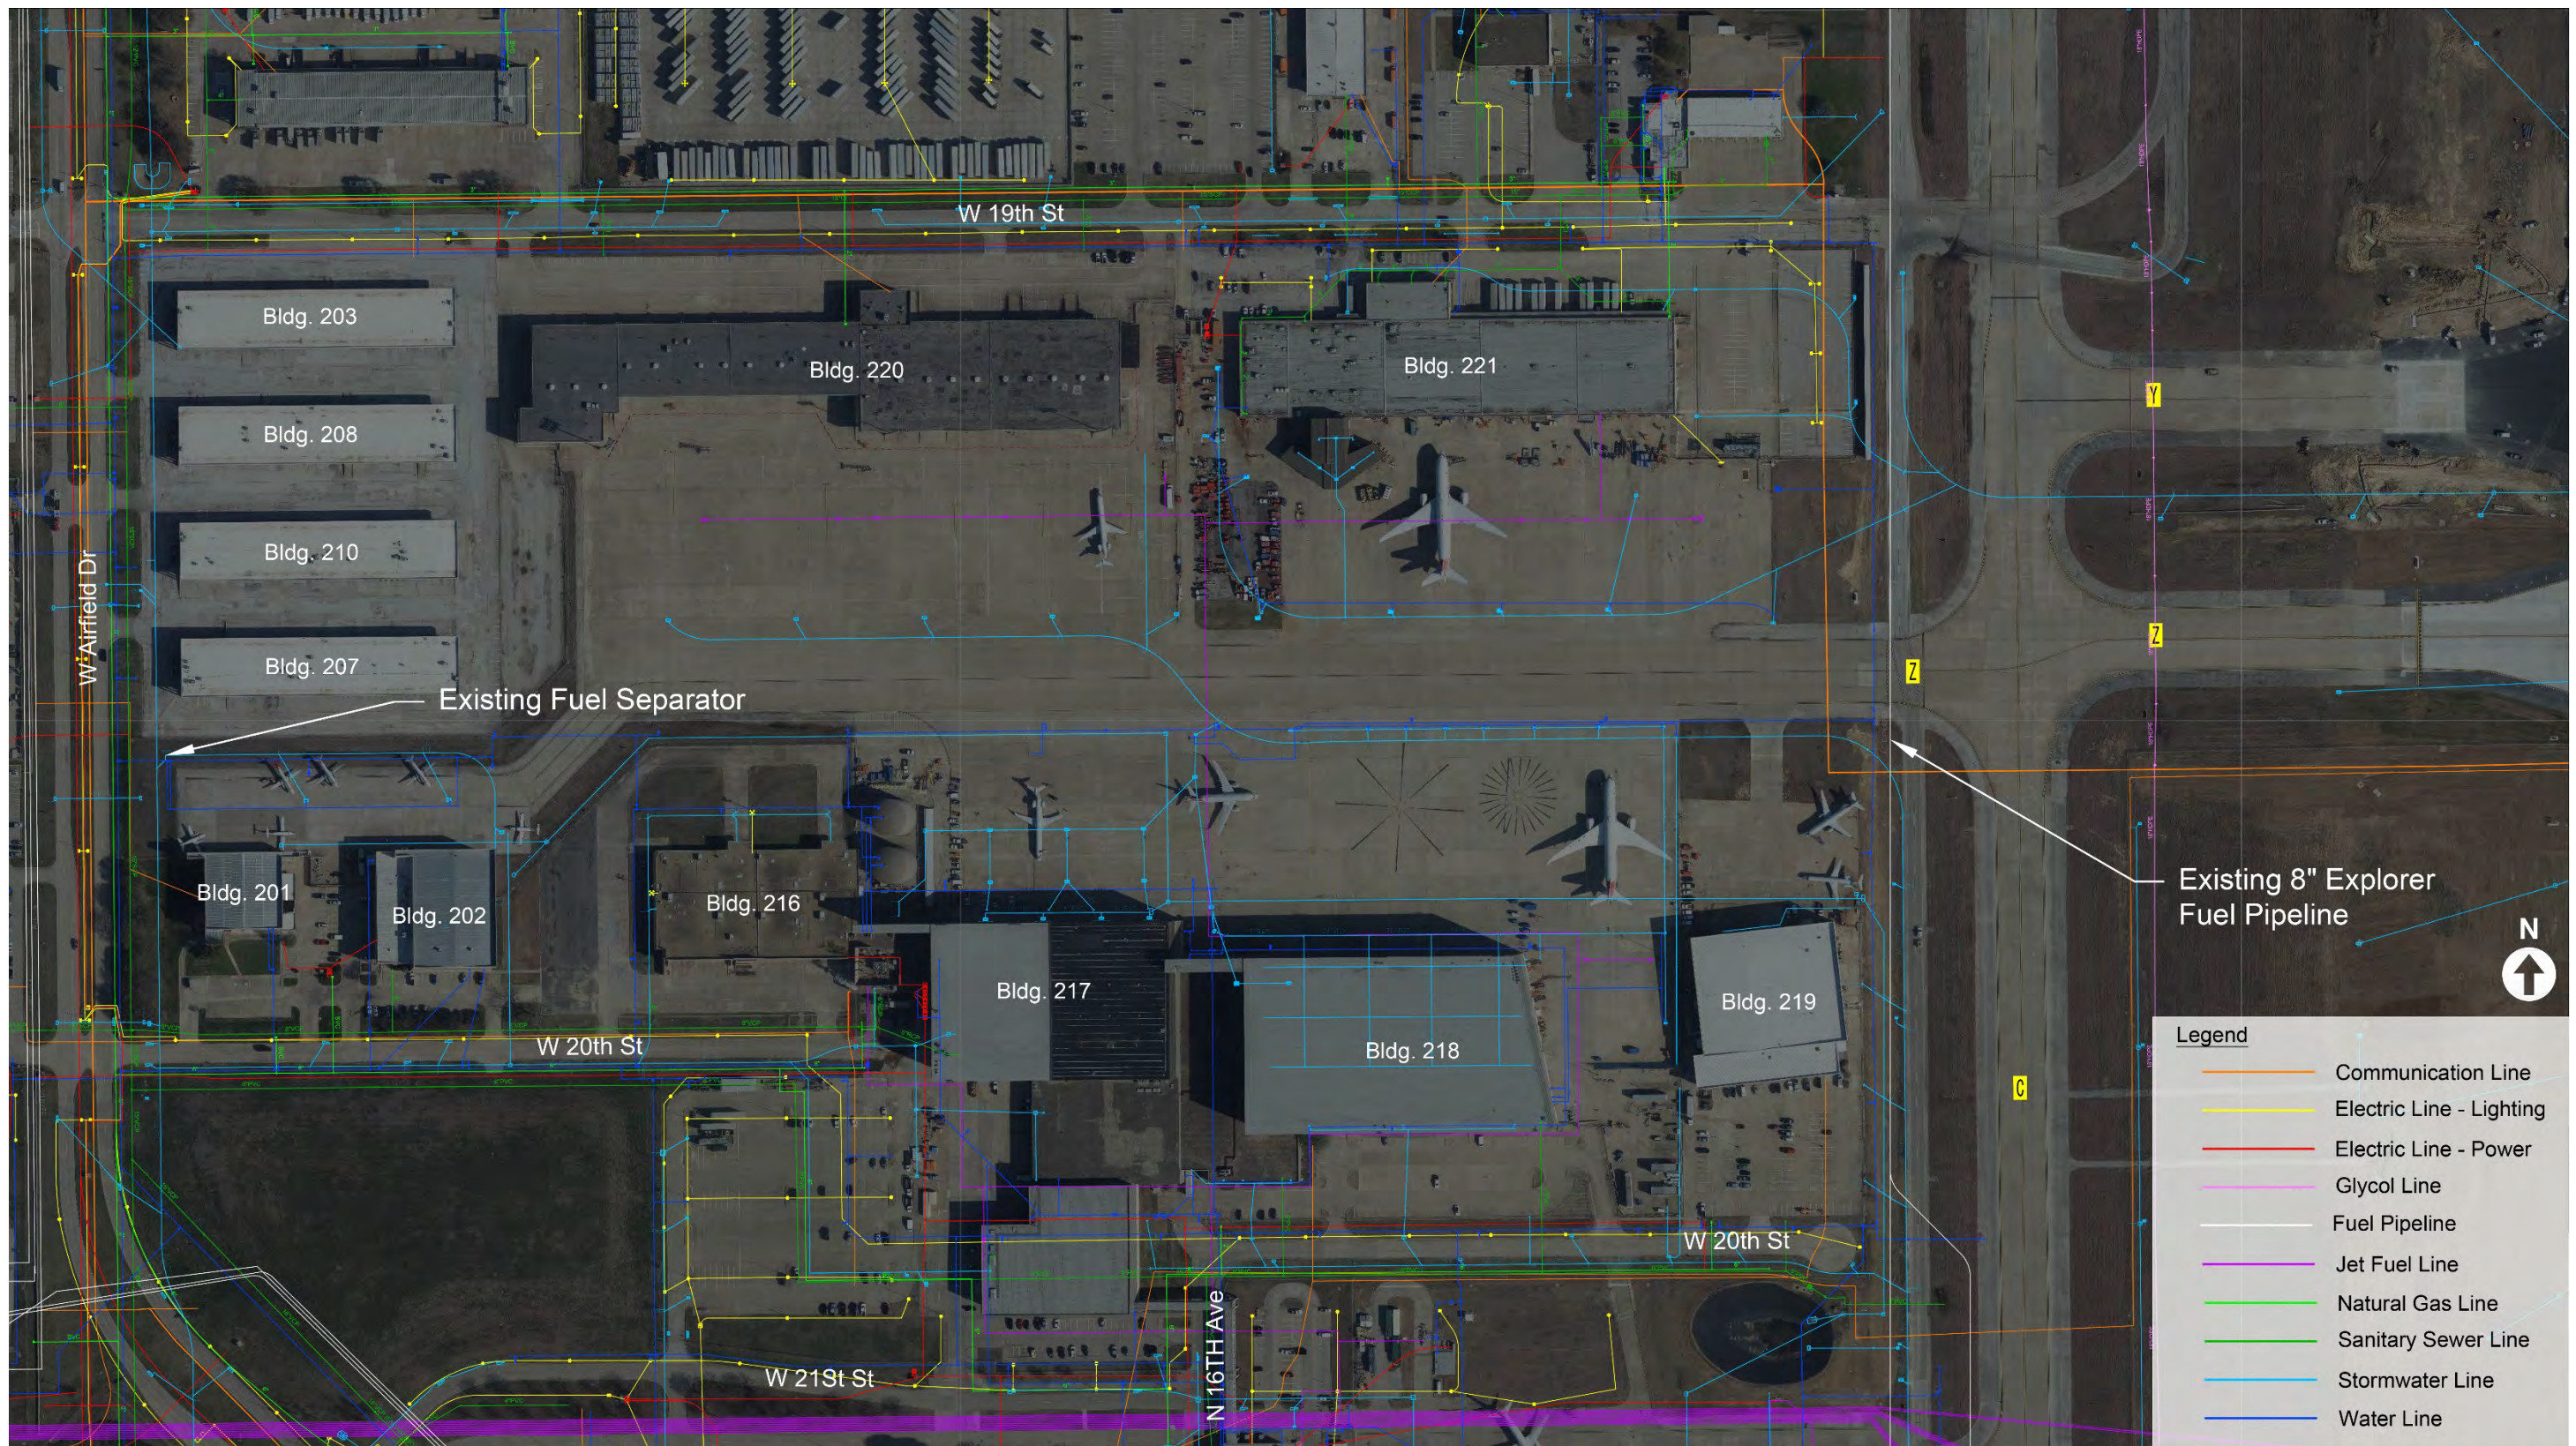
FIGURE 2-4 NW Cargo Campus Existing Utilities

Having already been extensively developed, this area has access to all the necessary utilities such as power, water, lighting, and sanitary sewer. **Figure 2-4, NW Cargo Campus Existing Utilities** provides an overview of the existing utility infrastructure for this area.

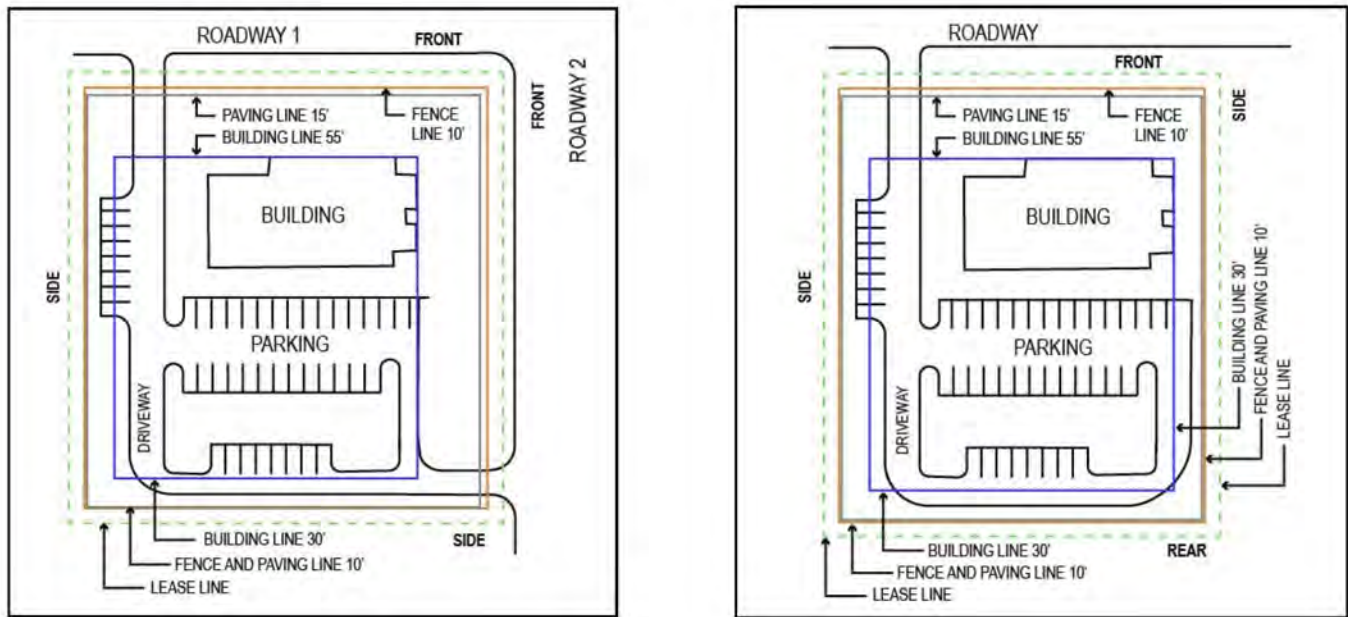
FIGURE 5-9 DFW Development Design Guideline Setbacks

One of the development guidelines for the site is the DFW Development Design Guidelines from June 2020. Upon recent discussions with stakeholders, it is anticipated that the project will need to follow these standards. Included within these guidelines are provisions for setbacks from the lease lines. Section 2.2.1.1., Front, Side, and Rear Yard Setbacks details the possible requirements for the site which are shown below in **Figure 5-9, DFW Development Design Guideline Setbacks**.

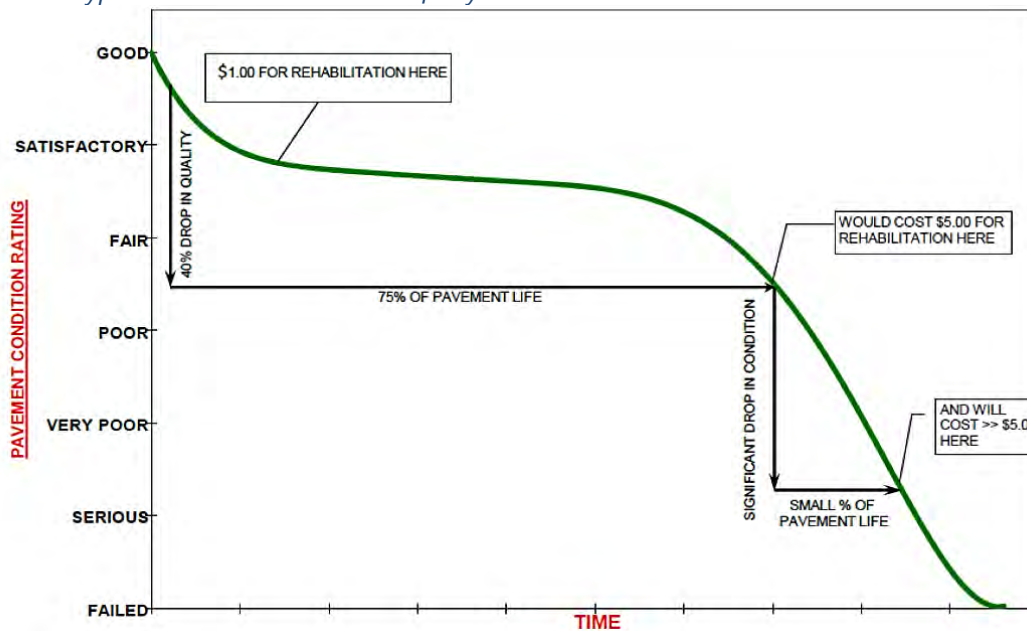
Figure 5: Typical Pavement Condition Life Cycle

In the typical pavement condition life cycle (**Figure 5**), pavement deteriorates slowly at first, while in "Good" to "Satisfactory" condition. This is the most opportune time to perform routine maintenance such as spall repairs and crack sealing to preserve pavement life. When the pavement is in this condition, the relative cost for maintenance or rehabilitation is \$1.00.

Lastly, when the pavement is rated as "Failed", the pavement has deteriorated and progressed to the point that safe aircraft operations are no longer possible. Maintenance and rehabilitation efforts are no longer possible and complete reconstruction is required.

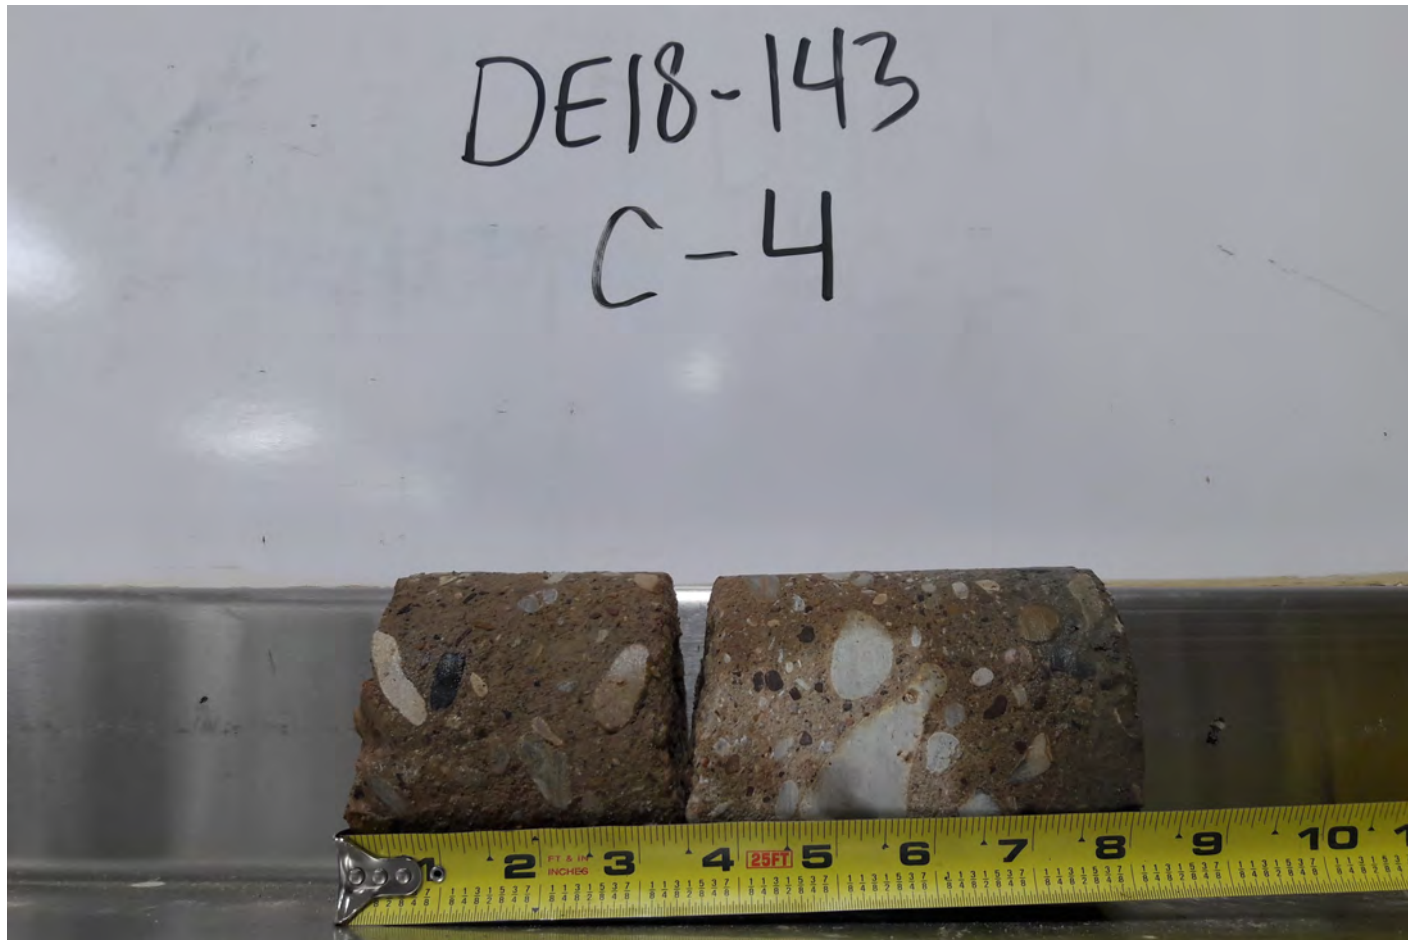
Photo 7: Photo of Pavement Core at Boring C-4.

Photo 8: Photo of Pavement Core at Boring C-4.

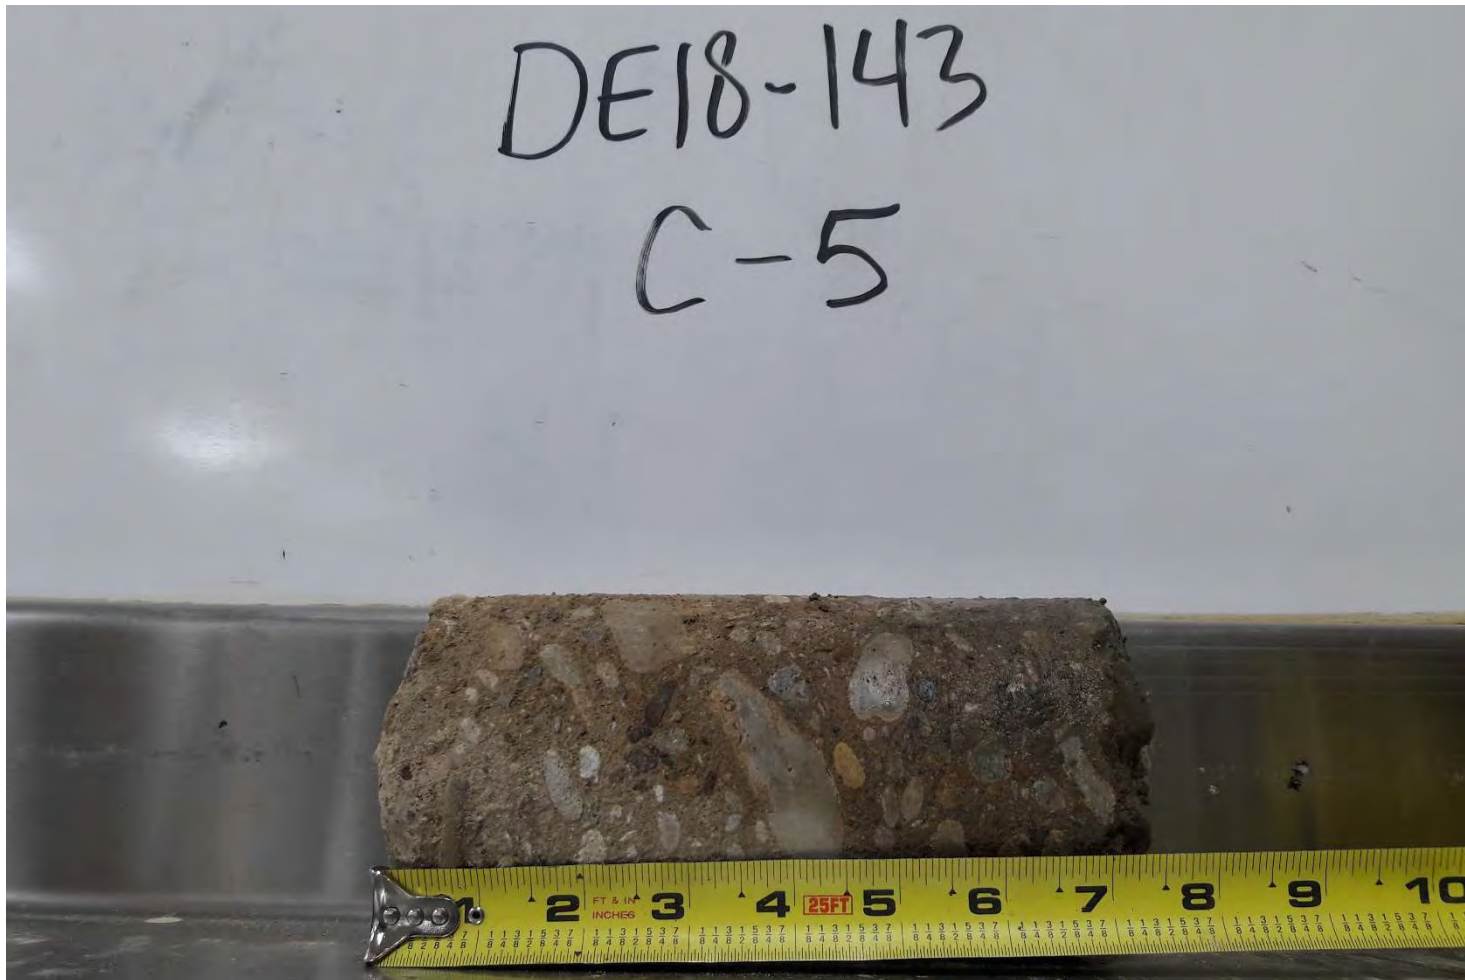
Photo 9: Photo of Pavement Core at Boring C-5.

Photo 10: Photo of Pavement Core at Boring C-5.

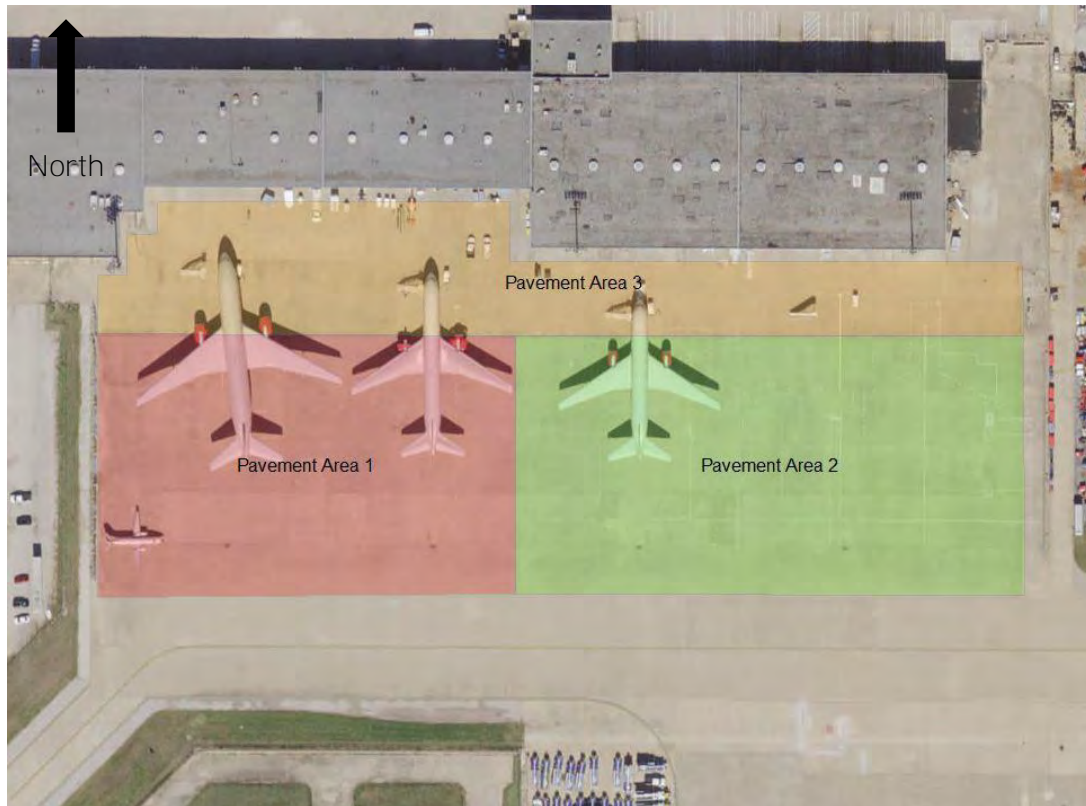
Figure 4 Pavement Areas

Figure 4 shows how the three pavement areas are defined for the analysis of the pavement structural support. Pavement Area 1 represents the thicker pavement section with higher deflections, Pavement Area 2 represents the thicker pavement section with lower deflections, and Pavement Area 3 represents the thinner pavement section with variable deflection results.
