# Annual Compliance Report

Project name: Lockyer Energy Project  
EPBC Act Approval number: 2017/7994

FINAL  
28 November 2025

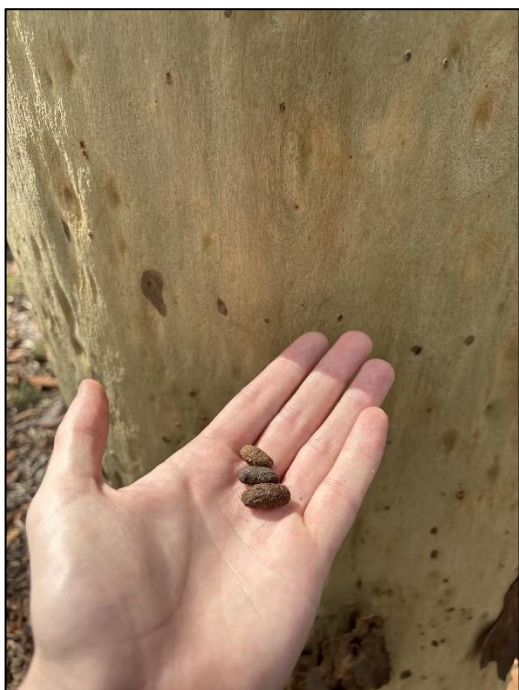
Within AU1, a utility value of 3.33 – 12.59% across four plots, indicating “medium (normal) use” and a utility value >12.59% across three plots, indicating “high use”. The BKSS identified a utility value of >12.59% for Plot 7 within AU1, indicating “high use”. No evidence of scats was detected within AU3, indicating “low use” by the koala for the surveyed area (Plot 9). Recent scats were assessed as occurring within Plots 1 and 2 (see **Plate 1** to **Plate 2**). Refer to **Table 3**, below for BKSS assessment data and results.

Plate 1 Koala Scats Assessed as 'Recent' recorded within Plot 1

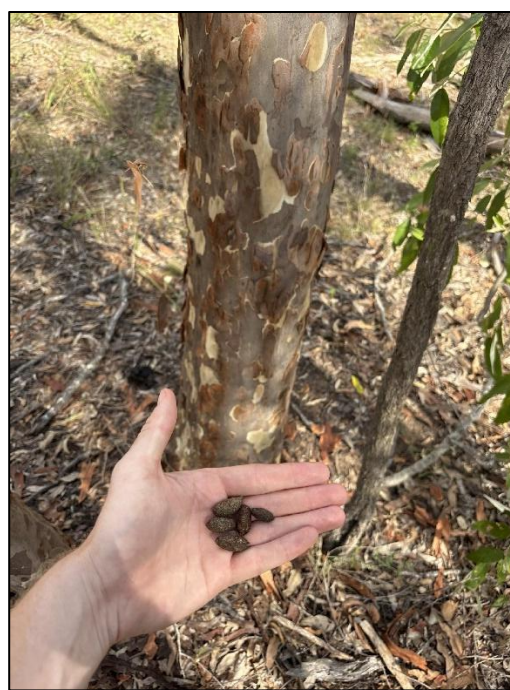
Plate 2 Koala Scats Assessed as 'Recent' recorded within Plot 2

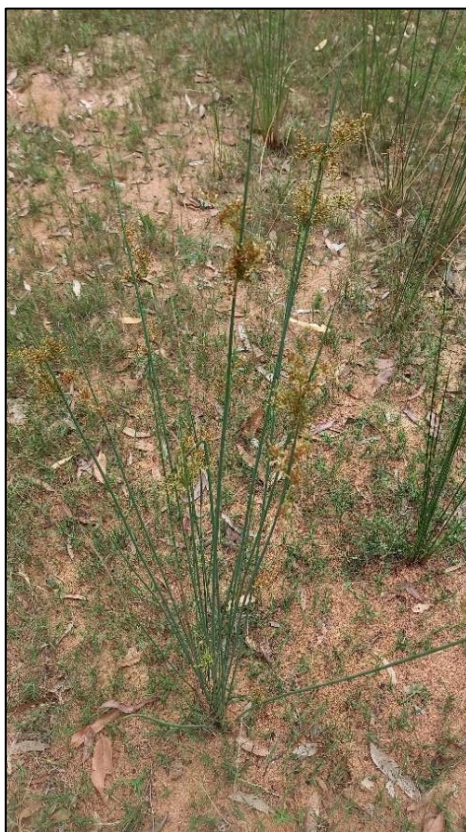
Two areas of erosion denoted as E2 and E4 within the below figure, were observed to be associated with the two dams located within the Offset Area A. During the time of the survey, no water was observed within either of the dams. However, native water tolerant *Juncus sp.* was noted within and fringing the waterway (see **Plate 3**), while water tolerant canopy and sub-canopy species including soap tree (*Alphitonia excelsa*) and scattered QLD blue gums (*Eucalyptus tereticornis*) were also noted fringing the waterway banks. Dense stands of lantana (*L. camara*) were noted within the understorey adjacent to the waterway (refer to **Figure 9** below).

**Plate 3 Juncus sp. within waterway.**

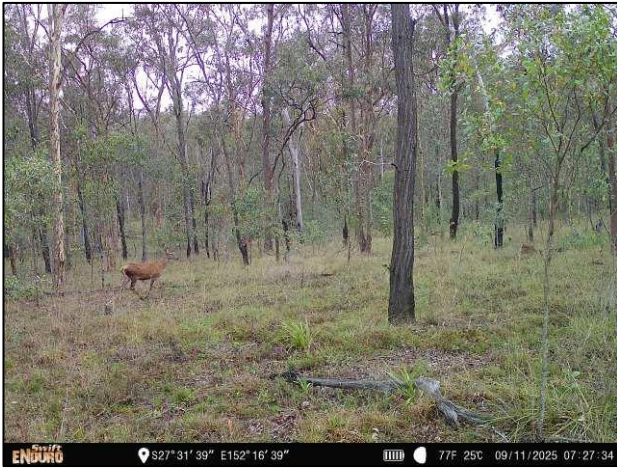
S5 Environmental understand that feral red deer (*Cervus elaphus*) and a potential wild dog (*Canis familiaris*) have been recorded as occurring within the site (see **Plate 4** to **Plate 5**). A majority of the recordings have been detected by Camera four (4) located within the cleared southern portion of the site, beyond the Offset Area. However, a lone red deer was recorded by Camera one (1), as occurring within Offset Area A. **Table 6** below outlines the data collected to date by Stanwell.

**Plate 4** Red deer (*Cervus elaphus*) recorded within Offset Area by Camera 1.

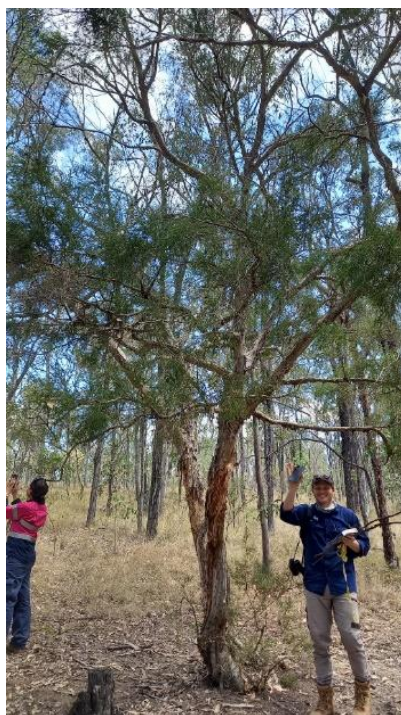
Further, one protected plant, weeping paperbark (*Melaleuca irbyana*), listed as "Endangered", under the NC Act was identified within Offset Area A. Refer to **Figure 11** below for the location of this protected plant and **Plate 10**.

**Plate 10** 'Endangered'  
weeping melaleuca (*M. irbyana*).

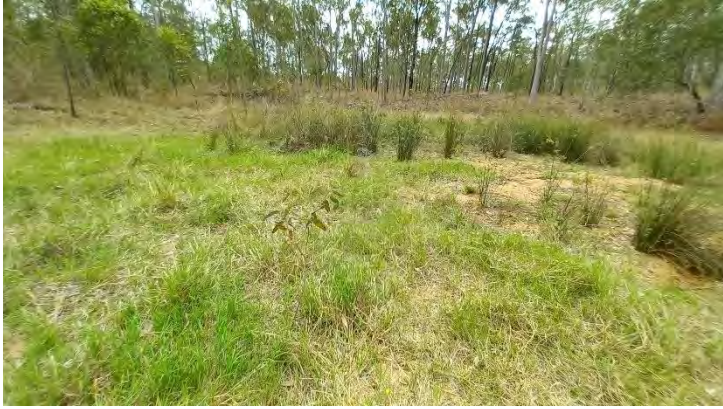
**Plate 1** Fireweed (F1) north view.

- Engage a suitably qualified rehabilitation contractor to treat WONS and State Category 3 weeds identified across the Offset site, with a particular focus within Offset Area B and the areas identified on **Figure 9** within Offset Area A. Weed maintenance within Offset Area B should be in accordance with the Landscape and Rehabilitation Plan Issue C (Littoria Consulting; Issue C; 22/11/2022) where applicable;

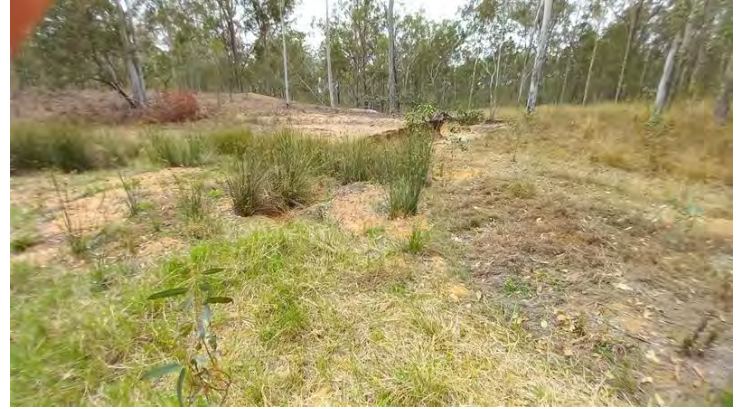
**Plate 2** Fireweed (F1) east view.

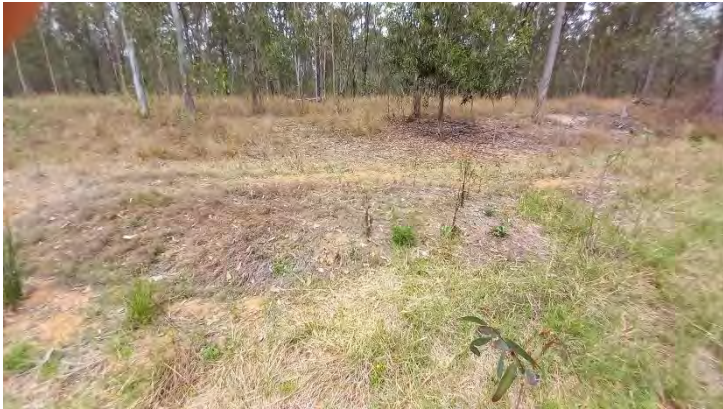
**Plate 3** Fireweed (F1) south view.

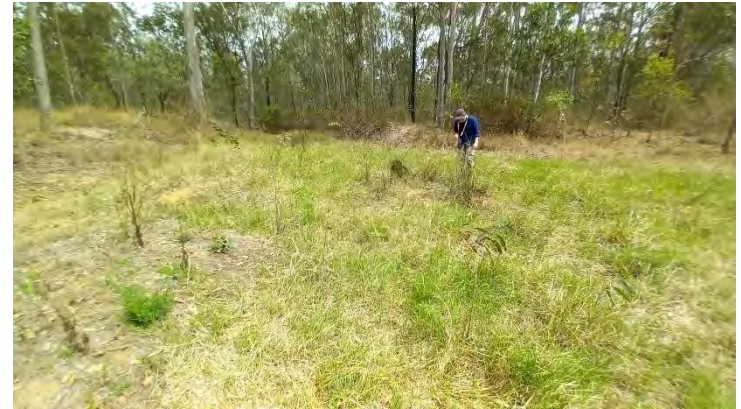
**Plate 4** Fireweed (F1) west view.

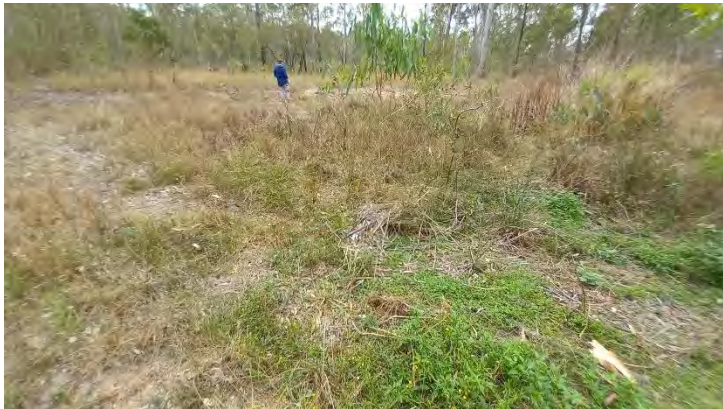
**Plate 5** Fireweed (F2) north view.

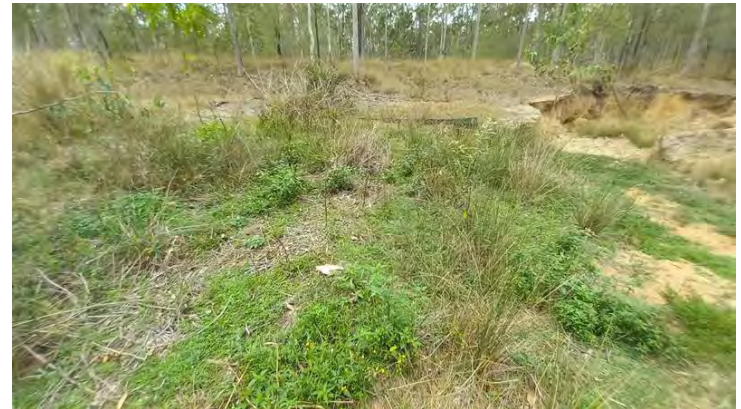
**Plate 6** Fireweed (F2) east view.

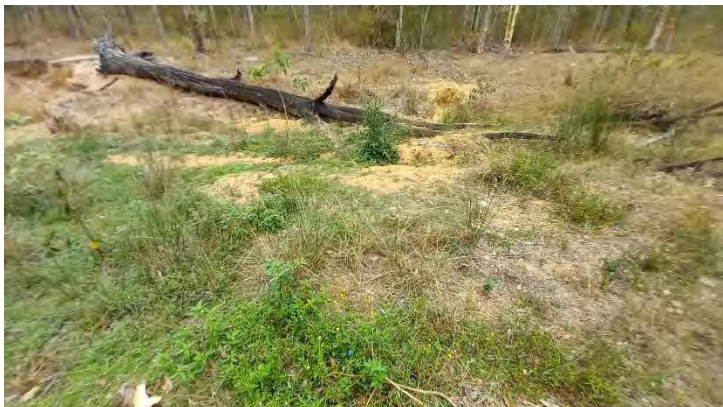
**Plate 7** Fireweed (F2) south view.

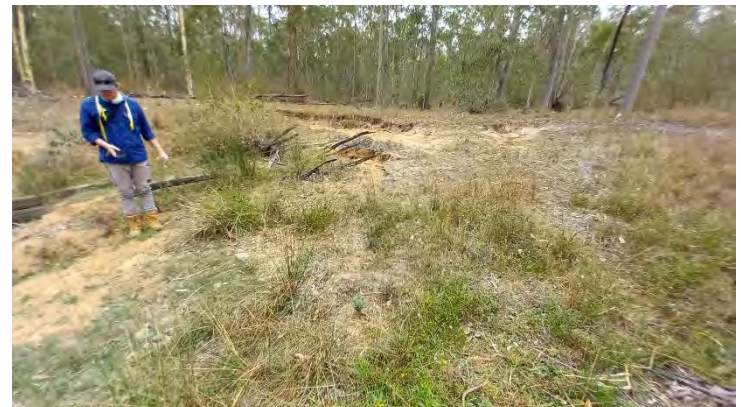
**Plate 8** Fireweed (F2) west view.

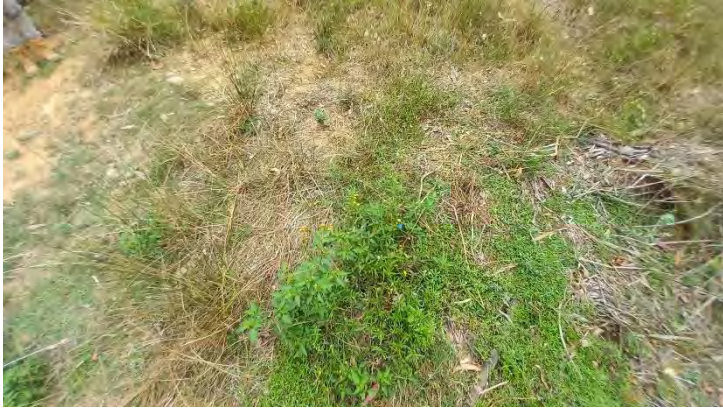
**Plate 9** General view of soil at F2.

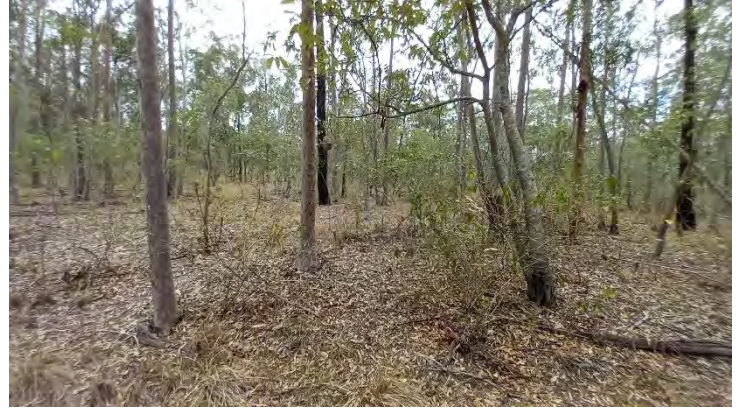
**Figure 12** below illustrates the extent of lantana mapped in 2024 compared with the extent recorded in the current assessment. This expansion suggests that weed incursion is exceeding the rate of weed control currently implemented within the Offset. Weed control should be prioritised to ensure habitat quality within AU1 does not further decline in value.

**Plate 10** *L. camara* fringing creek line. North view.

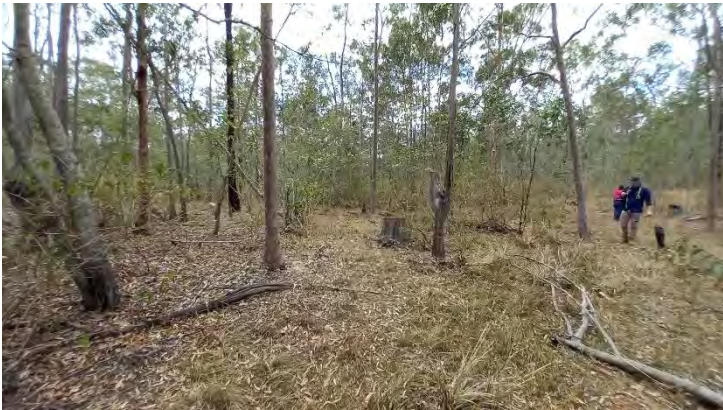
**Plate 11** *L. camara* fringing creek line. East view.

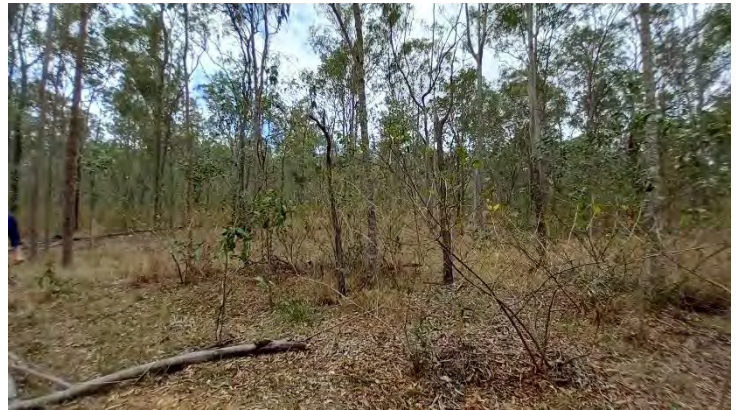
**Plate 12** *L. camara* fringing creek line. South view.

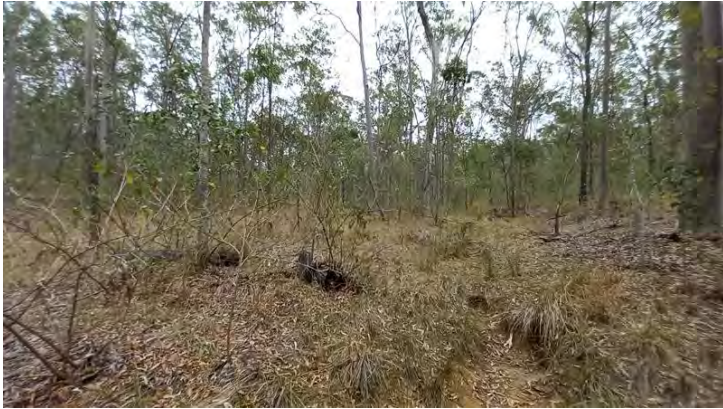
**Plate 13** *L. camara* fringing creek line. West view.

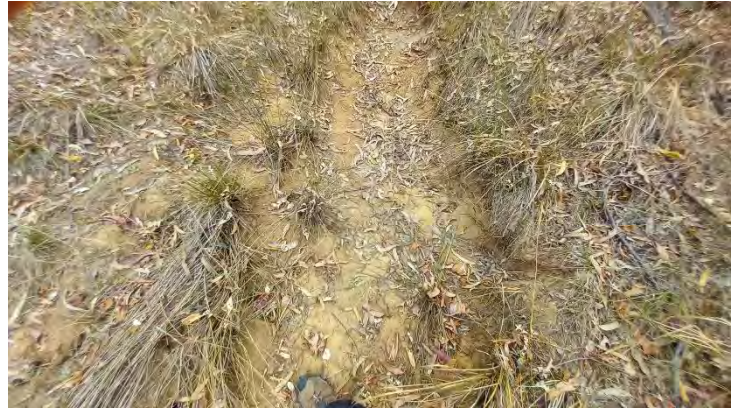
**Plate 14** Soil at *L. camara* infestation fringing creek line.

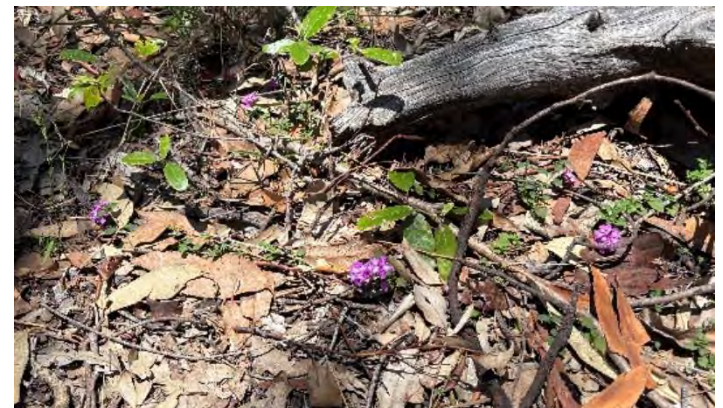
**Plate 15** *L. montedivensis*.

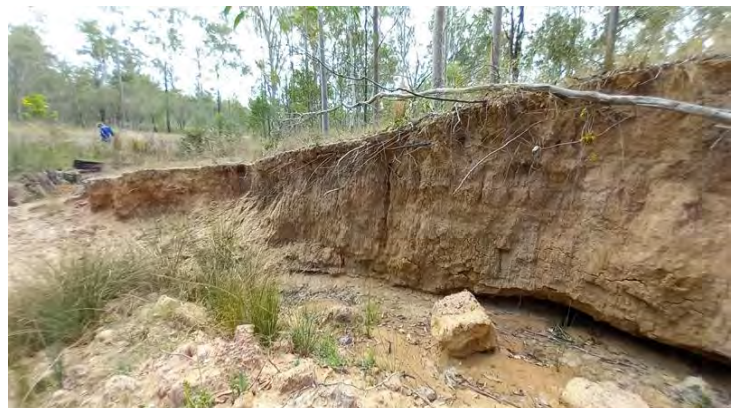
**Plate 16** *Melinis* sp. north view.

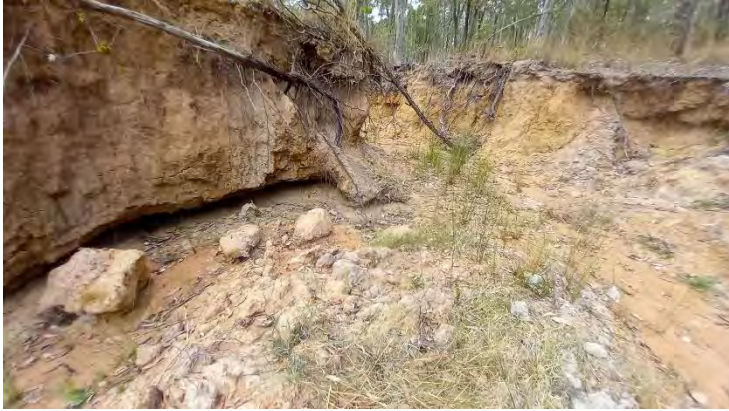
**Plate 17** *Melinis* sp. east view.

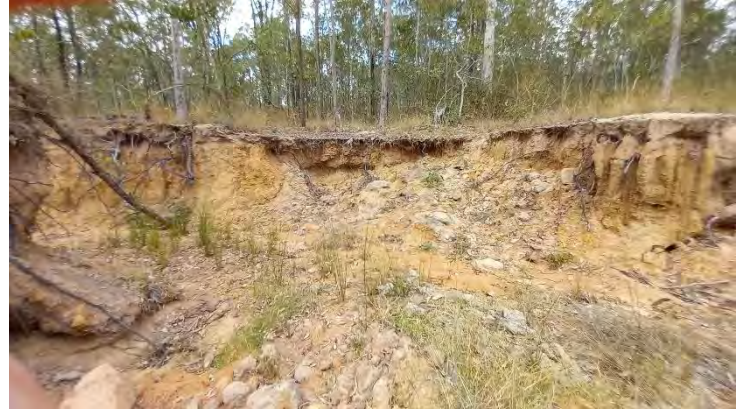
**Plate 18** *Melinis* sp. south view.

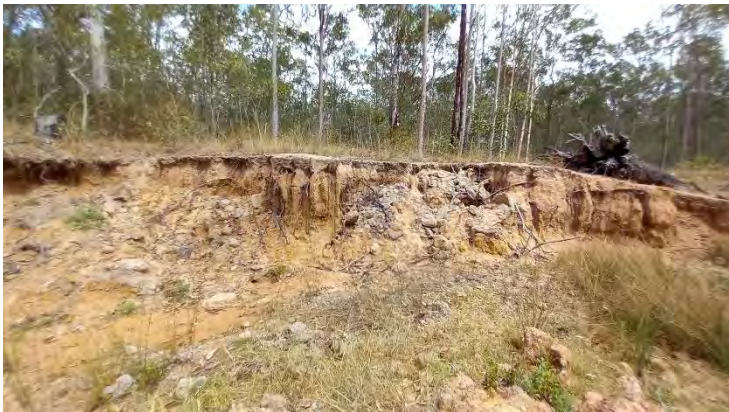
**Plate 19** *Melinis* sp. west view.

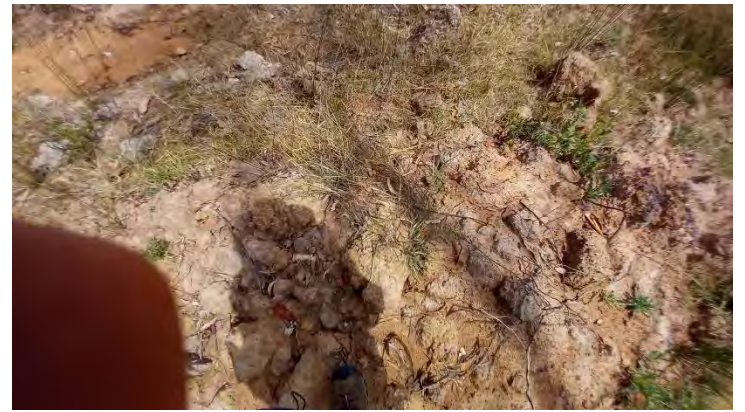
**Plate 20** *Melinis* sp. soil.

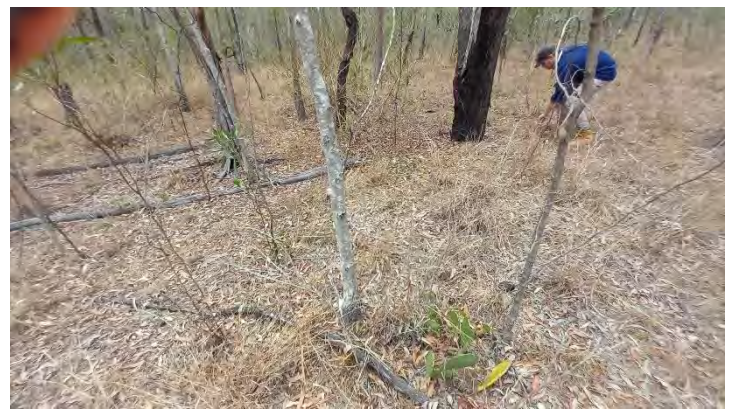
**Plate 21** *Opuntia* spp. (O3) north view.

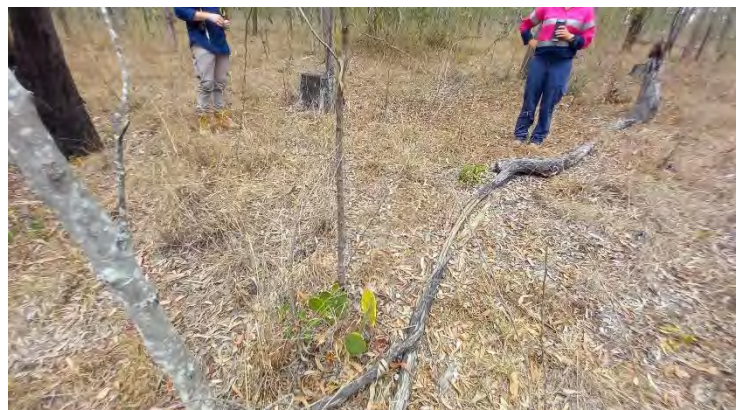
**Plate 22** *Opuntia* spp. (O3) east view.

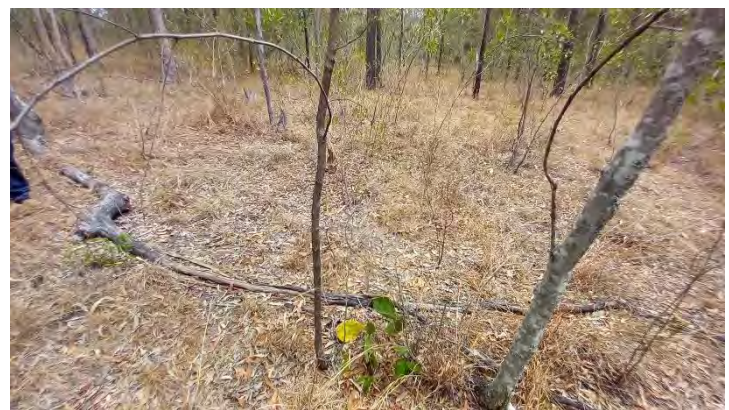
**Plate 23** *Opuntia* spp. (O3) south view.

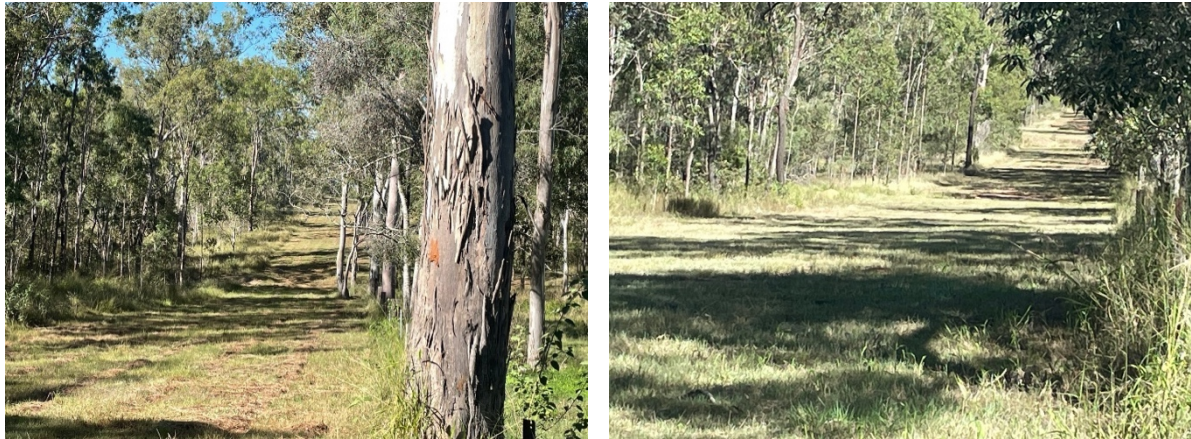
- d. I also inspected all sections of the wildlife friendly fences along the western, northern and eastern sides of the lot. They are all in good condition. They include a plain top wire, a plain bottom wire, and variously two or three middle wires which are ordinary barbed wire. No other damage was discovered. Several dozen Eastern Grey Kangaroos (*Macropus giganteus*) were onsite and were observed to pass freely backwards and forwards through the wildlife-friendly fence on the eastern boundary of the property.
- e. The fence maintenance lines along the western, northern and eastern boundaries were also mowed by Horrigan Slashing and are all in good condition. See photographs below,

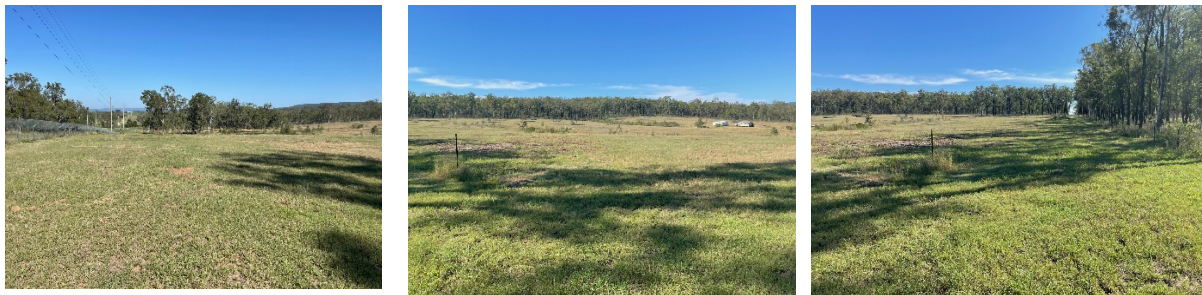
- f. The cleared project footprint was also mowed by Horrigan Slashing and is now in good condition. See photographs below:

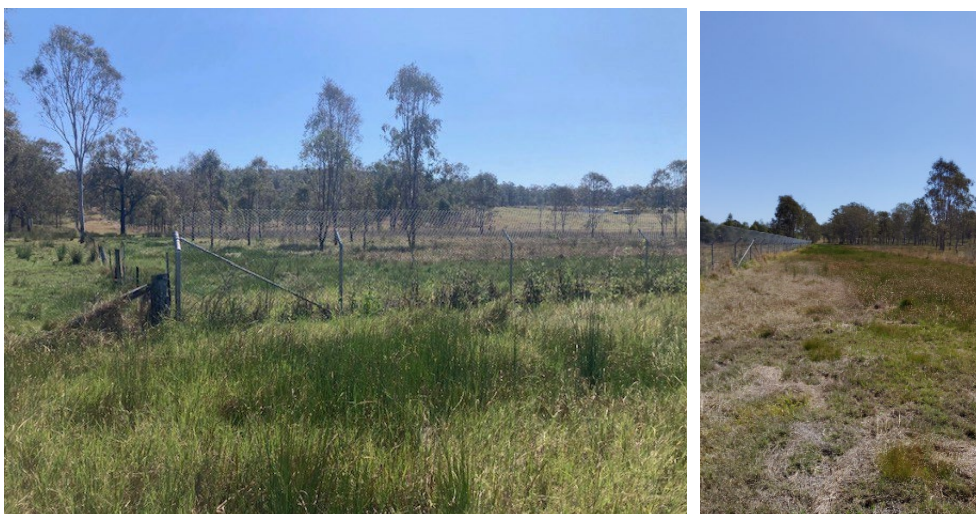
- f. No other fence damage was discovered. The low-lying area in the south-west corner of the lot was not accessible however the fence appeared to be in good condition.

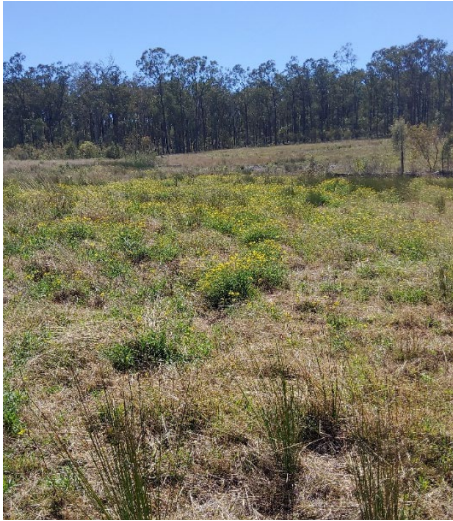
Fireweed (*Senecio madagascariensis*) is present on the cleared area that is being slashed, as well as the surrounding properties and roadside. The optimum time for spraying of Fireweed is during the early growth/flowering period June-August each year. A treatment plan will be developed to address the infestation. Biosecurity measures including blow down/wash down of vehicles and boots will be required for all vehicles and personnel accessing the site.

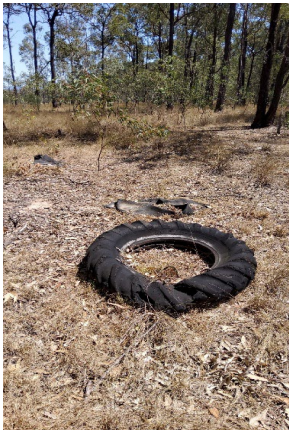
- a. Waste on site – An old tractor tyre (regulated waste) and inner tube were identified during the inspection. These are in the southeastern area of Offset A. A strategy to remove these from the property in a controlled manner will be progressed.

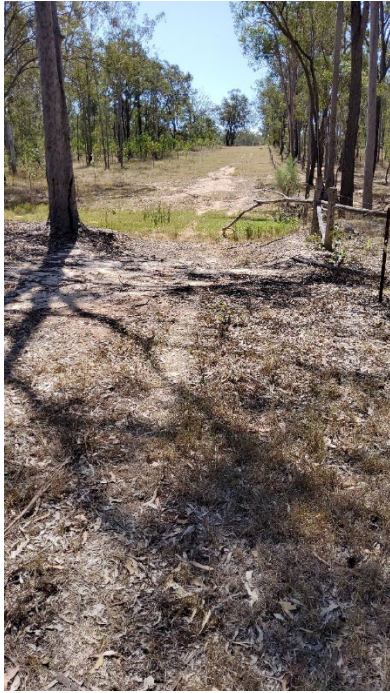
Eastern Track

- b. Erosion control outside offset areas – Creek and drain crossings on fence maintenance and fire access track eastern (1) Northern (2) Western (1) – These crossings are currently serviceable in a 4WD vehicle, however an opportunity to progress approvals and action crossing upgrades to reduce the potential for future erosion should be considered.
