## Interim Validation Letter (LTR01) – Proposed Lot 1, Lot 3 and Part Roads

Westlink Stage 1 – Aldington Road and Abbotts Road, Kemps Creek, NSW, 2178

Prepared for: ESR Australia

EP3244.005\_VAL\_LTR01\_ESR\_Westlink Stage 1\_v2 | 27 May 2024

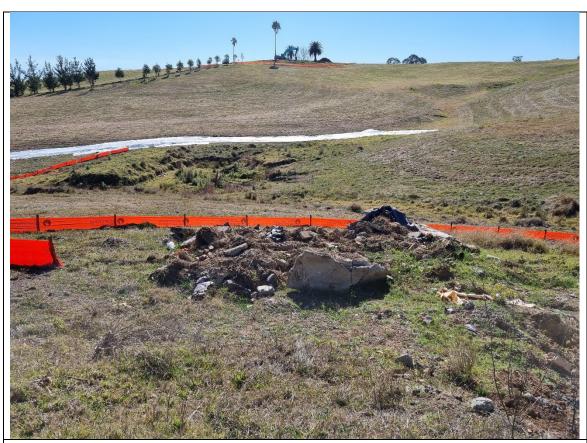
Plate 1 – 09/08/2023
SP05 prior to removal off-site. No photo sourced of the ground surface following the removal of SP05.

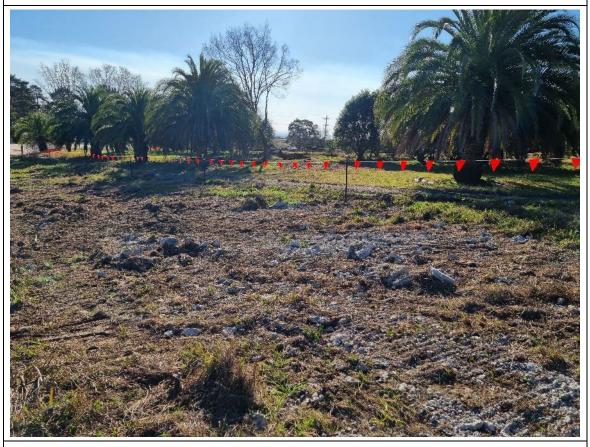
Plate 2 – 01/08/2023
Ground surface following removal of SP11, facing northwest.

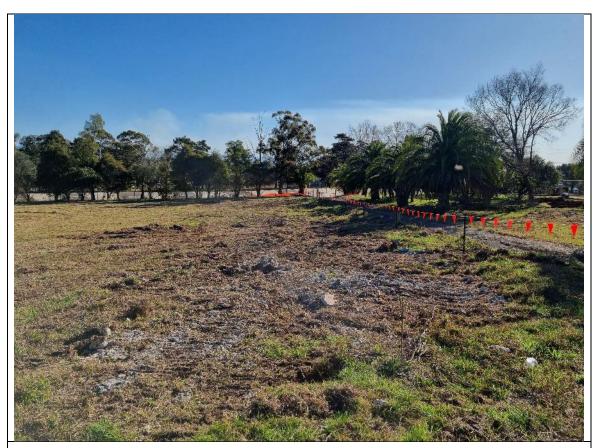
Plate 3 – 01/08/2023
Ground surface following removal of SP11, facing northwest.

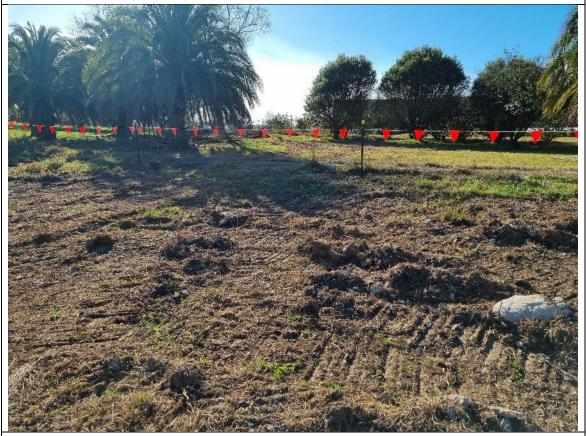
Plate 4 – 01/08/2023
Ground surface following removal of SP12, facing north.

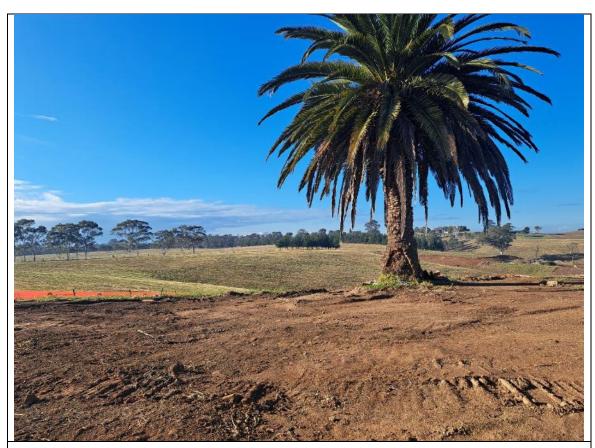
Plate 5 – 01/08/2023
Ground surface following removal of SP13 and SP14, facing north.

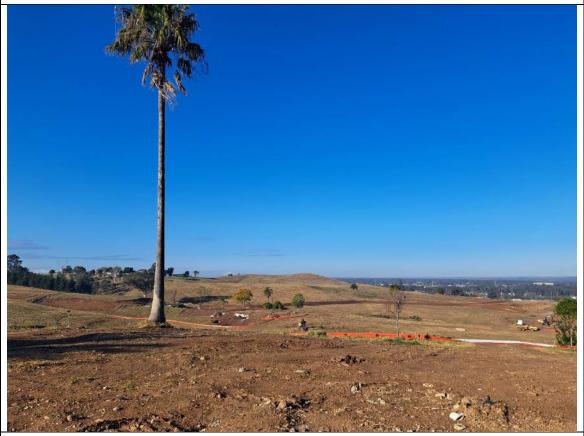
$\label{eq:Plate 6-01/08/2023} \textbf{Plate 6-01/08/2023}$  Ground surface following removal of SP13 and SP14, facing north.

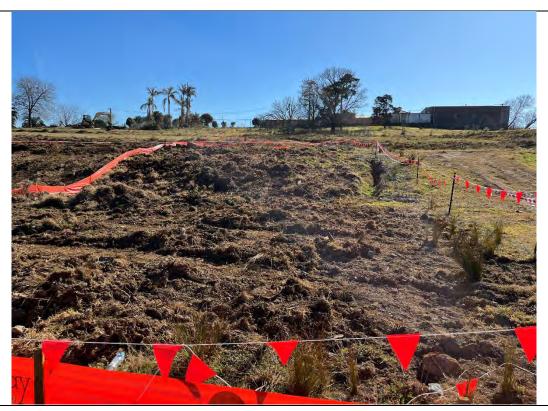
Plate 1-24/07/2023 Surficial soils within AEC01a subsequent to in-situ mechanical raking and emu picking of bonded (non-friable) ACM fragments.

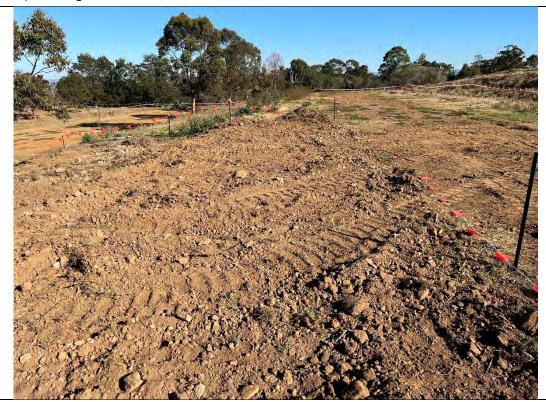
Plate 2-24/07/2023 Surficial soils within AEC01a subsequent to in-situ mechanical raking and emu picking of bonded (non-friable) ACM fragments.

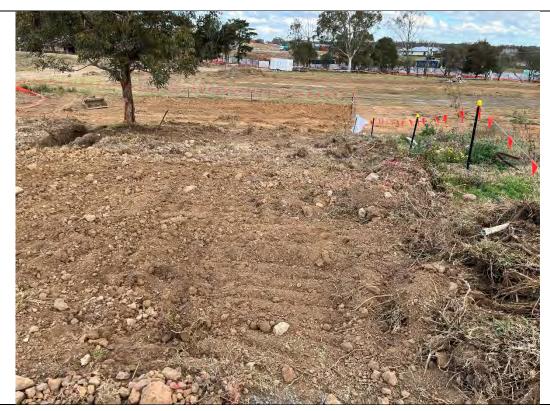
Plate 3-24/07/2023 Surficial soils within AEC01a subsequent to in-situ mechanical raking and emu picking of bonded (non-friable) ACM fragments.

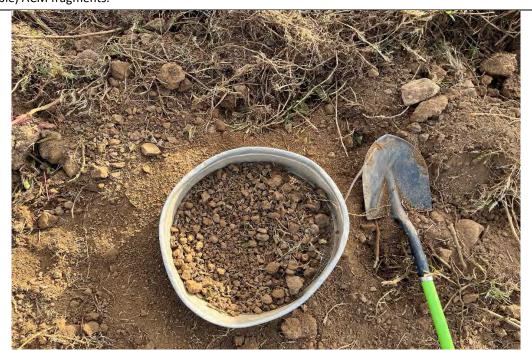
Plate 4 - 24/07/2023

Validation sieving within AEC01a subsequent to in-situ mechanical raking and emu picking of bonded (non-friable) ACM fragments.

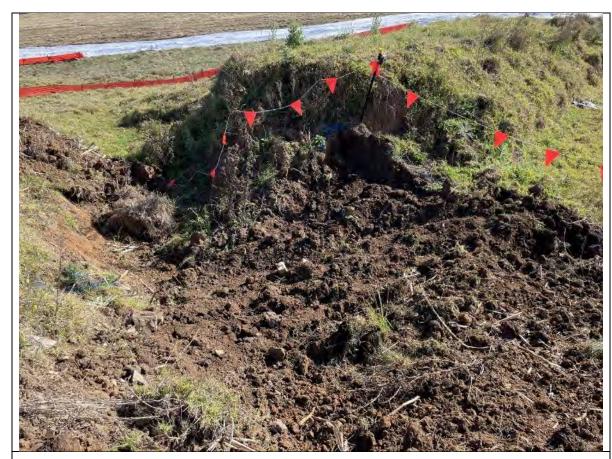
Plate 1 – 08/08/2023
AEC09b following in-situ mechanical rake and emu pick of surficial soils.

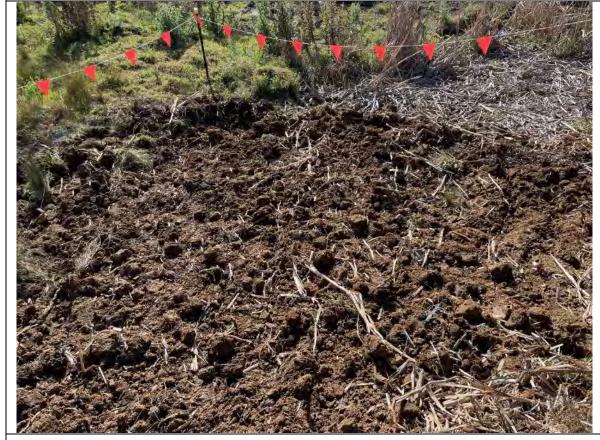
Plate 2 – 08/08/2023
AEC09b following in-situ mechanical rake and emu pick of surficial soils.

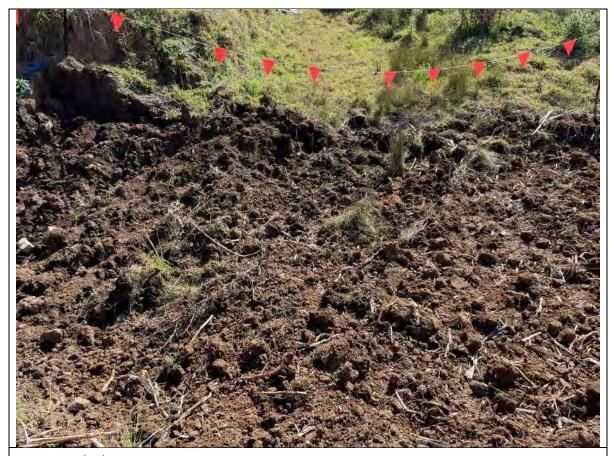
Plate 3 – 08/08/2023
AEC09b following in-situ mechanical rake and emu pick of surficial soils.

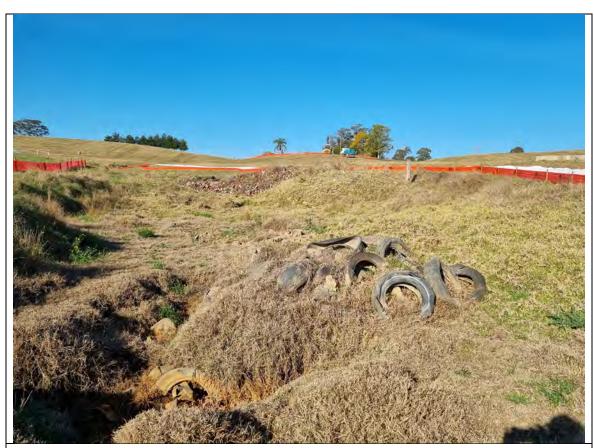
Plate 1 – 07/08/2023 AEC14 prior to remediation works.

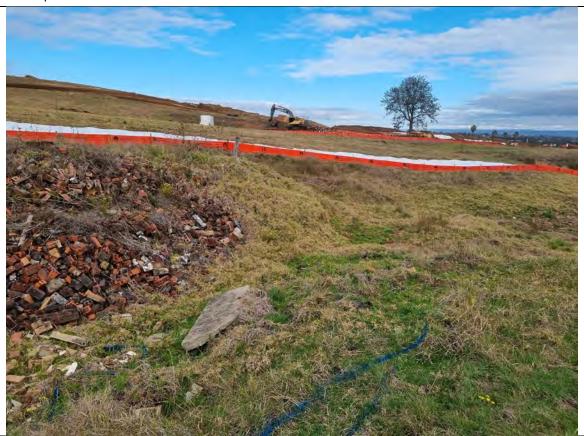
Plate 2 – 07/08/2023
AEC14 prior to remediation works.

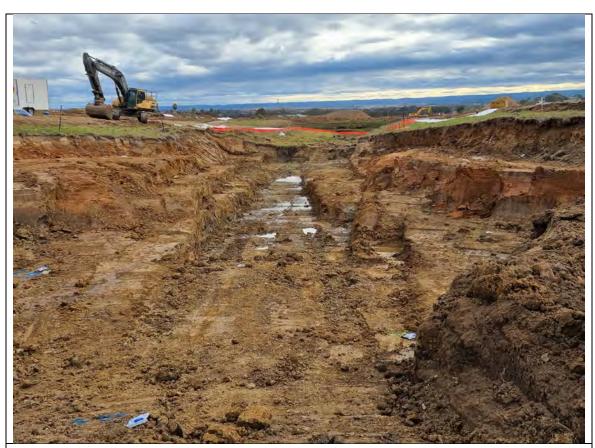
$\label{eq:Plate 3-23/08/2023} Plate \ 3-23/08/2023$  Residual soils within AEC14 subsequent to excavation of friable ACM impacted soils to natural.

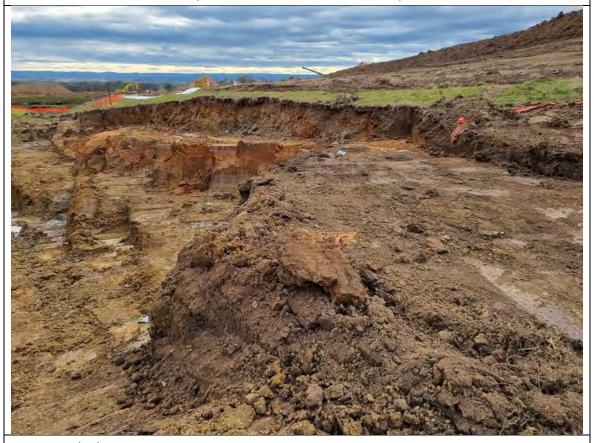
Plate 4 - 23/08/2023Residual soils within AEC14 subsequent to excavation of friable ACM impacted soils to natural.

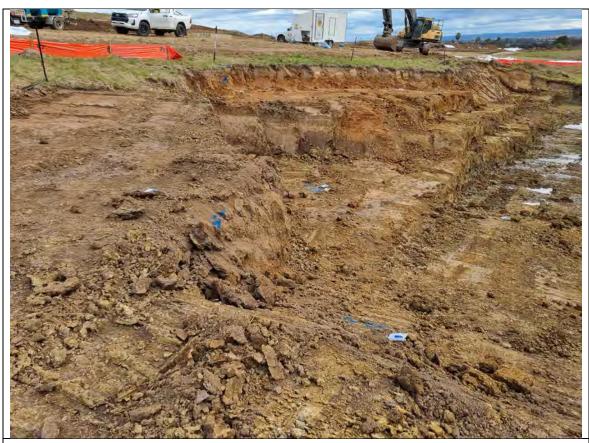
$\label{eq:Plate 5-23/08/2023} Plate 5-23/08/2023$  Residual soils within AEC14 subsequent to excavation of friable ACM impacted soils to natural.

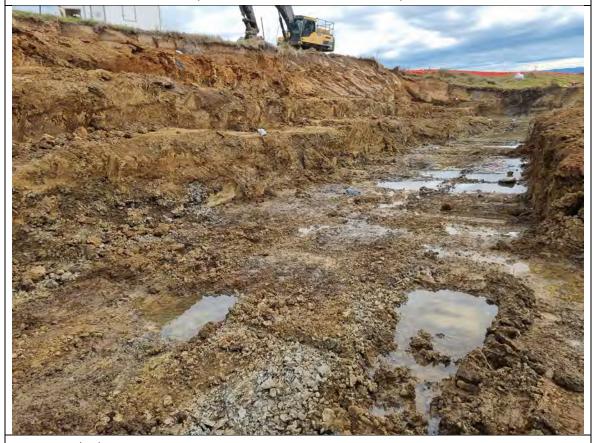
$\label{eq:Plate 6-23/08/2023} Plate 6-23/08/2023$  Residual soils within AEC14 subsequent to excavation of friable ACM impacted soils to natural.

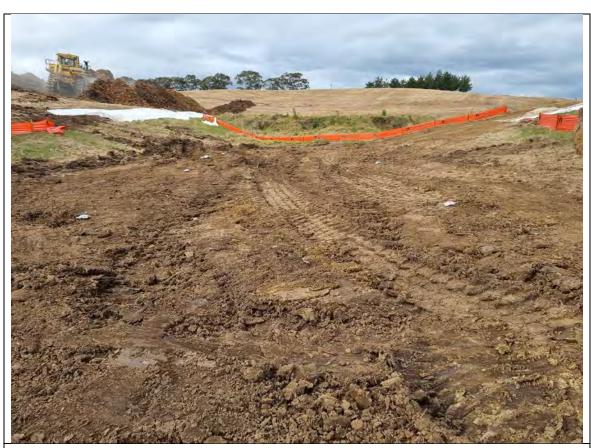
Plate 7 - 23/08/2023Residual soils within AEC14 subsequent to excavation of friable ACM impacted soils to natural.

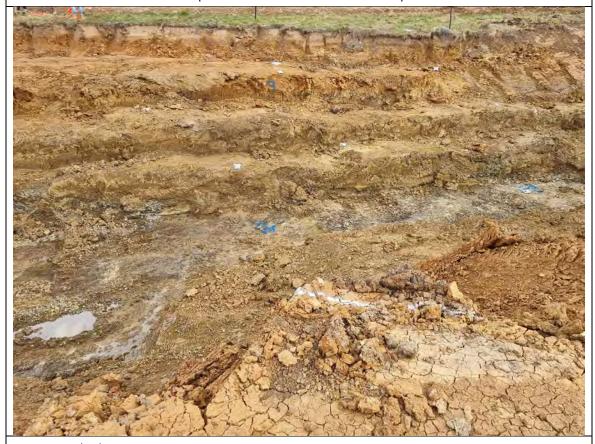
$\label{eq:Plate 8-23/08/2023} Plate 8-23/08/2023$  Residual soils within AEC14 subsequent to excavation of friable ACM impacted soils to natural.

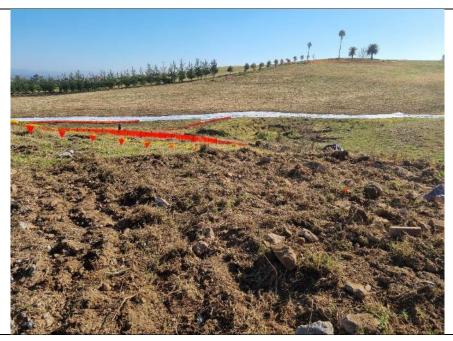
Plate 1-03/08/2023 Surficial soils within AEC15 subsequent to in-situ mechanical raking and emu picking of bonded (non-friable) ACM fragments.

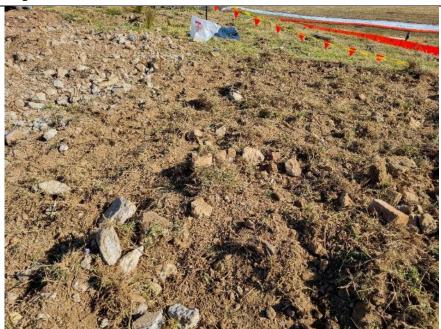
Plate 2 – 03/08/2023 Surficial soils within AEC15 subsequent to in-situ mechanical raking and emu picking of bonded (non-friable) ACM fragments.

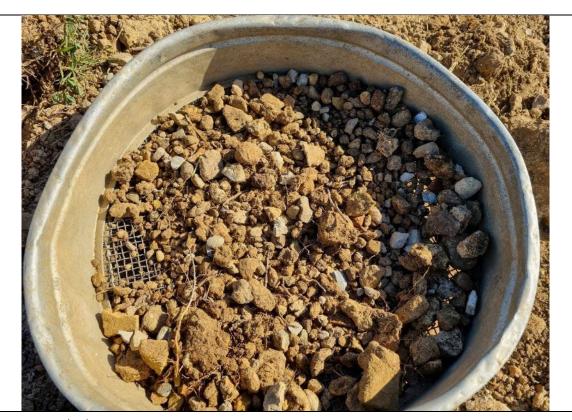
**Plate 3** – 03/08/2023

Field screening of residual rake footprint in AEC15 following in-situ mechanical raking and emu picking of bonded (non-friable) ACM fragments.

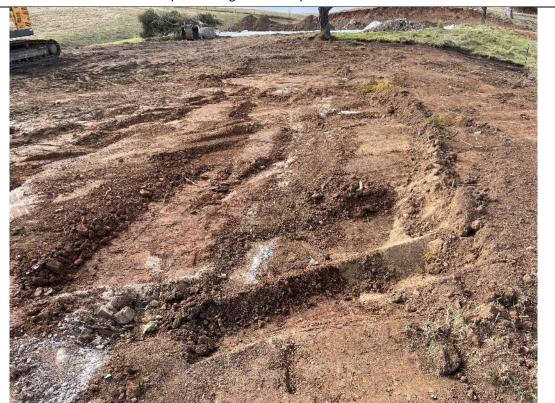
$\label{eq:Plate 6-07/08/2023}$  Residual soils within the former house footprint in AEC15 subsequent to B3 scrape.

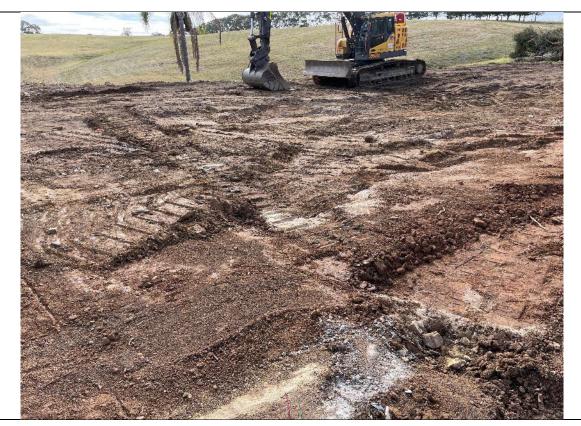
Plate 7-07/08/2023 Residual soils within the former house footprint in AEC15 subsequent to B3 scrape.

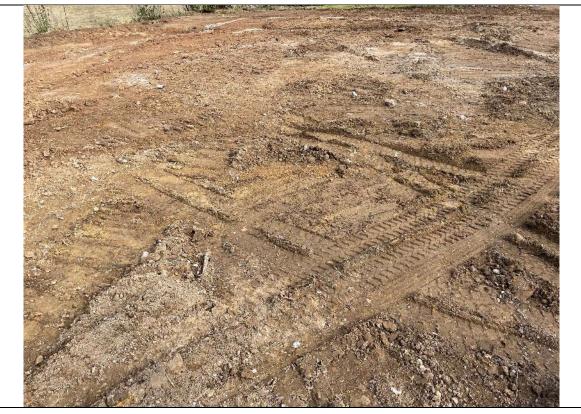
Plate 8-07/08/2023 Residual soils within the former house footprint in AEC15 subsequent to B3 scrape.

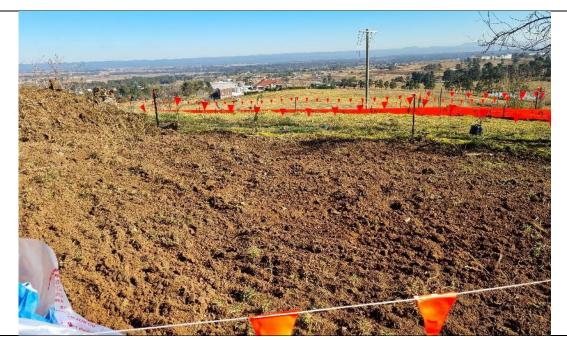
Plate 1-26/07/2023Surficial soils within AEC32 – TP201 subsequent to in-situ mechanical raking and emu picking of bonded (non-friable) ACM fragments.

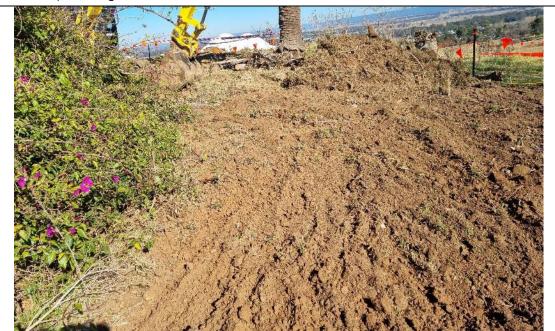
Plate 2-26/07/2023Surficial soils within AEC32 – TP201 subsequent to in-situ mechanical raking and emu picking of bonded (non-friable) ACM fragments.

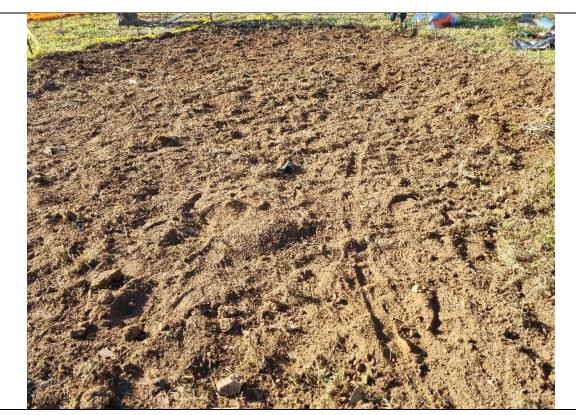
Plate 3-26/07/2023 Surficial soils within AEC32 – TP201 subsequent to in-situ mechanical raking and emu picking of bonded (non-friable) ACM fragments.

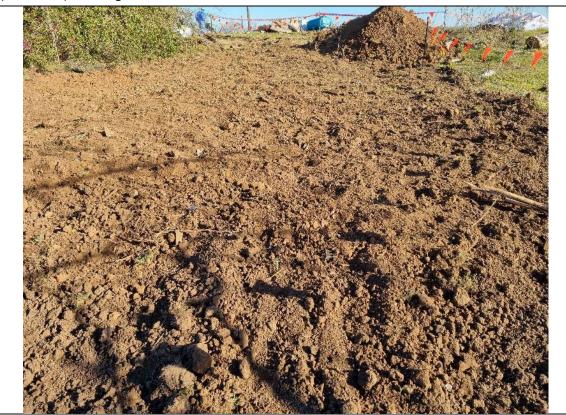
Plate 4 - 26/07/2023Surficial soils within AEC32 – TP201 subsequent to in-situ mechanical raking and emu picking of bonded (non-friable) ACM fragments.

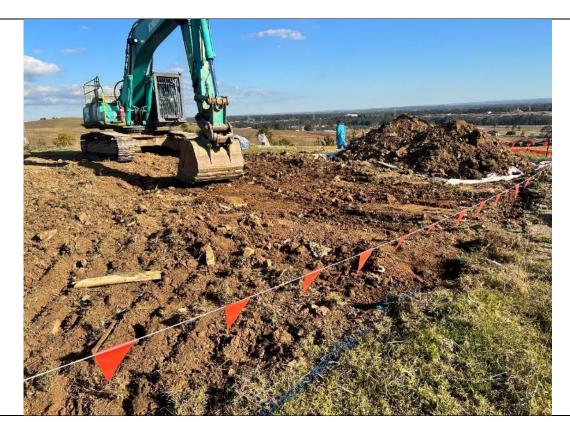
Plate 5-25/07/2023Surficial soils within AEC32 – TP207 in the process of in-situ mechanical raking.

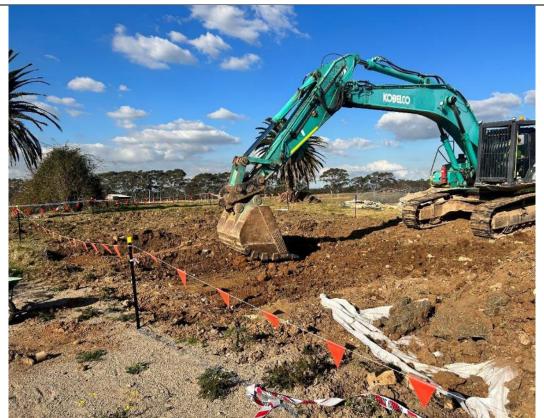
Plate 6-25/07/2023 Surficial soils within AEC32 – TP207 in the process of in-situ mechanical raking.

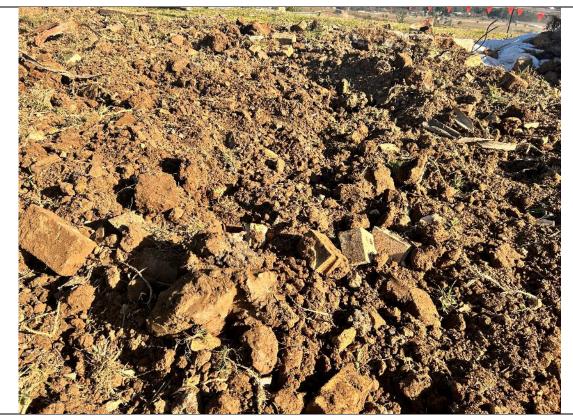
Plate 7 - 25/07/2023Surficial soils within AEC32 – TP207 subsequent to in-situ mechanical raking and emu picking of bonded (non-friable) ACM fragments.

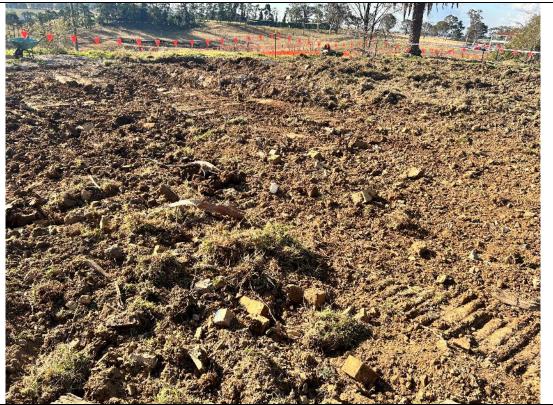
Plate 8 – 25/07/2023

Surficial soils within AEC32 – TP207 subsequent to in-situ mechanical raking and emu picking of bonded (non-friable) ACM fragments.

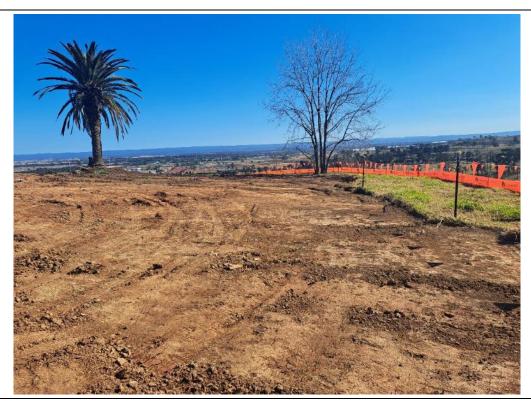
**Plate 9** – 01/08/2023

AEC32 and AEC32a subsequent to a vegetation scrape and scrape to 0.2 mBGL in the eastern end and emu picking of bonded (non-friable) ACM fragments.

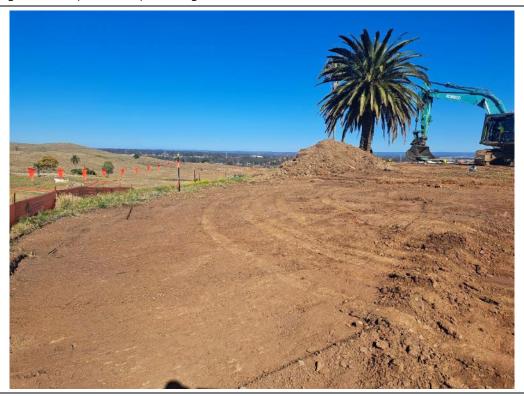
Plate 10 - 01/08/2023

AEC32 and AEC32a subsequent to a vegetation scrape and scrape to 0.2 mBGL in the eastern end and emu picking of bonded (non-friable) ACM fragments.

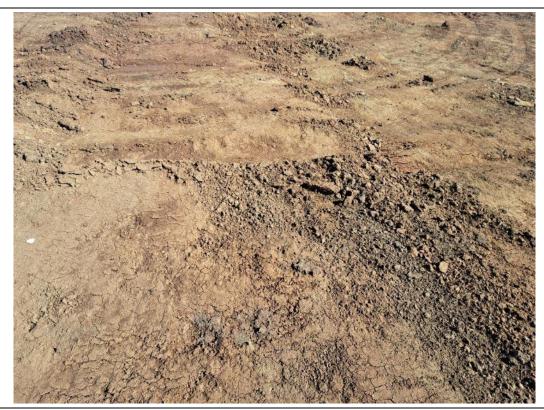
Plate 10 - 01/08/2023AEC32 and AEC32a subsequent to a vegetation scrape and scrape to 0.2 mBGL in the eastern end and emu picking of bonded (non-friable) ACM fragments.

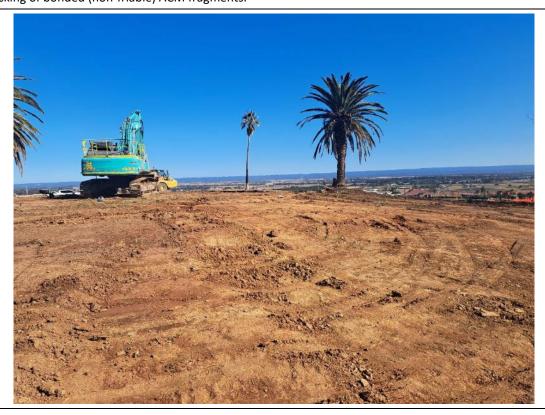
Plate 10 - 01/08/2023 AEC32 and AEC32a subsequent to a vegetation scrape and scrape to 0.2 mBGL in the eastern end and emu picking of bonded (non-friable) ACM fragments.

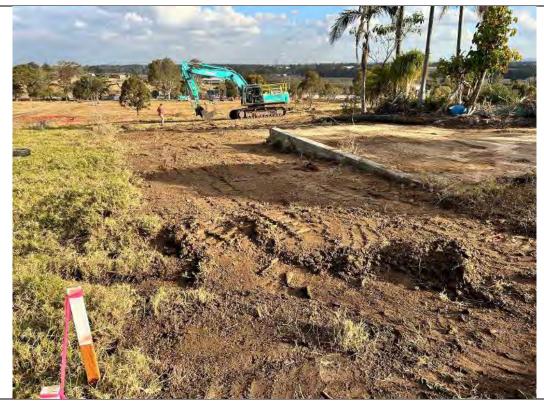
Plate 1 – 02/08/2023
Surficial soils within AEC33 subsequent to vegetation scrape & emu picking of ACM fragments.

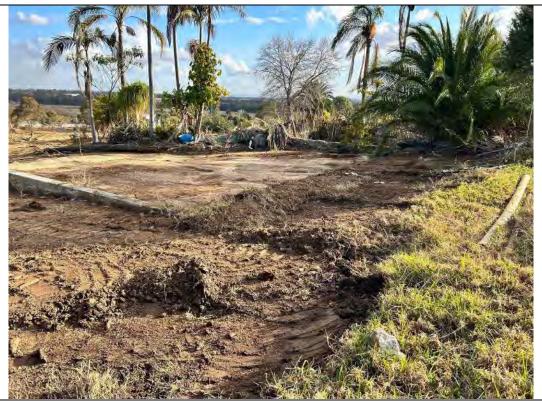
Plate 2 – 02/08/2023
Surficial soils within AEC33 subsequent to vegetation scrape & emu picking of ACM fragments.

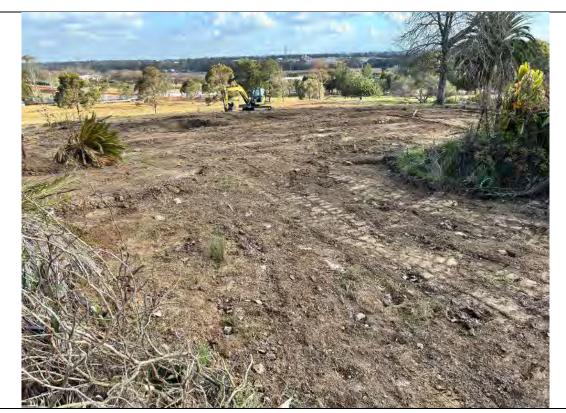
Plate 3-02/08/2023 Surficial soils within AEC33 subsequent to vegetation scrape & emu picking of ACM fragments.

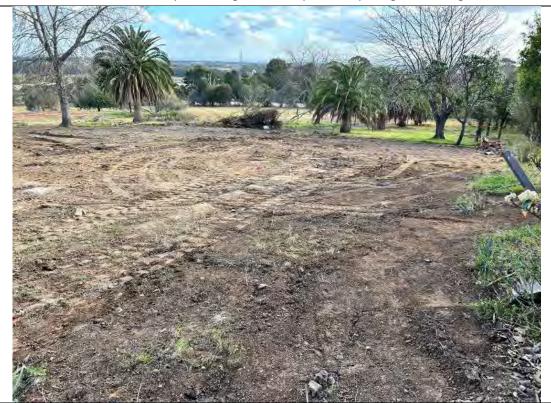
Plate 4-02/08/2023 Surficial soils within AEC33 subsequent to vegetation scrape & emu picking of ACM fragments.

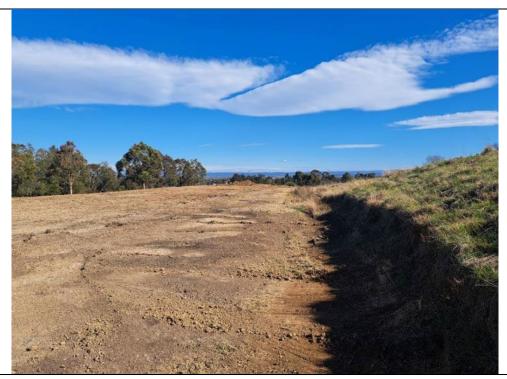
Plate 1 – 28/07/2023
AEC38 (Upper) following vegetation scrape + emu pick of surficial soils.

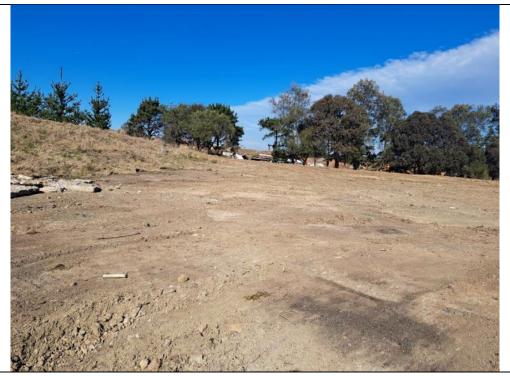
Plate 2 – 28/07/2023
AEC38 (Upper) following vegetation scrape + emu pick of surficial soils.

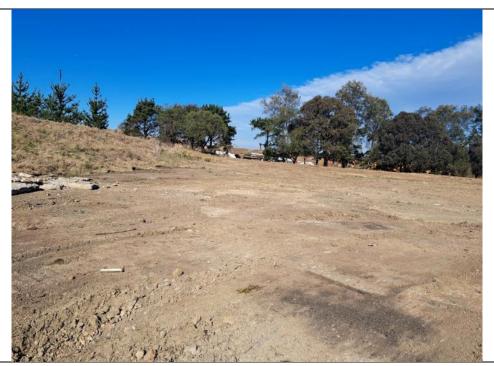
Plate 3 –28/07/2023
AEC38 (Upper) following vegetation scrape + emu pick of surficial soils.

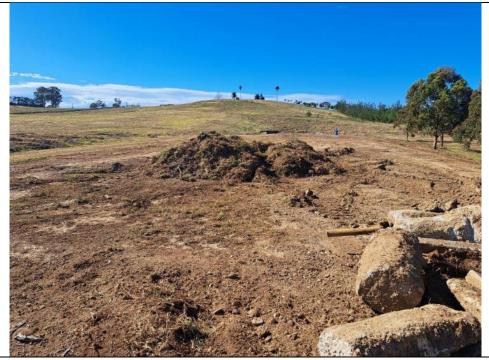
Plate 4 – 28/07/2023
AEC38 (Upper) following vegetation scrape + emu pick of surficial soils.

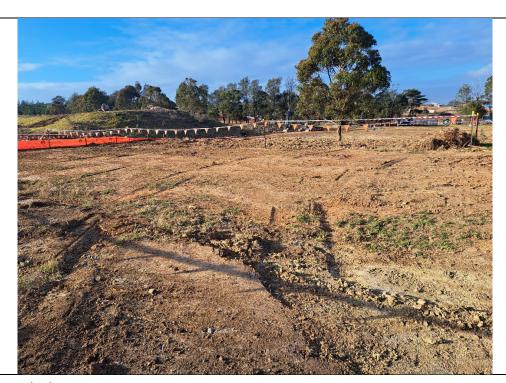
Plate 5 – 02/08/2023
AEC38 (Lower) following vegetation scrape + emu pick of surficial soils.

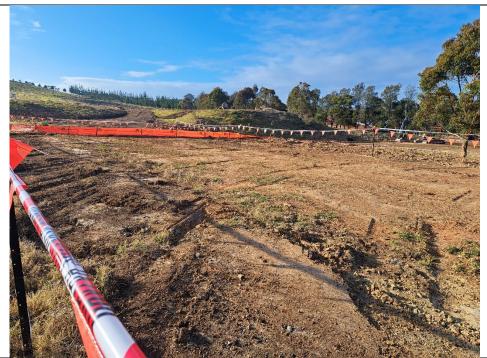
Plate 6 – 02/08/2023
AEC38 (Lower) following vegetation scrape + emu pick of surficial soils.

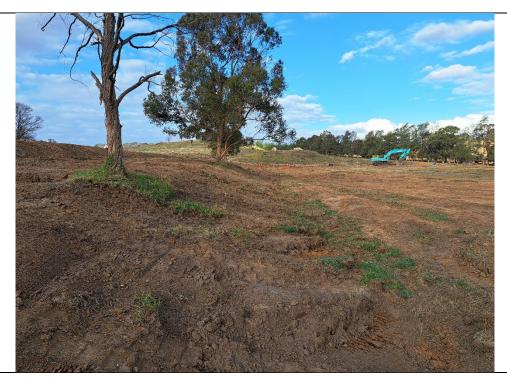
Plate 7 – 02/08/2023
AEC38 (Lower) following vegetation scrape + emu pick of surficial soils.

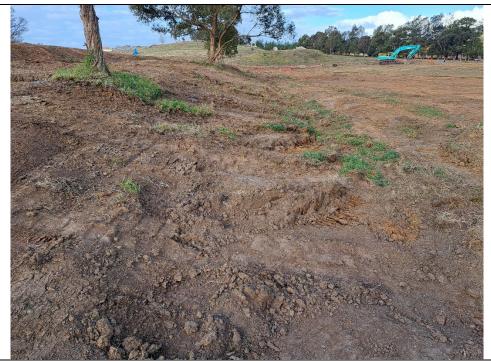
Plate 8 – 02/08/2023
AEC38 (Lower) following vegetation scrape + emu pick of surficial soils.

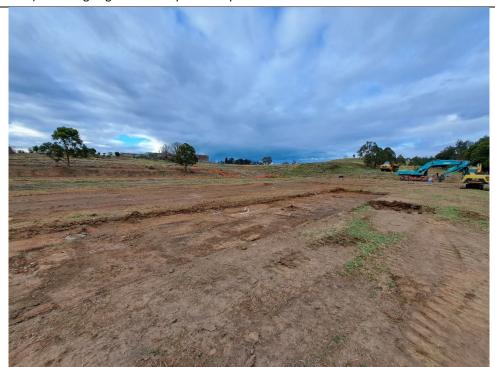
Plate 10 – 07/08/2023
AEC38 (Lower) following vegetation scrape + emu pick of surficial soils.

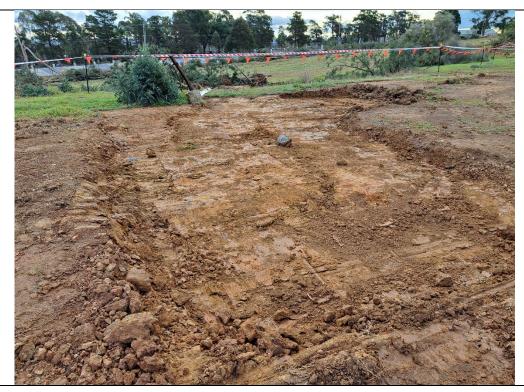
Plate 11 – 07/08/2023
AEC38 (Lower) following vegetation scrape + emu pick of surficial soils.

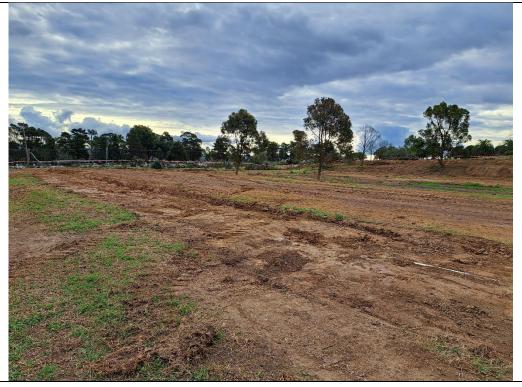
Plate 12 – 07/08/2023
AEC38 (Lower) following vegetation scrape + emu pick of surficial soils.

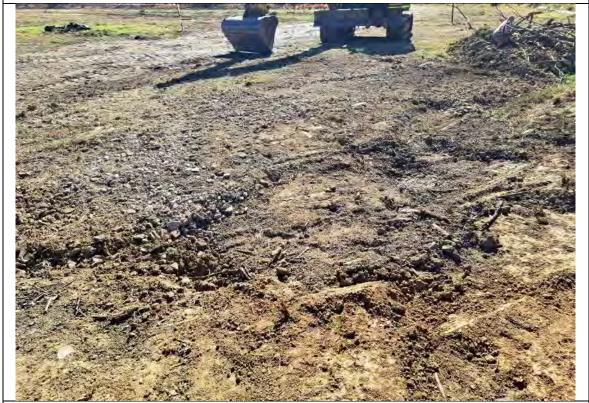
Plate 4 - 31/07/2023 UF001 subsequent to excavation of surficial soils as F3 material.

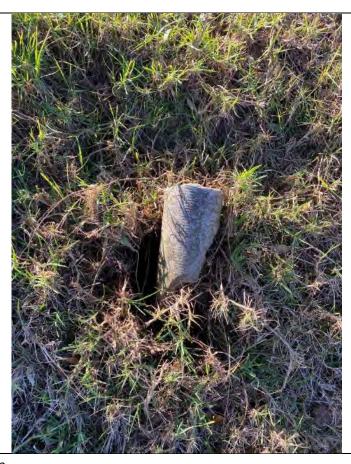
Plate 1 – 14/07/2023
UF003 – Asbestos cement conduit identified within AEC01a during remediation in-situ treatment works.

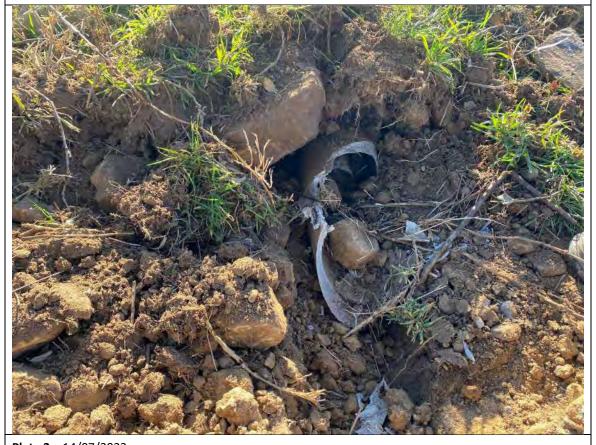
Plate 2 – 14/07/2023 UF003 – Breakpoint of asbestos cement conduit.

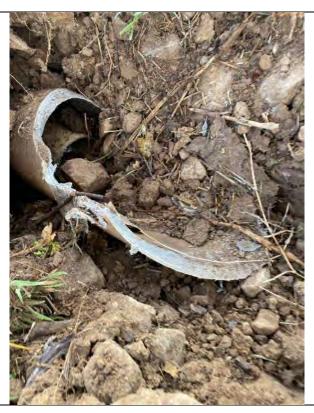
Plate 3 – 14/07/2023 UF003 – Breakpoint of asbestos cement conduit.

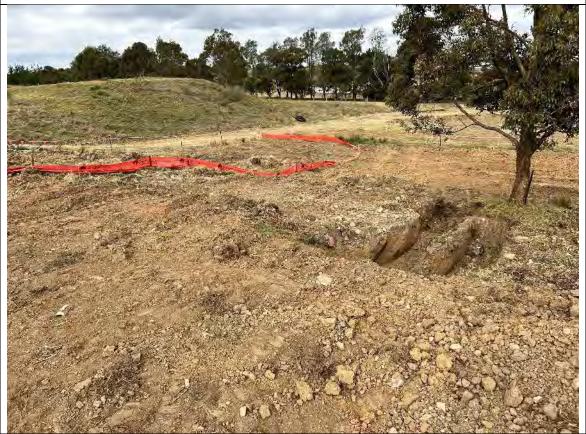
Plate 3 - 14/07/2023Post remedial works: Excavated trench and 1 m x 1 m box out at the breakpoint of asbestos cement conduit.

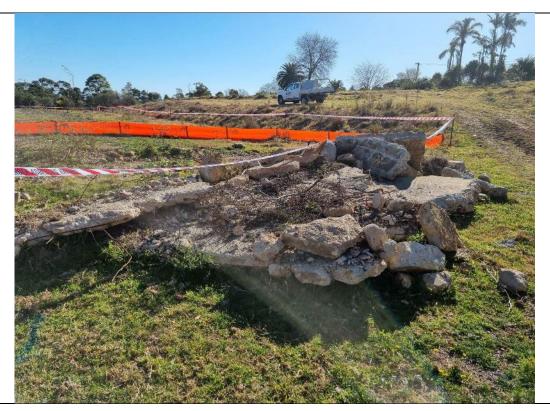
Plate 1 – 12/07/2023
UF019 - Concrete stockpile contaminated with ACM fragments.

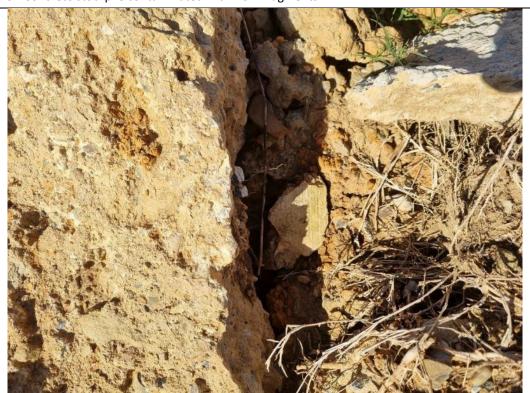
**Plate 2** – 12/07/2023 UF019 - Concrete stockpile contaminated with ACM fragments.

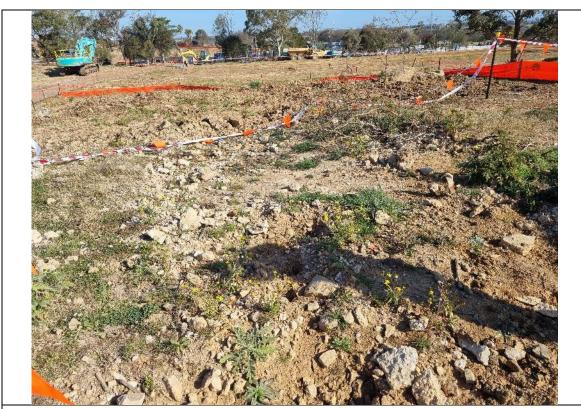
Plate 3 - 03/08/2023 Ground surface following removal of UF019 - concrete stockpile contaminated with ACM fragments.

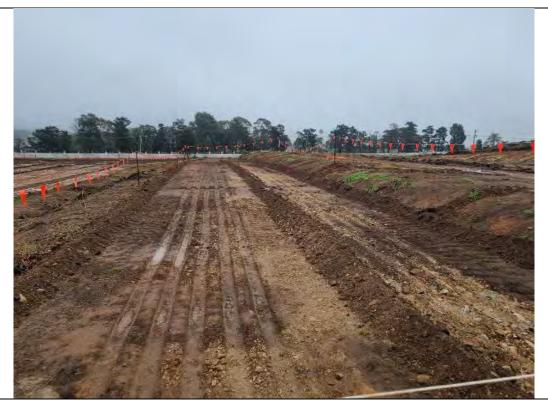
Plate 1 – 14/08/2023
UF024 (conduits within AEC38 Lower) prior to remediation works.

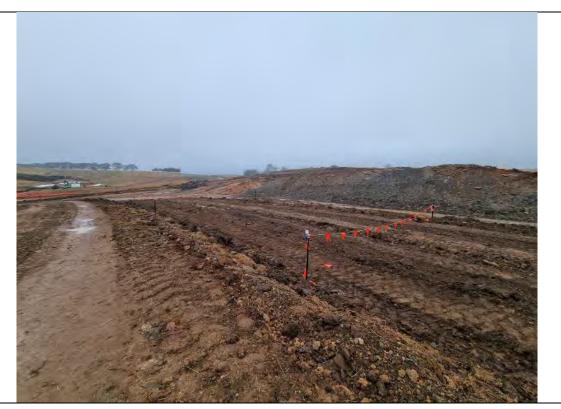
Plate 5 - 14/08/2023 UF024 (2x loads of ASBINS) prior to remediation works.

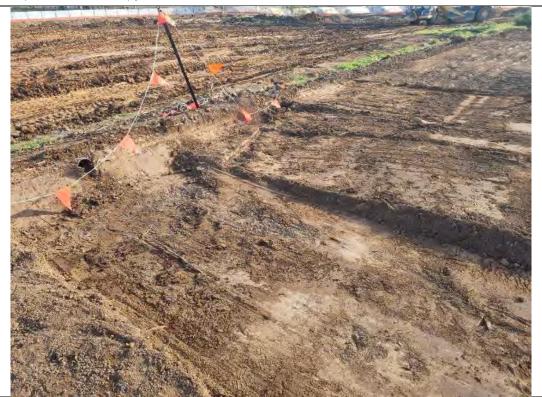
Plate 6 – 15/08/2023
Residual excavation footprint of UF024 (conduits) subsequent to excavation of F3 material

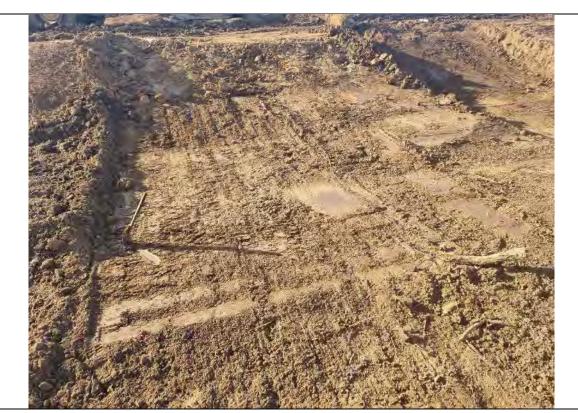
Plate 7 - 15/08/2023 Residual excavation footprint of UF024 (conduits) subsequent to excavation of F3 material

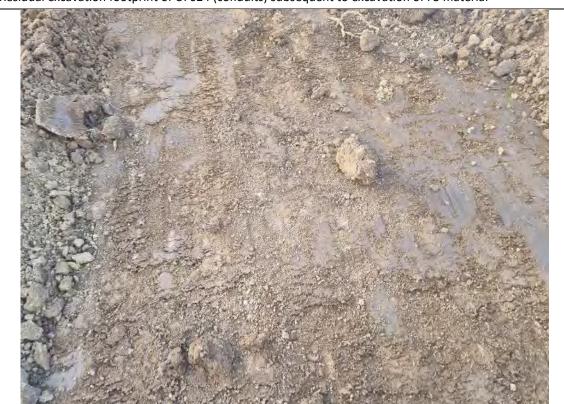
Plate 8-15/08/2023Residual excavation footprint of UF024 (conduits) subsequent to excavation of F3 material.

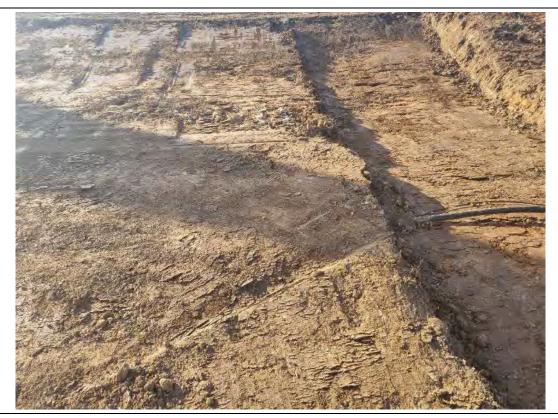
Plate 9 – 15/08/2023
Residual excavation footprint of UF024 (conduits) subsequent to excavation of F3 material.

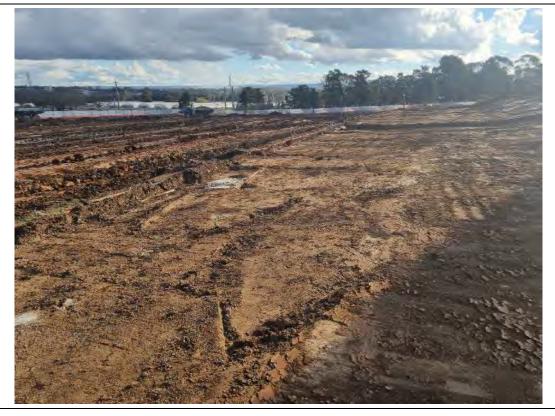
Plate 10 – 15/08/2023
Residual excavation footprint of UF024 (conduits) subsequent to excavation of F3 material.

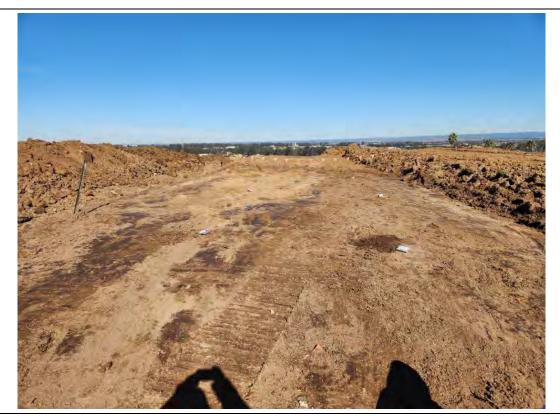
Plate 11 – 16/08/2023
Residual excavation footprint of UF024 (2x loads of ASBINS) subsequent to excavation of F3 material.

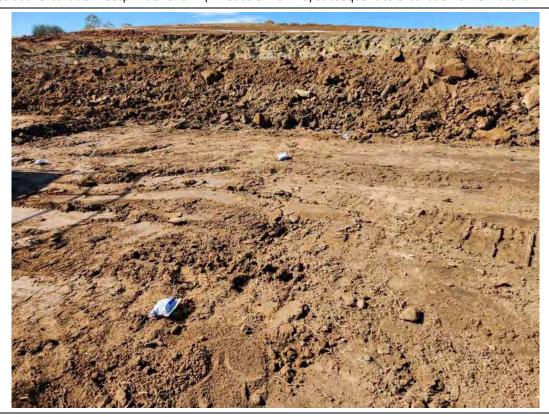
Plate 12 – 16/08/2023
Residual excavation footprint of UF024 (2x loads of ASBINS) subsequent to excavation of F3 material.

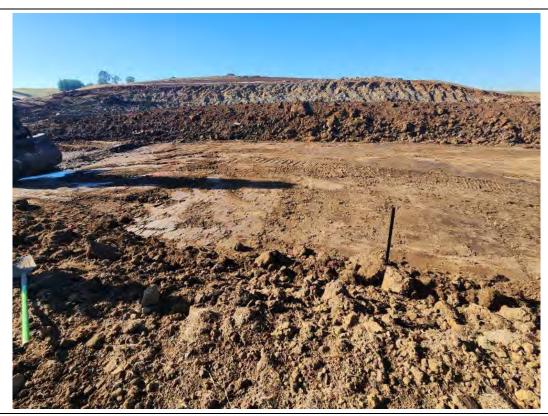
Plate 13 – 16/08/2023
Residual excavation footprint of UF024 (2x loads of ASBINS) subsequent to excavation of F3 material.

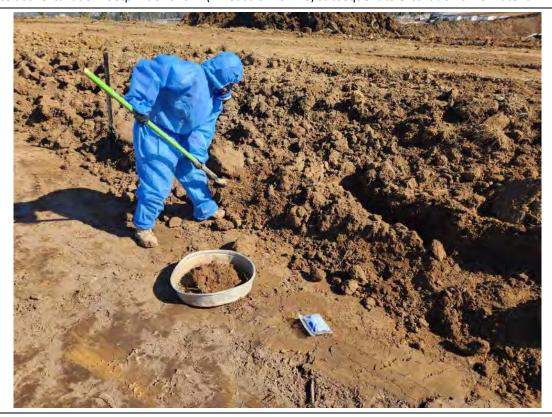
Plate 14 - 16/08/2023

Validation sampling undertaken within UF024 (2x loads of ASBINS) subsequent to excavation of F3 material.

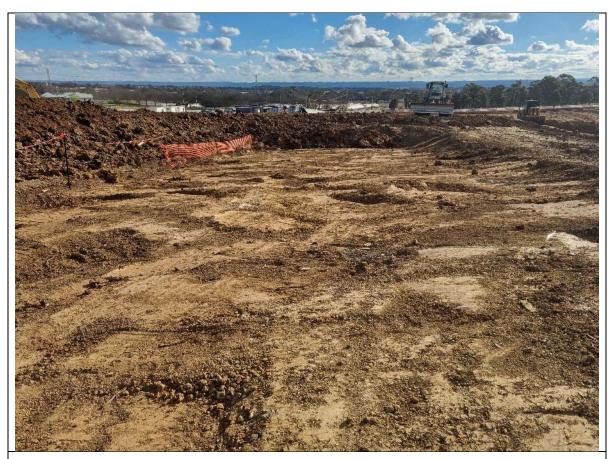
Plate 1 – 16/08/2023
UF025 following excavation of 0.3m BGL of in-situ soils and ex-situ stockpile.

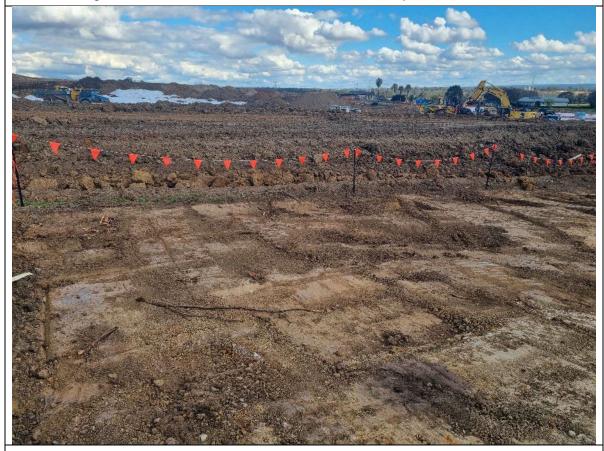
Plate 2 – 16/08/2023 UF025 following excavation of 0.3m BGL of in-situ soils and ex-situ stockpile.

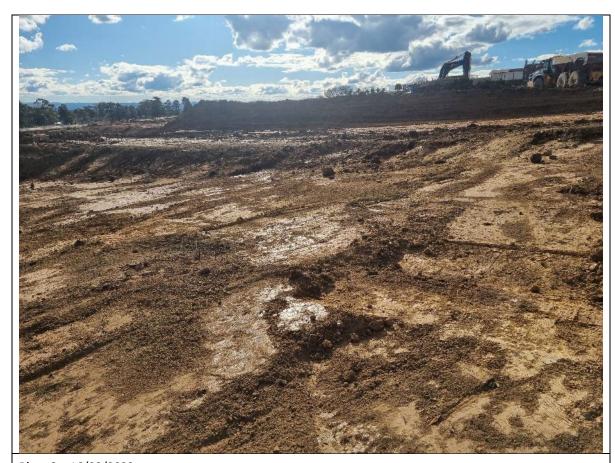
Plate 3 – 16/08/2023
UF025 following excavation of 0.3m BGL of in-situ soils and ex-situ stockpile.

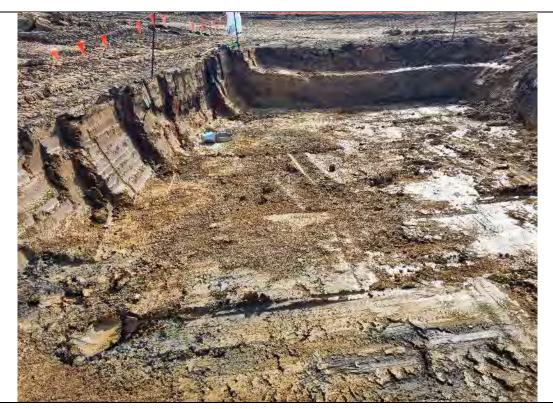
Plate 1 – 22/08/2023
Residual excavation footprint of UF026 subsequent to removal of B3 material.

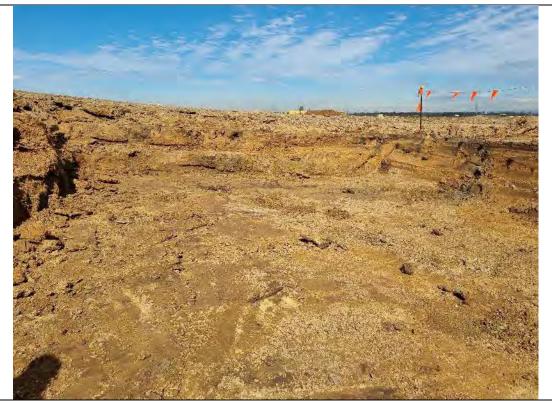
Plate 2 – 22/08/2023
Residual excavation footprint of UF026 subsequent to removal of B3 material.

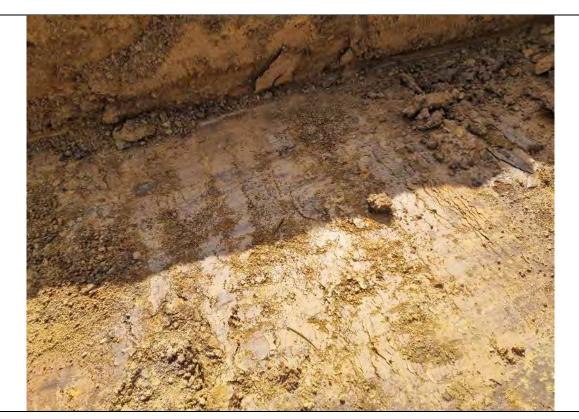
Plate 3-22/08/2023Residual excavation footprint of UF026 subsequent to removal of B3 material.

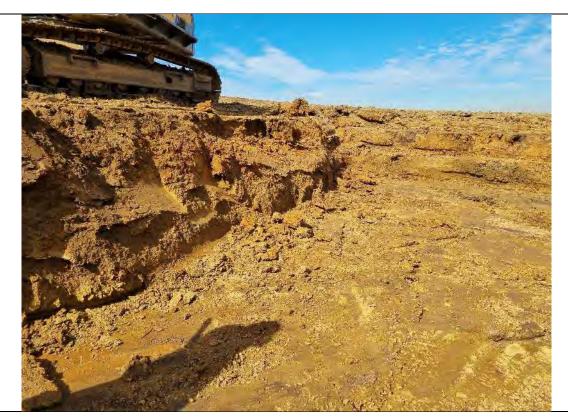
Plate 5-22/08/2023Residual excavation footprint of UF026 subsequent to removal of B3 material.

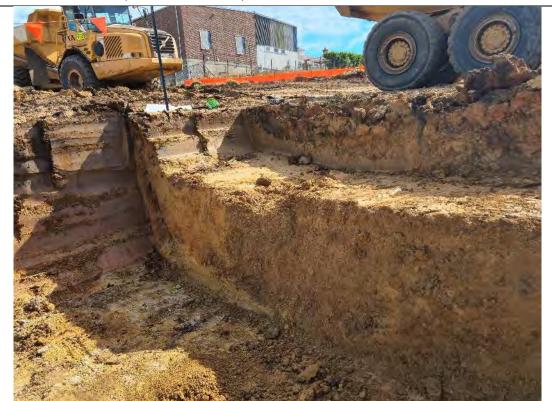
$\label{eq:Plate 6-2/08/2023} Plate 6-2/08/2023$  Residual excavation footprint of UF026 subsequent to removal of B3 material.

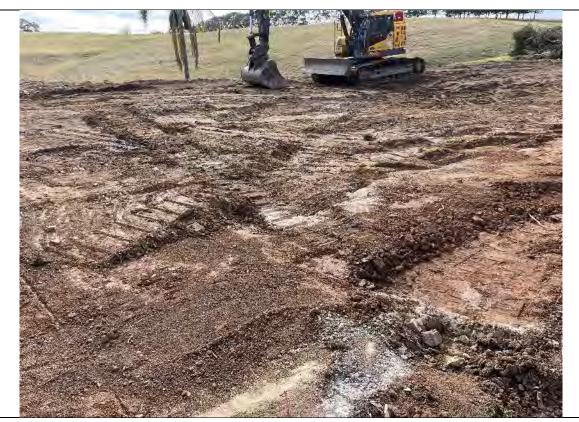
Plate 7-07/08/2023 Residual soils within the former house footprint in AEC15 subsequent to B3 scrape.

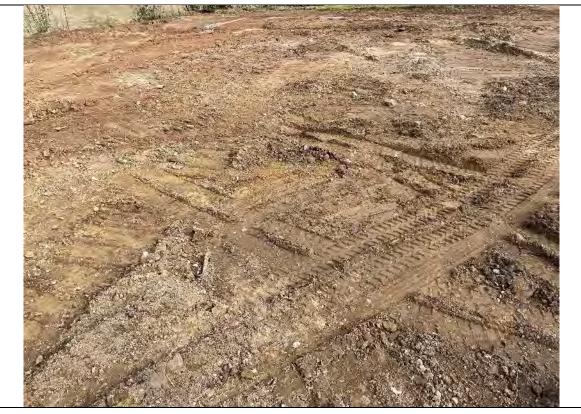
Plate 8-07/08/2023 Residual soils within the former house footprint in AEC15 subsequent to B3 scrape.

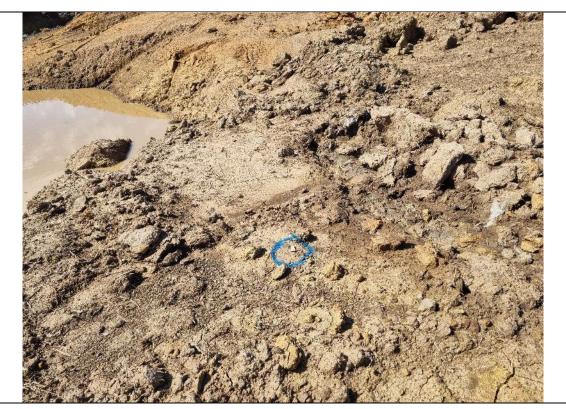
Plate 1 – 04/09/2023
UF027 – Sporadic ACM fragments identified to the east of AEC14 prior to emu-picking works.

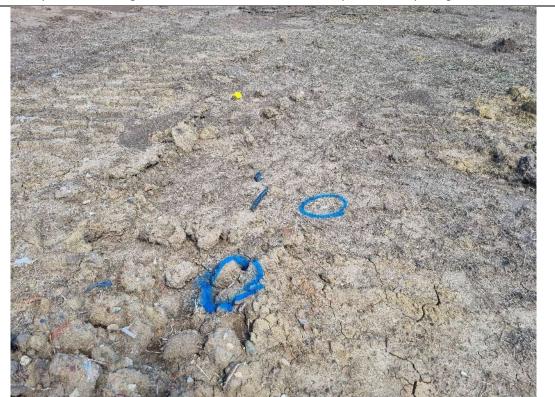
Plate 2 – 04/09/2023
UF027 – Sporadic ACM fragments identified to the east of AEC14 prior to emu picking works.

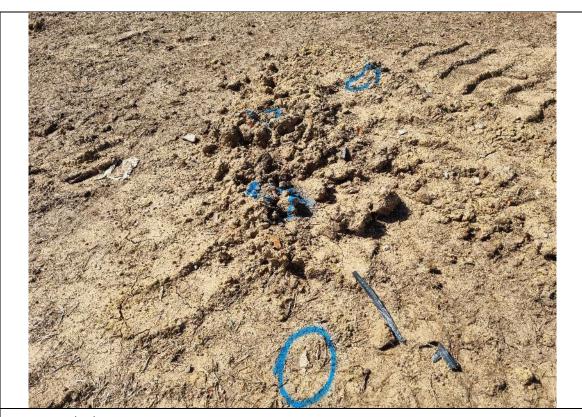
Plate 3 - 04/09/2023UF027 – Sporadic ACM fragments identified to the east of AEC14 prior to emu picking works.

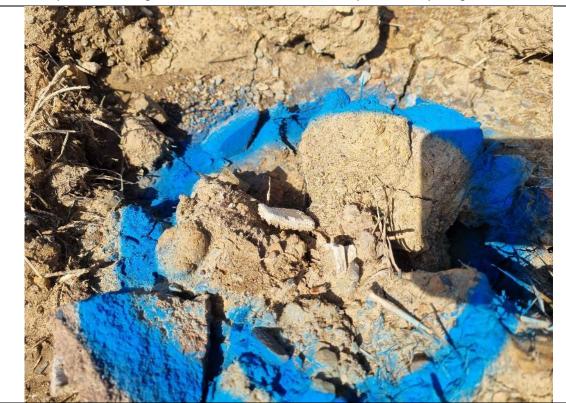
Plate 4 - 04/09/2023UF027 – Sporadic ACM fragments identified to the east of AEC14 prior to emu picking works.

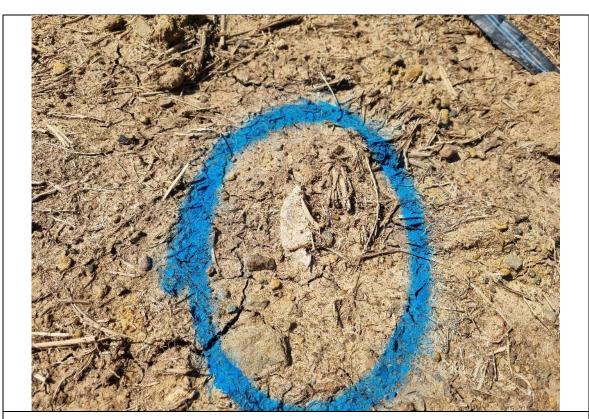
Plate 5 - 04/09/2023UF027 – Sporadic ACM fragments identified to the east of AEC14 prior to emu picking works.
