## Interim Validation Letter (LTR01) – Proposed Lot 1, Lot 3 and Part Roads

Westlink Stage 1 – Aldington Road and Abbotts Road, Kemps Creek, NSW, 2178

Prepared for: ESR Australia

EP3244.005\_VAL\_LTR01\_ESR\_Westlink Stage 1\_v2 | 27 May 2024

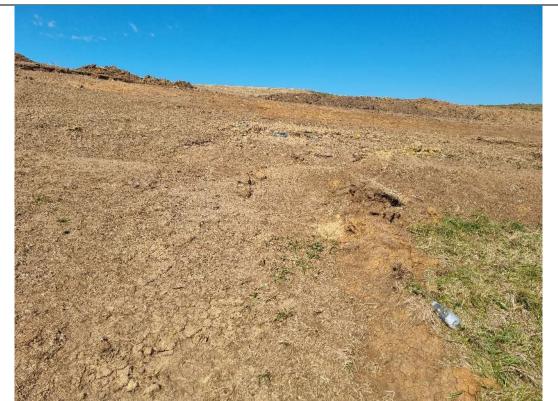
Plate 6-04/09/2023UF027 — Clearance Area subsequent to emu picking works by TCE to remove sporadic ACM fragments.

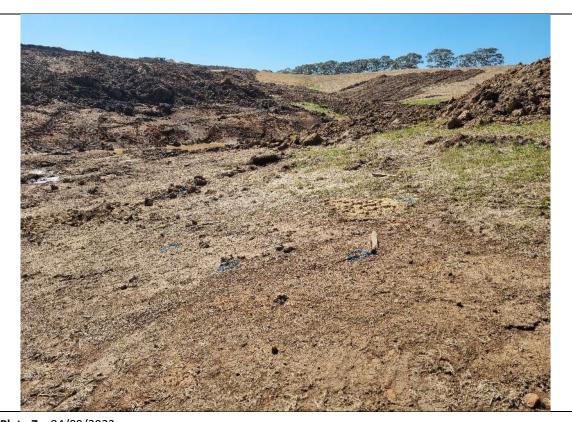
Plate 7 - 04/09/2023UF027 – Clearance Area subsequent to emu picking works by TCE to remove sporadic ACM fragments.

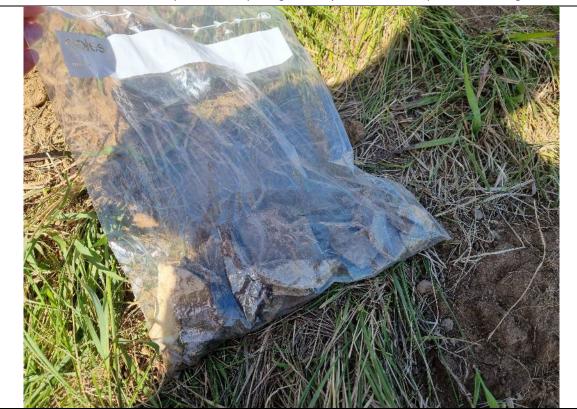
Plate 8 - 04/09/2023 UF027 - ACM fragments removed by TCE during emu picking works.
