DILAPIDATION REPORT

Mamre Road, Kemps Creek

This report is intended to be a record of the council assets at Mamre Road, Kemps Creek at the time of the inspection.

The inspection was carried out on 19 April 2023.

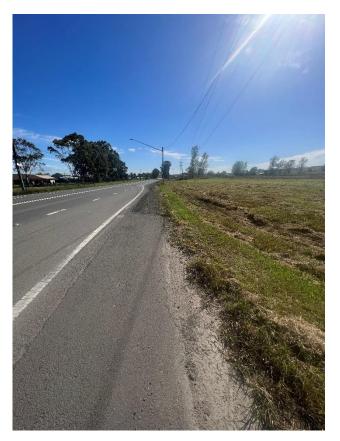
Figure 2 – Crack propagation to the road.

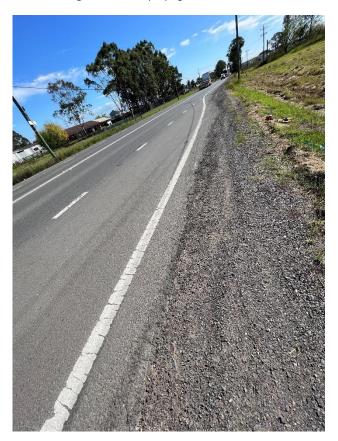
Figure 4 – Crack propagation to the road.

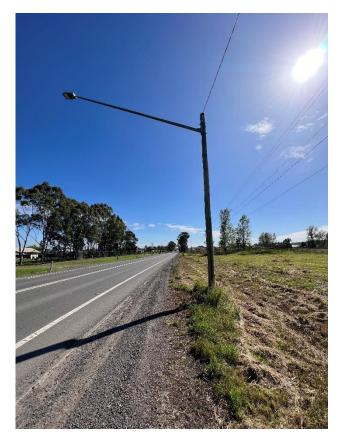
Figure 7 – General condition of the street light post.

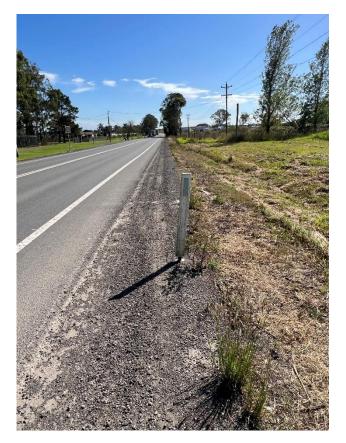
Figure 8 – General condition of the nature strip.

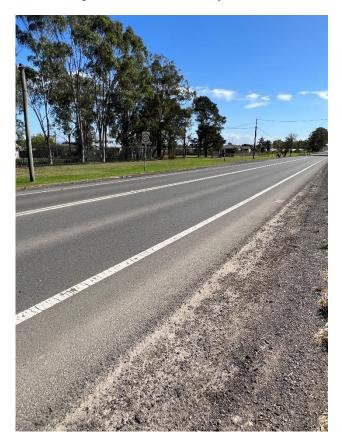
Figure 10 – General condition of the road.

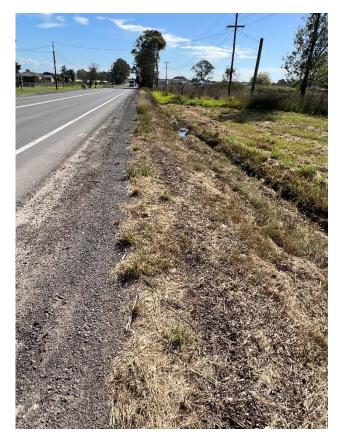
Figure 11 – General condition of the nature strip.

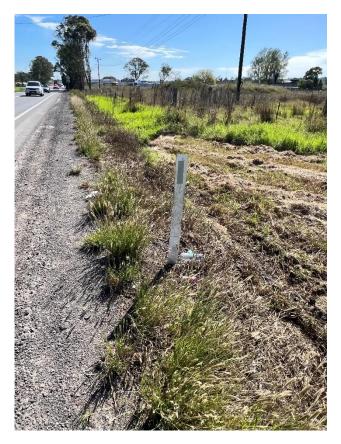
Figure 12 – General condition of the nature strip.

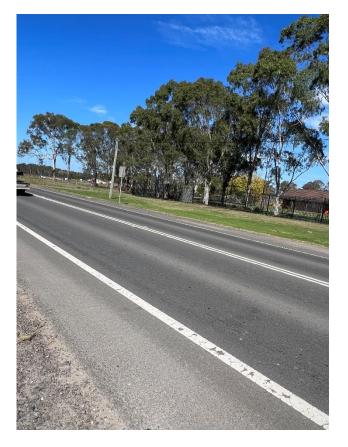
Figure 13 – General condition of the road.

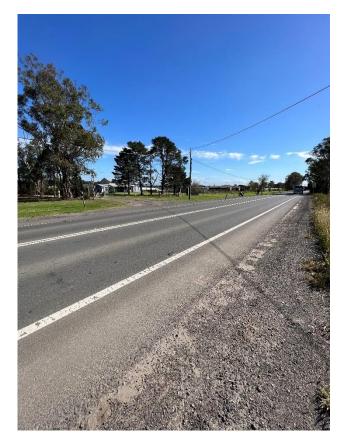
Figure 14 – General condition of the road.

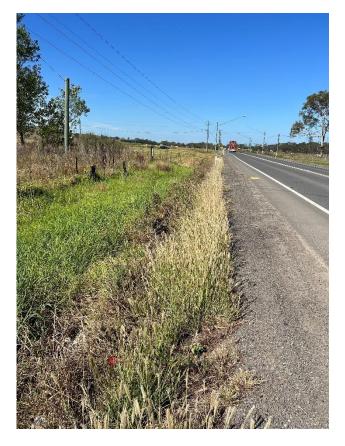
Figure 15 – General condition of the nature strip.

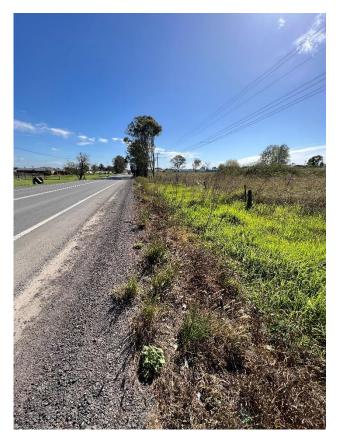
Figure 16 – General condition of the nature strip.

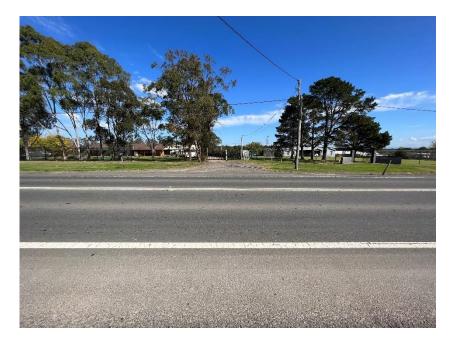
Figure 17 – General condition of the road.

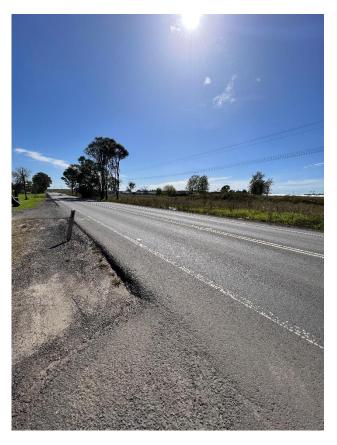
Figure 18 – General condition of the road.

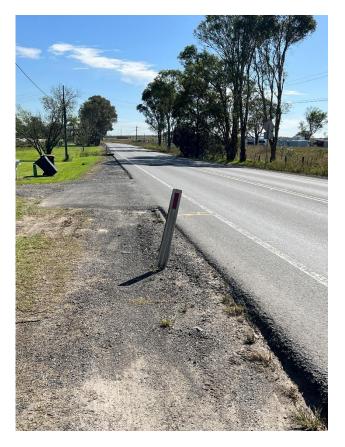
Figure 19 – General condition of the bollards.

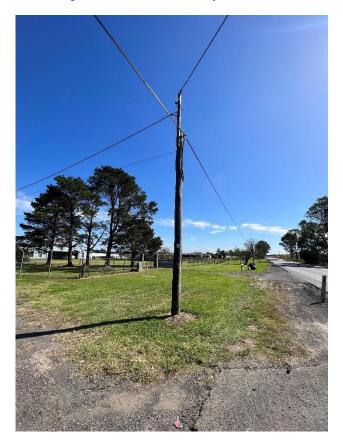
Figure 20 – General condition of the electrical post.

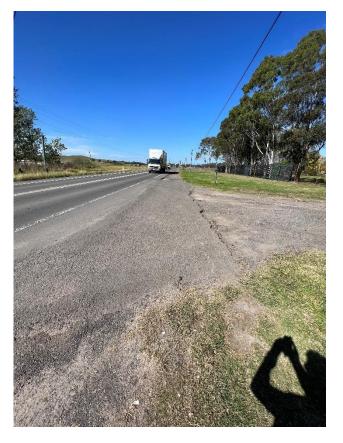
Figure 21 – General condition of the driveway.

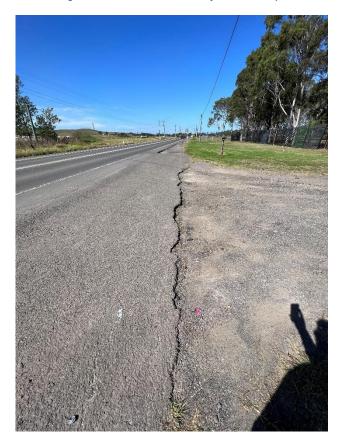
Figure 22 – Crack propagation to the driveway.

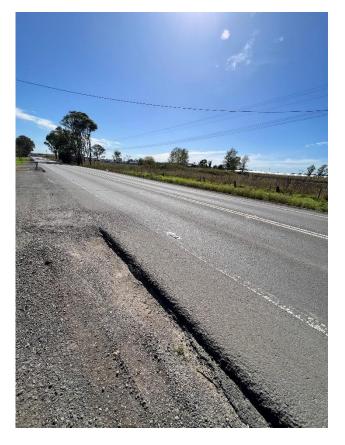
Figure 23 – General condition of the road.

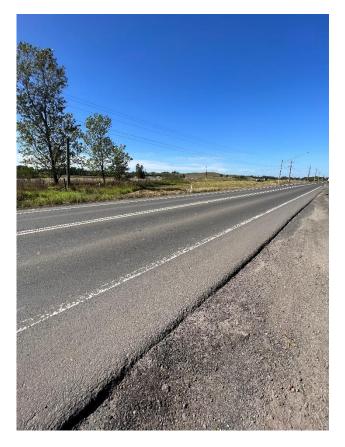
Figure 24 – General condition of the road.

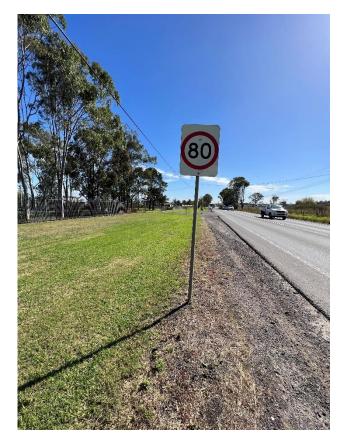
Figure 25 – General condition of the nature strip/street signpost.

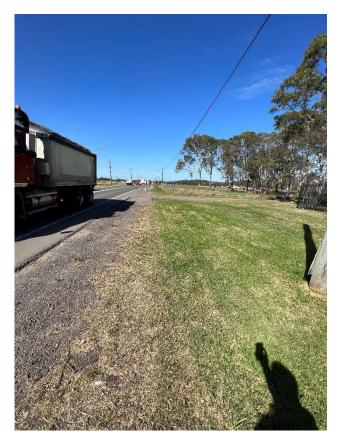
Figure 26 – General condition of the nature strip.

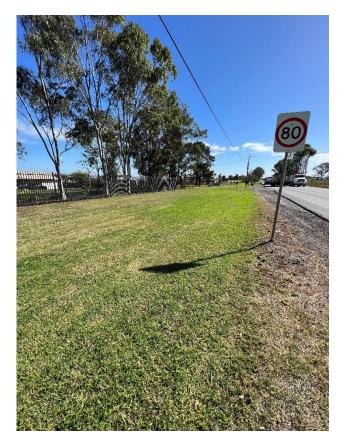
Figure 27 – General condition of the nature strip.

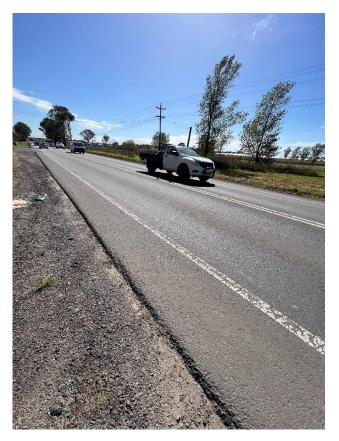
Figure 28 – General condition of the road.

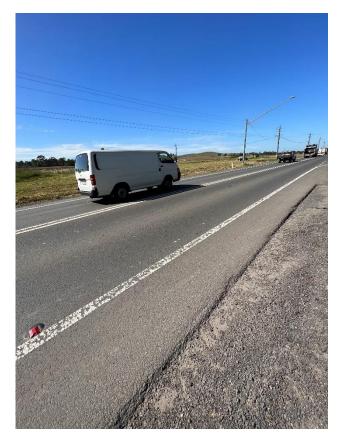
Figure 29 – General condition of the road.

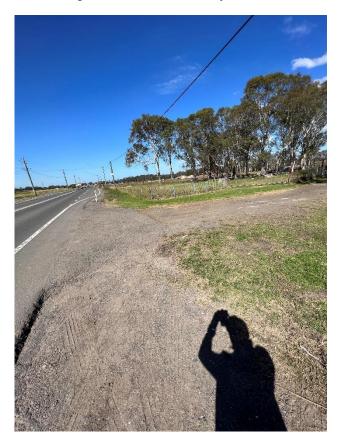
Figure 30 – General condition of the driveway/nature strip.

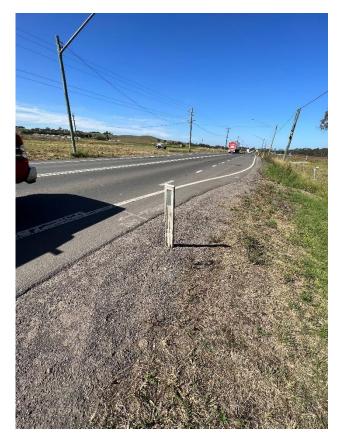
Figure 31 – General condition of the bollards.

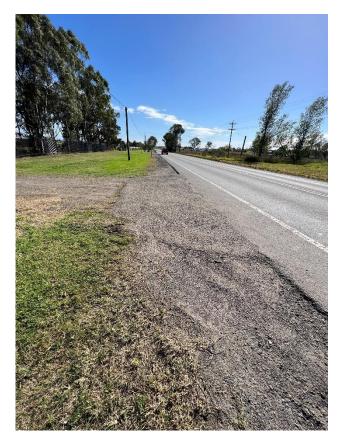
Figure 32 – General condition of the nature strip/driveway.

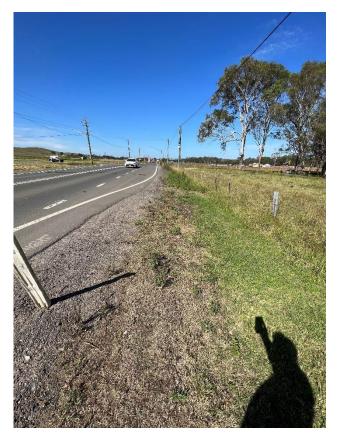
Figure 33 – General condition of the nature strip.

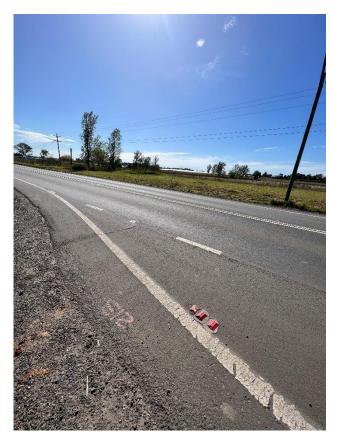
Figure 34 – Crack propagation to the road.

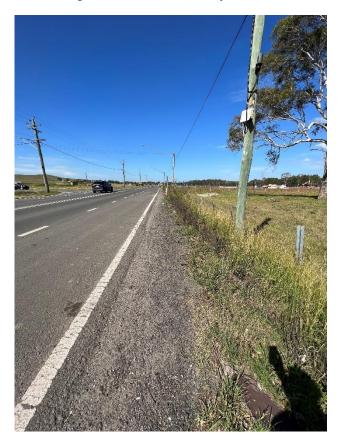
Figure 36 – General condition of the nature strip.

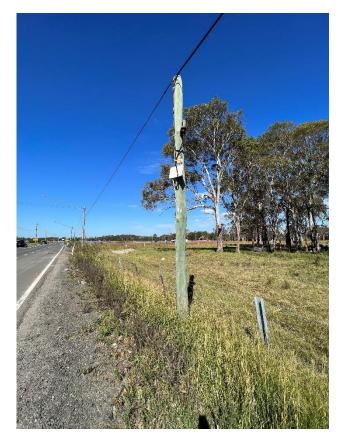
Figure 37 – General condition of the electrical post.

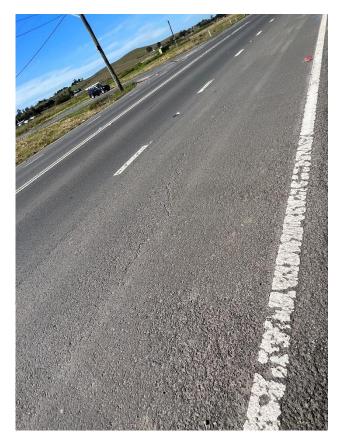
Figure 38 – Crack propagation to the road.

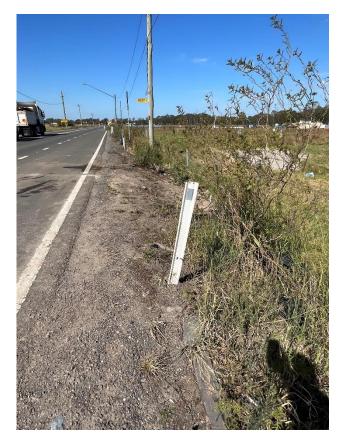
Figure 39 – General condition of the bollards.

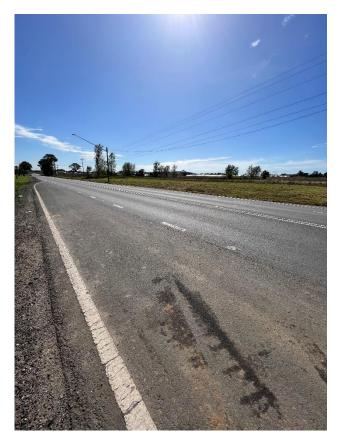
Figure 40 – Crack propagation to the road.

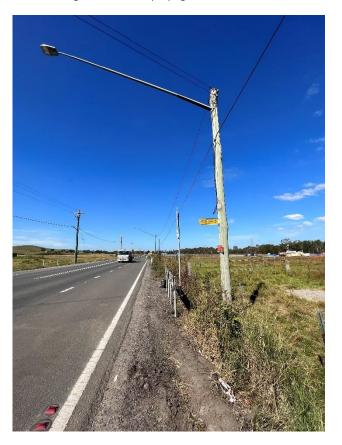
Figure 42 – General condition of the street light post.

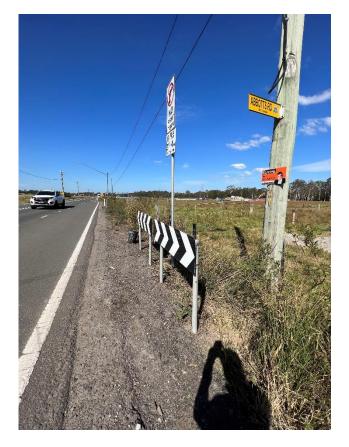
Figure 43 – General condition of the street signpost/street railings.

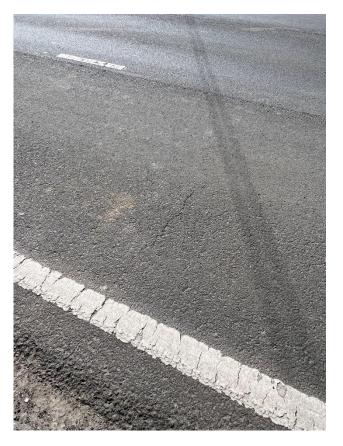
Figure 44 – Crack propagation to the road.

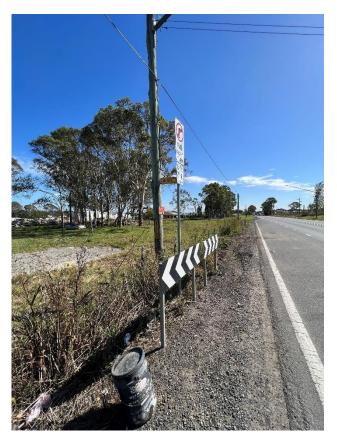
Figure 46 – General condition of the street railings.

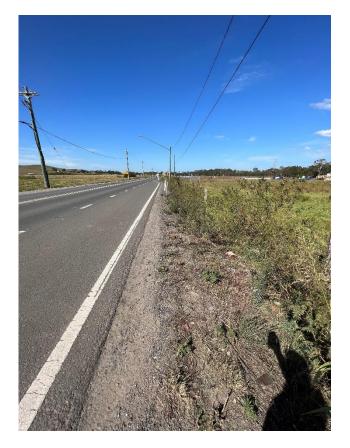
Figure 47 – General condition of the nature strip.

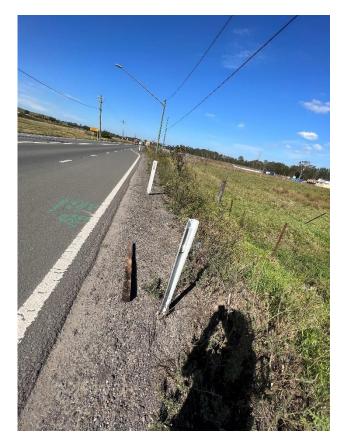
Figure 49 – General condition of the bollards.

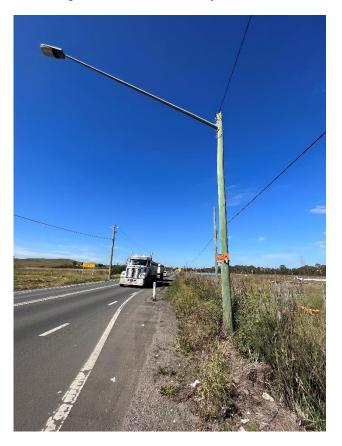
Figure 50 – General condition of the street light post.

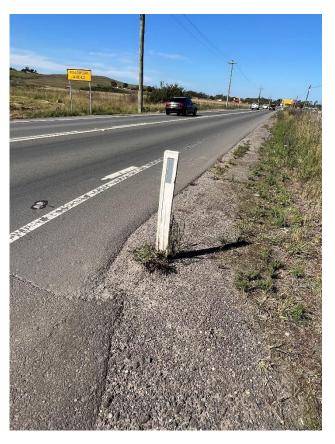
Figure 54 – General condition of the bollards.

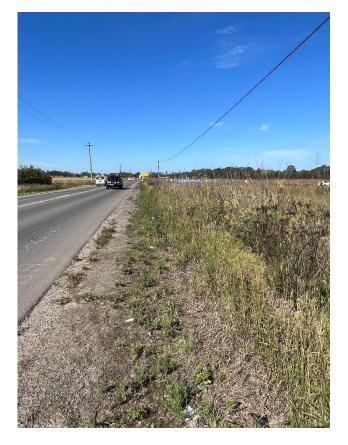
Figure 55 – General condition of the nature strip.

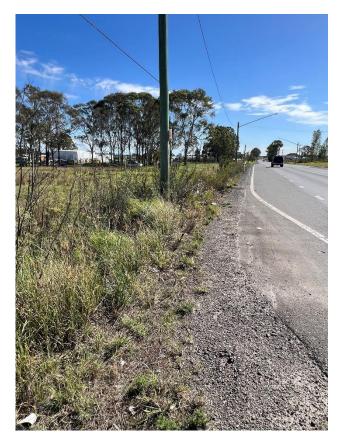
Figure 56 – General condition of the nature strip.

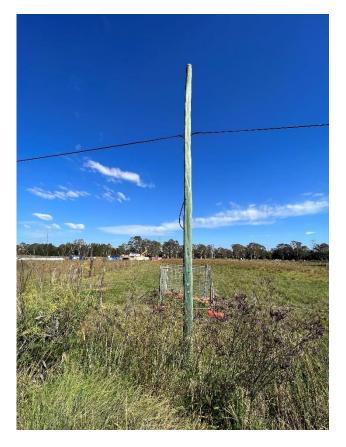
Figure 57 – General condition of the nature strip/electrical post.

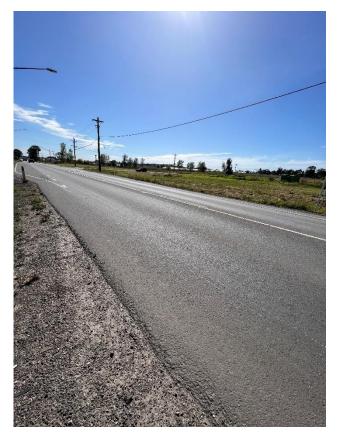
Figure 59 – General condition of the road.

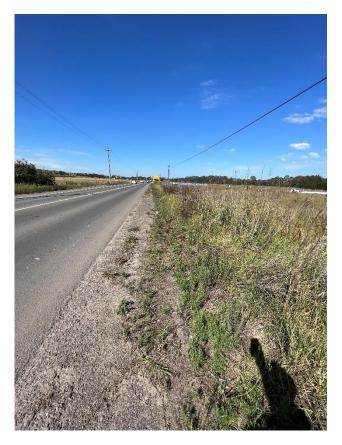
Figure 60 – General condition of the nature strip.

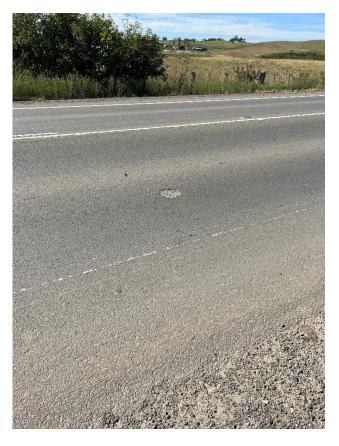
Figure 61 – Crack propagation to the road.

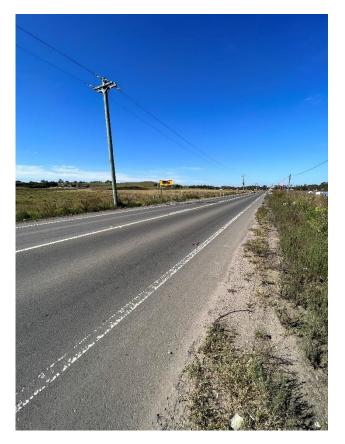
Figure 62 – General condition of the road.

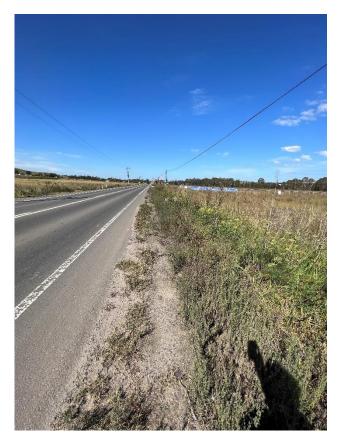
Figure 64 – General condition of the nature strip.

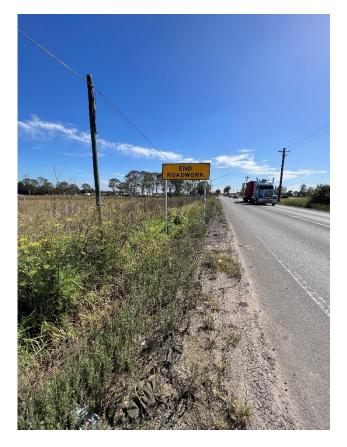
Figure 65 – General condition of the nature strip.

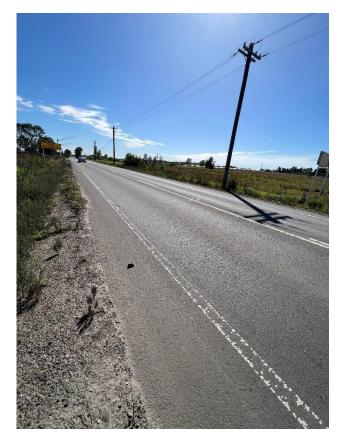
Figure 67 – General condition of the road.

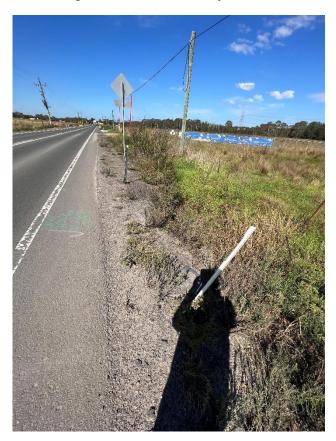
Figure 68 – General condition of the nature strip.

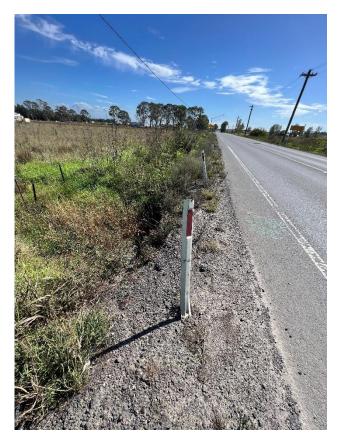
Figure 69 – General condition of the nature strip/bollards.

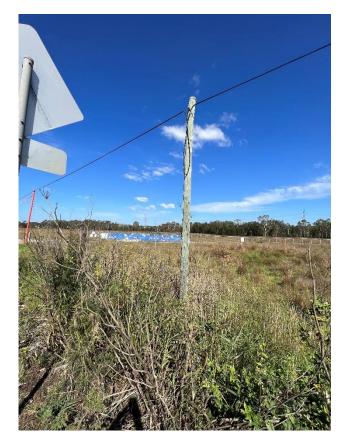
Figure 70 – General condition of the nature strip/electrical post.

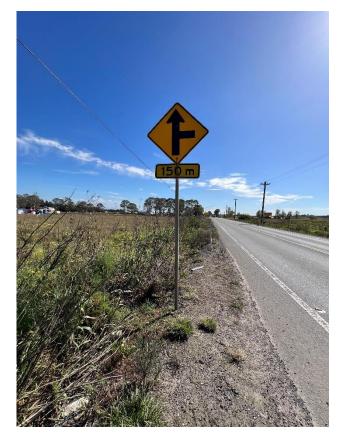
Figure 71 – General condition of the street signpost.

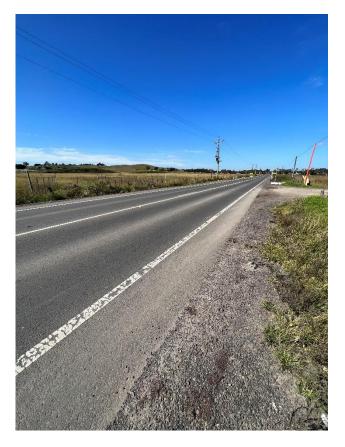
Figure 72 – General condition of the road.

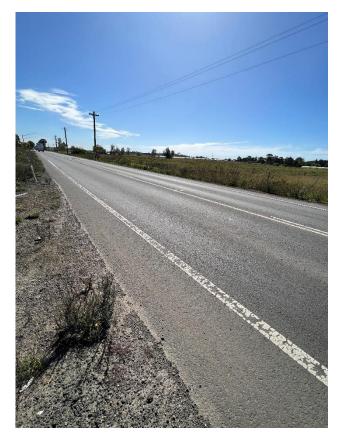
Figure 73 – General condition of the road.

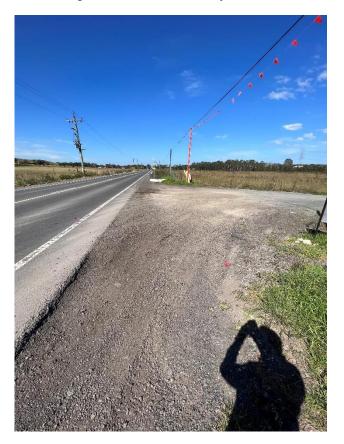
Figure 74 – General condition of the driveway.

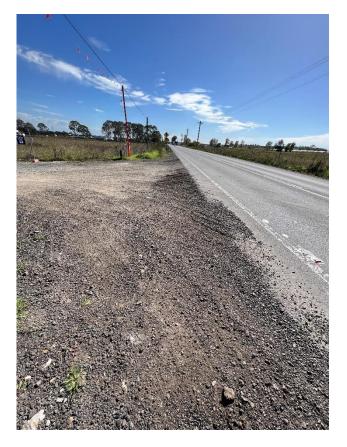
Figure 75 – General condition of the driveway.

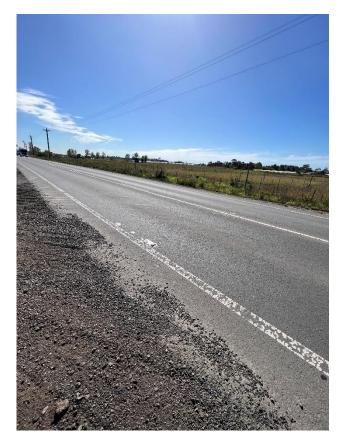
Figure 76 – General condition of the road.

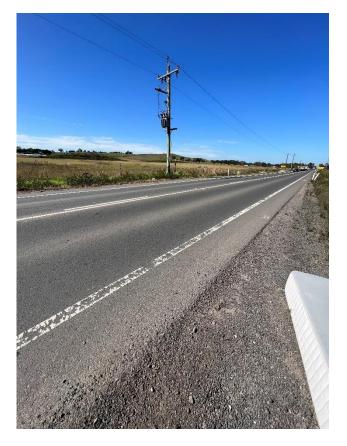
Figure 77 – General condition of the road.

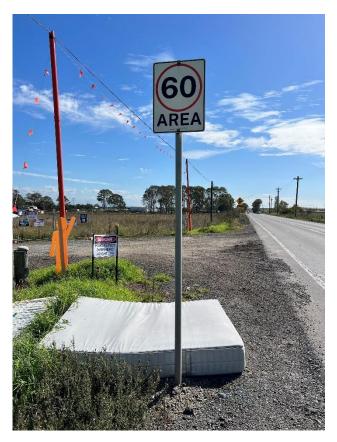
Figure 78 – General condition of the street signpost.

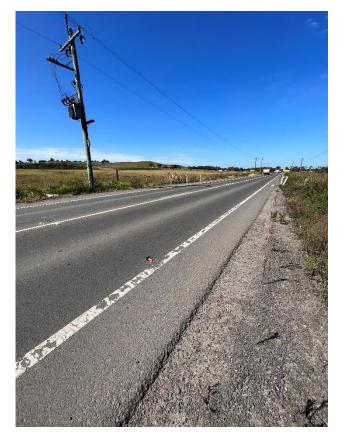
Figure 79 – General condition of the road.

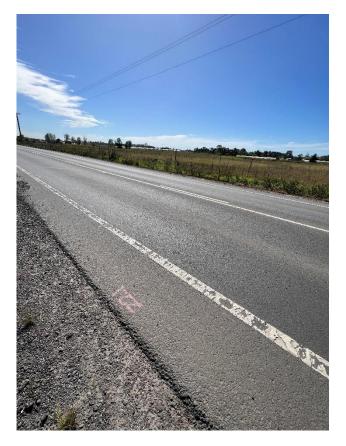
Figure 80 – General condition of the road.

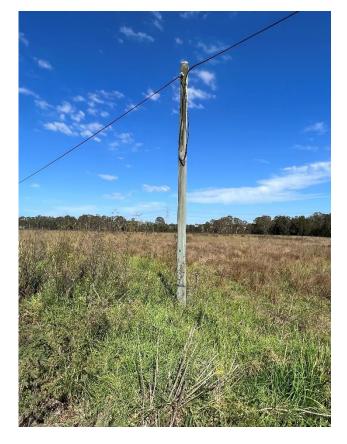
Figure 81 – General condition of the nature strip/electrical post.

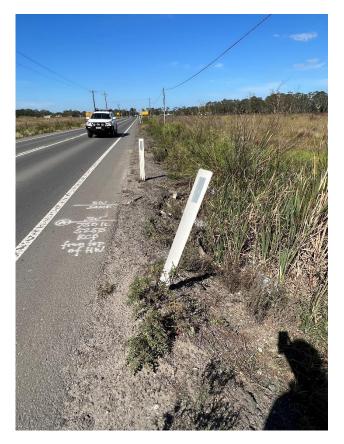
Figure 82 – General condition of the bollards.

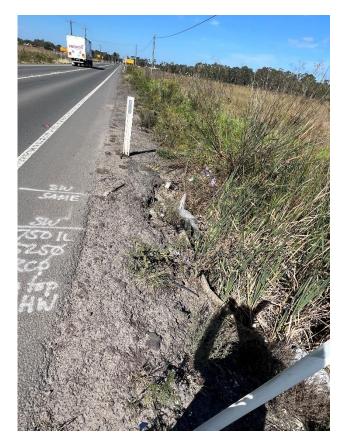
Figure 83 – General condition of the nature strip.

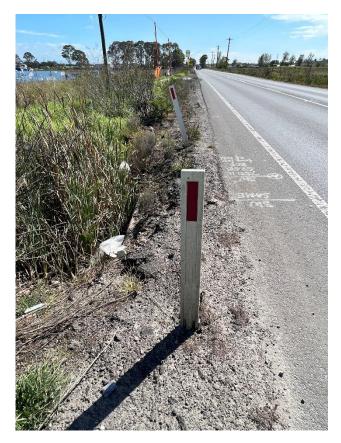
Figure 84 – General condition of the bollards.

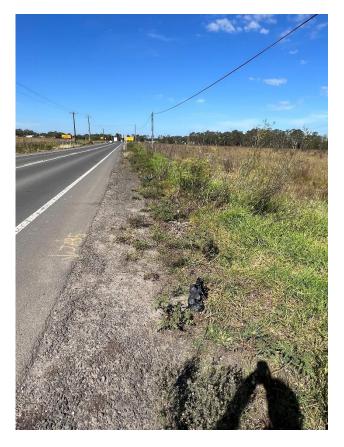
Figure 85 – General condition of the nature strip.

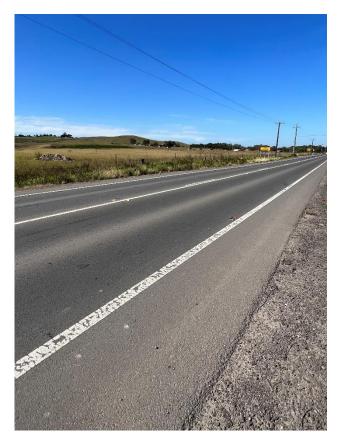
Figure 86 – General condition of the road.

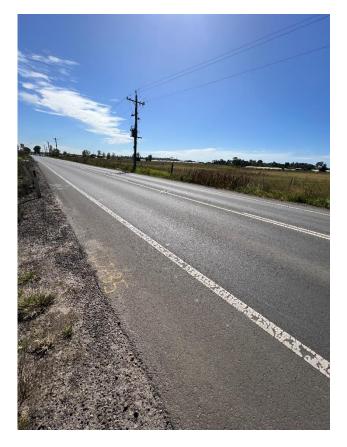
Figure 87 – General condition of the road.

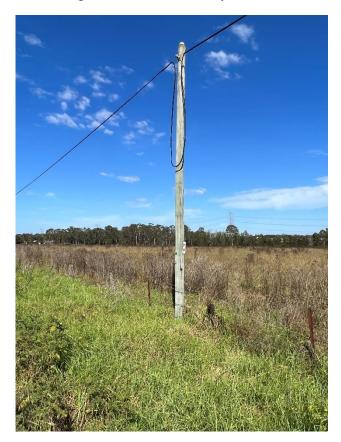
Figure 88 – General condition of the nature strip/electrical post.

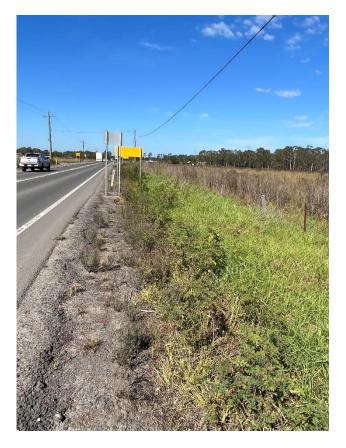
Figure 89 – General condition of the nature strip.

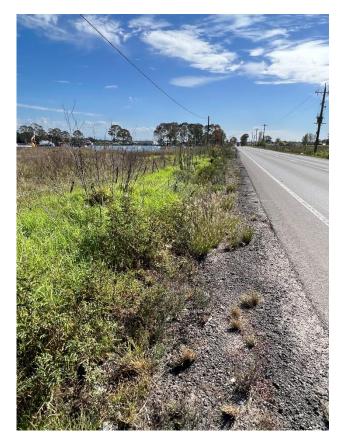
Figure 90 – General condition of the nature strip.

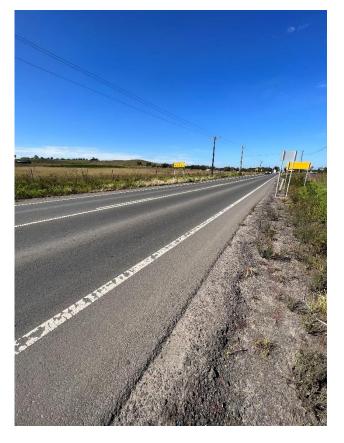
Figure 91 – General condition of the road.

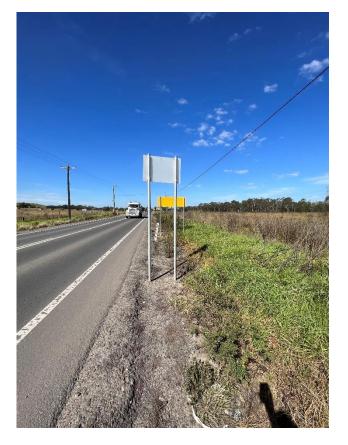
Figure 93 – General condition of the nature strip.

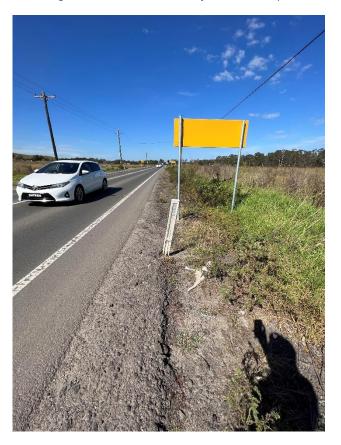
Figure 94 – General condition of the bollards, street signpost.

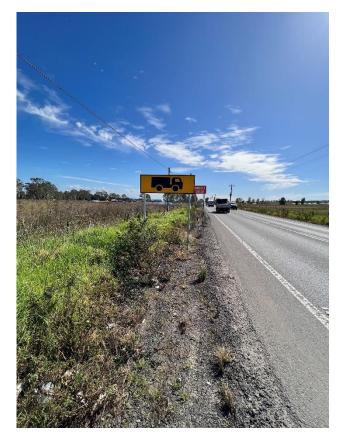
Figure 95 – General condition of the nature strip.

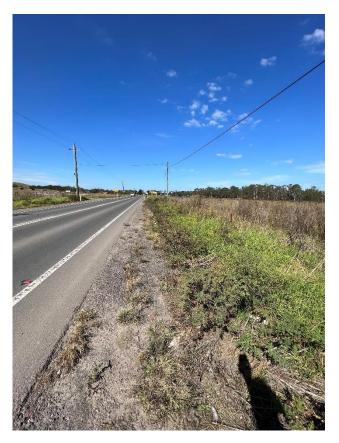
Figure 96 – General condition of the nature strip.

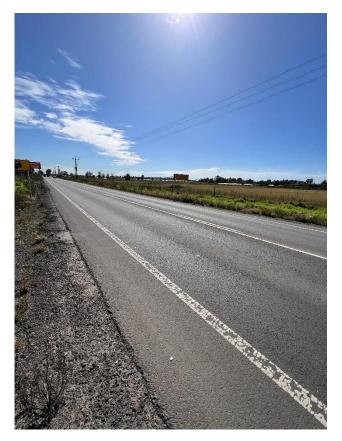
Figure 98 – General condition of the road.

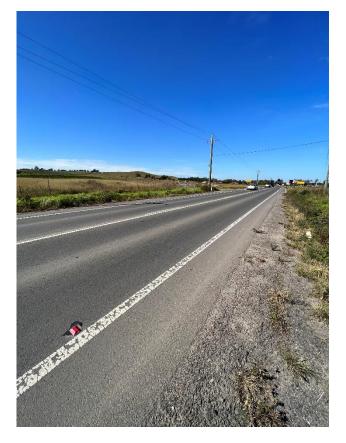
Figure 99 – General condition of the road.

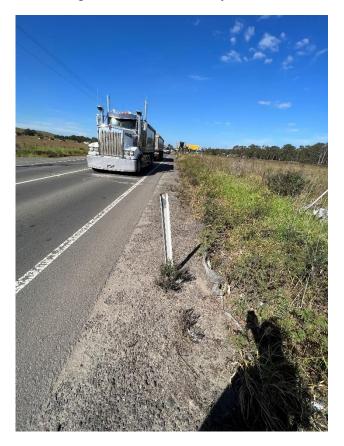
Figure 100 – General condition of the bollards.

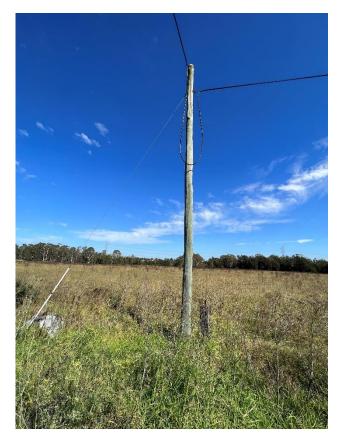
Figure 101 – General condition of the nature strip/electrical post.

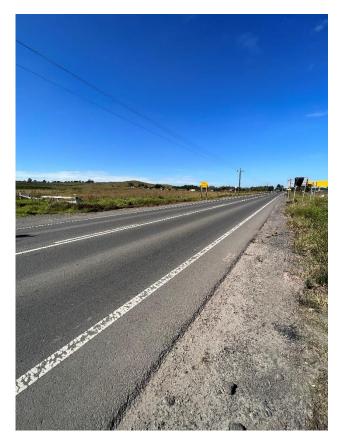
Figure 102 – General condition of the road.

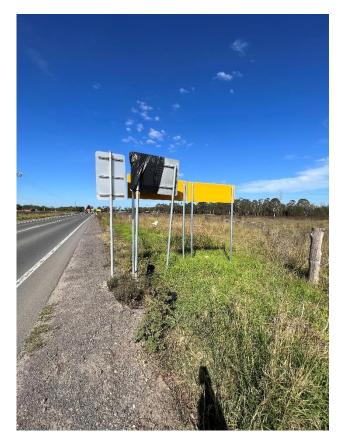
Figure 104 – General condition of the nature strip/street signpost.

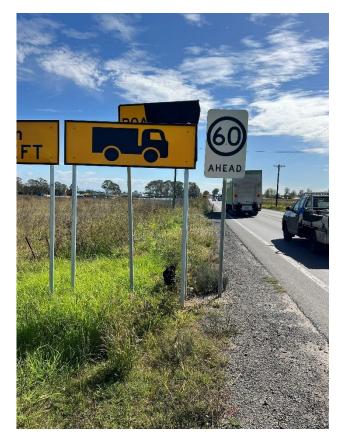
Figure 105 – General condition of the street signpost.

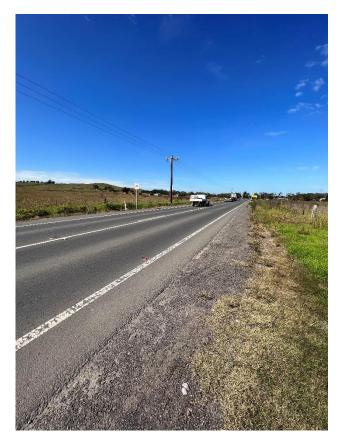
Figure 106 – General condition of the road.

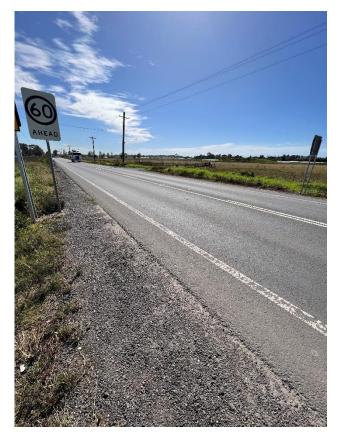
Figure 107 – General condition of the road.

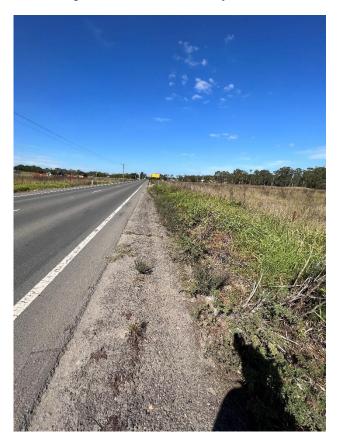
Figure 108 – General condition of the nature strip.

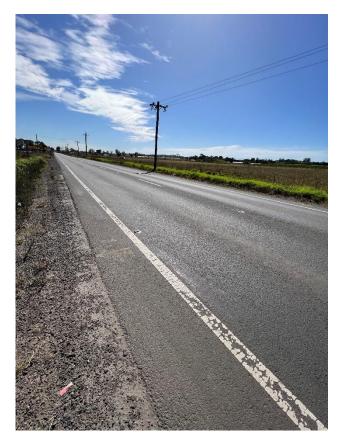
Figure 110 – General condition of the road.

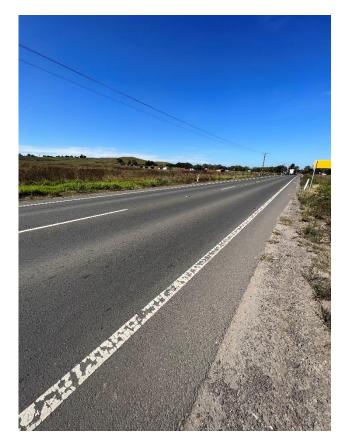
Figure 111 – General condition of the road.

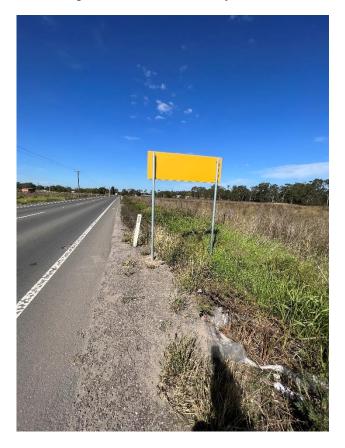
Figure 112 – General condition of the nature strip/street signpost.

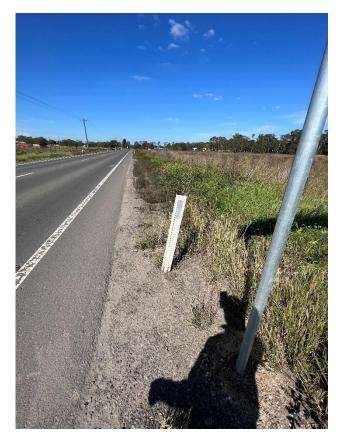
Figure 113 – General condition of the bollards.

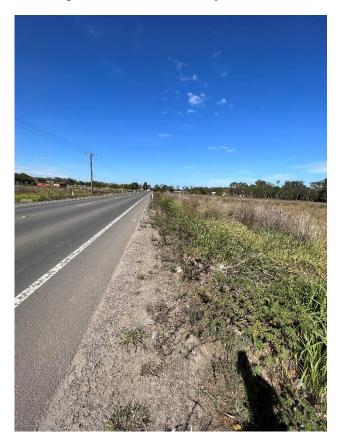
Figure 114 – General condition of the nature strip.

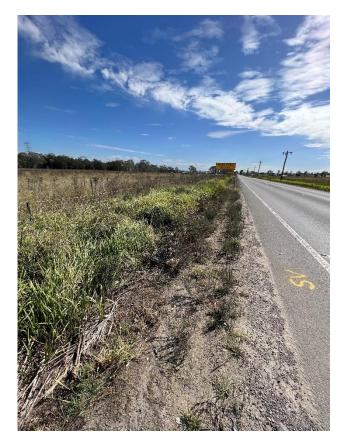
Figure 115 – General condition of the nature strip.

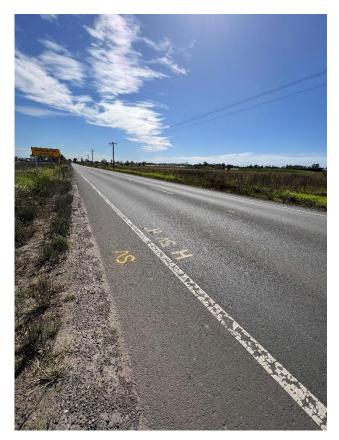
Figure 116 – General condition of the road.

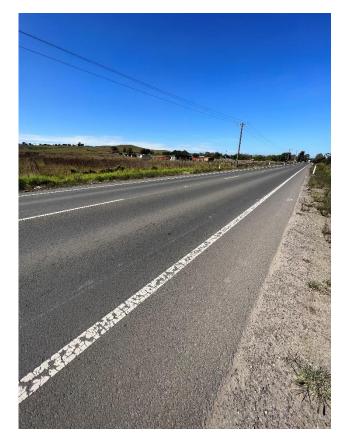
Figure 117 – General condition of the road.

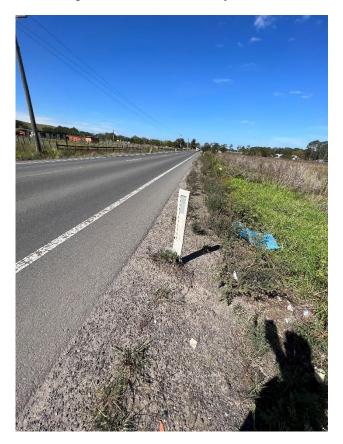
Figure 118 – General condition of the bollards.

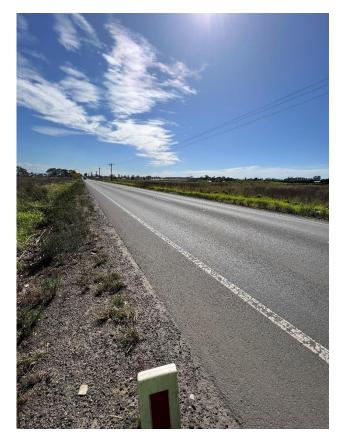
Figure 119 – General condition of the road.

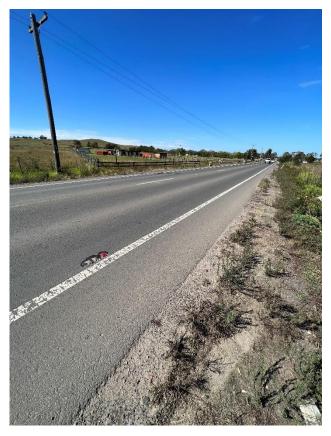
Figure 120 – General condition of the road/nature strip.

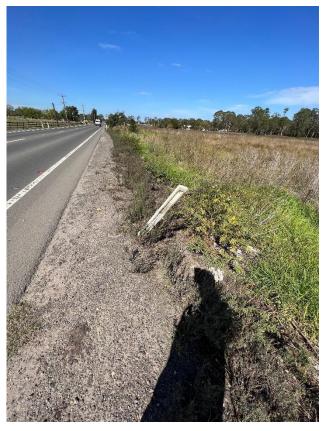
Figure 121 – General condition of the bollards/nature strip.

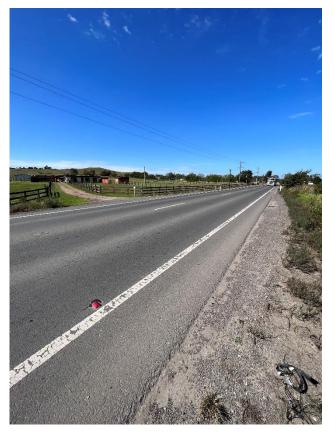
Figure 122 – General condition of the road.

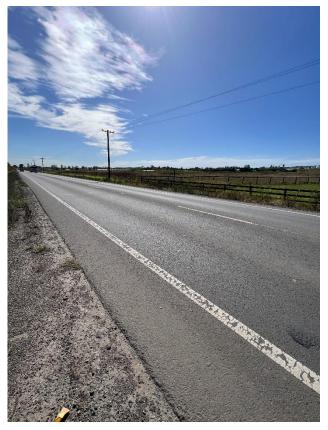
Figure 123 – General condition of the road.

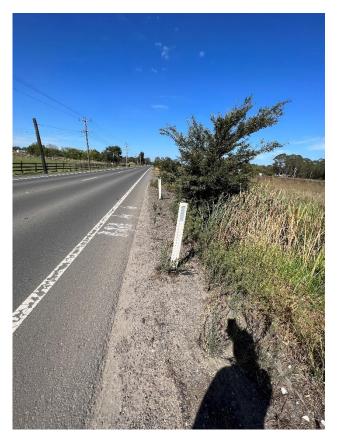
Figure 124 – General condition of the bollards.

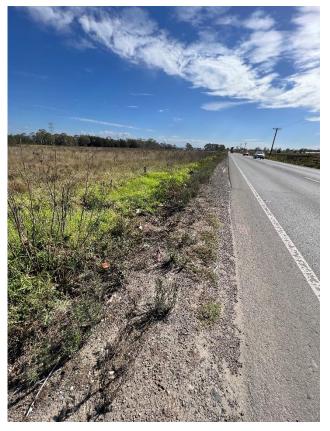
Figure 125 – General condition of the nature strip.

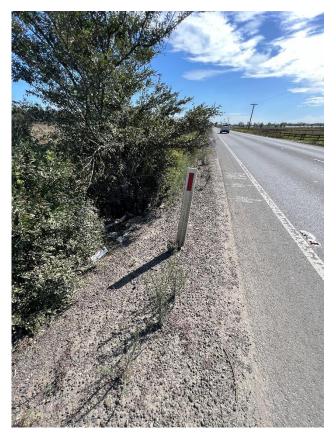
Figure 126 – General condition of the nature strip/bollards.

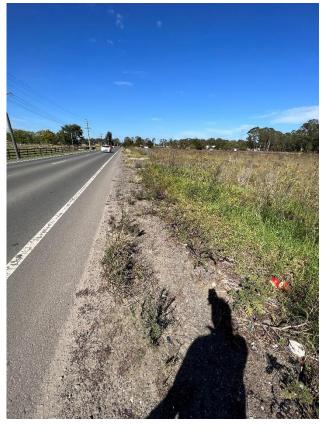
Figure 127 – General condition of the nature strip.

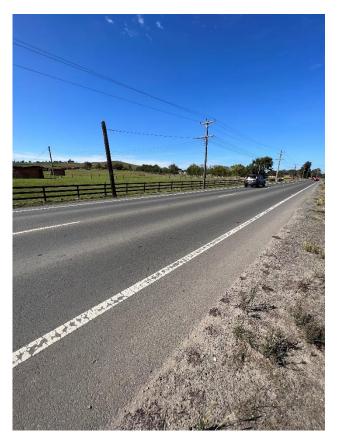
Figure 128 – General condition of the road.

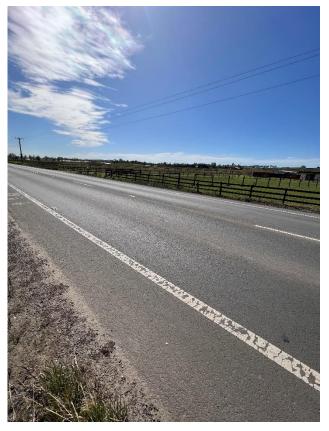
Figure 129 – General condition of the road.

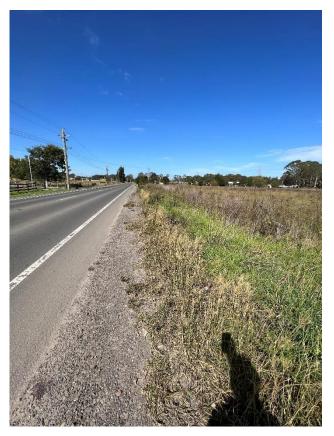
Figure 132 – General condition of the nature strip.

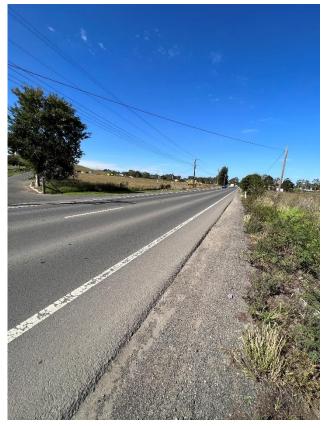
Figure 133 – General condition of the road.

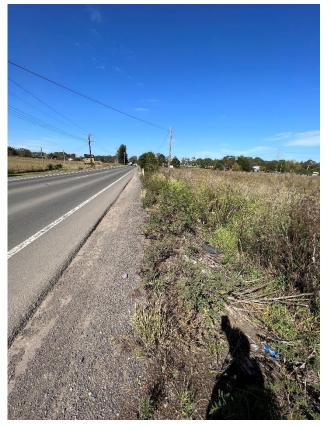
Figure 135 – General condition of the nature strip.

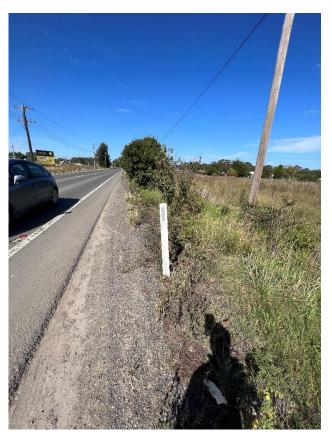
Figure 136 – General condition of the nature strip/bollards.

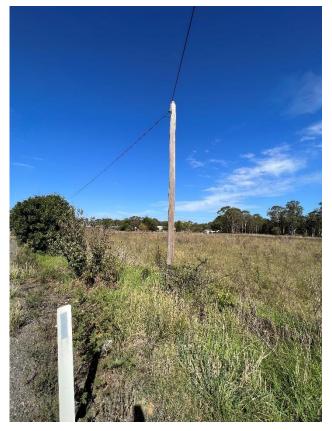
Figure 137 – General condition of the nature strip/electrical post.

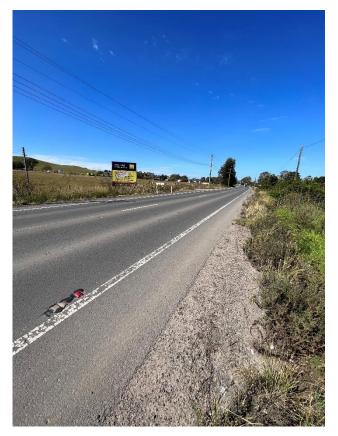
Figure 138 – General condition of the road.

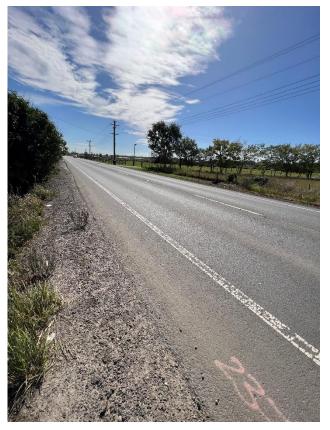
Figure 139 – General condition of the road.

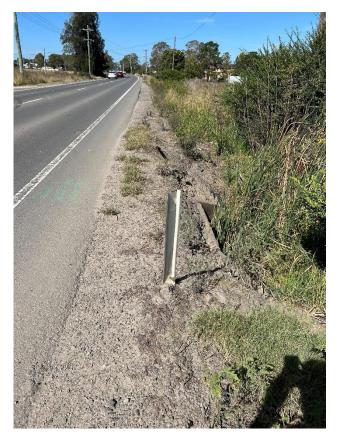
Figure 140 – General condition of the bollards.

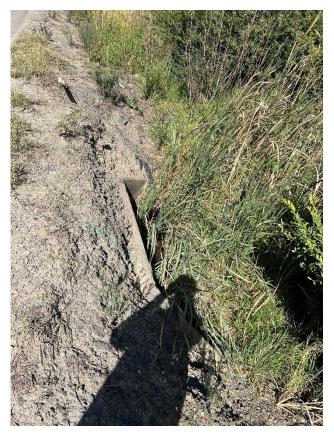
Figure 141 – General condition of the nature strip.

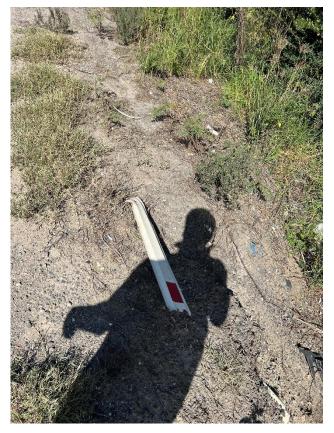
Figure 142 – Damage condition is noted to the bollards.

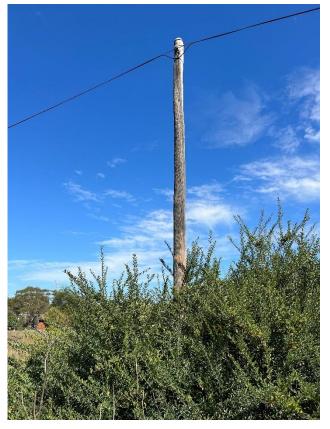
Figure 143 – General condition of the electrical post.

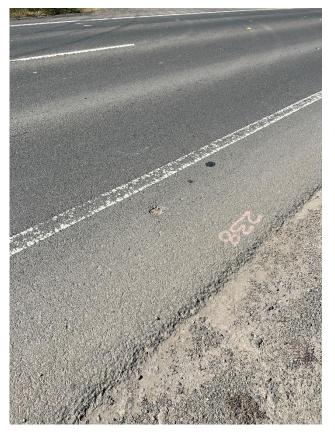
Figure 144 – Crack propagation to the road.

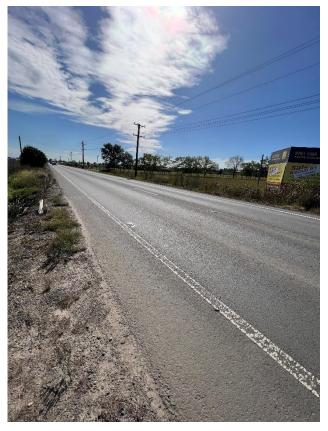
Figure 145 – General condition of the road.

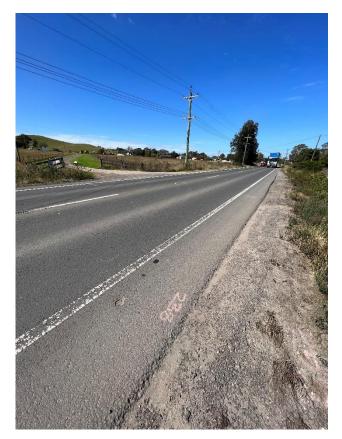
Figure 146 – Crack propagation to the road.

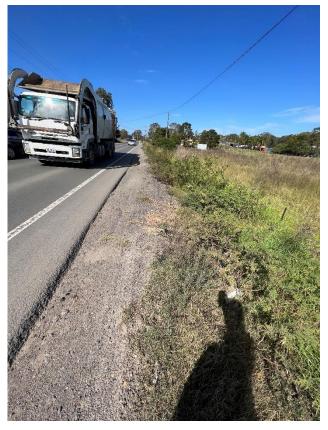
Figure 147 – General condition of the nature strip.

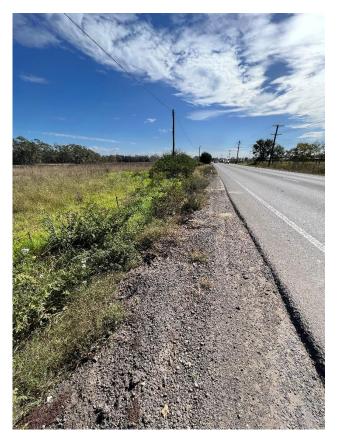
Figure 148 – General condition of the nature strip.

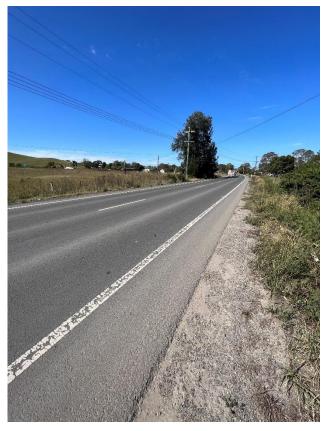
Figure 149 – General condition of the road.

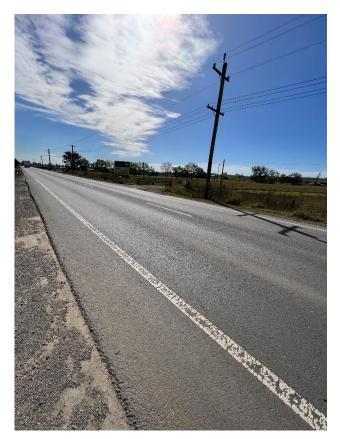
Figure 150 – General condition of the road.

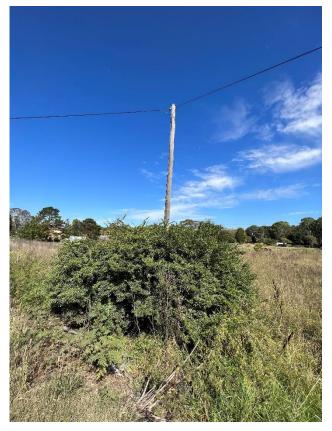
Figure 151 – General condition of the nature strip/electrical post.

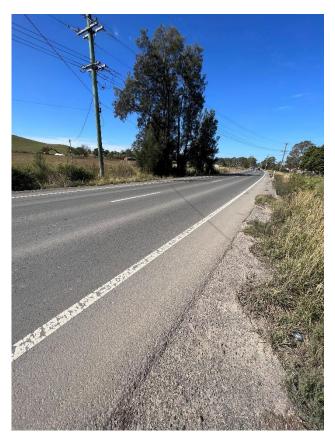
Figure 152 – General condition of the road.

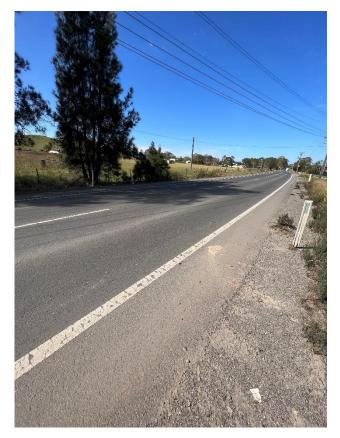
Figure 154 – General condition of the road.

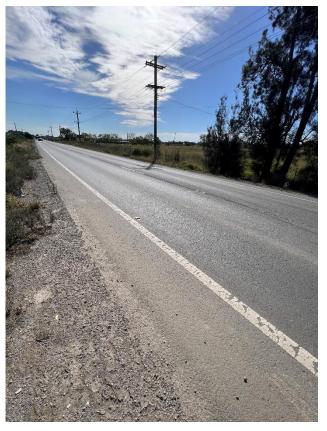
Figure 155 – General condition of the road.

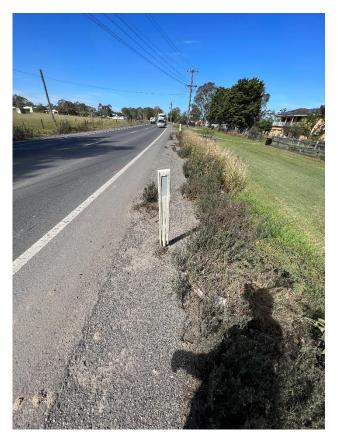
Figure 156 – General condition of the bollards/nature strip.

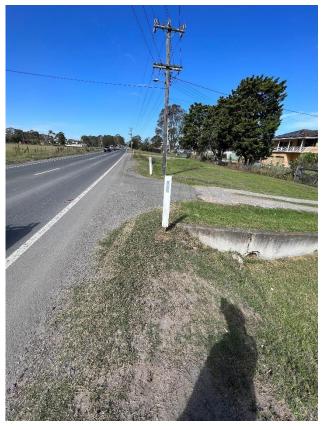
Figure 157 – General condition of the bollards/nature strip.

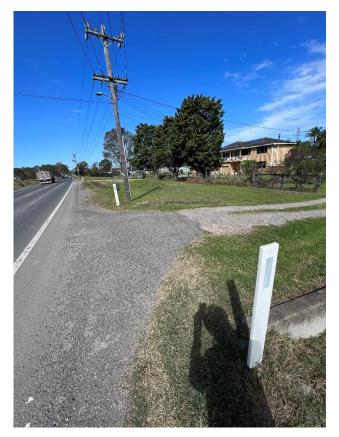
Figure 158 – General condition of the driveway.

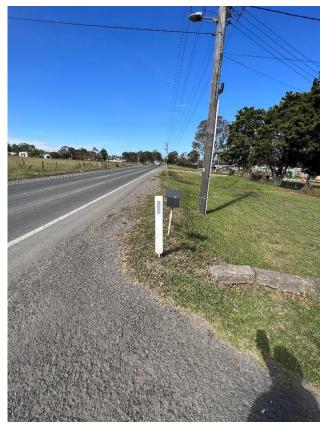
Figure 159 – General condition of the nature strip/bollards.

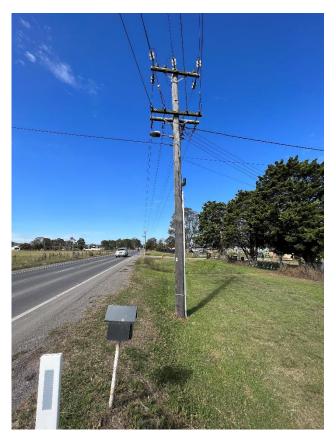
Figure 160 – General condition of the nature strip/electrical post.

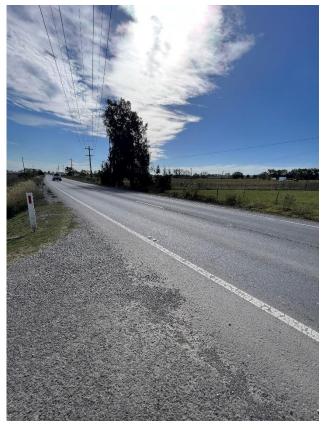
Figure 161 – General condition of the road.

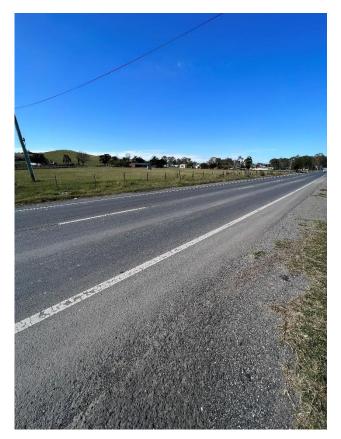
Figure 162 – General condition of the road.

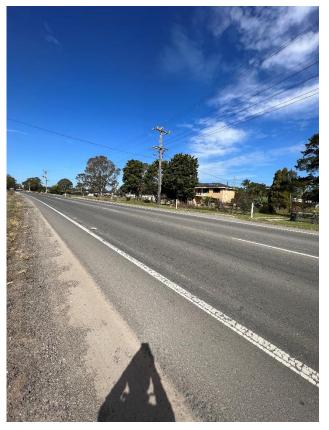
Figure 163 – General condition of the road.
