DILAPIDATION REPORT

Mamre Road, Kemps Creek

This report is intended to be a record of the council assets at Mamre Road, Kemps Creek at the time of the inspection.

The inspection was carried out on 19 April 2023.

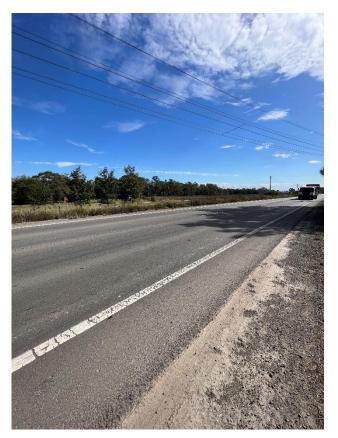
Figure 164 – General condition of the road.

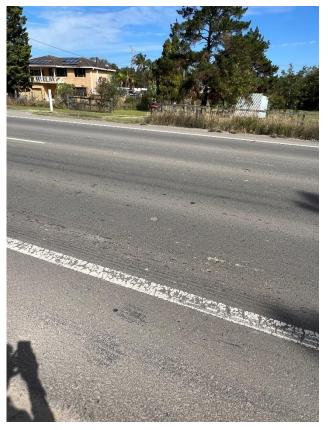
Figure 165 – General condition of the road.

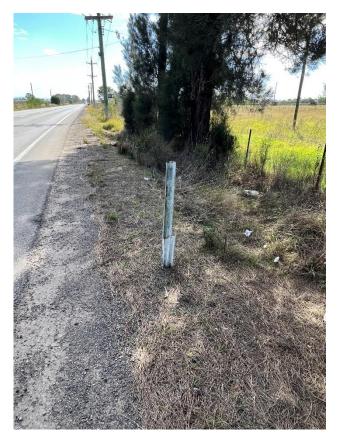
Figure 166 – General condition of the bollards/nature strip.

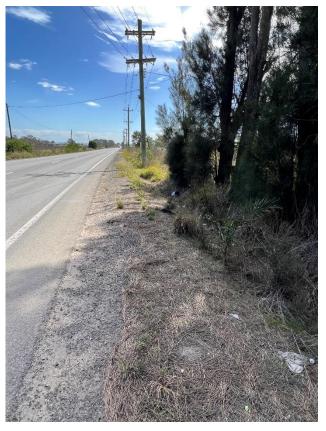
Figure 167 – General condition of the nature strip.

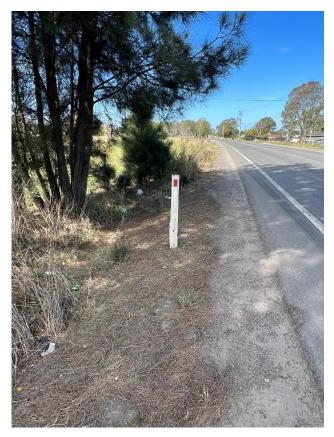
Figure 168 – General condition of the bollards/nature strip.

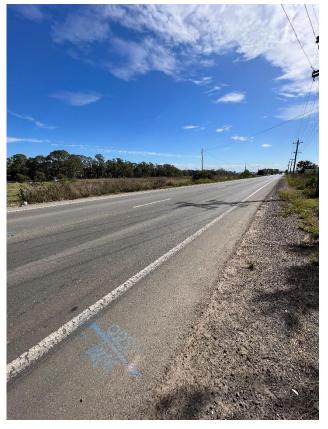
Figure 169 – General condition of the road.

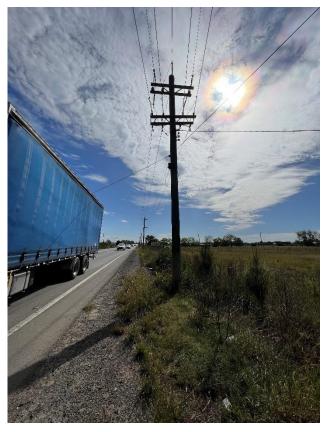
Figure 171 – General condition of the nature strip/electrical post.

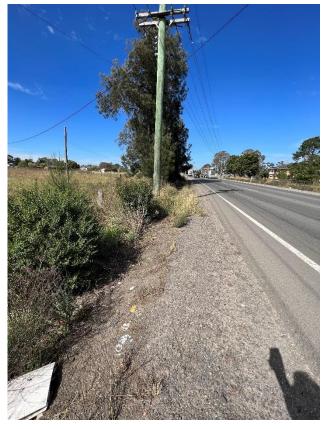
Figure 173 – General condition of the nature strip.

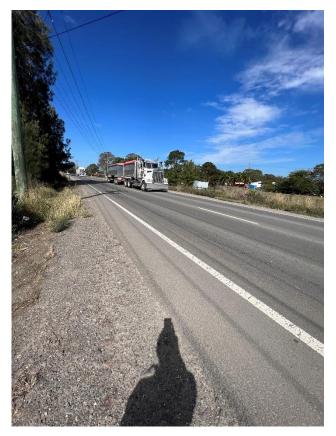
Figure 174 – General condition of the road.

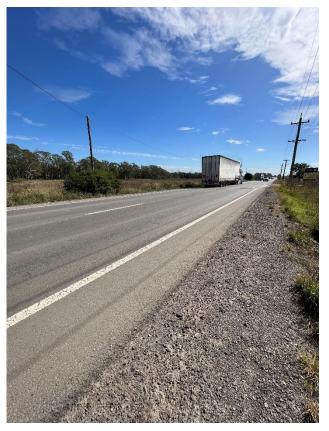
Figure 175 – General condition of the road.

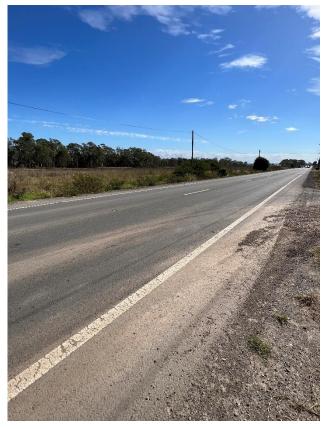
Figure 177 – Crack propagation to the road.

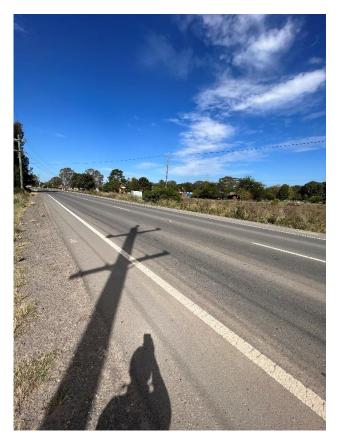
Figure 178 – General condition of the road.

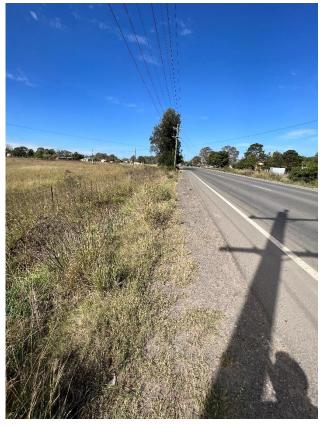
Figure 179 – General condition of the nature strip.

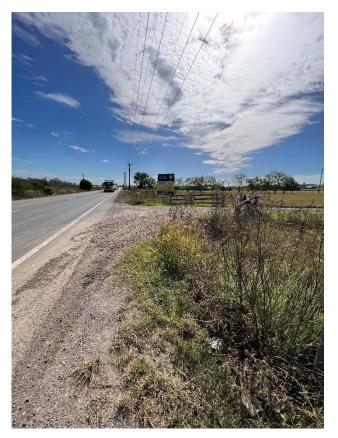
Figure 180 – General condition of the nature strip.

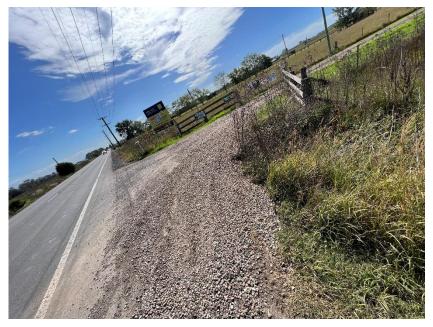
Figure 181 – General condition of the driveway/nature strip.

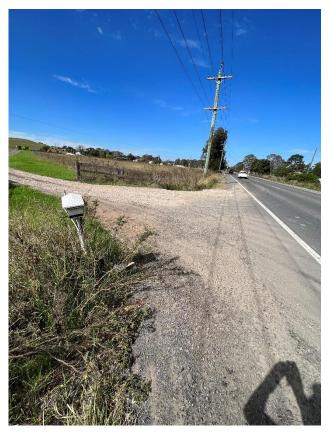
Figure 182 – General condition of the nature strip/driveway.

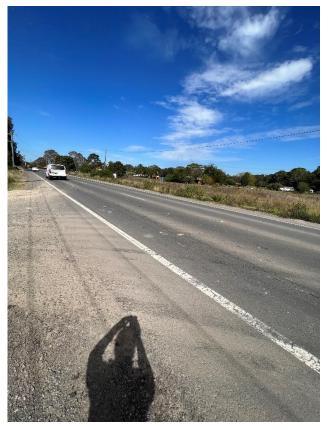
Figure 183 – General condition of the road.

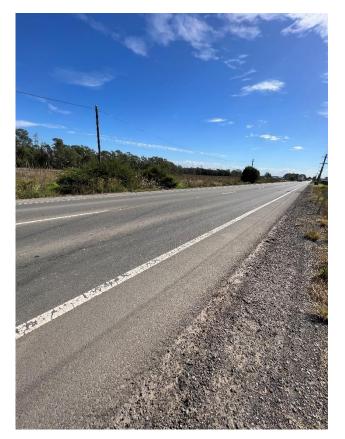
Figure 184 – Crack propagation to the road.

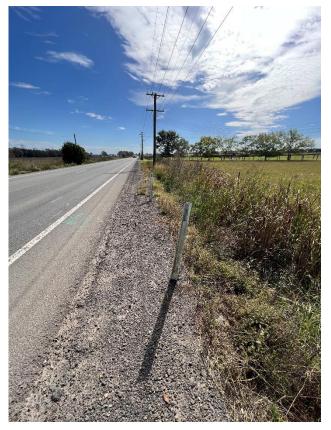
Figure 185 – General condition of the bollards.

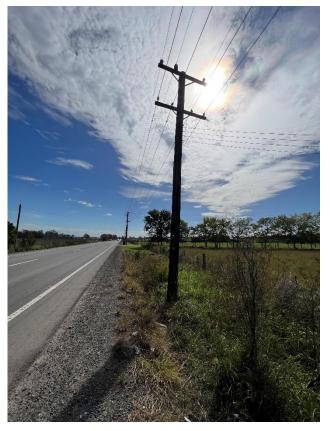
Figure 187 – General condition of the electrical post.

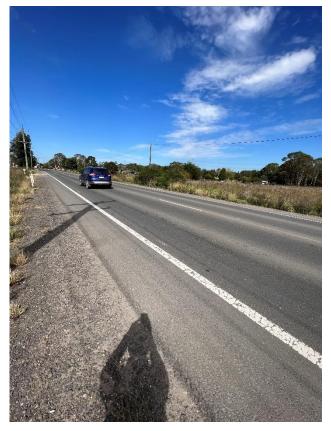
Figure 189 – General condition of the road.

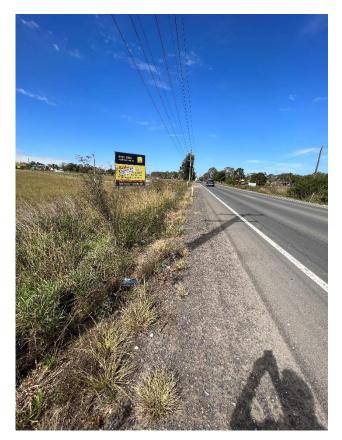
Figure 190 – General condition of the nature strip.

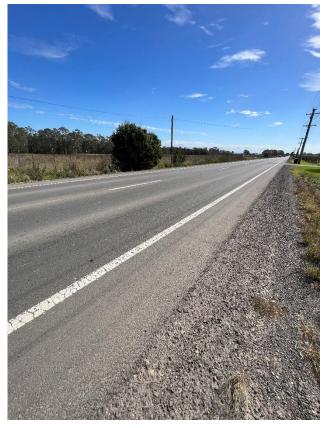
Figure 191 – General condition of the road.

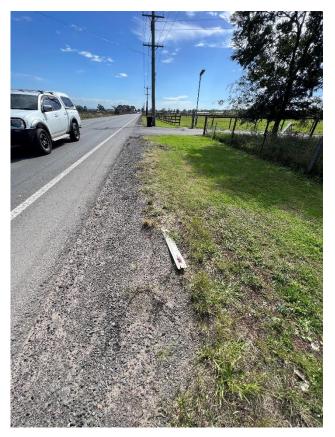
Figure 192 – Damage condition is noted to the bollards.

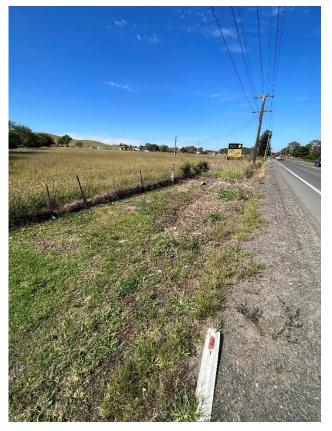
Figure 193 – General condition of the nature strip.

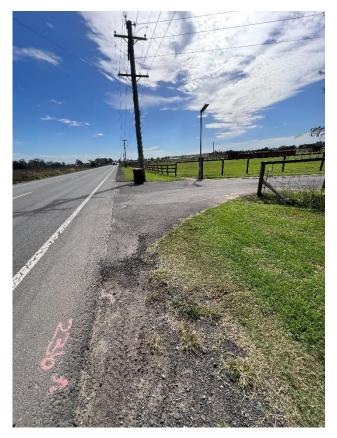
Figure 194 – General condition of the driveway/nature strip.

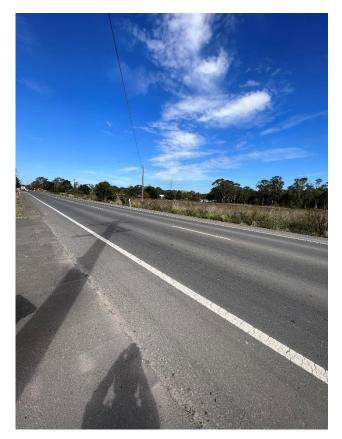
Figure 196 – General condition of the road.

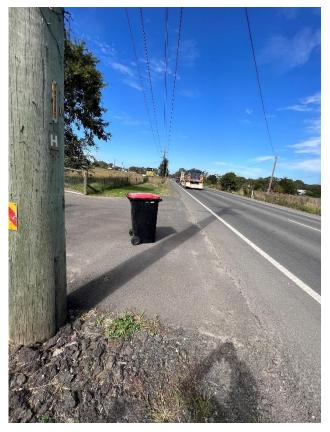
Figure 197 – General condition of the driveway.

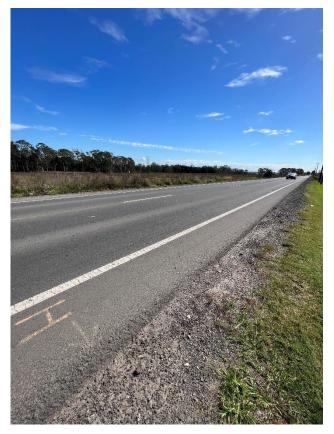
Figure 198 – General condition of the road.

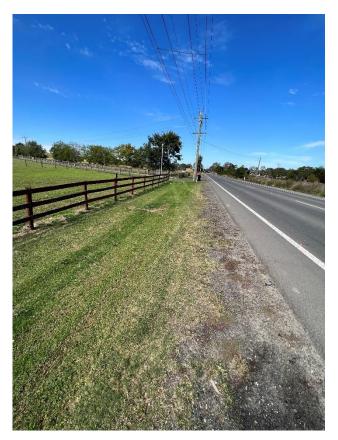
Figure 200 – General condition of the nature strip.

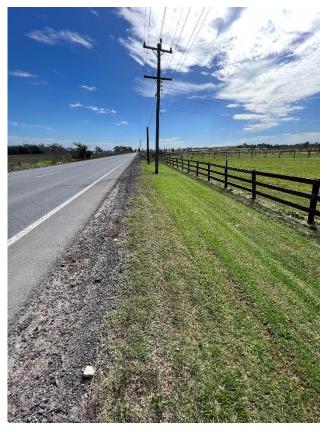
Figure 203 – General condition of the nature strip.

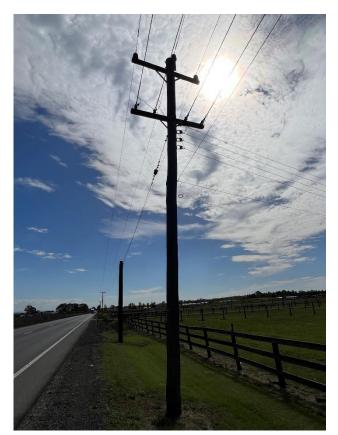
Figure 204 – General condition of the electrical post.

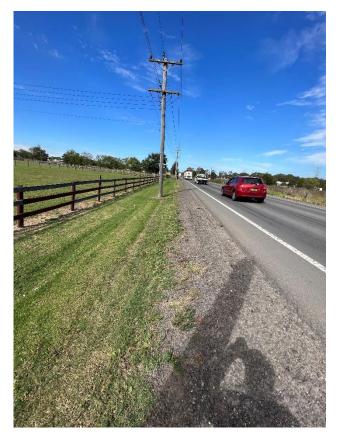
Figure 206 – General condition of the nature strip.

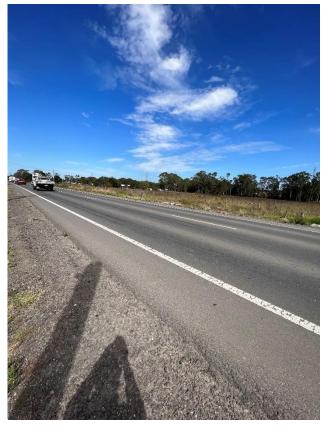
Figure 207 – General condition of the road.

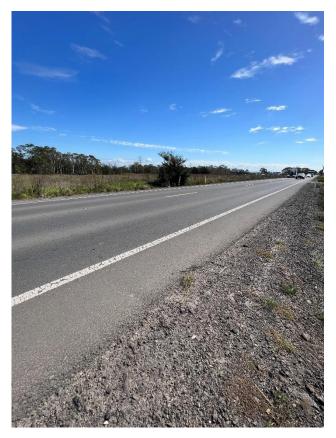
Figure 208 – General condition of the road.

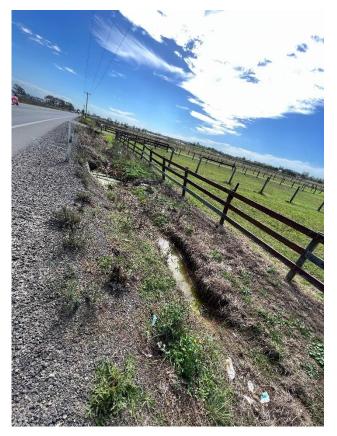
Figure 210 – General condition of the nature strip.

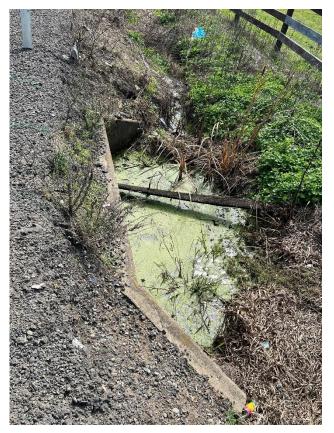
Figure 211 – General condition of the drain.

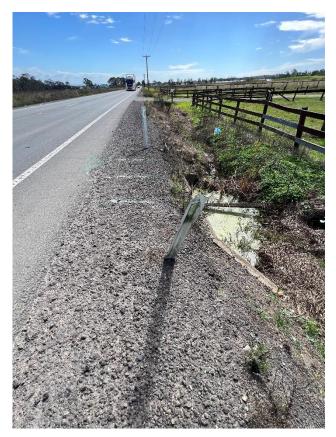
Figure 212 – General condition of the bollards.

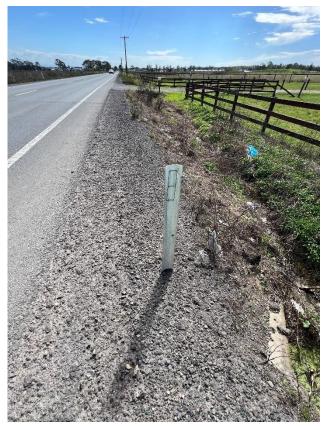
Figure 213 – General condition of the bollards.

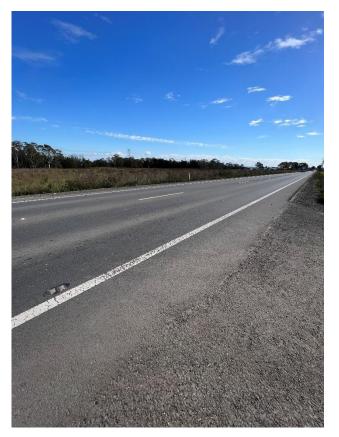
Figure 216 – General condition of the road.

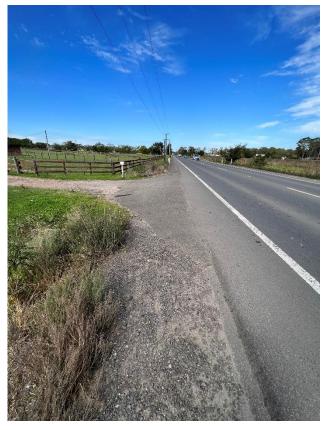
Figure 217 – General condition of the nature strip/driveway.

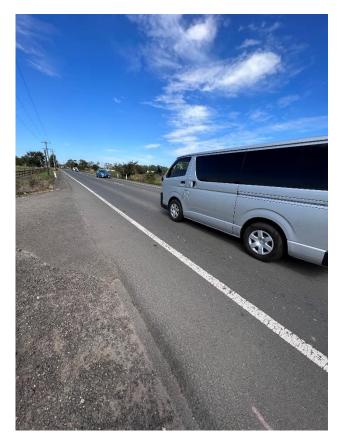
Figure 218 – General condition of the road.

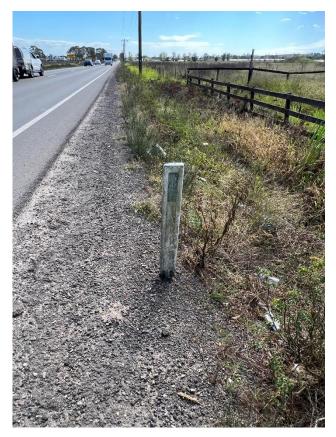
Figure 220 – General condition of the bollards.

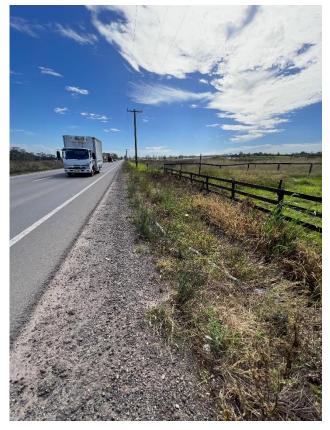
Figure 221 – General condition of the nature strip.

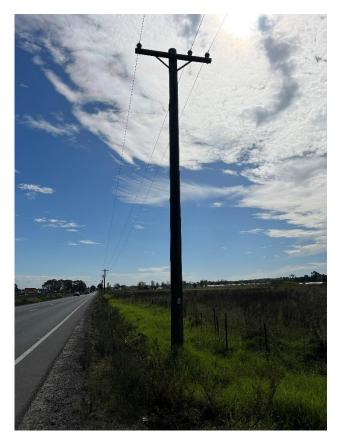
Figure 222 – General condition of the electrical post.

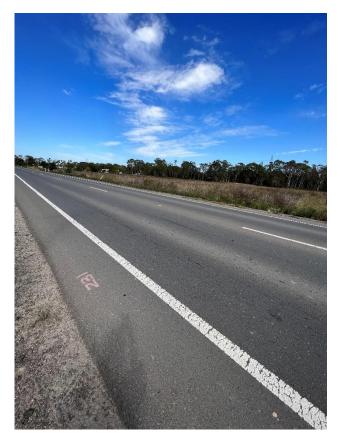
Figure 224 – General condition of the road.

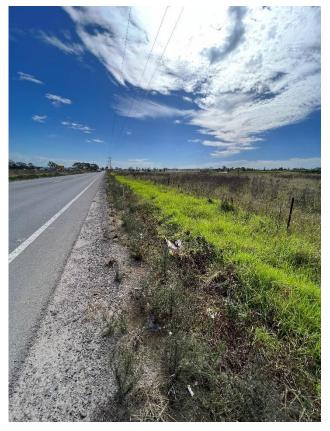
Figure 225 – General condition of the nature strip.

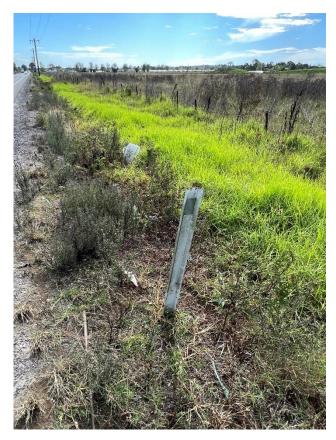
Figure 226 – General condition of the bollards/nature strip.

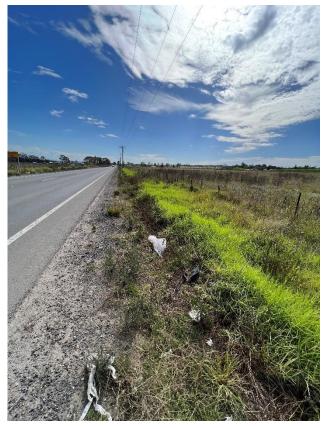
Figure 227 – General condition of the nature strip.

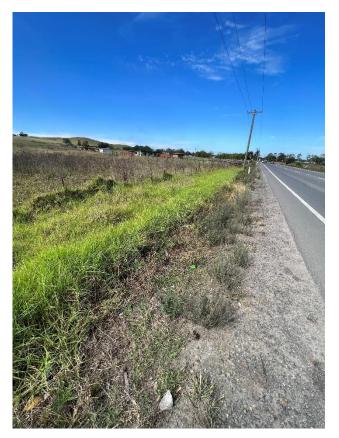
Figure 228 – General condition of the nature strip.

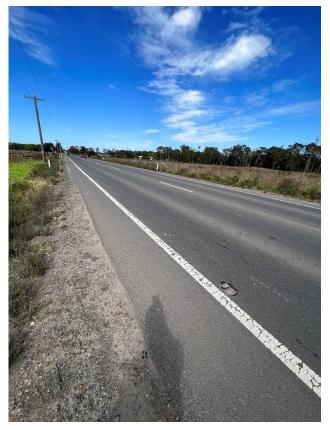
Figure 229 – General condition of the road.

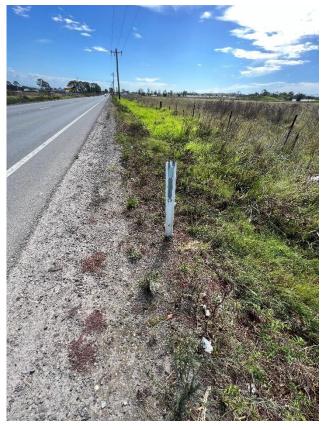
Figure 231 – General condition of the bollards/nature strip.

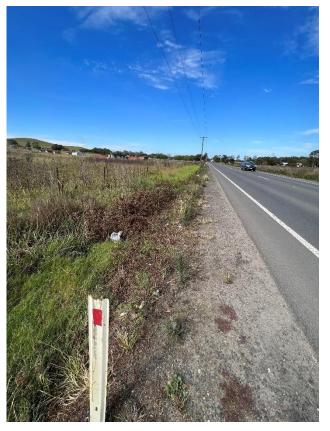
Figure 233 – General condition of the nature strip.

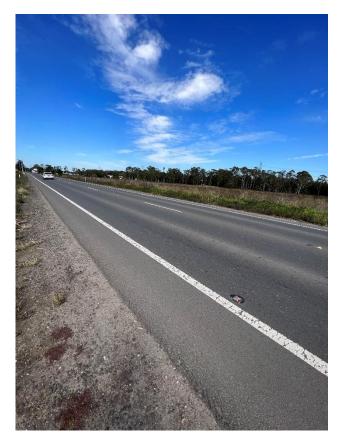
Figure 234 – General condition of the road.

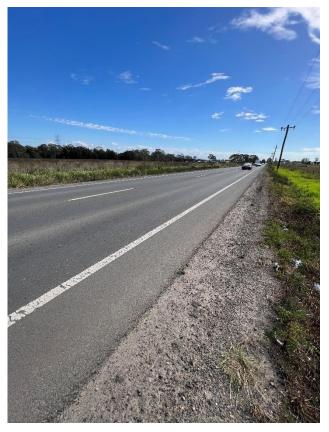
Figure 235 – General condition of the road.

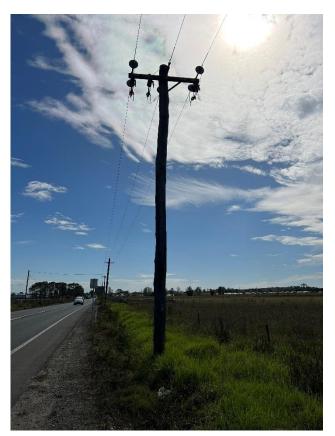
Figure 236 – General condition of the electrical post.

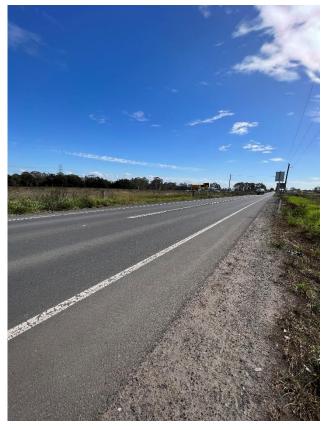
Figure 237 – General condition of the road.

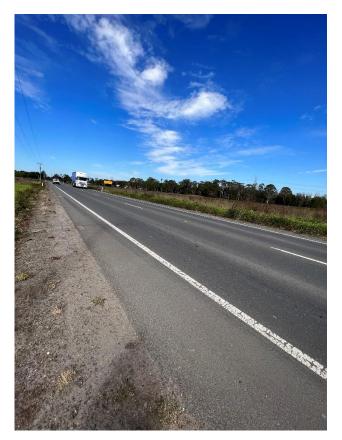
Figure 238 – General condition of the road.

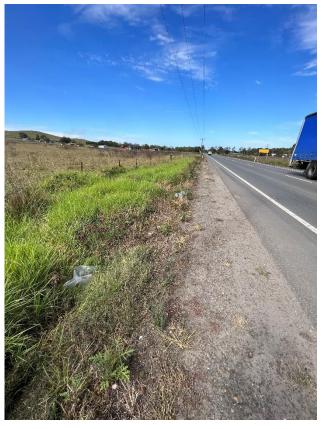
Figure 239 – General condition of the nature strip.

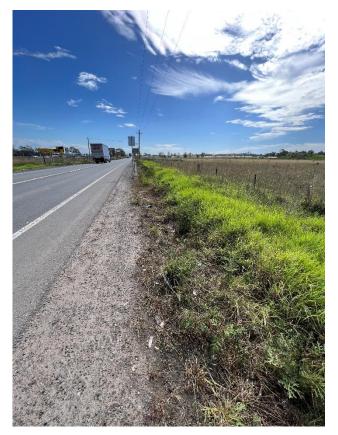
Figure 240 – General condition of the nature strip.

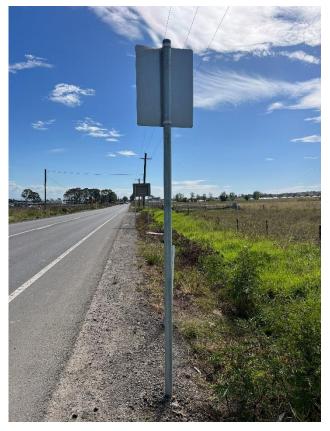
Figure 241 – General condition of the street signpost.

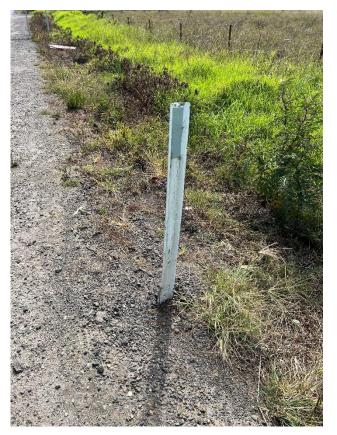
Figure 242 – General condition of the bollards.

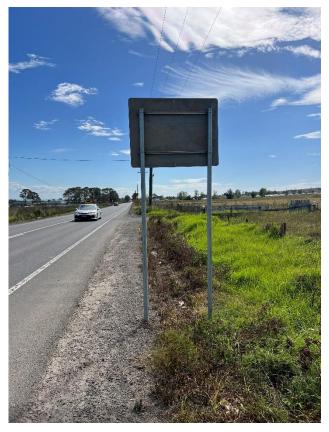
Figure 243 – General condition of the nature strip/street signpost.

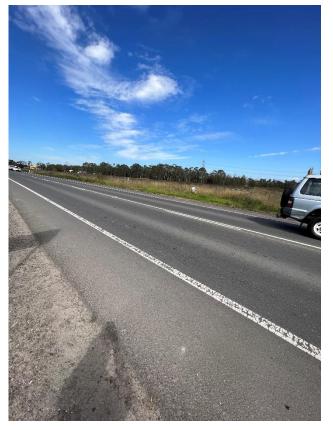
Figure 245 – General condition of the road.

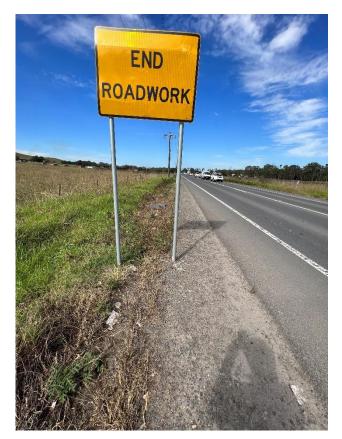
Figure 246 – General condition of the street signpost.

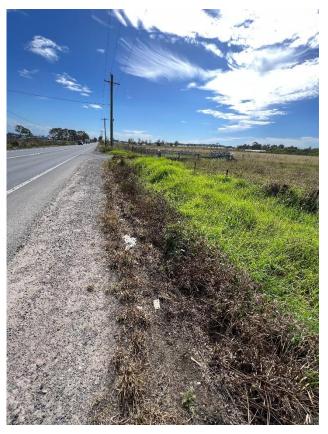
Figure 247 – General condition of the nature strip.

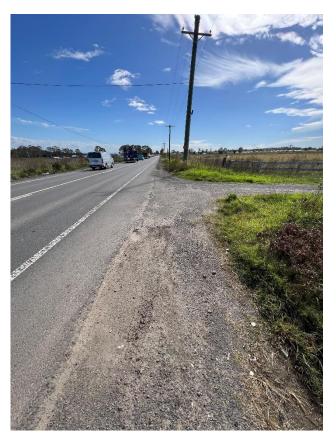
Figure 248 – General condition of the road.

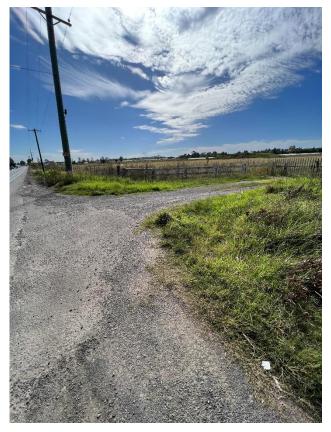
Figure 249 – General condition of the driveway/nature strip.

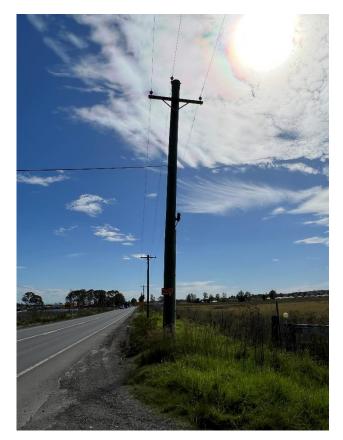
Figure 250 – General condition of the electrical post.

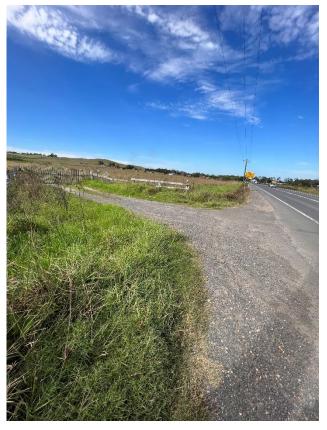
Figure 251 – General condition of the nature strip.

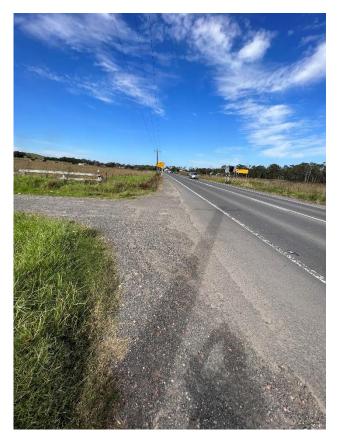
Figure 252 – General condition of the driveway.

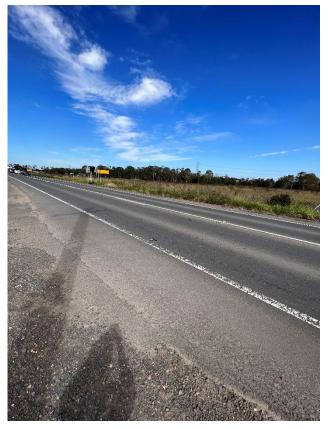
Figure 253 – General condition of the road.

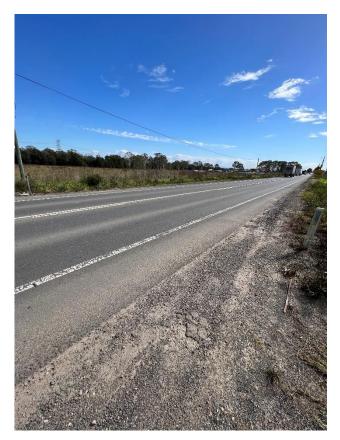
Figure 254 – General condition of the road.

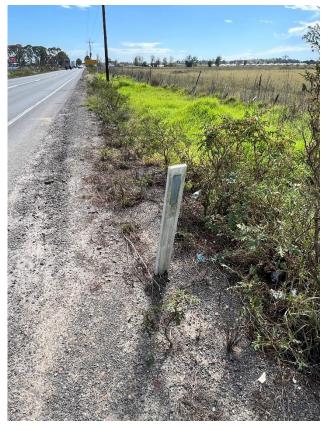
Figure 255 – General condition of the bollards.

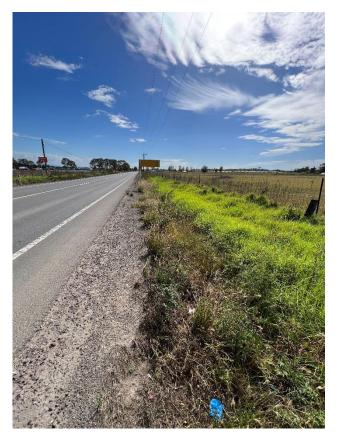
Figure 256 – General condition of the nature strip.

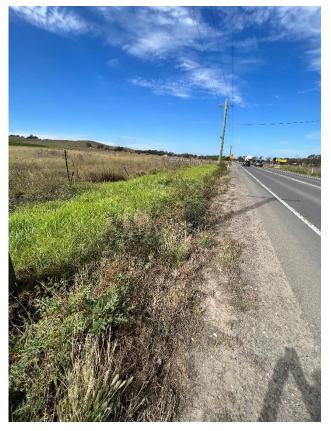
Figure 257 – General condition of the nature strip.

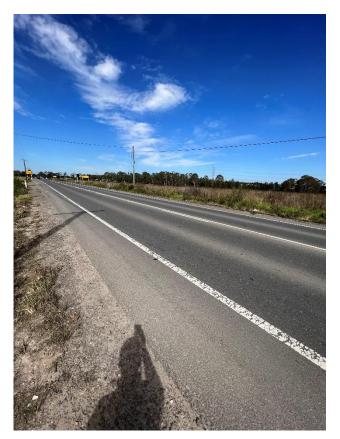
Figure 258 – General condition of the road.

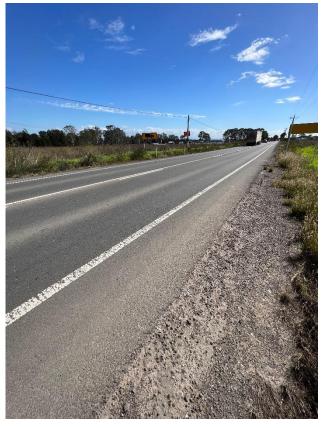
Figure 259 – General condition of the road.

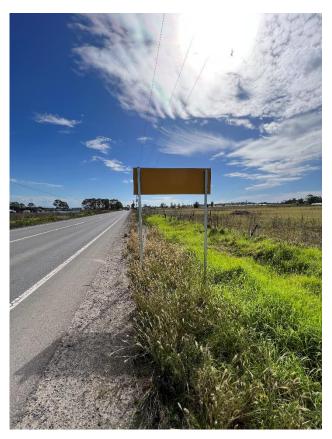
Figure 260 – General condition of the nature strip/street signpost.

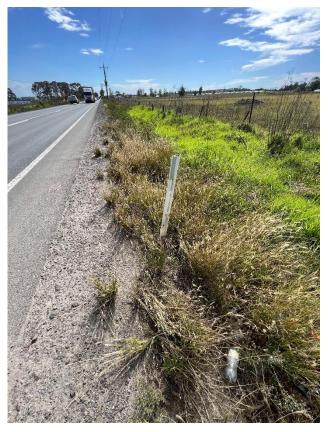
Figure 261 – General condition of the bollards/nature strip.

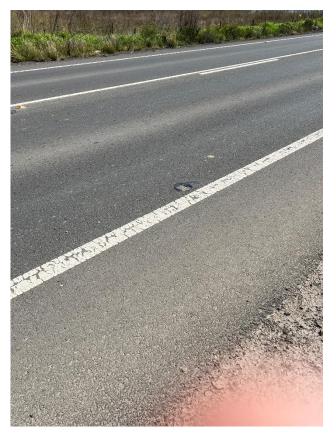
Figure 262 – General condition of the road.

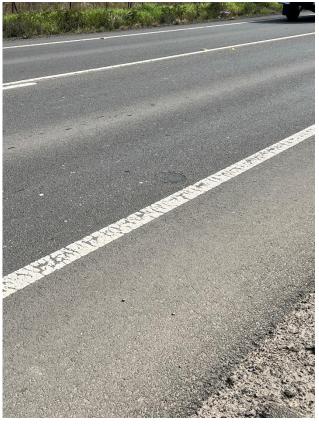
Figure 263 – General condition of the road.

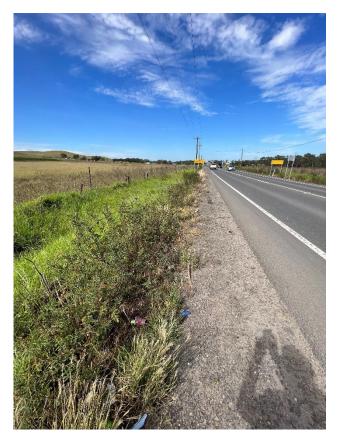
Figure 264 – General condition of the nature strip.

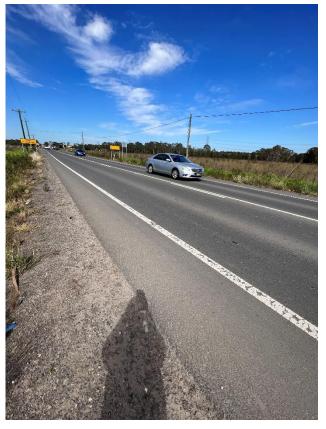
Figure 265 – General condition of the road.

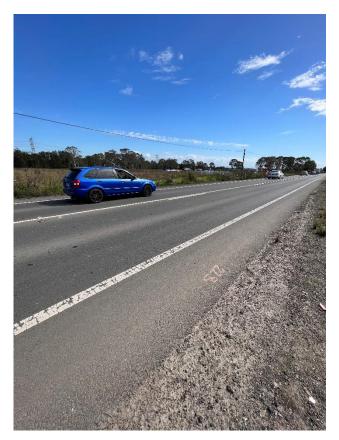
Figure 266 – General condition of the road.

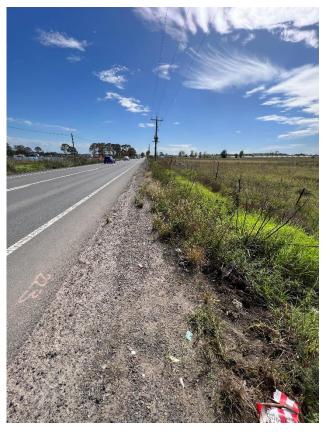
Figure 267 – General condition of the nature strip.

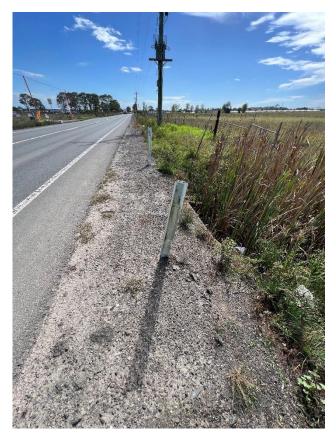
Figure 268 – General condition of the bollards.

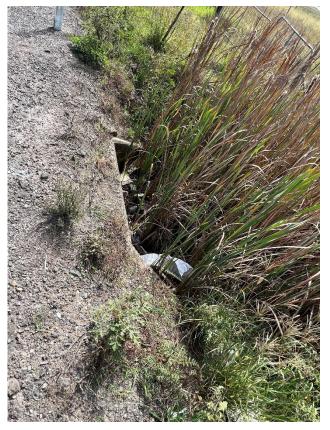
Figure 269 – General condition of the nature strip.

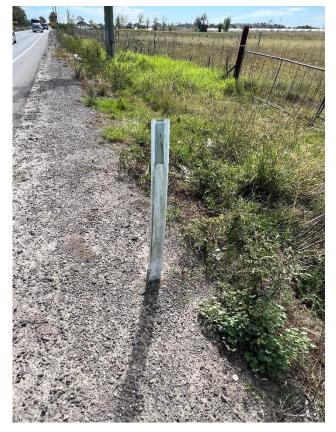
Figure 270 – General condition of the bollards.

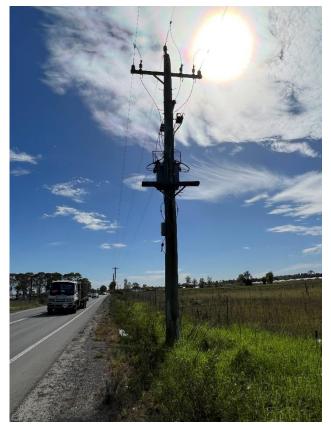
Figure 271 – General condition of the electrical post.

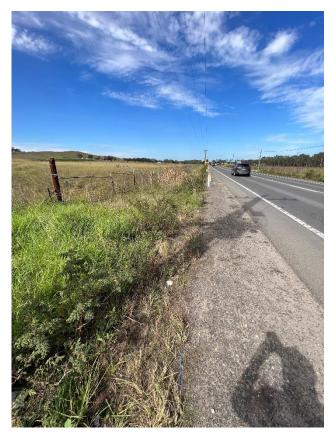
Figure 272 – General condition of the nature strip.

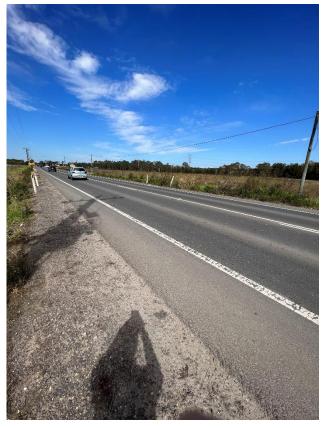
Figure 273 – General condition of the road.

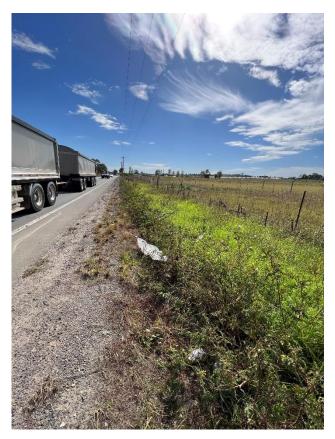
Figure 274 – General condition of the nature strip.

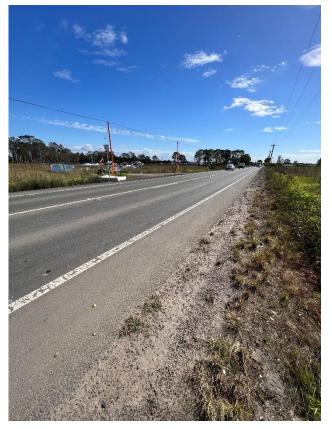
Figure 275 – General condition of the road.

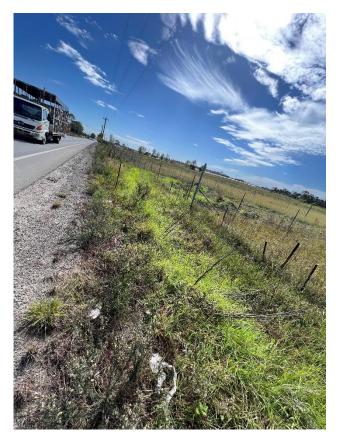
Figure 276 – General condition of the nature strip.

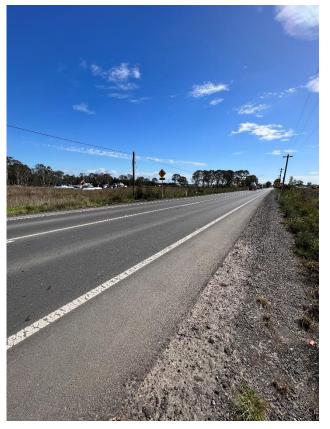
Figure 277 – General condition of the road.

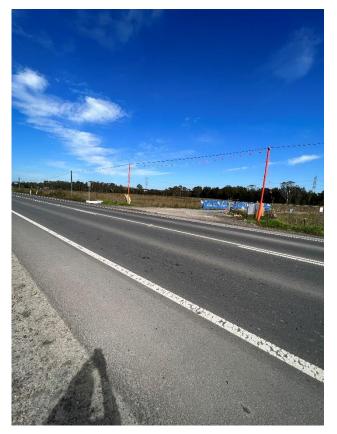
Figure 278 – General condition of the road.

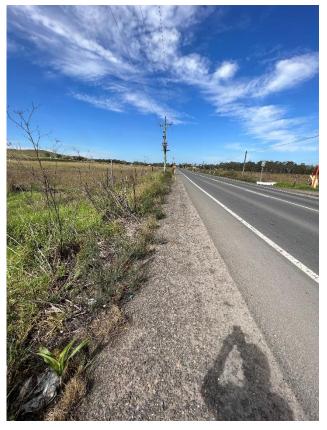
Figure 279 – General condition of the nature strip.

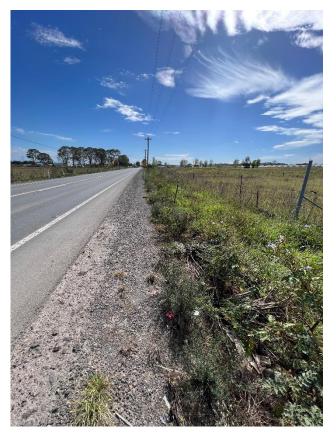
Figure 280 – General condition of the nature strip.

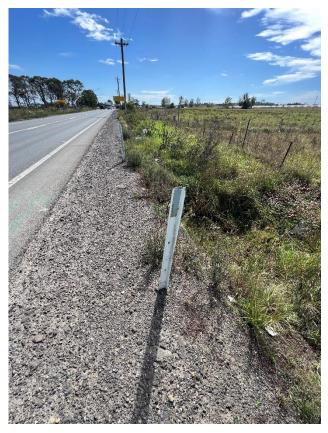
Figure 281 – General condition of the bollards.

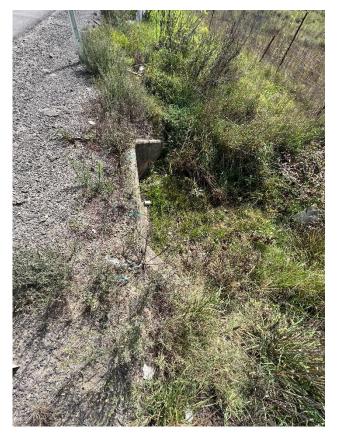
Figure 282 – General condition of the nature strip.

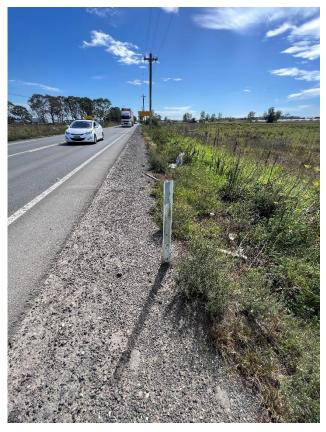
Figure 283 – General condition of the bollards/nature strip.

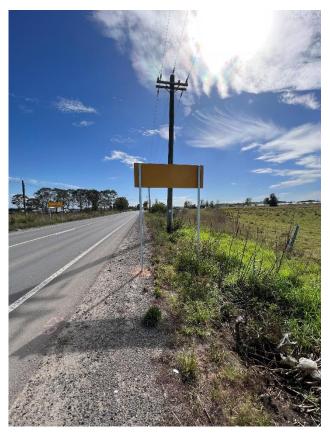
Figure 284 – General condition of the nature strip/street signpost.

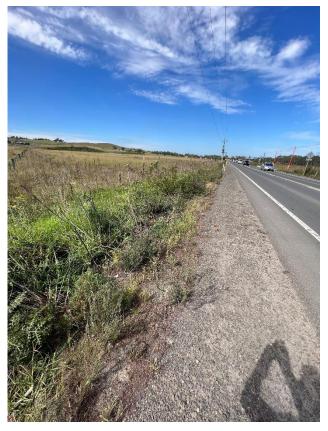
Figure 285 – General condition of the nature strip.

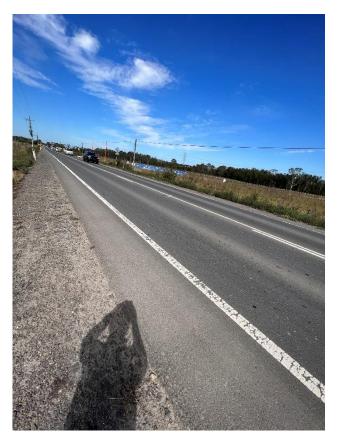
Figure 286 – General condition of the road.

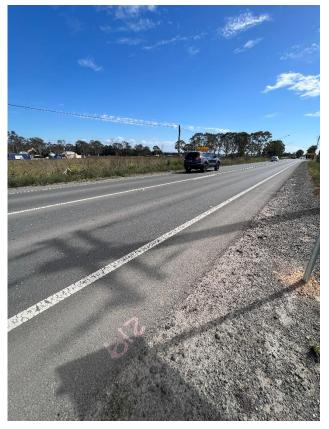
Figure 287 – General condition of the road.

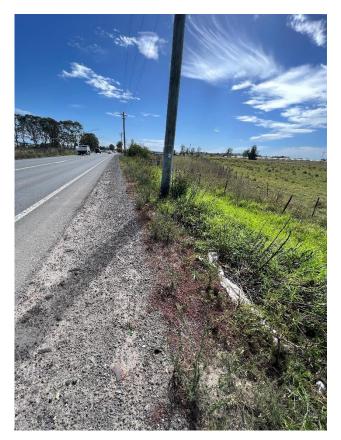
Figure 288 – General condition of the nature strip.

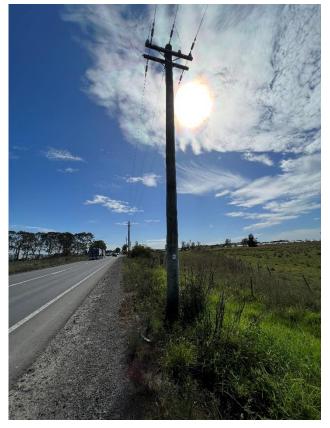
Figure 289 – General condition of the electrical post.

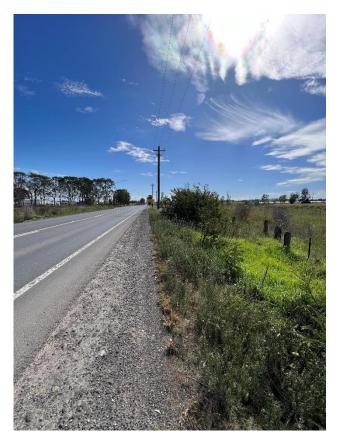
Figure 290 – General condition of the nature strip.

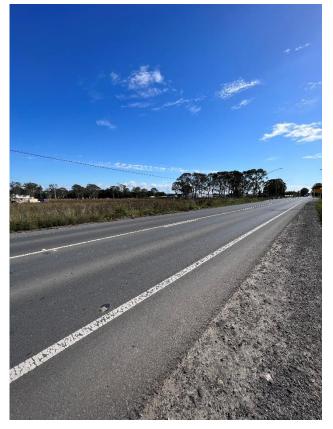
Figure 291 – General condition of the road.

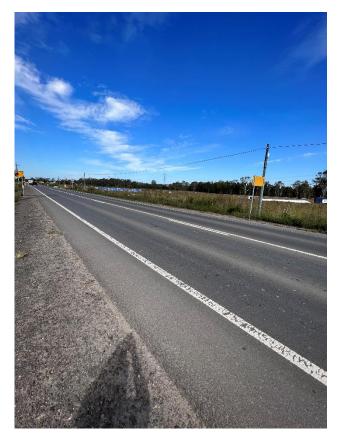
Figure 292 – General condition of the road.

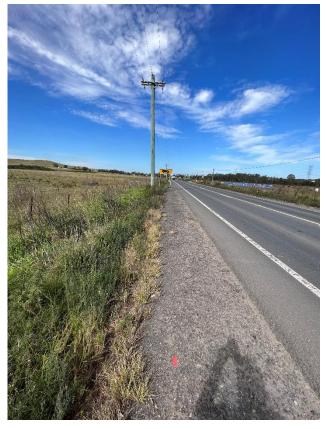
Figure 293 – General condition of the nature strip.

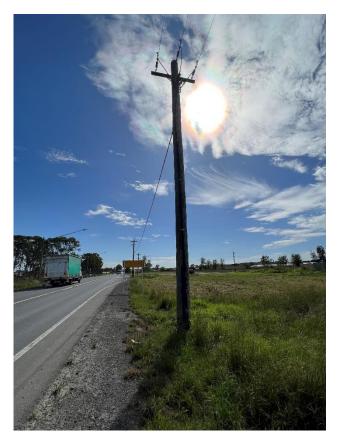
Figure 294 – General condition of the electrical post.

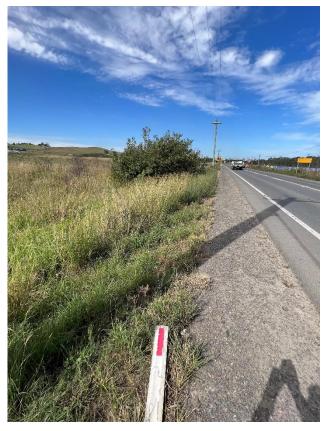
Figure 295 – General condition of the nature strip.

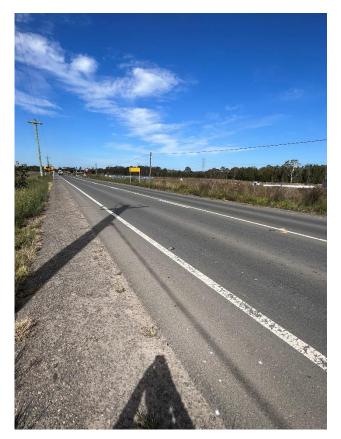
Figure 296 – General condition of the road.

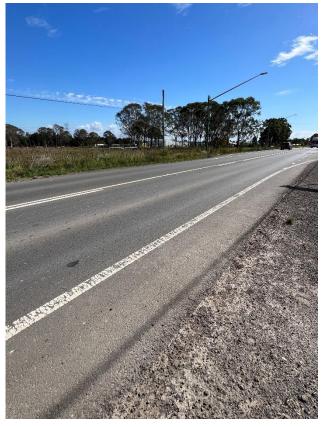
Figure 297 – General condition of the road.

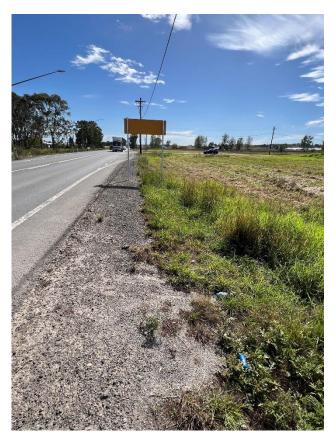
Figure 298 – General condition of the nature strip.

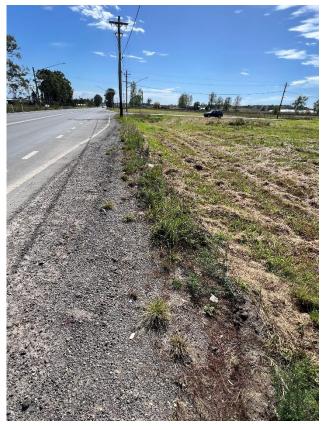
Figure 299 – General condition of the nature strip.

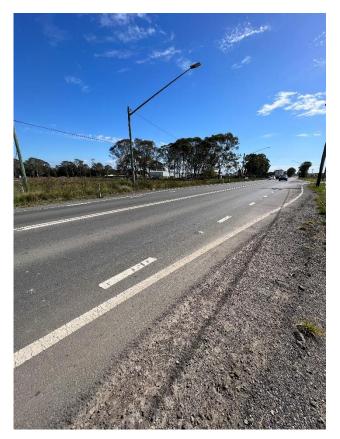
Figure 300 – General condition of the road.

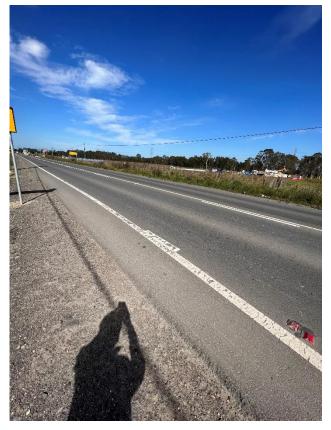
Figure 301 – General condition of the road.

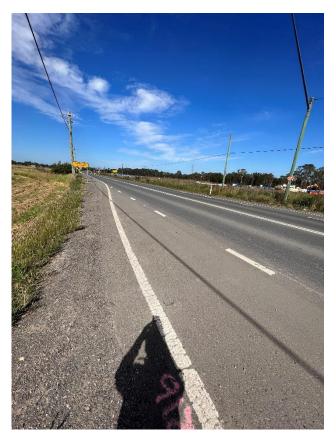
Figure 302 – General condition of the road.

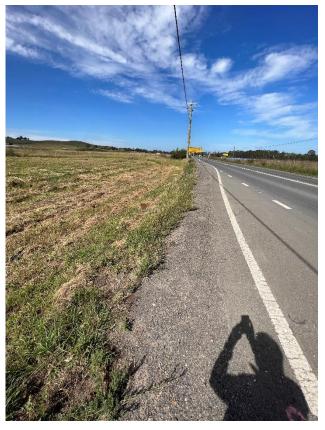
Figure 303 – General condition of the nature strip.

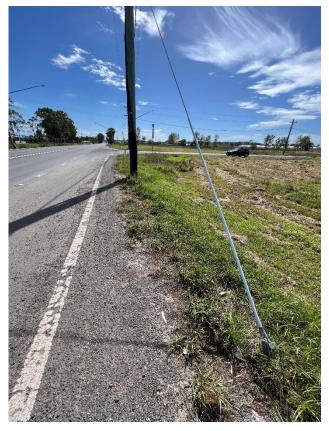
Figure 305 – General condition of the nature strip.

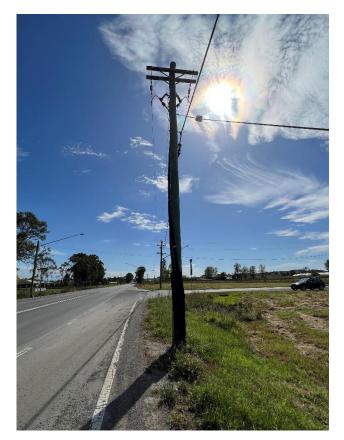
Figure 306 – General condition of the electrical post.

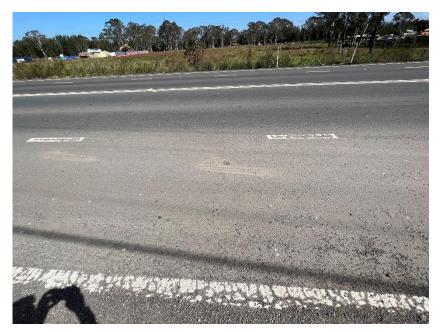
Figure 307 – General condition of the road.

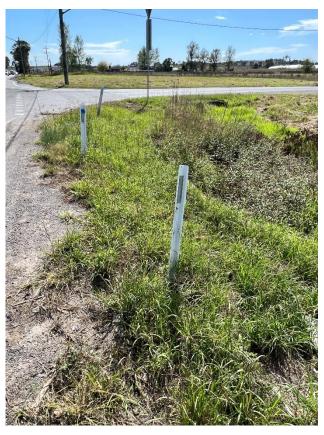
Figure 308 – General condition of the bollards/nature strip.

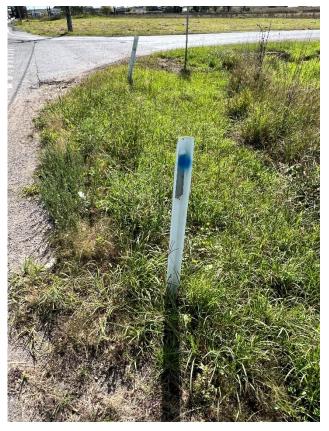
Figure 309 – General condition of the bollards/nature strip.

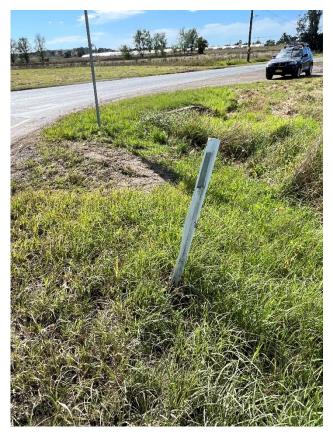
Figure 310 – General condition of the bollards/nature strip.

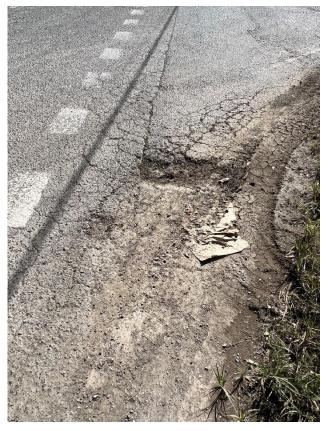
Figure 311 – Crack propagation to the driveway.

The council assets were found to be in a fair condition with evidence of crack propagation to the road and driveway. Damage condition is noted to the bollards.

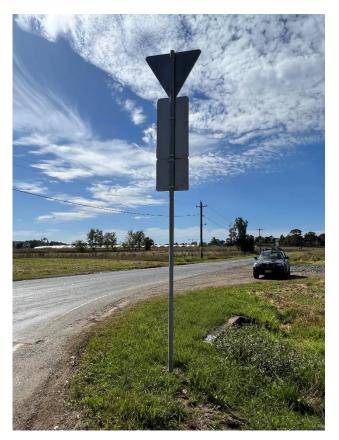
Figure 312 – General condition of the street signpost/nature strip.

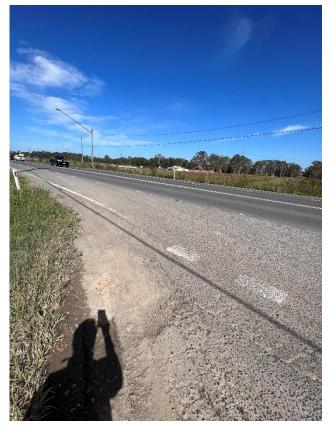
Figure 313 – Crack propagation to the driveway.

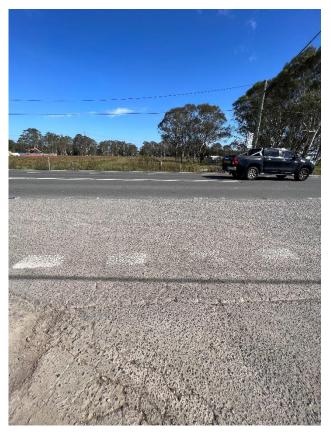
Figure 314 – Crack propagation to the driveway.

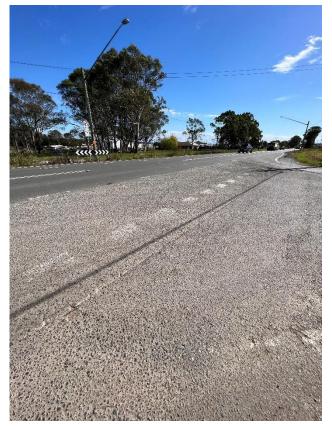
Figure 315 – Crack propagation to the driveway.
