# **DILAPIDATION REPORT**

**Addington Road, Kemps Creek**

This report is intended to be a record of the council assets at Addington Road, Kemps Creek at the time of the inspection.

The inspection was carried out on 18 April 2023.

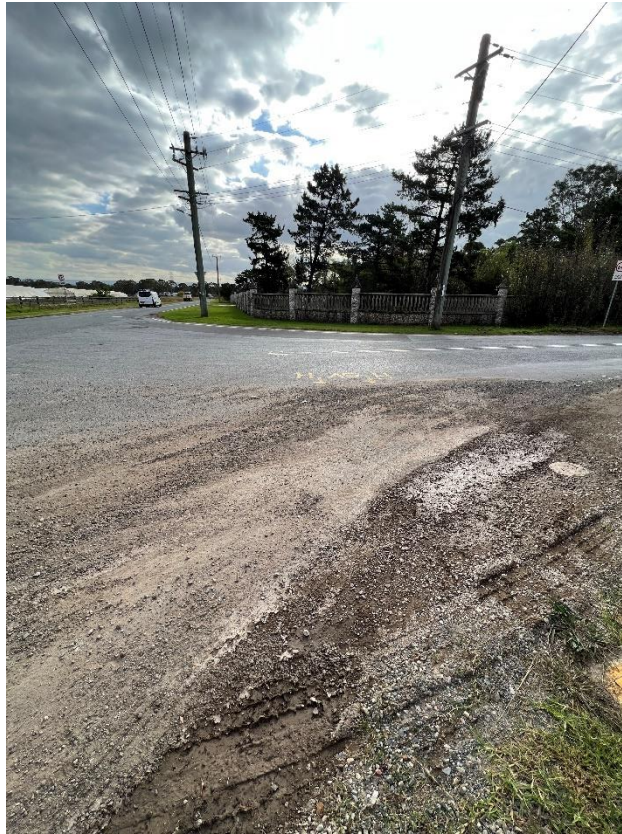
*Figure 7 – General condition of the road.*

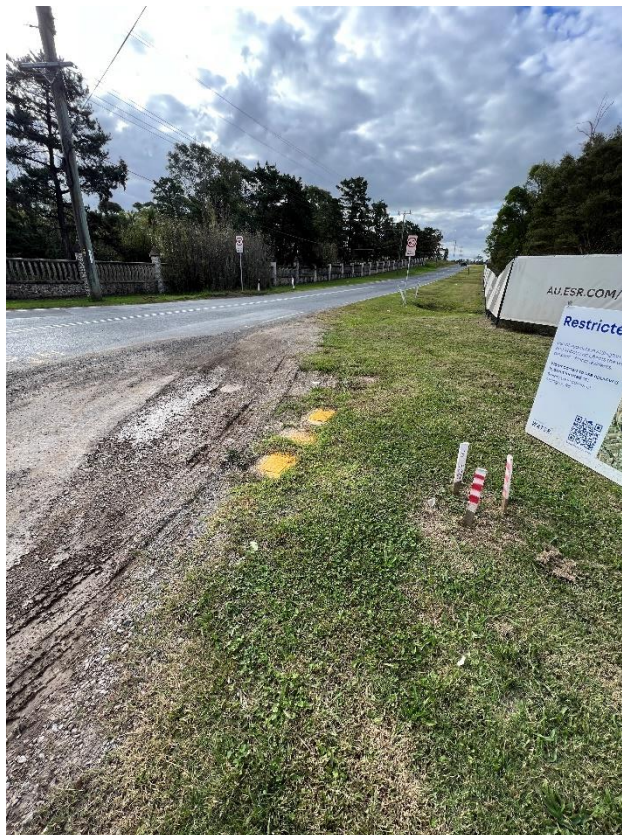
*Figure 8 – General condition of the nature strip.*

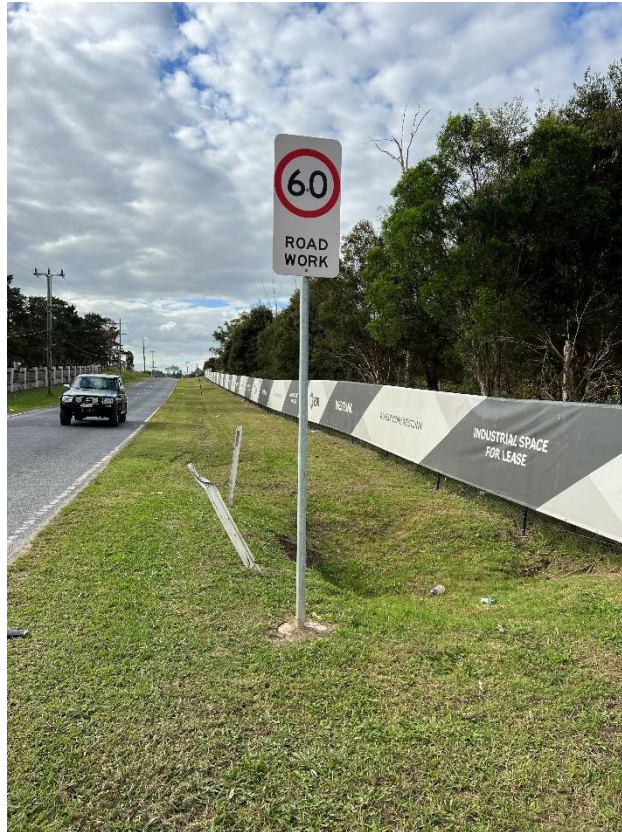
*Figure 9 – General condition of the street signpost/nature strip.*

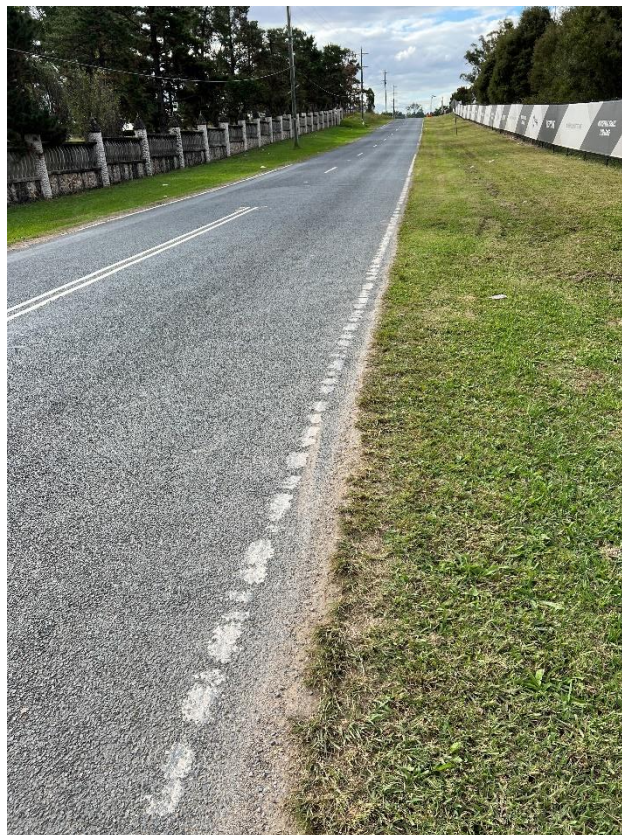
*Figure 10 – General condition of the road.*

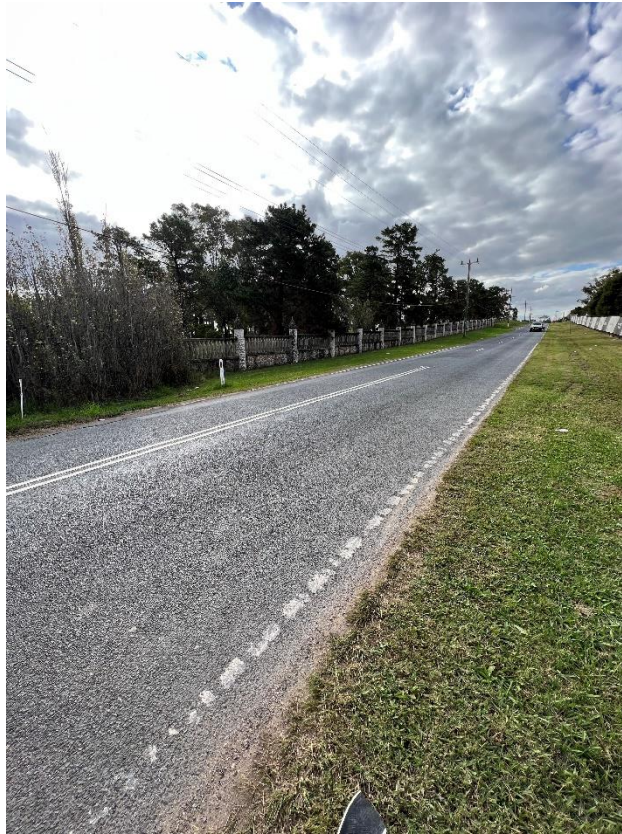
*Figure 11 – General condition of the road.*

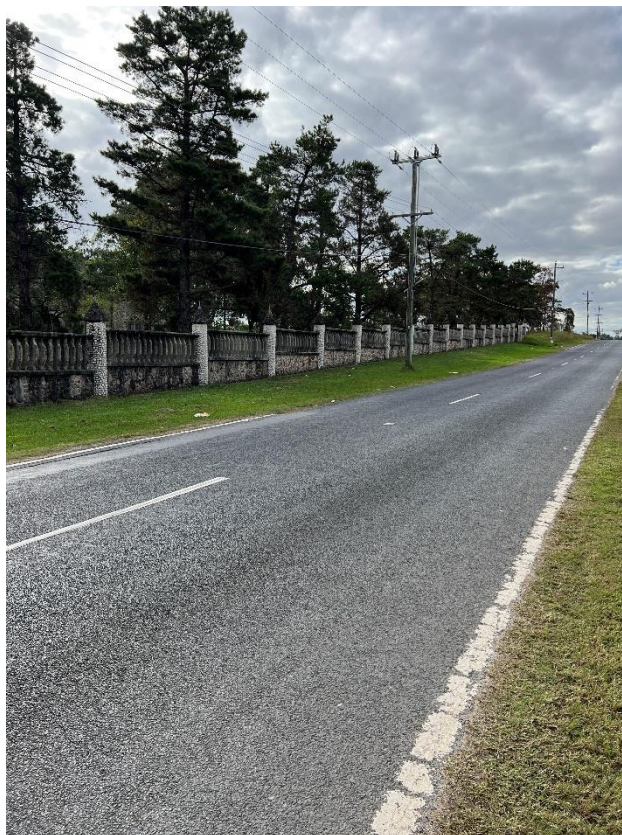
*Figure 12 – General condition of the road.*

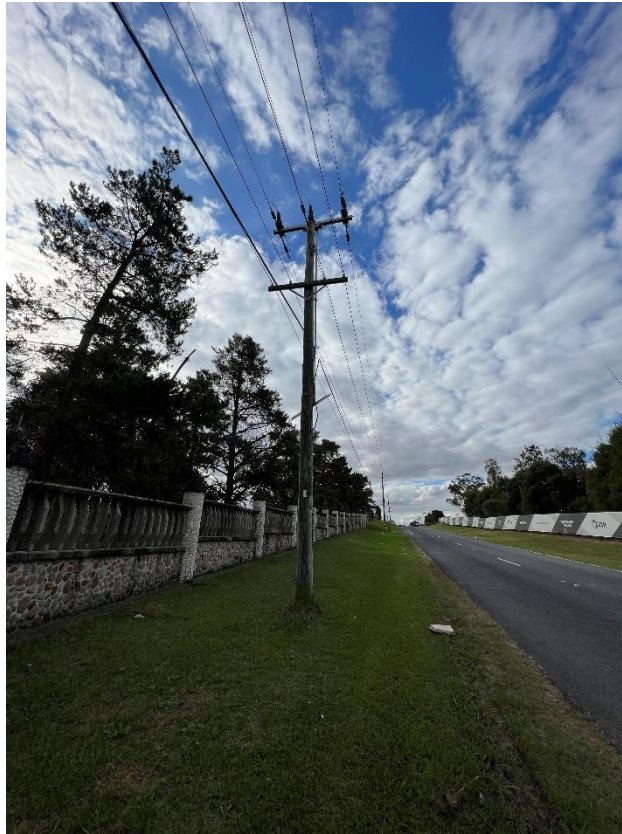
*Figure 13 – General condition of the electrical post.*

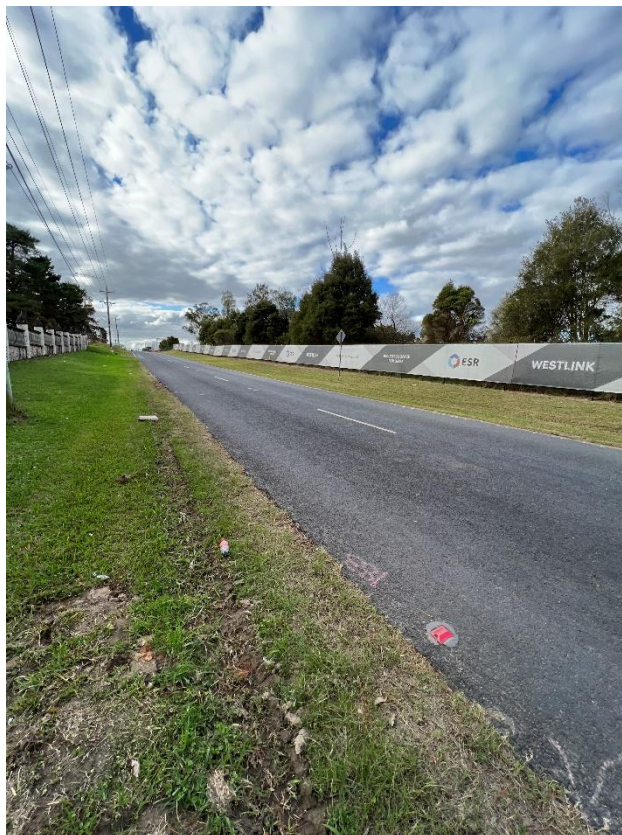
*Figure 14 – General condition of the road.*

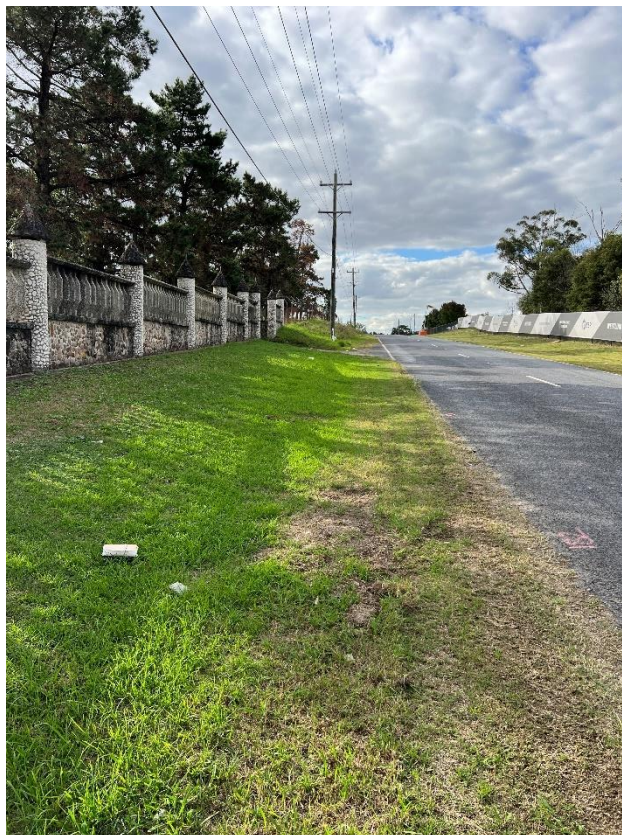
*Figure 16 – General condition of the nature strip.*

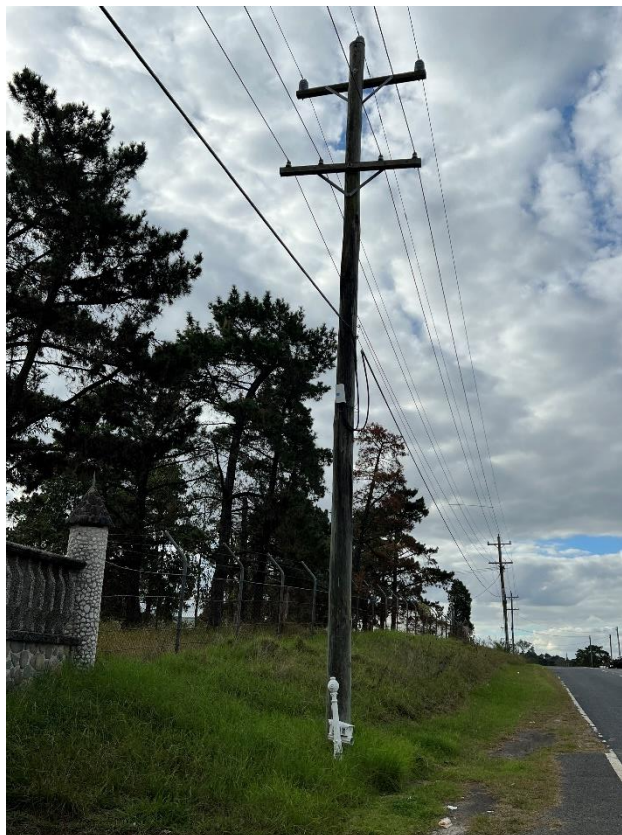
*Figure 20 – General condition of the electrical post.*

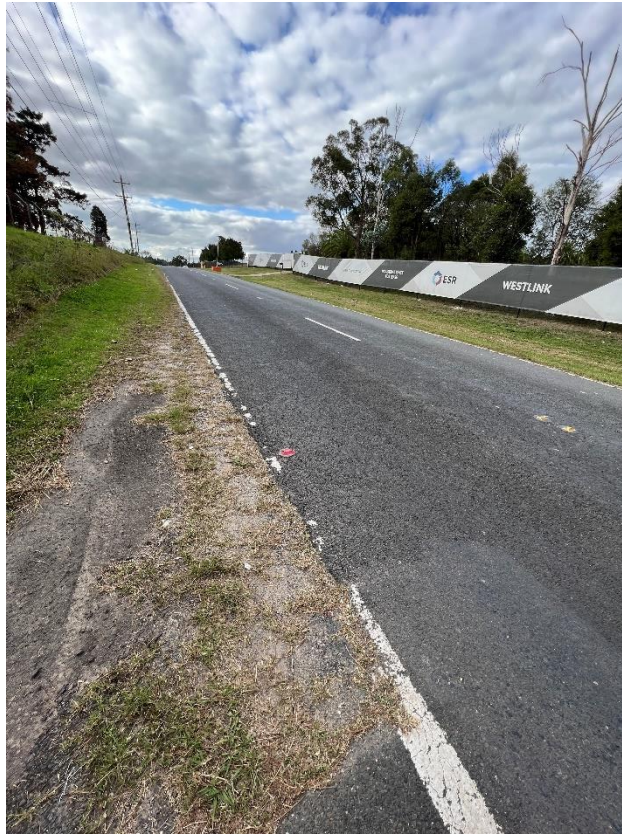
*Figure 21 – General condition of the road/nature strip.*

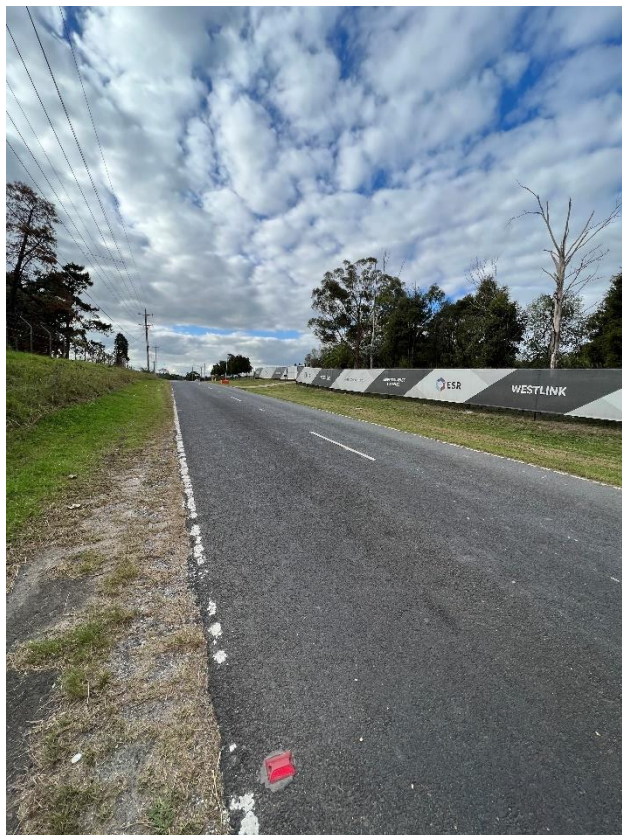
*Figure 22 – General condition of the road.*

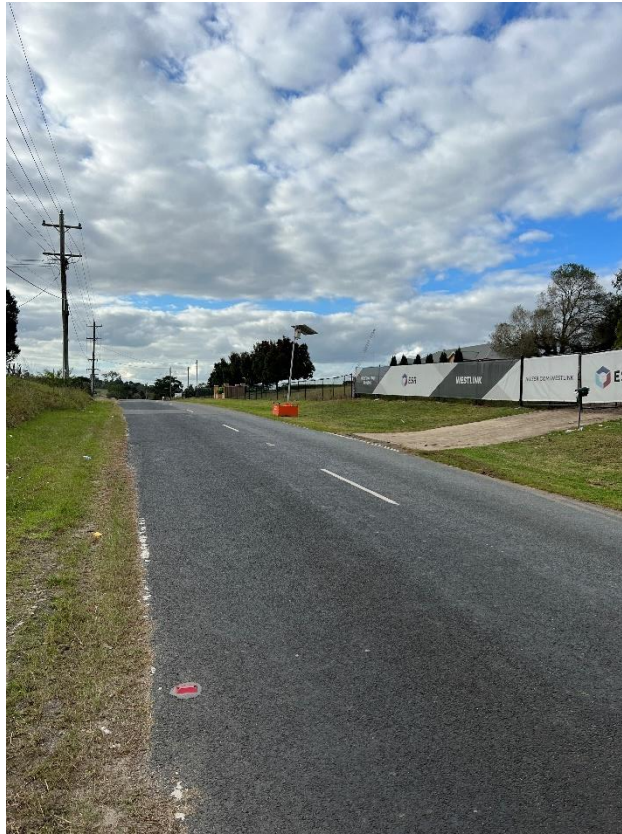
*Figure 23 – General condition of the road.*

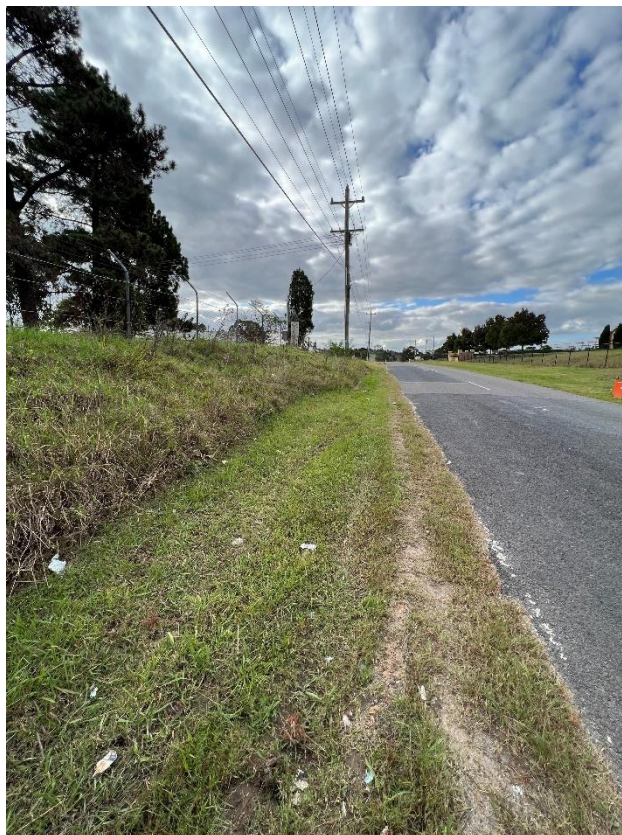
*Figure 26 – General condition of the nature strip.*

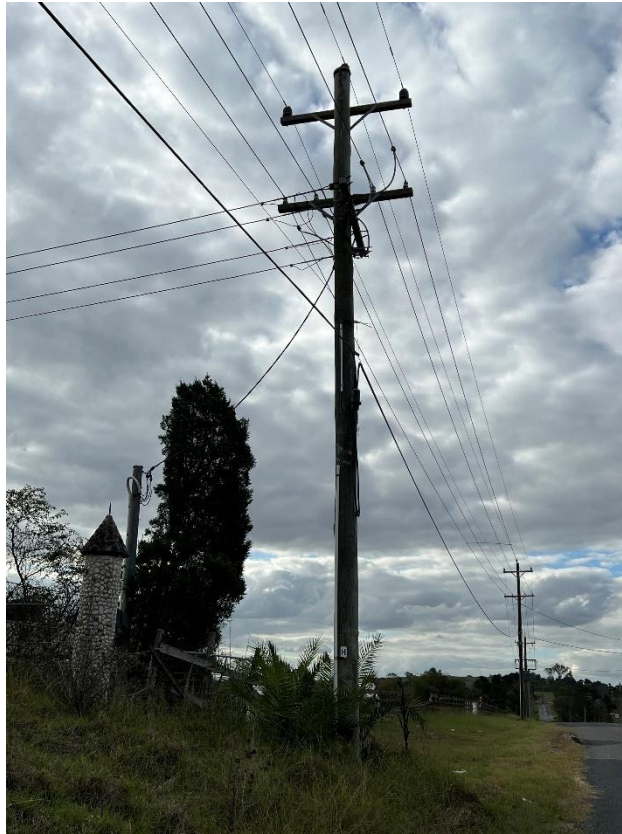
*Figure 27 – General condition of the electrical post.*

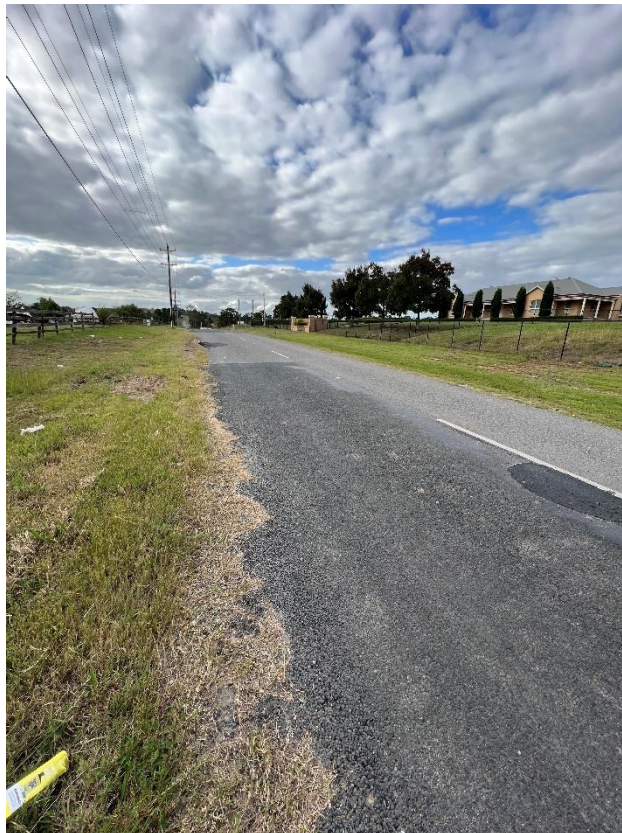
*Figure 28 – Crack propagation to the road.*

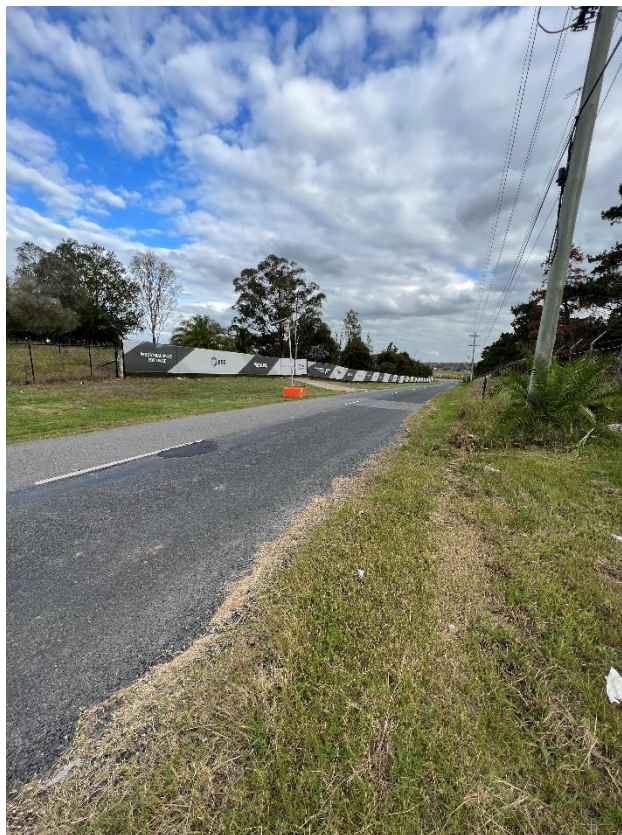
*Figure 30 – General condition of the nature strip.*

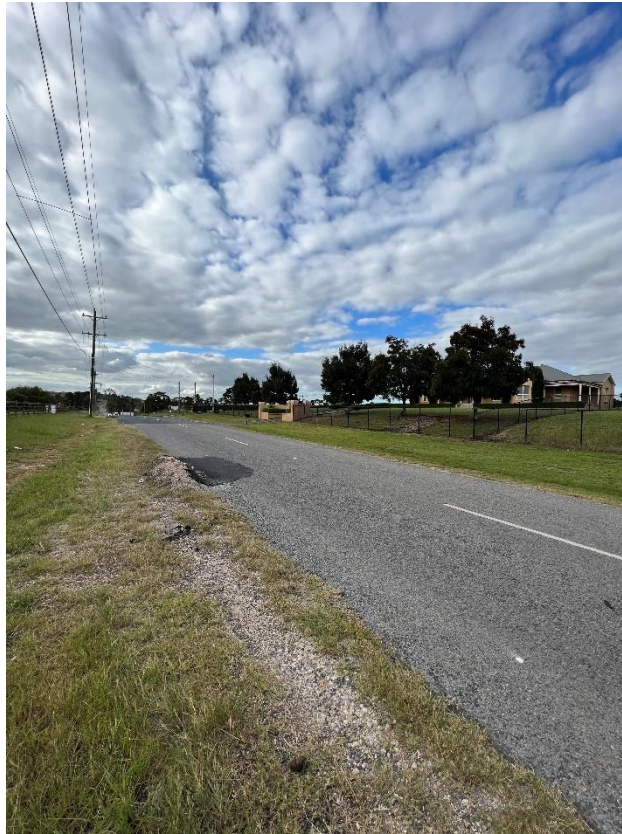
*Figure 31 – General condition of the road/nature strip.*

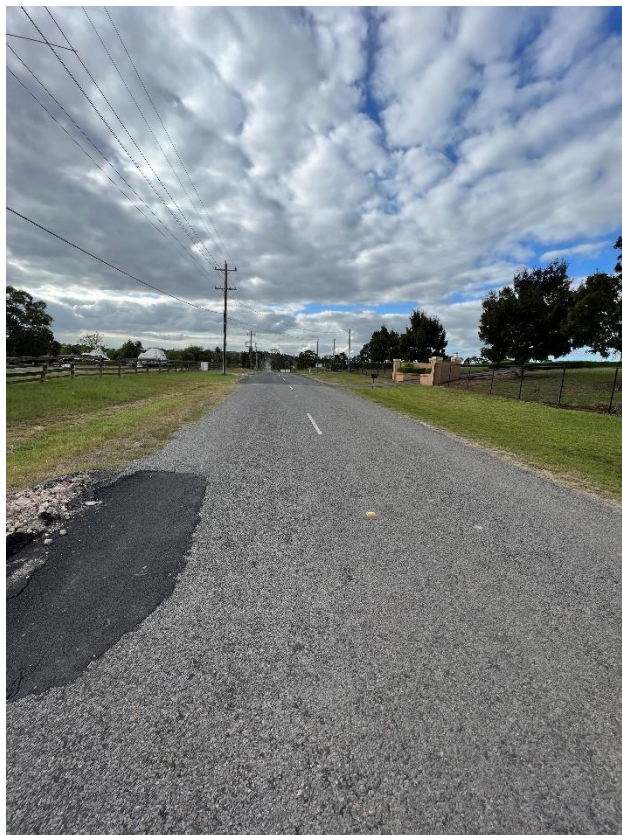
*Figure 32 – General condition of the road.*

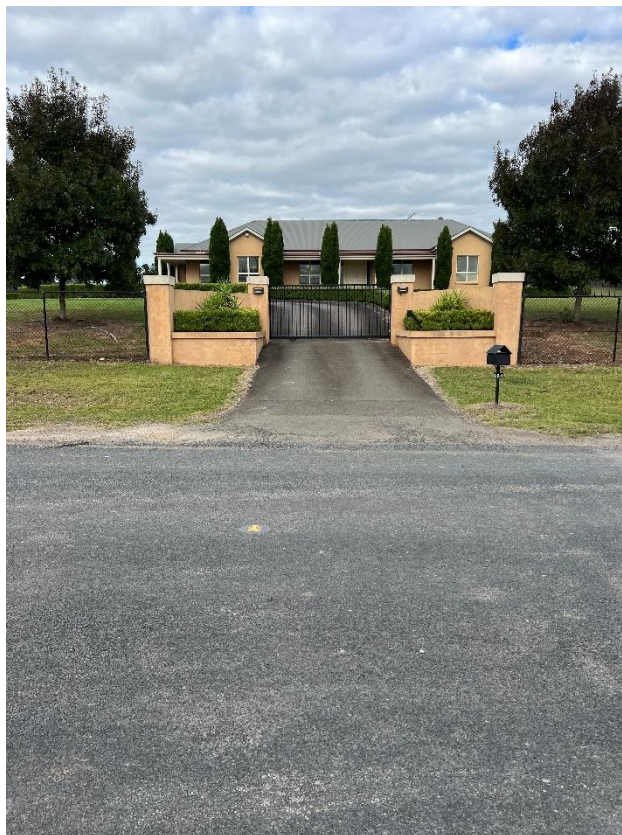
*Figure 34 – General condition of the road.*

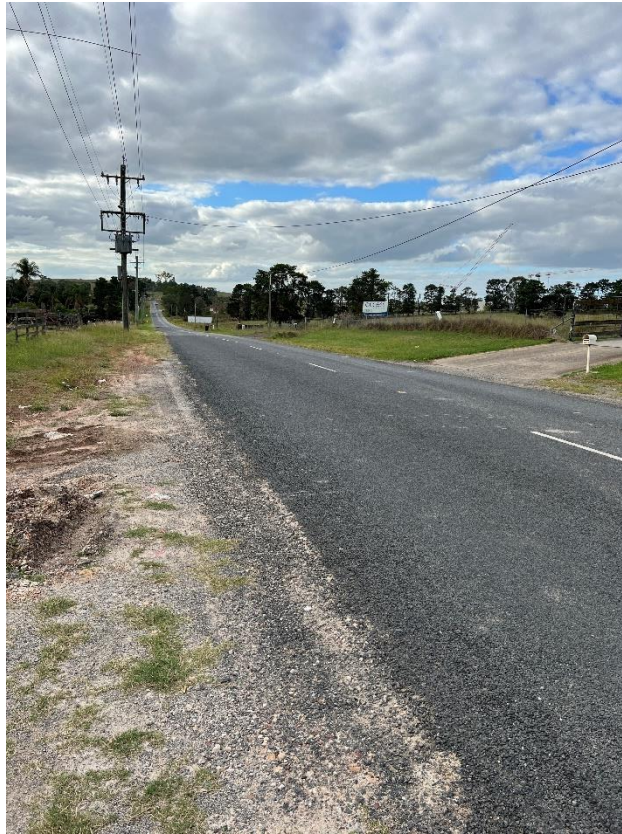
*Figure 35 – General condition of the road.*

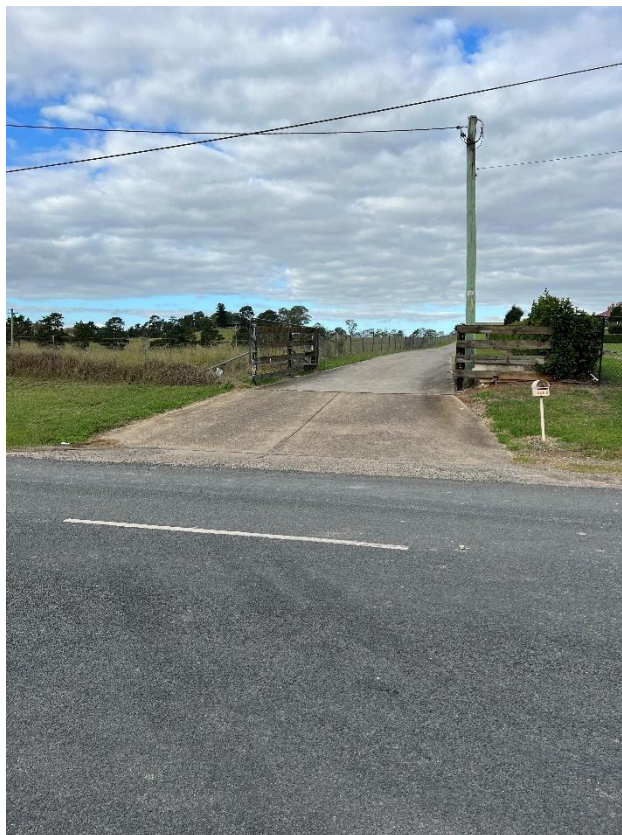
*Figure 36 – General condition of the road.*

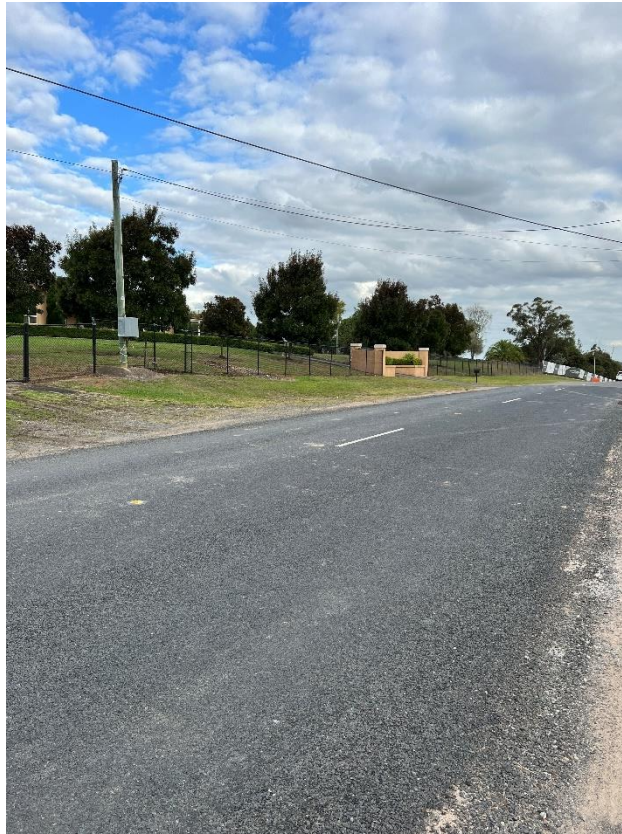
*Figure 37 – General condition of the road.*

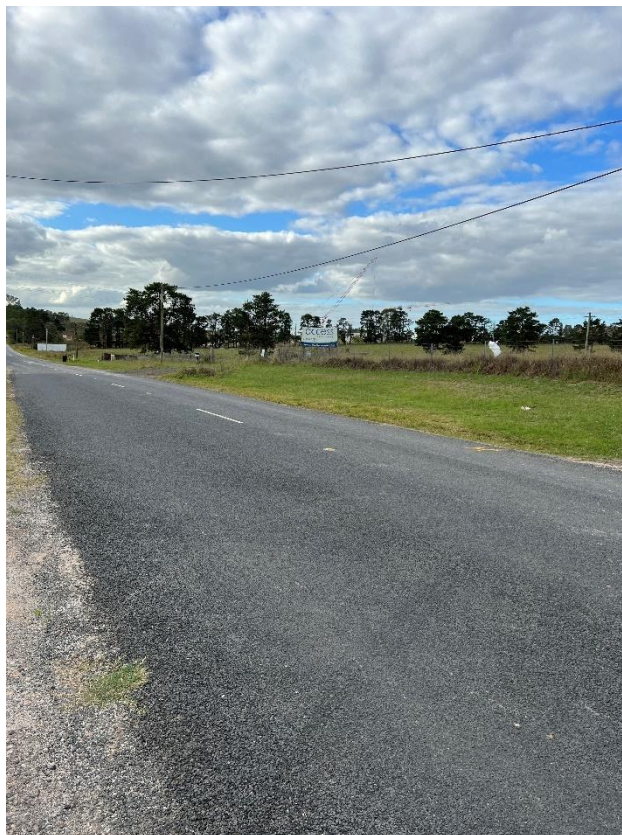
*Figure 38 – General condition of the road.*

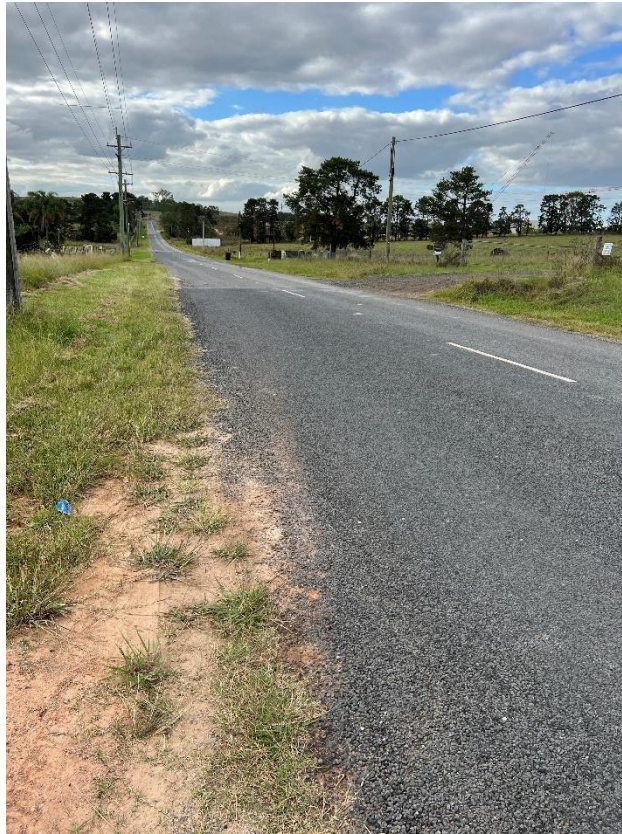
*Figure 39 – General condition of the road.*

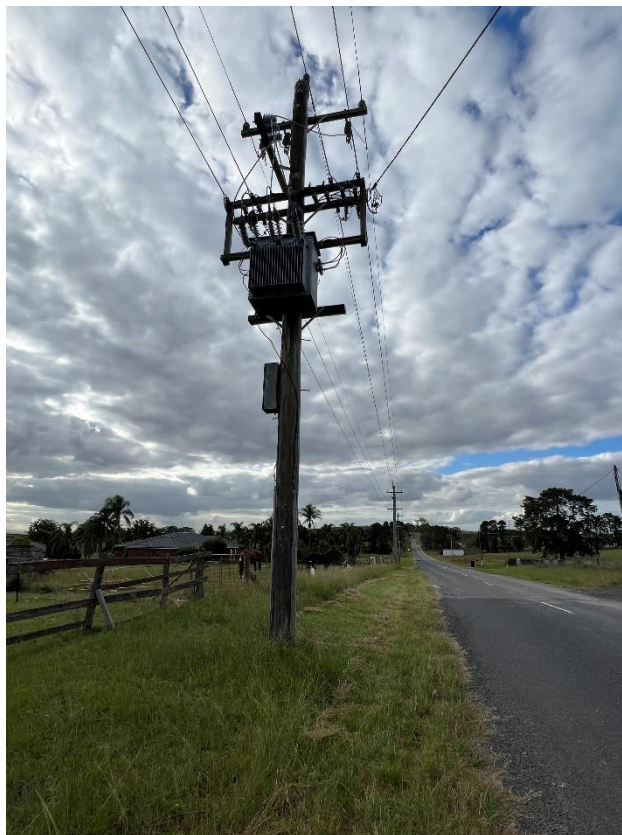
*Figure 40 – General condition of the electrical post.*

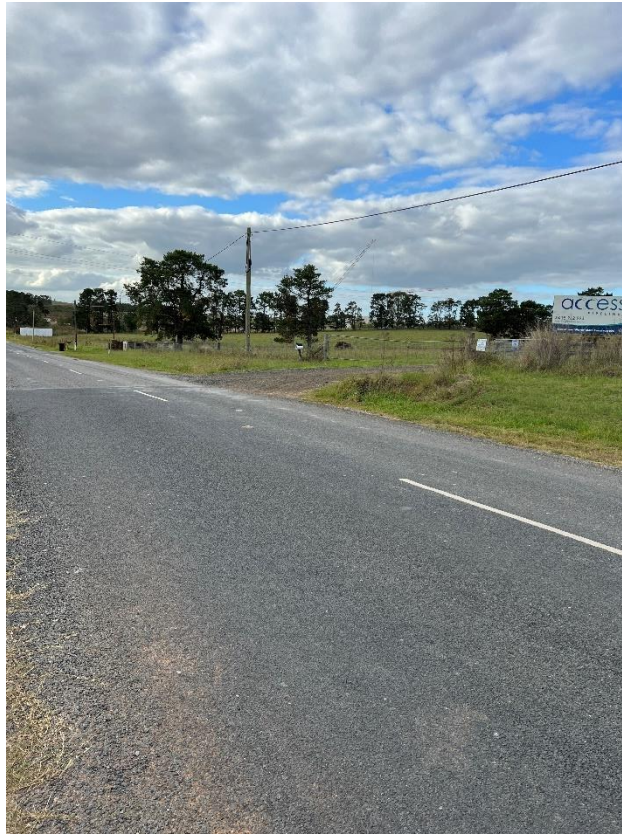
*Figure 41 – General condition of the road.*

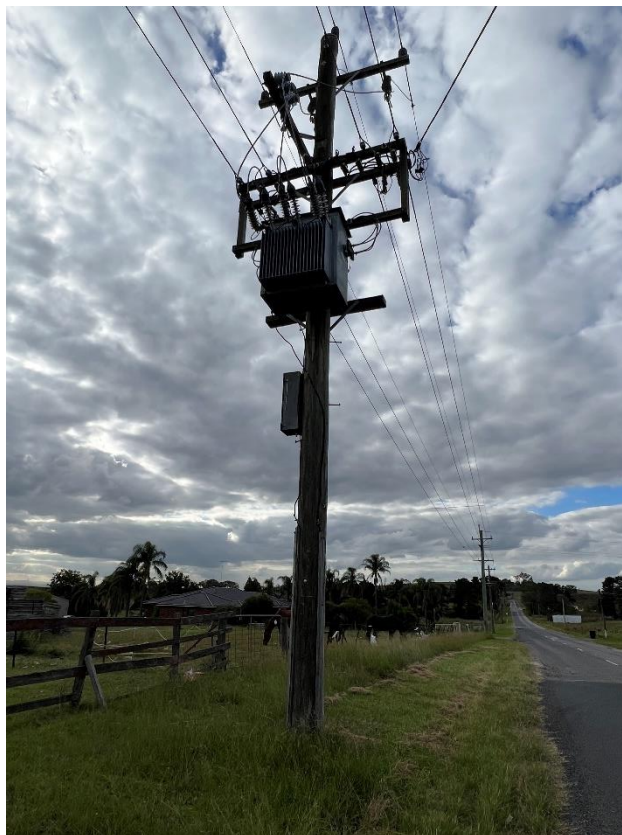
*Figure 42 – General condition of the electrical post.*

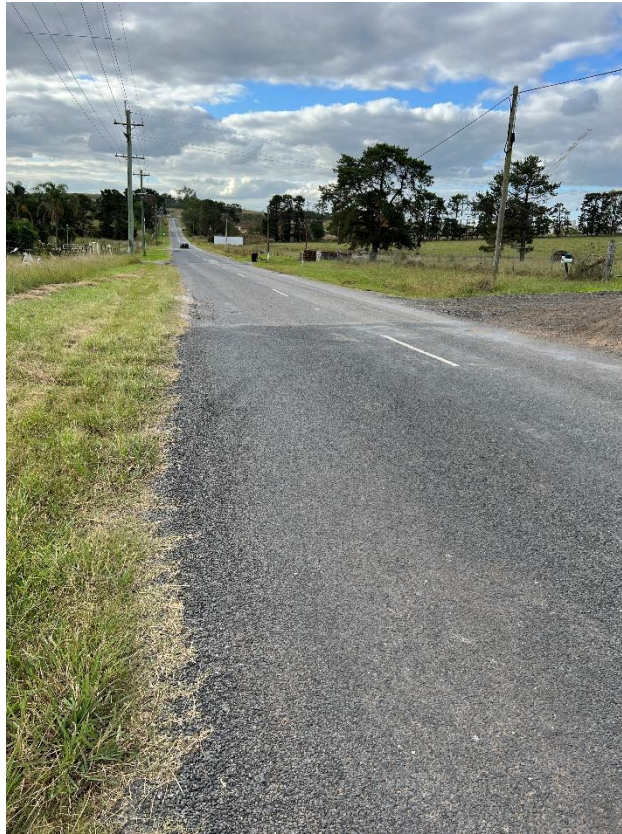
*Figure 43 – General condition of the road.*

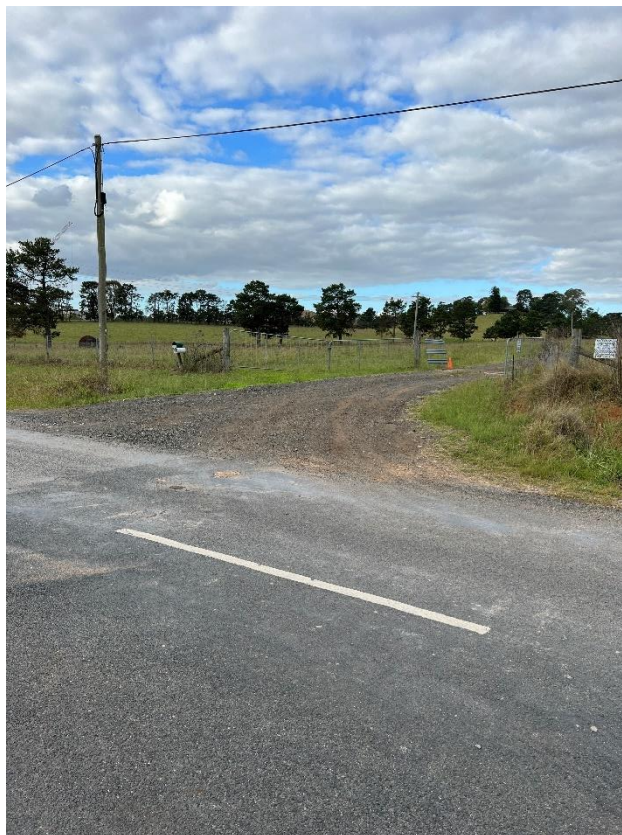
*Figure 44 – General condition of the road.*

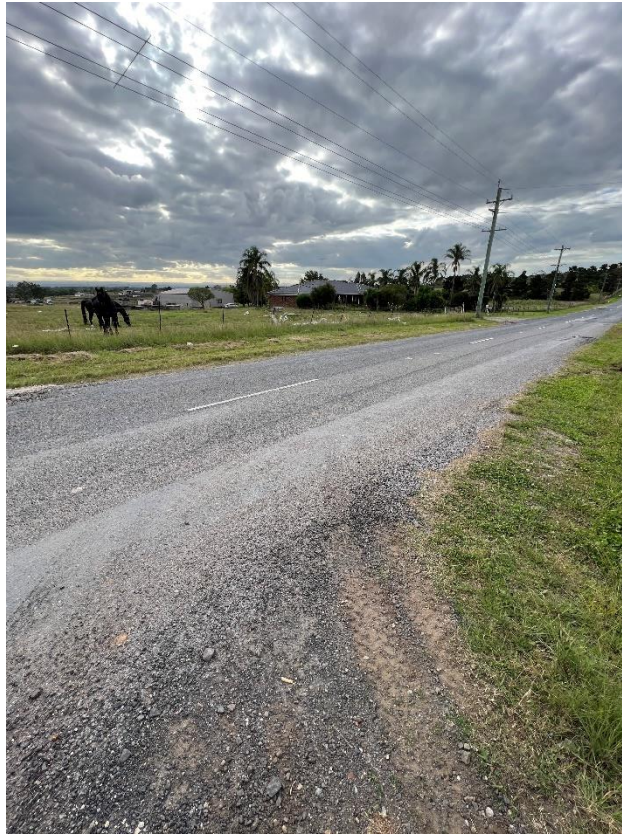
*Figure 45 – Crack propagation to the driveway.*

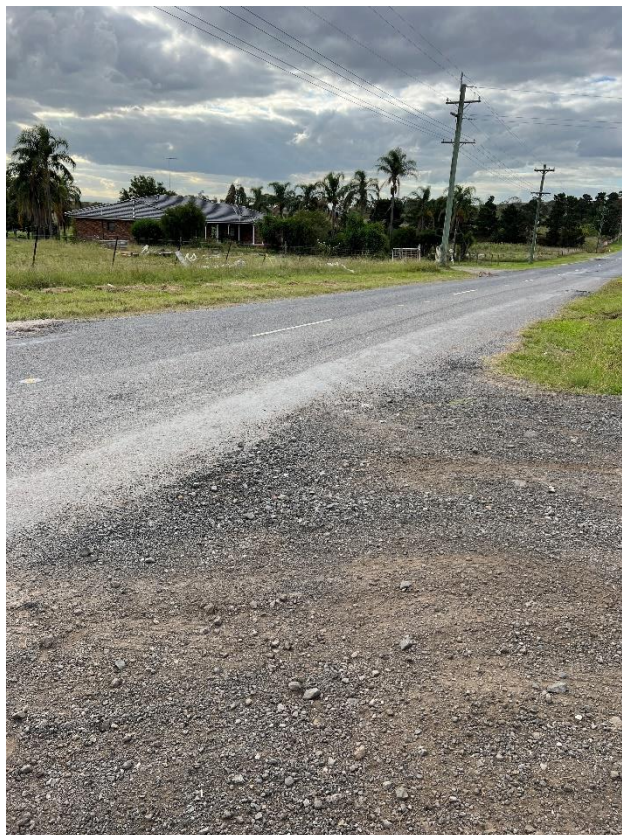
*Figure 46 – General condition of the driveway.*

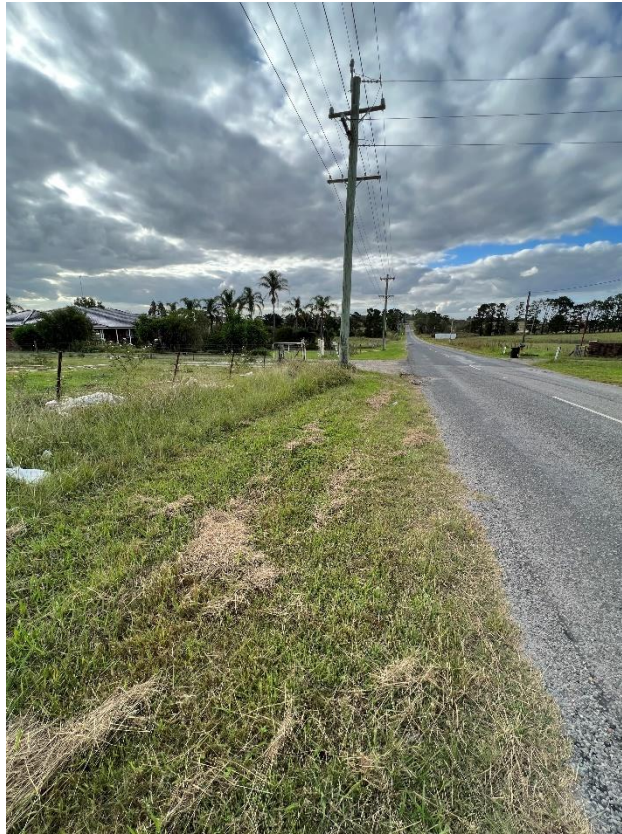
*Figure 47 – General condition of the nature strip.*

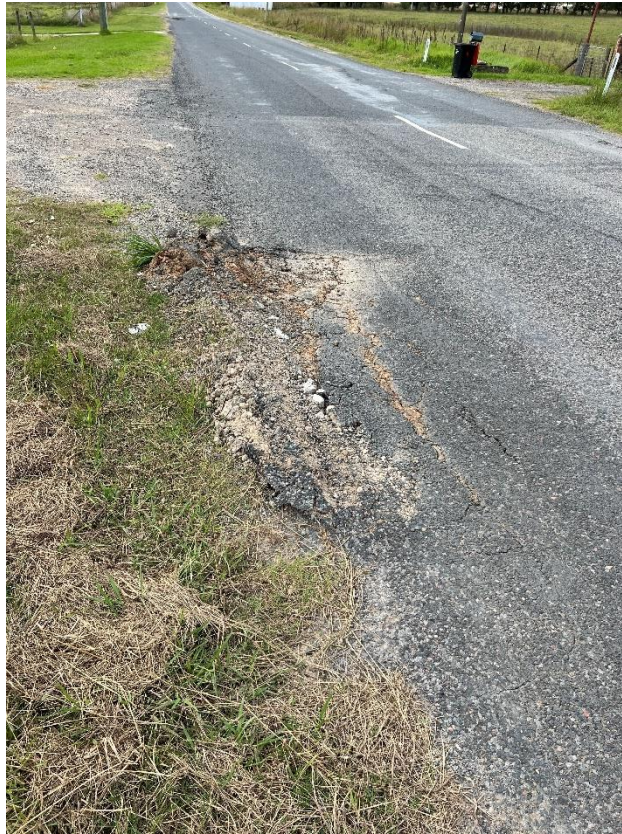
*Figure 49 – Crack propagation to the road.*

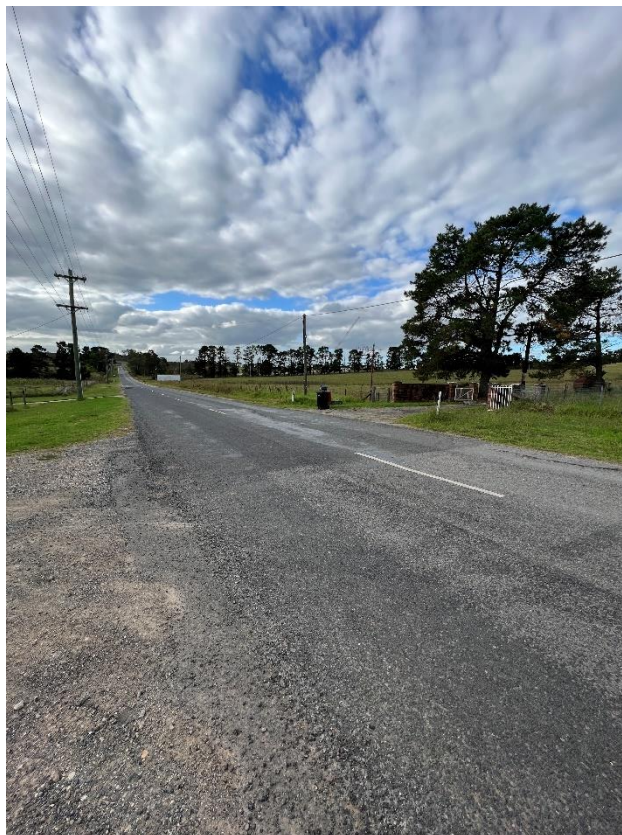
*Figure 50 – General condition of the road.*

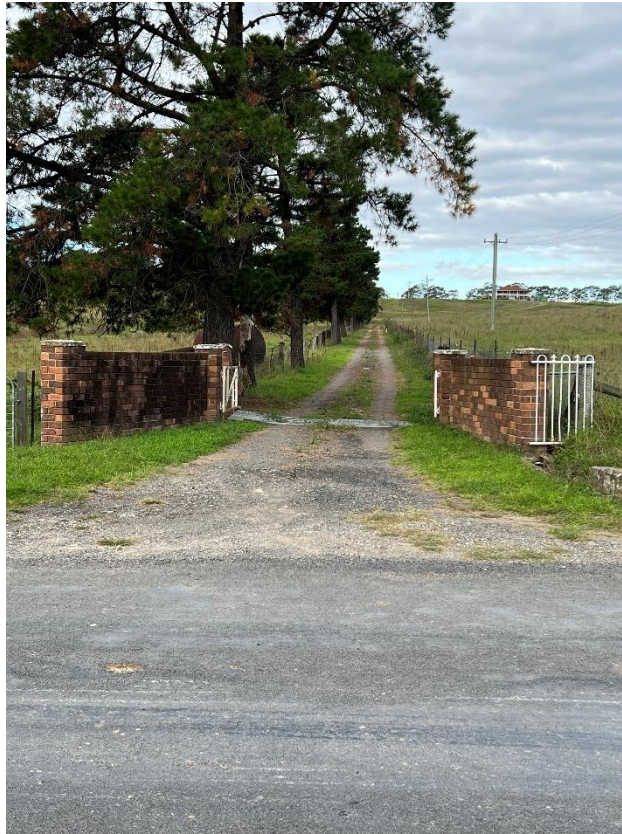
*Figure 51 – General condition of the road.*

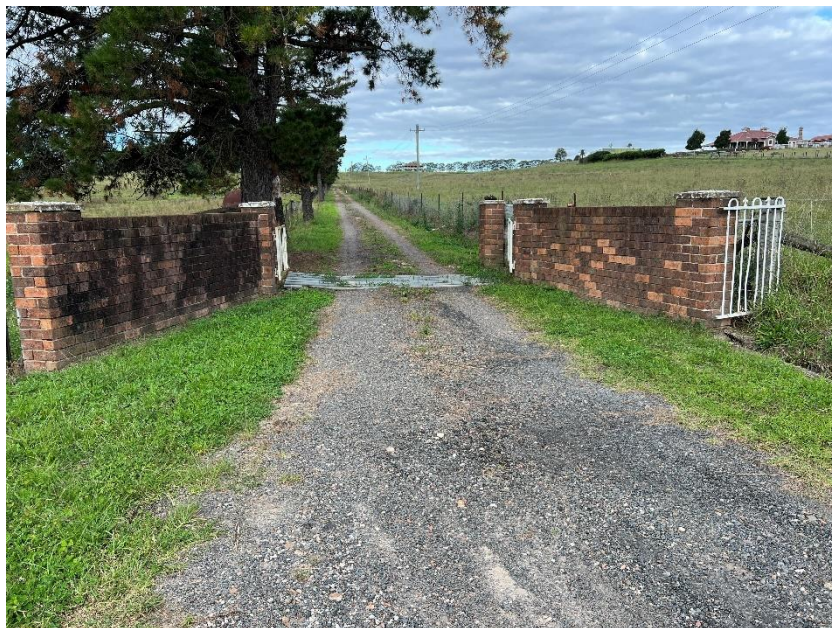
*Figure 52 – General condition of the driveway.*

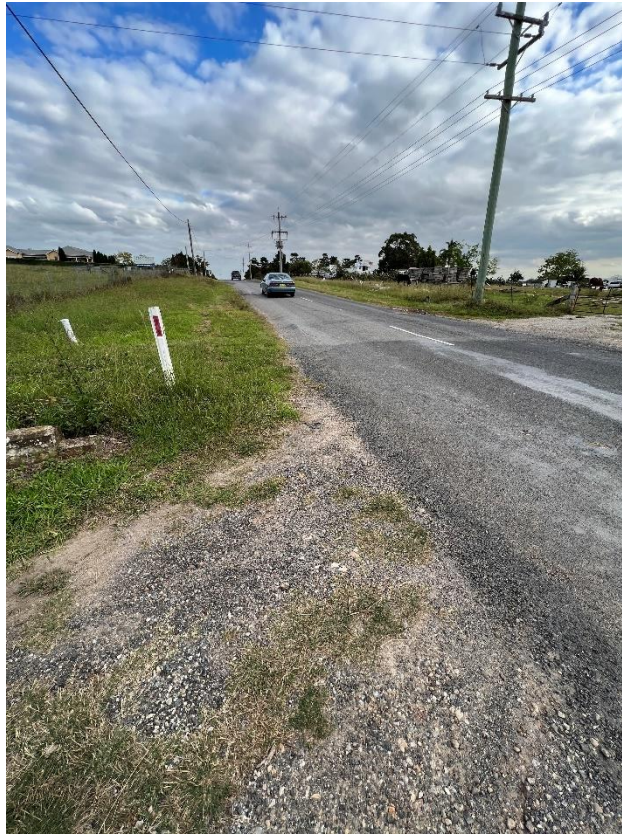
*Figure 53 – General condition of the driveway.*

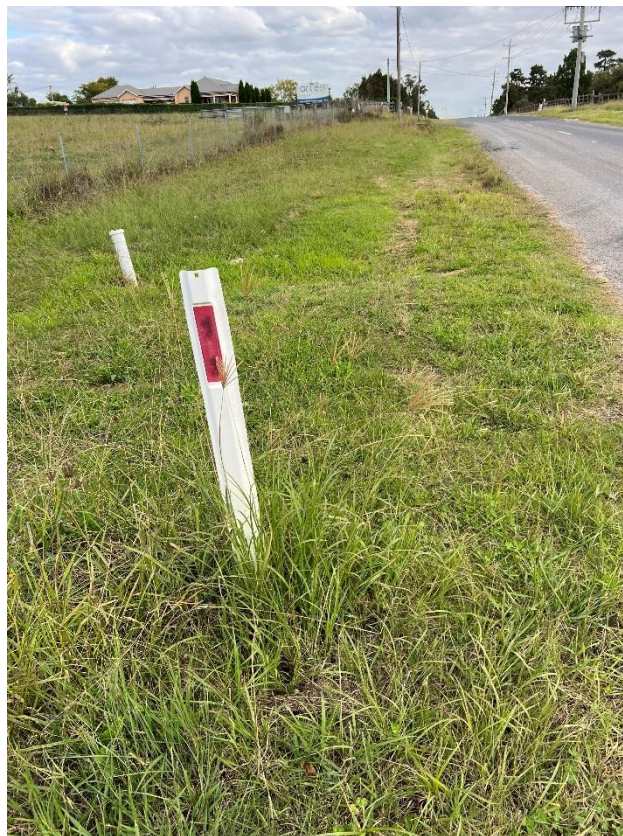
*Figure 56 – General condition of the nature strip/bollards.*

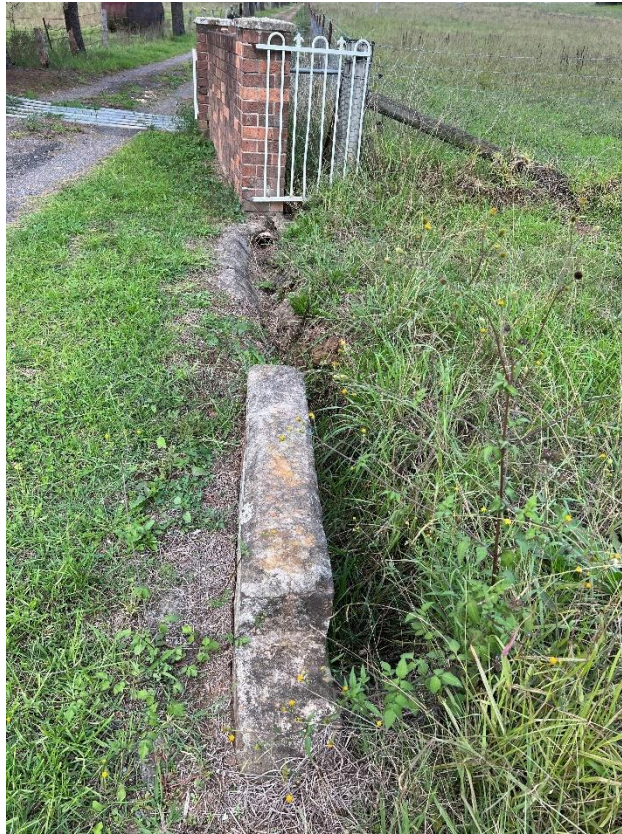
*Figure 57 – General condition of the drain.*

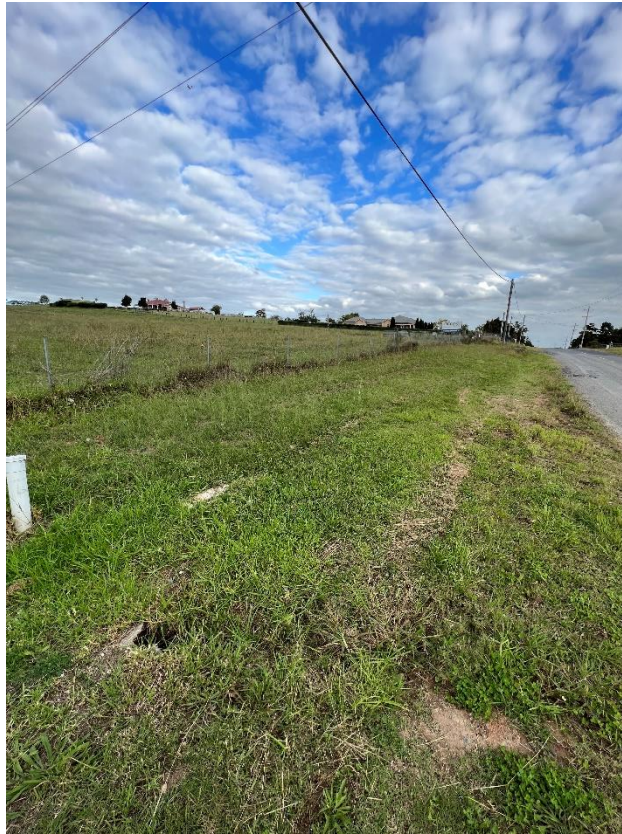
*Figure 59 – General condition of the nature strip.*

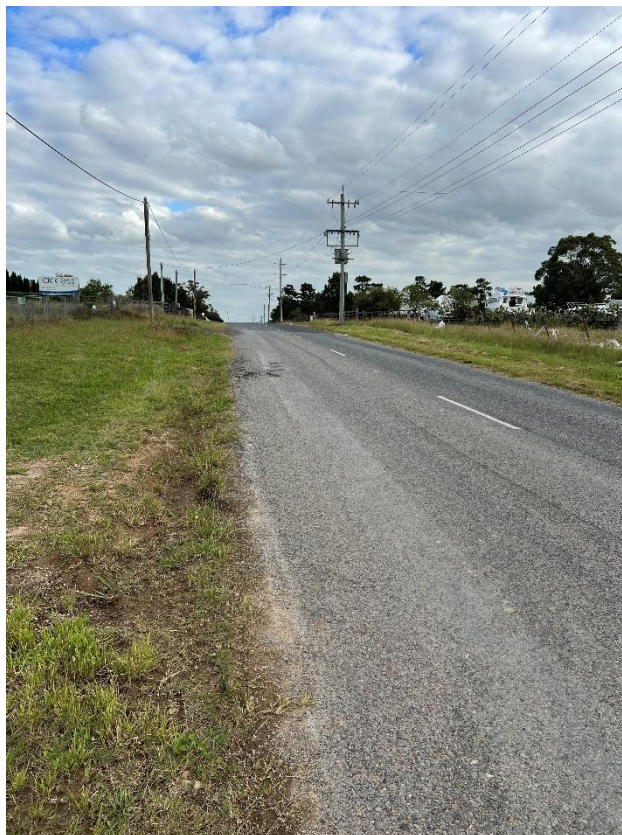
*Figure 60 – General condition of the road.*

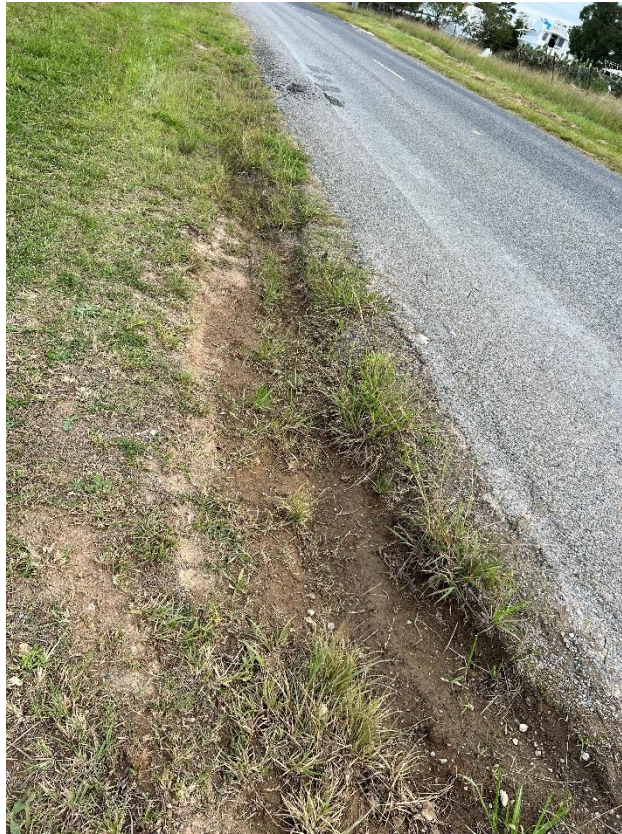
*Figure 61 – General condition of the nature strip.*
