# **DILAPIDATION REPORT**

**Addington Road, Kemps Creek**

This report is intended to be a record of the council assets at Addington Road, Kemps Creek at the time of the inspection.

The inspection was carried out on 18 April 2023.

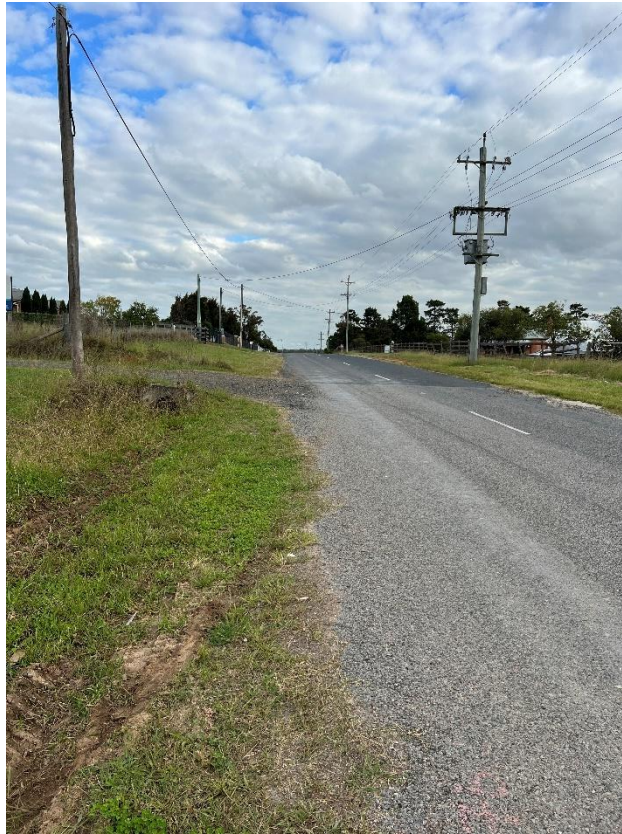
*Figure 63 – General condition of the road/nature strip.*

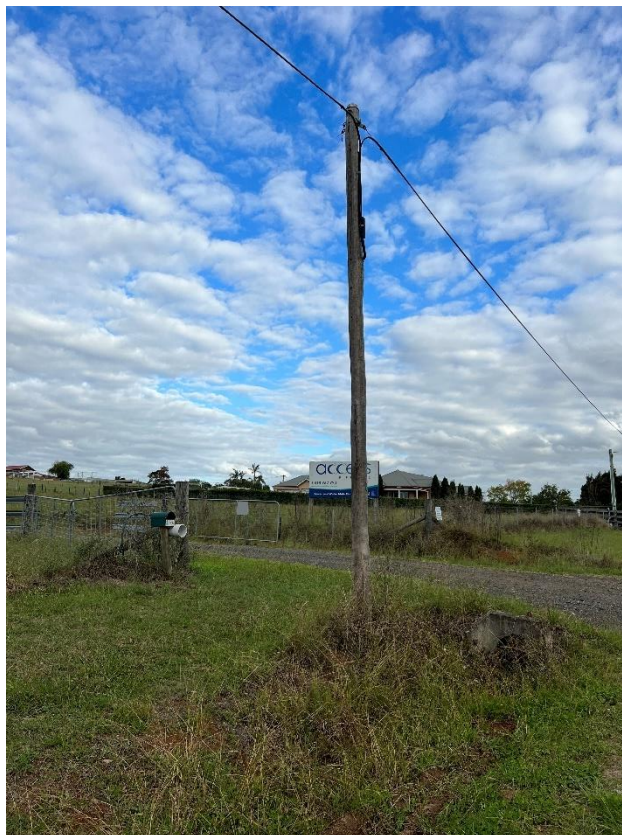
*Figure 64 – General condition of the nature strip/electrical post.*

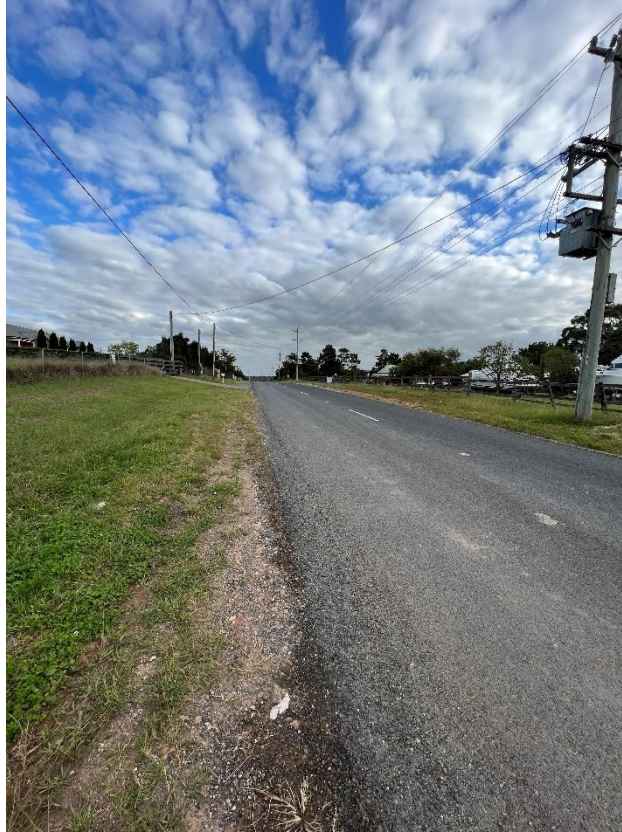
*Figure 65 – General condition of the road.*

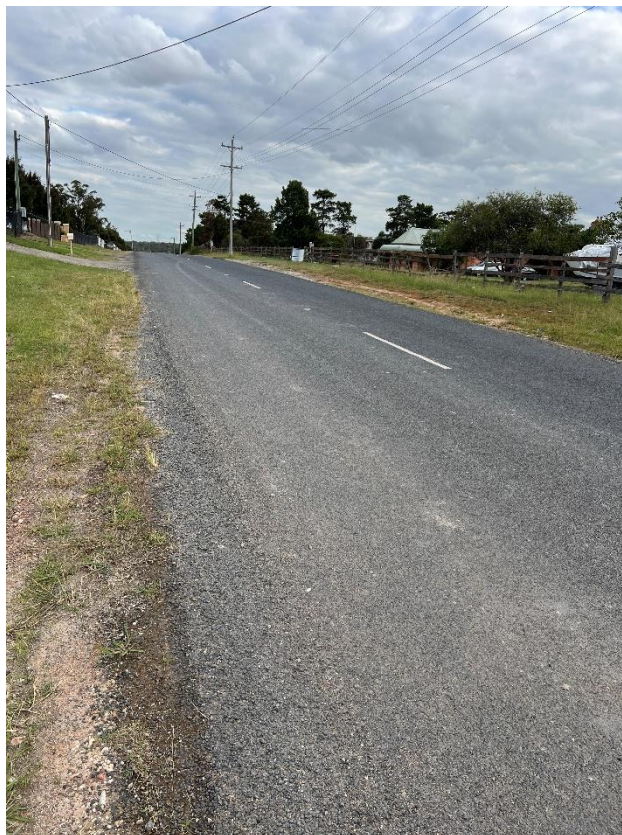
*Figure 66 – General condition of the road.*

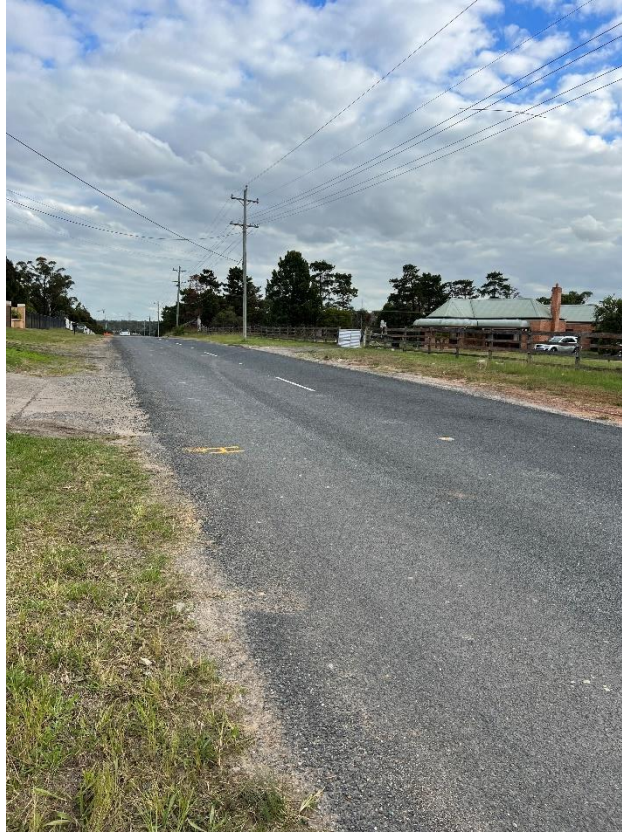
*Figure 67 – General condition of the road.*

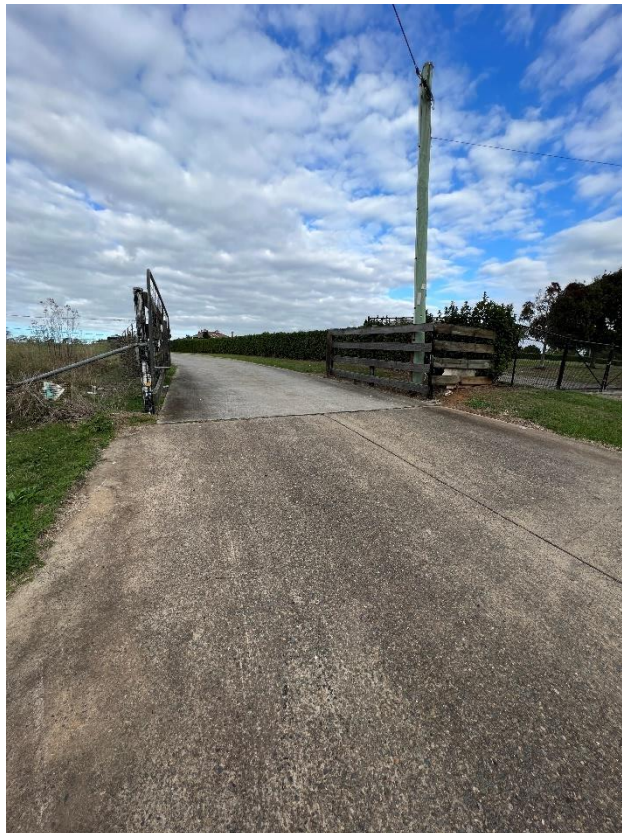
*Figure 68 – General condition of the driveway.*

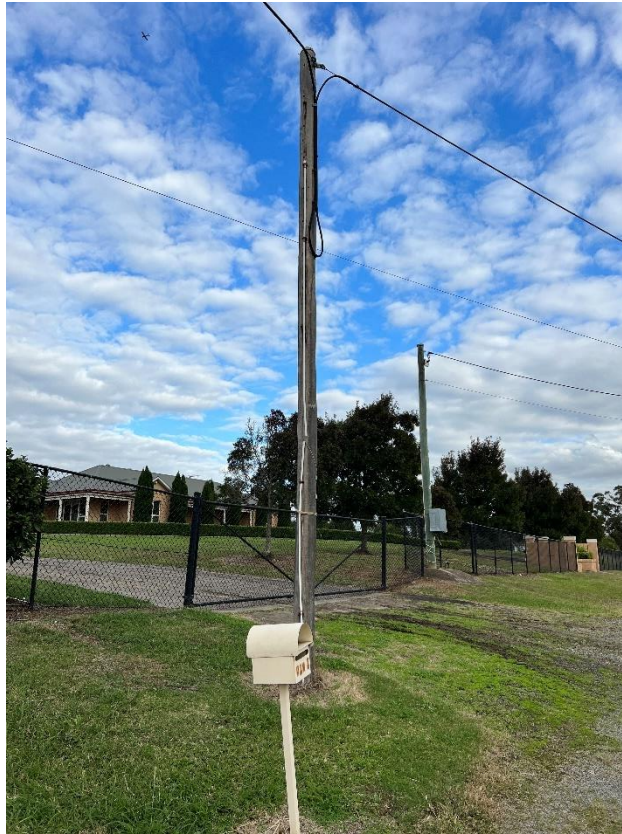
*Figure 69 – General condition of the electrical post.*

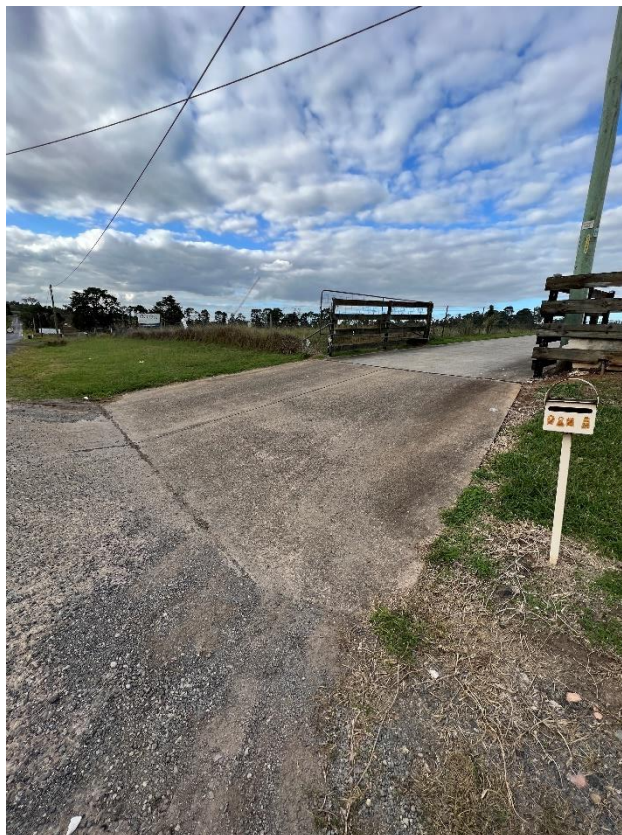
*Figure 70 – General condition of the driveway.*

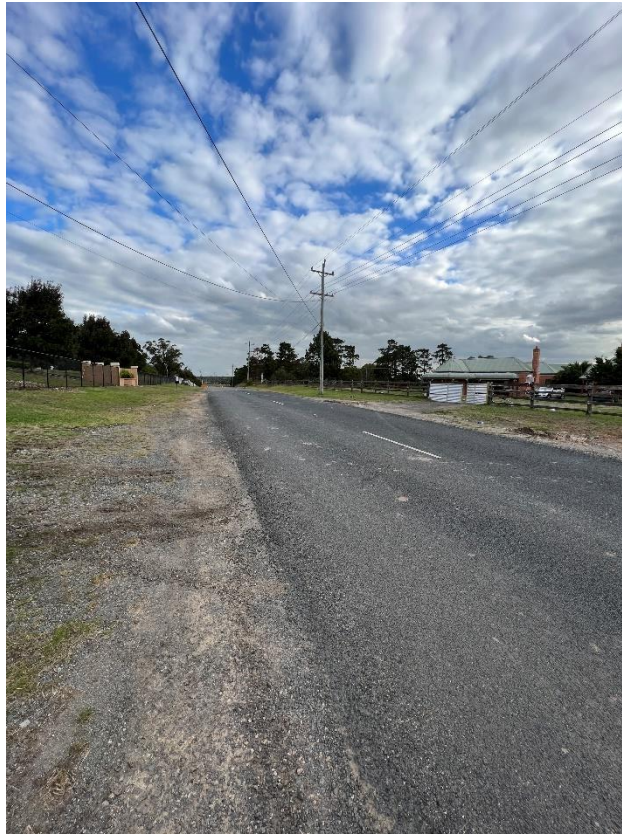
*Figure 71 – General condition of the road.*

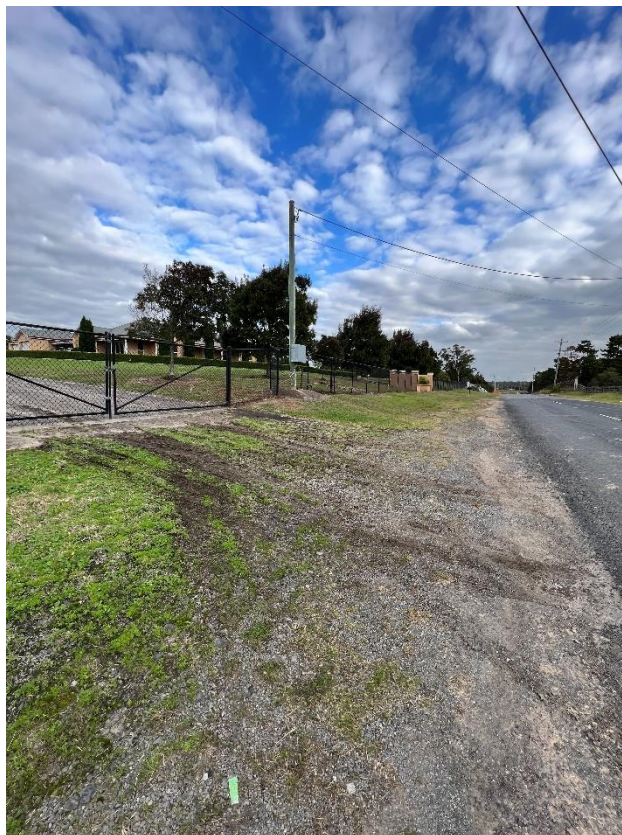
*Figure 72 – General condition of the driveway/nature strip.*

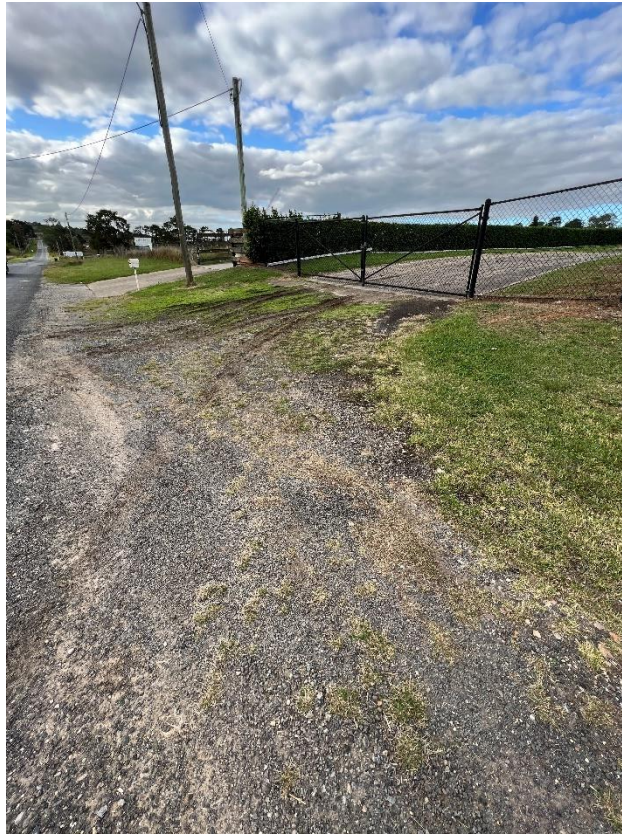
*Figure 73 – General condition of the driveway/nature strip.*

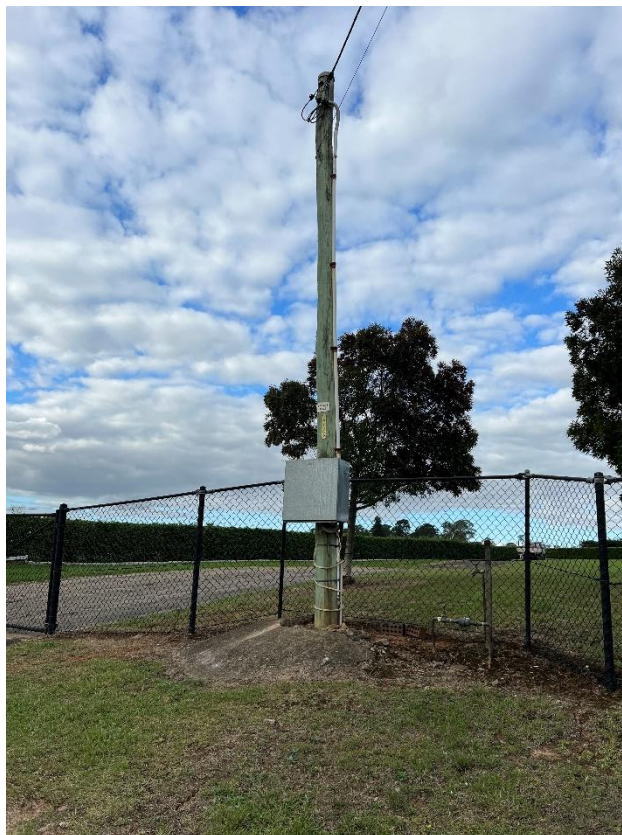
*Figure 74 – General condition of the electrical post/box.*

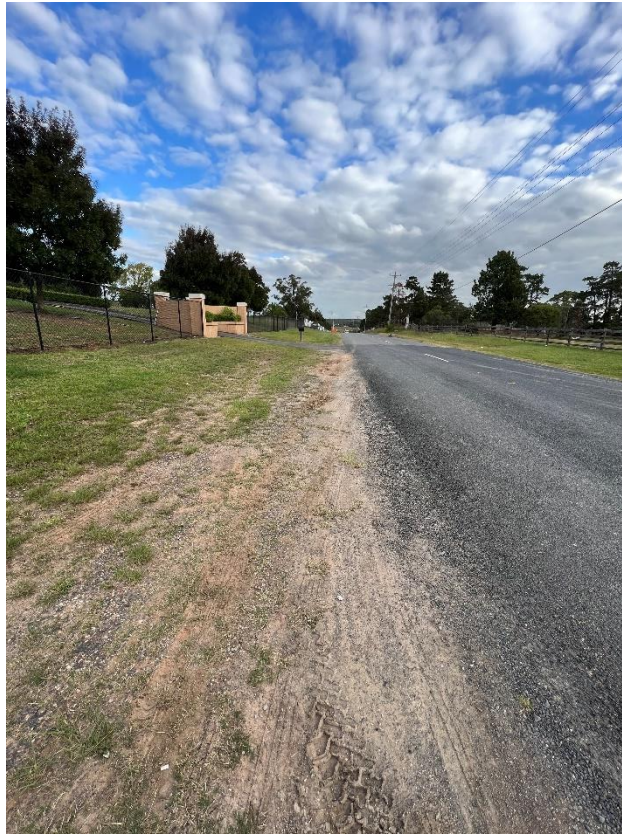
*Figure 75 – General condition of the nature strip.*

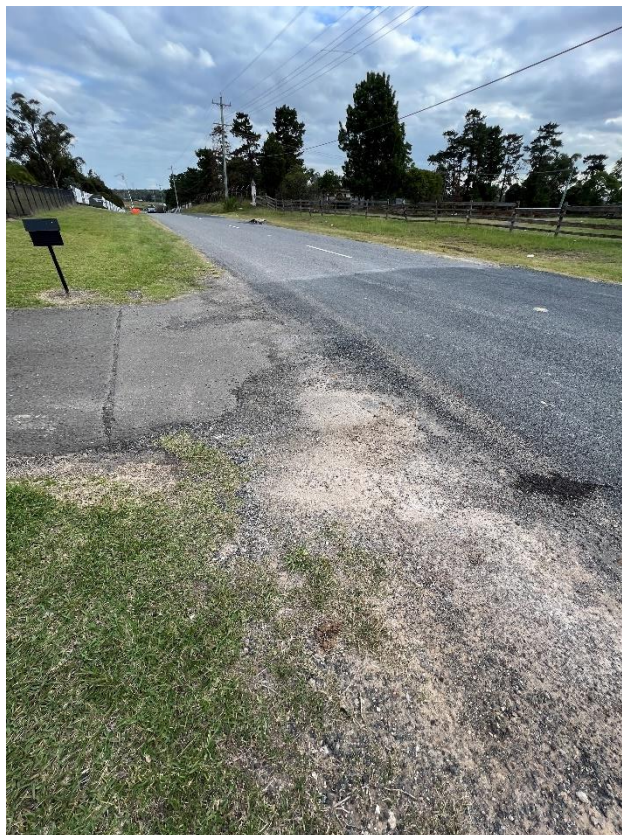
*Figure 76 – Crack propagation to the driveway.*

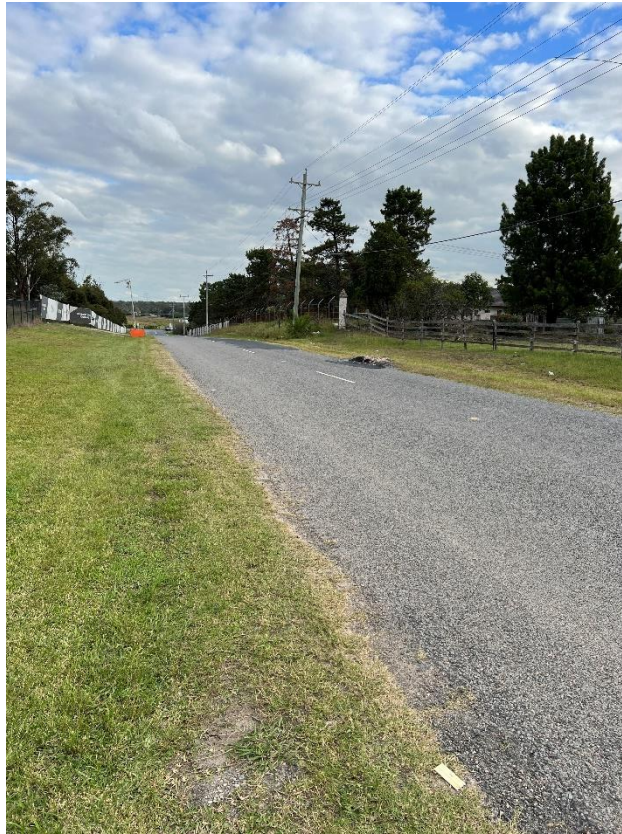
*Figure 77 – General condition of the road/nature strip.*

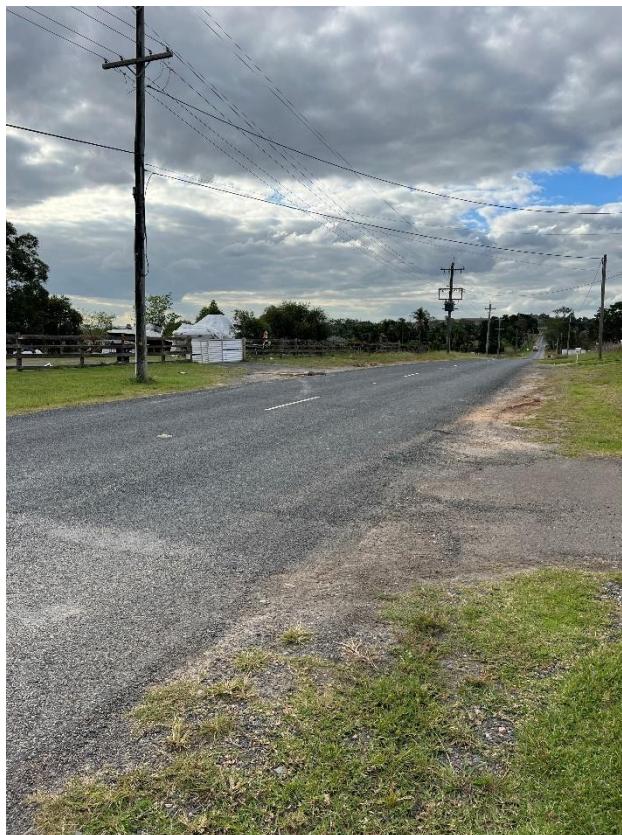
*Figure 78 – Crack propagation to the driveway.*

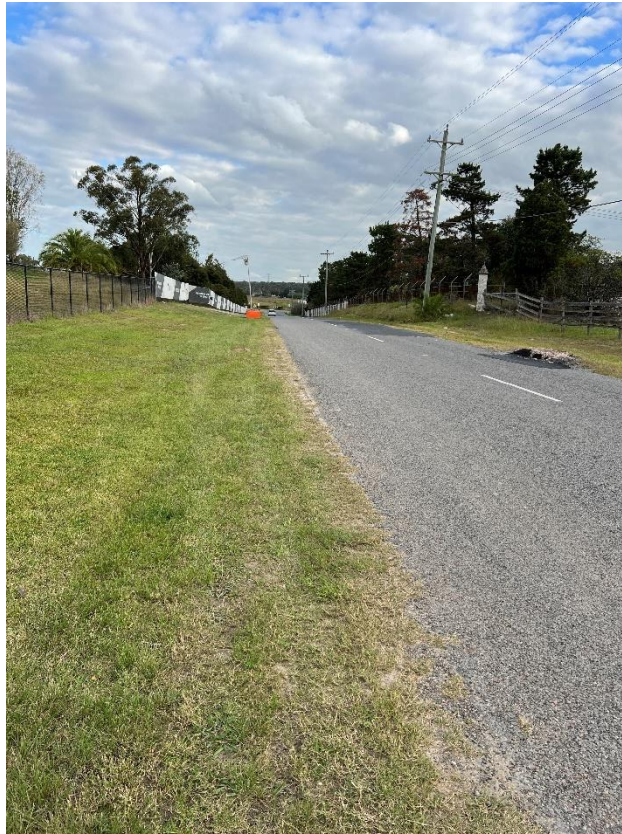
*Figure 79 – General condition of the road/nature strip.*

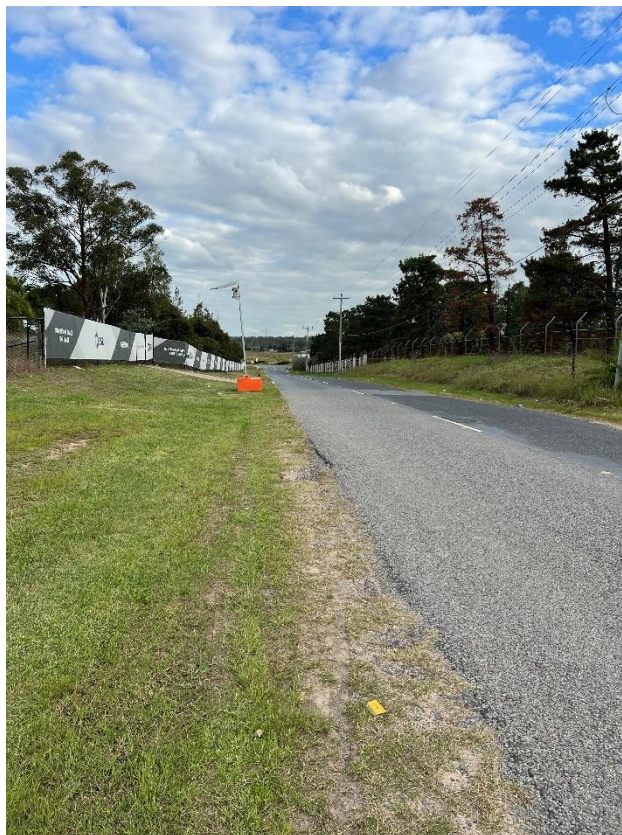
*Figure 80 – General condition of the road/nature strip.*

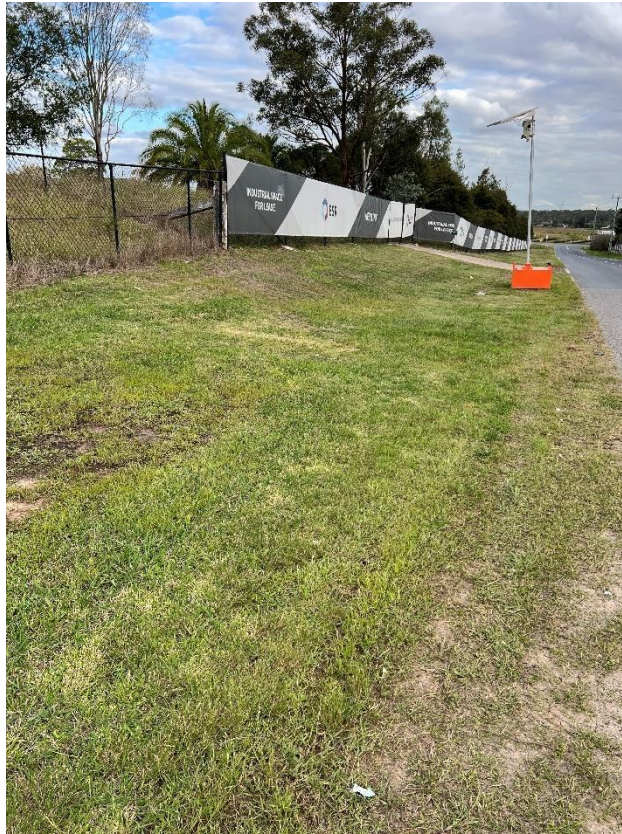
*Figure 81 – General condition of the nature strip.*

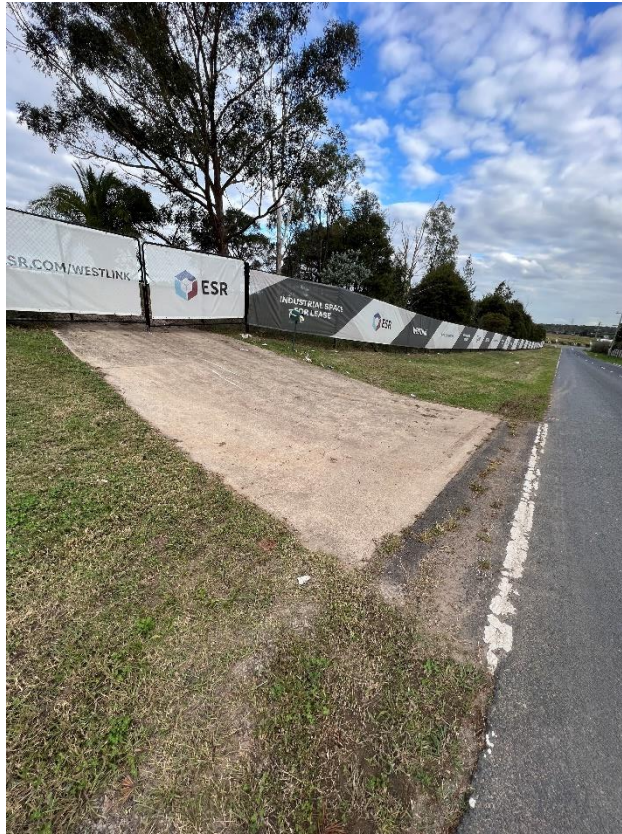
*Figure 83 – General condition of the driveway.*

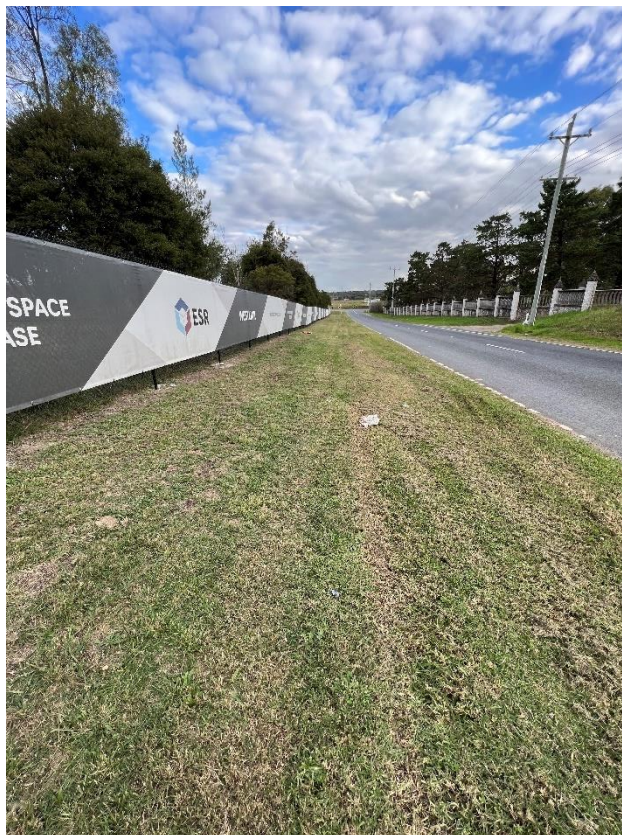
*Figure 84 – General condition of the nature strip.*

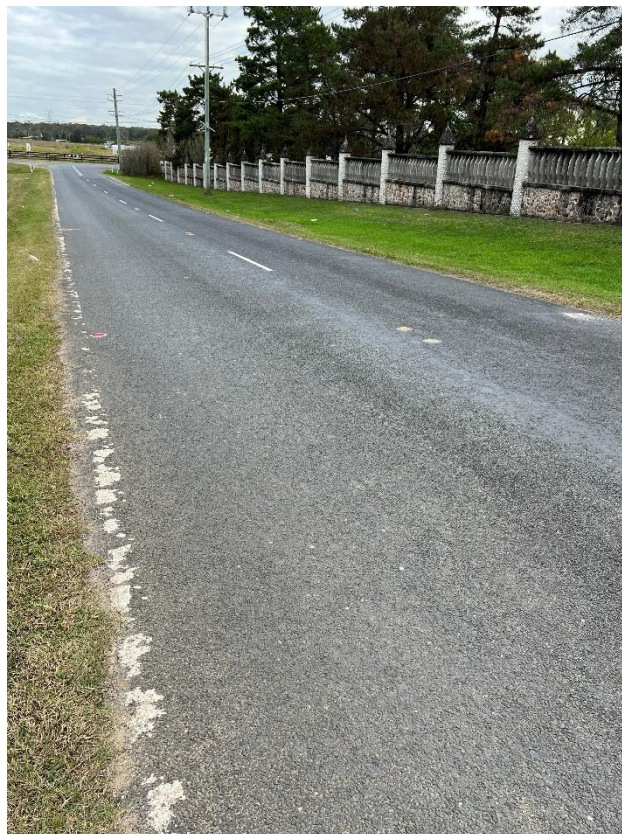
*Figure 86 – General condition of the road.*

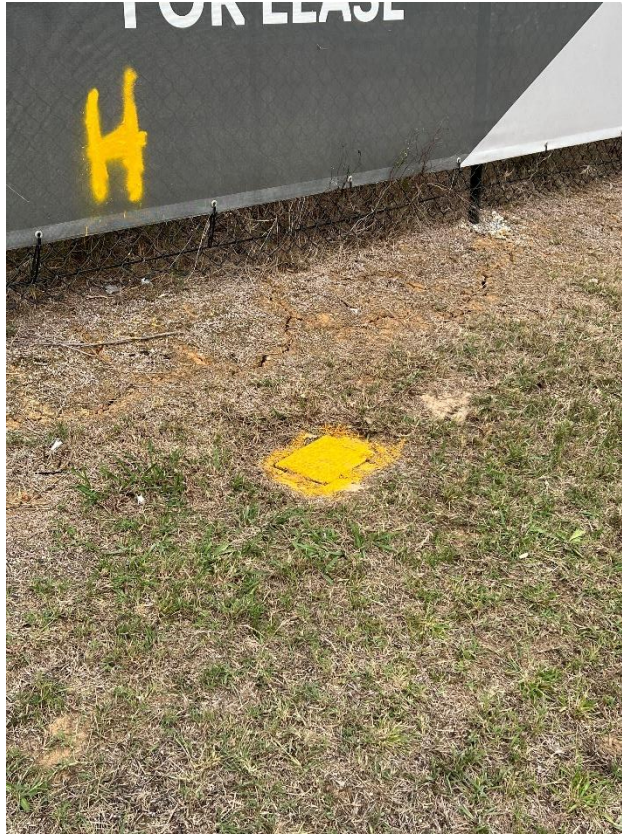
*Figure 87 – General condition of the utility lid.*

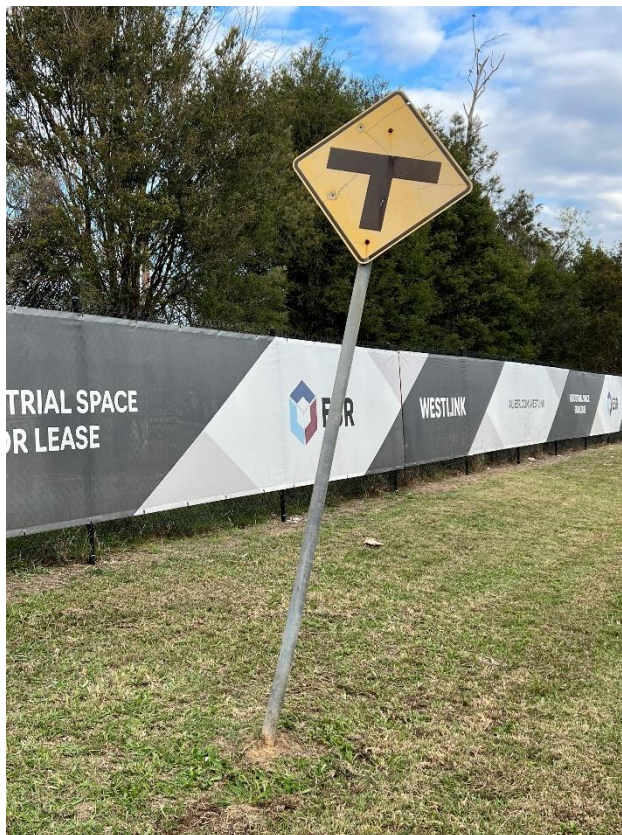
*Figure 88 – General condition of the street signpost.*

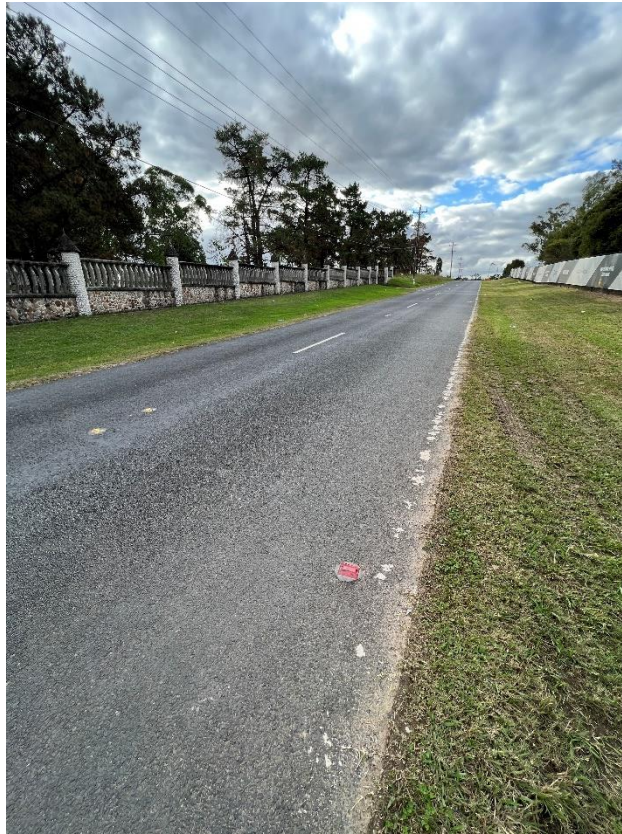
*Figure 89 – General condition of the road.*

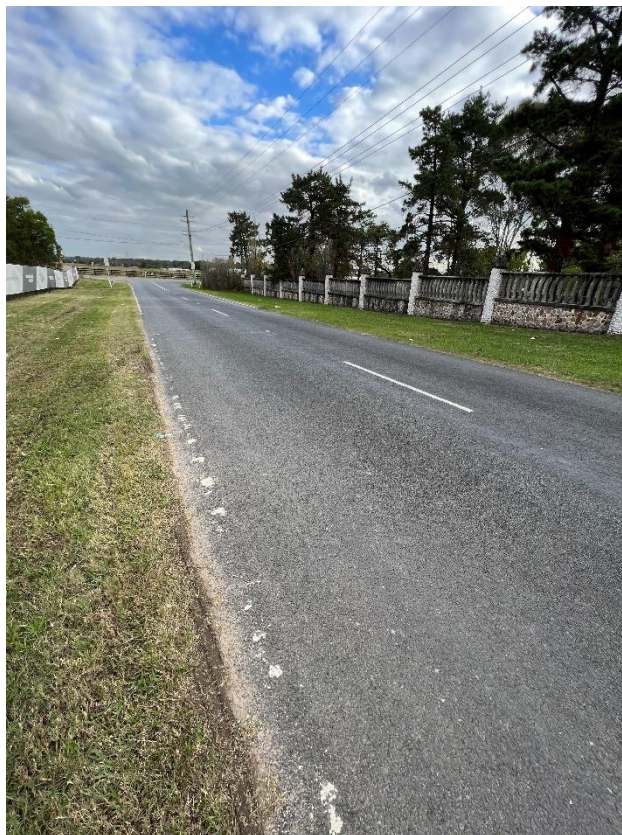
*Figure 90 – General condition of the road.*

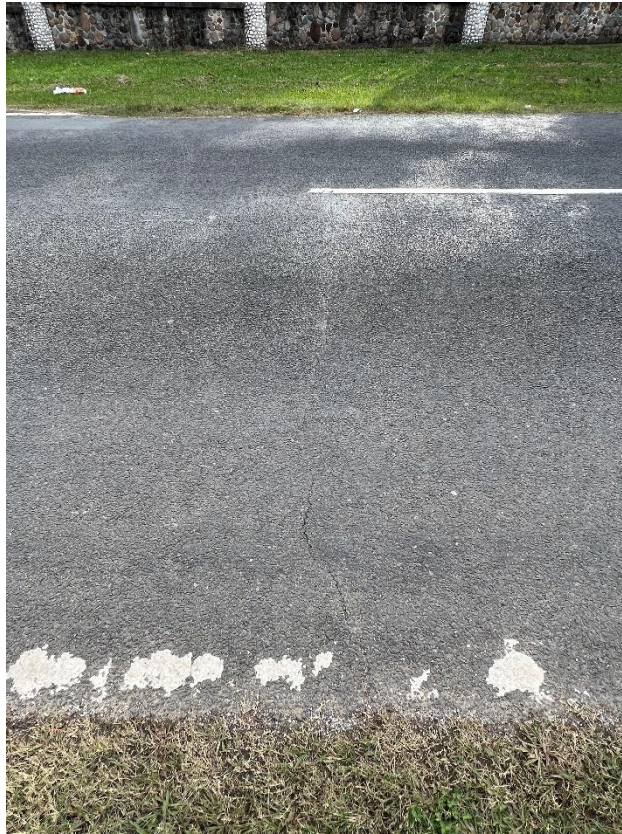
*Figure 91 – Crack propagation to the road.*

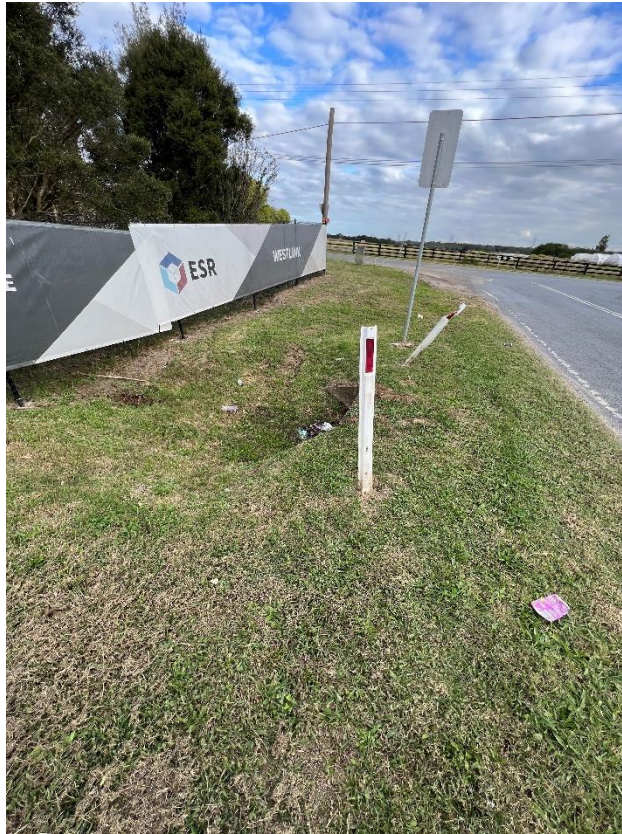
*Figure 93 – General condition of the nature strip/bollards.*

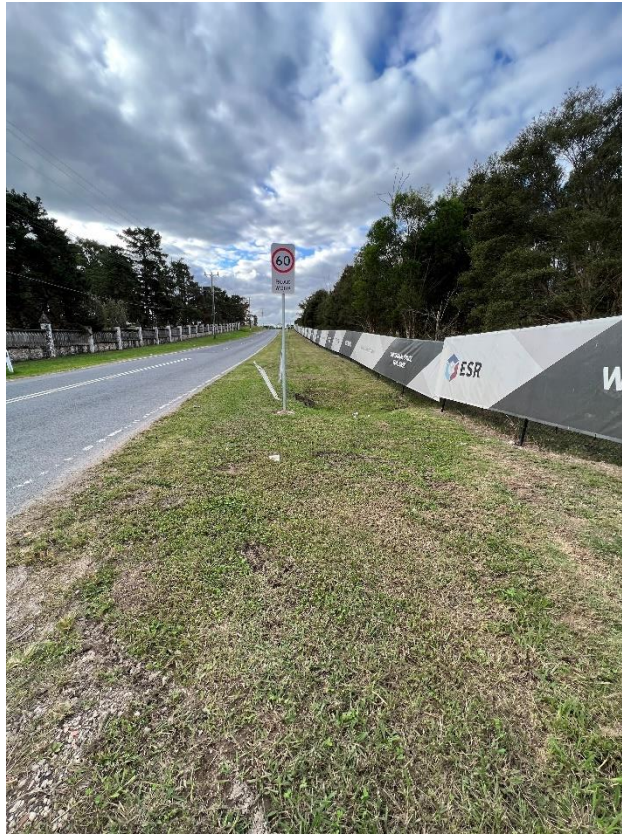
*Figure 95 – General condition of the nature strip.*

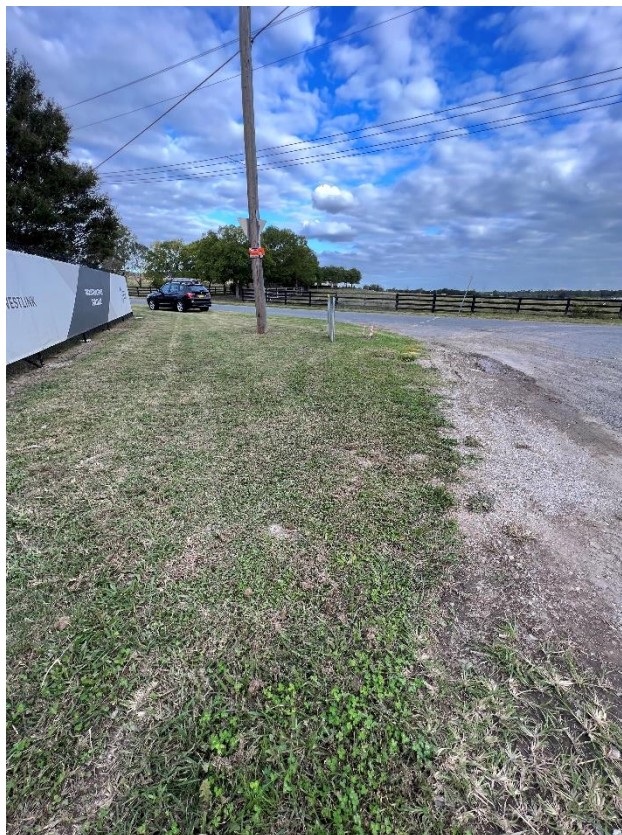
*Figure 96 – General condition of the nature strip.*

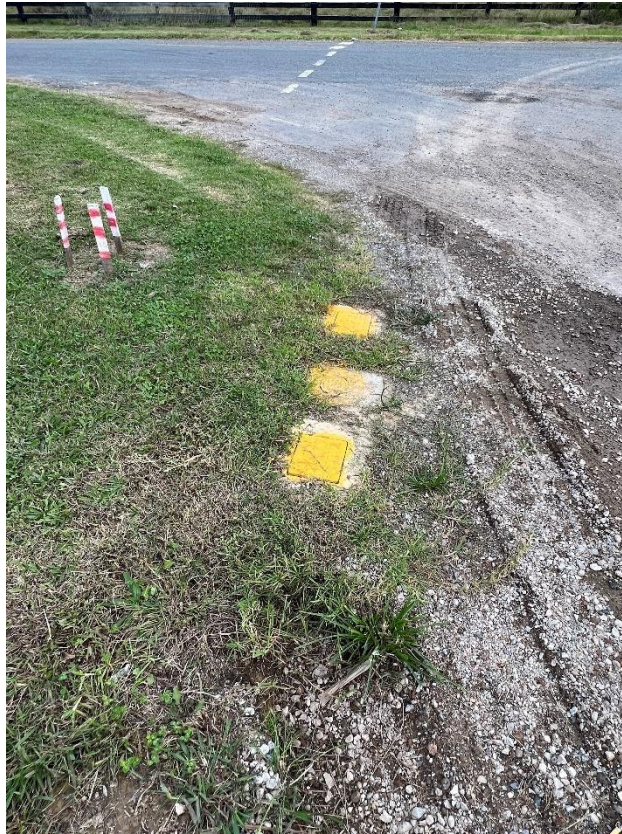
*Figure 97 – General condition of the nature strip/utility lid.*

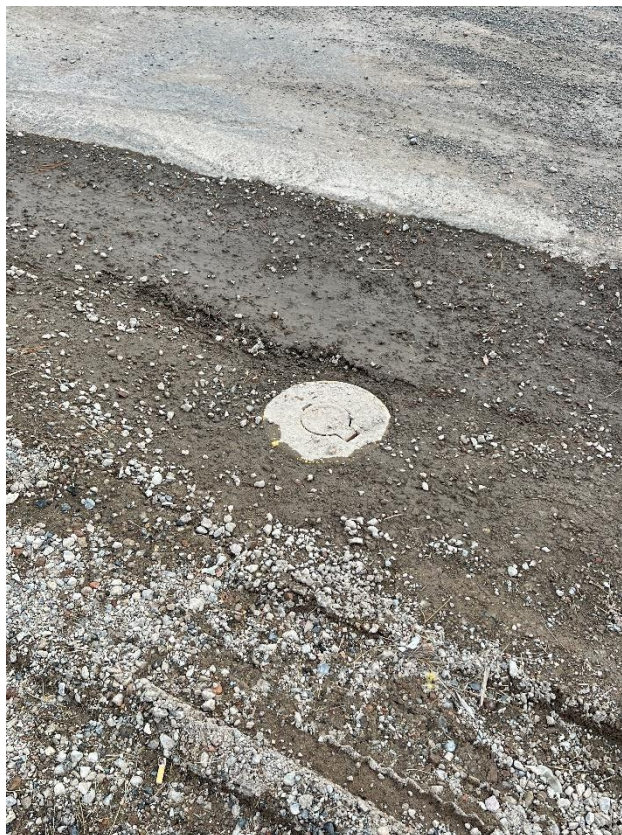
*Figure 98 – General condition of the utility lid.*

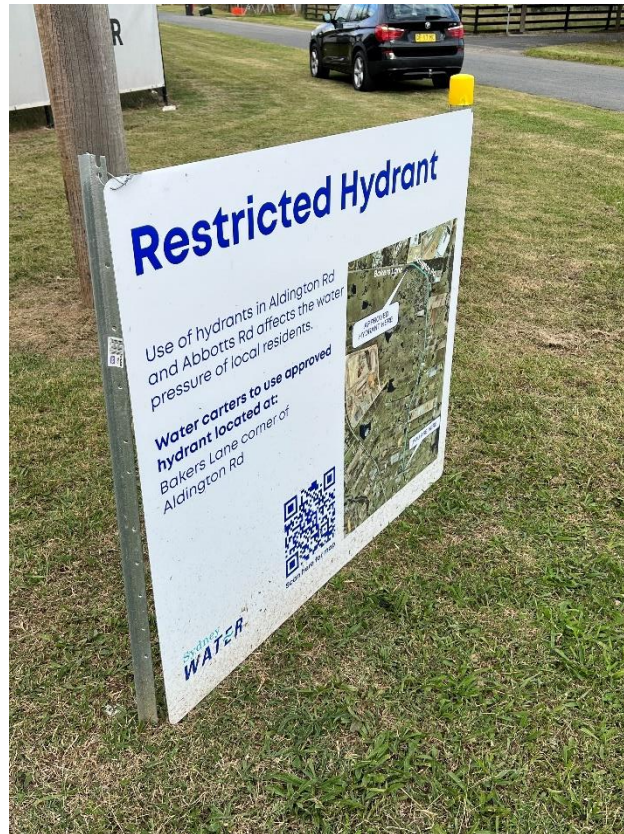
Figure 99 – General condition of the signage.

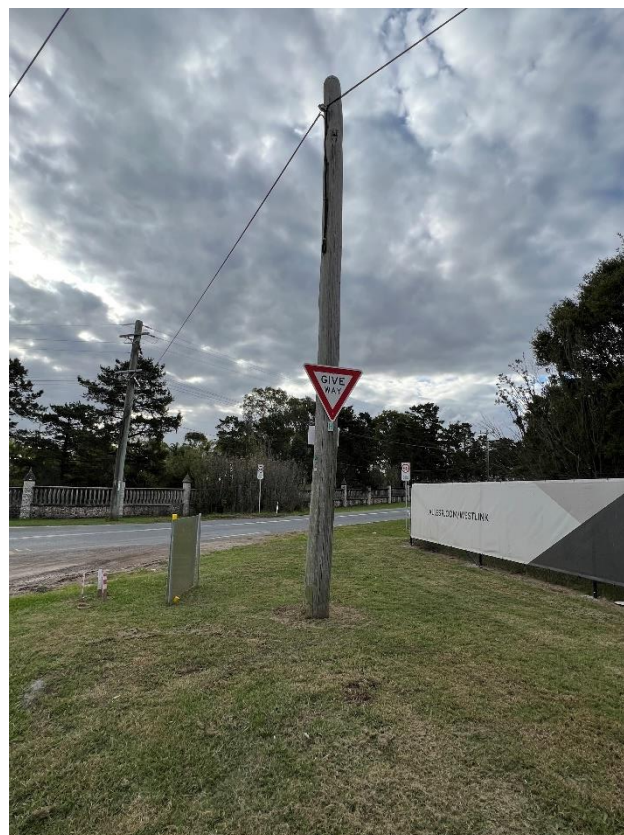
Figure 100 – General condition of the electrical/signpost
