DILAPIDATION REPORT

Abbotts Road, Kemps Creek

Prepared by: Rezoning Pty Ltd t/as Effective Building & Consultancy

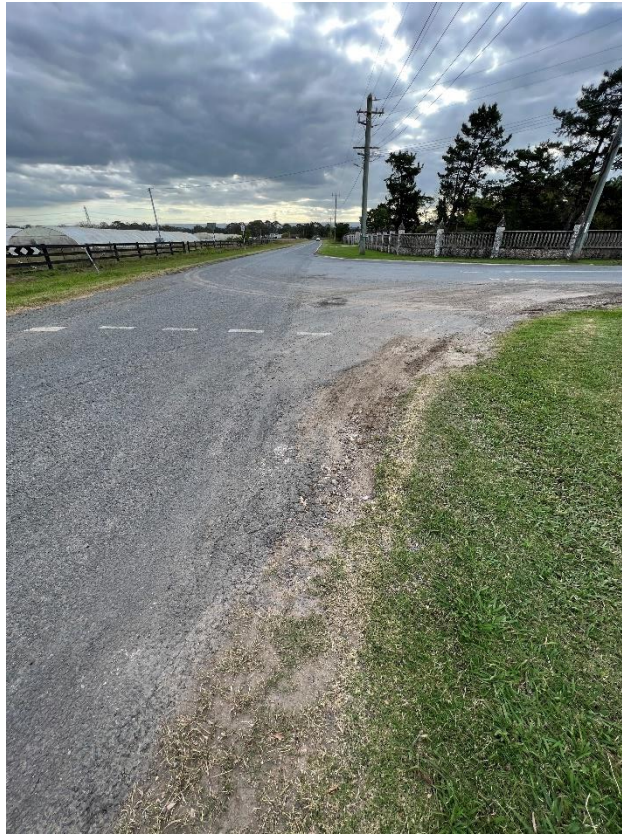
Figure 1 – Crack propagation to the driveway.

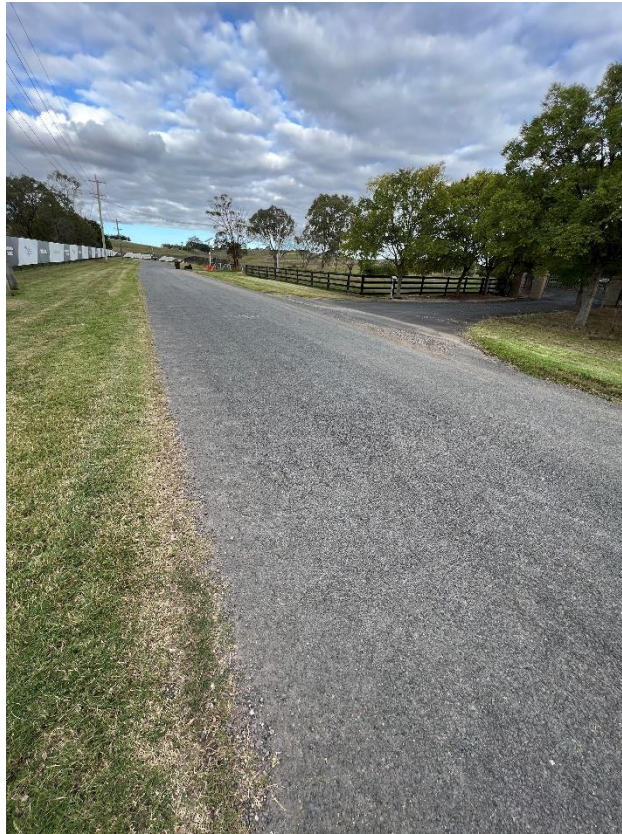
Figure 3 – General condition of the road.

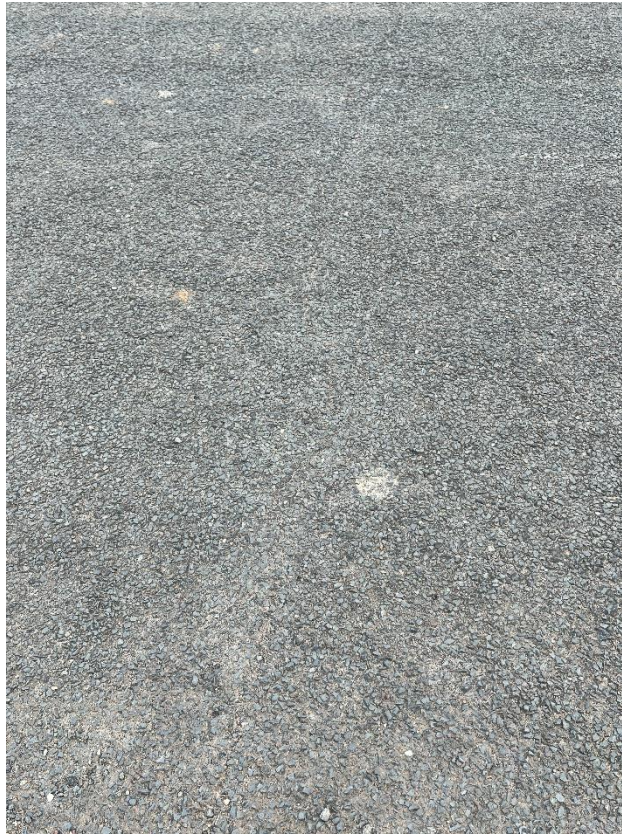
Figure 5 – General condition of the road.

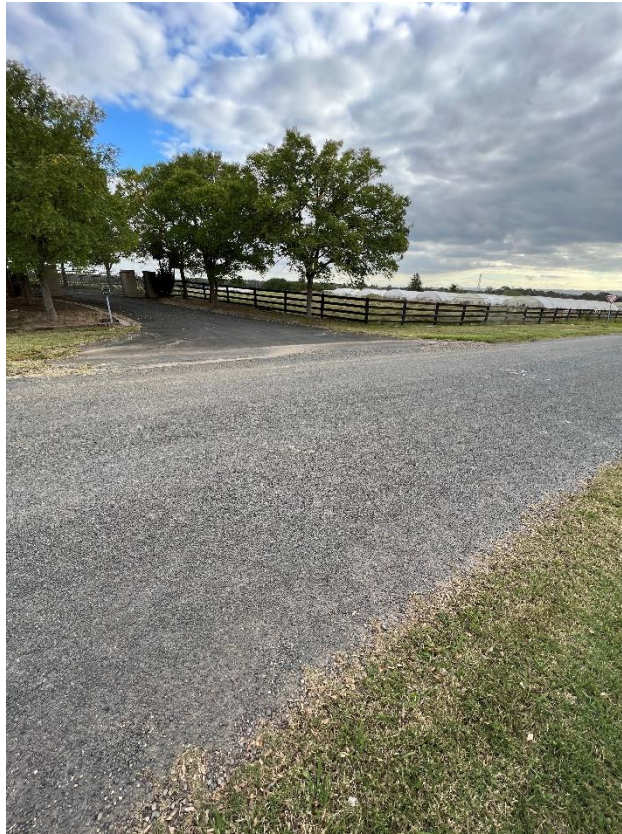
Figure 7 – General condition of the road.

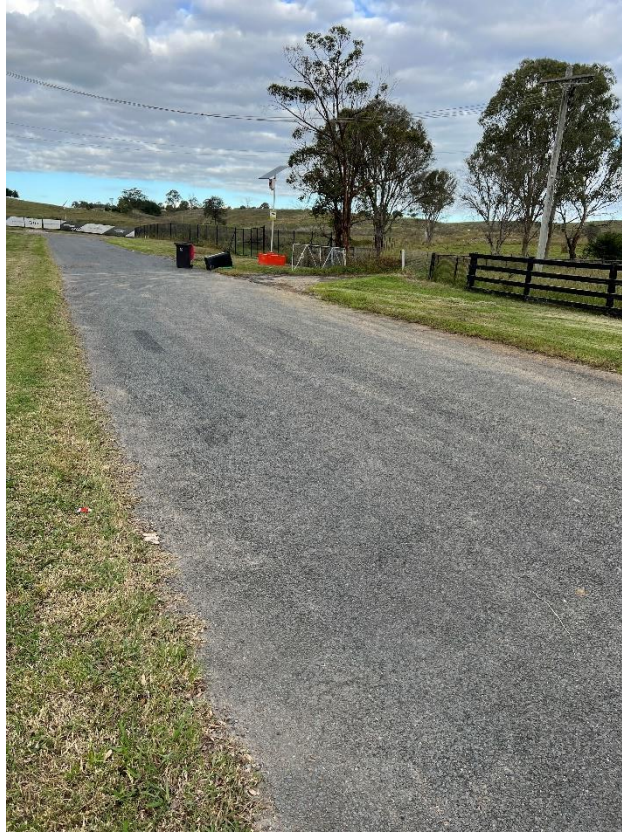
Figure 9 – General condition of the road.

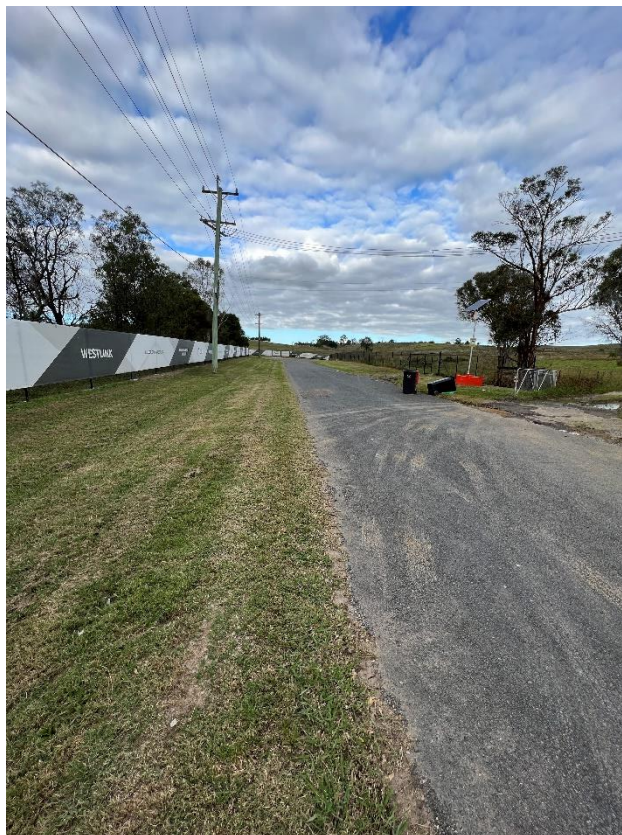
Figure 10 – General condition of the nature strip.

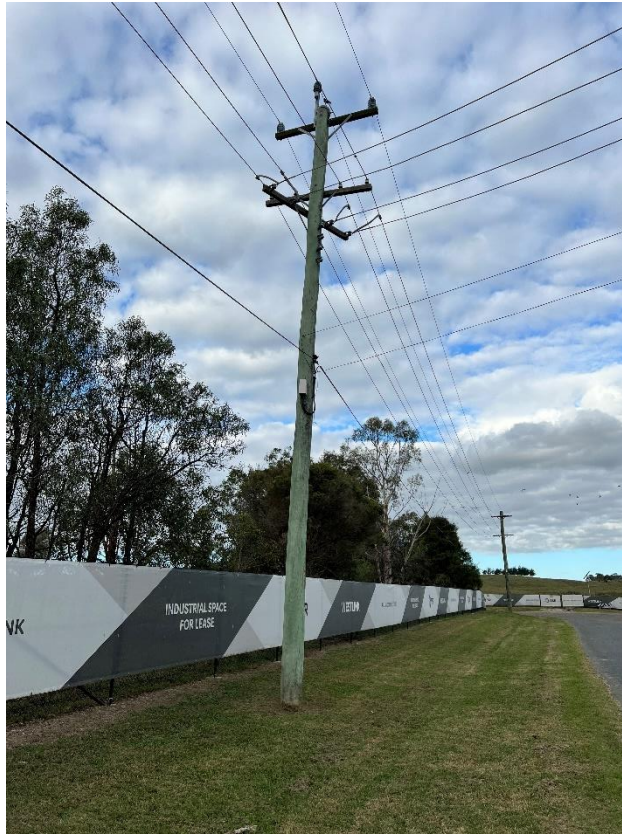
Figure 11 – General condition of the electrical post.

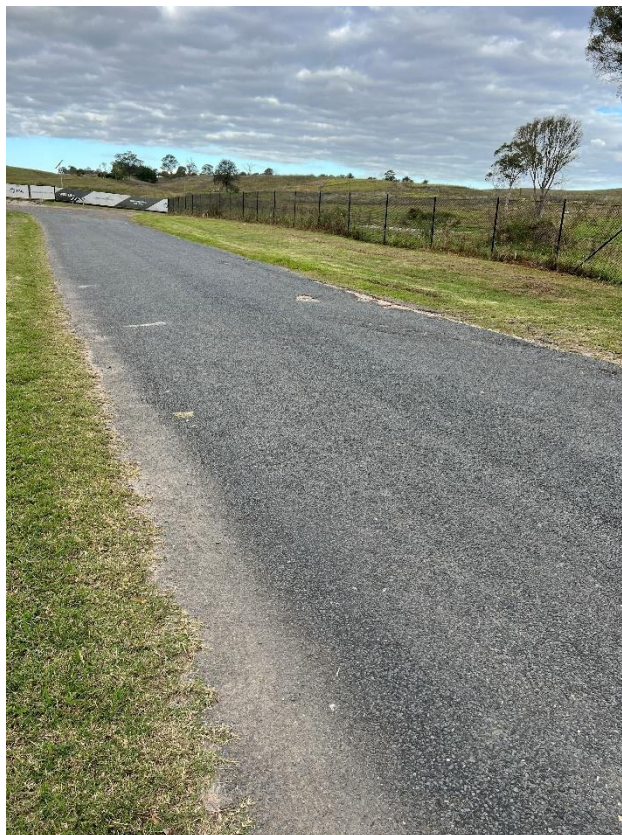
Figure 12 – General condition of the road.

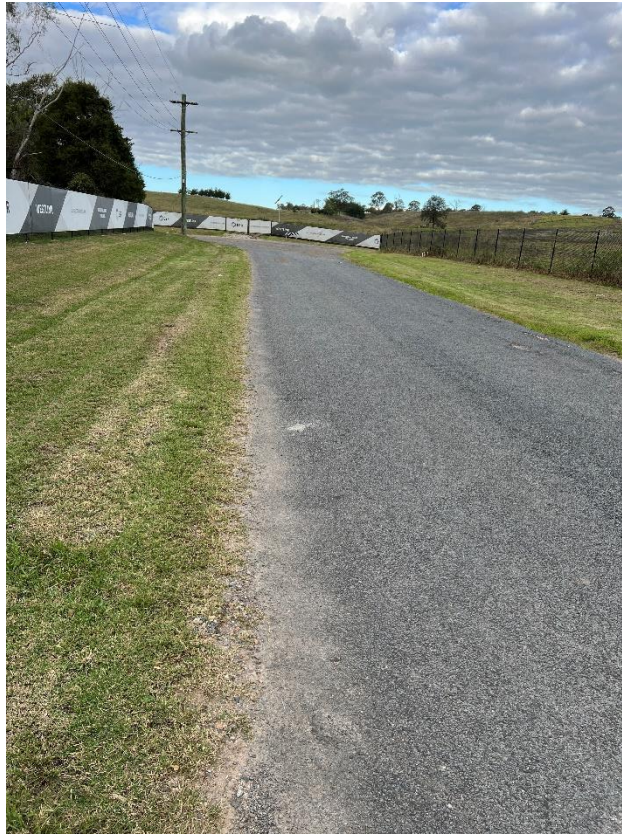
Figure 13 – General condition of the road.

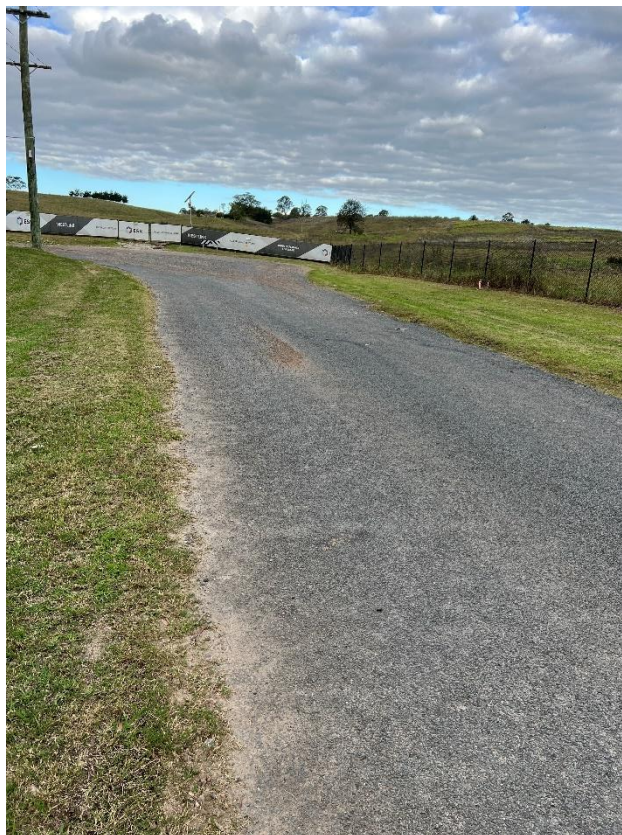
Figure 14 – General condition of the road.

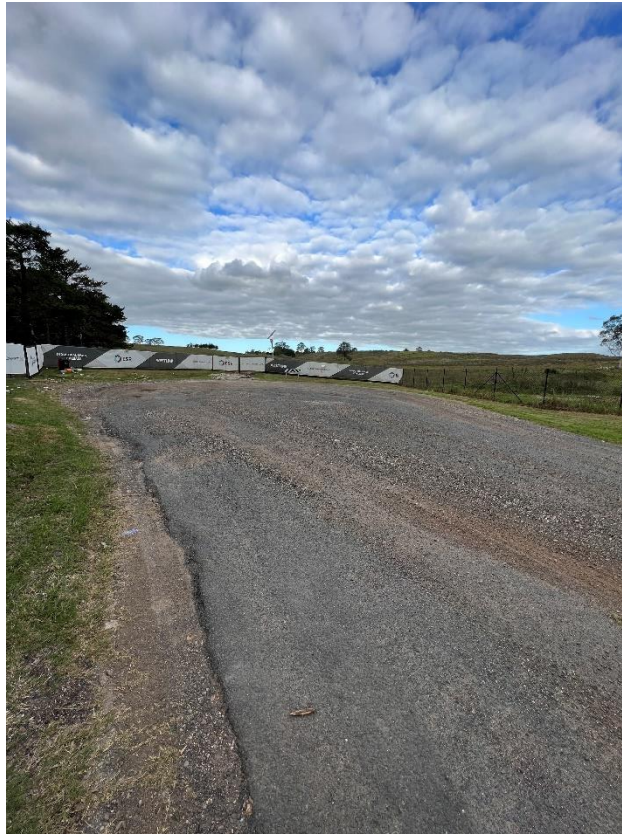
Figure 15 – Crack propagation to the road.

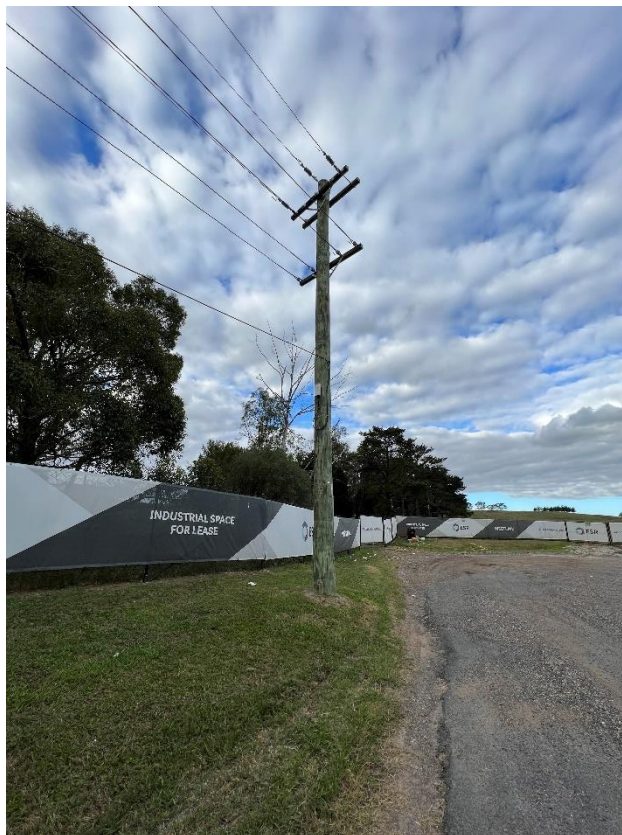
Figure 16 – General condition of the electrical post.

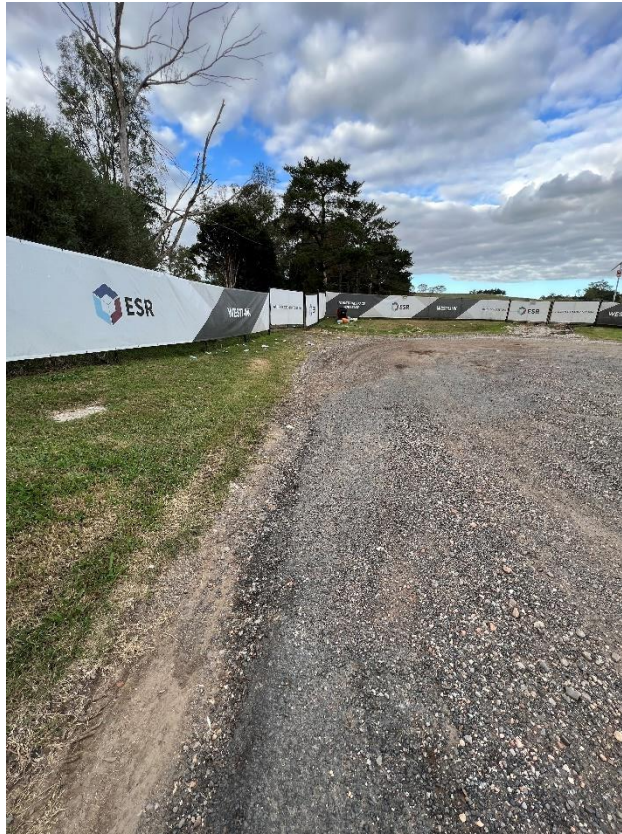
Figure 17 – General condition of the road.

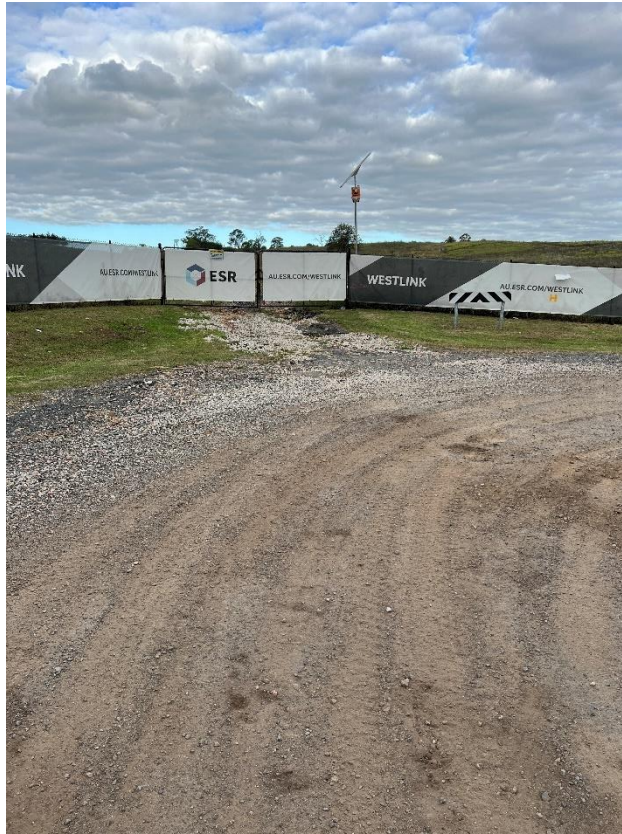
Figure 19 – General condition of the road.

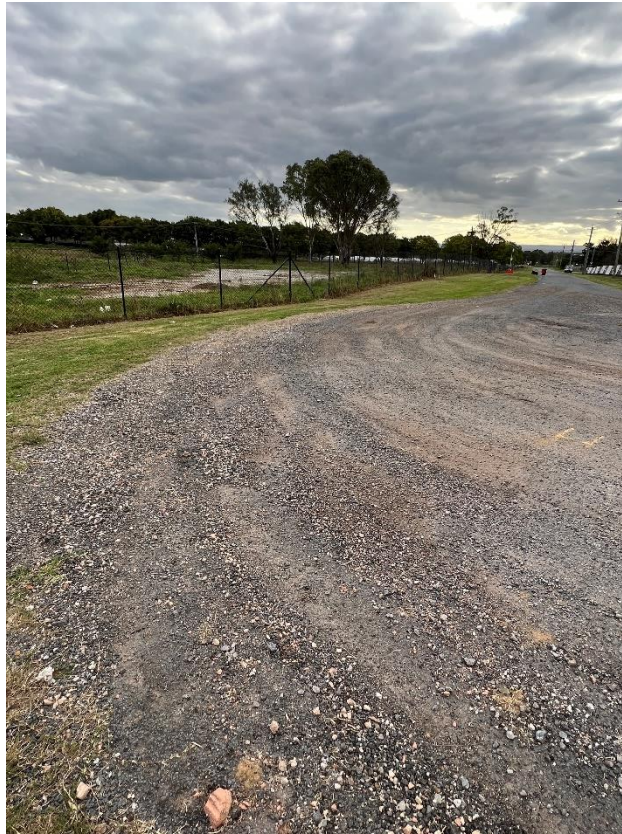
Figure 21 – General condition of the road.

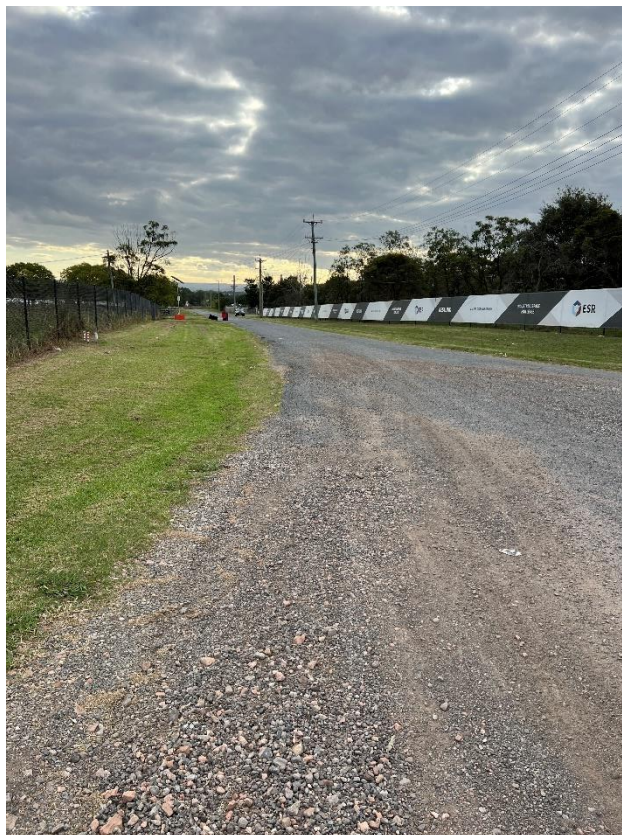
Figure 22 – General condition of the road.

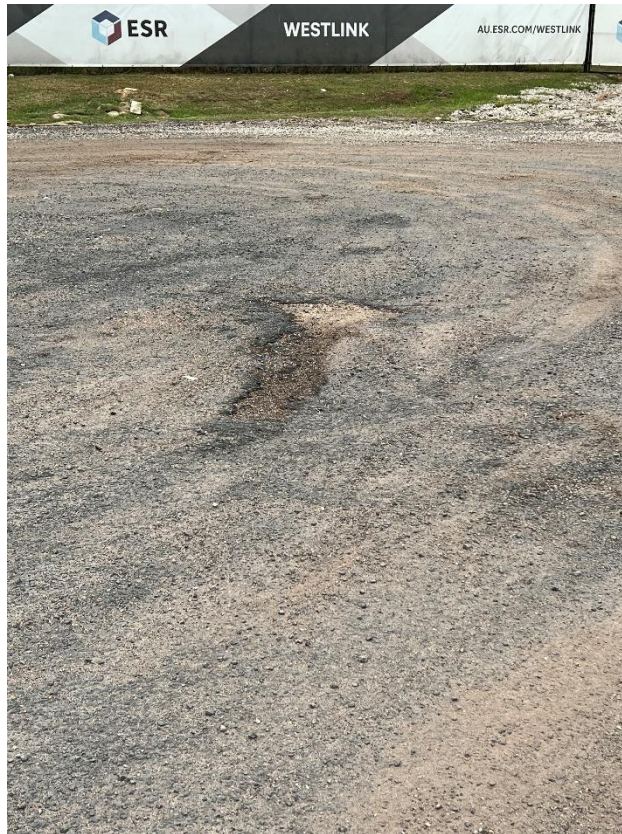
Figure 23 – Crack propagation to the road.

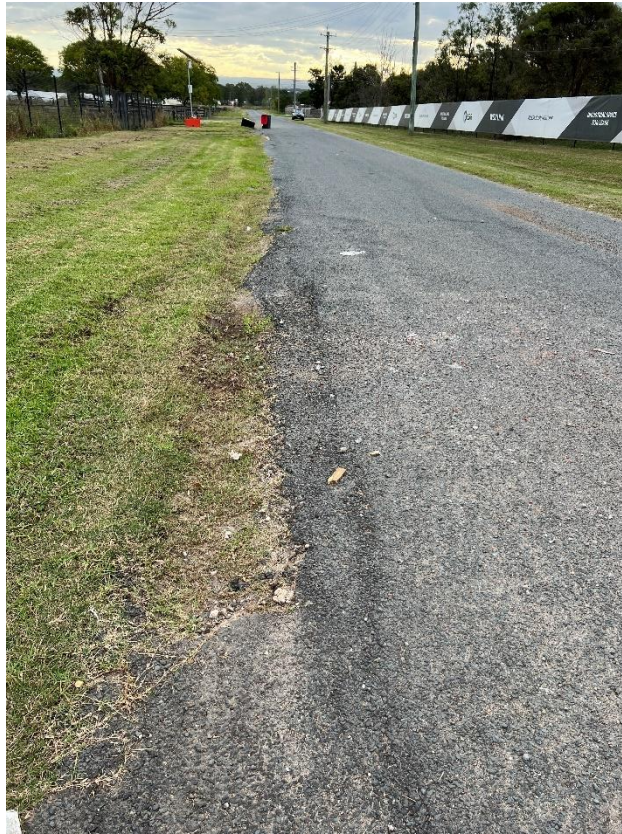
Figure 25 – Crack propagation to the road.

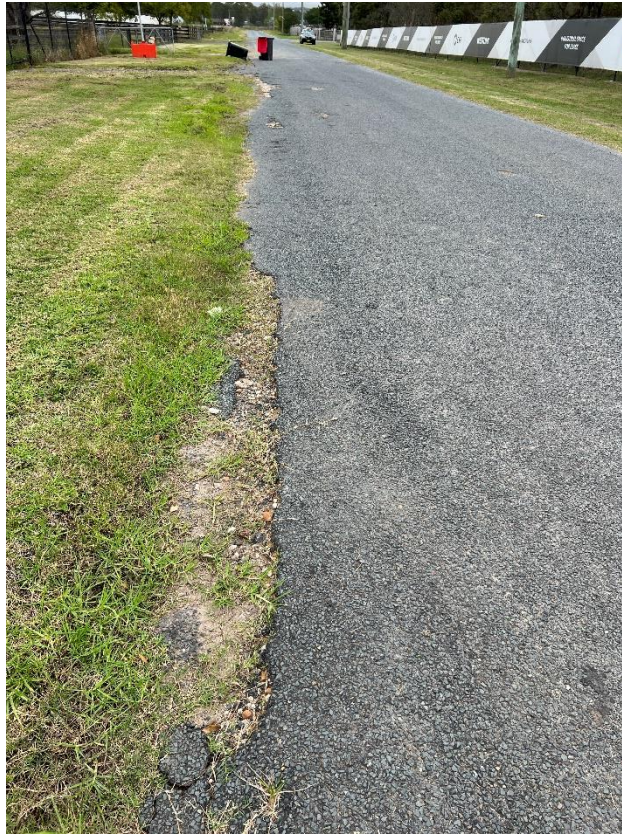
Figure 27 – Crack propagation to the road.

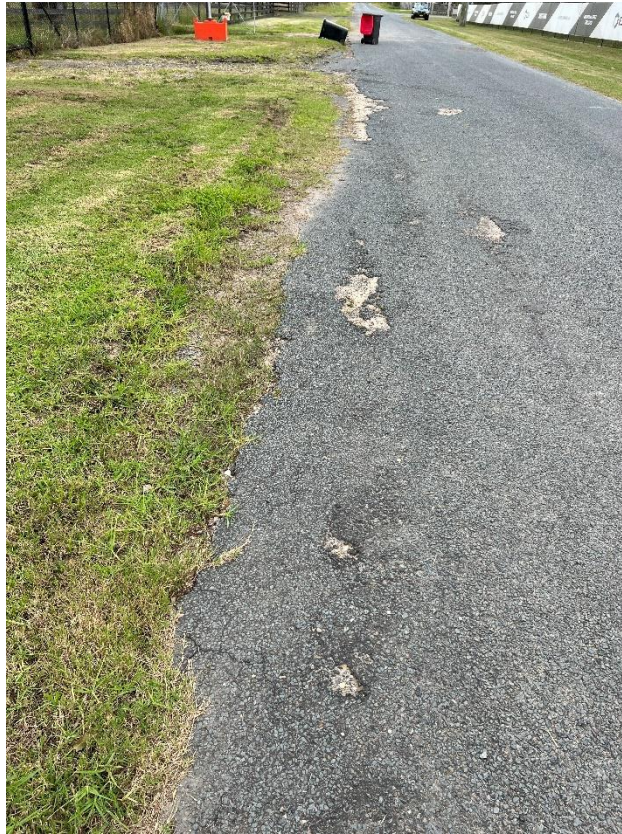
Figure 29 – Crack propagation to the road.

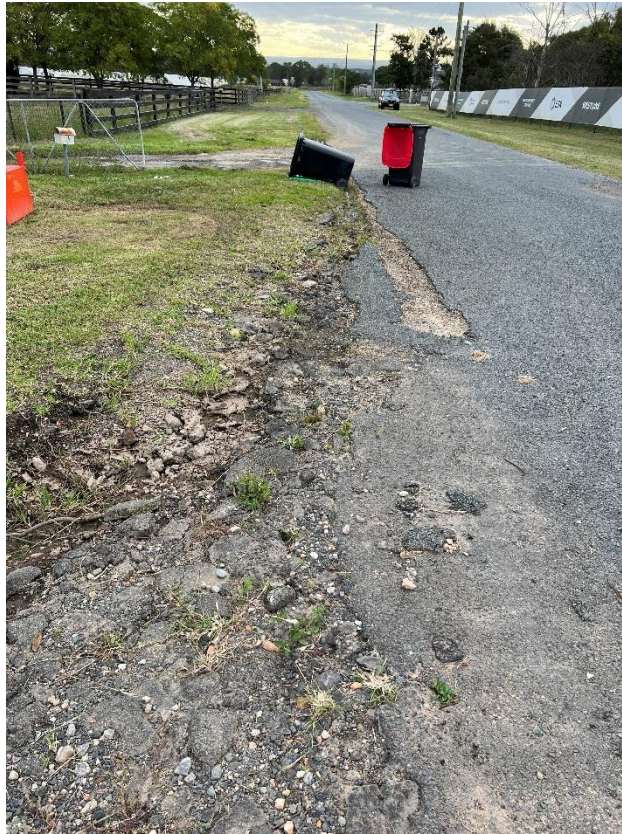
Figure 31 – Crack propagation to the road.

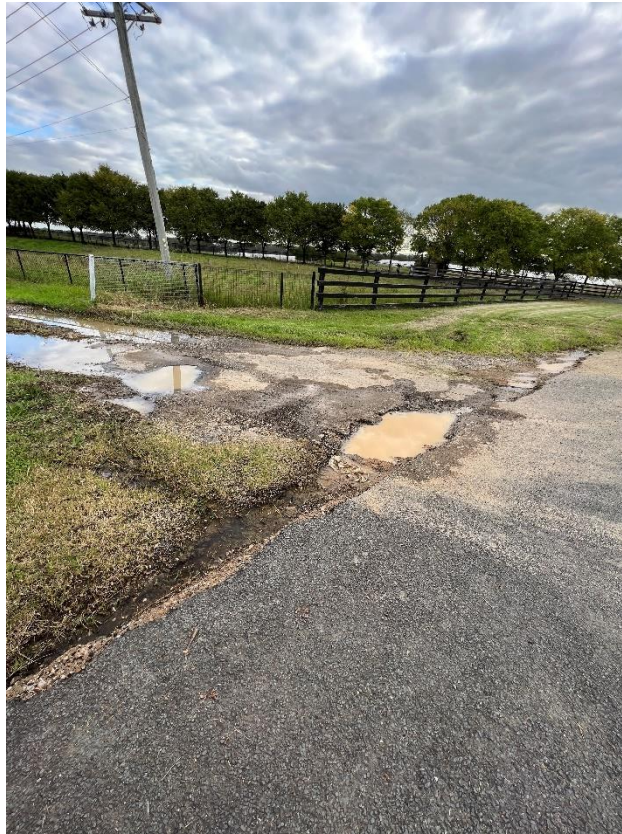
Figure 33 – Crack propagation to the driveway.

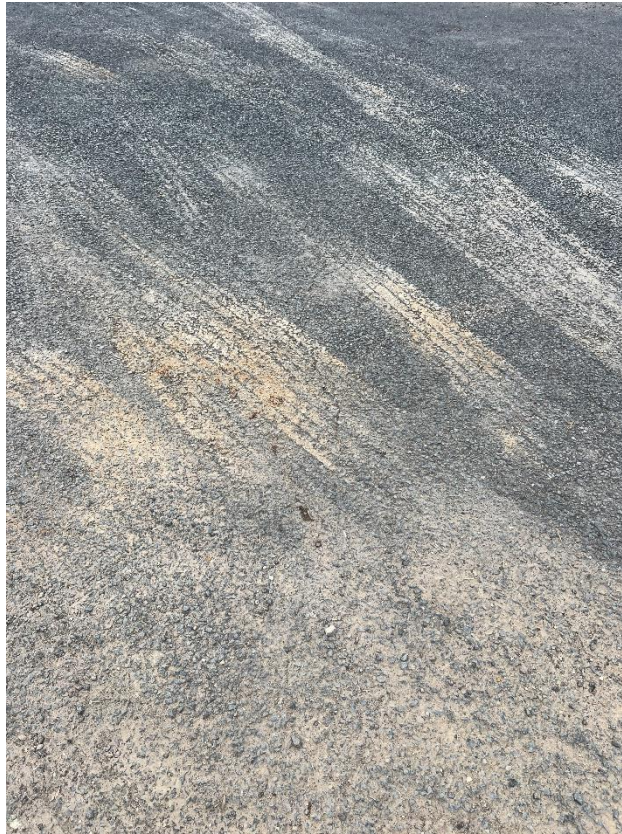
Figure 35 – Crack propagation to the driveway.

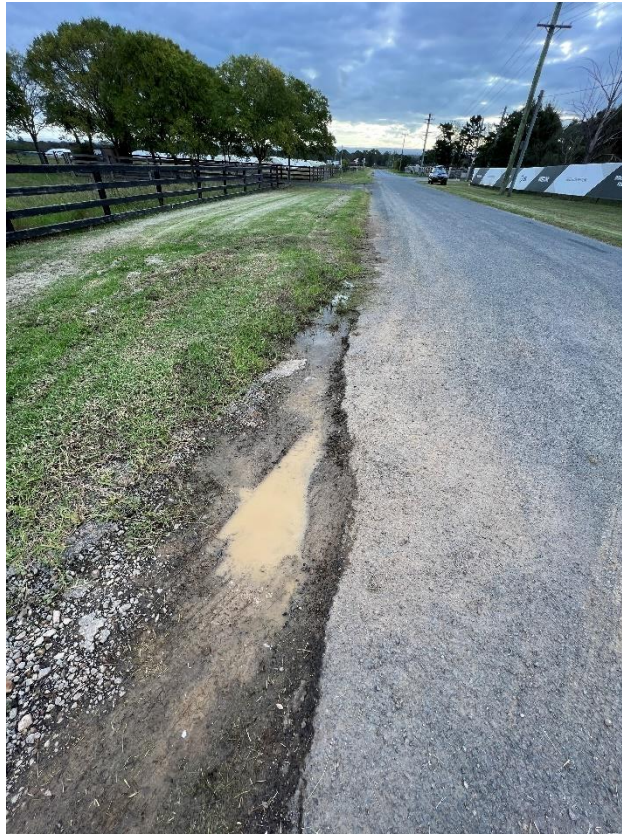
Figure 37 – Crack propagation to the road.

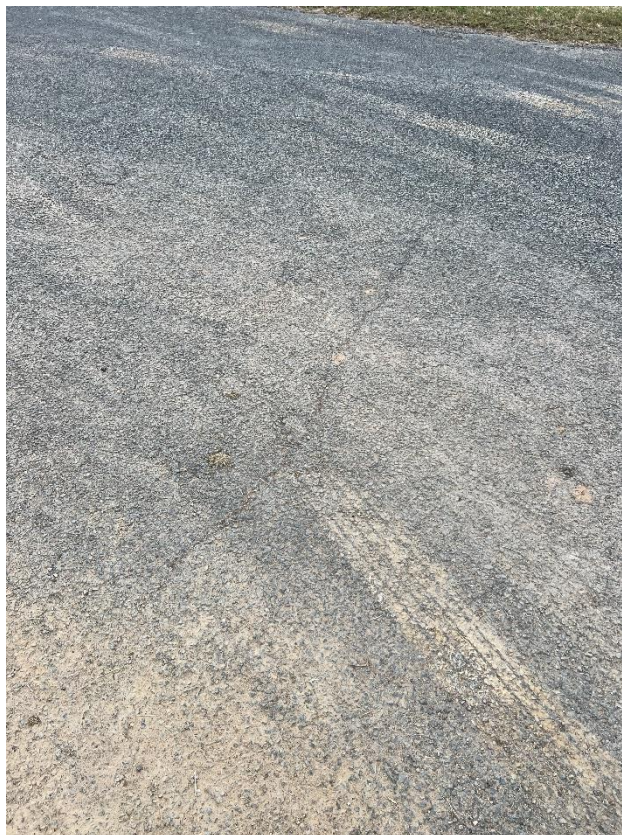
Figure 38 – Crack propagation to the road.

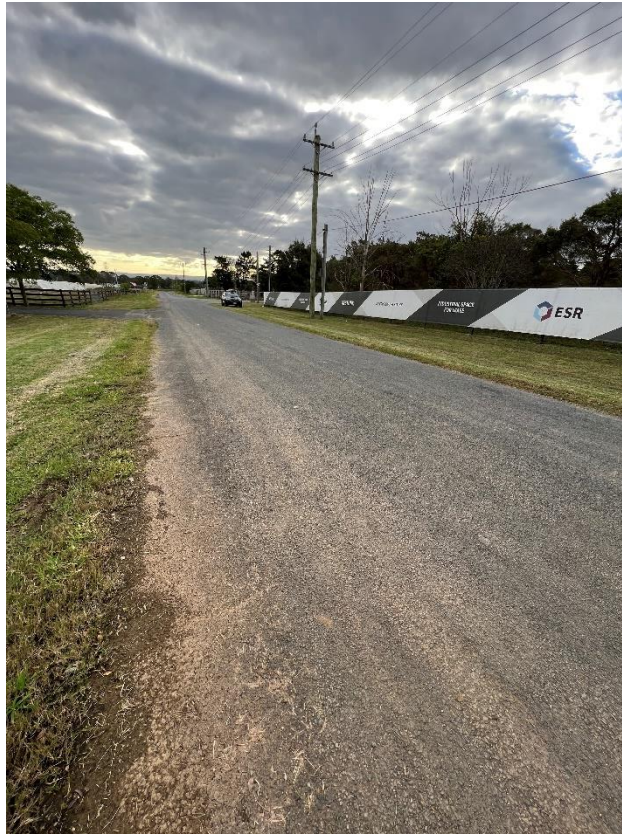
Figure 39 – General condition of the road.

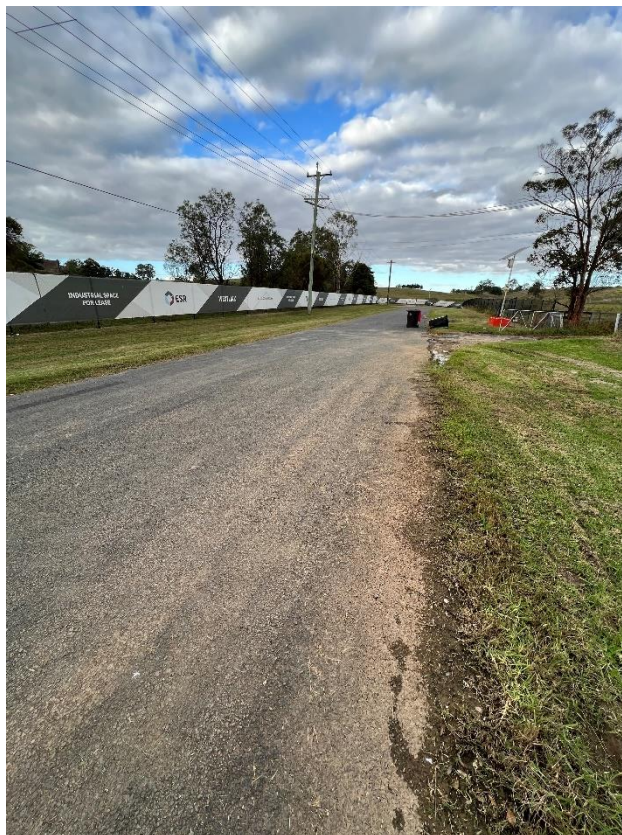
Figure 40 – General condition of the road.

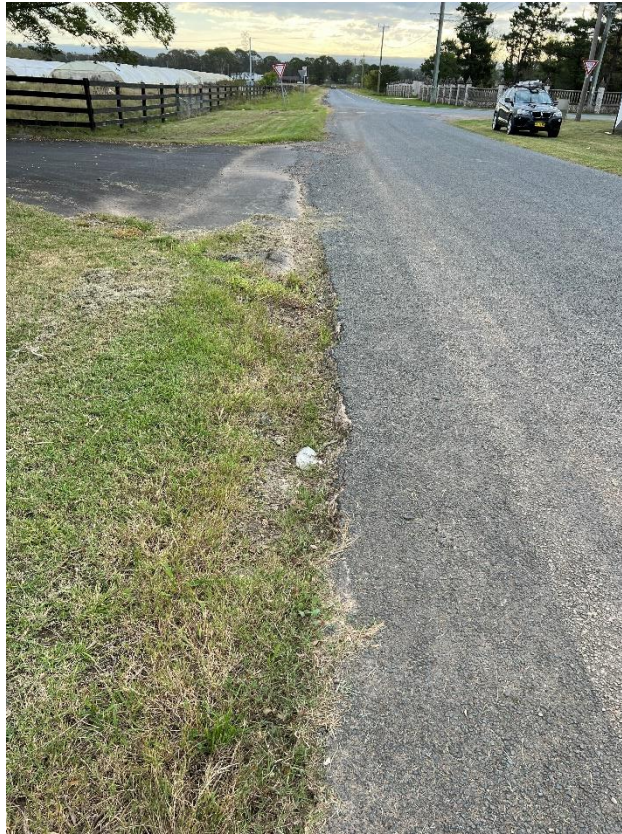
Figure 41 – Crack propagation to the road.

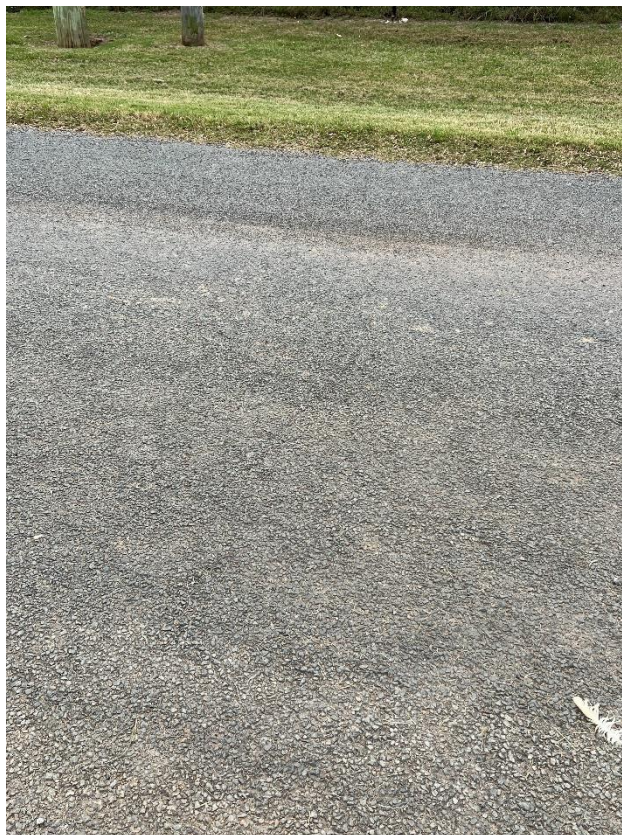
Figure 42 – Crack propagation to the road.

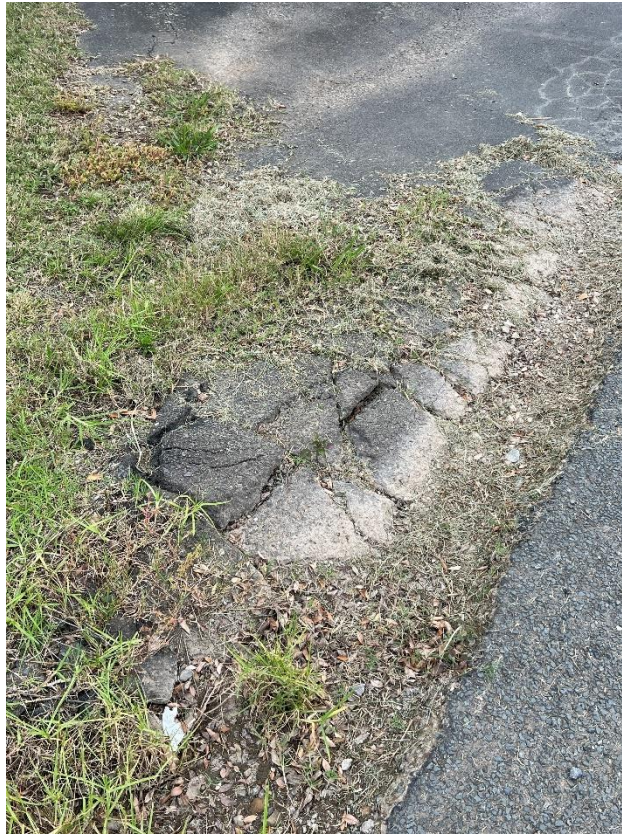
Figure 43 – Crack propagation to the driveway.

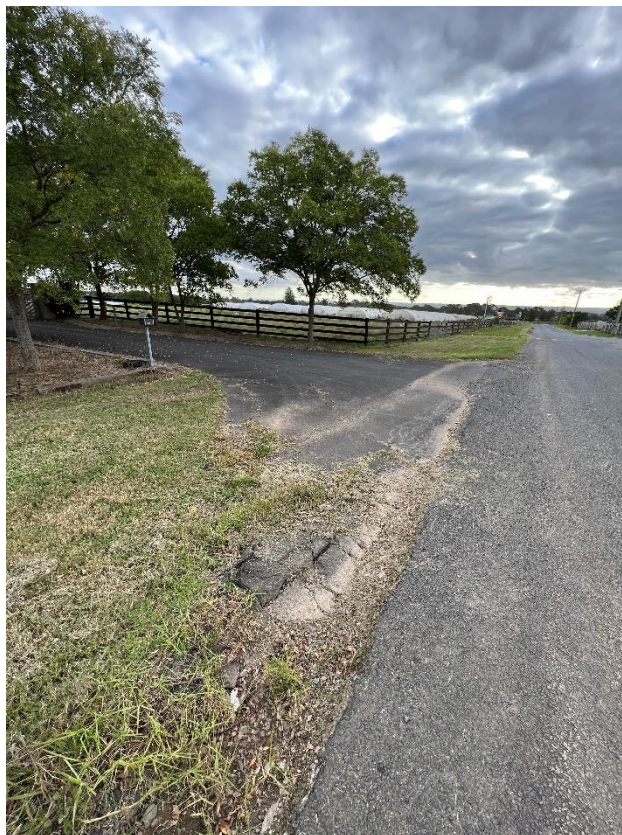
Figure 44 – Crack propagation to the driveway.

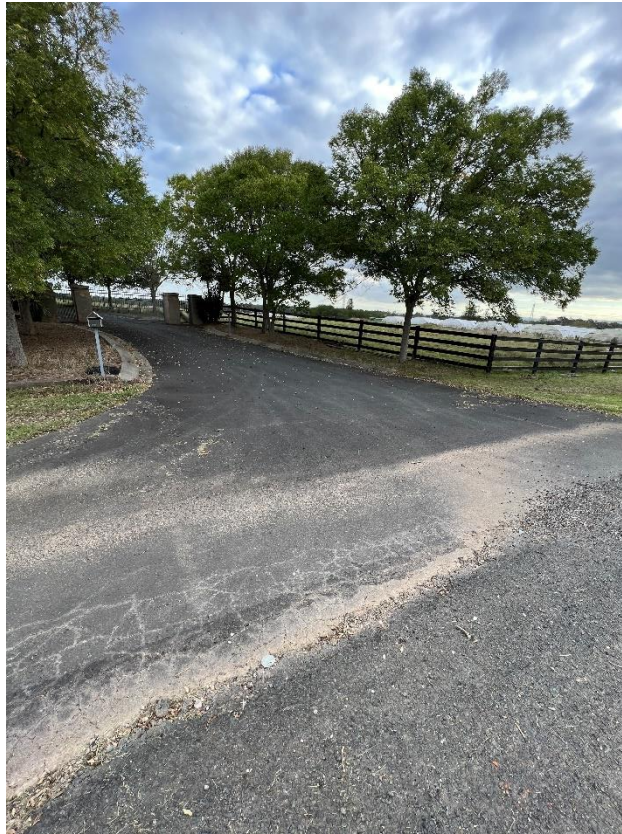
Figure 45 – Crack propagation to the driveway.

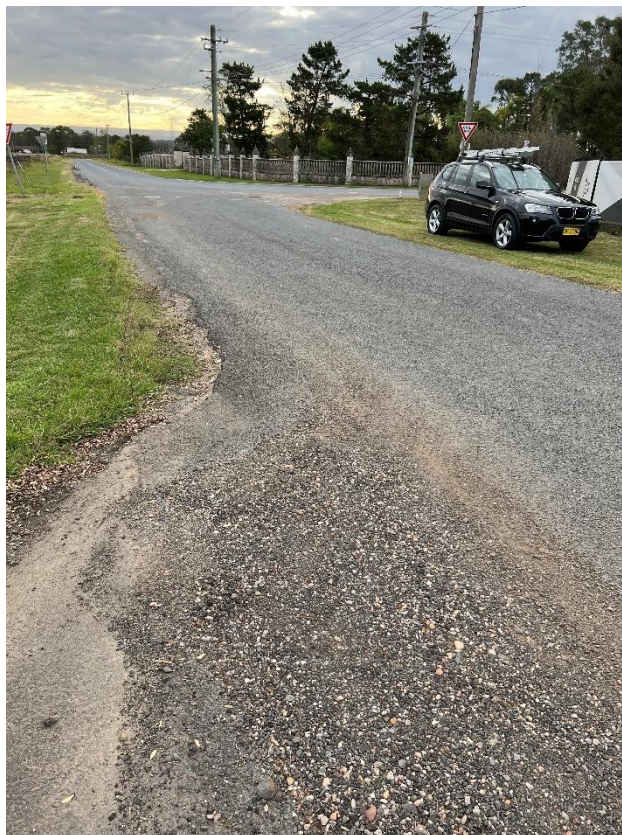
Figure 46 – Crack propagation to the driveway.

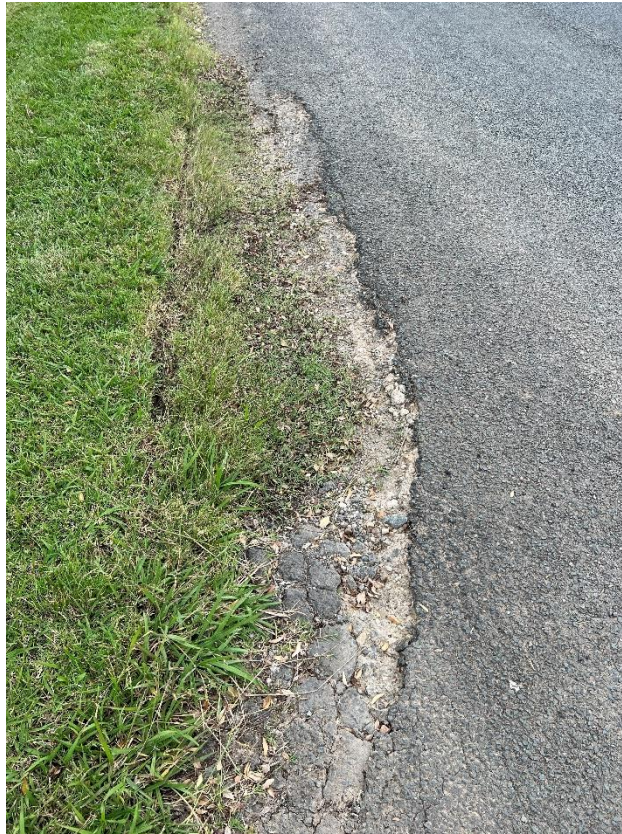
Figure 47 – Crack propagation to the driveway.

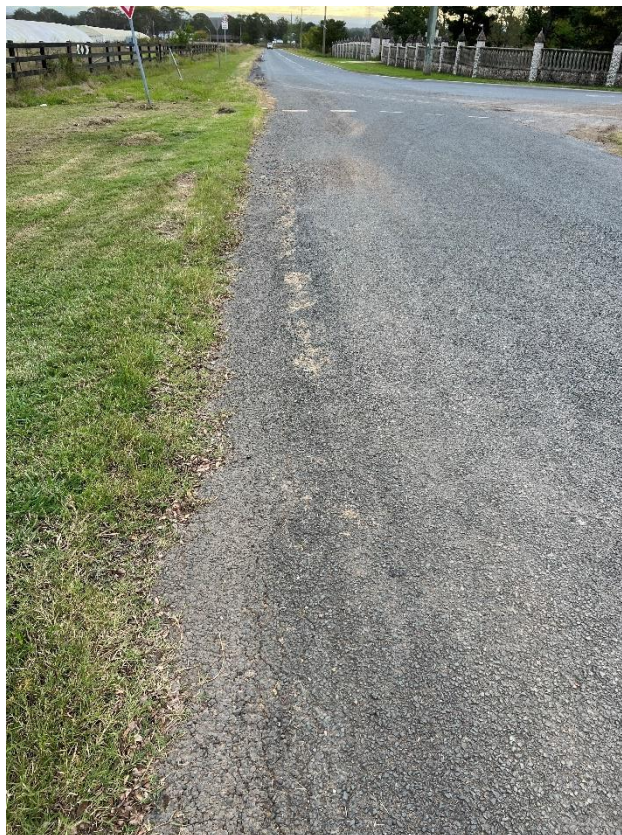
Figure 48 – Crack propagation to the road.

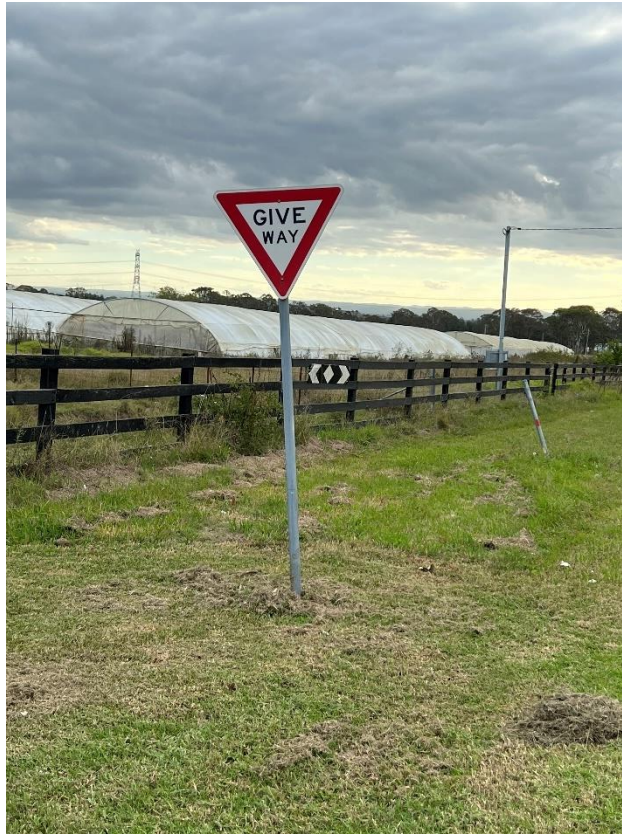
Figure 49 – General condition of the street signpost.

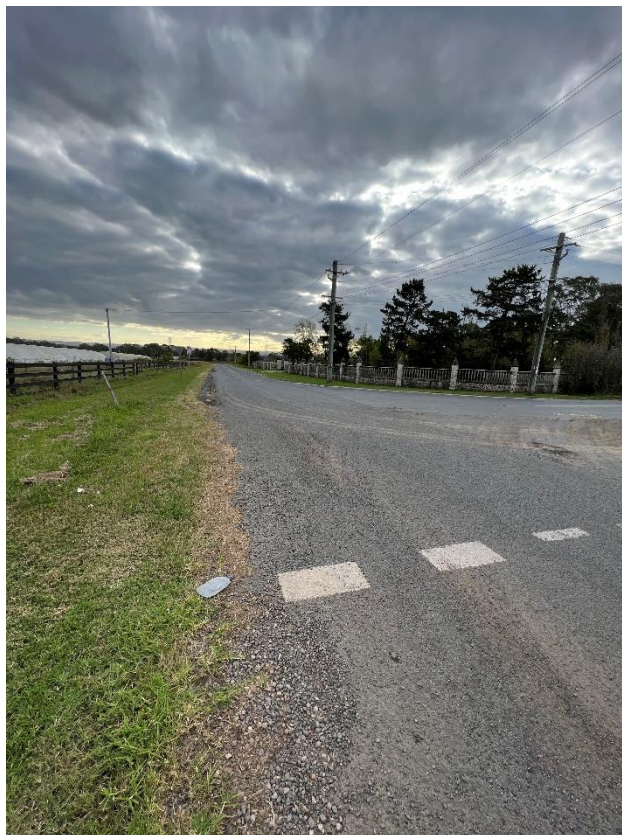
Figure 50 – General condition of the road.

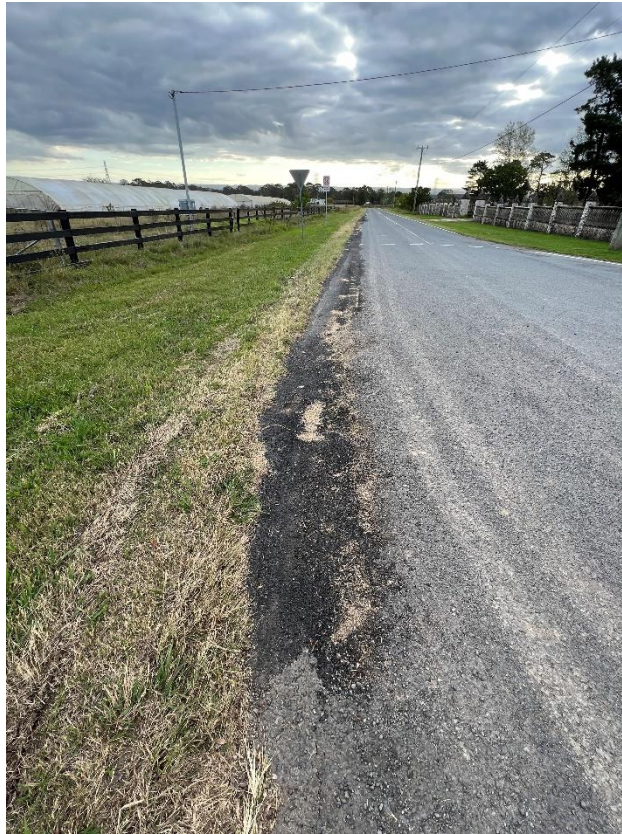
Figure 51 – Crack propagation to the road.

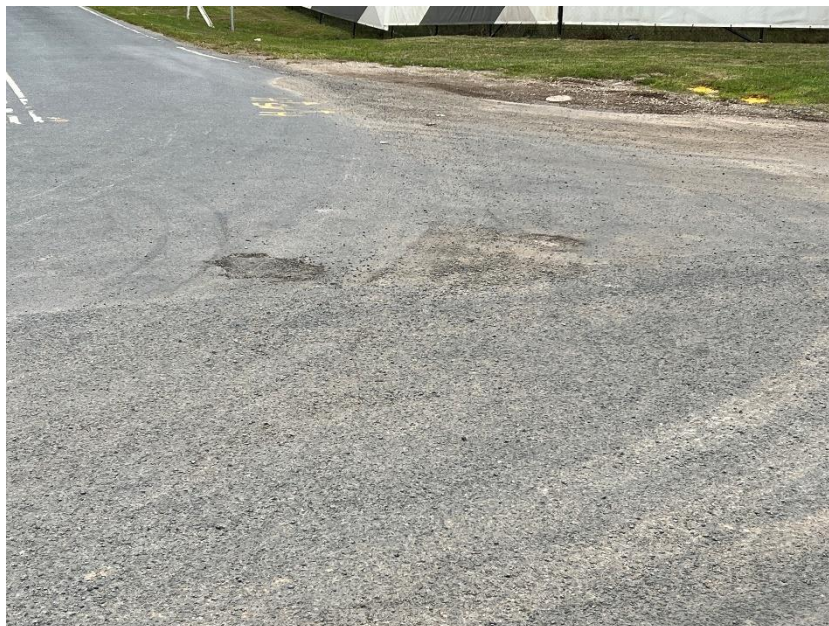
Figure 52 – Crack propagation to the road.

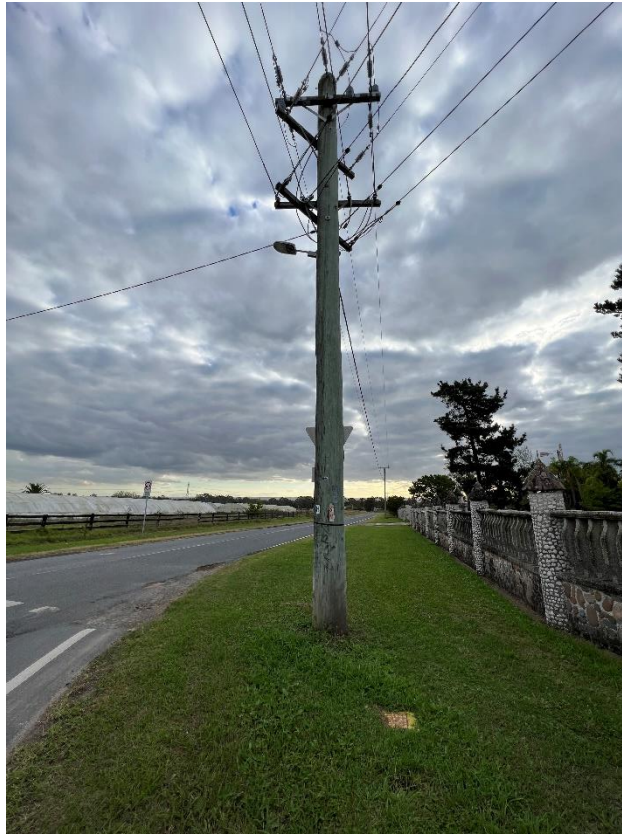
Figure 55 – General condition of the electrical post.

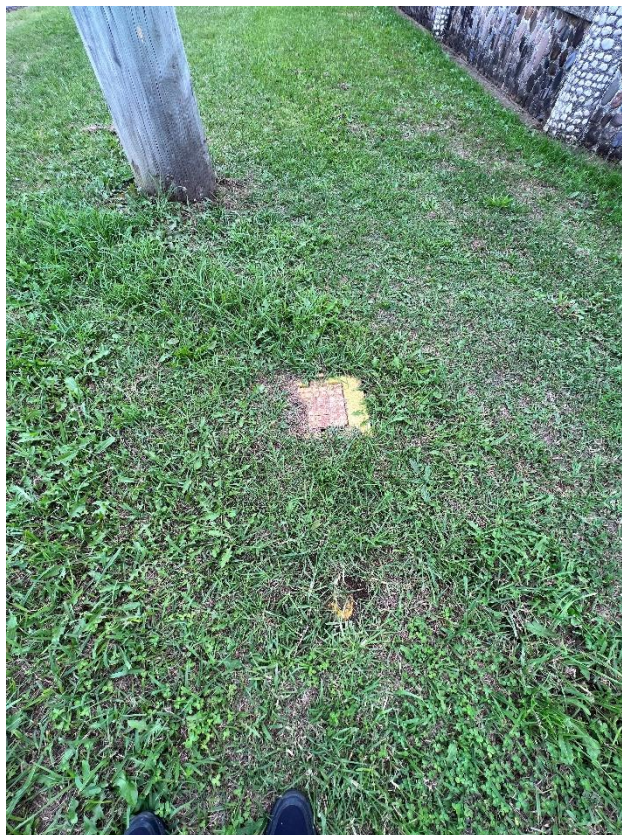
Figure 56 – General condition of the utility lid.

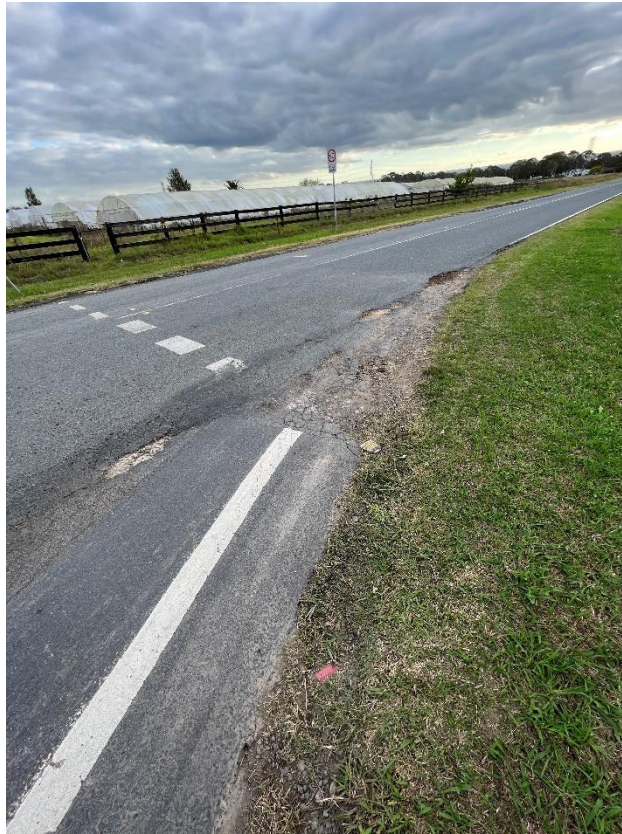
Figure 57 – Crack propagation to the road.

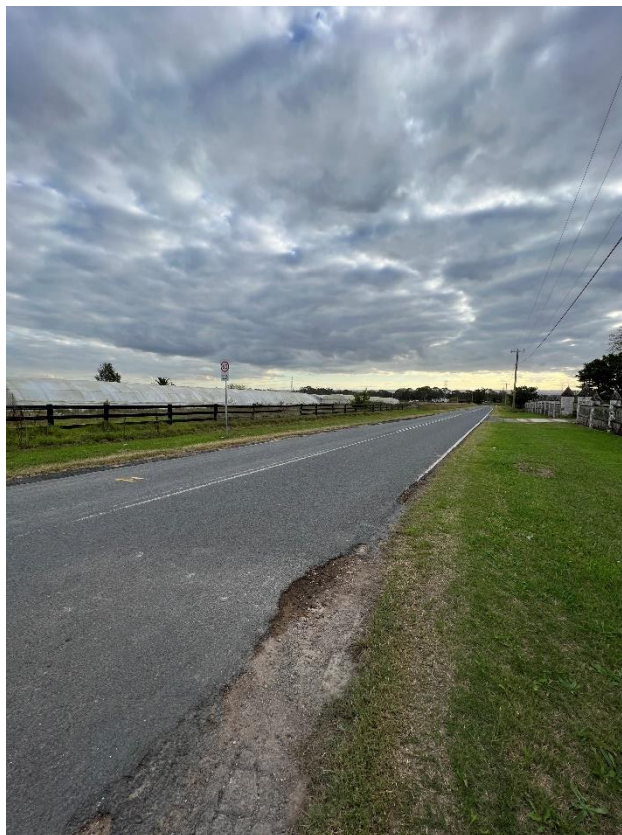
Figure 58 – Crack propagation to the road.

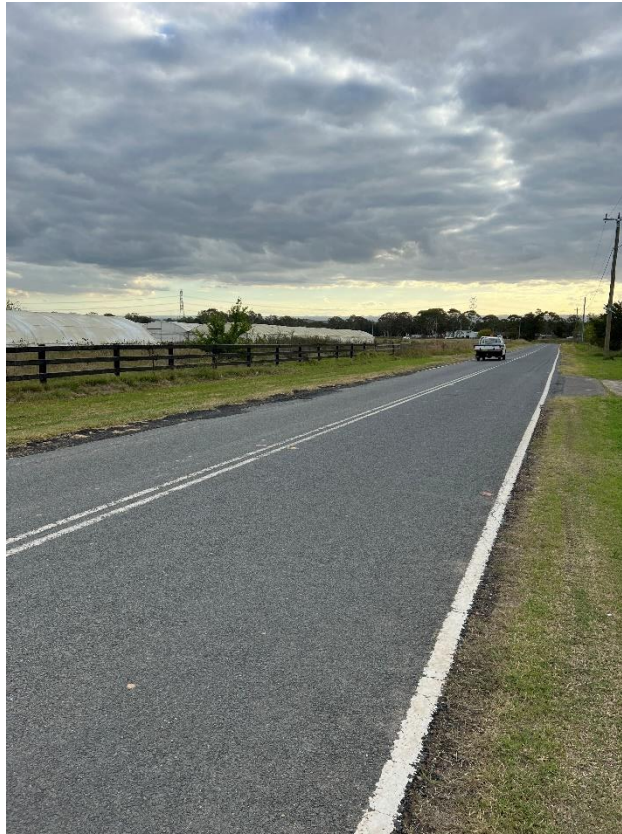
Figure 59 – General condition of the road.
