DILAPIDATION REPORT

Abbotts Road, Kemps Creek

Prepared by: Rezoning Pty Ltd t/as Effective Building & Consultancy

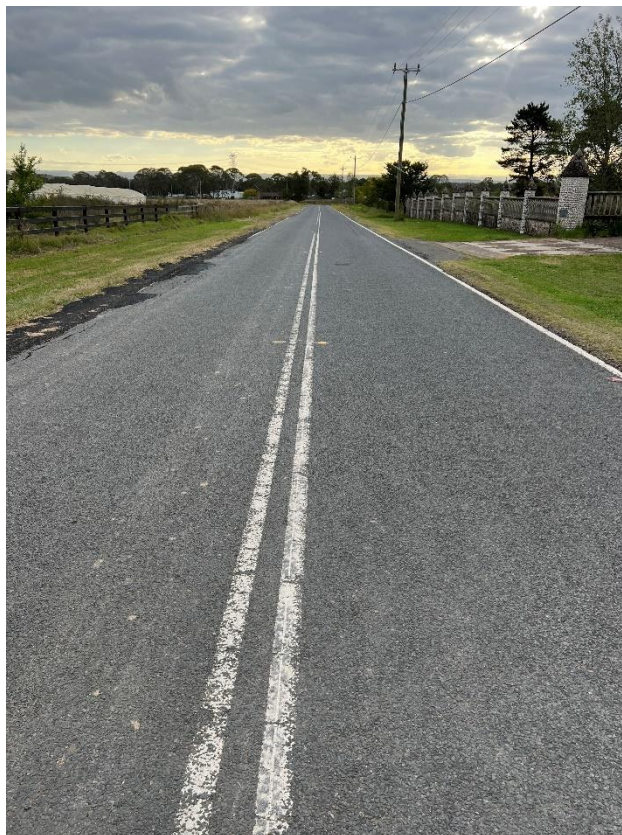
Figure 60 – General condition of the road.

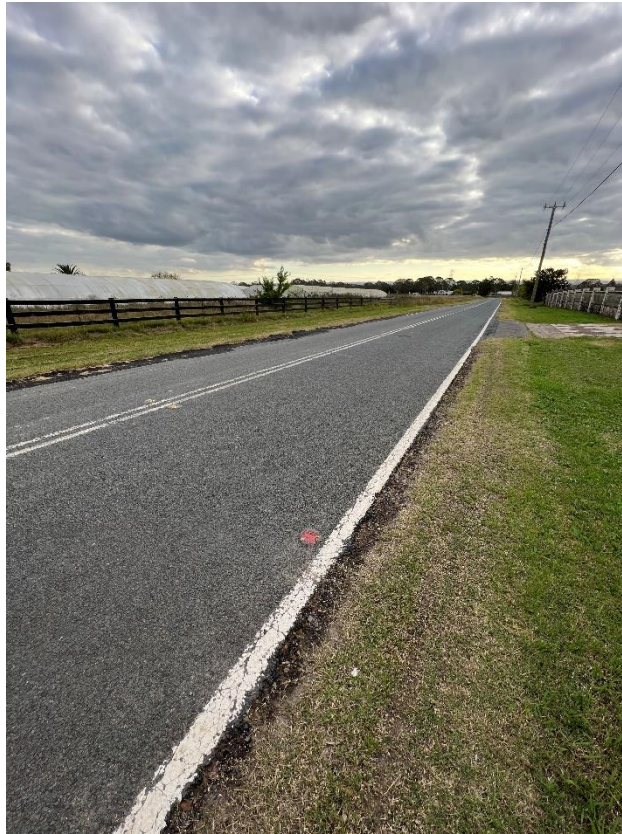
Figure 61 – General condition of the road.

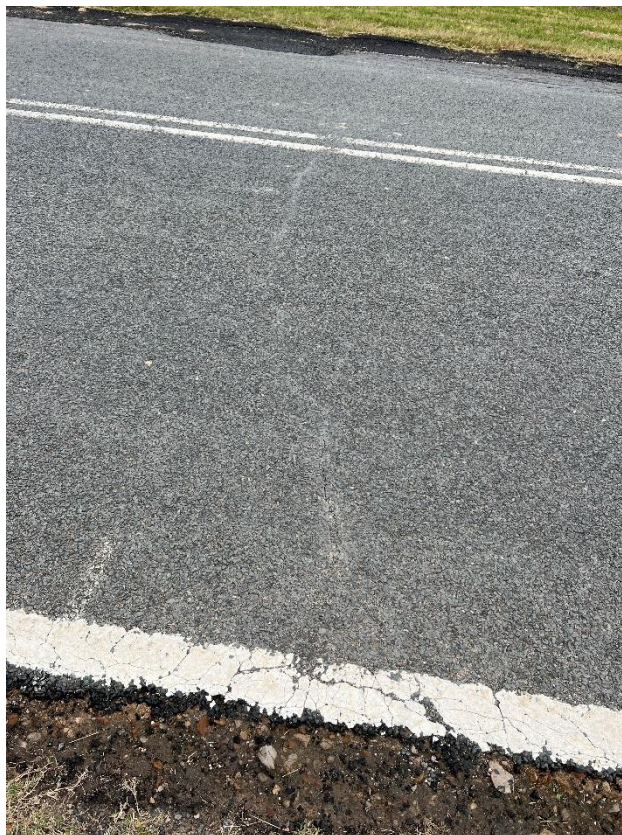
Figure 62 – Crack propagation to the road.

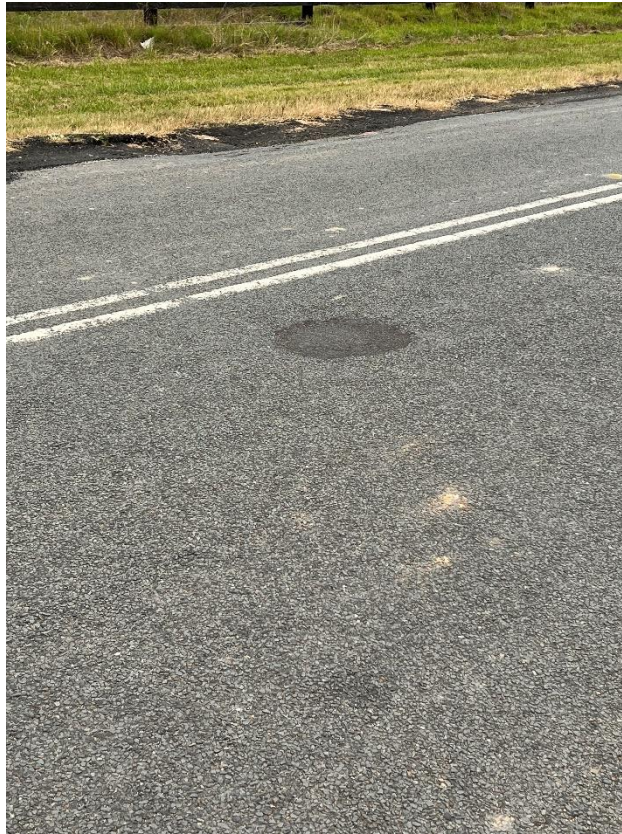
Figure 63 – Crack propagation to the road.

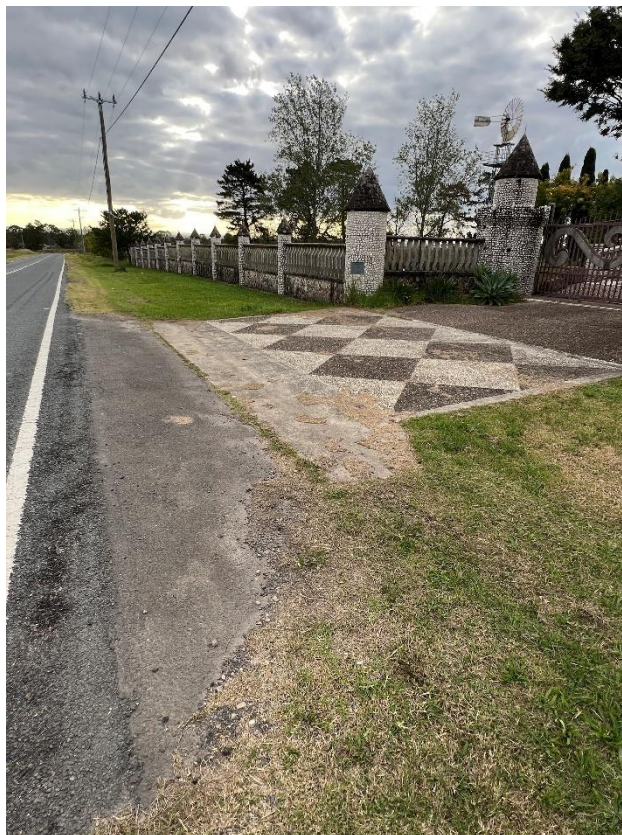
Figure 64 – Crack propagation to the driveway.

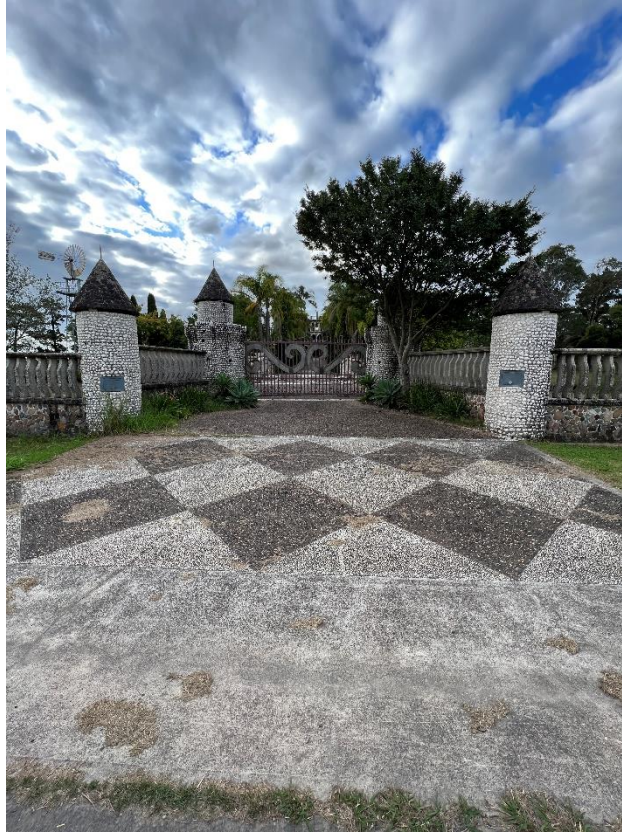
Figure 65 – Crack propagation to the driveway.

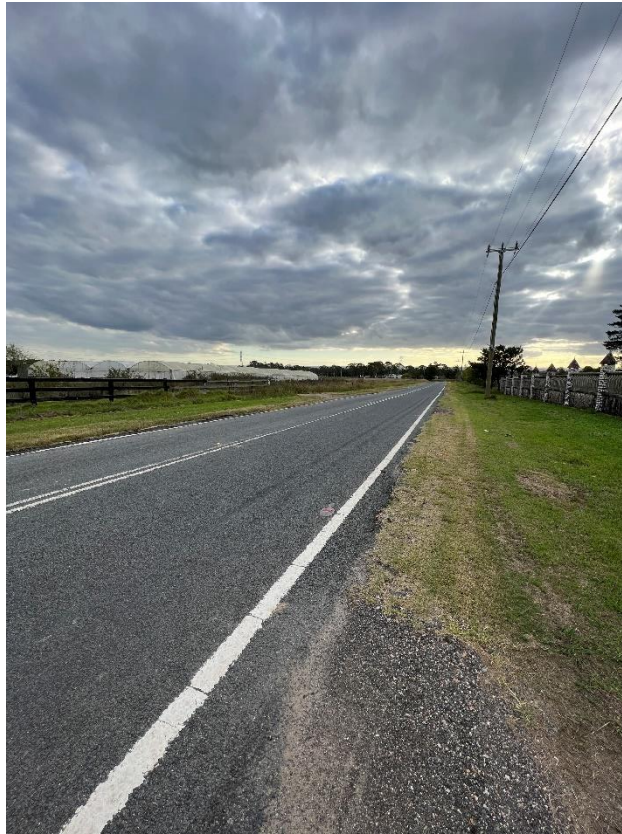
Figure 67 – General condition of the road.

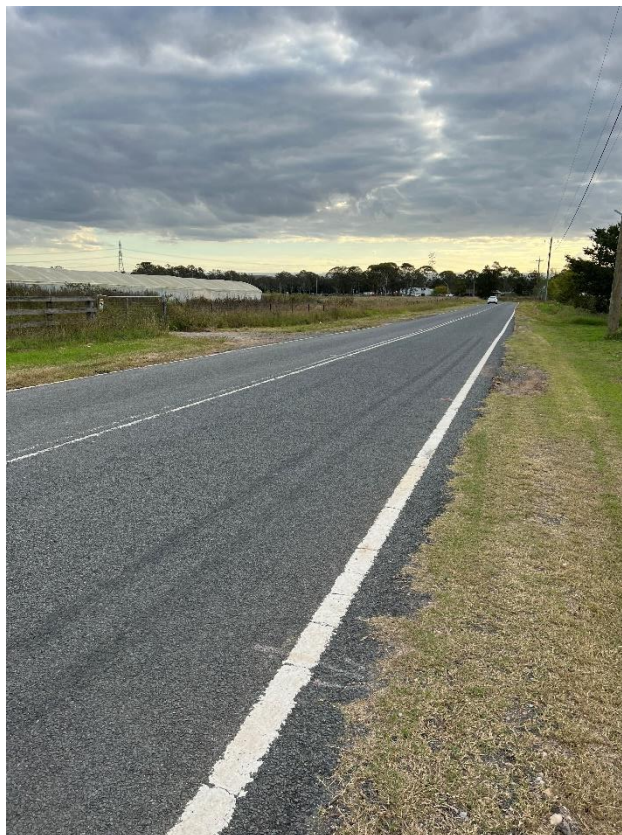
Figure 68 – General condition of the road.

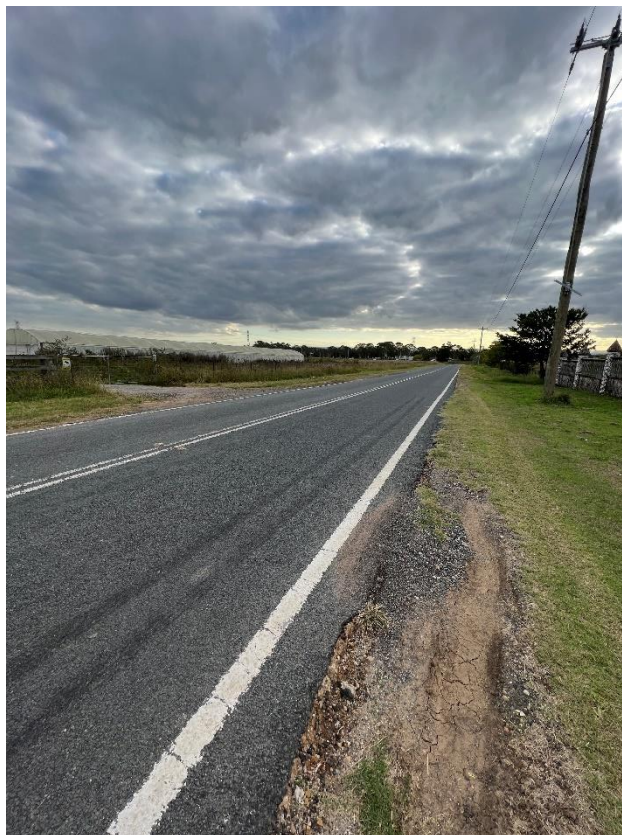
Figure 70 – General condition of the road.

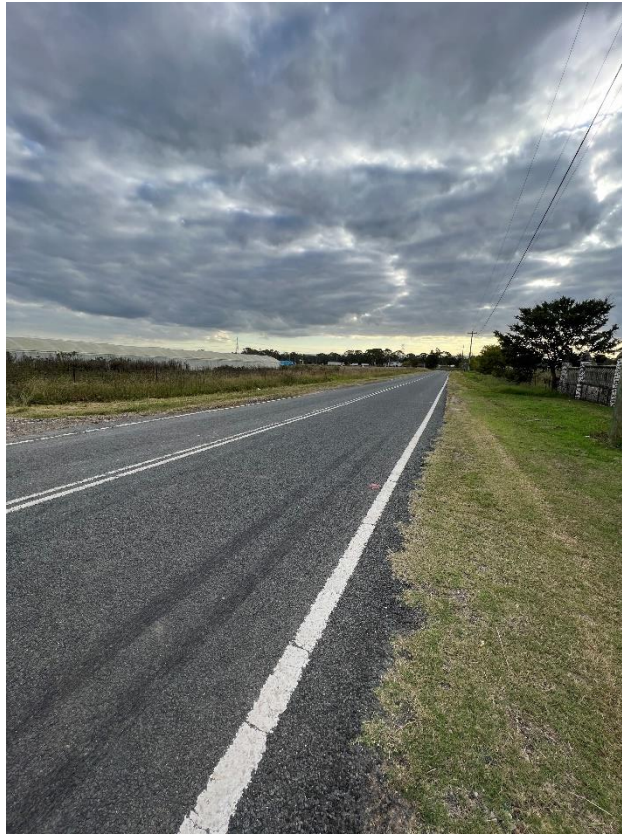
Figure 71 – General condition of the road.

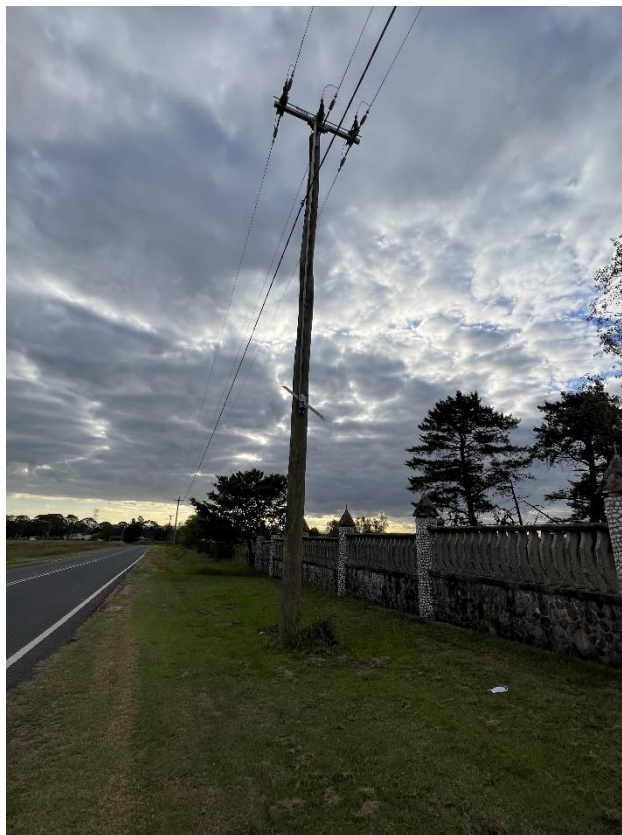
Figure 72 – General condition of the electrical post.

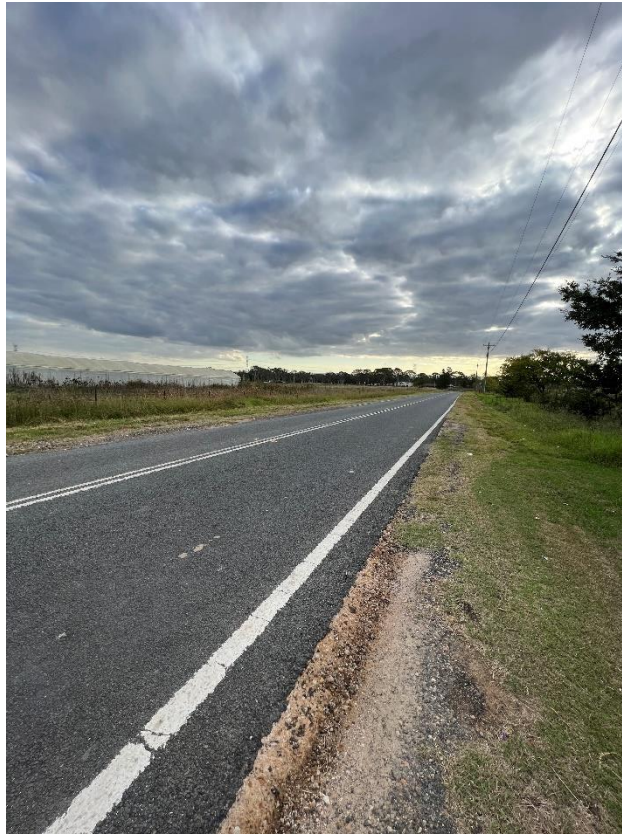
Figure 73 – General condition of the road.

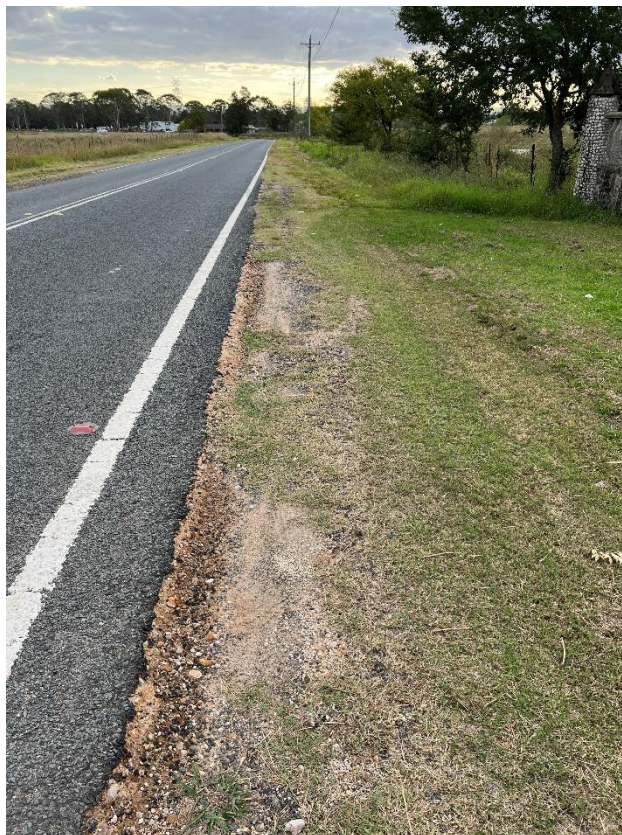
Figure 74 – General condition of the nature strip.

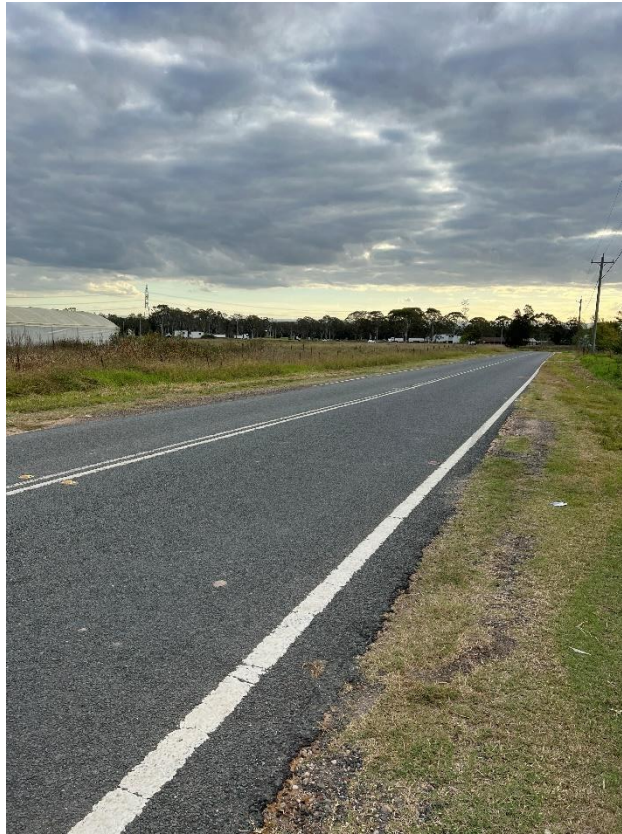
Figure 75 – General condition of the road.

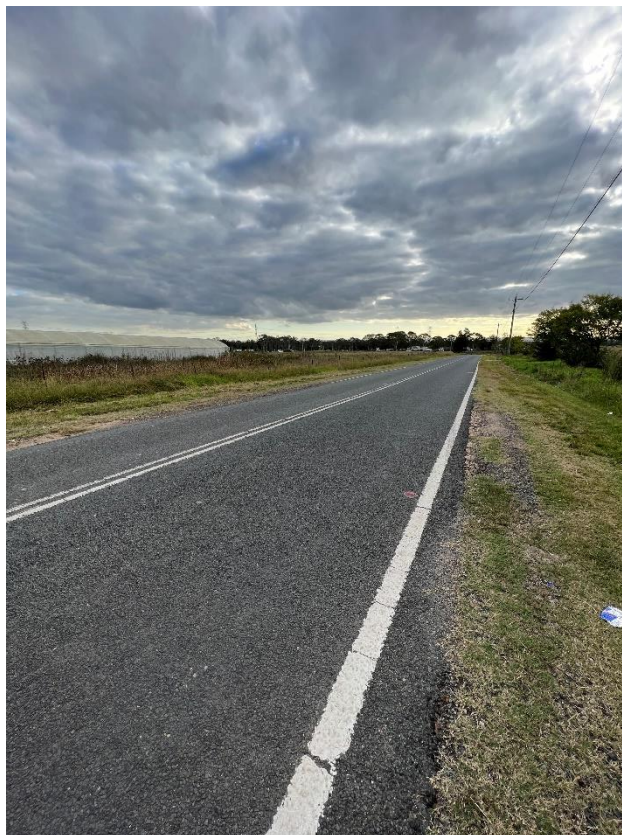
Figure 76 – Crack propagation to the road.

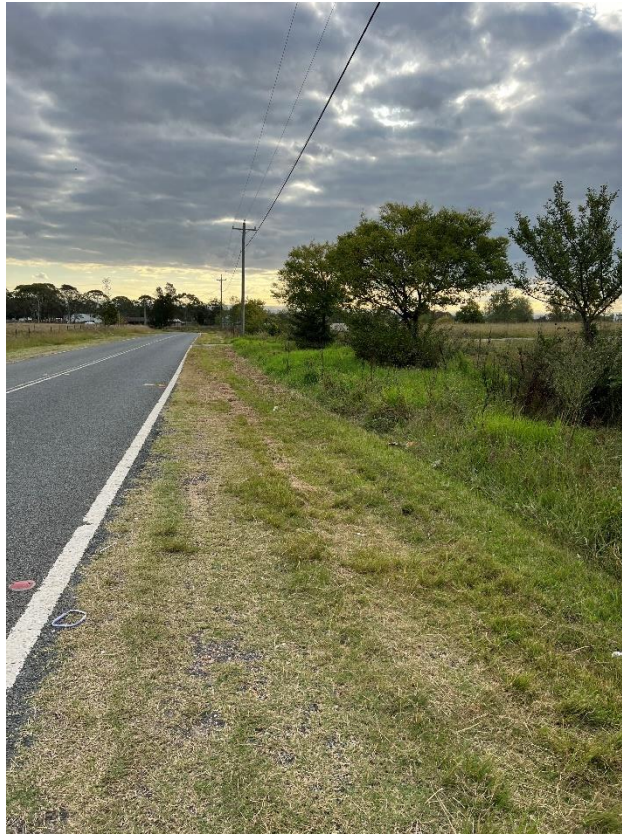
Figure 77 – General condition of the nature strip.

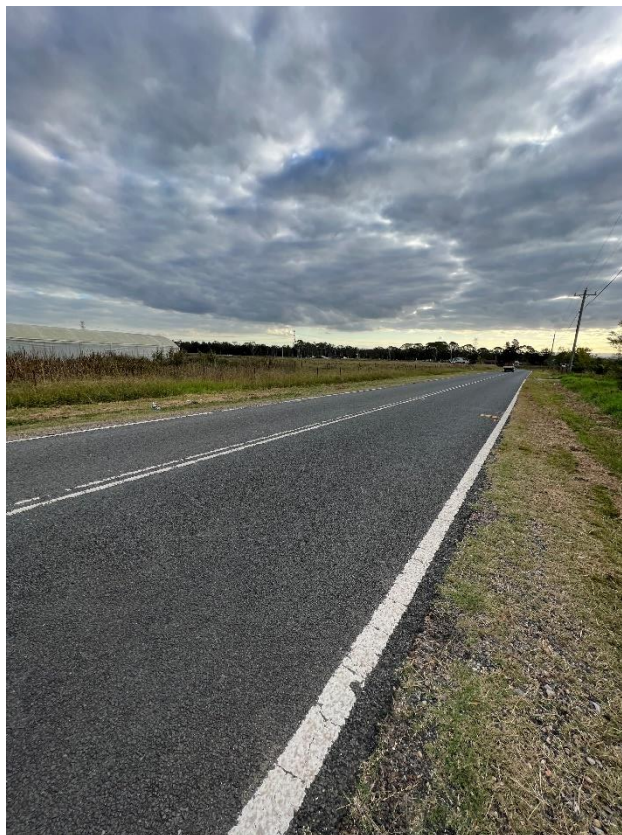
Figure 78 – General condition of the road.

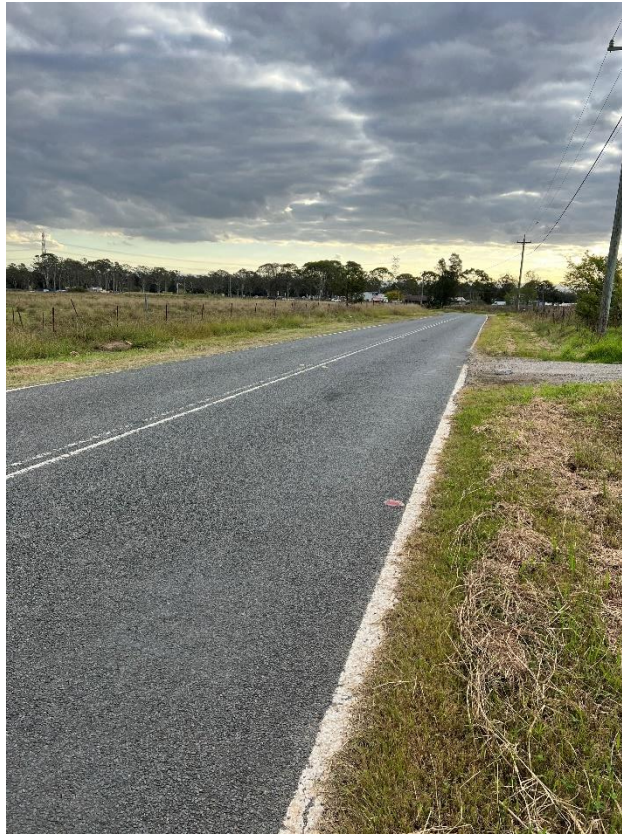
Figure 79 – General condition of the road.

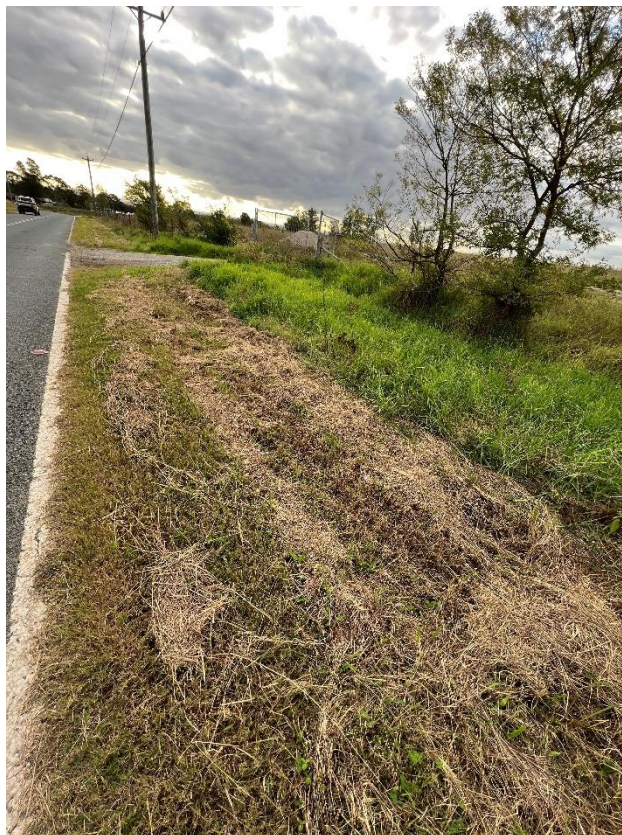
Figure 80 – General condition of the nature strip.

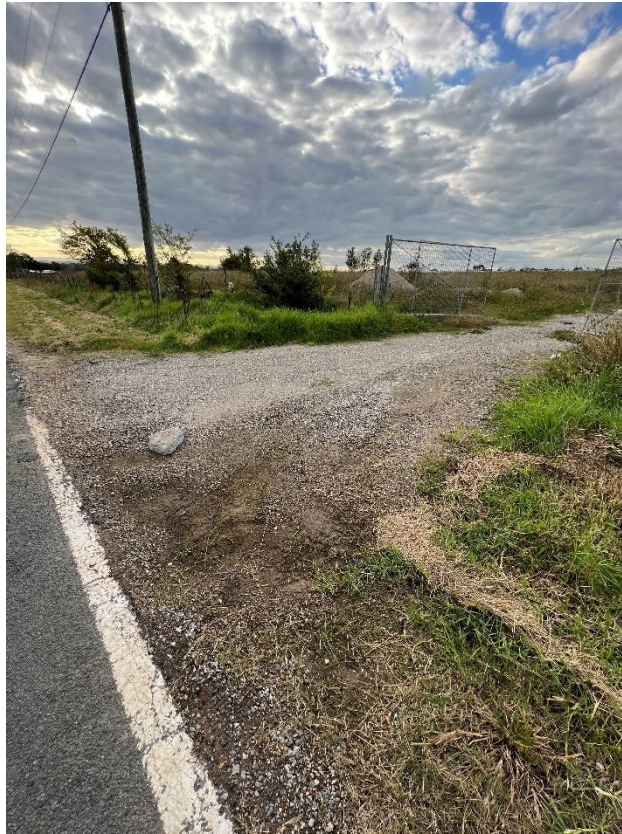
Figure 81 – General condition of the driveway.

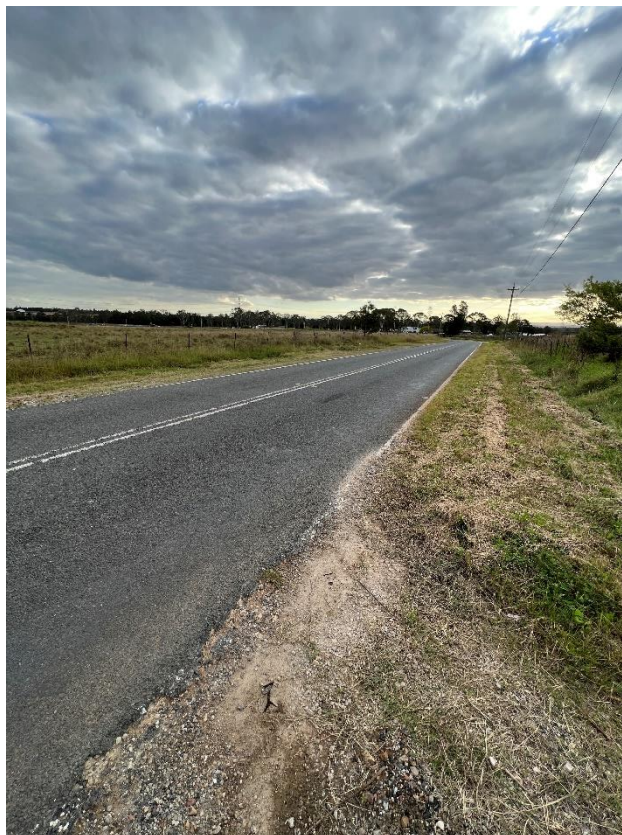
Figure 82 – General condition of the road.

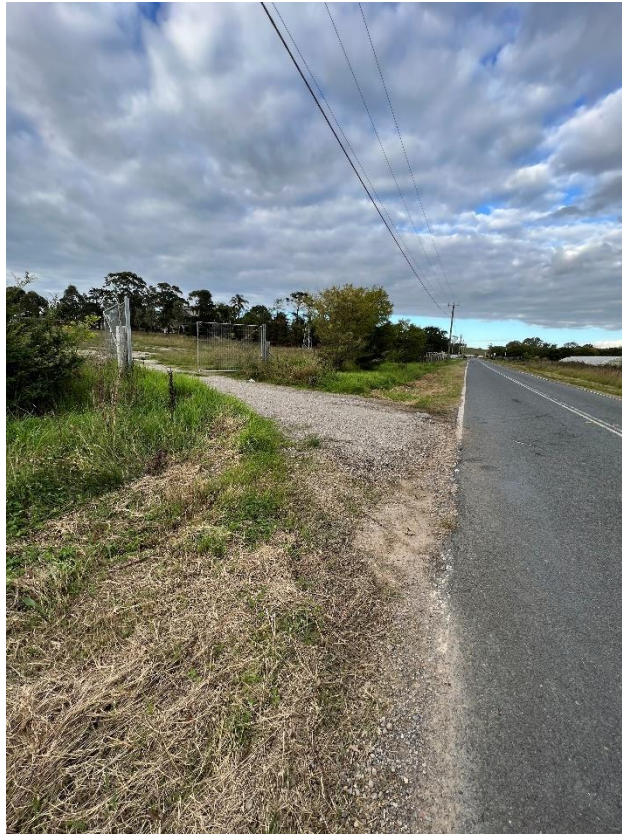
Figure 83 – General condition of the nature strip/driveway.

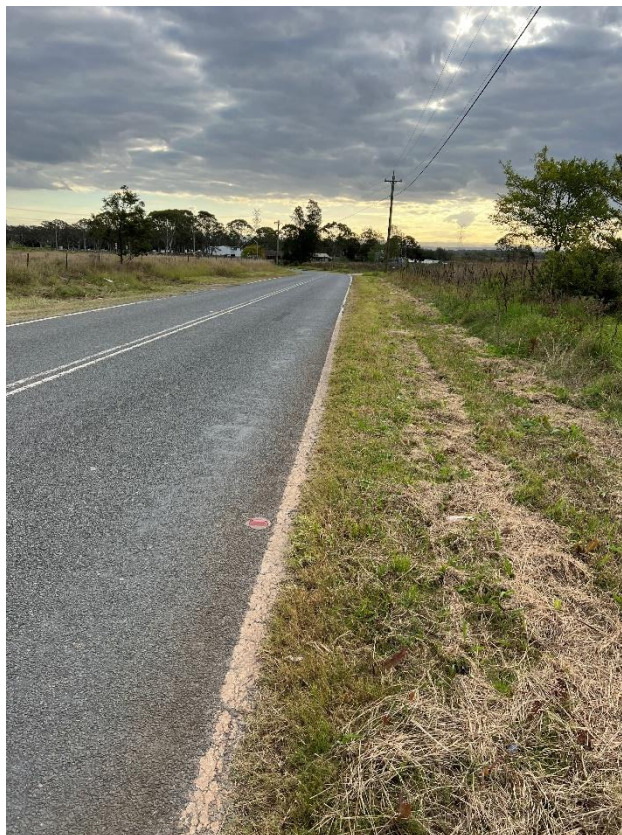
Figure 84 – General condition of the nature strip.

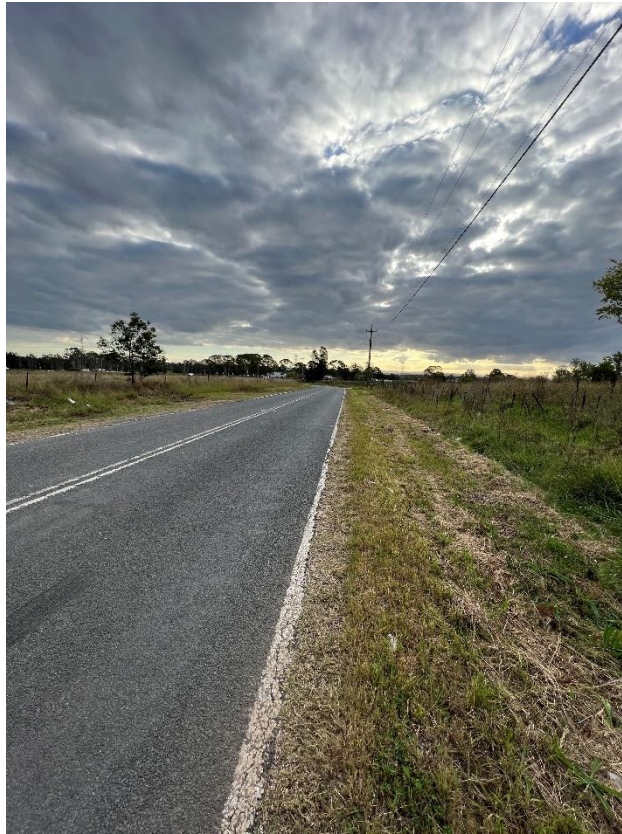
Figure 85 – General condition of the nature strip.

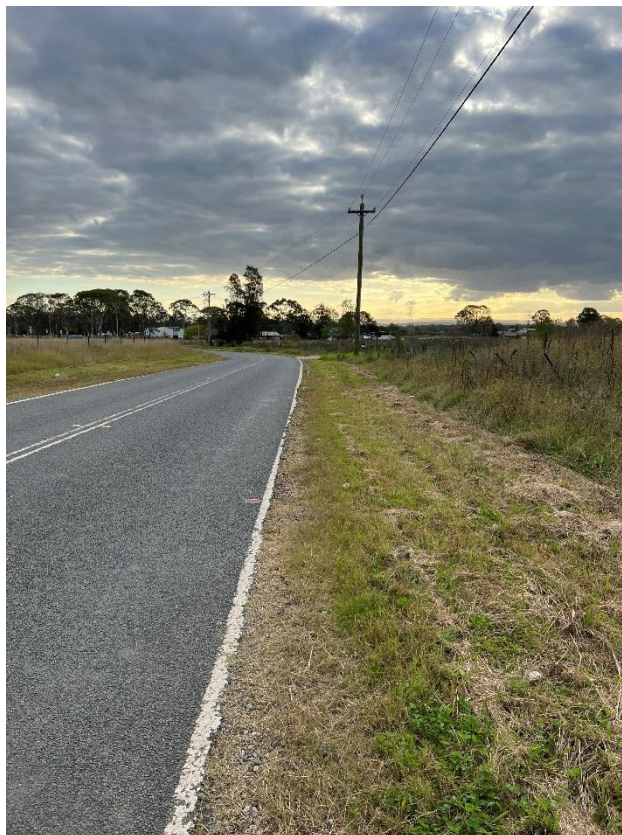
Figure 86 – General condition of the nature strip.

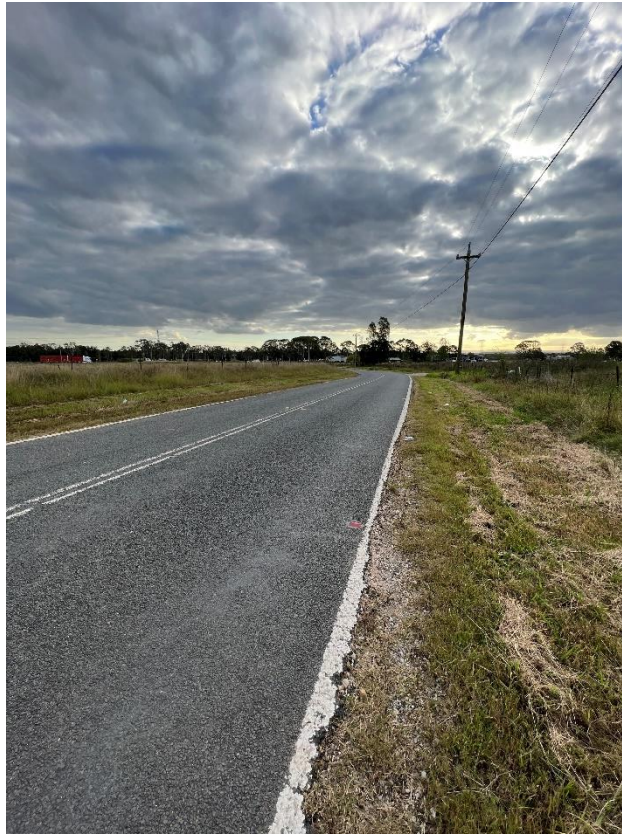
Figure 87 – General condition of the road.

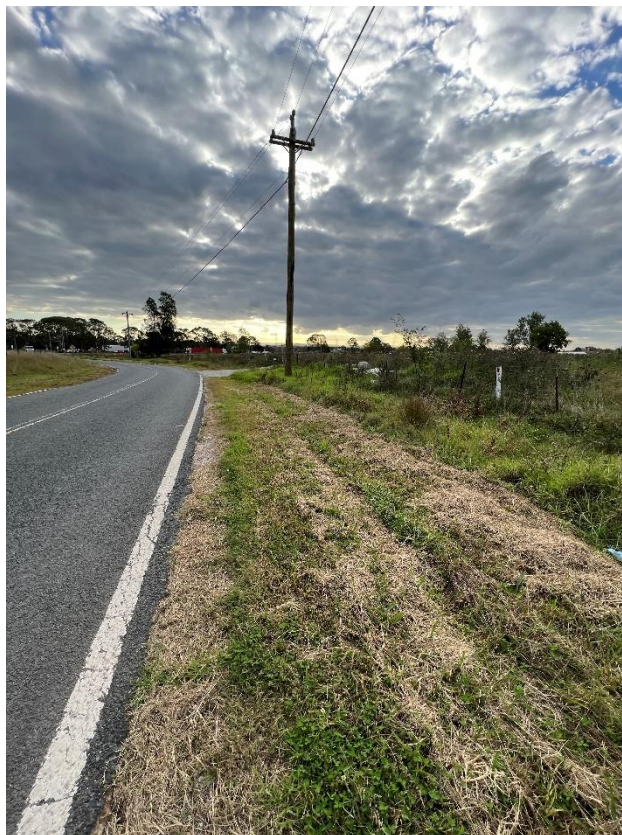
Figure 88 – General condition of the nature strip.

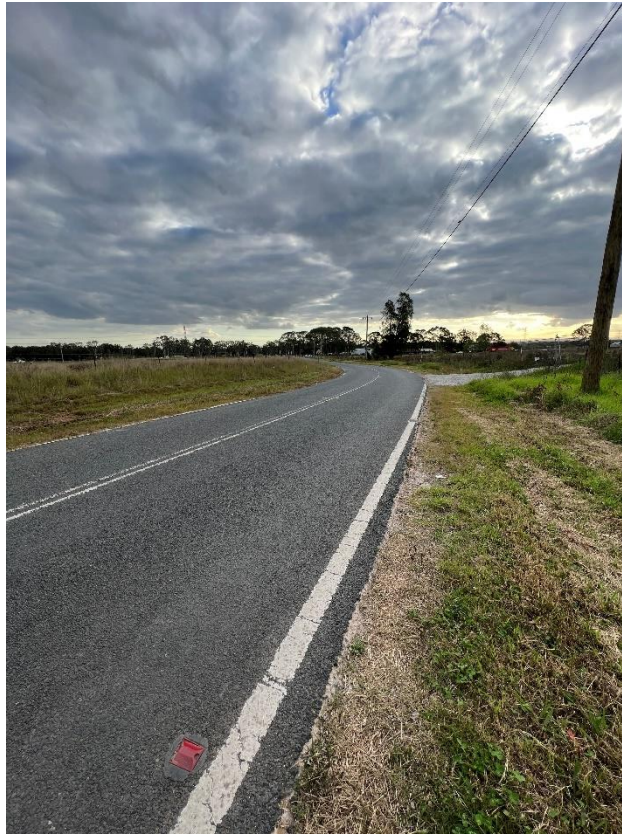
Figure 89 – General condition of the road.

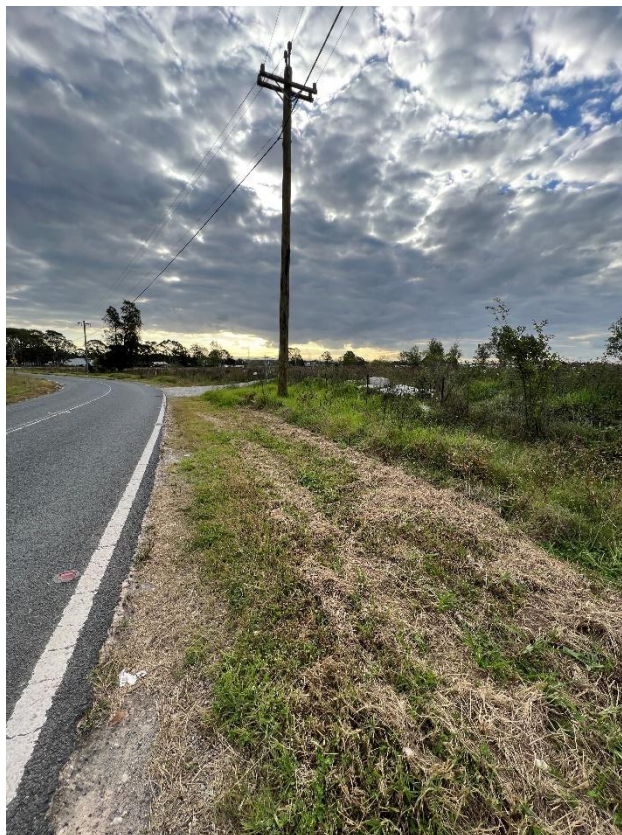
Figure 90 – General condition of the nature strip.

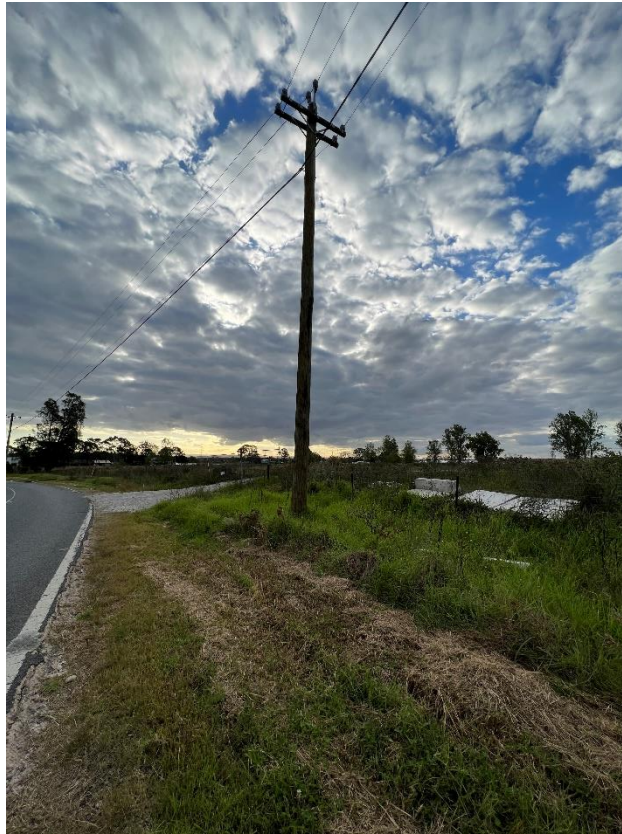
Figure 91 – General condition of the electrical post.

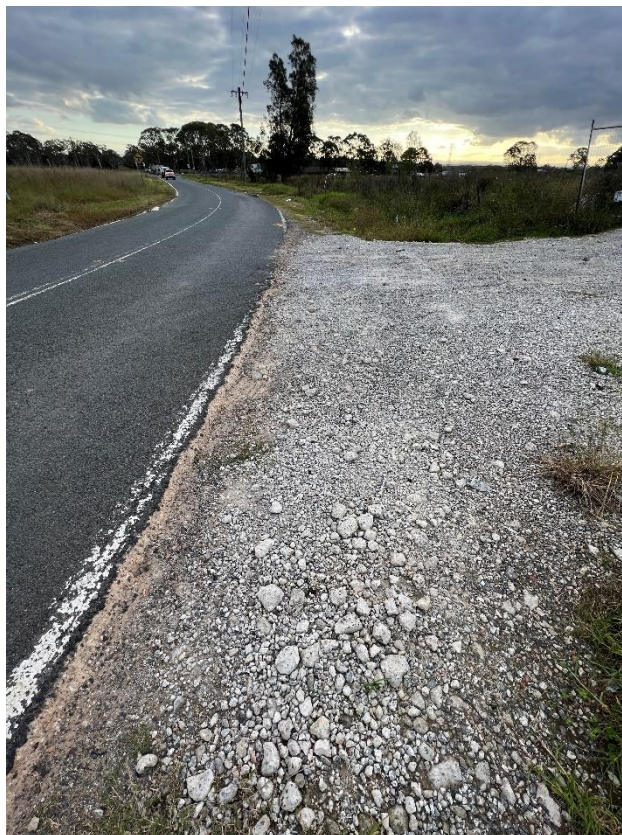
Figure 93 – General condition of the driveway.

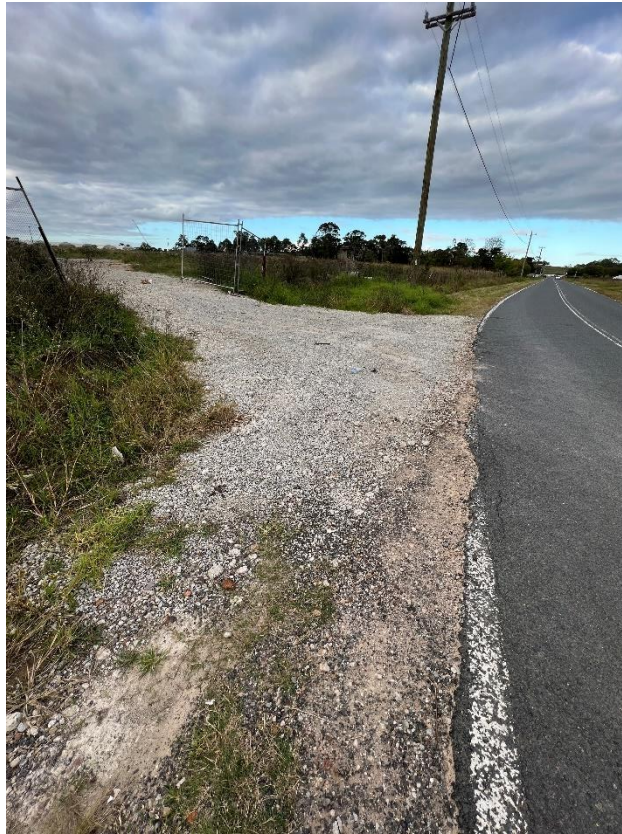
Figure 94 – General condition of the driveway.

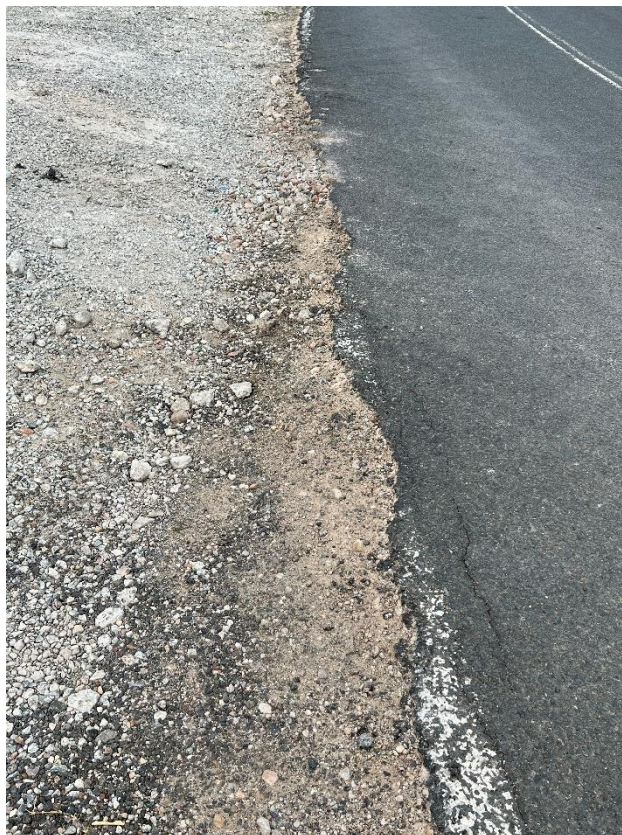
Figure 95 – General condition of the driveway.

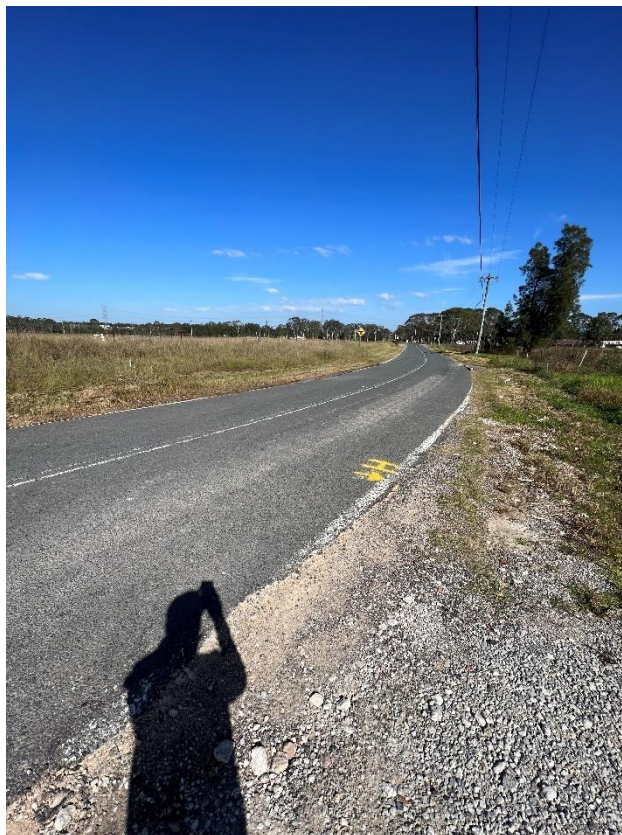
Figure 97 – General condition of the utility lid.

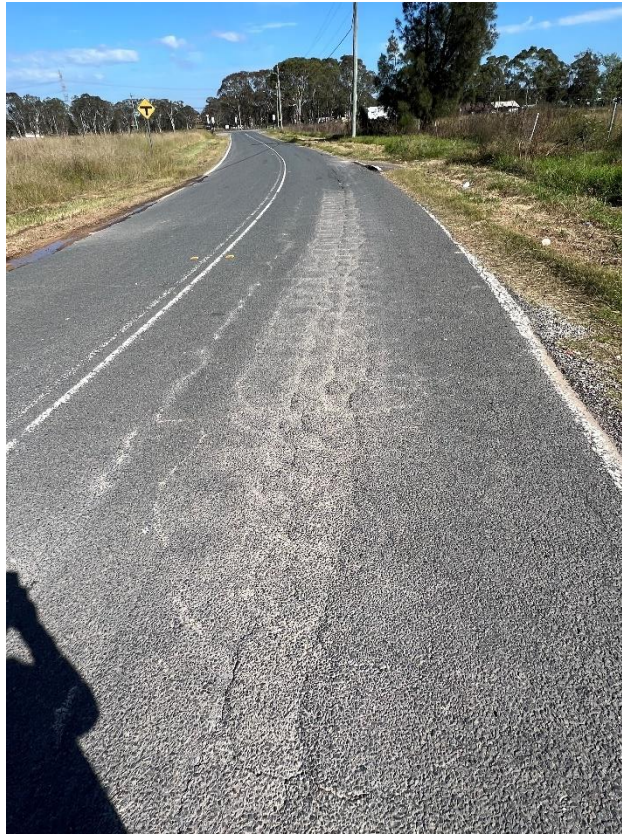
Figure 98 – General condition of the road.

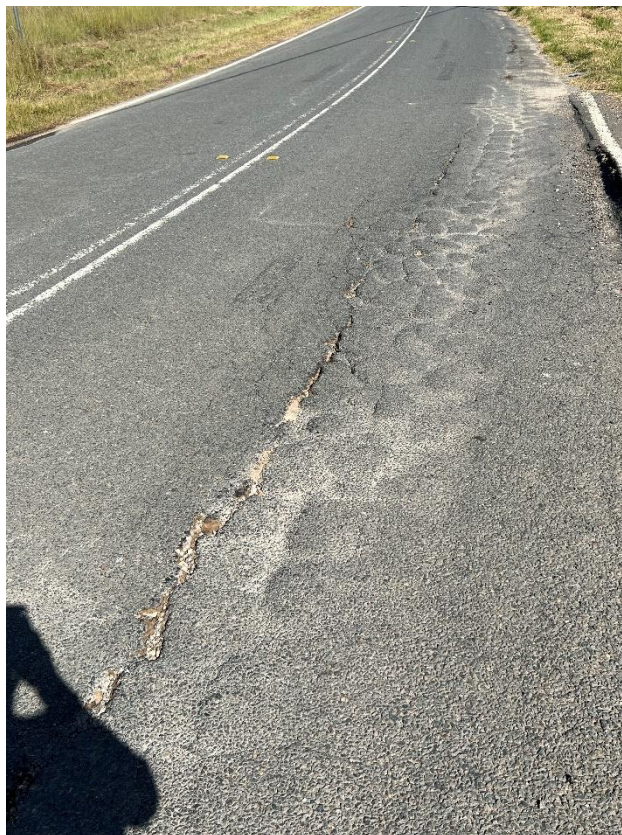
Figure 99 – Crack propagation to the road.

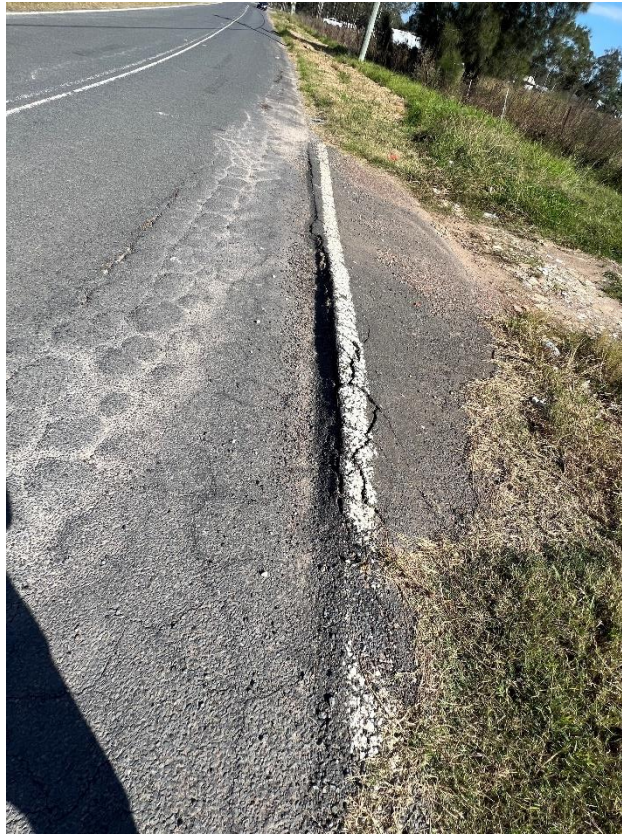
Figure 102 – Crack propagation to the driveway.

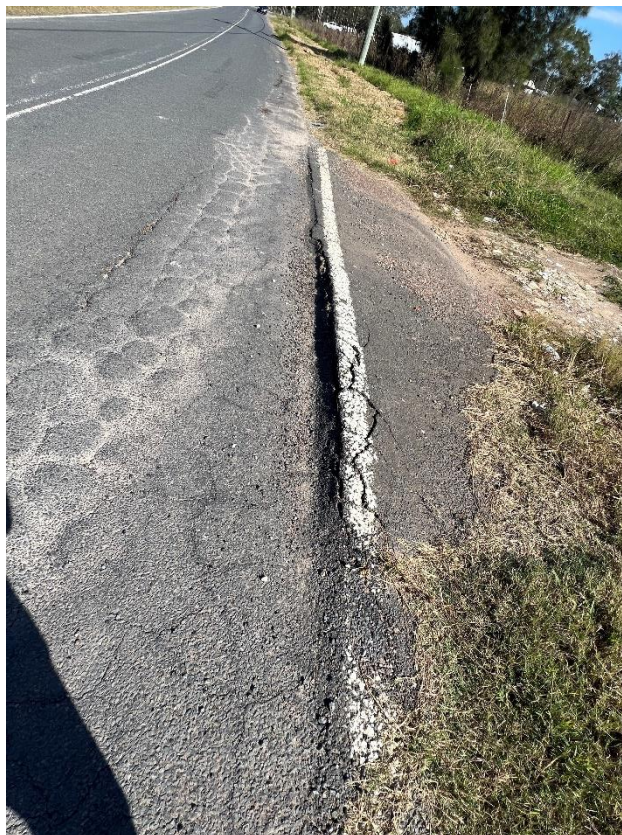
Figure 103 – Crack propagation to the road/driveway.

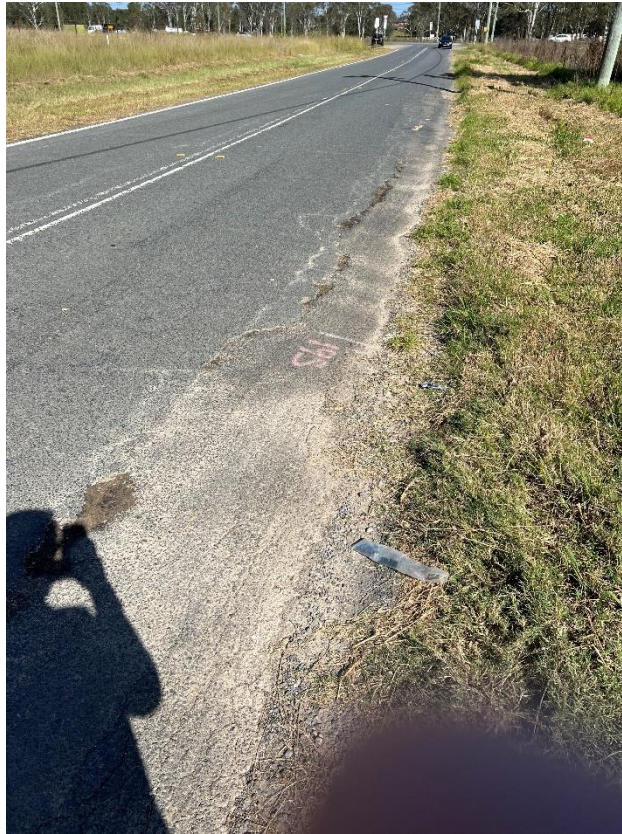
Figure 104 – Crack propagation to the road/driveway.

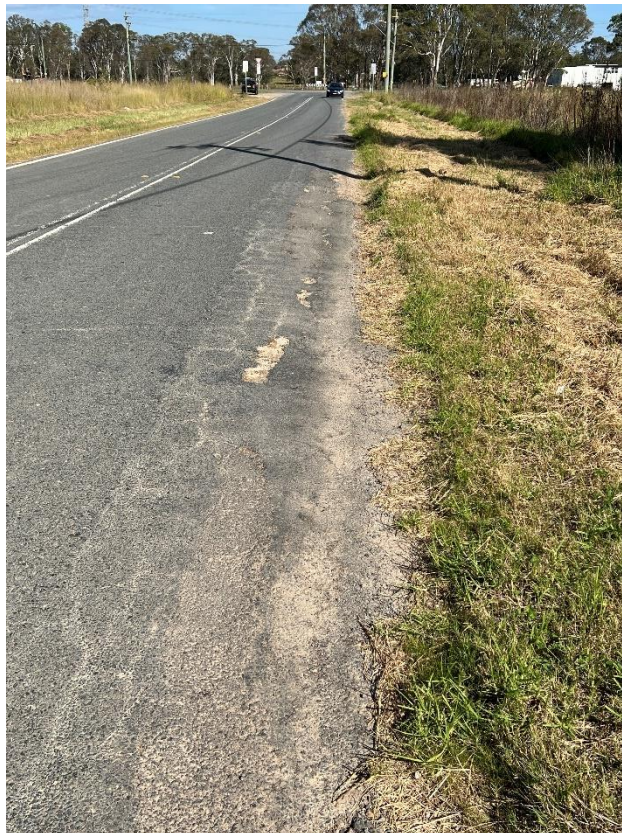
Figure 105 – Crack propagation to the road.

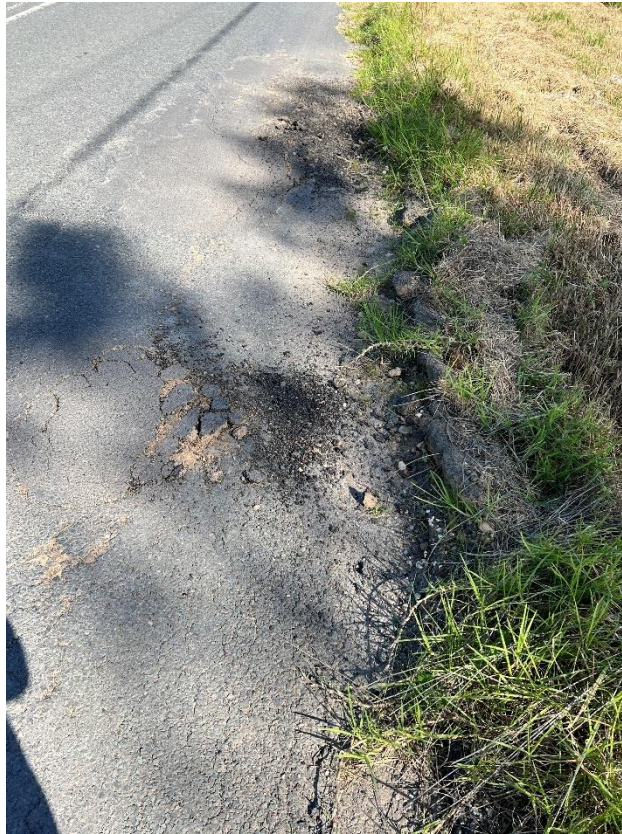
Figure 108 – Crack propagation to the road.

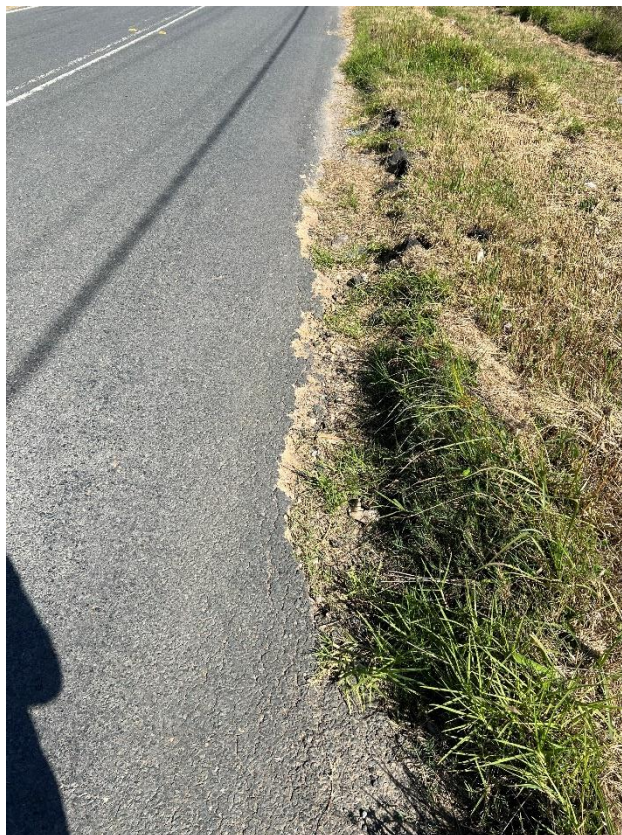
Figure 109 – Crack propagation to the road.

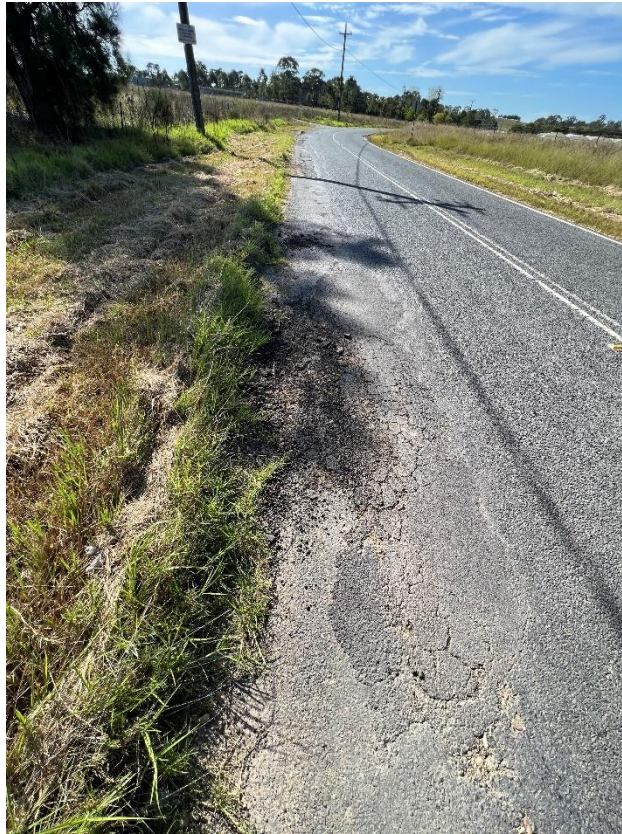
Figure 110 – Crack propagation to the road.
