DILAPIDATION REPORT

Abbotts Road, Kemps Creek

Prepared by: Rezoning Pty Ltd t/as Effective Building & Consultancy

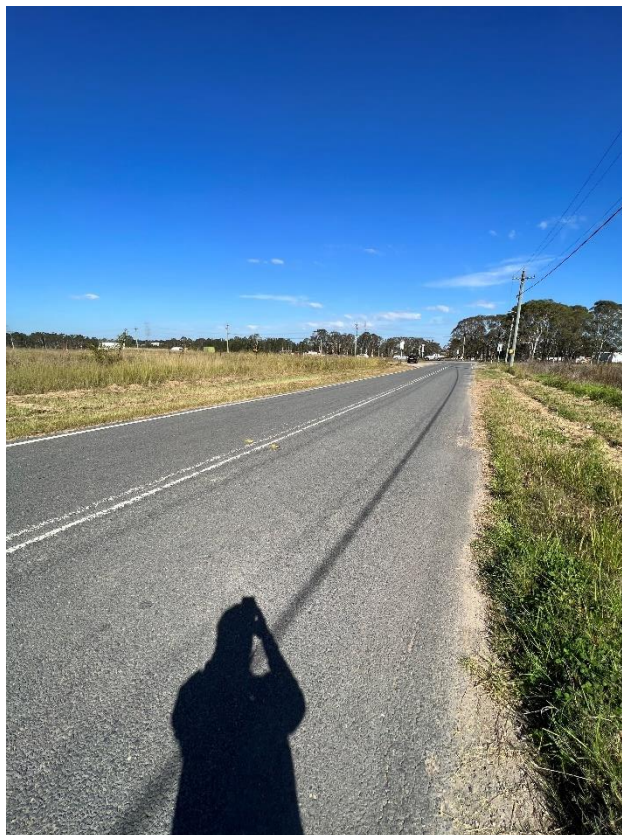
Figure 111 – Crack propagation to the road.

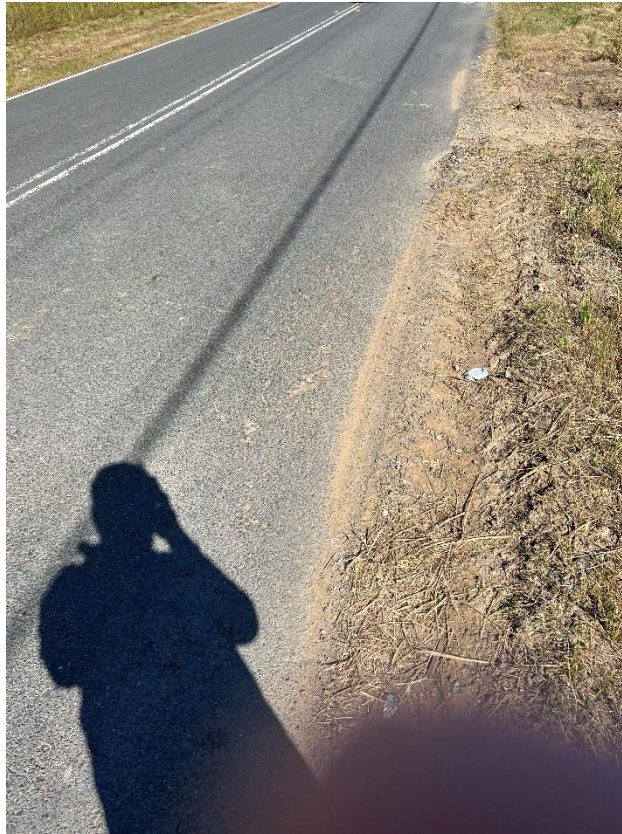
Figure 112 – Crack propagation to the road.

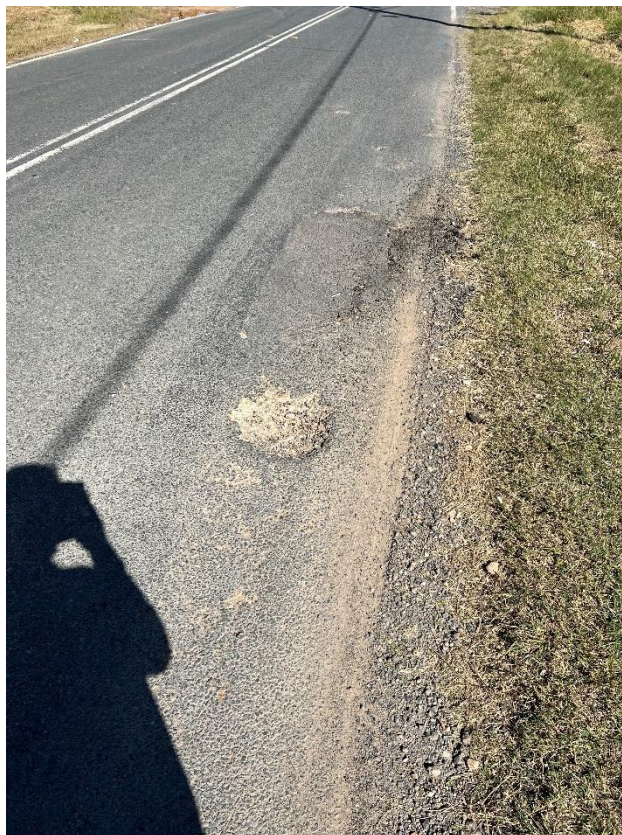
Figure 113 – Crack propagation to the road.

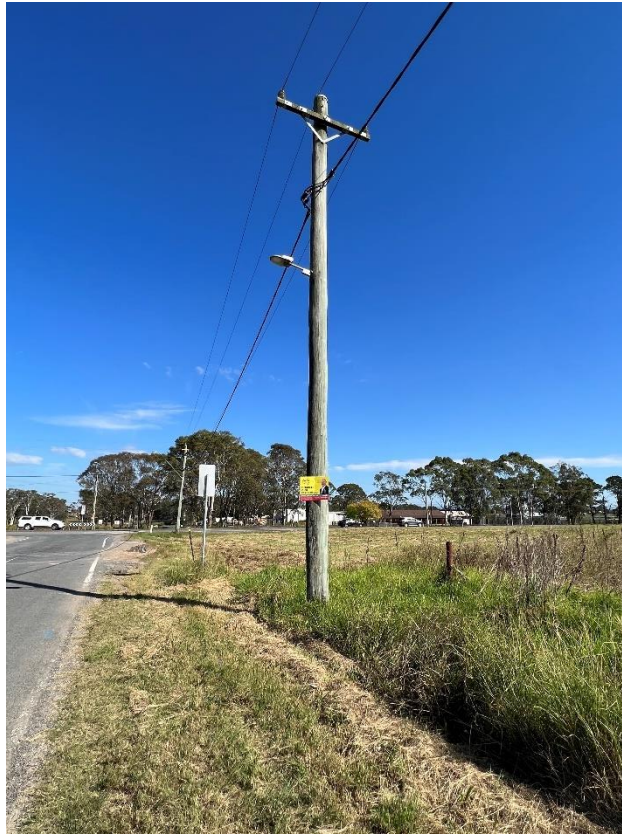
Figure 114 – Crack propagation to the road.

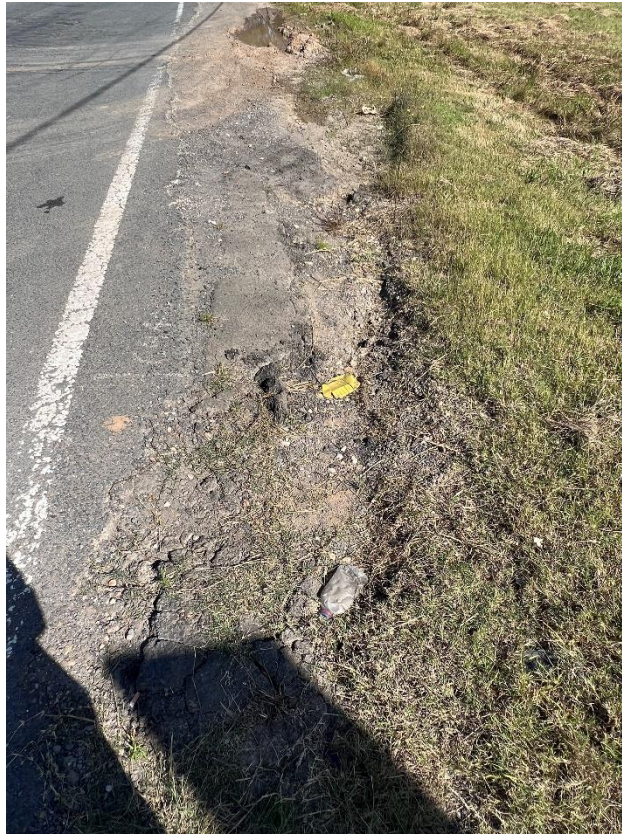
Figure 116 – General condition of the road.

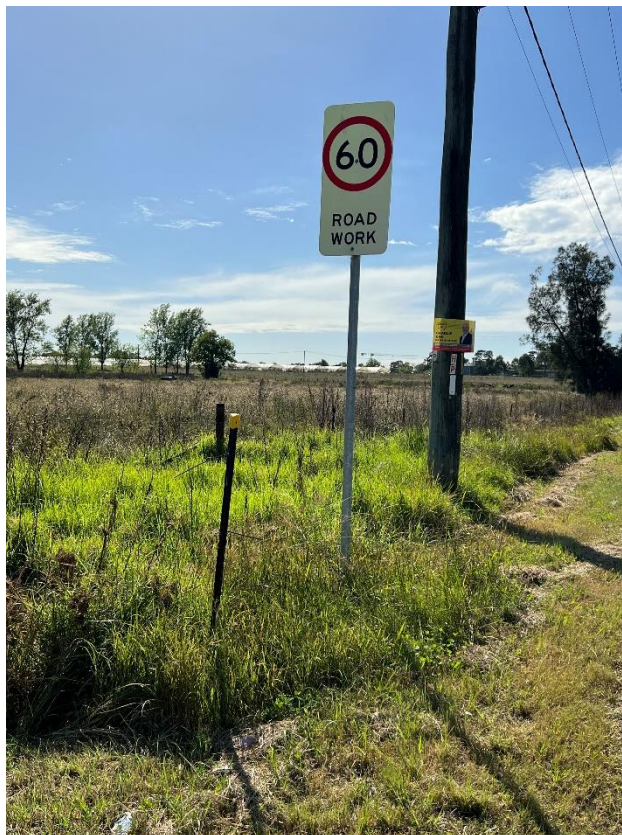
Figure 117 – Crack propagation to the road.

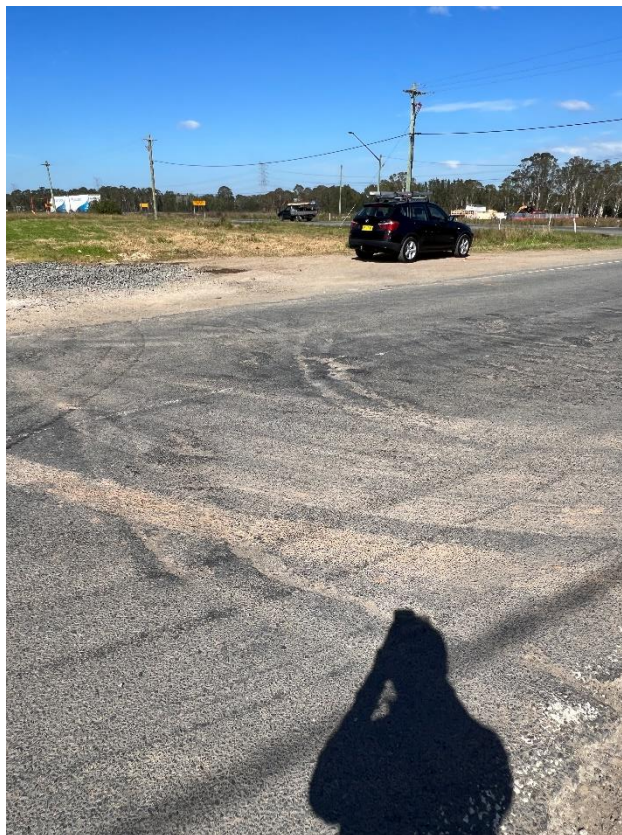
Figure 119 – General condition of the road.

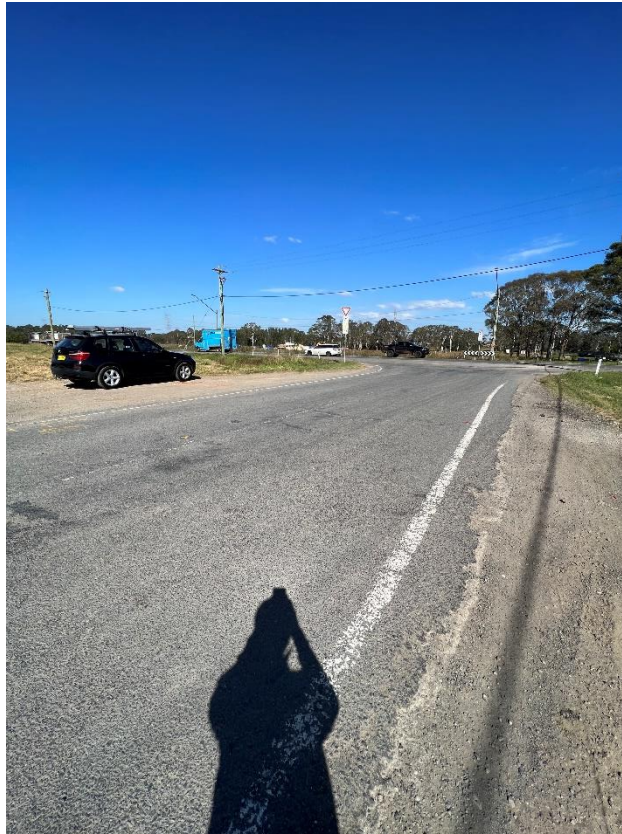
Figure 120 – Crack propagation to the road.

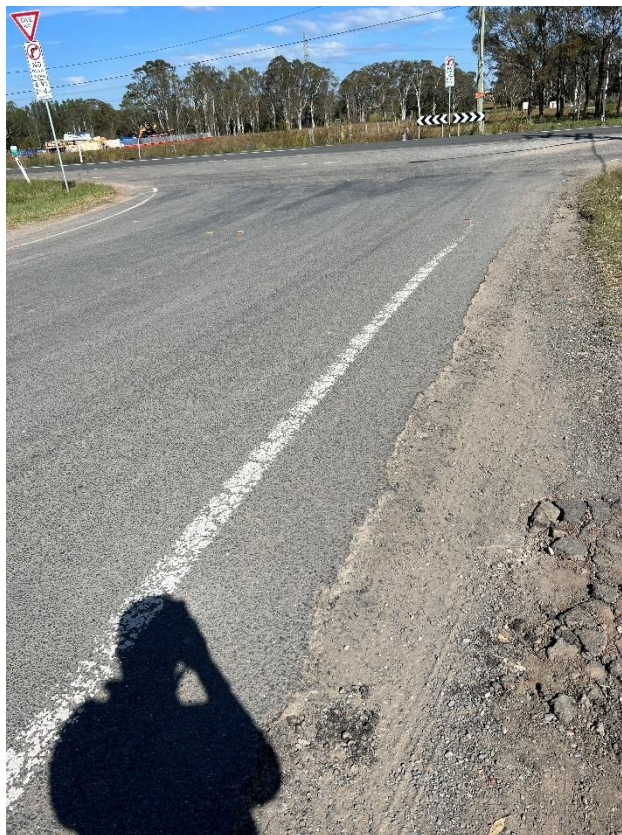
Figure 121 – General condition of the road.

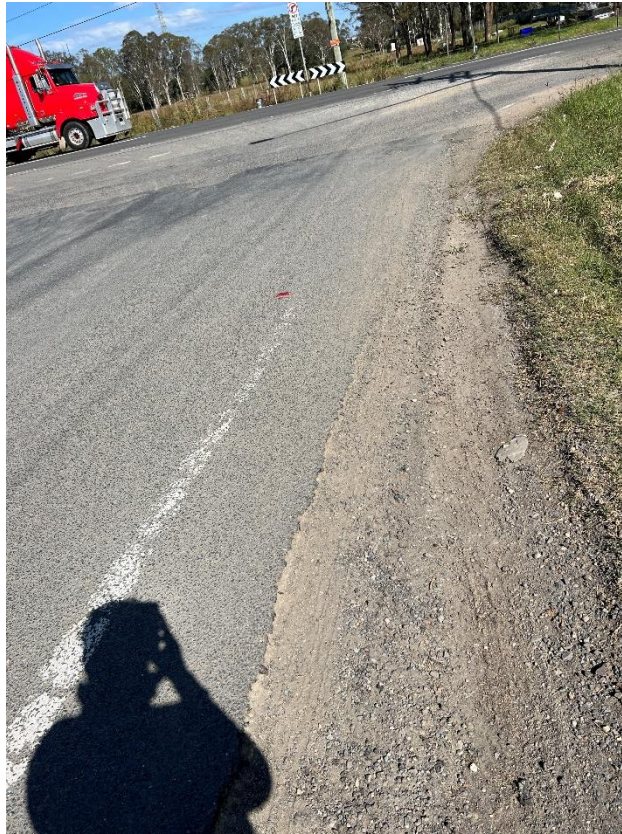
Figure 122 – General condition of the road.

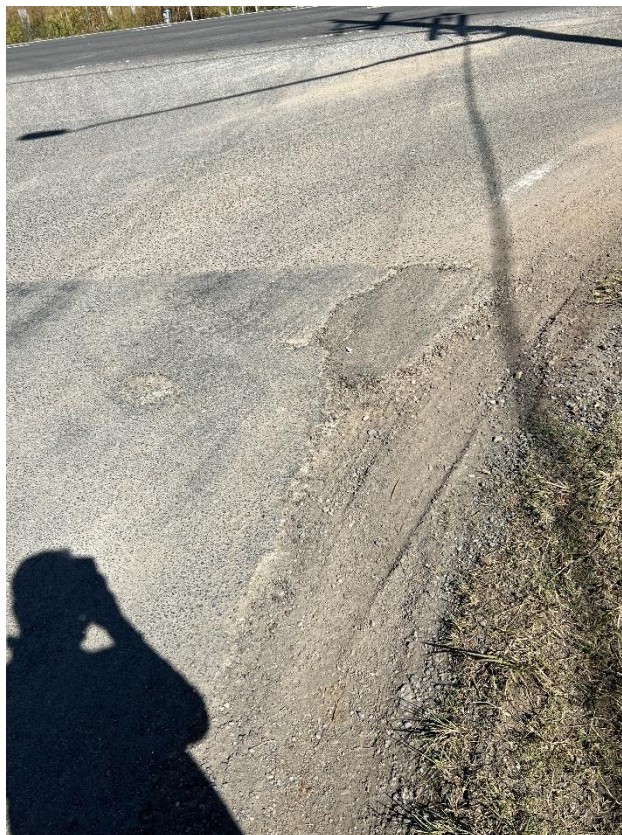
Figure 123 – General condition of the road.

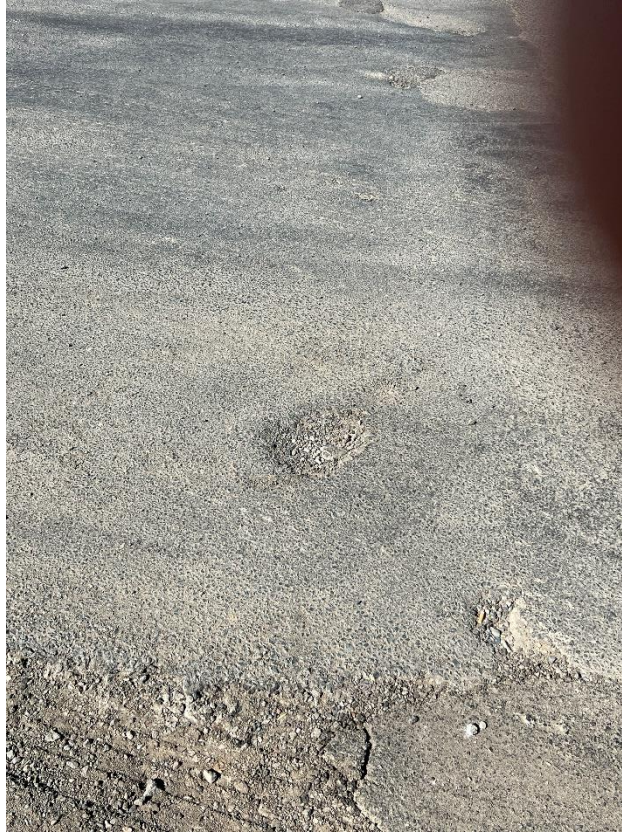
Figure 126 – Crack propagation to the road.

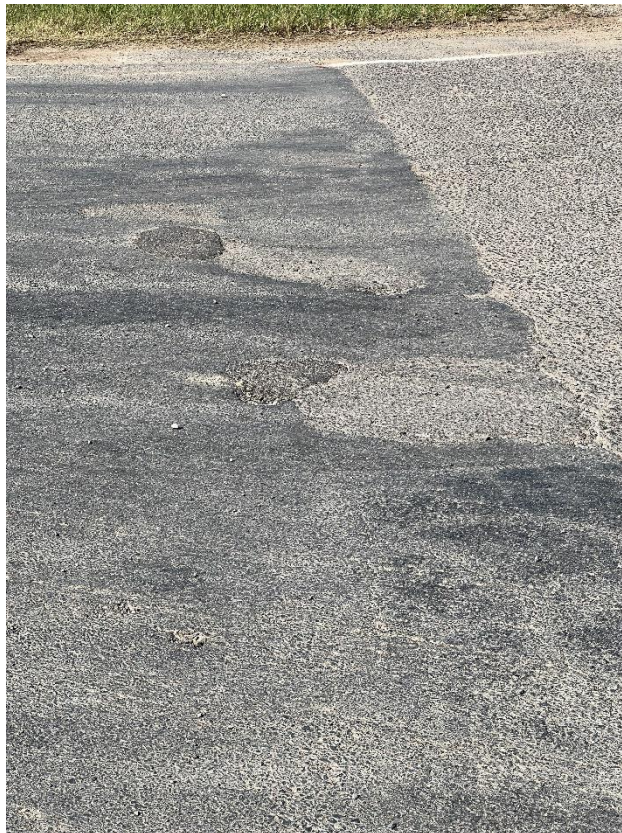
Figure 127 – Crack propagation to the road.

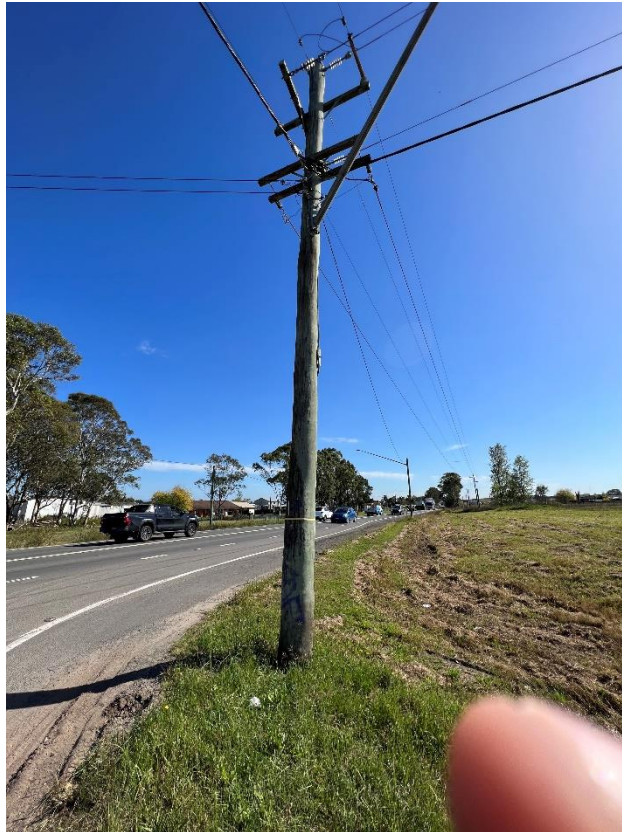
Figure 128 – Crack propagation to the road.

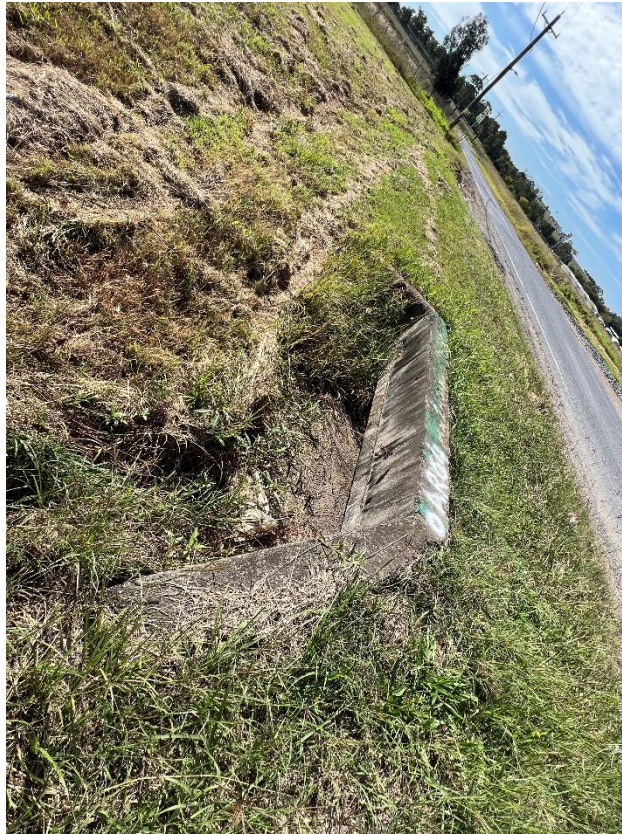
Figure 130 – General condition of the nature strip/drain.

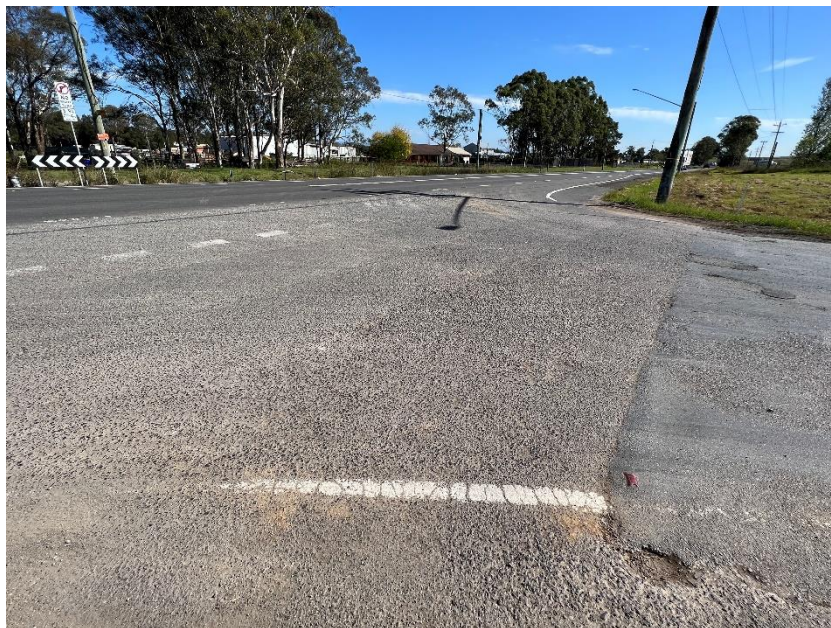
Figure 131 – General condition of the drain.

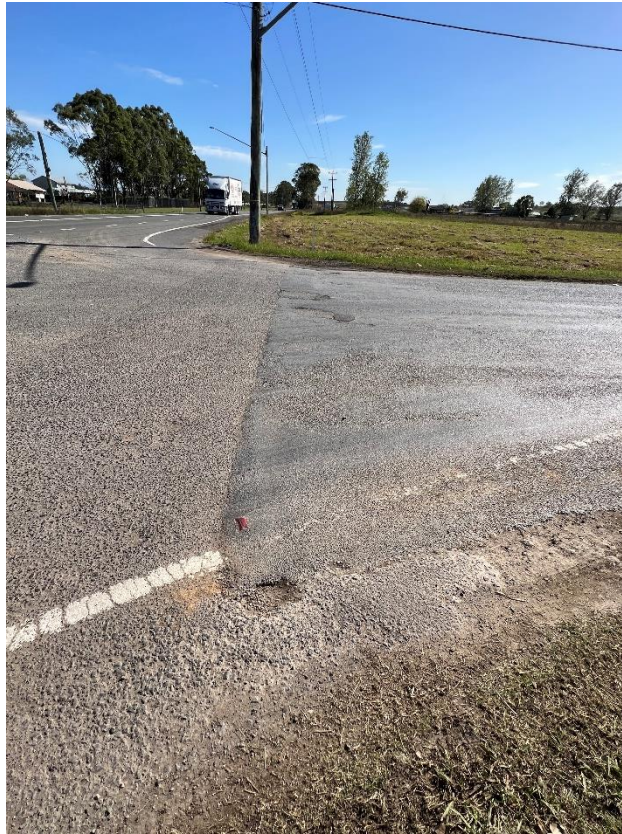
Figure 132 – Crack propagation to the road.

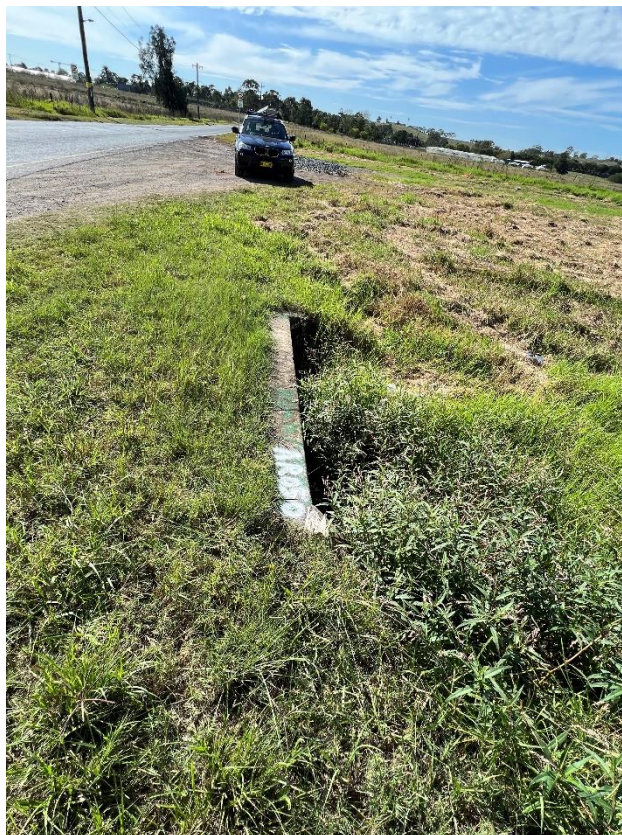
Figure 133 – Crack propagation to the road.

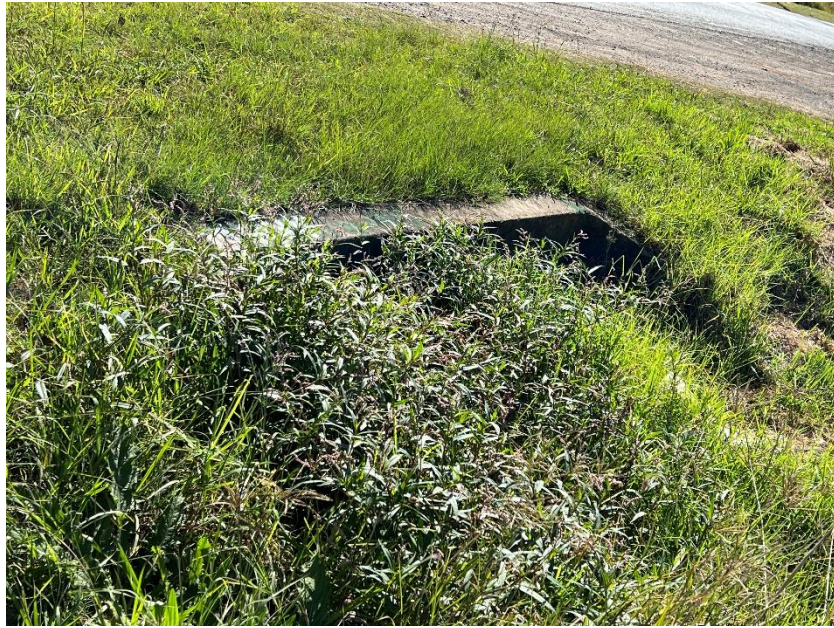
Figure 134 – General condition of the nature strip/drain.

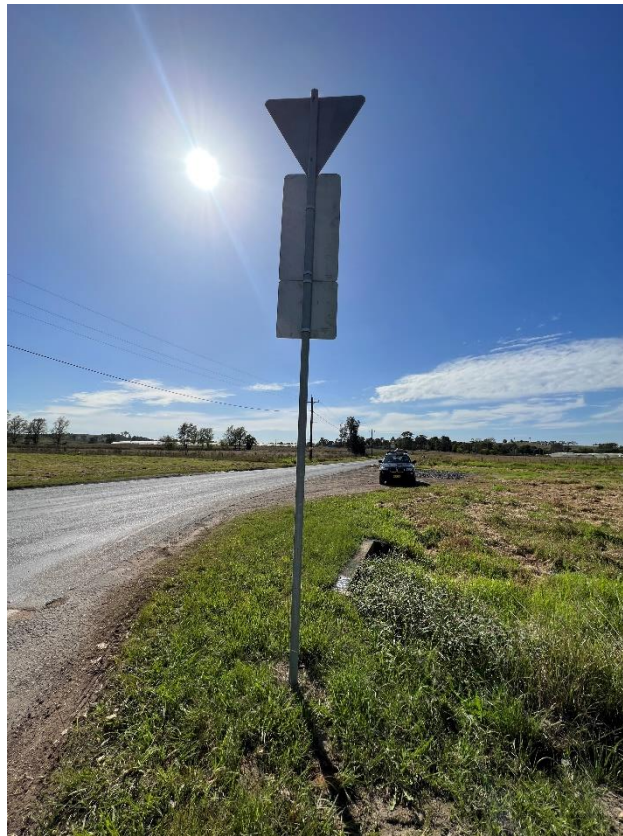
Figure 135 – General condition of the nature strip/drain.

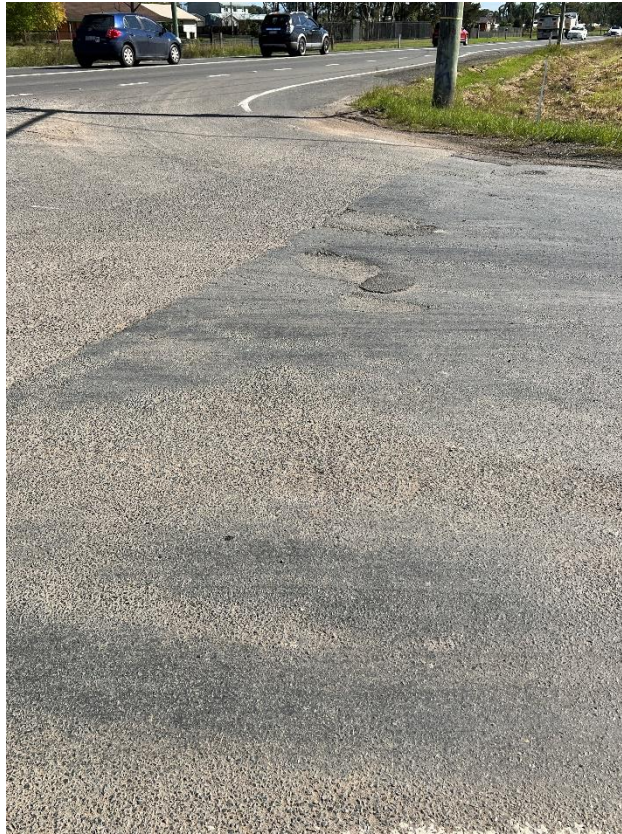
Figure 137 – Crack propagation to the road.

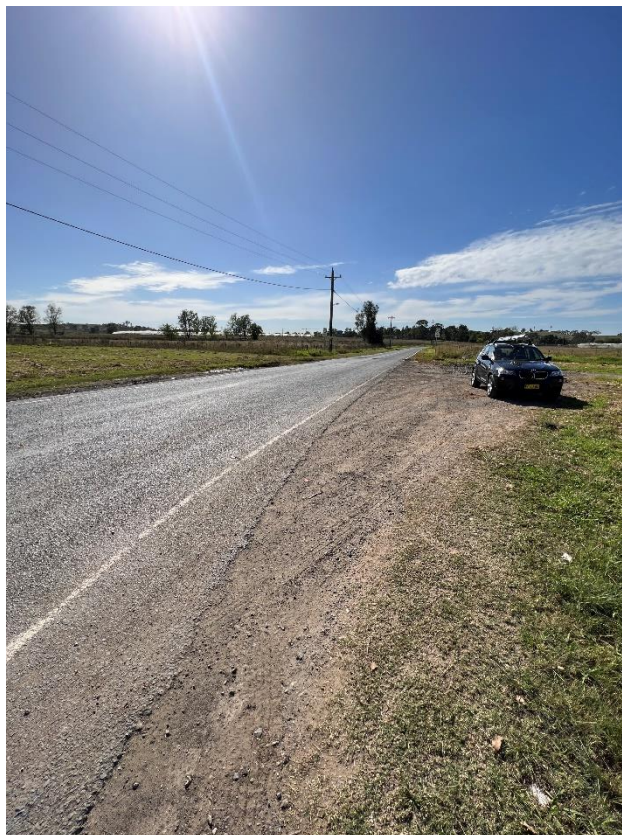
Figure 138 – General condition of the driveway.

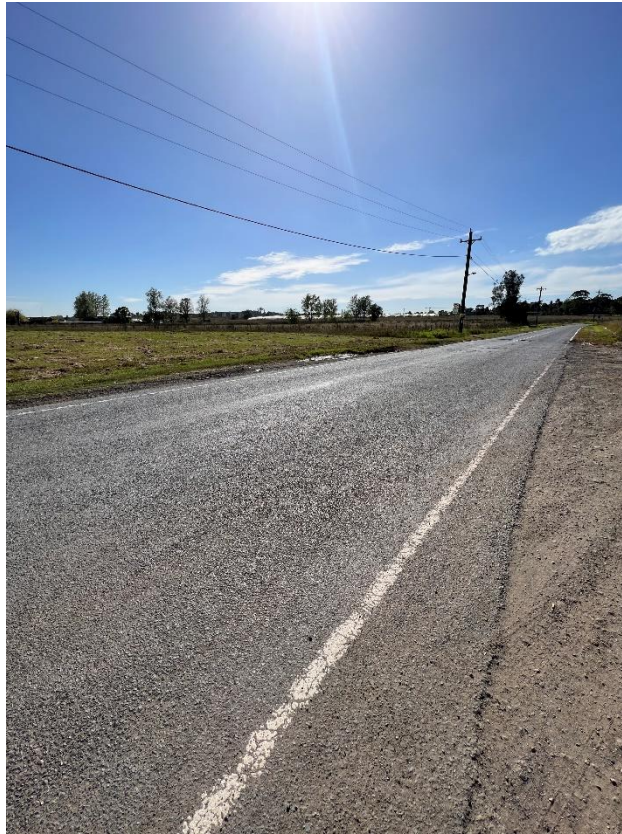
Figure 139 – General condition of the road.

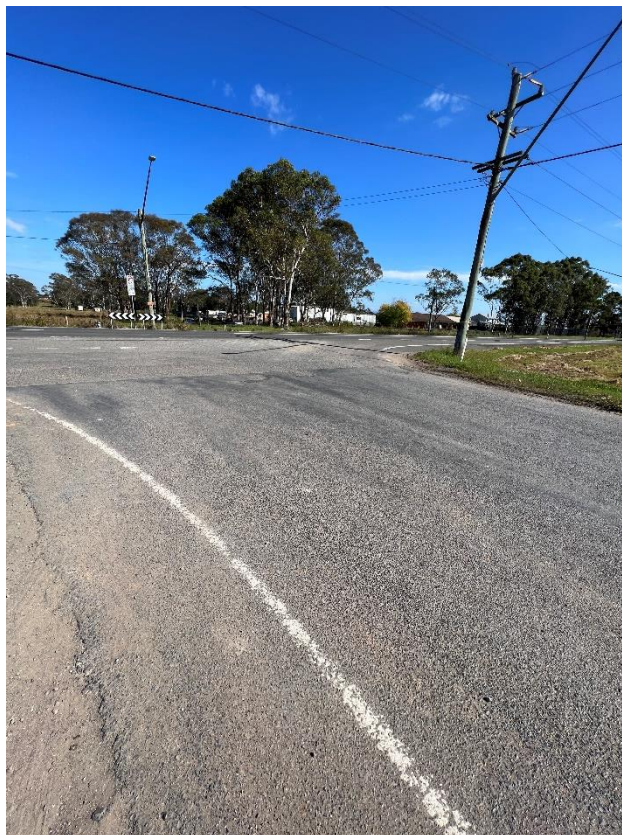
Figure 140 – General condition of the road.

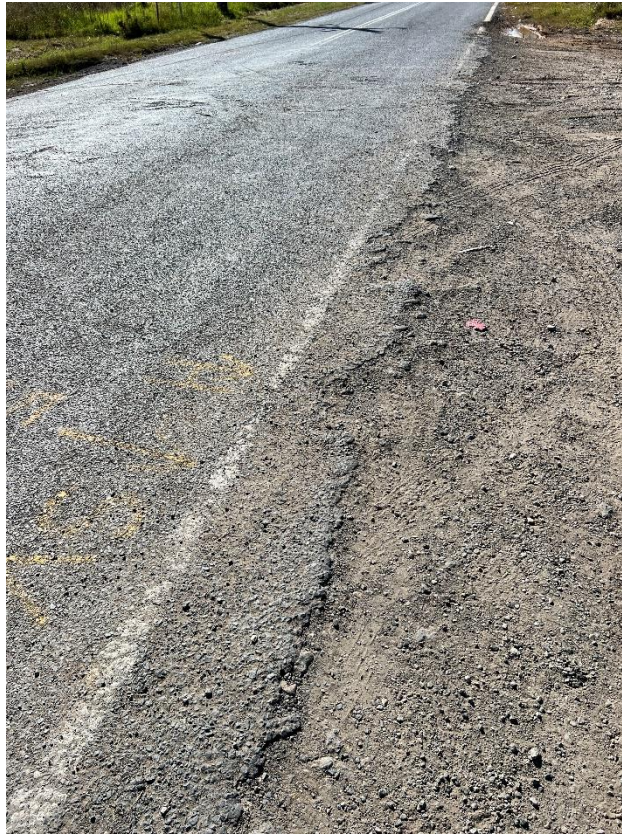
Figure 141 – Crack propagation to the road.

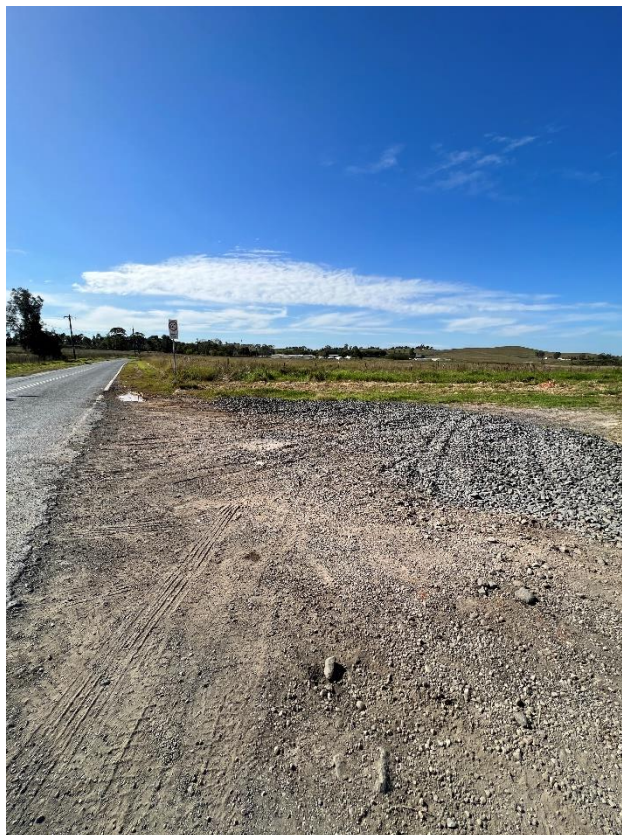
Figure 142 – General condition of the driveway.

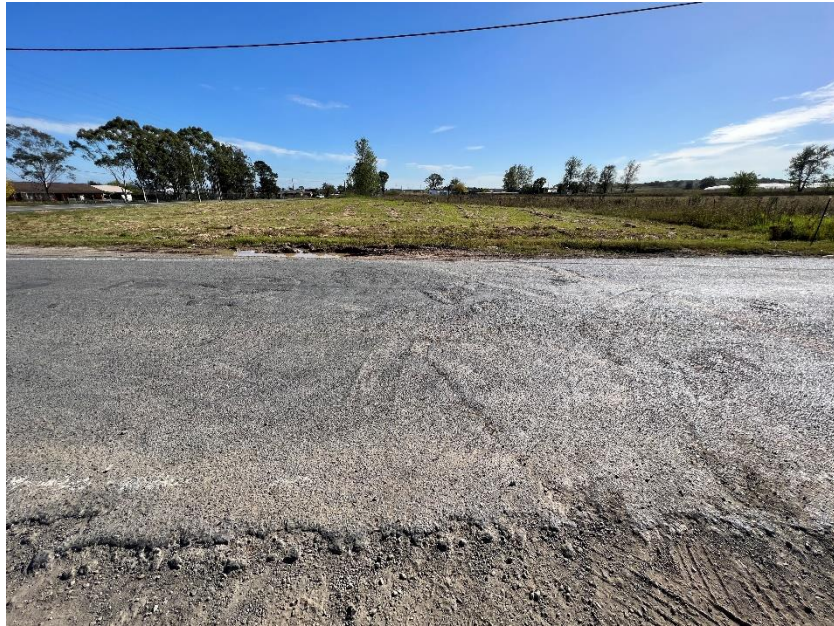
Figure 143 – Crack propagation to the road.

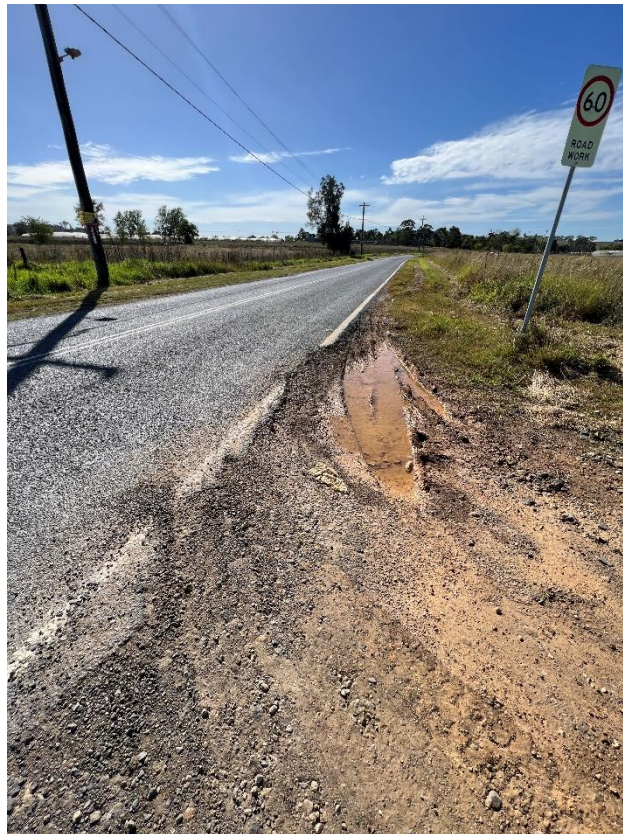
Figure 144 – Crack propagation to the road.

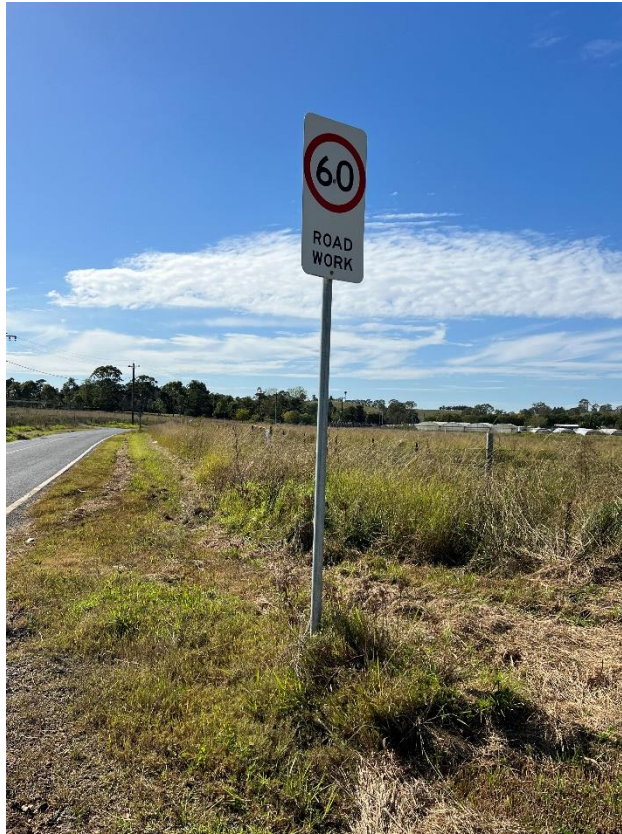
Figure 145 – General condition of the street signpost.

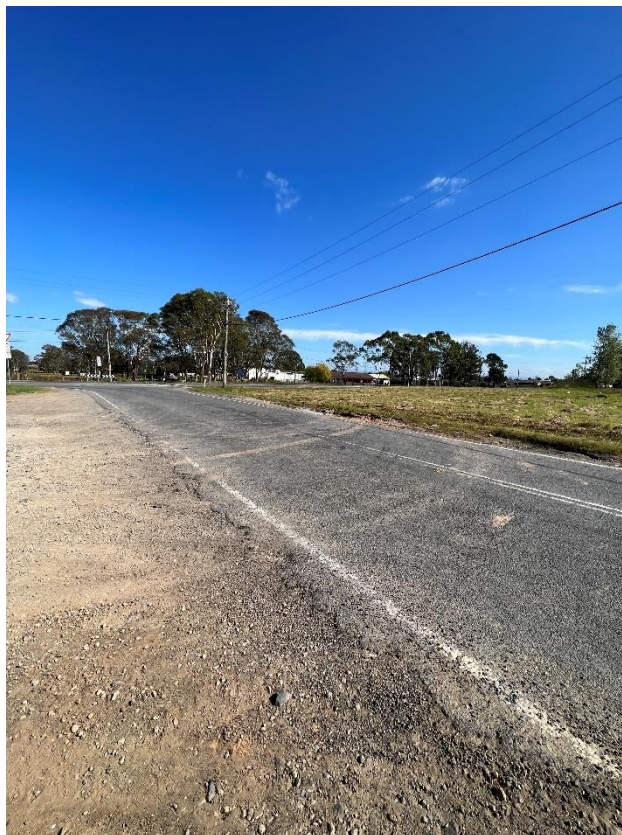
Figure 146 – Crack propagation to the road.

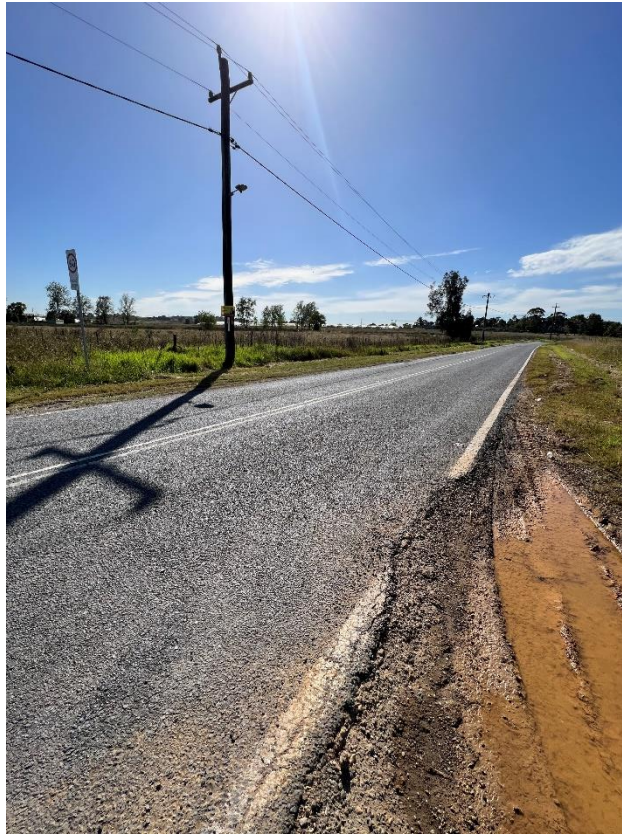
Figure 147 – Crack propagation to the road.

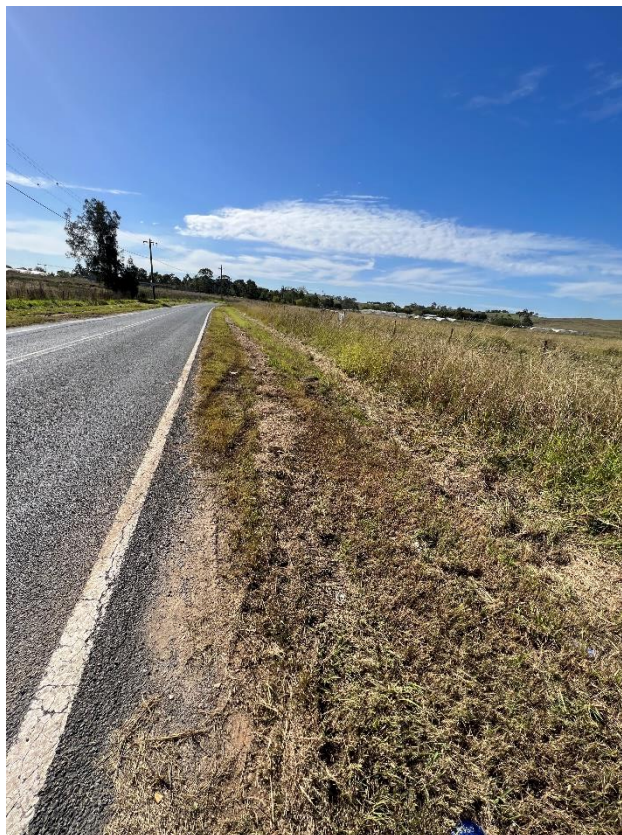
Figure 148 – General condition of the nature strip.

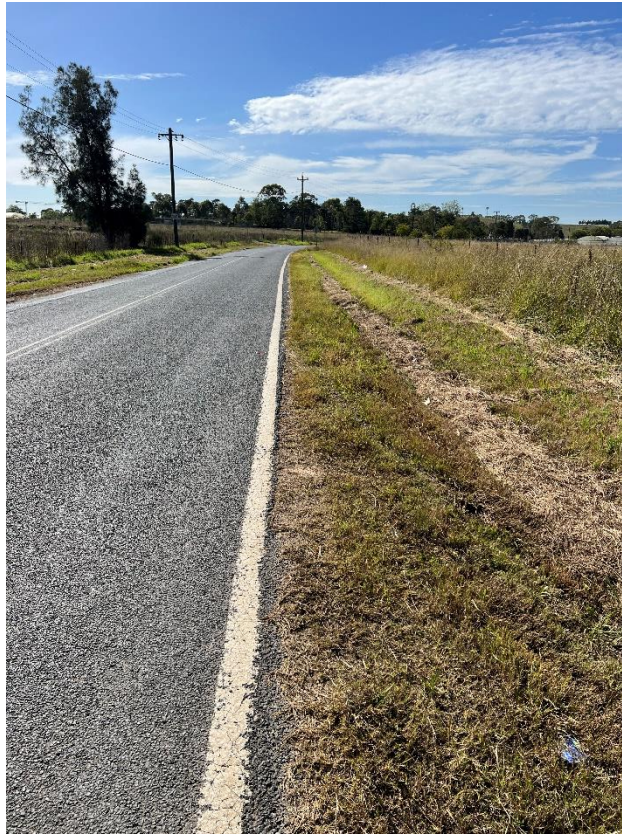
Figure 149 – General condition of the nature strip.

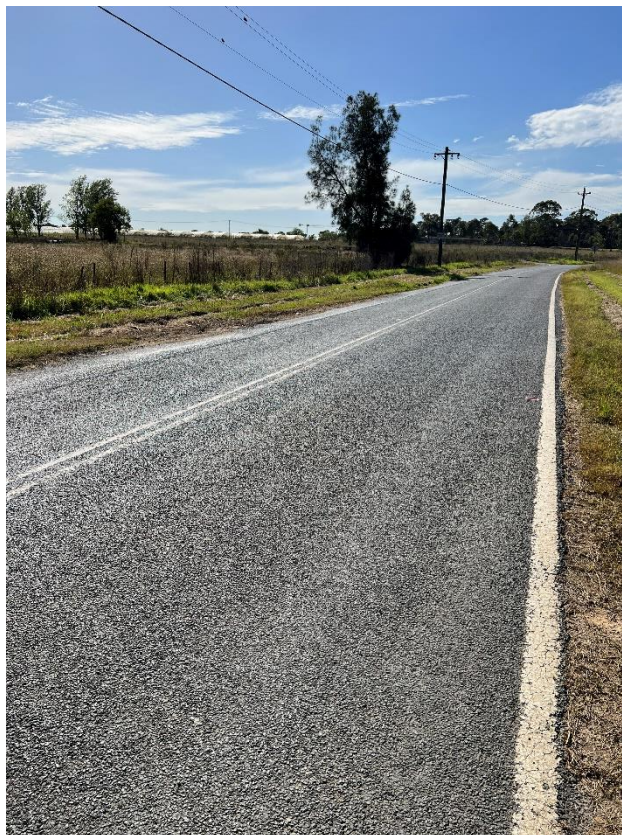
Figure 150 – General condition of the road.

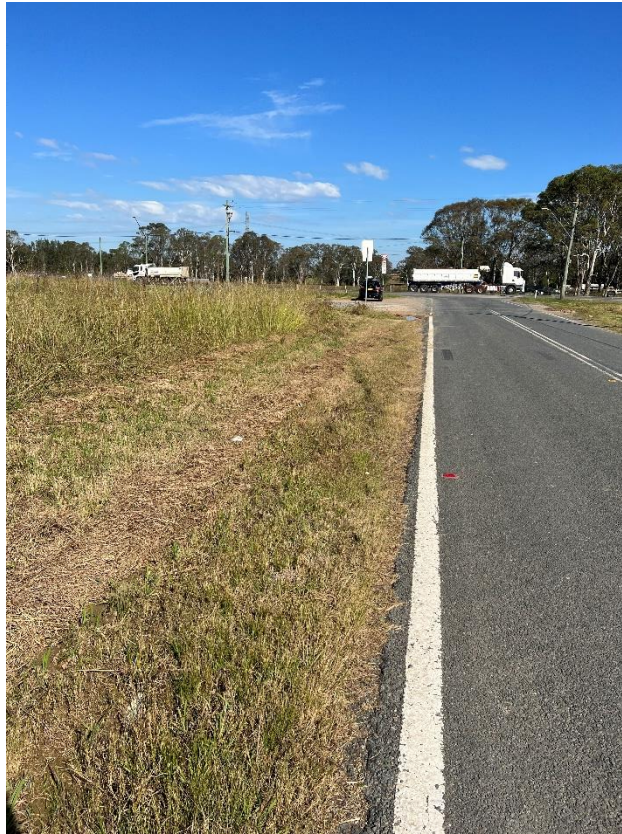
Figure 151 – General condition of the nature strip.

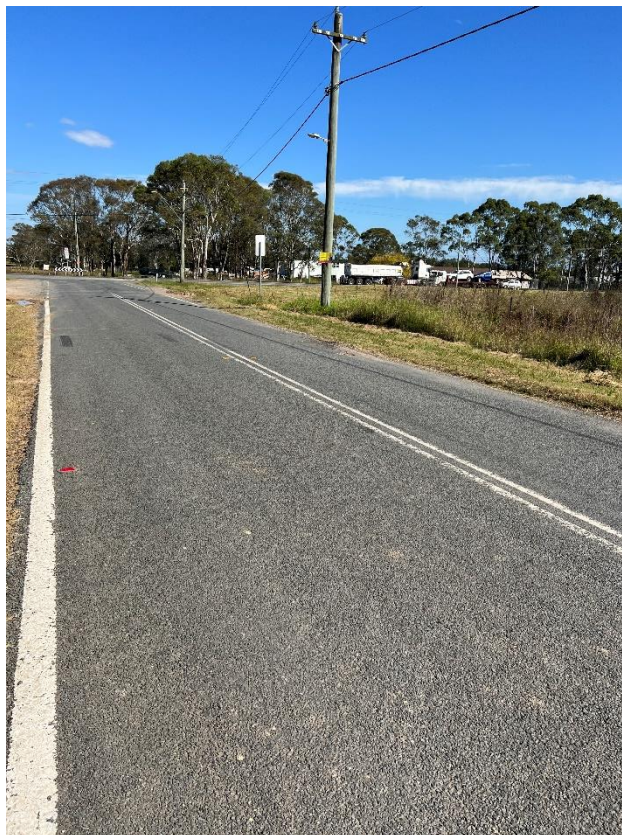
Figure 152 – General condition of the road.

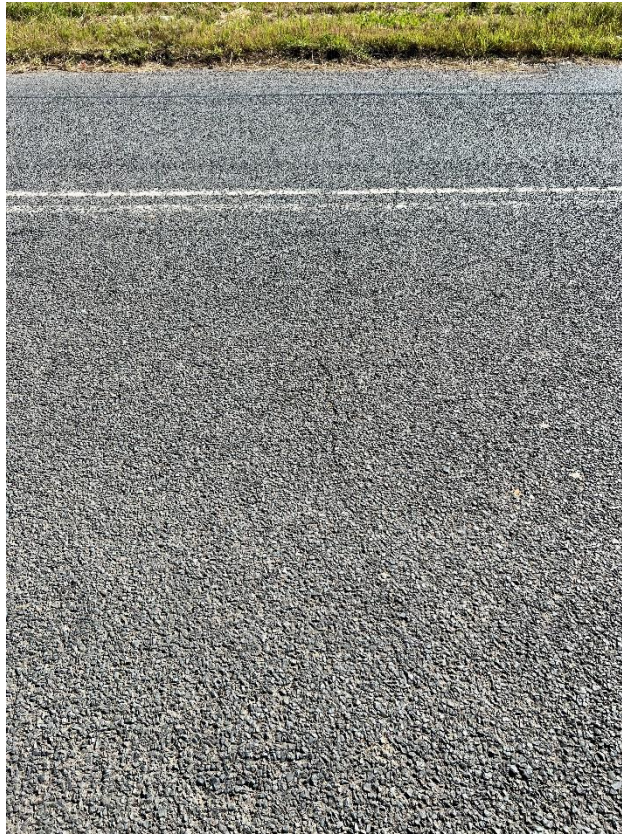
Figure 153 – Crack propagation to the road.

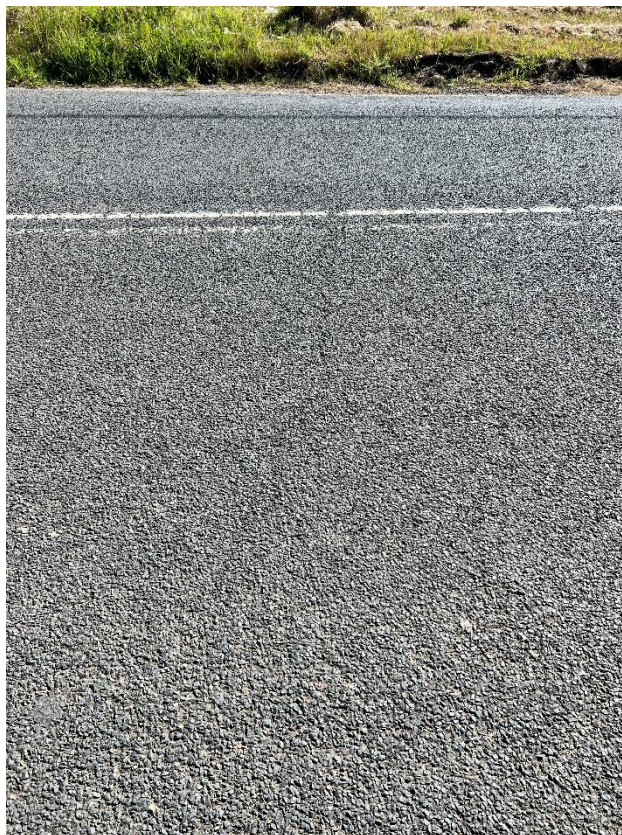
Figure 154 – Crack propagation to the road.

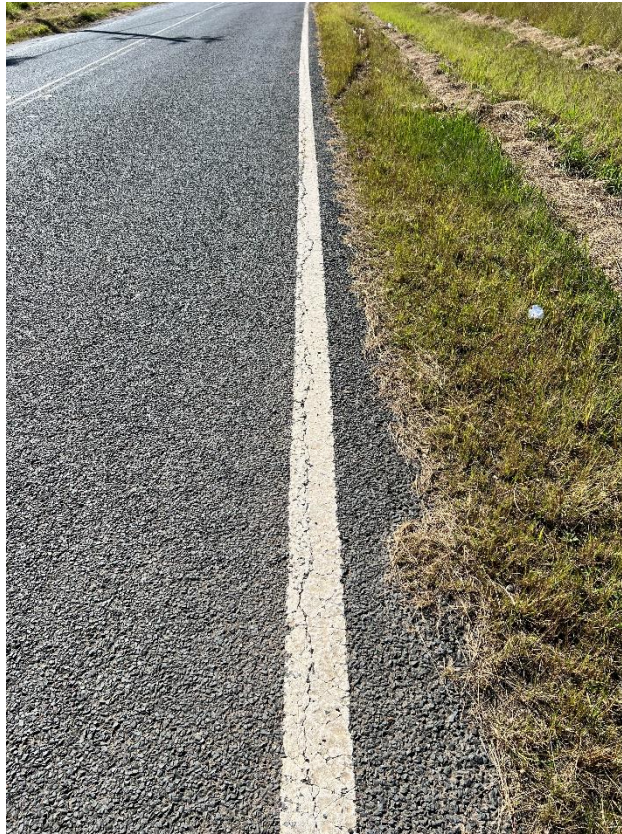
Figure 155 – Crack propagation to the road.

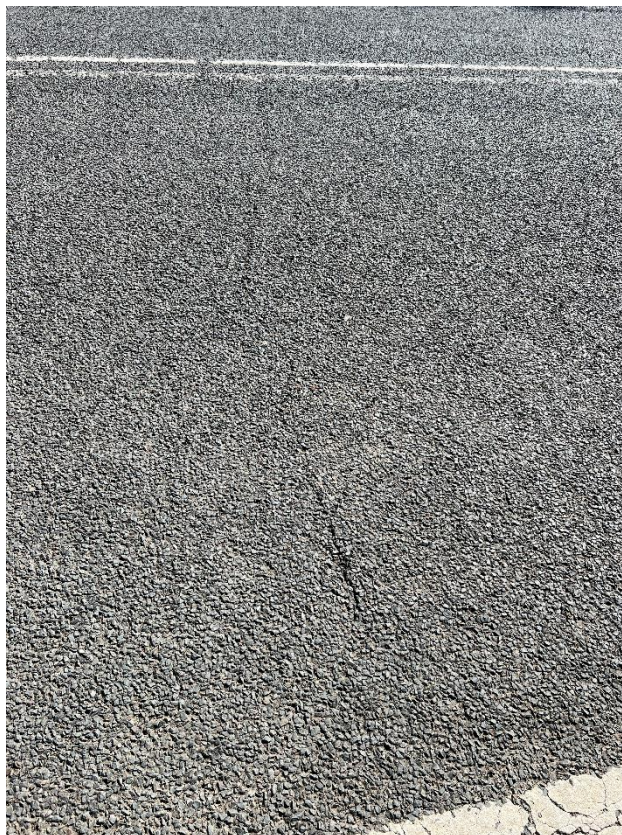
Figure 156 – Crack propagation to the road.

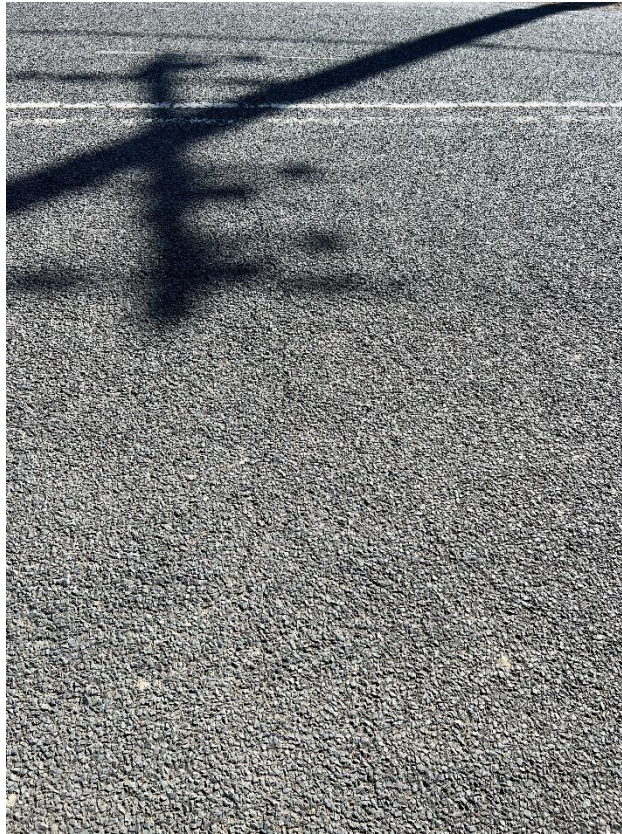
Figure 157 – Crack propagation to the road.

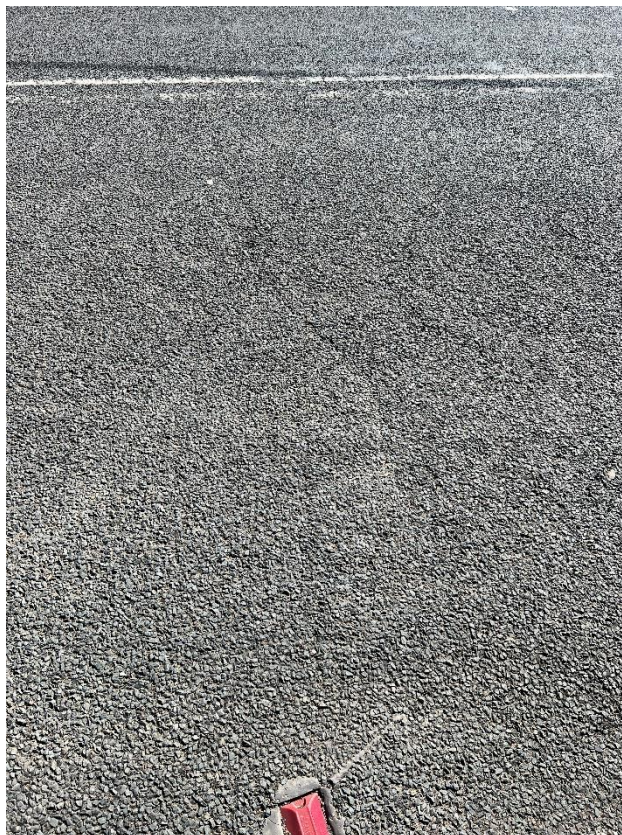
Figure 158 – Crack propagation to the road.

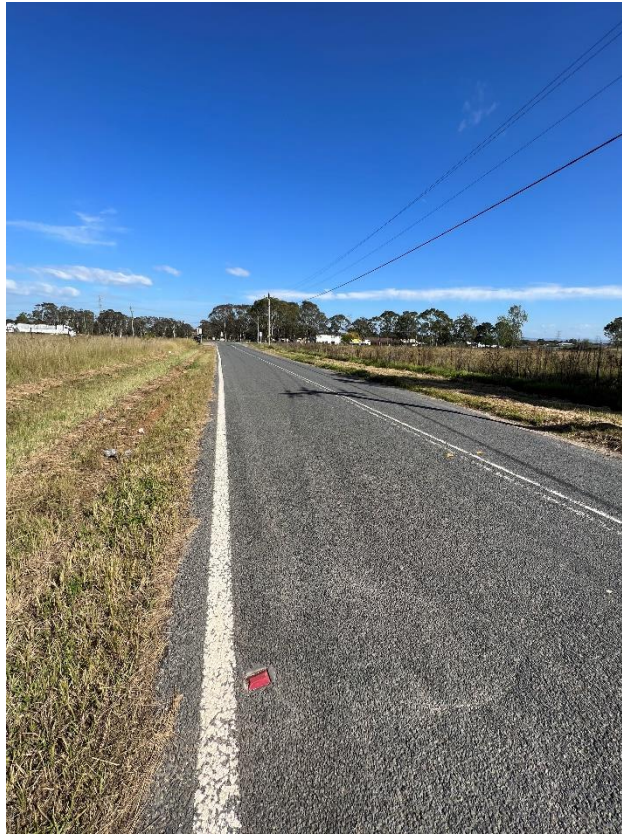
Figure 159 – Crack propagation to the road.
