DILAPIDATION REPORT

Abbotts Road, Kemps Creek

Prepared by: Rezoning Pty Ltd t/as Effective Building & Consultancy

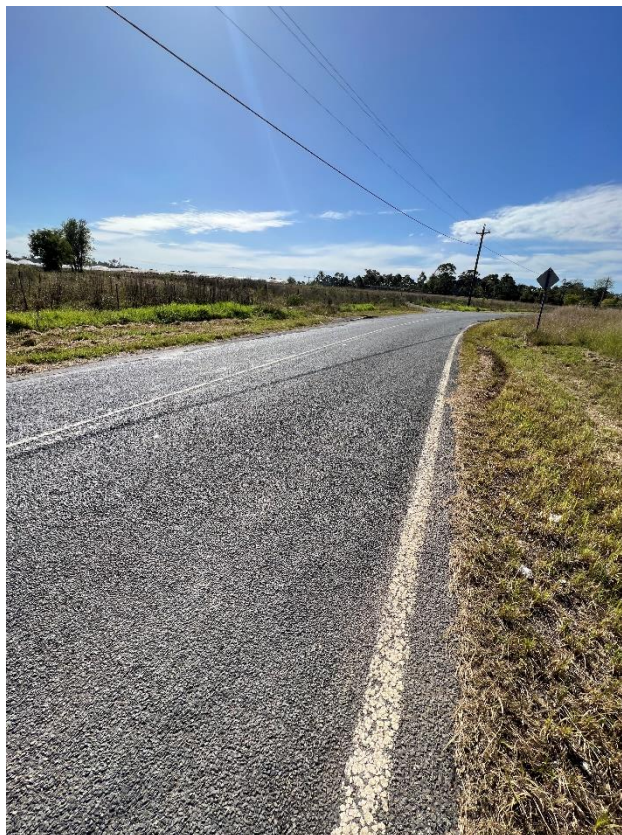
Figure 160 – General condition of the road.

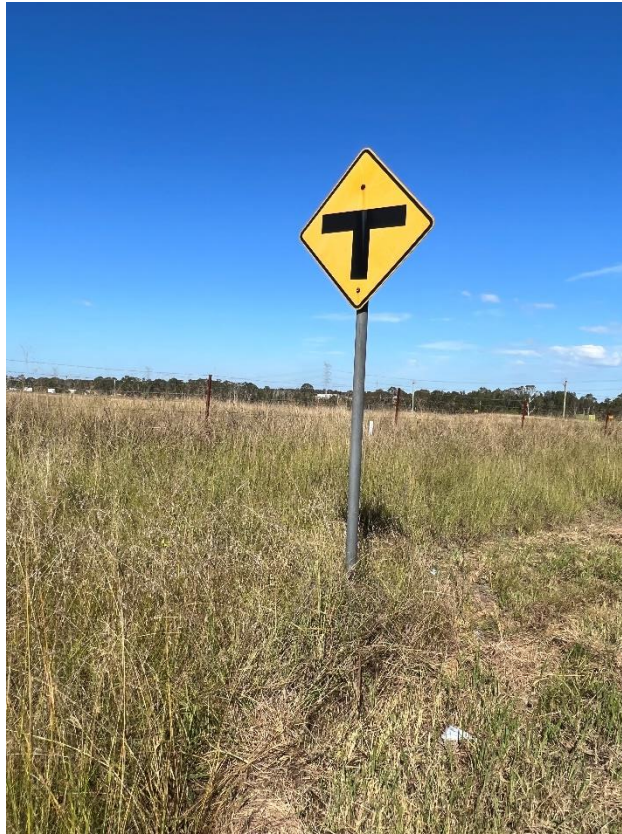
Figure 161 – General condition of the street signpost/nature strip.

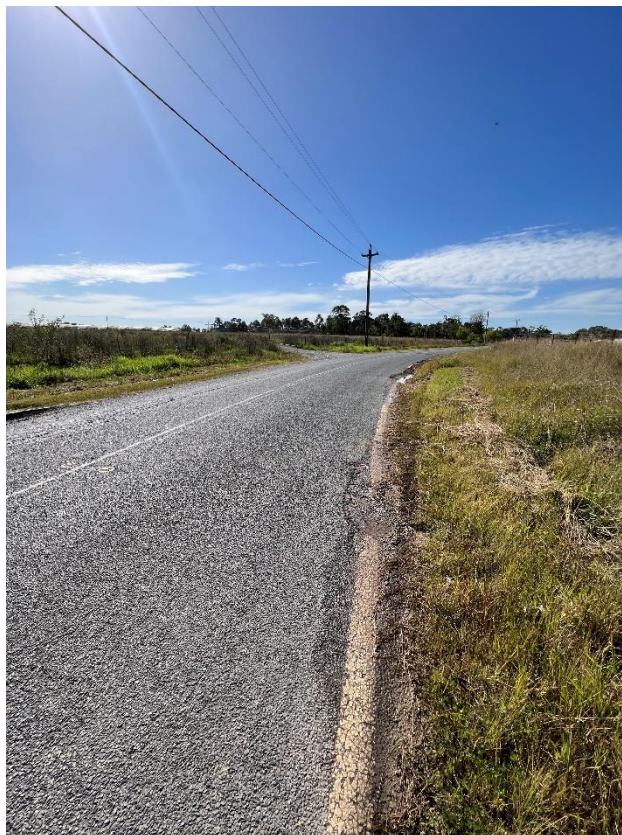
Figure 162 – Crack propagation to the road.

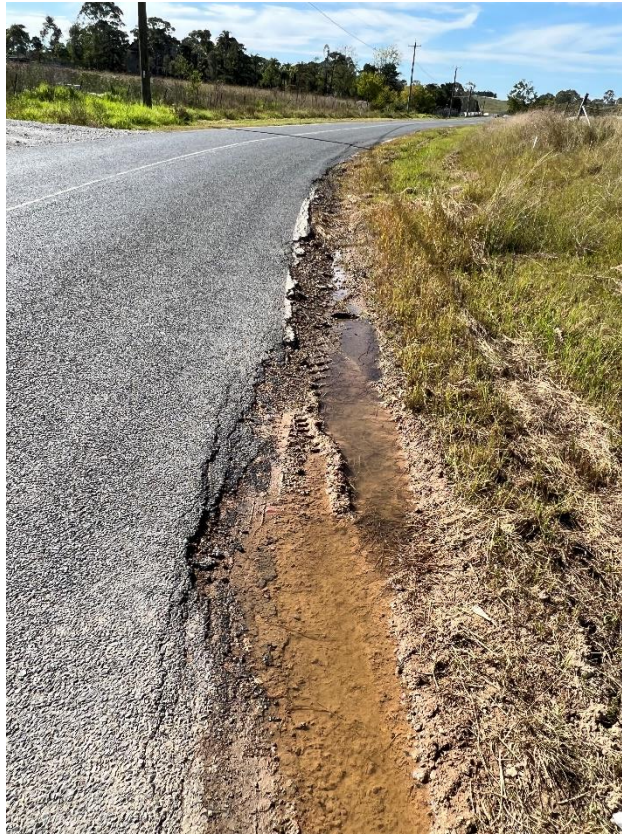
Figure 163 – Crack propagation to the road.

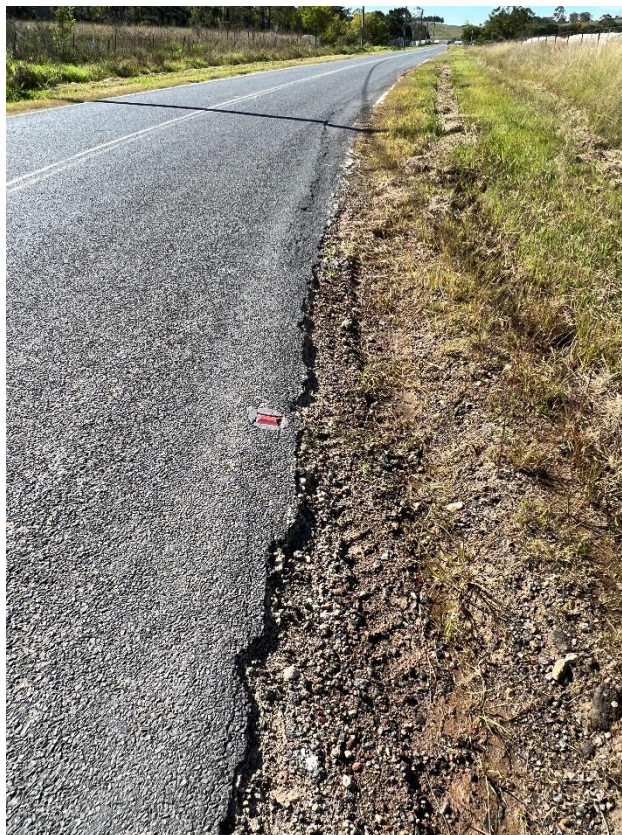
Figure 164 – Crack propagation to the road.

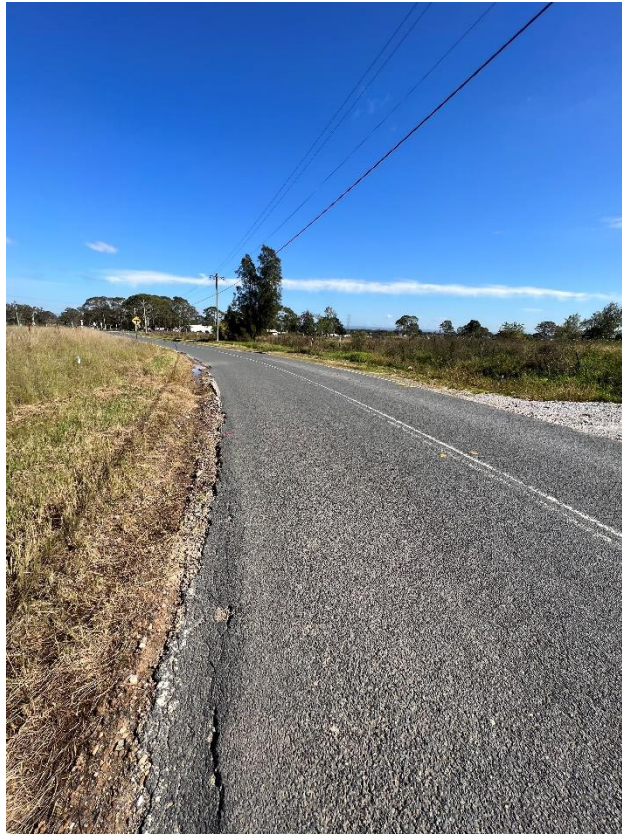
Figure 165 – Crack propagation to the road.

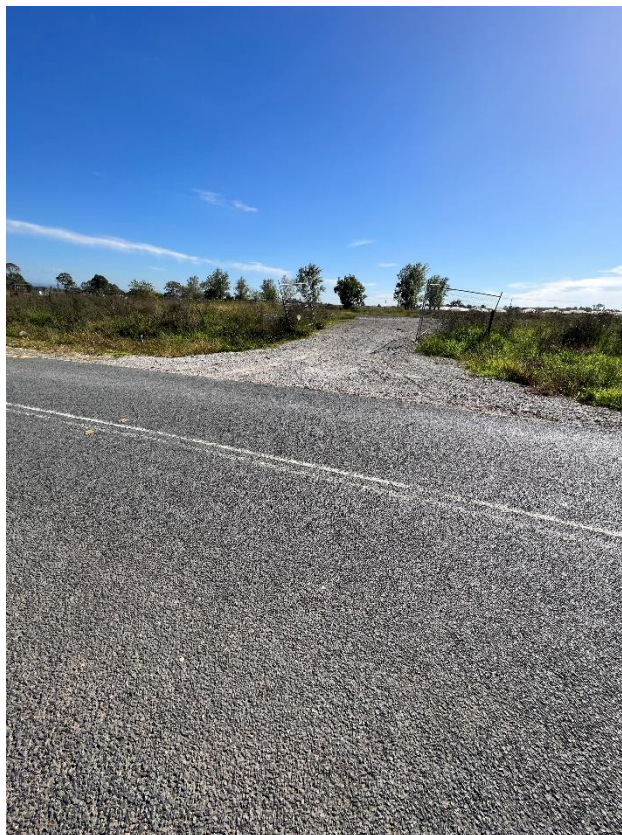
Figure 166 – General condition of the road.

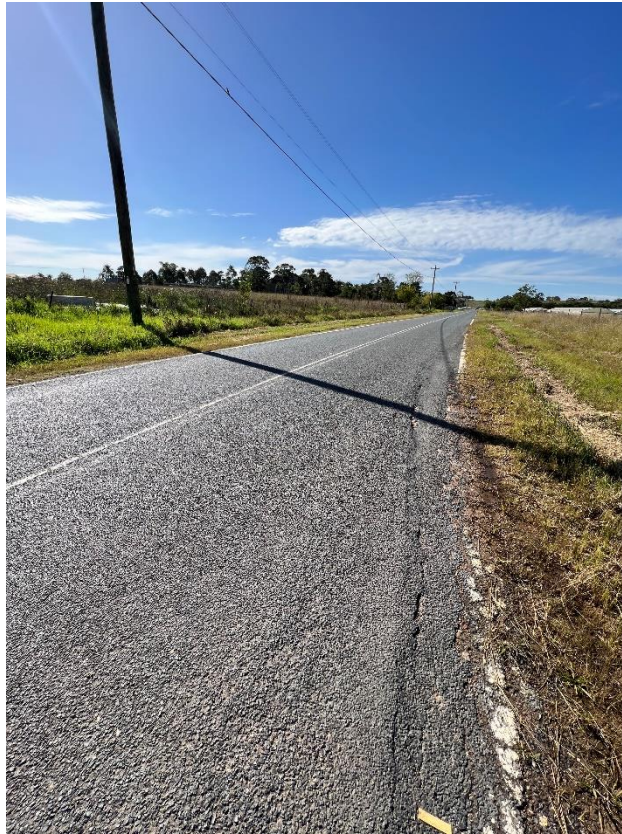
Figure 167 – Crack propagation to the road.

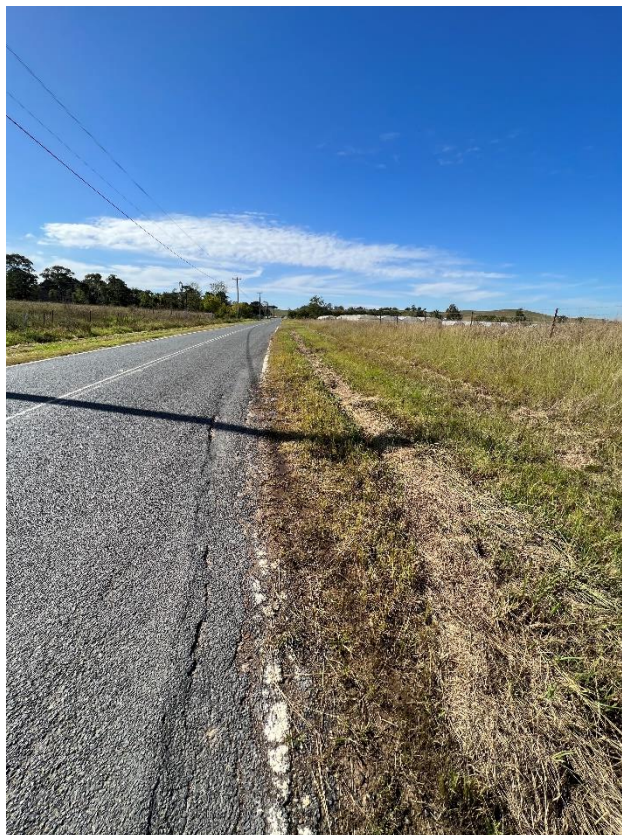
Figure 168 – Crack propagation to the road.

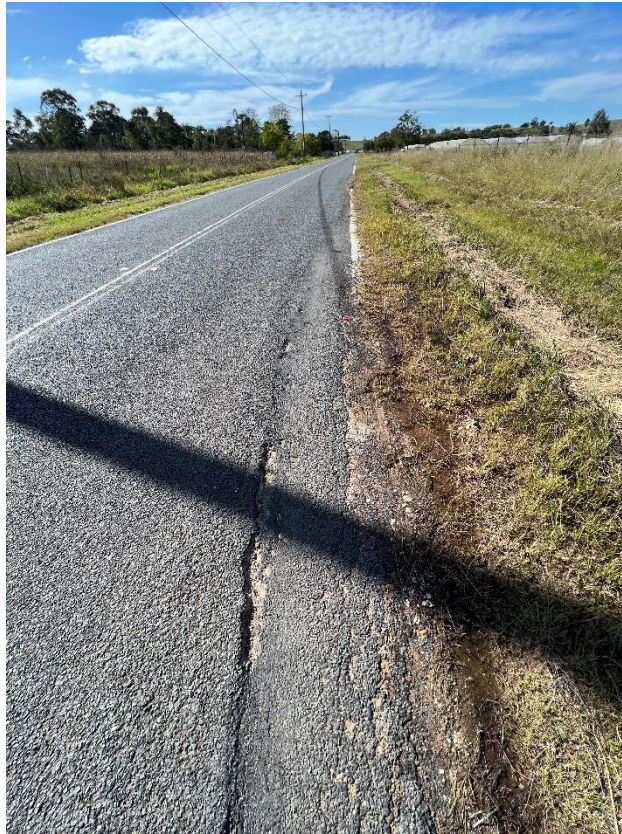
Figure 169 – Crack propagation to the road.

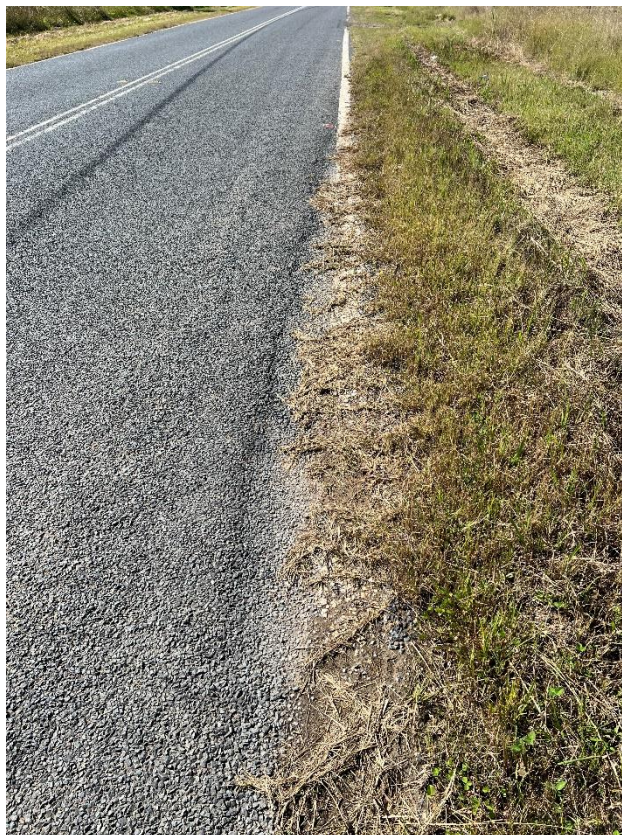
Figure 170 – Crack propagation to the road.

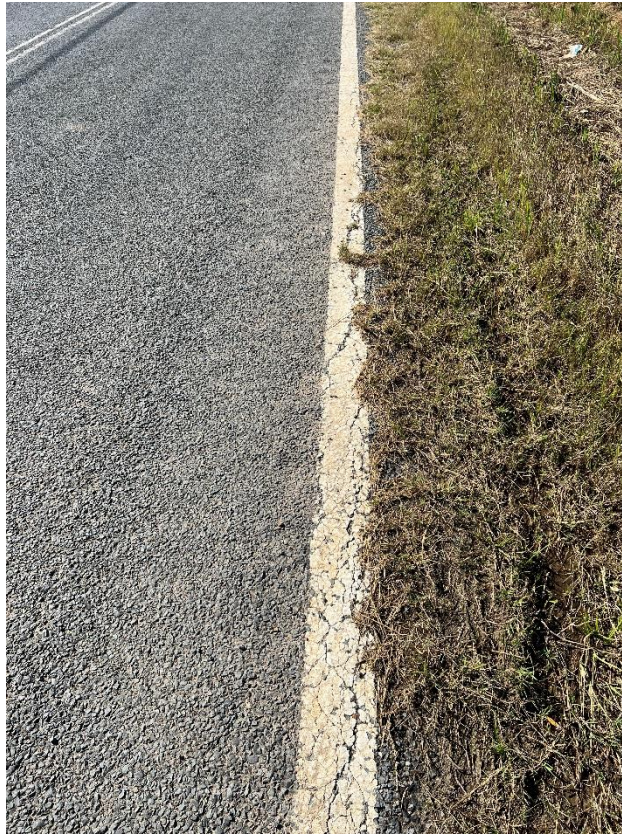
Figure 171 – Crack propagation to the road.

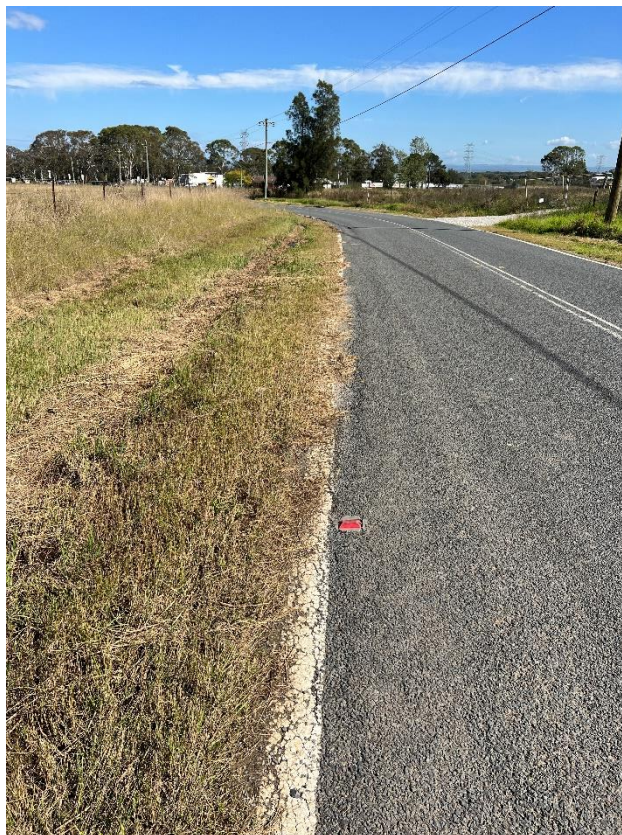
Figure 172 – Crack propagation to the road.

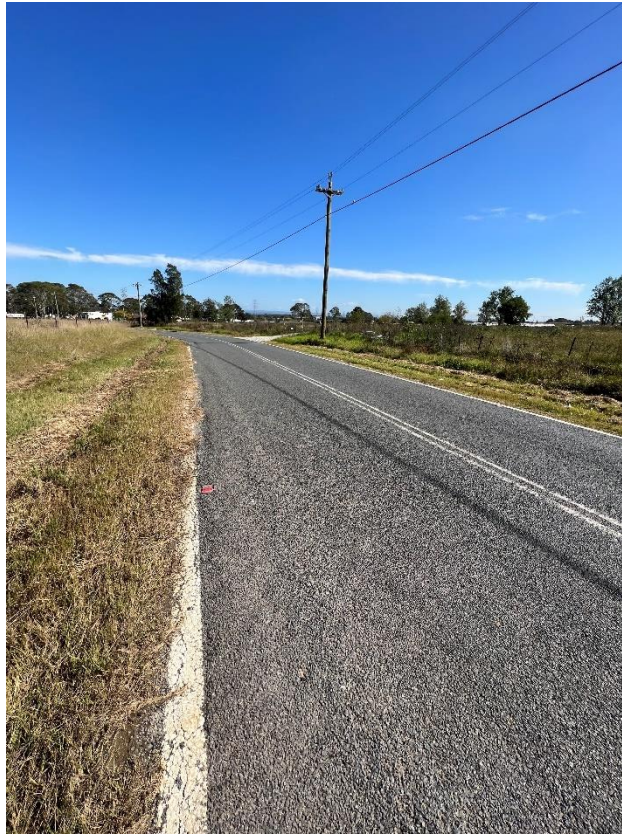
Figure 173 – Crack propagation to the road.

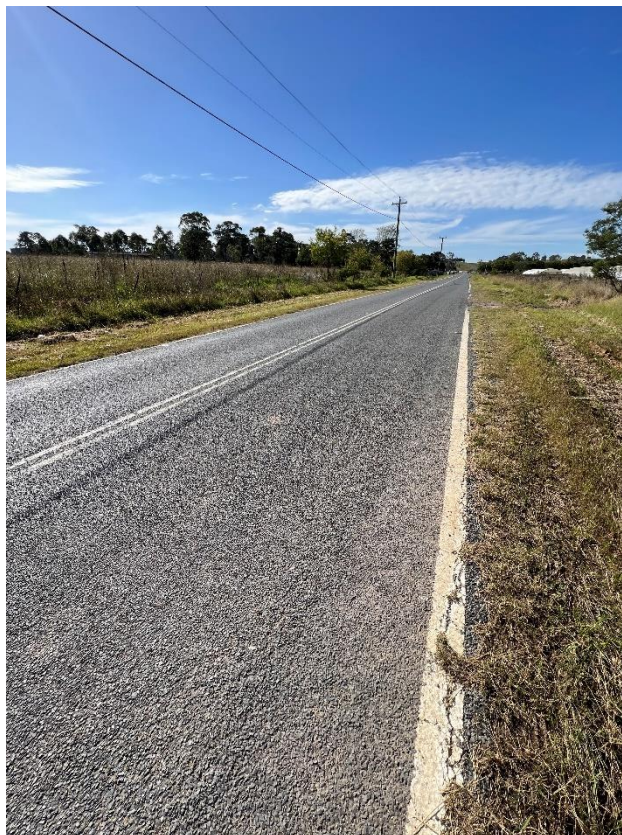
Figure 174 – Crack propagation to the road.

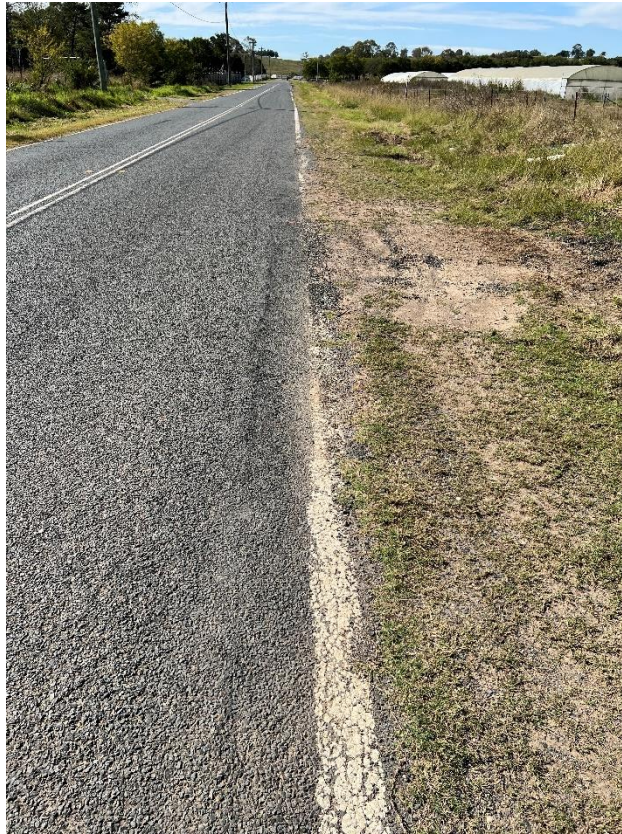
Figure 175 – Crack propagation to the road.

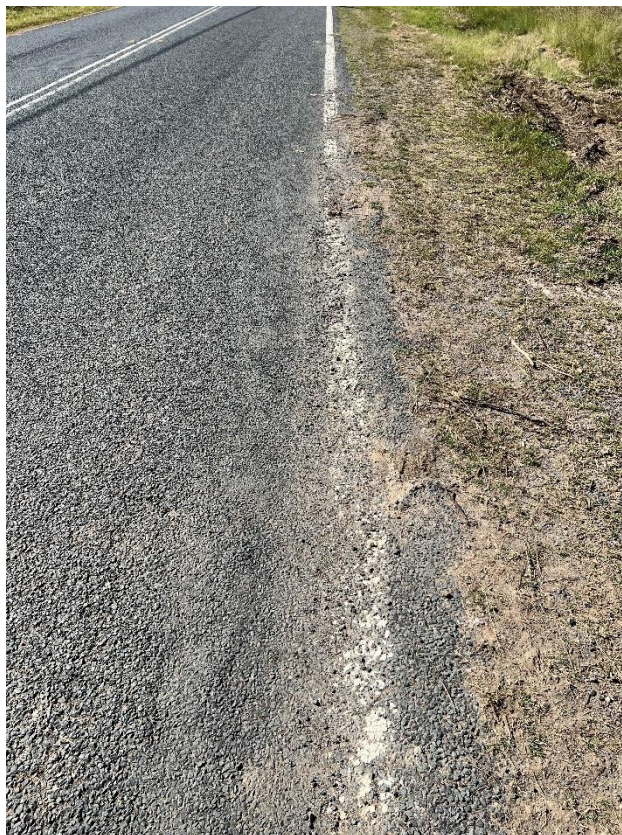
Figure 176 – Crack propagation to the road.

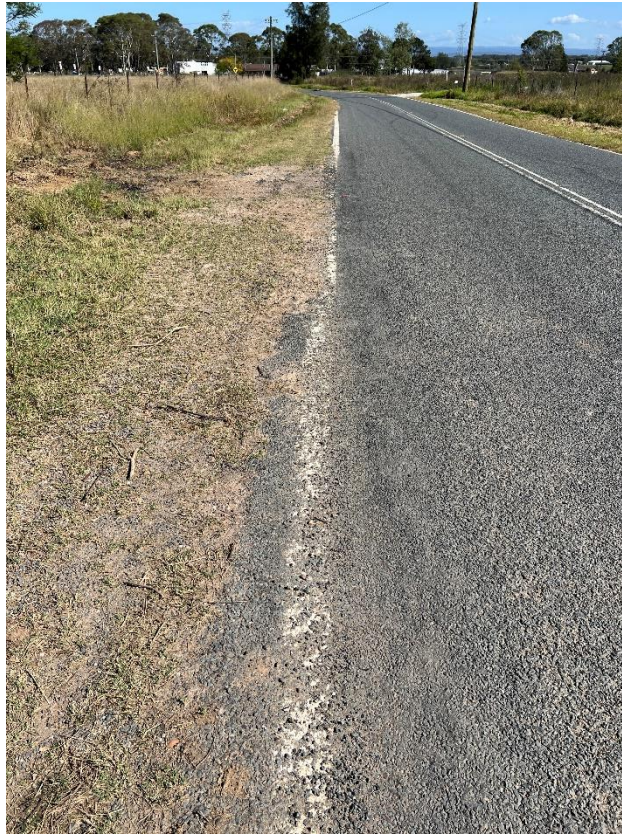
Figure 177 – Crack propagation to the road.

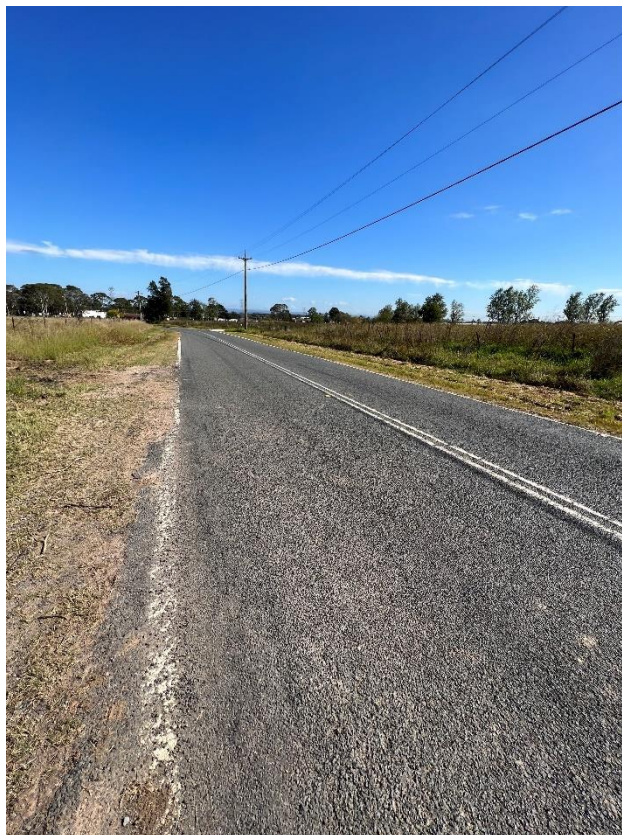
Figure 178 – General condition of the road.

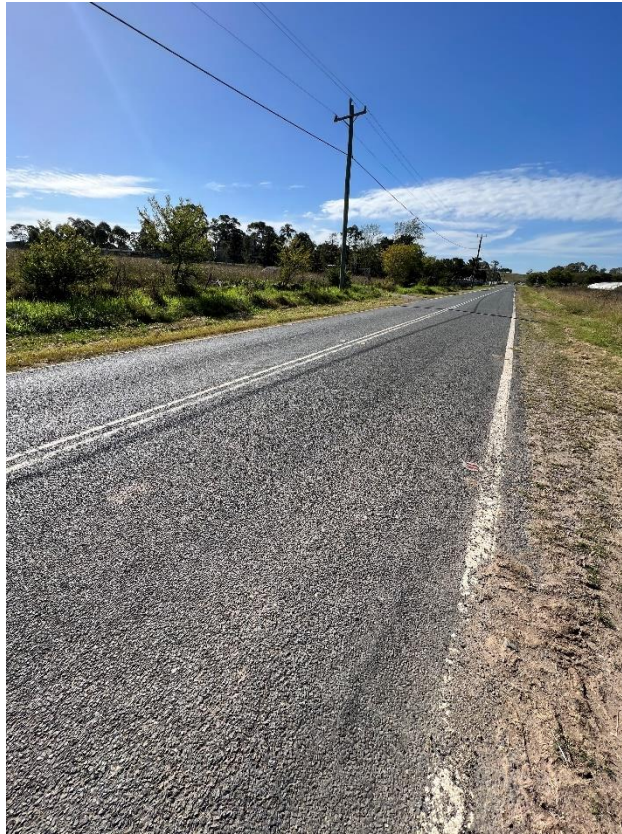
Figure 179 – Crack propagation to the road.

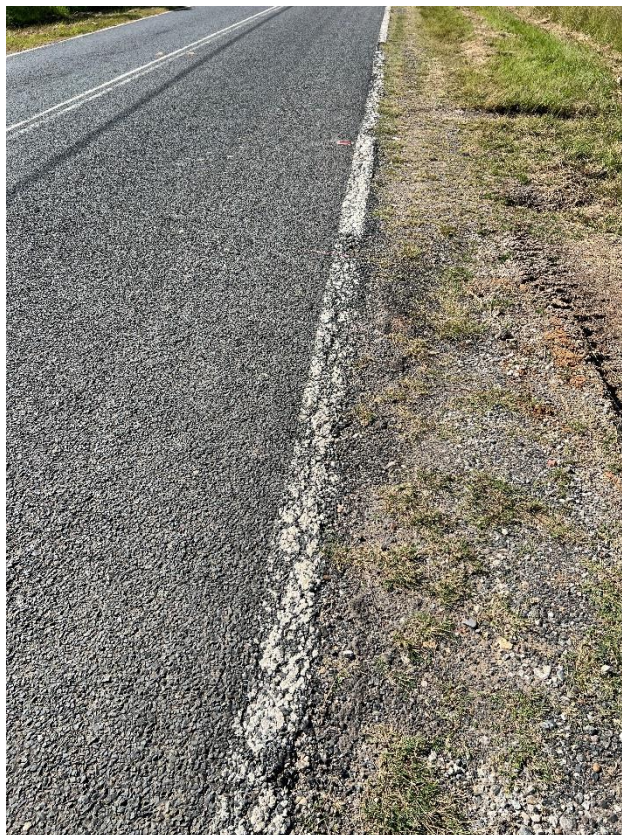
Figure 180 – Crack propagation to the road.

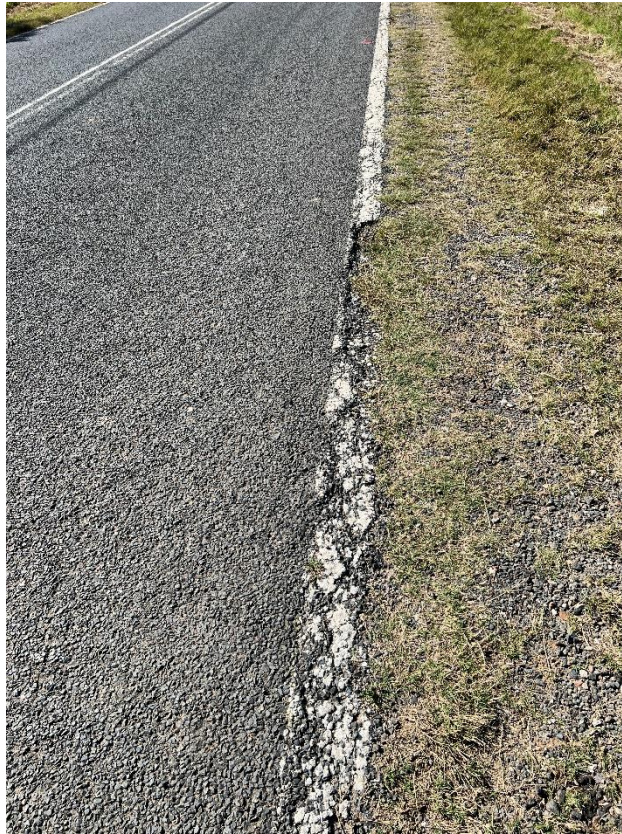
Figure 181 – Crack propagation to the road.

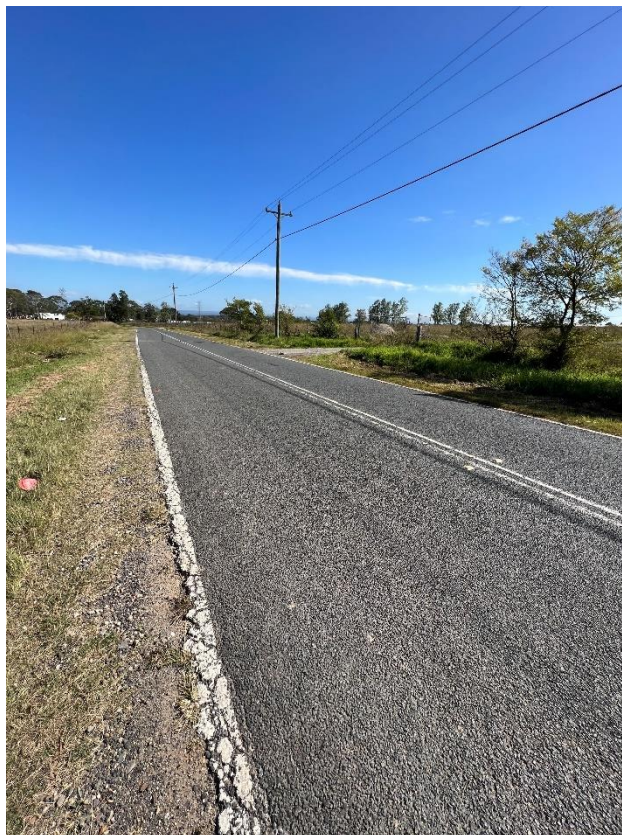
Figure 182 – Crack propagation to the road.

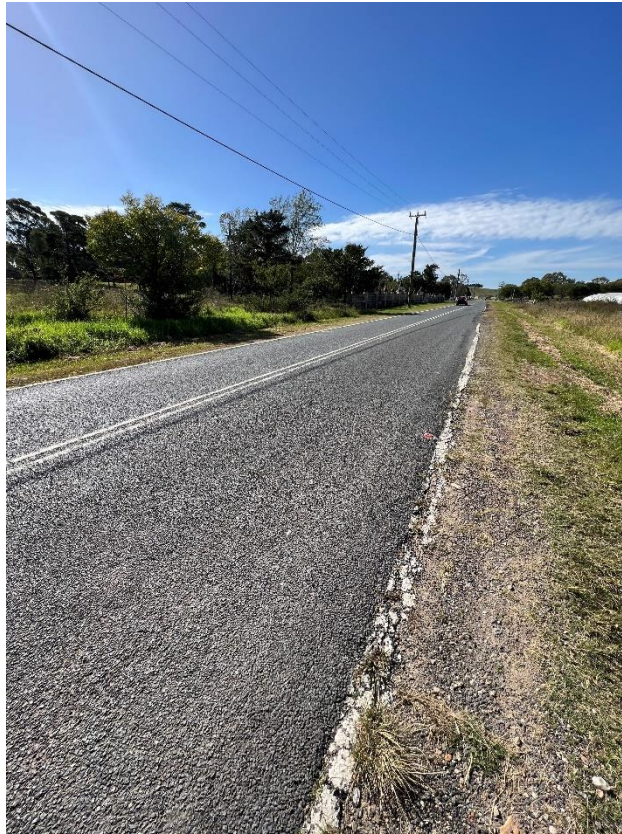
Figure 183 – Crack propagation to the road.

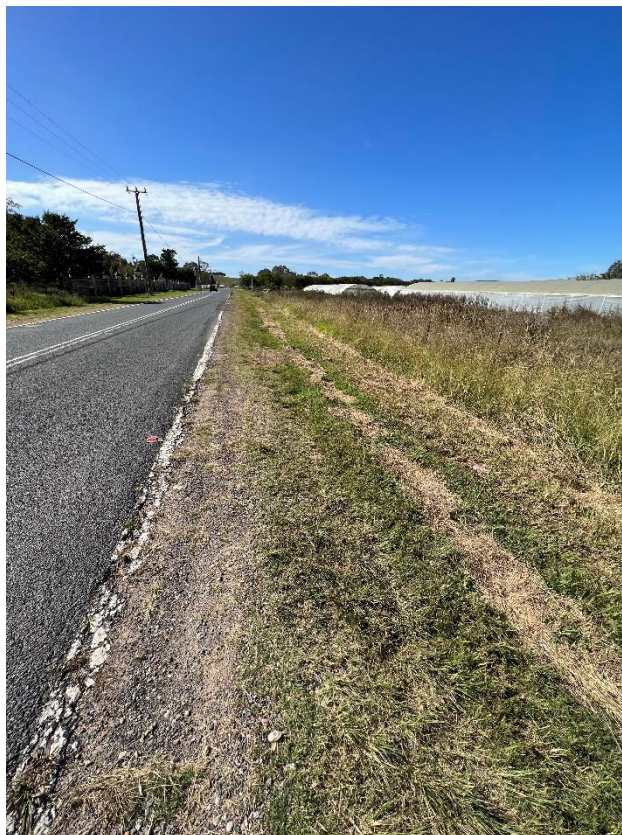
Figure 184 – General condition of the nature strip.

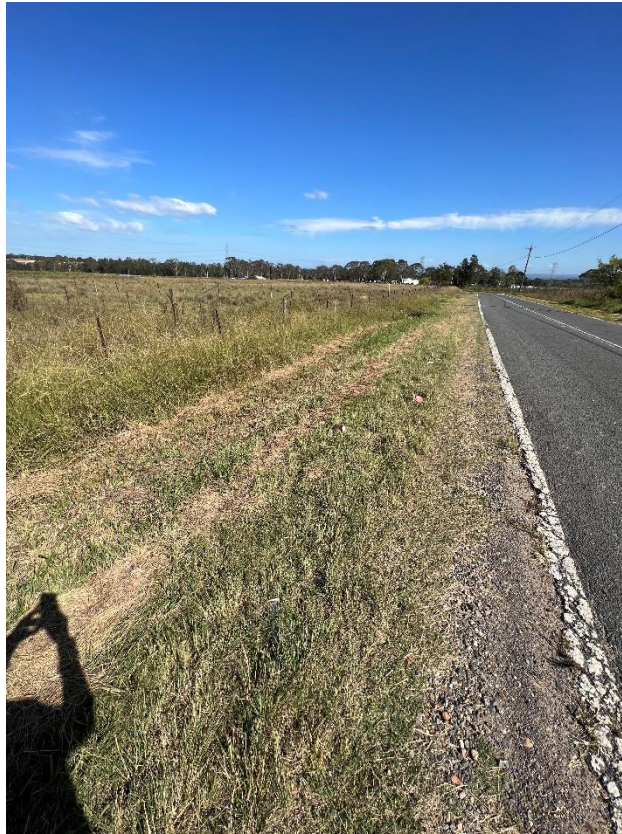
Figure 185 – General condition of the nature strip.

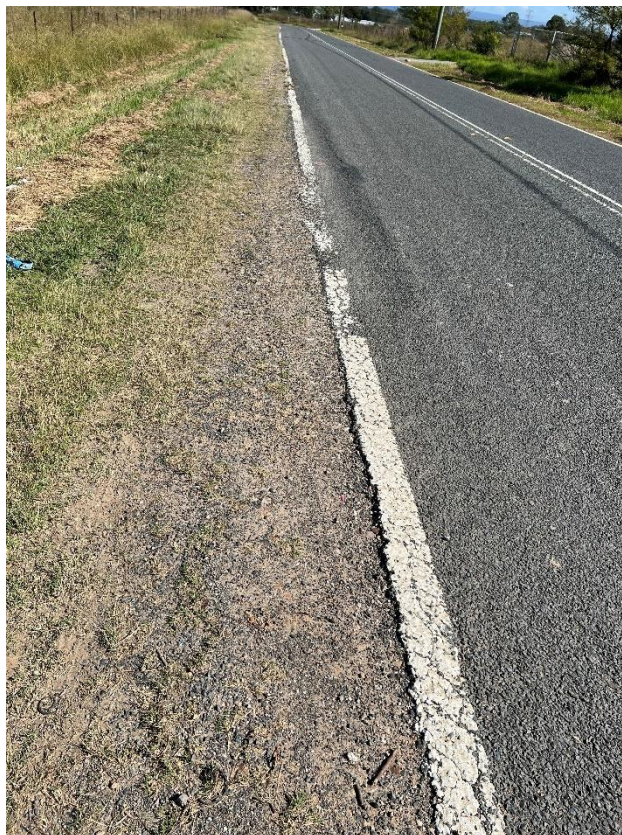
Figure 186 – Crack propagation to the road.

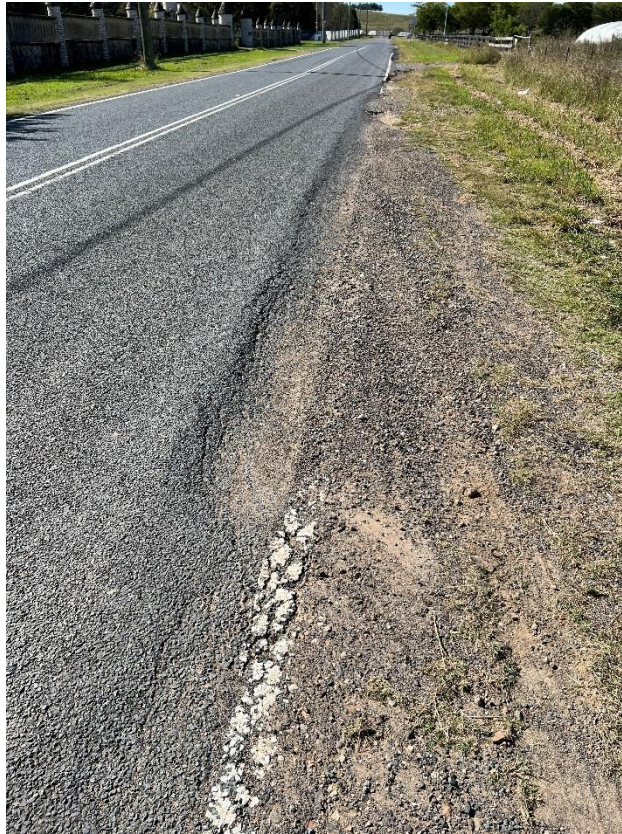
Figure 187 – Crack propagation to the road.

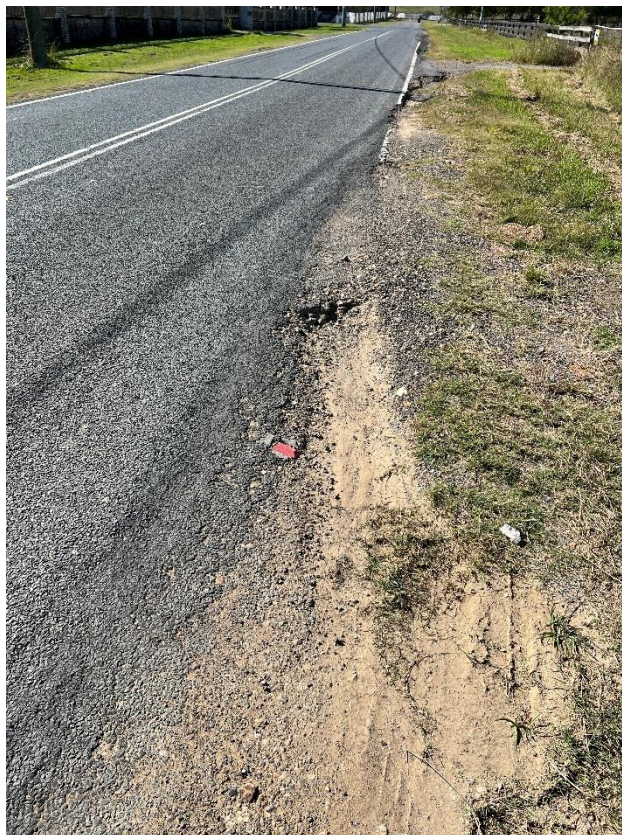
Figure 188 – Crack propagation to the road.

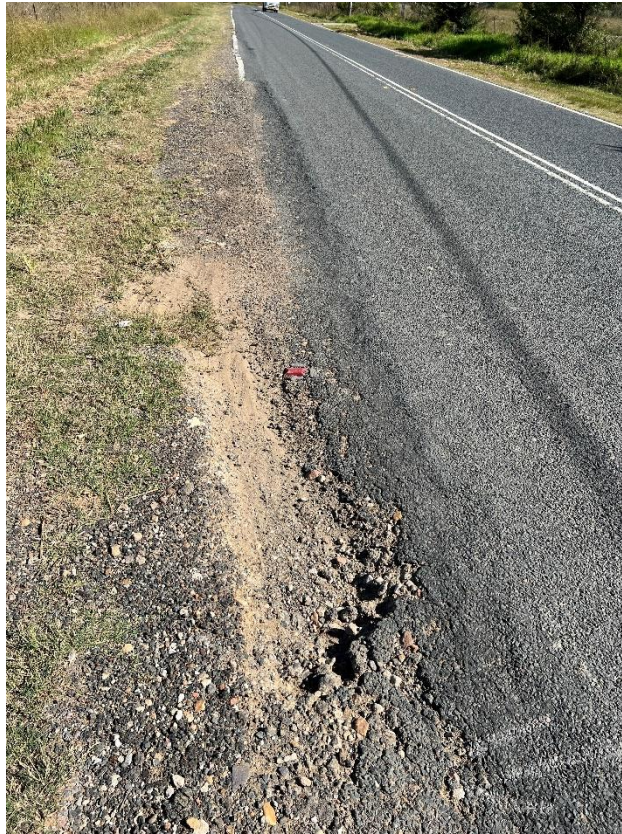
Figure 189 – Crack propagation to the road.

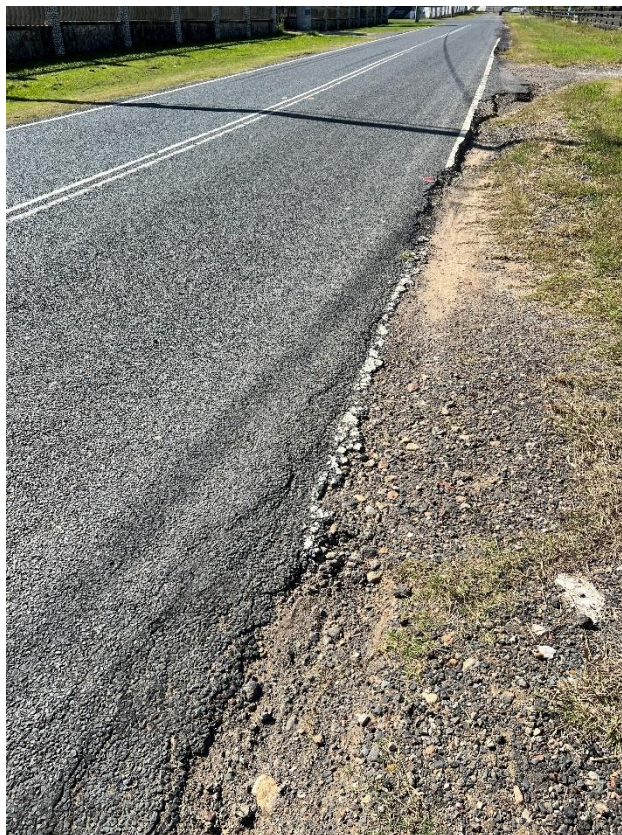
Figure 190 – Crack propagation to the road.

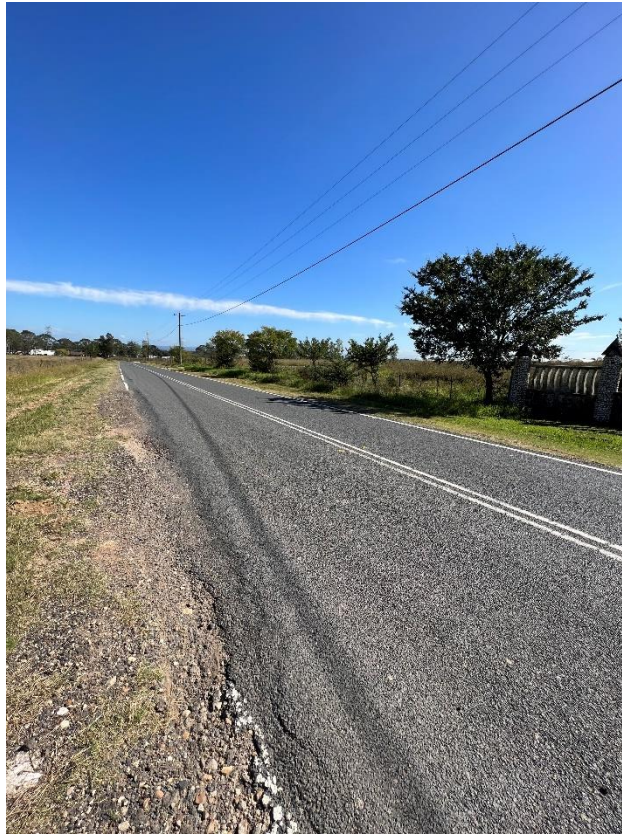
Figure 191 – Crack propagation to the road.

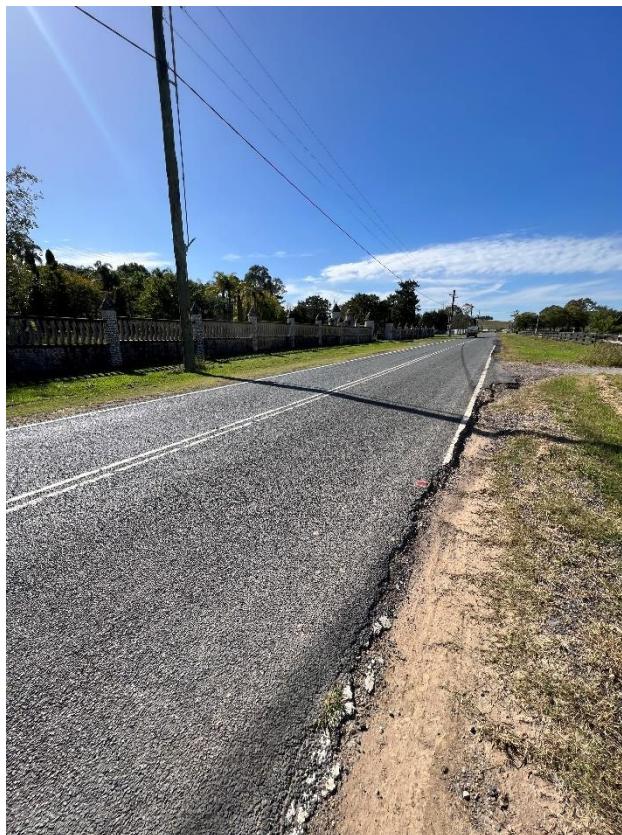
Figure 192 – Crack propagation to the road.

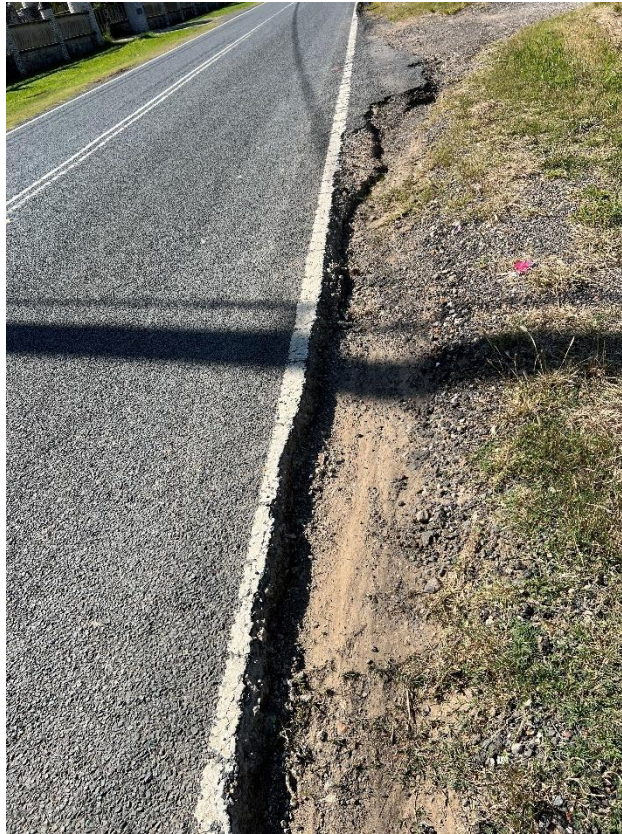
Figure 193 – Crack propagation to the road.

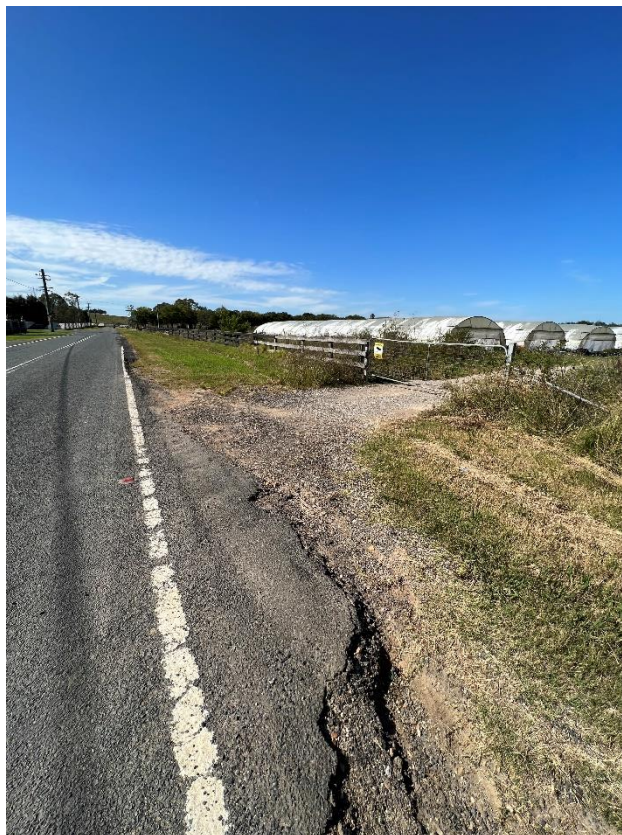
Figure 194 – Crack propagation to the road.

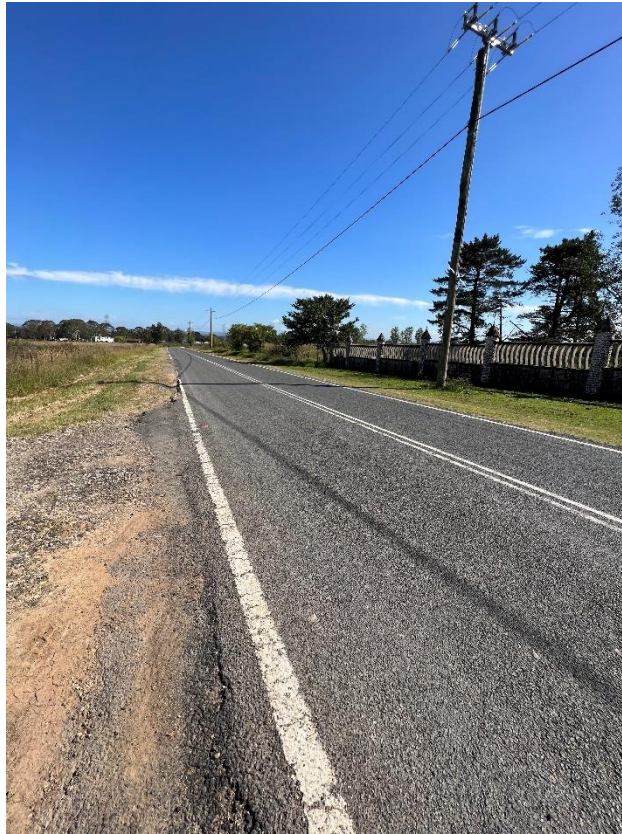
Figure 195 – General condition of the road.

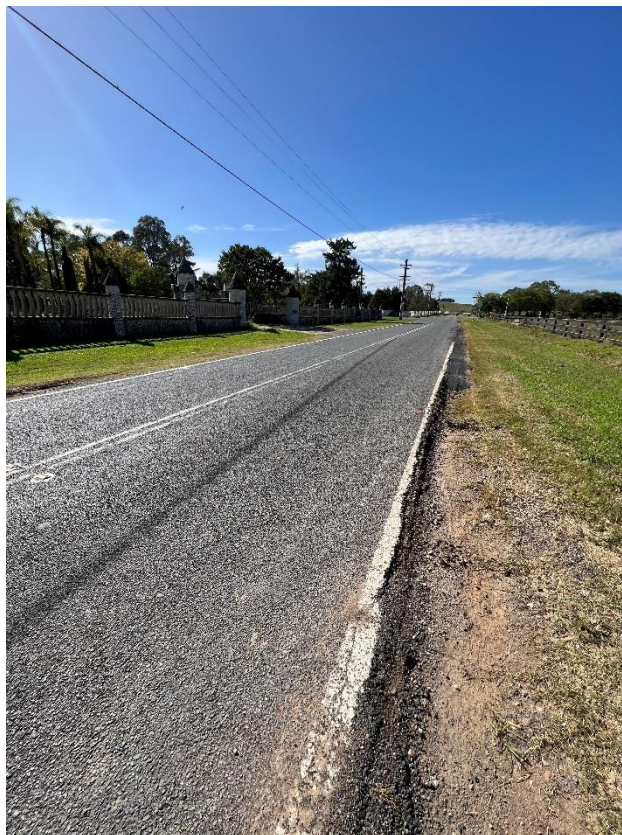
Figure 196 – Crack propagation to the road.

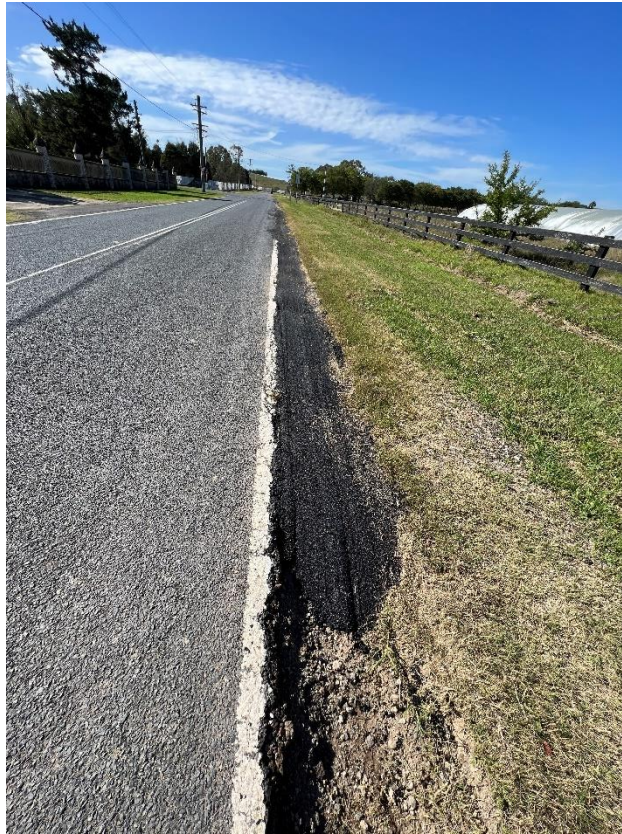
Figure 197 – Crack propagation to the road.

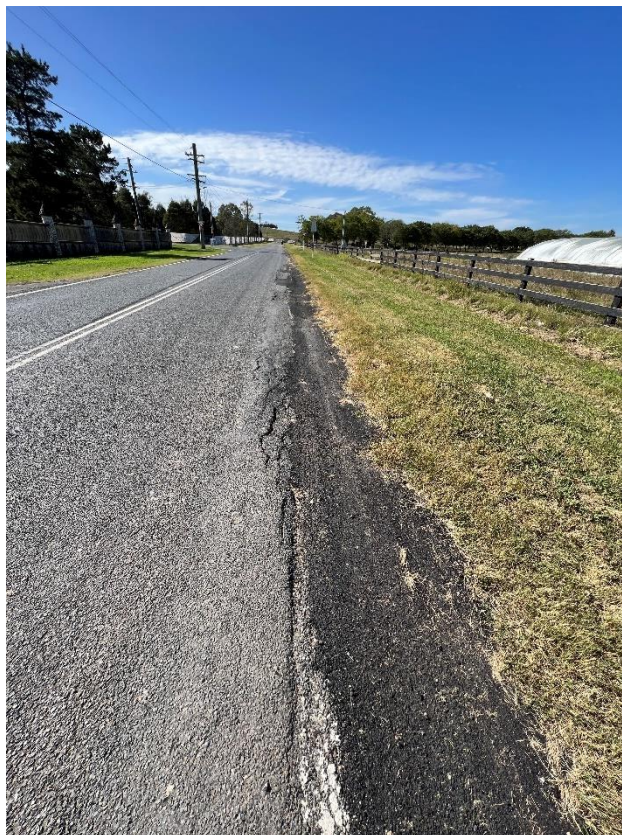
Figure 198 – Crack propagation to the road.

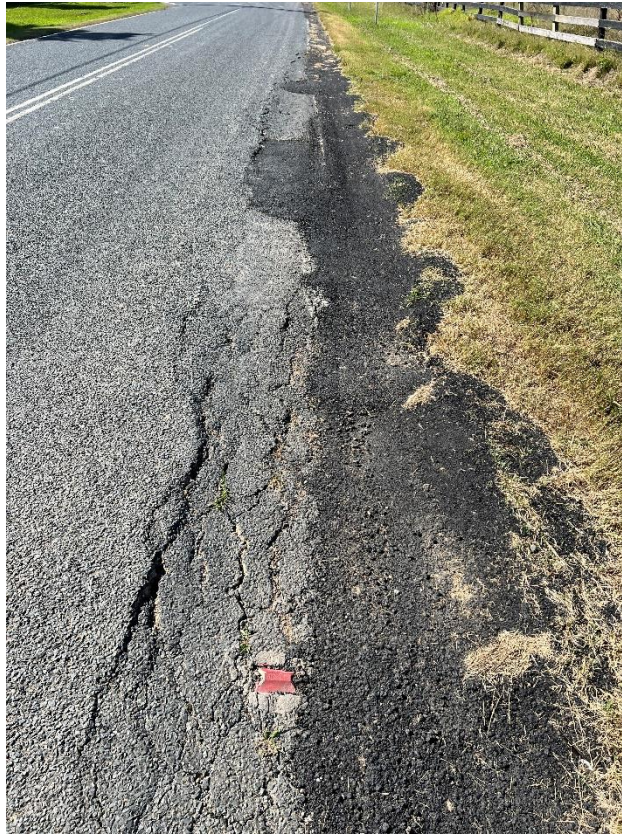
Figure 199 – Crack propagation to the road.

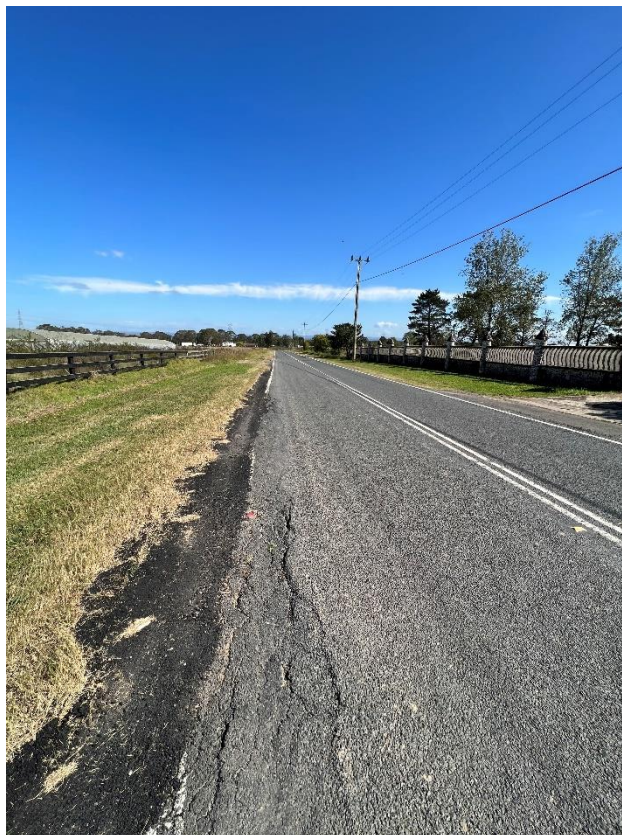
Figure 200 – Crack propagation to the road.

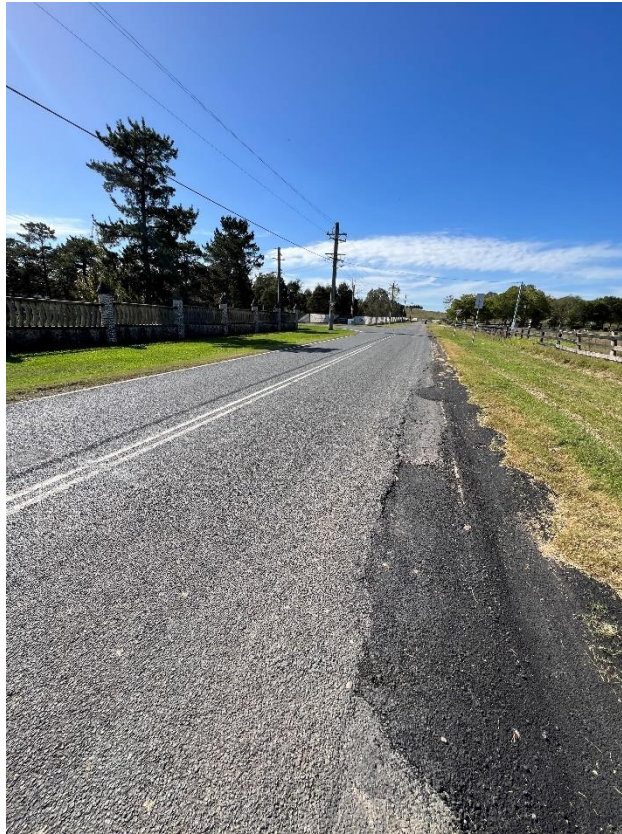
Figure 201 – Crack propagation to the road.

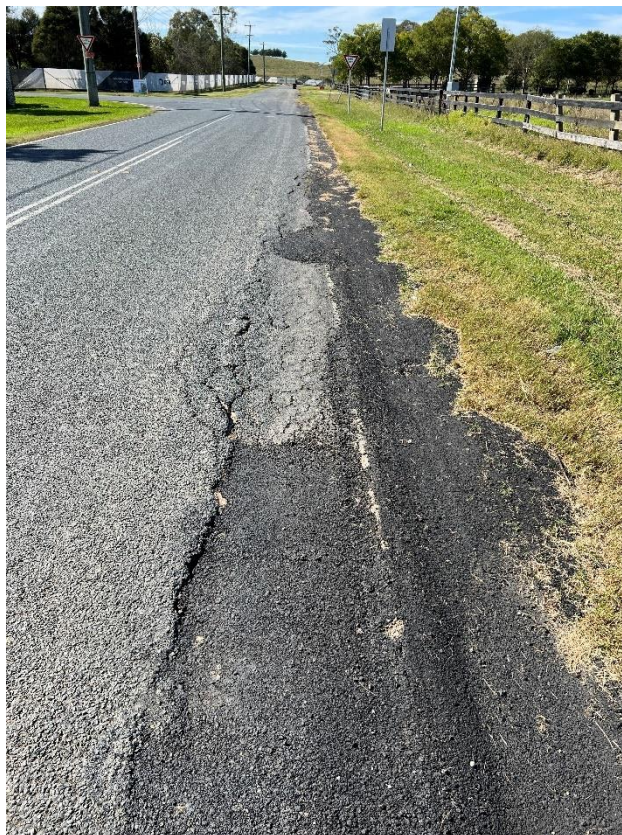
Figure 202 – Crack propagation to the road.
