DILAPIDATION REPORT

Abbotts Road, Kemps Creek

Prepared by: Rezoning Pty Ltd t/as Effective Building & Consultancy

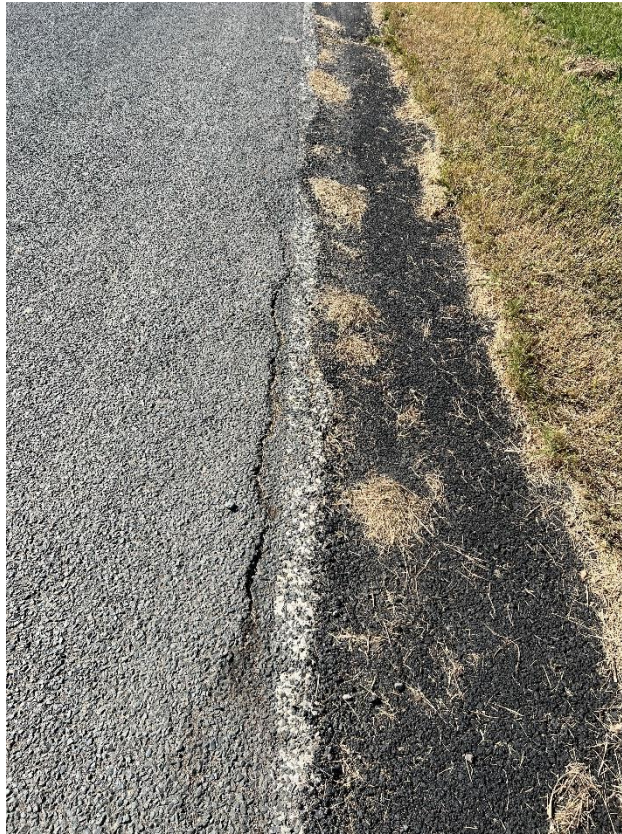
Figure 203 – Crack propagation to the road.

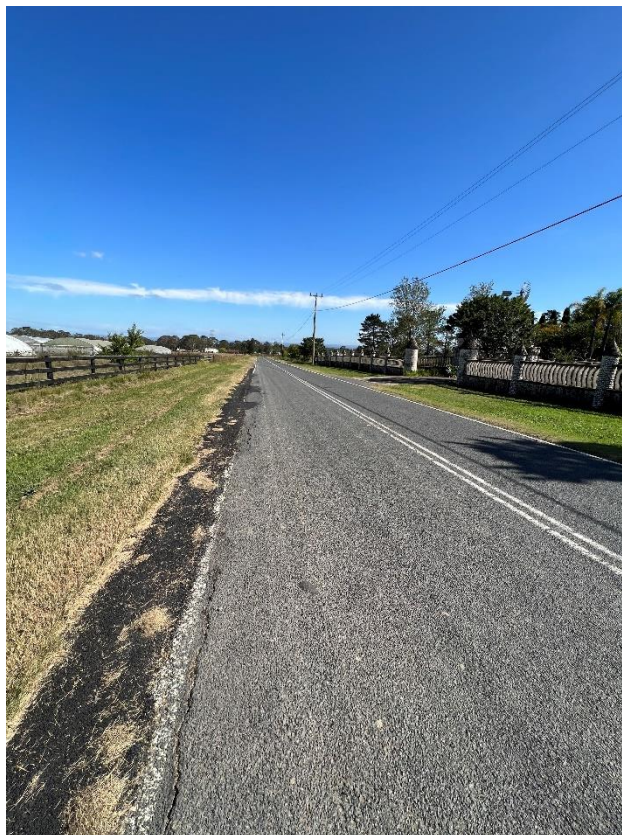
Figure 204 – Crack propagation to the road.

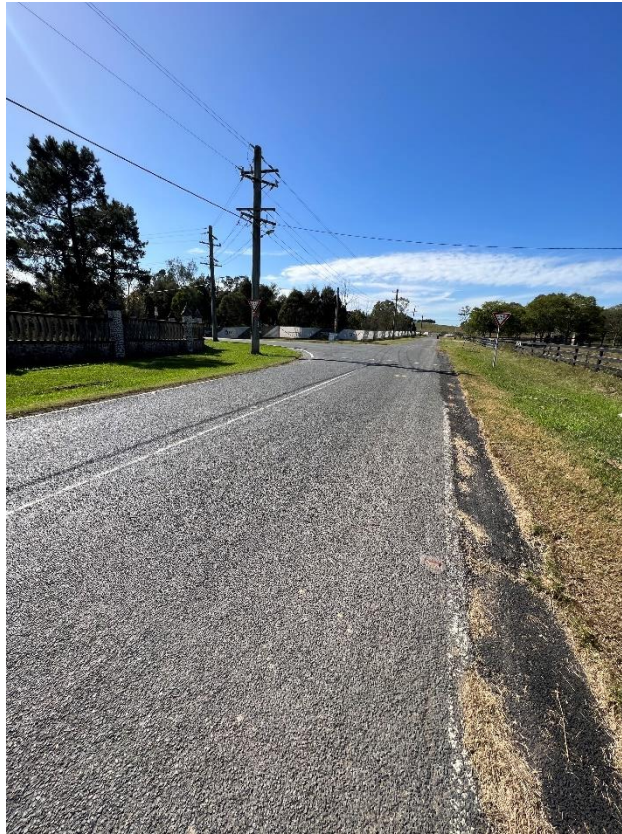
Figure 205 – Crack propagation to the road.

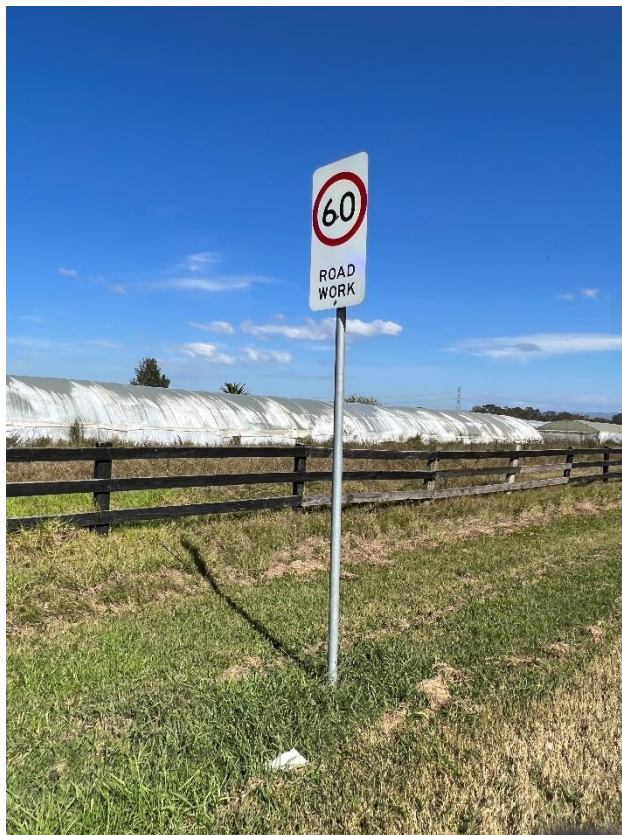
Figure 206 – General condition of the street signpost.

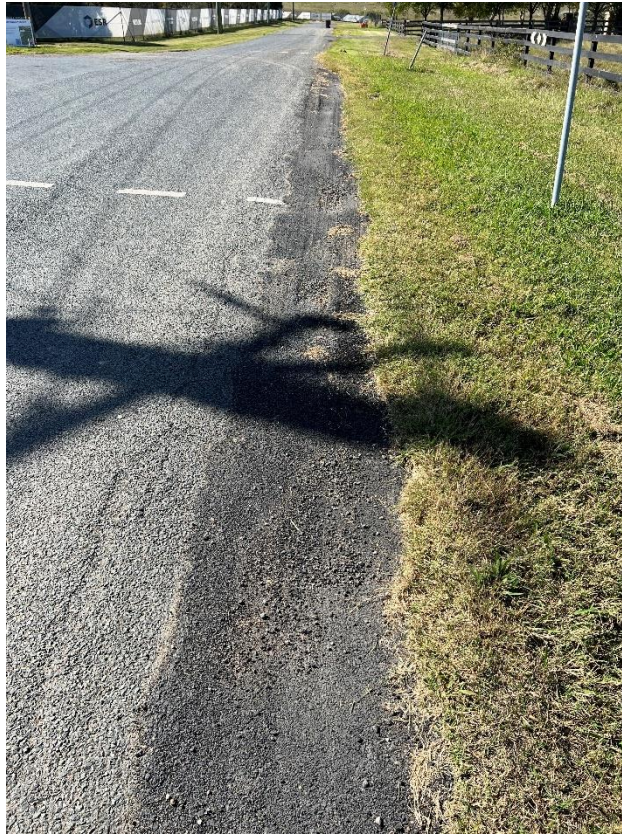
Figure 207 – Crack propagation to the road.

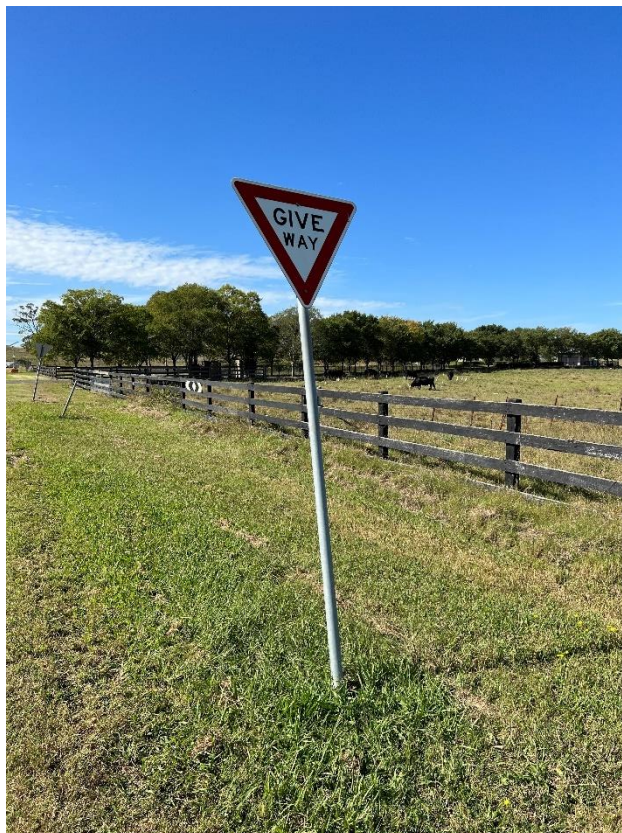
Figure 208 – General condition of the street signpost.

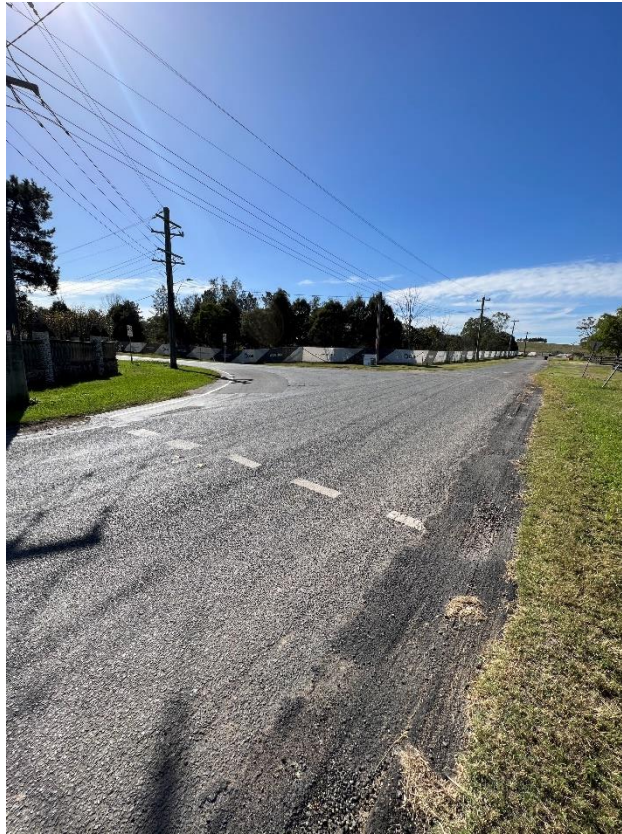
Figure 209 – Crack propagation to the road.

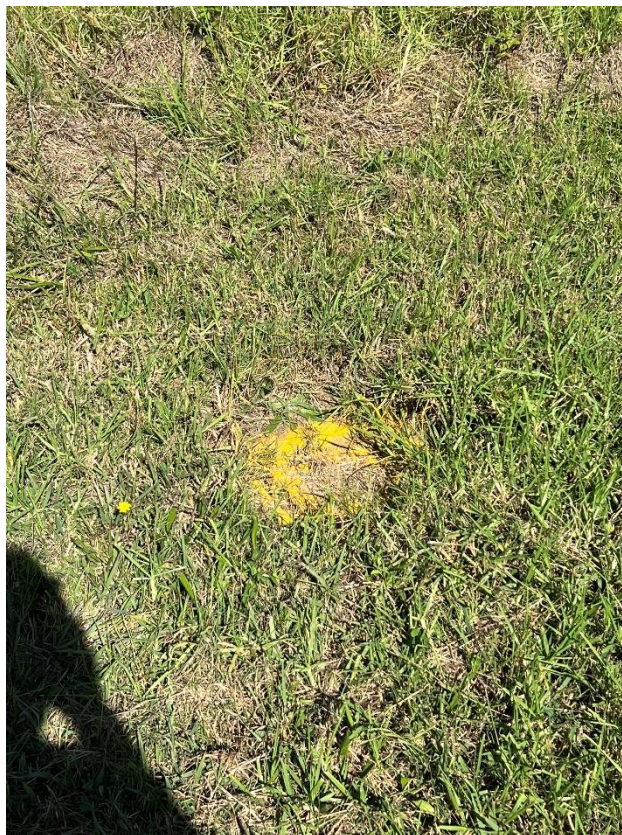
Figure 210 – General condition of the utility lid.

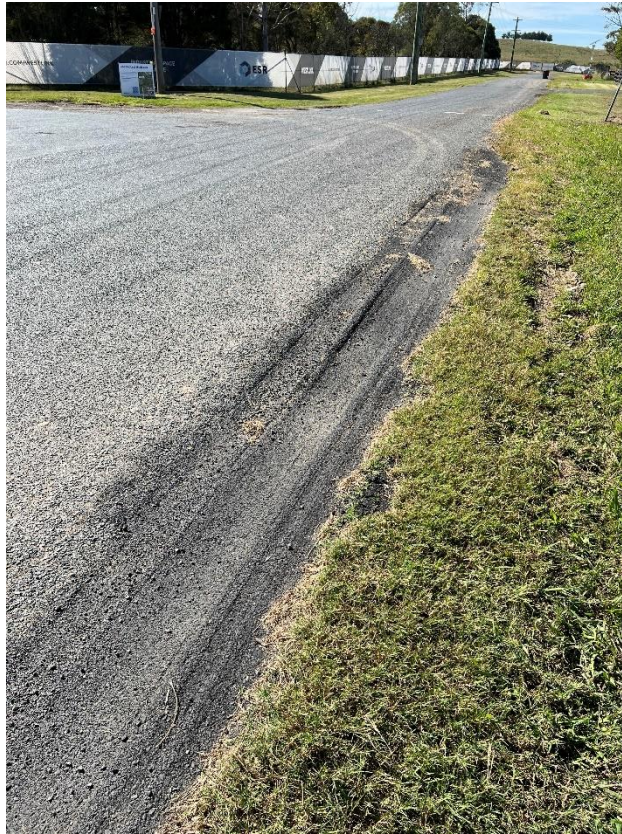
Figure 211 – Crack propagation to the road.

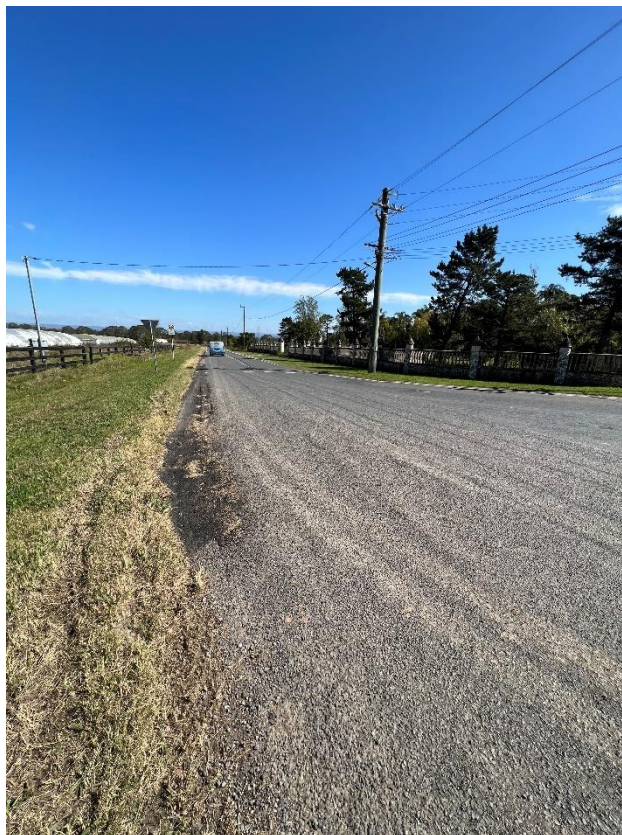
Figure 212 – Crack propagation to the road.

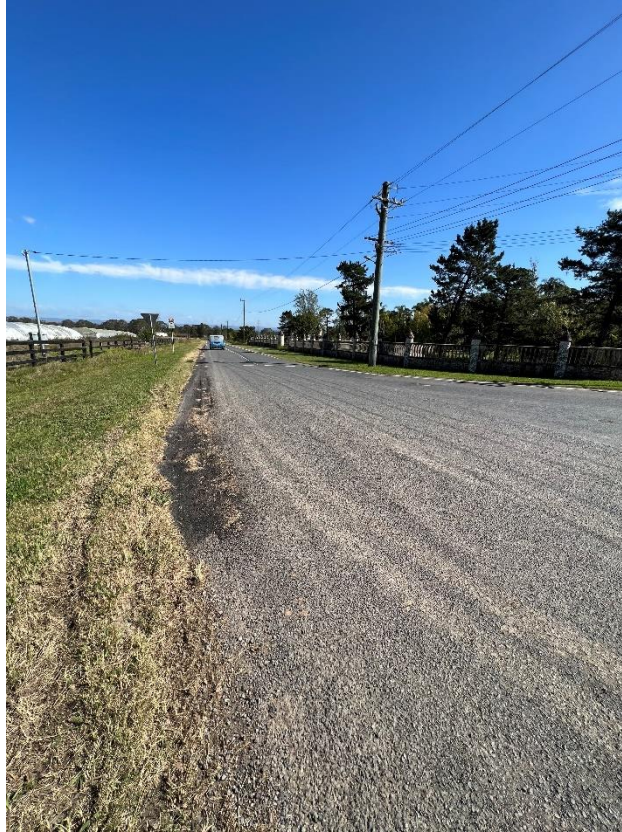
Figure 213 – Crack propagation to the road.

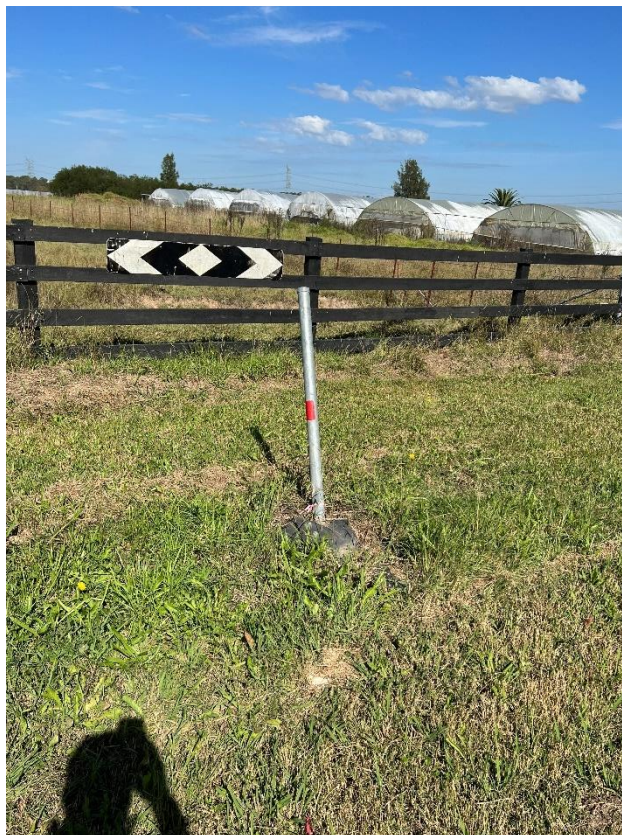
Figure 214 – General condition of the bollards.

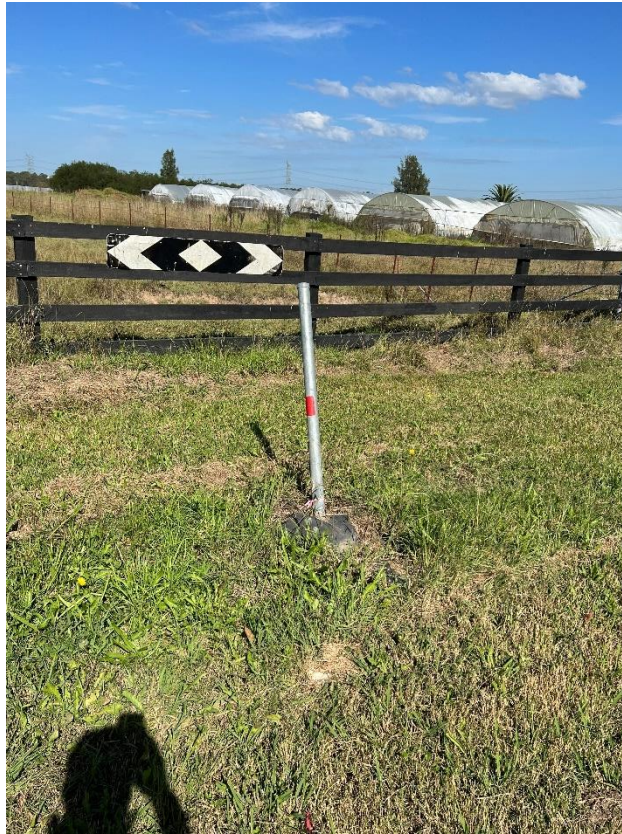
Figure 215 – General condition of the bollards/nature strip.
